# **PAVEMENT ASSESSMENT REPORT**

## **COLLECTOR RD – BETWEEN FEDERAL HWY AND BARINA QUARRY**

### **COLLECTOR FOR COLLECTOR RESOURCES**

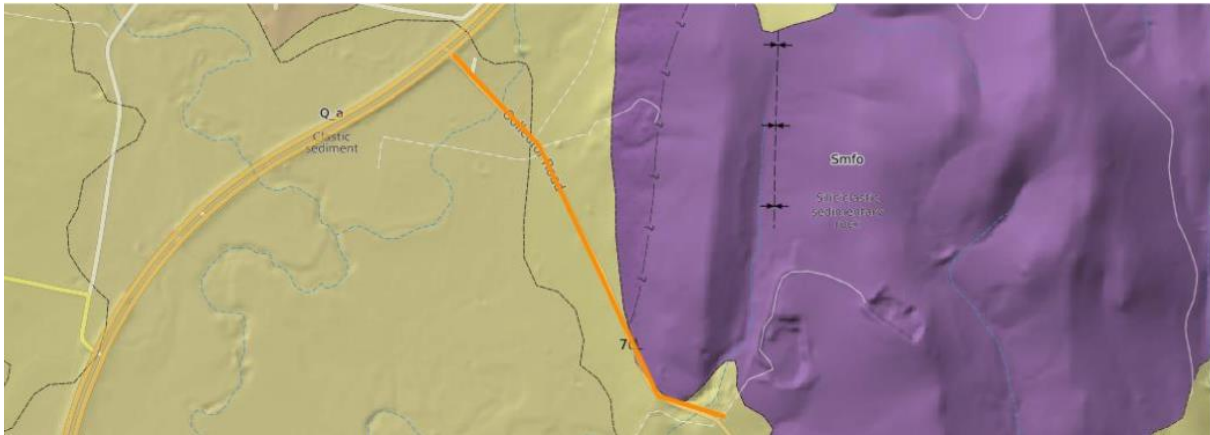
Figure 2-1 Extract of the NSW Seamless Geological Extent

An extract of the NSW seamless geological map below presents the above geological units, with the approximate site extents shown in orange.

Further, the site crosses Collector Creek at two locations, near the intersection of the Federal Highway, and the quarry entrance (shown in blue).

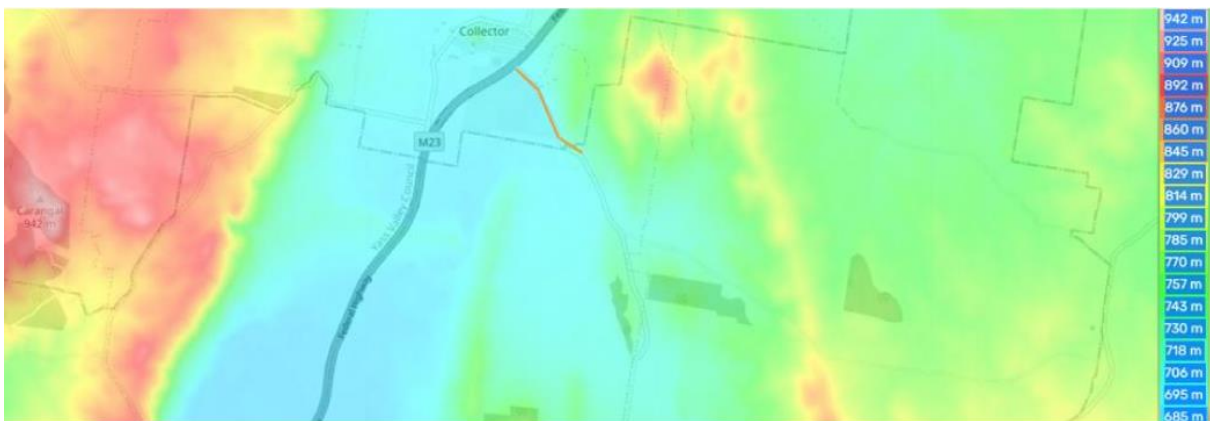
Figure 2-2 Extract of Published Topographic Information, with approximate site extents in orange

Published topographical information (shown in Figure 2-2 below), indicates the site follows locally lower terrain, with topographic highs to the northeast and west, beyond the site extents.
