FABRIC SURVEY

St. John of God Hospital
No. 177 Grose Vale Road, Richmond
November 2021| J3780

**Weir
Phillips**
Heritage
and Planning

FABRIC SURVEY: Belmont House, St. John of God Richmond Hospital
Hexagonal stone storage building

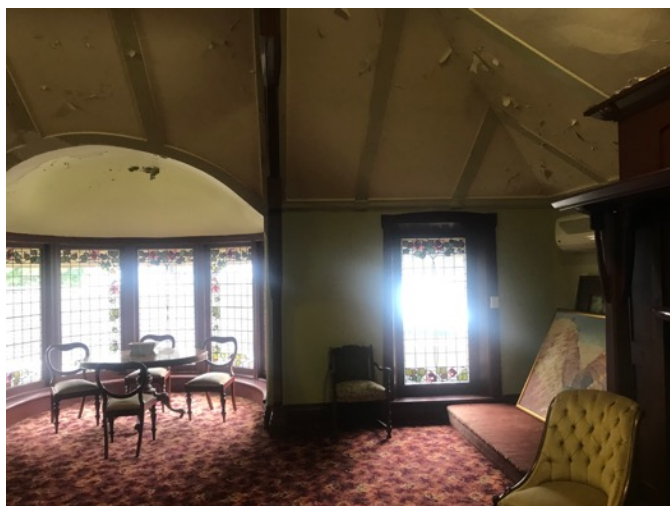
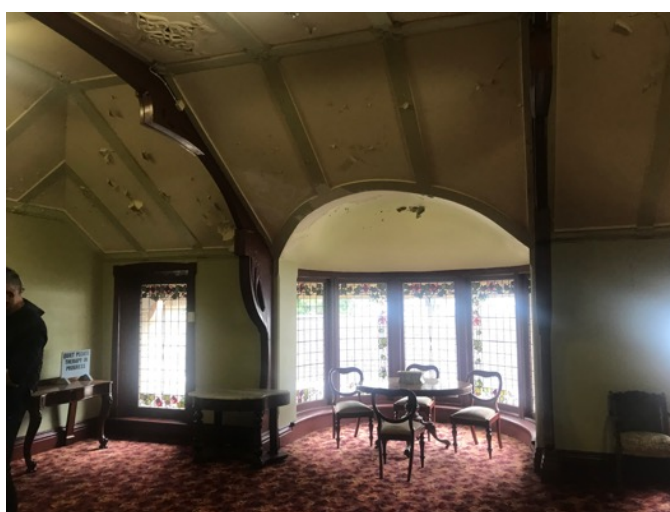
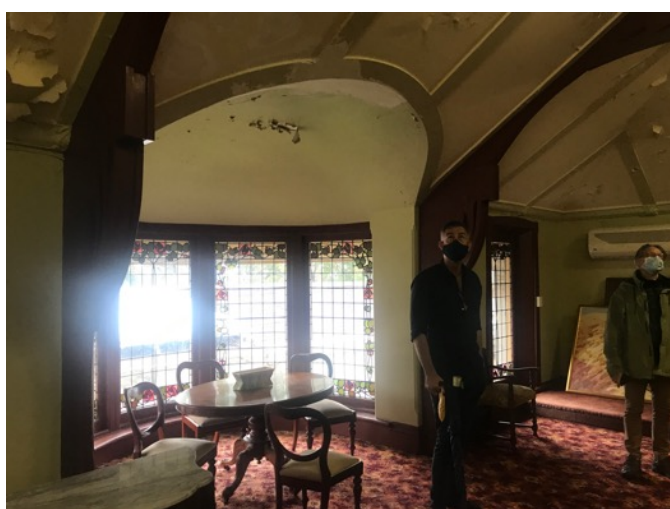
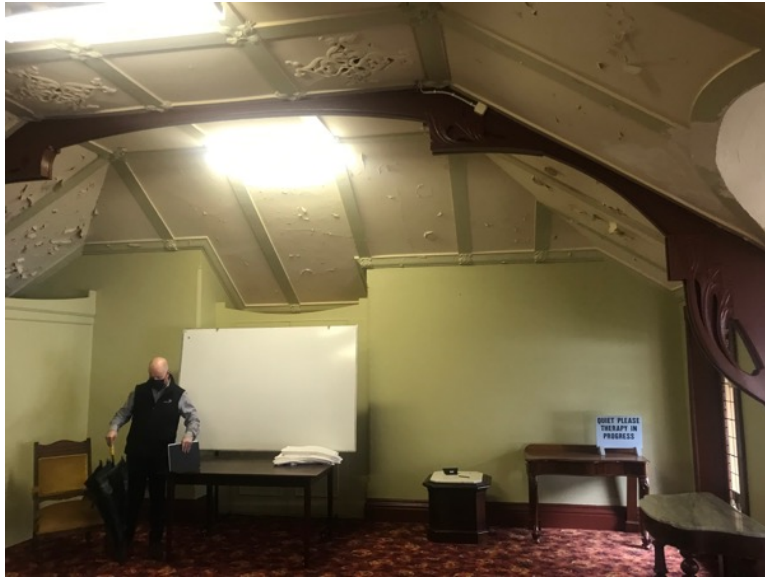
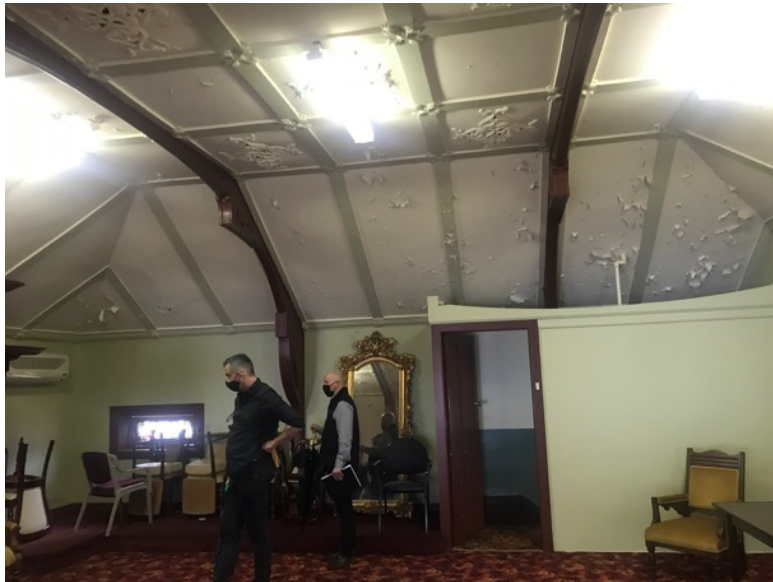
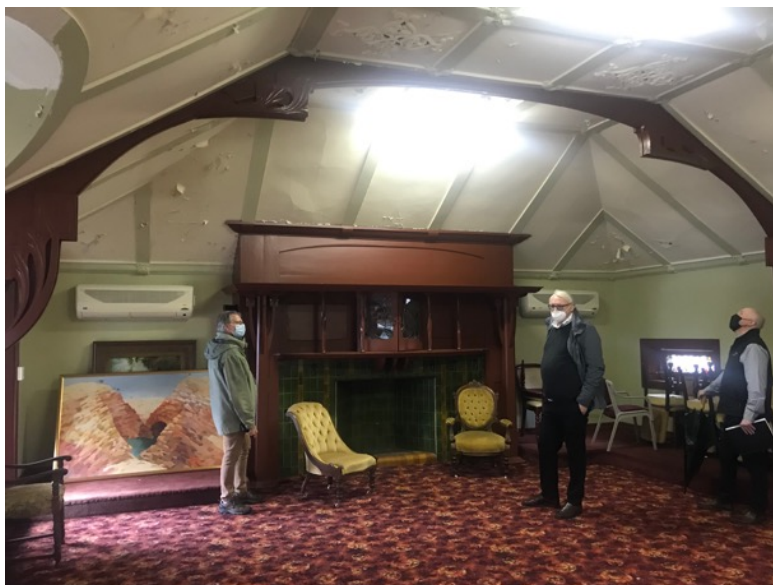
FABRIC SURVEY: Belmont House, St. John of God Richmond Hospital First Floor Grenada Room	
ELEMENT	COMMENT
Ceiling	Original ceiling with timber battens. Plaster ceiling rose details between battens.
Cornice	Timber batten.
Architrave & Skirting	Original timber architraves. Original timber skirting.
Floor	Contemporary carpet over timber floorboards. Step up in wall adjacent stair and fireplace.
Walls	Render and paint over masonry. Flaking paint. Minor plaster repairs visible.
Windows	Original timber framed circular fixed leadlight windows. Awning leadlight window.
Doors	Contemporary passage door.
Fireplace	Original tiles fireplace and hearth with surrounding painted timber mantel and wall joinery.
Joinery	2 Decorative timber arches within the room. Timber enclosure and door around stair
Other Notes	Air conditioning unit mounted on fireplace wall.

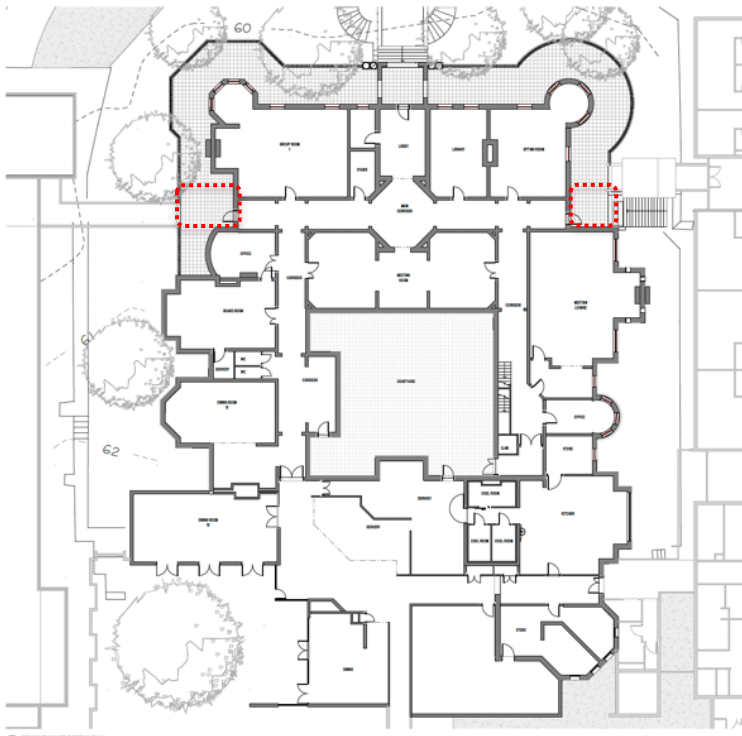
Figure 50: EXISTING GROUND FLOOR PLAN. Verandah balustrade restoration. outlined in red.

ELEMENT	COMMENT
Stone Handrail	Handrail cut to enable connection to contemporary ramp.
Painted concrete Balusters	Some concrete balusters have been removed to enable connection to contemporary ramp.
Mosaic tiled verandah Floor	The mosaic tile floor adjacent to the contemporary ramp has been covered over with a concrete screed.
Verandah Ceiling	Timber lined tongue n groove ceiling boards.
Fireplace	Rendered and chimney with curved staff moulds on the corners.
Other Notes	Contemporary lighting and hardware unless otherwise noted.
