## **Geotechnical Assessment Report**

**200 Aldington Rd, Kemps Creek, NSW 2178**  
**Dam Walls Stability Analysis**

**Prepared for: Fife Kemps Creek Ltd**

A201021.1725.03.v1f\_200 Aldington Rd\_Dam Stability\_JP | 21.03.2022

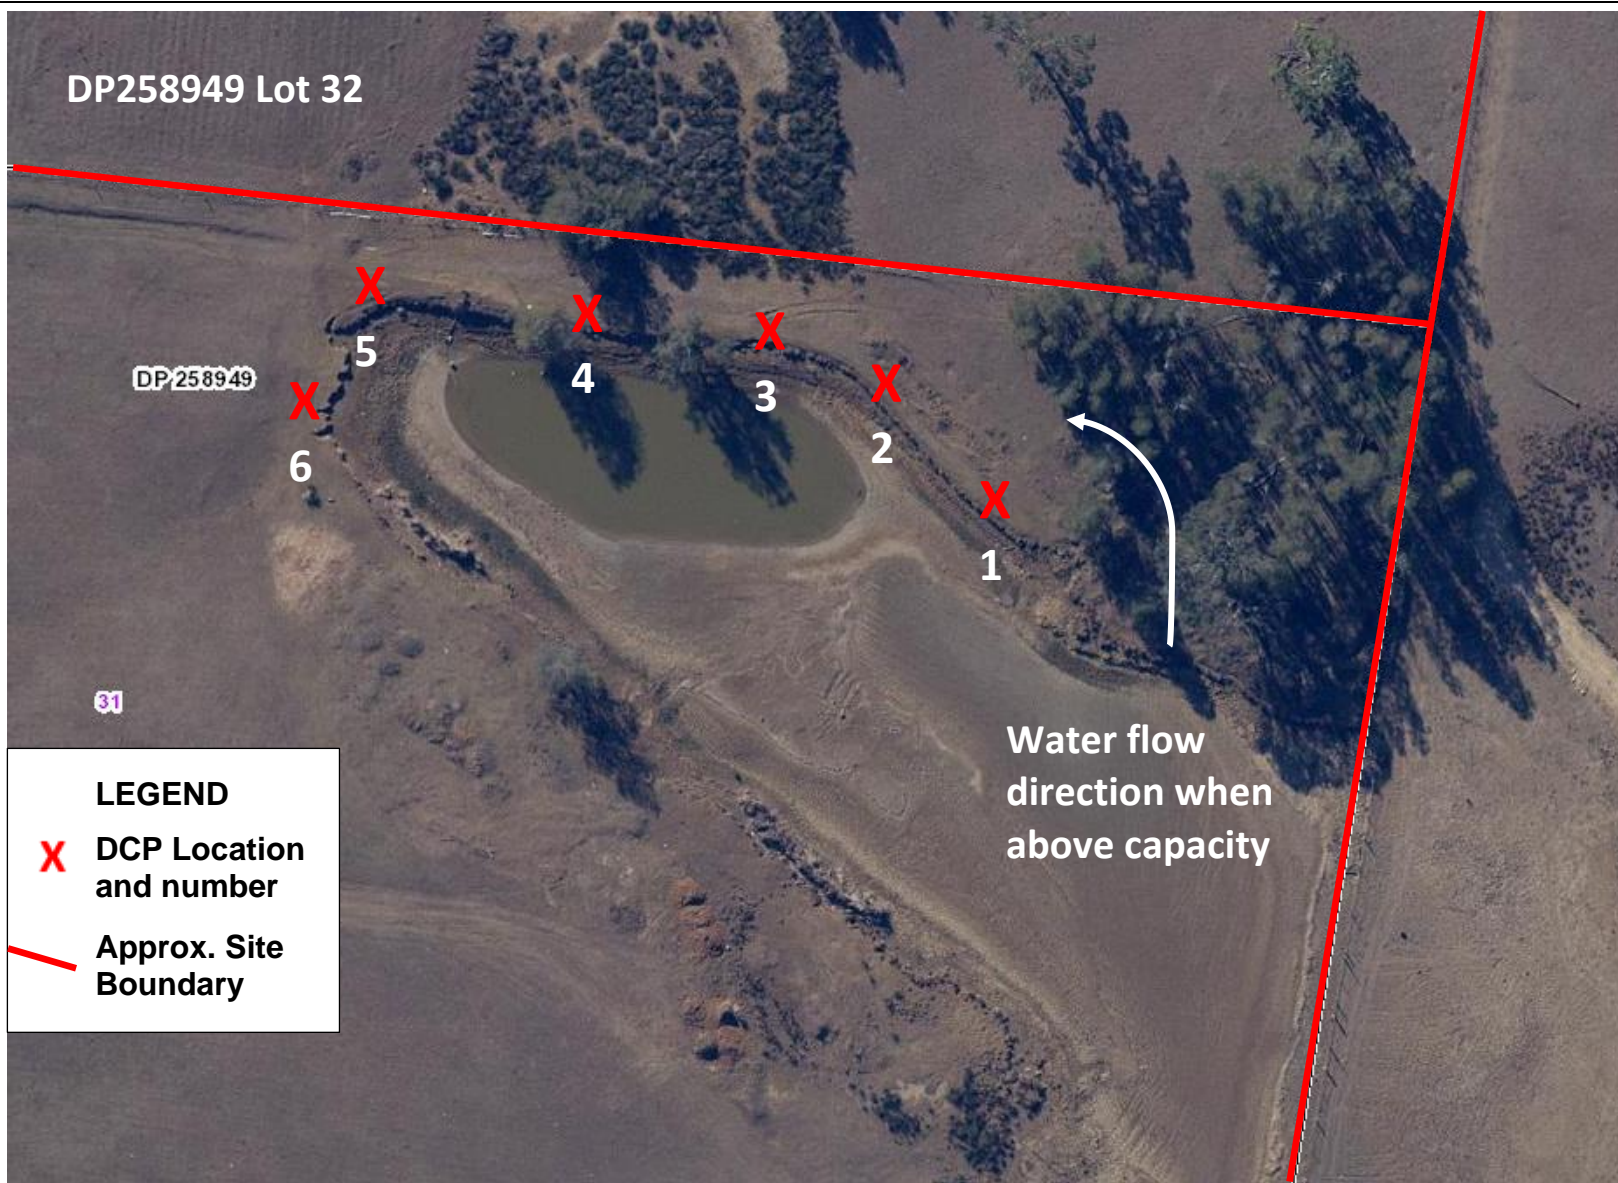
drawn	<b>JY</b>	client:	Fife Kems Creek Limited
approved	<b>JP</b>	project:	Dam Walls Stability Analysis
date	<b>14<sup>th</sup> March 2022</b>	title:	200 Aldington Rd, Kems Creek
scale	<b>Not to scale</b>	project no:	A201021.1725.03
Original size	<b>A4</b>	figure no	Drawing 1

The sectional crest width of the northern dam wall of Dam 1 was observed to be between 3-4 m reducing to 2m approaching the natural spillway marked in **Appendix I**. Each bank of the wall was observed to be inclined between 30 - 60°. At the time of inspection the water level in Dam 1 was approximately 1m below the crest of the northern dam wall.

No formal spillway structures were observed at Dam 1. An overland natural spillway (no flow direction was visible at time of inspection) was observed at the northeast corner of the dam, leading north through a forested area towards Dam 2.
