**Re: Sirius Building - Tree numbers 50 and 51 - Basement rectification works.**

# Sirius - Tree Removal on Gloucester Walk

This letter is prepared to provide comment on the existing Sirius eastern basement retaining walls design and condition and to also comment on the stability of Trees T50 and T51 on Gloucester walk due to the required basement wall structural upgrade and proposed basement construction works.

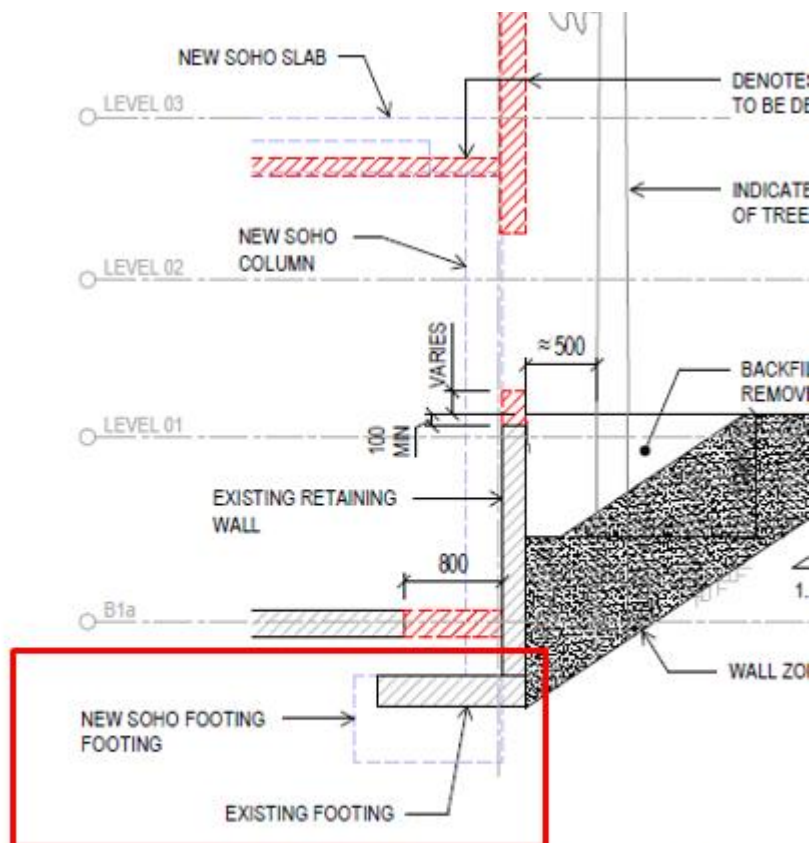
**TREE - T51**  
SCALE 1 : 50

We note the existing retaining walls are of age and have been compromised by Tree 50 and 51. At Tree 50, the tree roots have penetrated the walls inducing forces onto the wall as well as compromising the integrity and waterproofing of the wall. At tree 51, the wall displays a vertical crack at the centre line of the tree trunk indicating the tree has imparted significant lateral pressure on the wall and caused the wall to fail in horizontal bending. This crack in the wall is at least 1 to 1.5mm in width indicating structural failure of the wall. We note the wall at this location also presents a 30mm lean into the basement. The lean is indicative of flexural failure at the base of the wall, or instability of the wall as a result of the added induced lateral pressure of the tree root system.

For the reasons of structural non-compliance of the existing retaining wall; localized demolition required to construct the new approved SoHo and podium structure along Gloucester Walk and the existing and on-going damage to the existing retaining walls caused by Tree 50 and 51 the existing retaining wall is required to be demolished and rebuilt to the current standards. To ensure safety and as a result of the required demolition of the existing retaining wall including the removal of soil behind trees 50 and 51; both trees will become unstable as noted in the Arborist report.
