Harbourside Development

Maritime Heritage Dilapidation Survey Report

Darling Harbour
NSW

July 2022

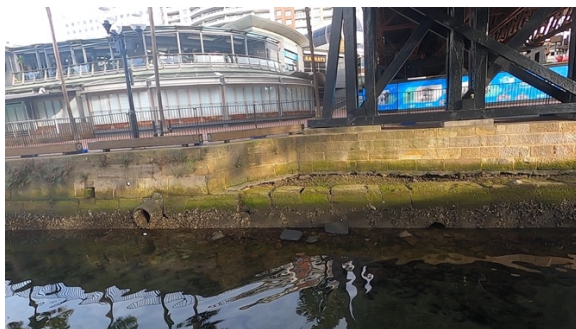
Figure 7: Stone seawall underneath the Pymont Bridge. Underwater survey began at the drain to the left of image (Image 220624 Harbourside stone wall above water_linear, 00:25).

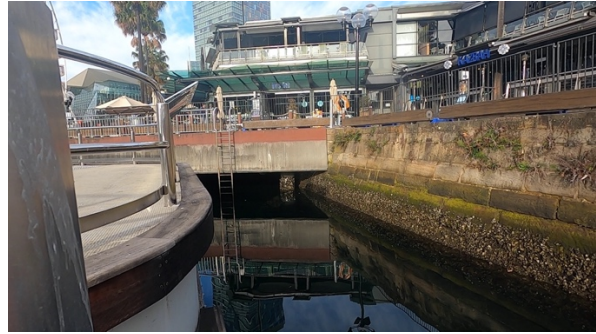
Figure 10: Stone seawall at the junction of the public promenade. (Image 220624 Harbourside stone wall above water_linear, 02:06).

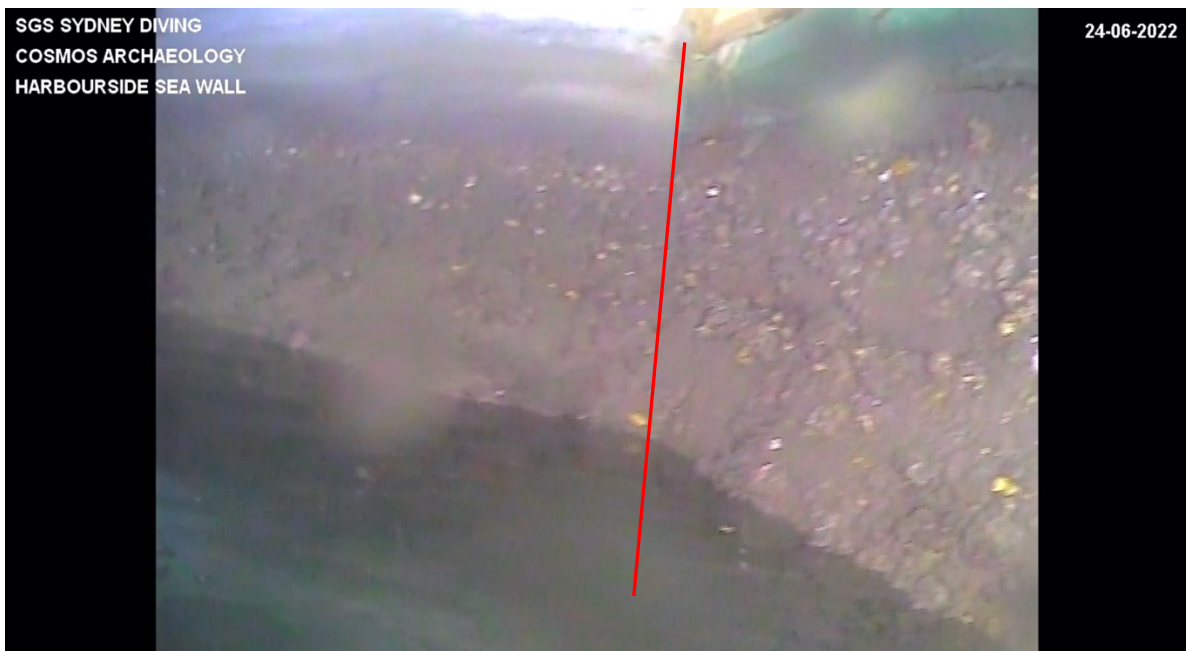
The visible section of the heritage stone wall ends where the new concrete section of seawall has been erected. The concrete wall angles east towards the centre of the harbour so it is possible the stone seawall extends into reclamation behind the concrete wall.

Figure 20: Junction of modern concrete seawall to the left of image and stone seawall to the right. (Image from 220624_Stone seawall dilapidation_S_walkway, 01:48).

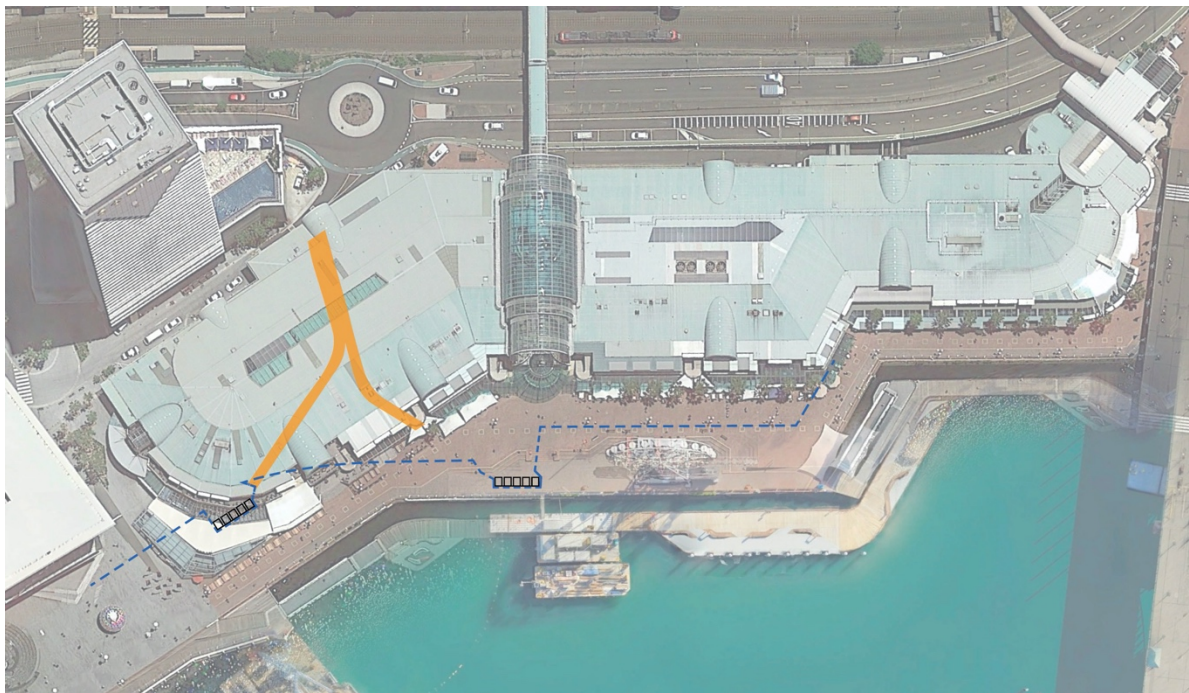
However, it does appear that when the current concrete seawall was built, new outlets were built into the concrete wall (Figure 21). It was not possible to ascertain what the extension conduits were made of, or indeed if they were extended.

Figure 21: Overlay showing tunnel outlets location within the concrete seawall. The saltwater conduits in orange and the concrete seawall (the dashed blue line) are overlaid onto a Google Earth image while the new outlets have been added in black.⁸

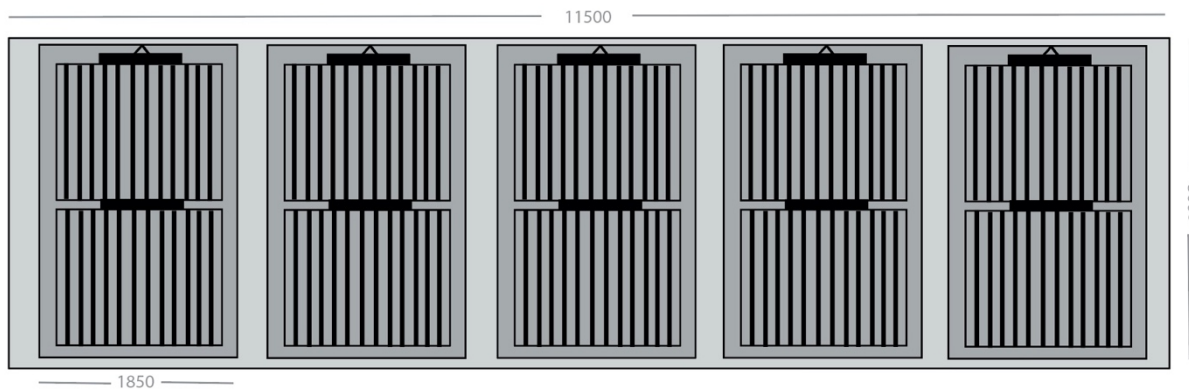
The visible entrances for both intake and discharge tunnels consist of a concrete surround with five 'entrances' each blocked by two gates which opened horizontally. Each opening measured 1,850 mm wide x 3,000 mm high, with the total width of the entrance being 11,500 mm. The gates were located 17,00 mm behind the rim of the opening, with a horizontal opening between gates. It would appear that these gates can be opened with mechanisms on the top of both the top and bottom gates. This was not attempted during the dive survey for safety reasons.

Figure 22: Digital representation of tunnel entrances in concrete seawall. Not to scale.

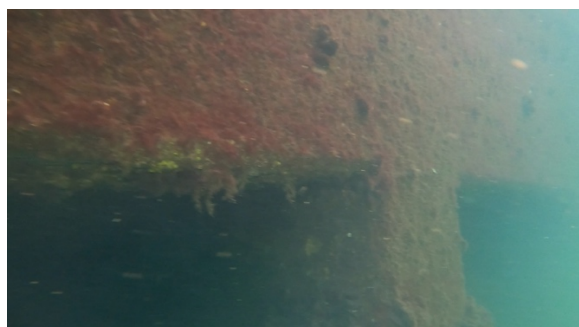
The discharge entrance appears very similar in construction to the intake entrance, with a square profile concrete surround (Figure 31). The gates within each of the five 'entrances'

Figure 31: Outside concrete surface of discharge entrance showing square profile. (Image 220624_Discharge conduit_2, 00:13).

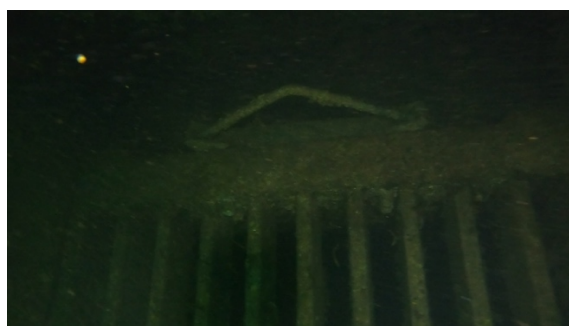
have less marine growth and silt build-up than the intake entrance (Figure 32). The gates appear to be able to open with a mechanism on both the upper and lower gates (Figure 33 and Figure 34). The gates are joined horizontally in the middle of the opening (Figure 35).

Figure 33: Example of top gate mechanism. (Image 220624_Discharge conduit_2, 02:39).

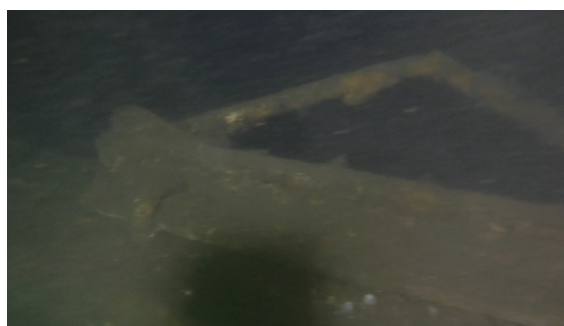
Figure 34: Example of bottom gate mechanism. (Image 220624_Discharge conduit_2, 00:59).

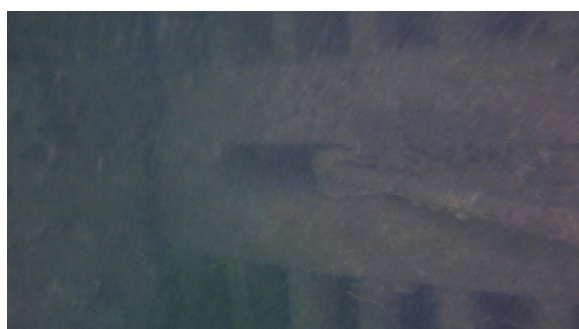
Figure 35: Example of join between gates. (Image 220624_Discharge conduit_2, 01:24).
