**Manildra – Port Kembla Bulk Liquid Terminal**

# Remedial Action Plan

Reference No. 30013038-R02

Prepared for Manildra Group Pty Ltd

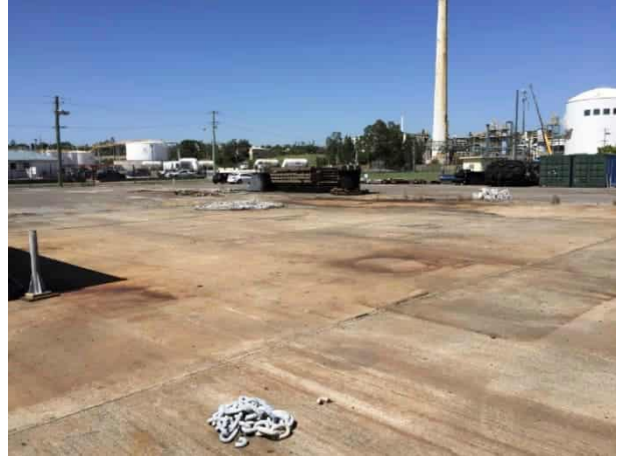
Photo 2-2 Looking south west along concrete slab area (March 2021)

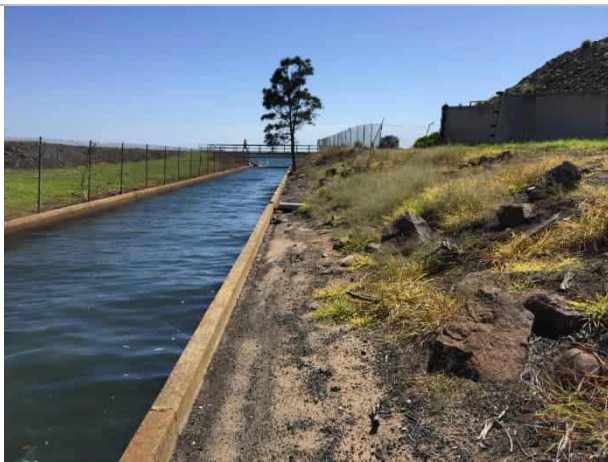
- A concrete lined tidal stormwater channel bisects the Site dividing the western portion (west of the channel) and central and eastern portion (east of the channel) (Photo 2-3). The stormwater channel is noted to be excluded from the Site
- The majority of the central and eastern portion of the Site was covered with an unbound granular slag wearing course (Photo 2-1). A concrete slab (approximately rectangular) was noted in the central portion of the Site (Photo 2-2). Strip drains were observed adjoining the southern edge of the concrete slab with a stormwater pit (Photo 2-5)
- The majority of the western portion of the Site was exposed fill/grass covered with some irregular areas of granular slag wearing course (Photo 2-11 and Photo 2-12)

Photo 2-3 Looking north along the stormwater channel (March 2021)

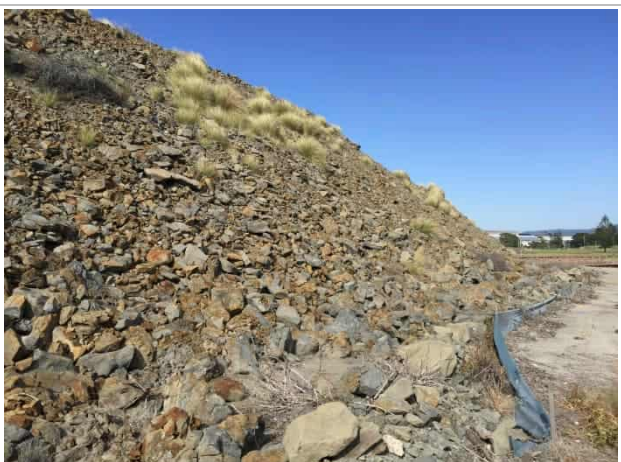
Photo 2-4 Looking west at surface of stockpile (March 2021)

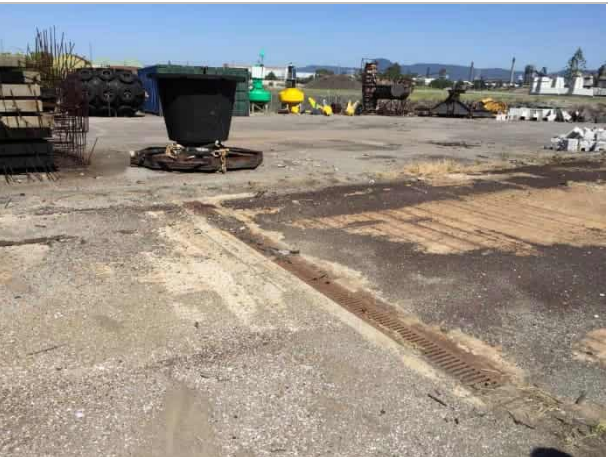
Photo 2-5 Looking west showing strip drains at edge of concrete slab (March 2021)

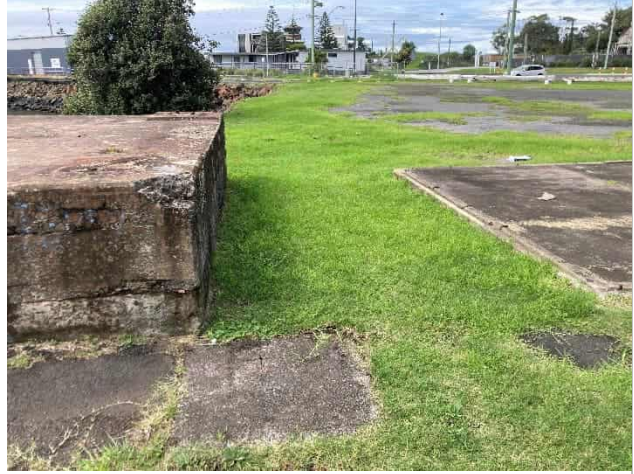
Photo 2-14 Looking east across grassed area near BH05 (Chainage 210m)

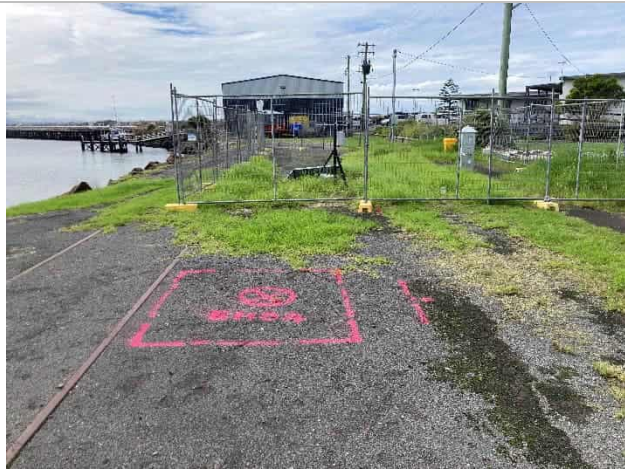
- Two rail lines were observed near borehole location BH04 (Chainage 260 to 270m) (Photo 2-15)
- A concrete bunded area containing coarse gravels (possibly inferred location of former No. 3 Jetty substation) was noted approximately 10m north of the Site near test pit location BH06 (Chainage 180m) (Photo 2-16)

Photo 2-15 Two rail lines near BH04 (Chainage 260m to 270m)

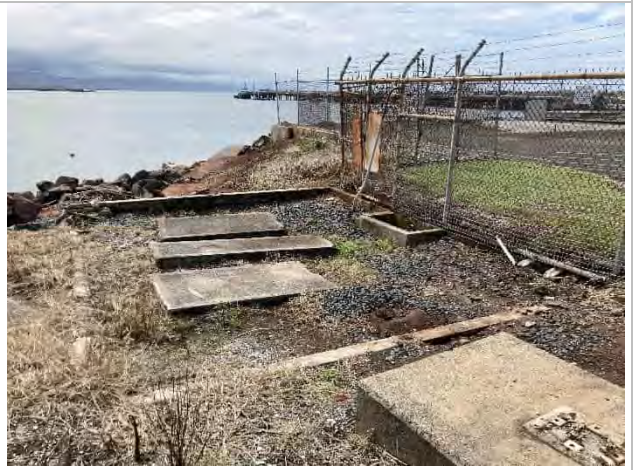
Photo 2-16 Concrete bunded area offsite north of BH06 (Chainage 180m)

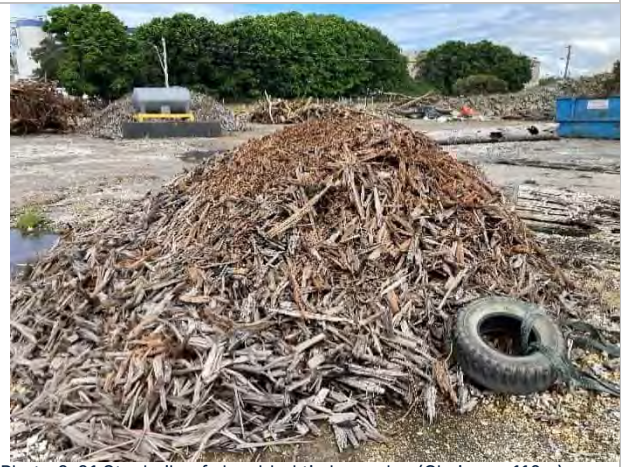
- Multiple timber poles were observed to be stockpiled in the vacant parcel of Lot 6 between Chainage 90 m and Chainage 150m (Photo 2-20). The timber poles were covered with shells and had been removed from marine timber structures associated with the former harbour jetty. Evidence of stockpiles of shredded timber were noted (Photo 2-21).

Photo 2-21 Stockpile of shredded timber poles (Chainage 110m)
