# Arboricultural Impact Assessment

**St Luke's Grammar School – New Senior Campus  
Midson Group  
800 Pittwater Road  
Dee Why NSW 2099**

**1 November 2019**

**Arboricultural Impact Assessment for sixty-two (62) trees located within the vicinity of the proposed redevelopment of 800 Pittwater Road, Dee Why and 224 Headland Rd, North Curl Curl**

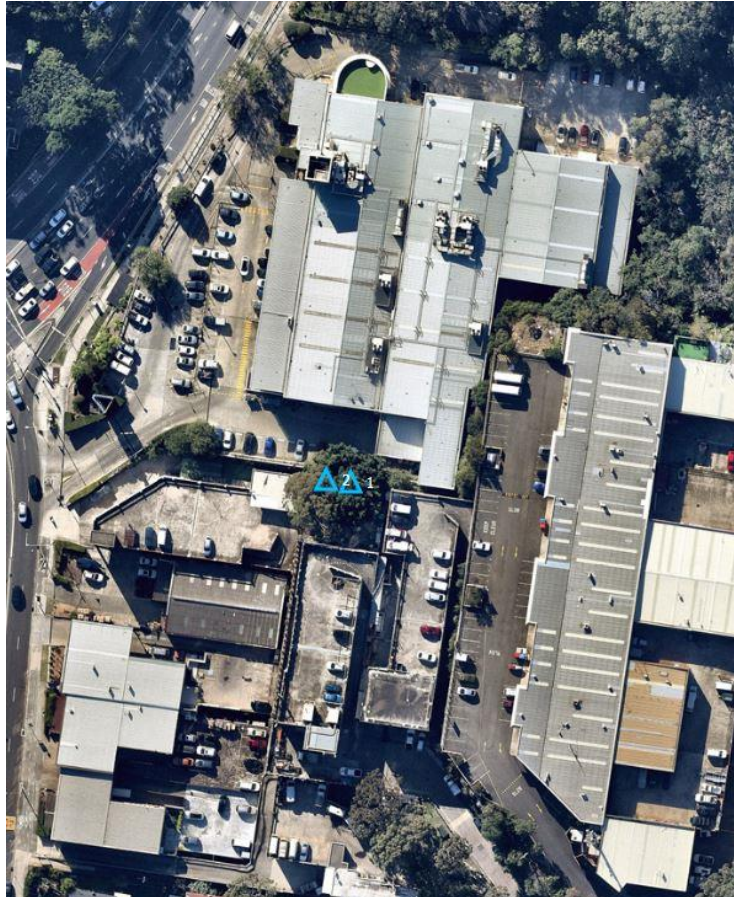
- 5.7.1 Two (2) trees were determined to be Category A Trees. Typically trees in this category are of high quality with an estimated remaining life expectancy of at least 25 years and of dimensions and prominence that it cannot be readily replaced in <20 years. The tree may make significant amenity contributions to the landscape and may make high environmental contributions. In some cases, trees within this category may not meet the above criteria, however, possess significant heritage or ecological value. Trees of this retention value warrant design consideration and amendment to ensure their viable retention.
- 5.7.2 Category A trees are numbered 1 and 2 and are shown in Figure 6. Both trees were located within the adjoining property, being SP65574, along the southern boundary.

Figure 6. Aerial image showing location of High Retention Value Trees. Tree attributes are to be obtained from the Appendix C – Preliminary Tree Assessment Data. (ArborSafe, 28 October 2019).

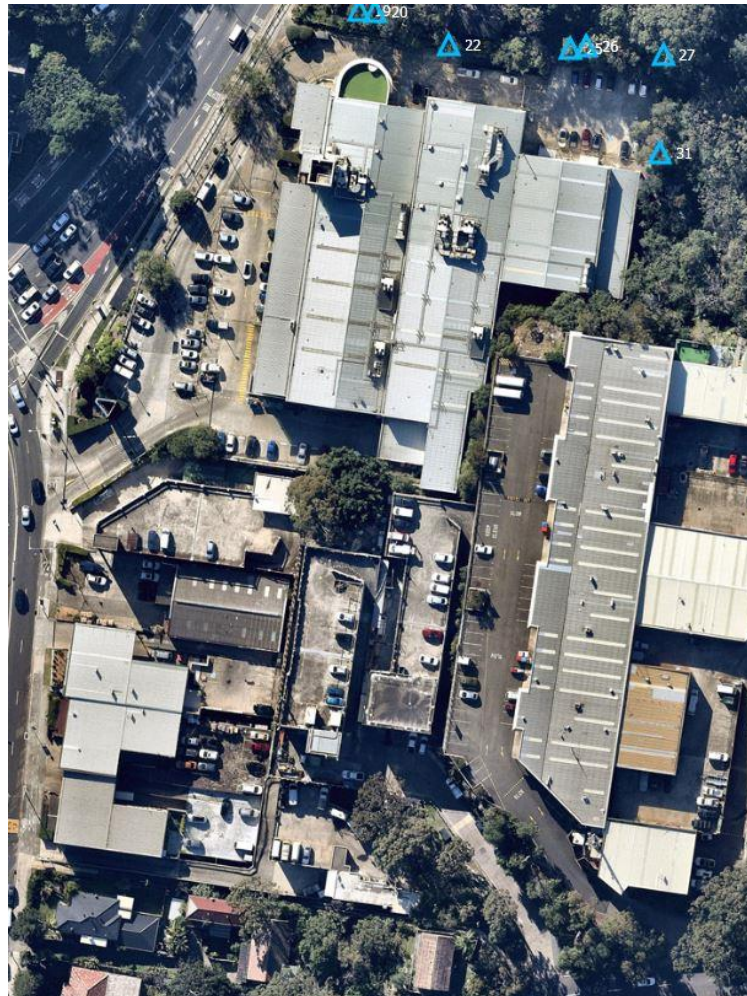
- 5.8.1 Seven (7) trees were considered to have a Moderate Retention Value. Typically trees in this category are of moderate quality with an estimated remaining life expectancy of 15–25 years and prominence of size dimensions that cannot be readily replaced within ten years. They may make moderate amenity contributions to the landscape and make low/moderate environmental contributions. Trees with this retention value warrant minor design consideration in an attempt to allow for their retention.
- 5.8.2 Category B trees are numbered 19, 20, 22, 25, 26, 27 and 31 and are shown in Figure 8. All Category B trees were located within Stony Range Botanic Garden in proximity to the subject site.

Figure 8. Aerial image showing location of Moderate Retention Value Trees. Note that icon colour indicates trees current risk rating (not Retention Value). Tree attributes are to be obtained from the Appendix C – Preliminary Tree Assessment Data. (ArborSafe, 28 October 2019).

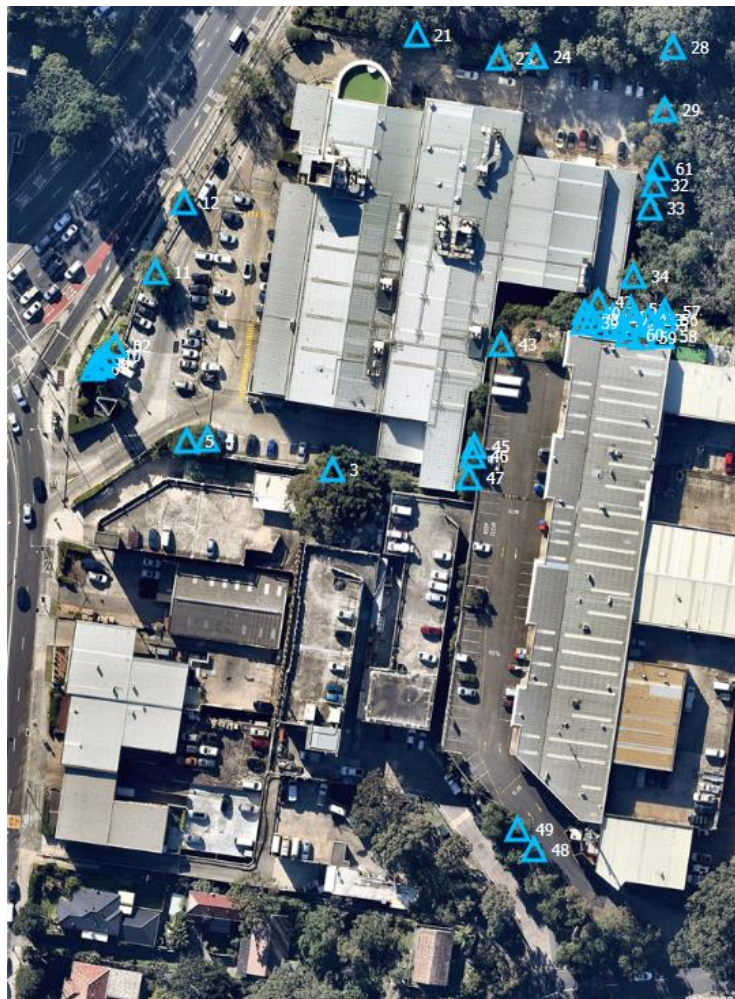
5.9.2 Category C trees are: Trees 3, 4, 5, 6, 7, 8, 9, 10, 11, 12, 21, 23, 24, 28, 29, 32, 33, 34, 35, 36, 37, 38, 39, 40, 42, 43, 45, 46, 47, 48, 49, 50, 51, 53, 54, 55, 56, 57, 58, 59, 60, 61 and 62 and are shown in Figure 11.

Figure 11. Aerial image showing location of Low Retention Value Trees. Tree attributes are to be obtained from the Appendix C – Preliminary Tree Assessment Data. (ArborSafe, 28 October 2019).

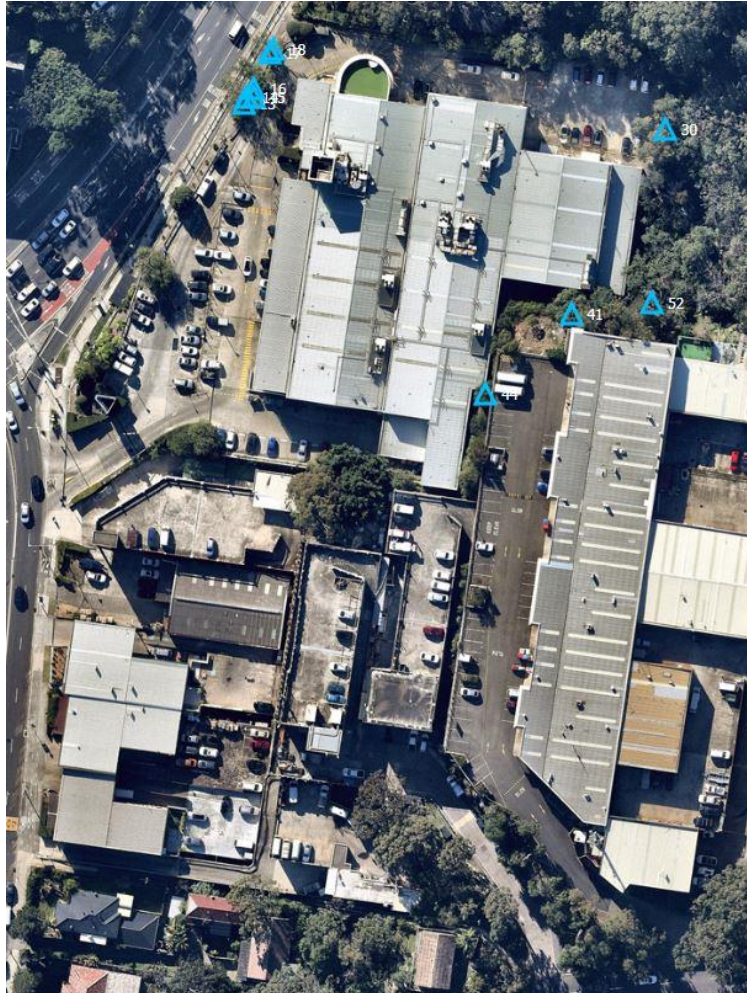
5.10.1 Ten (10) trees were found to be in such a condition that they cannot realistically be retained as viable trees in the context of the current land use for longer than five years. These trees may be dead and/or of a species recognised as a weed that resulted in them being unretainable. These trees should be removed irrespective of any future development on the site.

5.10.2 Category U Trees were 13, 14, 15, 16, 17, 18, 30, 41, 44 and 52 and are shown in Figure 14.

Figure 14. Aerial image showing location of Remove Retention Value Trees (Nil/No Retention Value). Tree attributes are to be obtained from the Appendix C – Preliminary Tree Assessment Data. (ArborSafe, 28 October 2019).

- 5.10.3 Trees 13–18 are *Acacia saligna* (Golden Wreath Wattle) located in the north-western corner of the site along the Pittwater Road frontage. These trees are listed as an exempt species in the Warringah Development Control Plan (DCP), 2011, are naturally short lived and are all either dead or in decline.

- 7.1.1 Twenty-six (26) trees would require removal to facilitate this development. These are trees 3, 4, 5, 6, 7, 8, 9, 10, 11, 12, 22, 35, 36, 37, 38, 39, 40, 42, 43, 45, 46, 47, 50, 51, 54 and 62.
- 7.1.2 Ten (10) trees were recommended for removal irrespective of future development on the site. These are trees 13, 14, 15, 16, 17, 18, 30, 41, 44 and 52.
