# Fort Street Public School

## ARBORICULTURAL DEVELOPMENT IMPACT ASSESSMENT REPORT

SSD 10340

Prepared by Birds Tree Consultancy

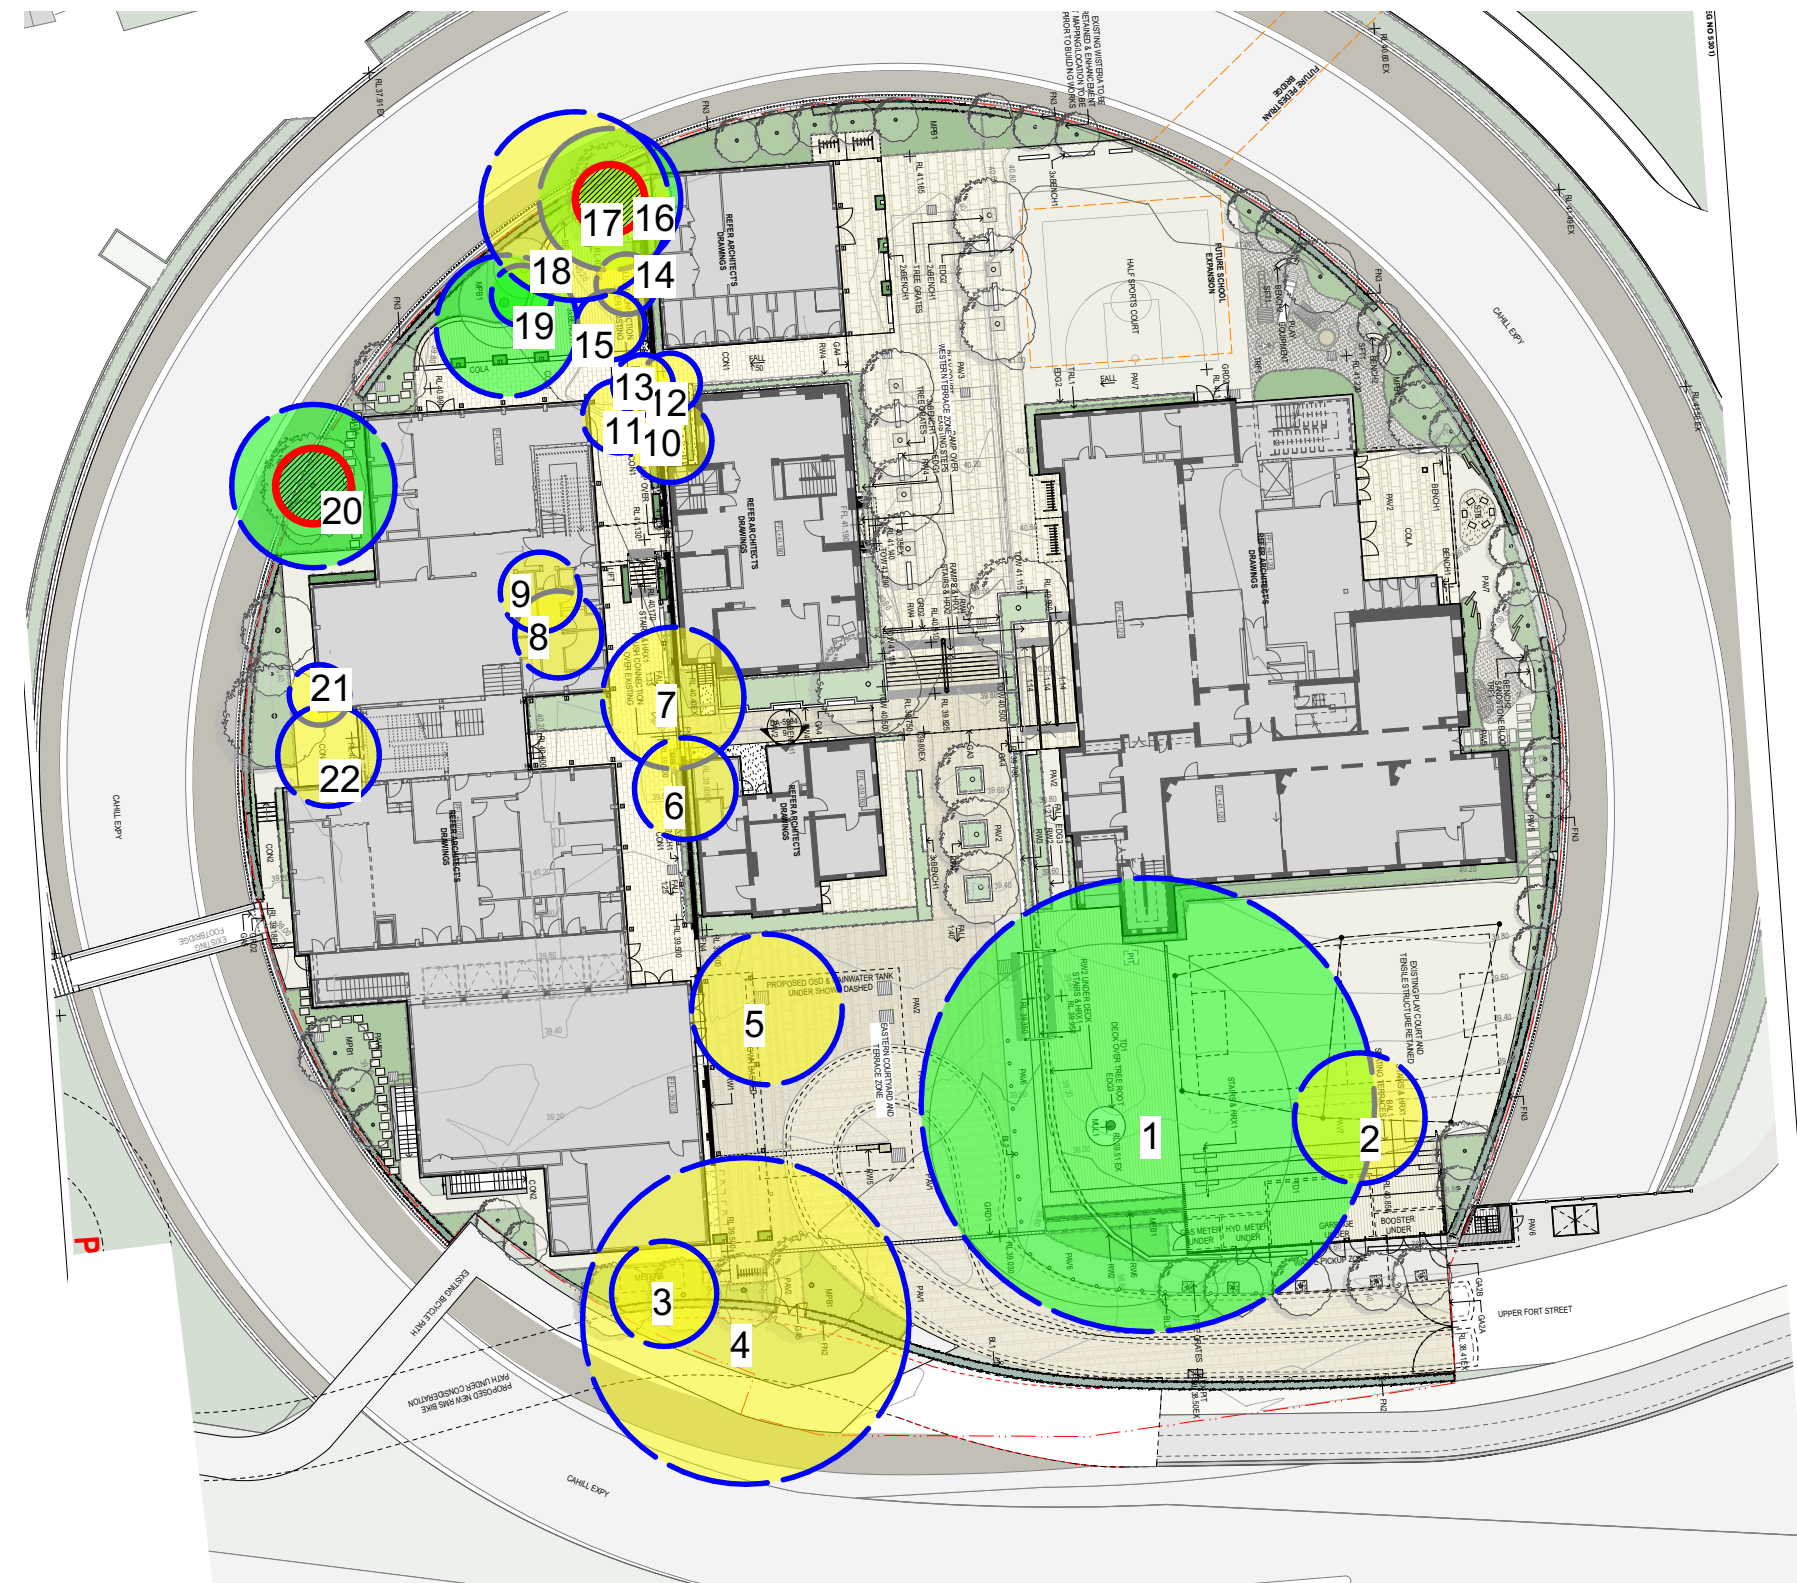
The Tree Protection Zones (TPZ) of Trees 2, 3, 4, 5, 6, 7, 8, 9, 10, 11, 12, 13, 14, 15, 17, 21 and 22 are encroached by the proposed construction and required earthworks by a total or major encroachment as defined by *AS4970-2009 Protection of Trees on Development Sites*. These trees will not be viable to be retained and are recommended for removal.

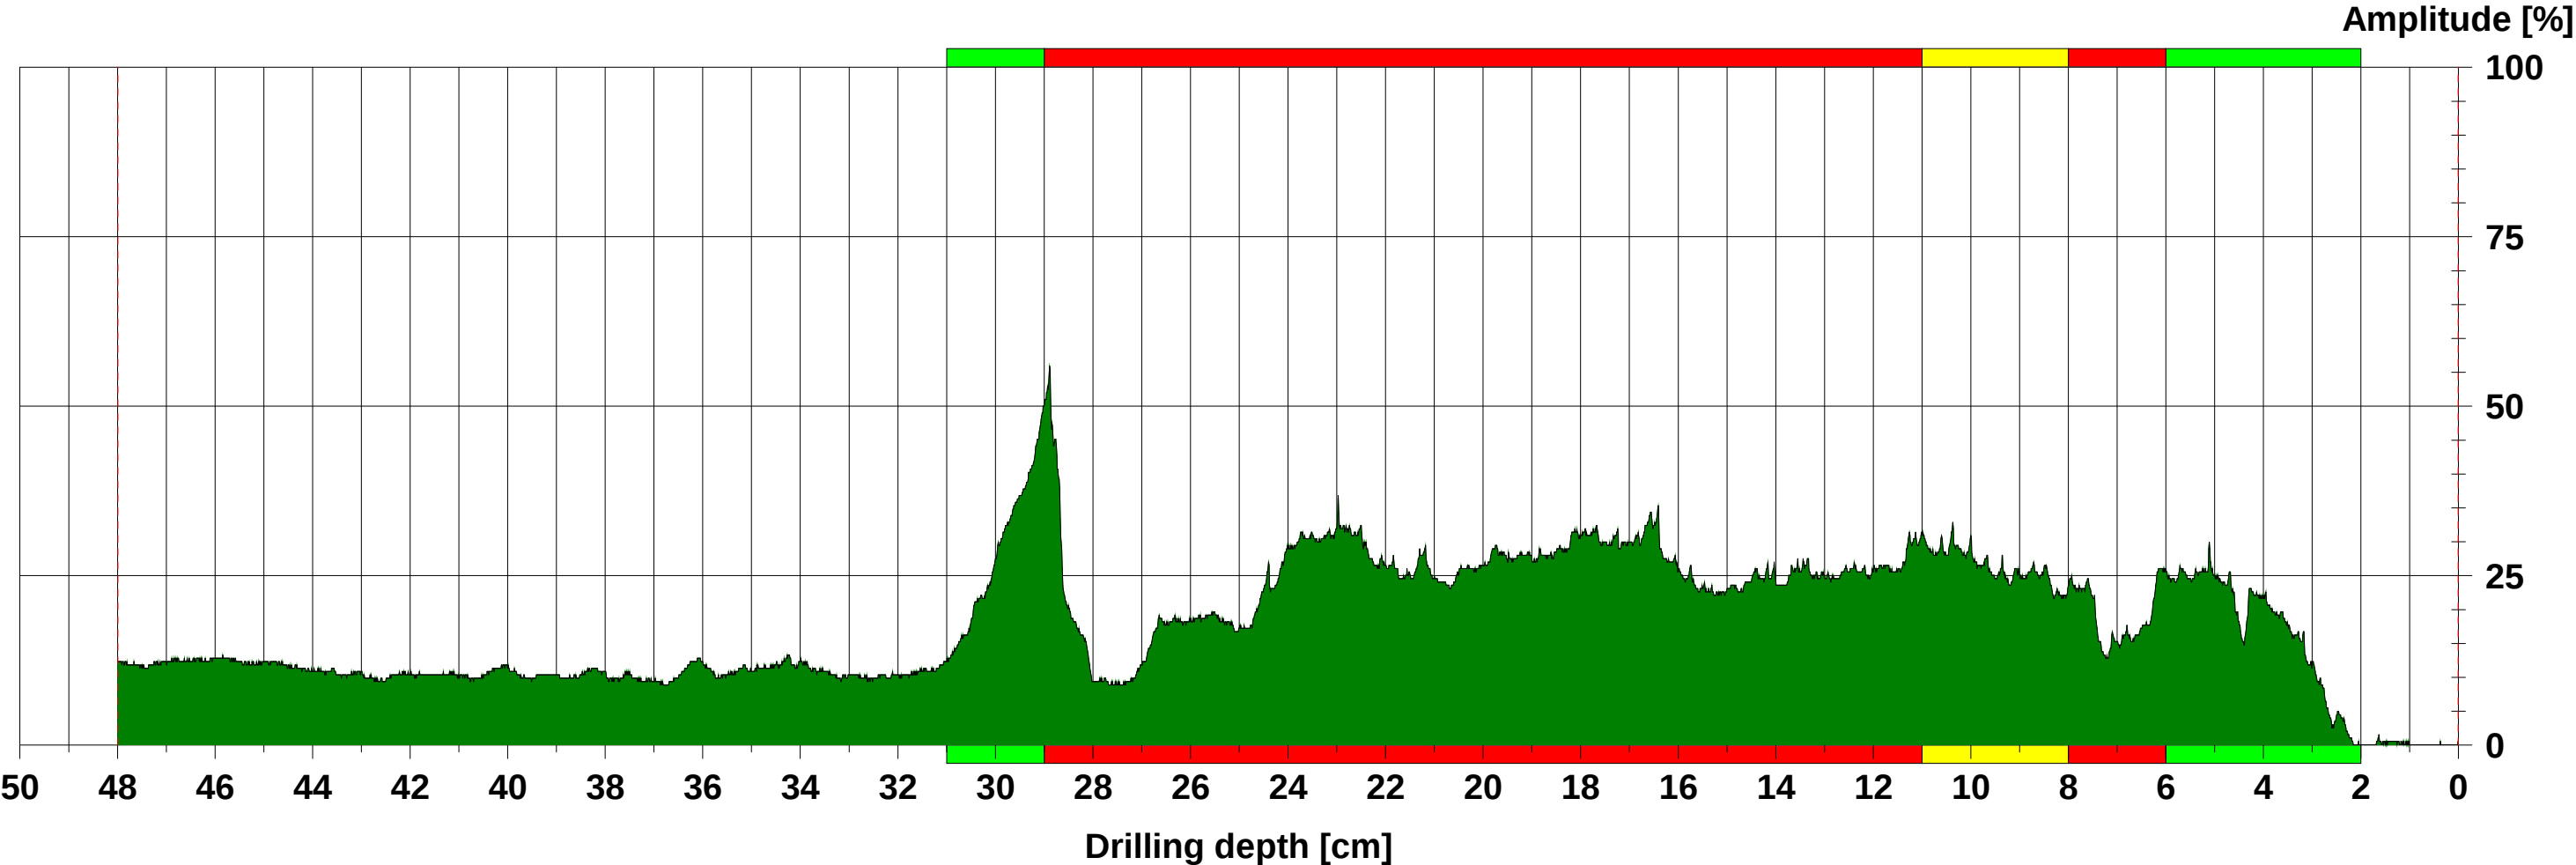
Assessment

| From 2.0 cm to 6.0 cm | : Sound wood |

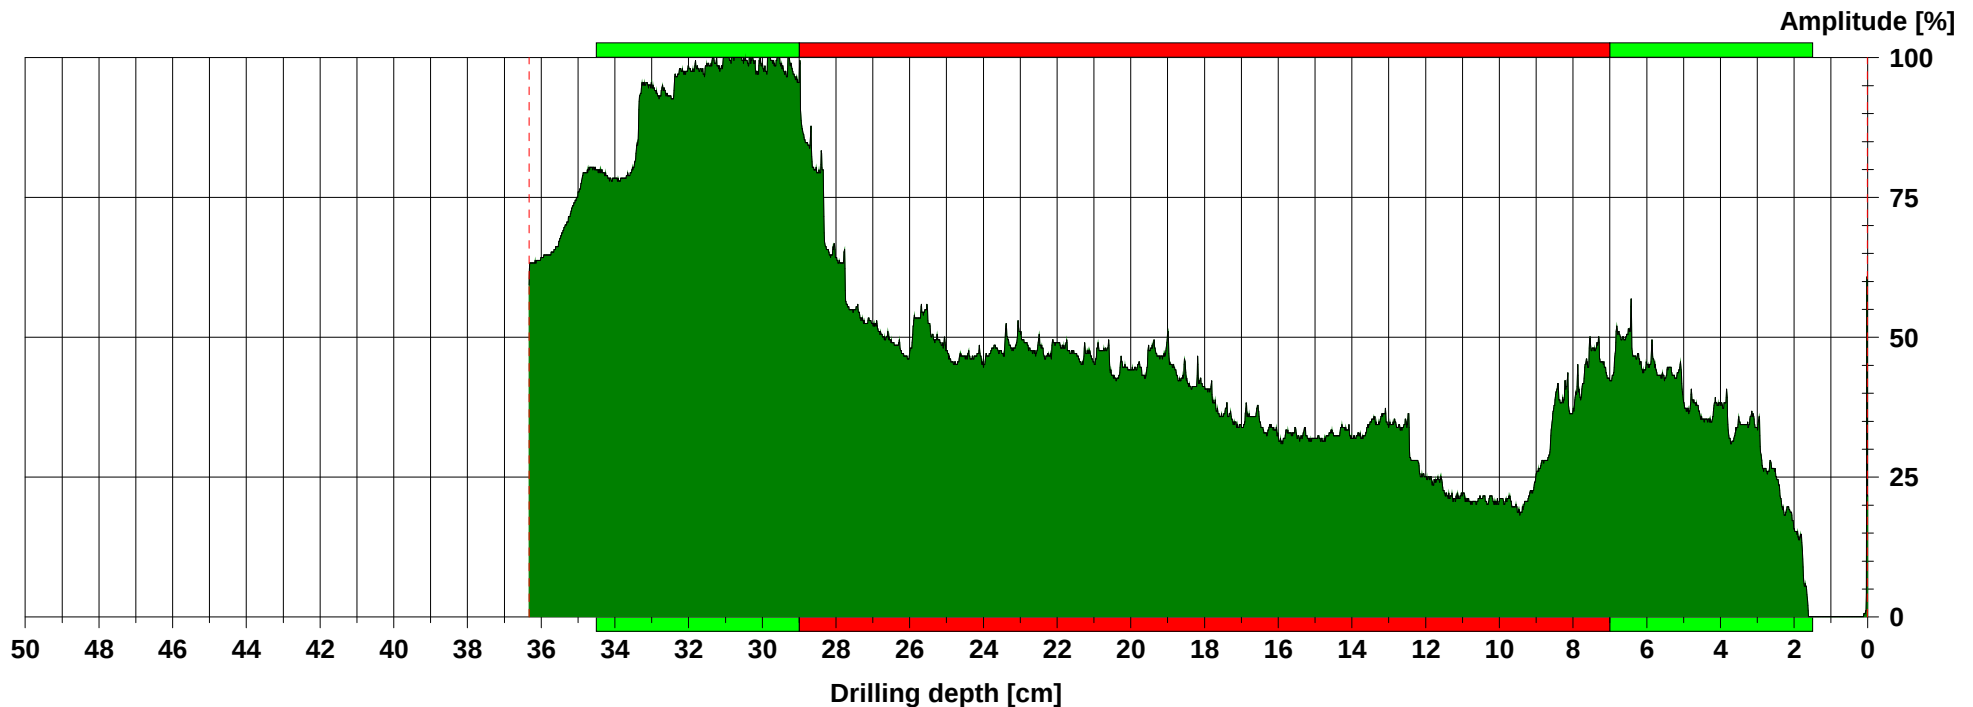
## Assessment

| From | 1.5 cm | to | 7.0 cm | : | Sound wood |
