# Preliminary Site Investigation Richard Gill Music Academy, Muswellbrook

Prepared for  
Richard Gill National Music Academy Ltd

7 May 2020

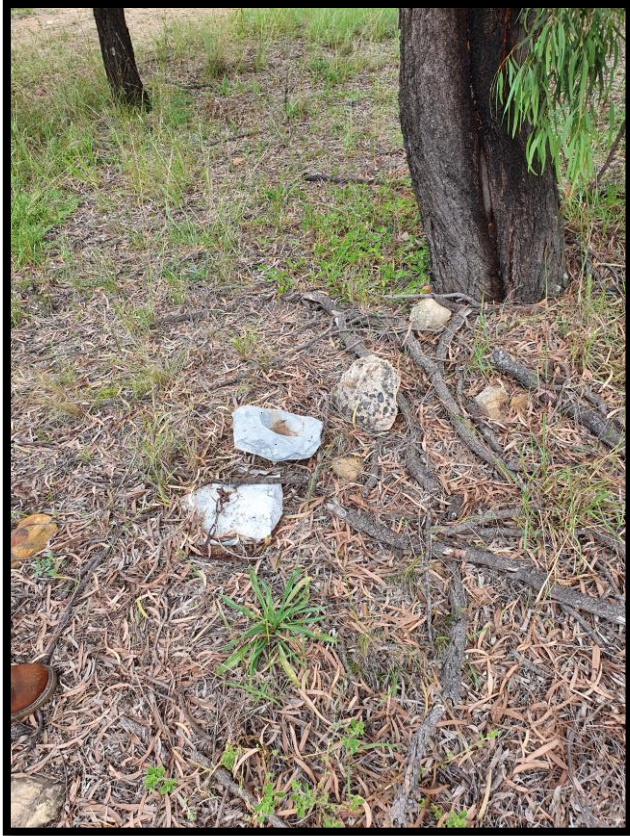
| Item | Observations |
|---|---|
| Solid waste deposition | There was no major stockpiling of waste on site, there were a few items that had been illegally dumped on site, <b>Figure 8-3</b> and <b>Figure 8-4</b> of <b>Appendix B</b> . |

Figure 8-3 Illegally disposed material

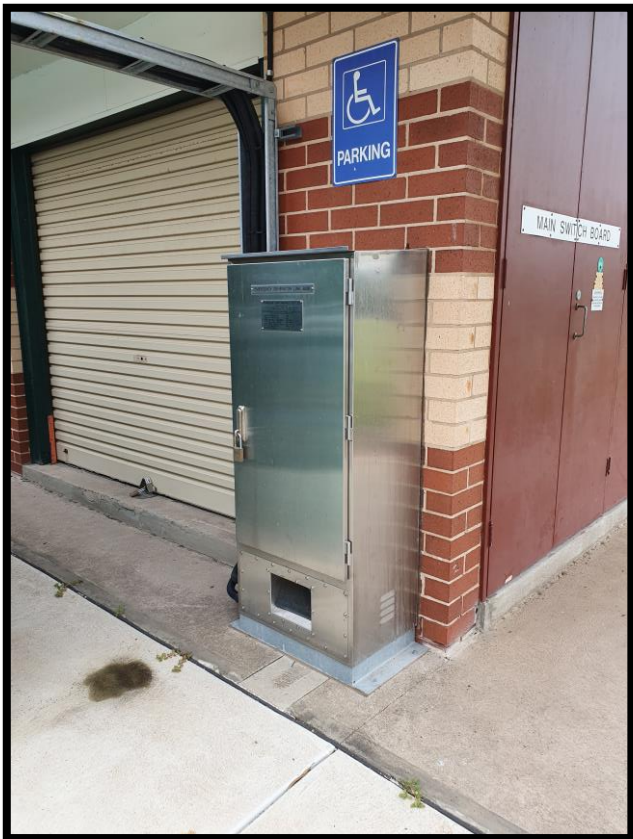
Figure 8-5 Building switch board
