Hazardous Materials Survey

2-60 Cumberland St, The Rocks NSW

Report Title: Hazardous Materials Survey - 2-60 Cumberland St, The Rocks NSW
Report No: E24614.E10_Rev1

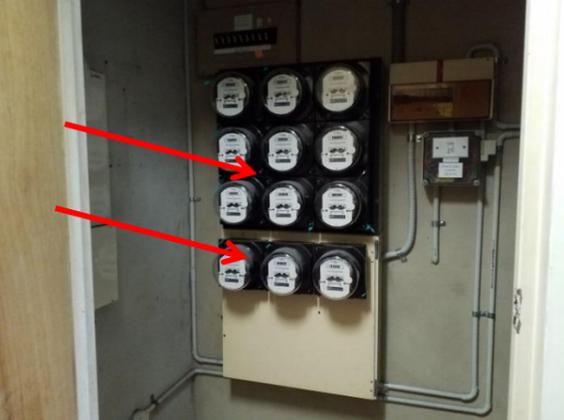
Location	Material Type	Friability	Sample	Analysis Result:	Quantity	Condition and Accessibility	Priority	Recommendations/ Comments	Photograph of material
36 Cumberland Street, The Rocks									
Inaccessible									
Internal, wall cavities	Possible hazardous materials	Unknown	Inaccessible	NA	Not determined	Unknown Inaccessible	Inaccessible	No access available at time of inspection. When areas are accessible, confirm status of hazardous materials.	
Internal, walls behind ceramic tiles, membranes	Possible hazardous materials	Unknown	Inaccessible	NA	Not determined	Unknown Inaccessible	Inaccessible	No access available at time of inspection. When areas are accessible, confirm status of hazardous materials.	
Asbestos									
Basement, electrical switch room	Electrical backing board	Non-friable	Similar to A12	Assume positive	1 unit	Good Maintenance only	Priority 4: Negligible Risk Level	Remove prior to refurbishment works

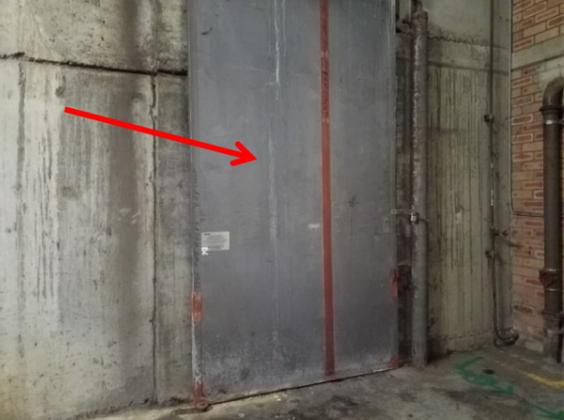
Basement, northern end, sliding fire door "Padde" (inner core)	Fire door (inner core)	Friable	Not sampled (inaccessible)	Assume positive	Not determined	Good Maintenance only	Priority 4: Negligible Risk Level	Remove prior to refurbishment works

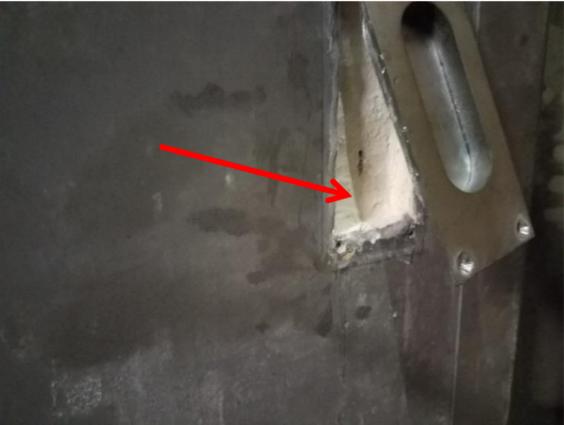
Basement, northern end, sliding fire door "Padde" (outer core only)	Fire door (outer core)	Friable	A45	No Asbestos Detected Organic Fibres Detected	NA	NA	NA	NA

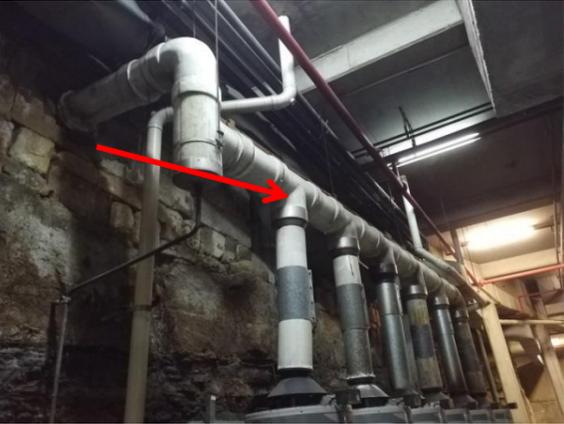
Basement, western side, hot water units, flues (goes through wall to vent outside)	Asbestos cement pipe	Non-friable	A46	Chrysotile Asbestos Detected Organic Fibres Detected	Not determined	Good Maintenance only	Priority 4: Negligible Risk Level	Remove prior to refurbishment works

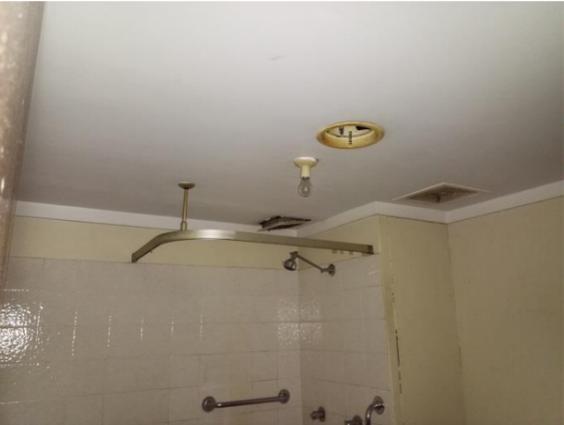
Unit 1, bathroom ceiling	Asbestos cement sheeting	Non-friable	A47	Chrysotile Asbestos Detected Organic Fibres Detected	6m ²	Good Maintenance only	Priority 4: Negligible Risk Level	Remove prior to refurbishment works

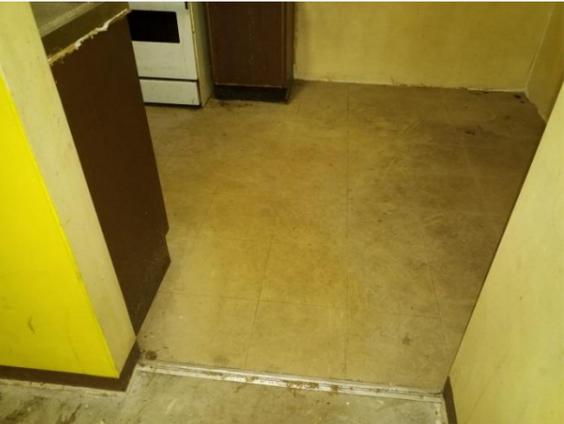
Unit 1, kitchen	Cream vinyl floor tiles	Non-friable	Similar to A16	Assume negative	NA	NA	NA	NA

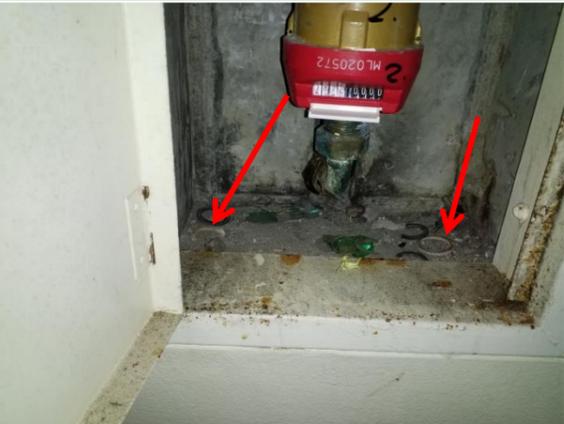
Outside unit 2, water meter cupboard, redundant gaskets	Gaskets	Friable	Similar to A38	Assume positive	Not determined	Fair Maintenance only	Priority 4: Negligible Risk Level	Remove prior to refurbishment works

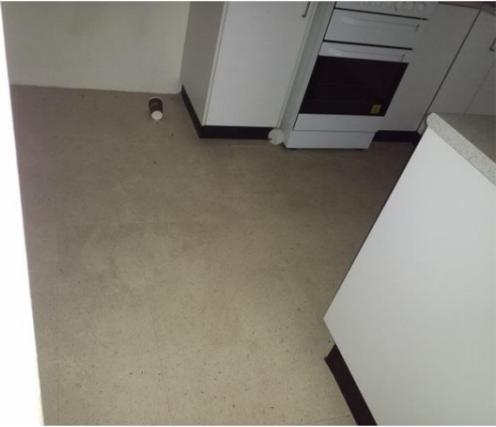
Unit 2, kitchen	Cream and blue speck vinyl floor tiles	Non-friable	Similar to A29	Assume negative	NA	NA	NA	NA

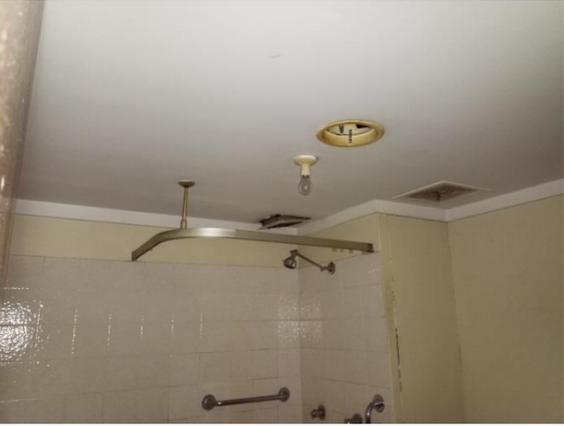
Unit 2, bathroom, ceiling	Asbestos cement sheeting	Non-friable	Similar to A47	Assume positive	6m ²	Good Maintenance only	Priority 4: Negligible Risk Level	Remove prior to refurbishment works

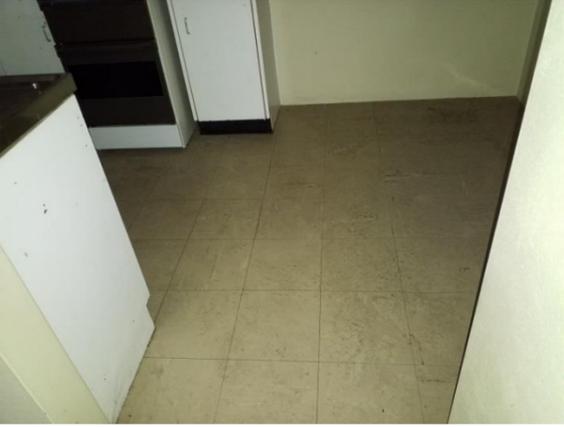
Unit 3, kitchen,	Cream vinyl floor tiles	Non-friable	Similar to A16	Assume negative	NA	NA	NA	NA

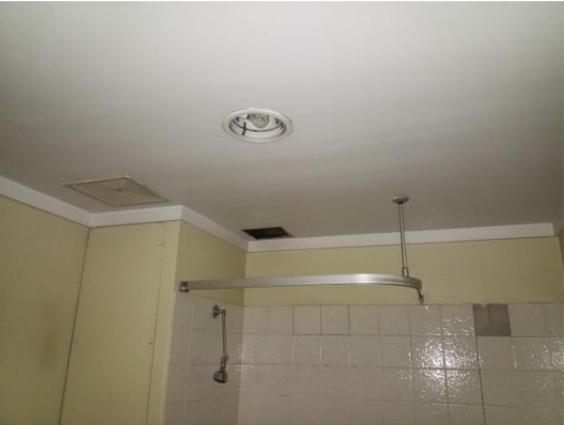
Unit 3, bathroom ceiling	Asbestos cement sheeting	Non-friable	Similar to A47	Assume positive	6m ²	Good Maintenance only	Priority 4: Negligible Risk Level	Remove prior to refurbishment works

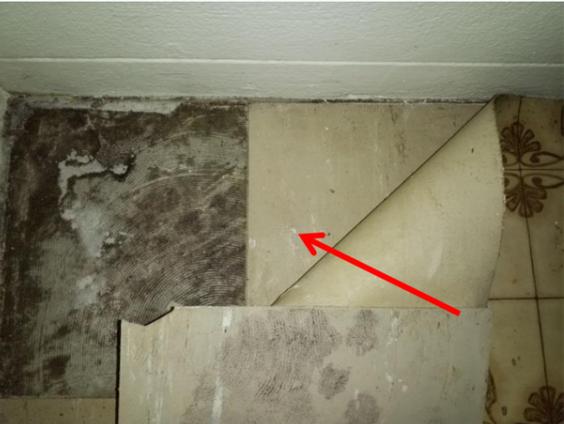
Unit 4, kitchen, under new style vinyl sheeting	Cream fleck vinyl floor tiles	Non-friable	Similar to A13	Assume negative	NA	NA	NA	NA

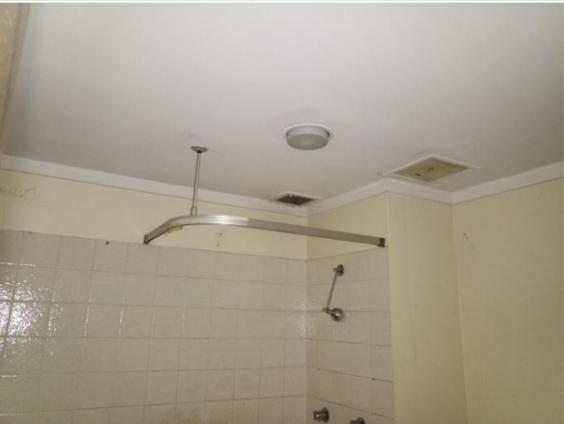
Unit 4, bathroom ceiling	Asbestos cement sheeting	Non-friable	Similar to A47	Assume positive	6m ²	Good Maintenance only	Priority 4: Negligible Risk Level	Remove prior to refurbishment works

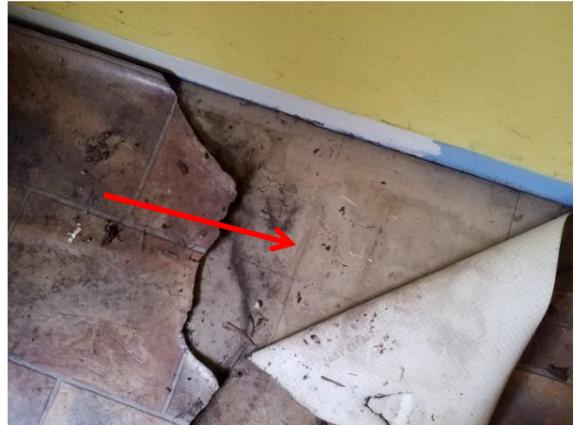
Unit 5, kitchen, under new style vinyl	Cream vinyl floor tiles	Non-friable	Similar to A16	Assume negative	NA	NA	NA	NA

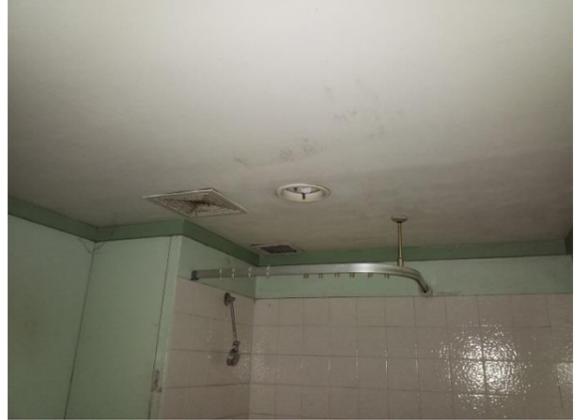
Unit 5, bathroom ceiling	Asbestos cement sheeting	Non-friable	Similar to A47	Assume positive	6m ²	Good Maintenance only	Priority 4: Negligible Risk Level	Remove prior to refurbishment works

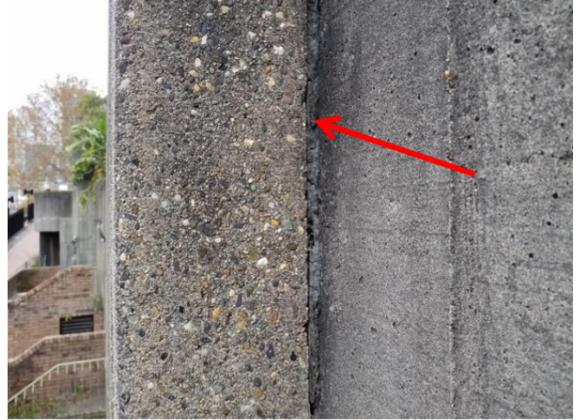
External, eastern elevation, concrete facade, beneath mortar	Sealant	Non-friable	A48	No Asbestos Detected	NA	NA	NA	NA

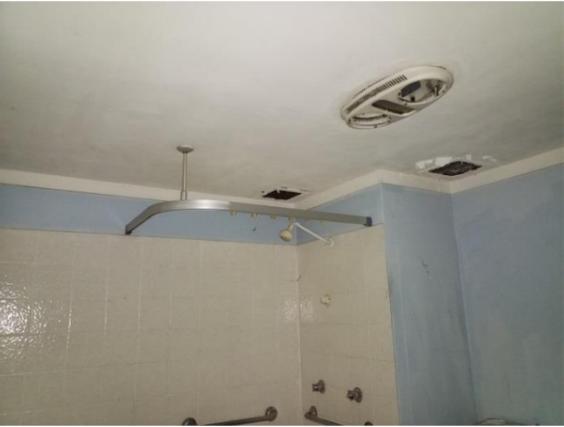
Unit 6, bathroom, ceiling	Asbestos cement sheeting	Non-friable	Similar to A47	Assume positive	6m ²	Good Maintenance only	Priority 4: Negligible Risk Level	Remove prior to refurbishment works

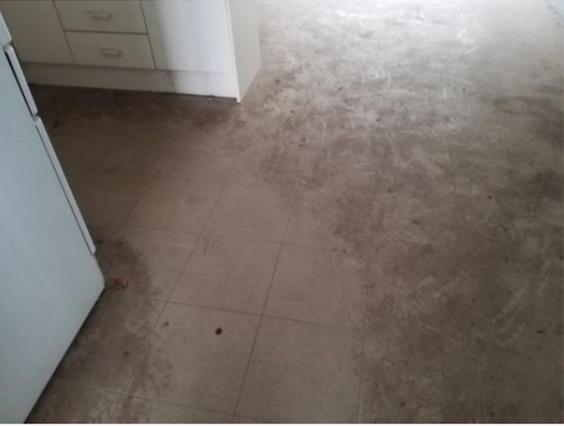
Unit 6, kitchen	Cream vinyl floor tiles	Non-friable	Similar to A16	Visual Inspection Assume negative	NA	NA	NA	NA

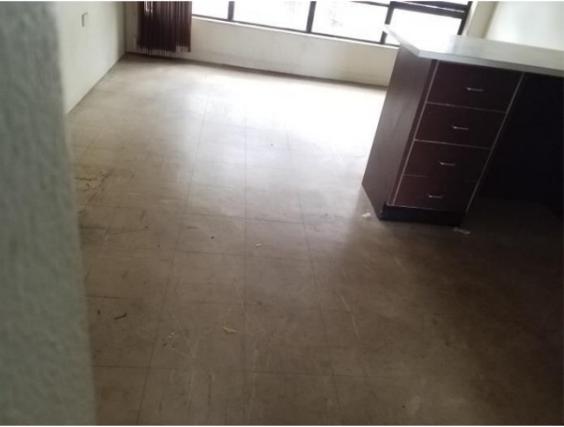
Unit 7, kitchen	Cream fleck vinyl floor tiles	Non-friable	Similar to A13	Visual Inspection Assume negative	NA	NA	NA	NA

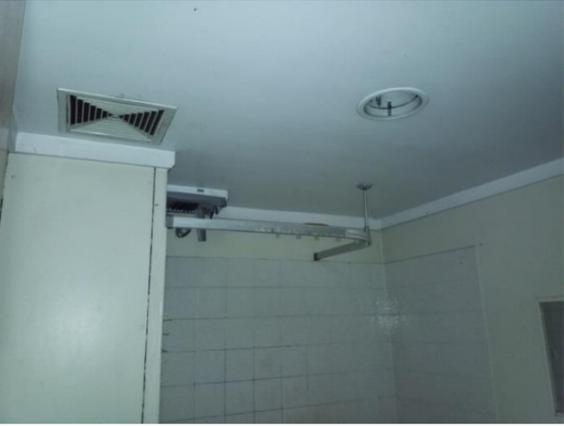
Unit 7, bathroom, ceiling	Asbestos cement sheeting	Non-friable	Similar to A47	Assume positive	6m ²	Good Maintenance only	Priority 4: Negligible Risk Level	Remove prior to refurbishment works

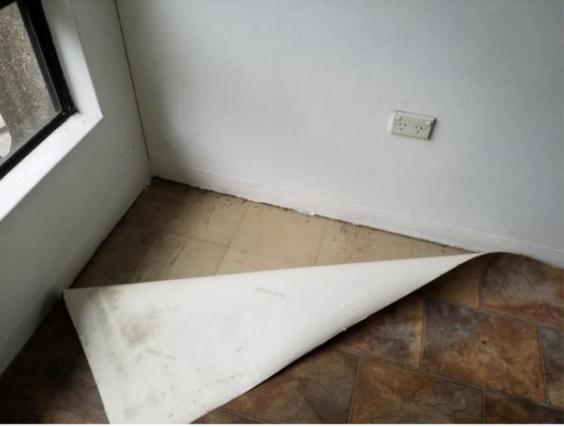
Unit 8, kitchen, beneath new vinyl	Cream vinyl floor tiles	Non-friable	Similar to A16	Visual Inspection Assume negative	NA	NA	NA	NA

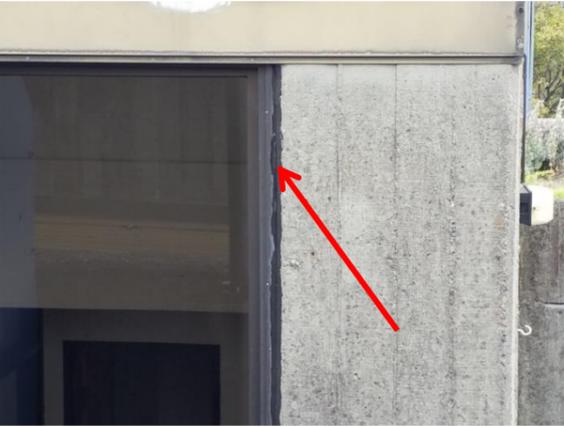
Unit 8, rooftop terrace, around door (black)	Membrane	Non-friable	A50	Chrysotile Asbestos Detected	Not determined	Good Maintenance only	Priority 4: Negligible Risk Level	Remove prior to refurbishment works

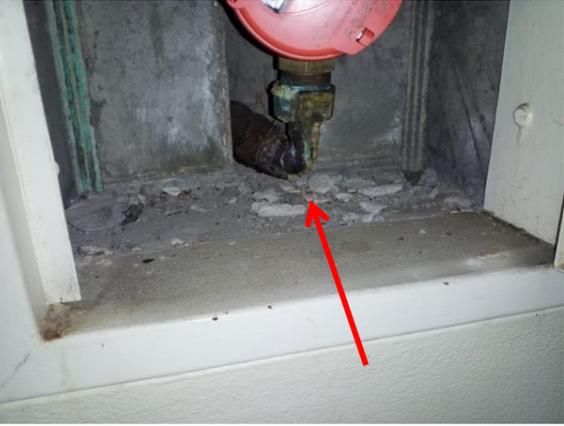
Outside Unit 9, water meter, redundant gaskets	Gaskets	NA	Similar to A38	Assume positive	Not determined	Fair Maintenance only	Priority 4: Negligible Risk Level	Remove prior to refurbishment works

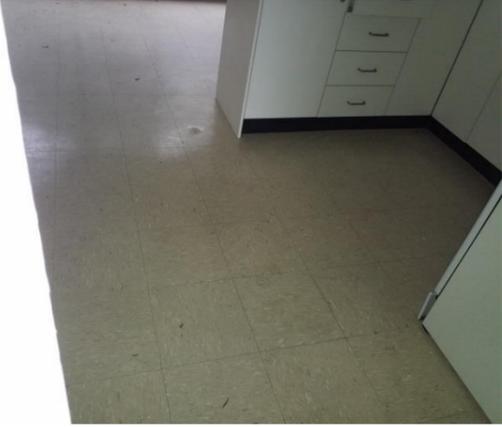
Unit 9, kitchen	Cream fleck vinyl floor tiles	Non-friable	Similar to A13	Visual Inspection Assume negative	NA	NA	NA	NA

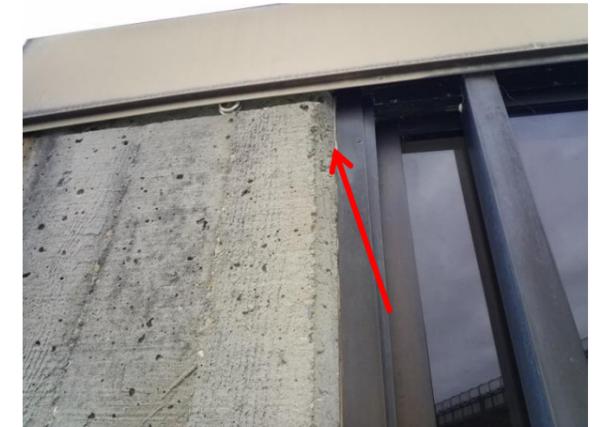
Unit 9, rooftop terrace door, sealant between frame and wall (brown)	Sealant	Non-friable	Similar to A52	Assume positive	Not determined	Good Maintenance only	Priority 4: Negligible Risk Level	Remove prior to refurbishment works
--	---------	-------------	----------------	------------------------	----------------	-----------------------	-----------------------------------	-------------------------------------

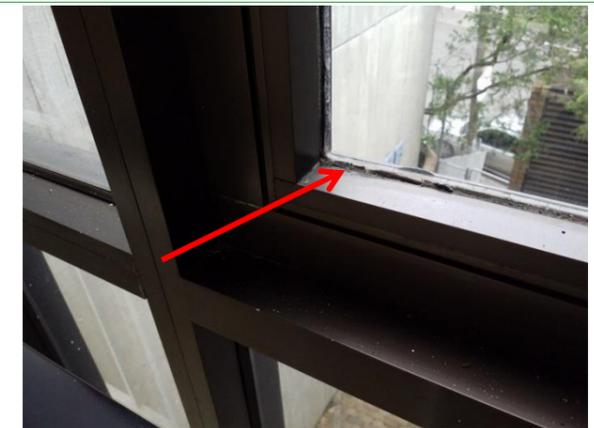
Internal window frame to pane putty	Sealant	Non-friable	A51	Assume positive	Not determined	Good Maintenance only	Priority 4: Negligible Risk Level	Remove prior to refurbishment works
-------------------------------------	---------	-------------	-----	------------------------	----------------	-----------------------	-----------------------------------	-------------------------------------

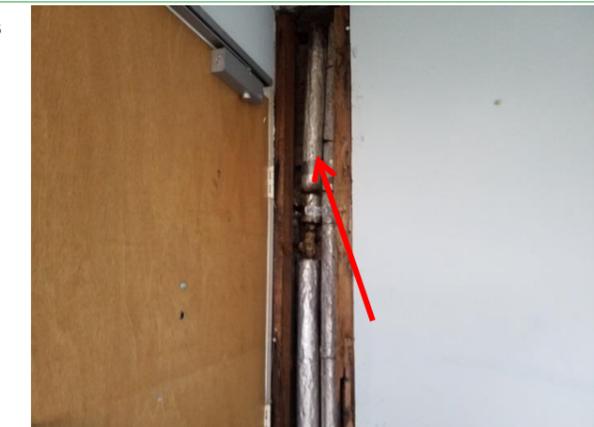
All floors, water risers, insulation to hot water pipes	Foil backed SMF insulation	Not friable	Not sampled Visual Inspection	Assume positive	Not determined	Good Maintenance only	Priority 4: Negligible Risk Level	Remove during demolition works
---	----------------------------	-------------	-------------------------------	------------------------	----------------	-----------------------	-----------------------------------	--------------------------------

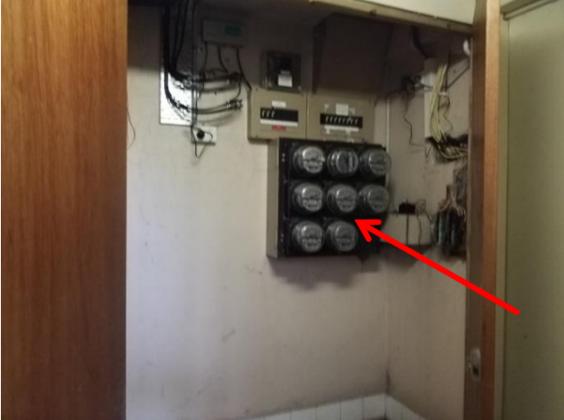
Location	Material Type	Friability	Sample	Analysis Result:	Quantity	Condition and Accessibility	Priority	Recommendations/ Comments	Photograph of material
38 Cumberland Street, The Rocks									
Inaccessible									
Internal, wall cavities	Possible hazardous materials	Unknown	Inaccessible	NA	Not determined	Unknown Inaccessible	Inaccessible	No access available at time of inspection. When areas are accessible, confirm status of hazardous materials.	
Internal, walls behind ceramic tiles, membranes	Possible hazardous materials	Unknown	Inaccessible	NA	Not determined	Unknown Inaccessible	Inaccessible	No access available at time of inspection. When areas are accessible, confirm status of hazardous materials.	
Asbestos									
Sub-basement, electrical switch room	Electrical backing board	Non-friable	Similar to A12	Assume positive	1 unit	Good Maintenance only	Priority 4: Negligible Risk Level	Remove prior to refurbishment works

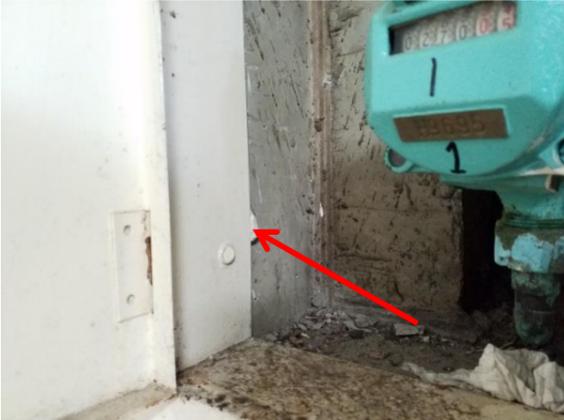
Common area, outside unit 1, water meter riser, packing to frame	Asbestos cement sheeting	Non-friable	Similar to A47	Assume positive	Not determined	Good Maintenance only	Priority 4: Negligible Risk Level	Remove prior to refurbishment works

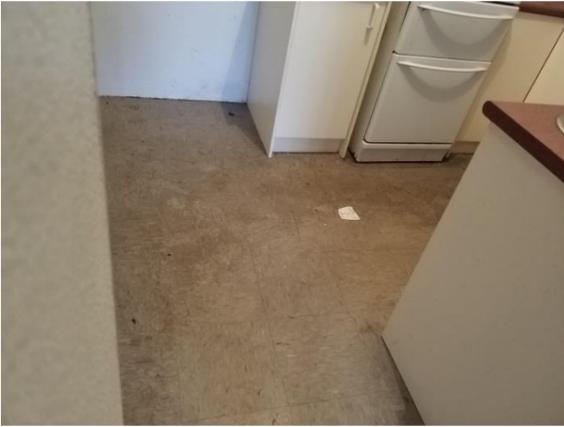
Unit 1, kitchen	Grey fleck vinyl floor tiles	Non-friable	Similar to A36	Assume negative	NA	NA	NA	NA

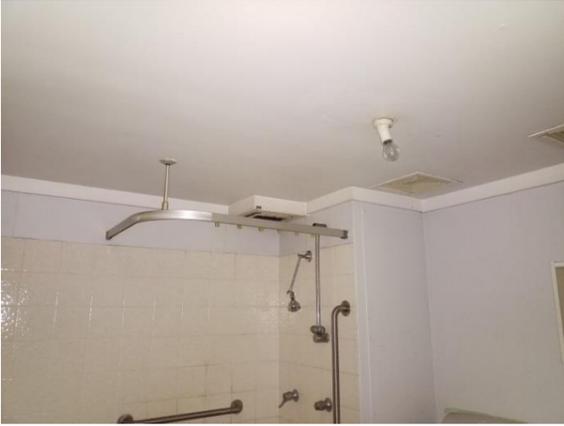
Unit 1, bathroom	Asbestos cement sheeting	Non-friable	Similar to A47	Assume positive	6m ²	Good Maintenance only	Priority 4: Negligible Risk Level	Remove prior to refurbishment works

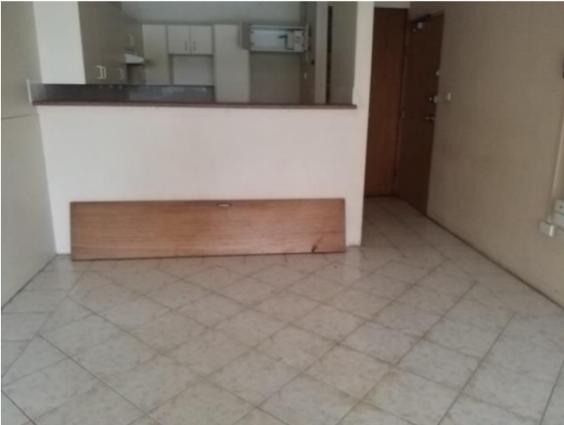
Unit 2, kitchen	Ceramic tiles	NA	Visual Inspection	Assume negative	NA	NA	NA	NA

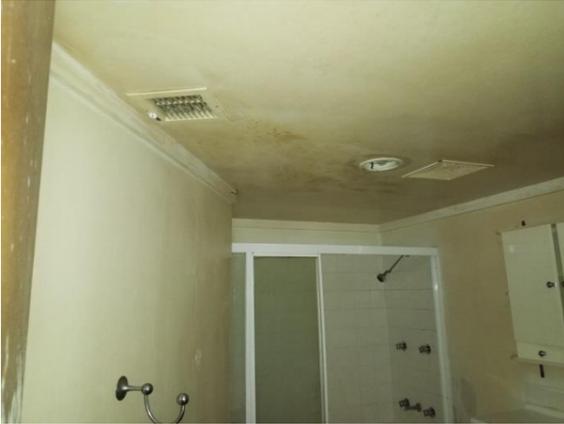
Unit 2, bathroom ceiling	Asbestos cement sheeting	Non-friable	Similar to A47	Assume positive	6m ²	Good Maintenance only	Priority 4: Negligible Risk Level	Remove prior to refurbishment works

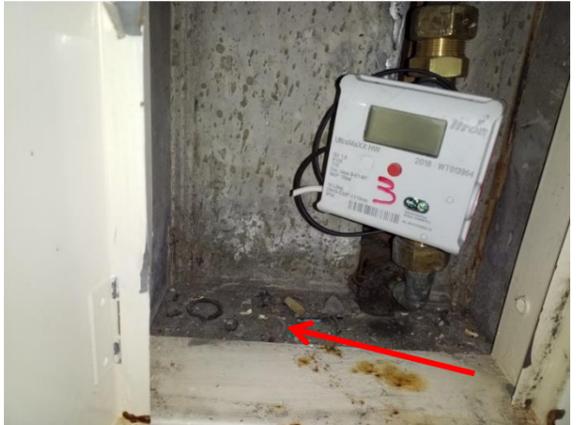
Common area, outside unit 3, water meter riser, redundant gaskets	Gasket	Friable	Similar to A38	Assume positive	Not determined	Fair Maintenance only	Priority 4: Negligible Risk Level	Remove prior to refurbishment works

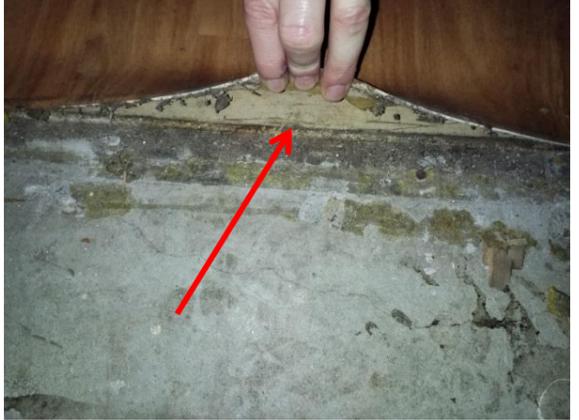
Unit 3, kitchen, under new style vinyl sheeting	Cream vinyl floor tiles	Non-friable	Similar to A16	Assume negative	NA	NA	NA	NA

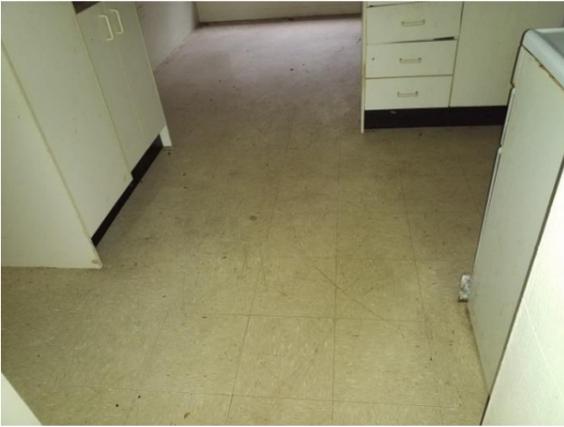
Unit 4, kitchen	Cream fleck vinyl floor tiles	Non-friable	Similar to A13	Assume negative	NA	NA	NA	NA

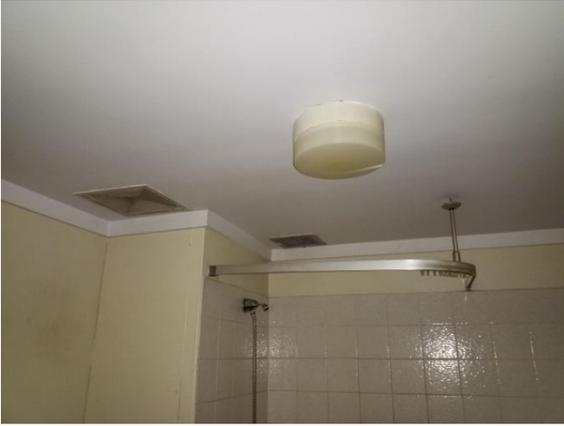
Unit 4, bathroom	Asbestos cement sheeting	Non-friable	Similar to A47	Assume positive	6m ²	Good Maintenance only	Priority 4: Negligible Risk Level	Remove prior to refurbishment works

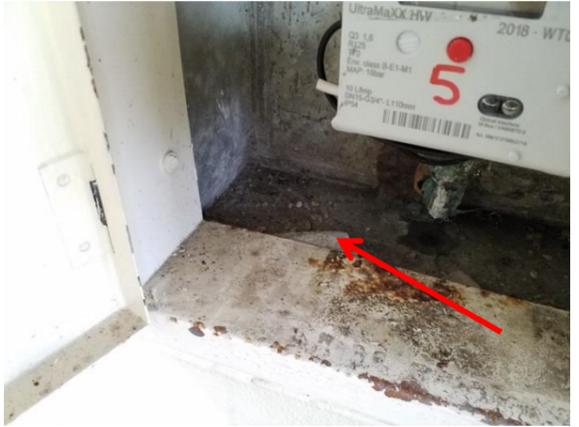
Common area, outside unit 5, water meter risers, packing to frame and concrete walls	Asbestos cement sheeting	Non-friable	Similar to A47	Assume positive	Not determined	Good Maintenance only	Priority 4: Negligible Risk Level	Remove prior to refurbishment works

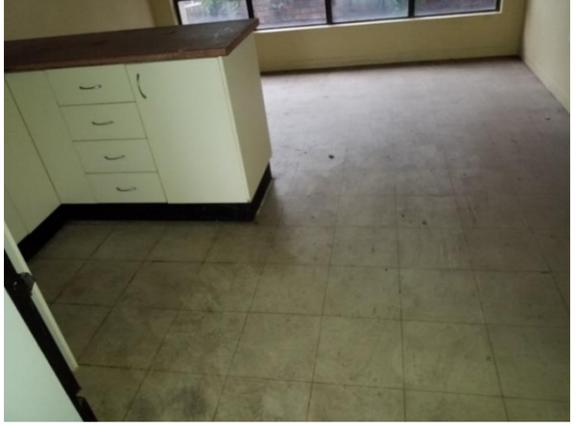
Unit 5, kitchen	Cream vinyl floor tiles	Non-friable	Similar to A16	Assume negative	NA	NA	NA	NA

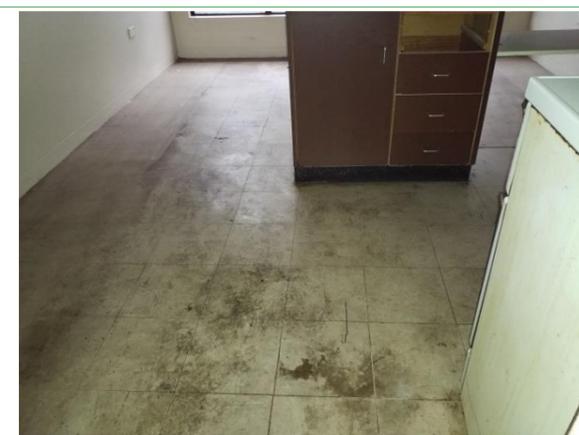
Unit 6, kitchen	Cream vinyl floor tiles	Non-friable	Similar to A16	Assume negative	NA	NA	NA	NA

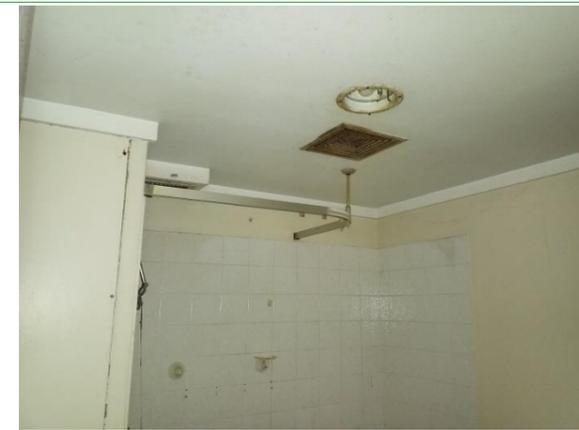
Unit 6, bathroom, ceiling	Asbestos cement sheeting	Non-friable	Similar to A47	Assume positive	6m ²	Good Maintenance only	Priority 4: Negligible Risk Level	Remove prior to refurbishment works

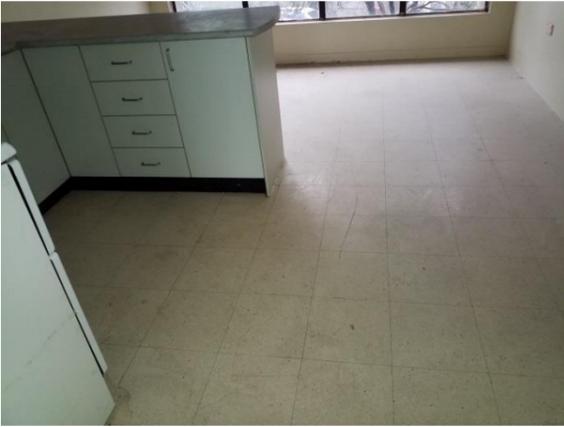
Unit 7, kitchen	Cream and blue speck vinyl floor tiles	Non-friable	Similar to A29	Assume negative	NA	NA	NA	NA

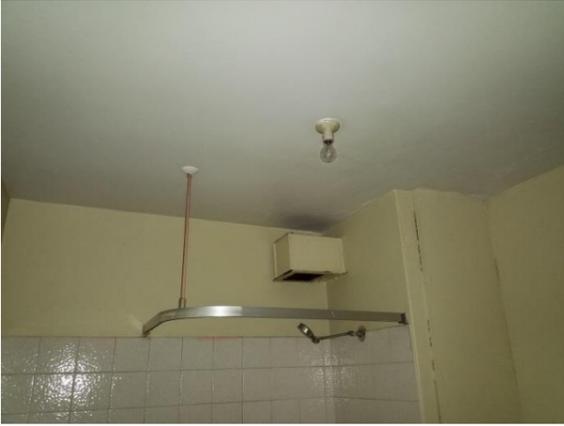
Unit 7, bathroom ceiling	Concrete	NA	Visual Inspection	Assume negative	NA	NA	NA	NA

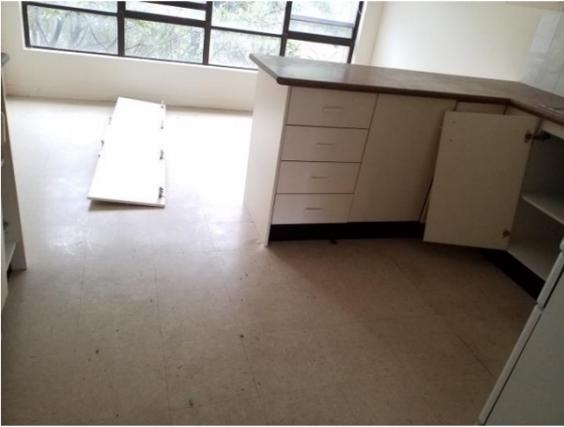
Unit 8, kitchen	Cream fleck vinyl floor tiles	Non-friable	Similar to A13	Assume negative	NA	NA	NA	NA

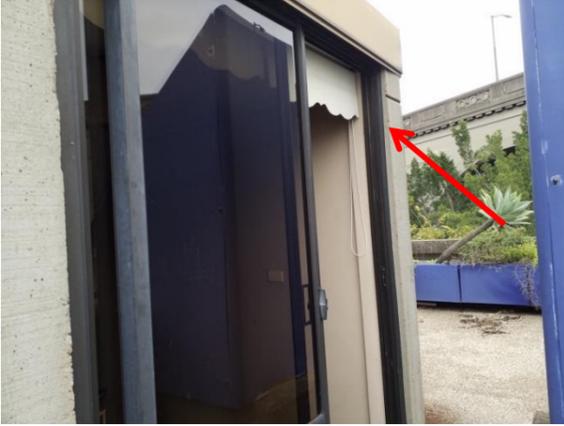
Unit 8 bathroom ceiling	Concrete	NA	Visual Inspection	Assume negative	NA	NA	NA	NA	
Unit 8, rooftop terrace door, sealant between frame and wall (brown)	Sealant	Non-friable	Similar to A52	Assume positive	Not determined	Good Maintenance only	Priority 4: Negligible Risk Level	Remove prior to refurbishment works

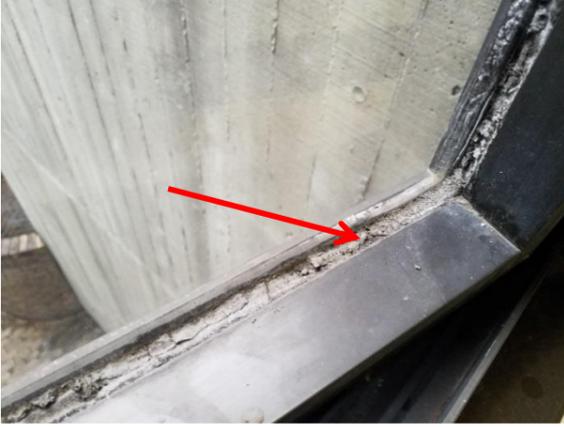
Common area, hinged windows, frame to pane putty (white)	Sealant	Non-friable	A53	No Asbestos Detected	NA	NA	NA	NA

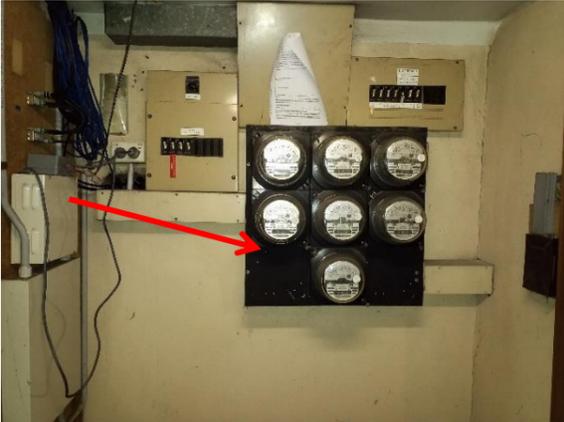
Location	Material Type	Friability	Sample	Analysis Result:	Quantity	Condition and Accessibility	Priority	Recommendations/ Comments	Photograph of material
40 Cumberland Street, The Rocks									
Inaccessible									
Internal, wall cavities	Possible hazardous materials	Unknown	Inaccessible	NA	Not determined	Unknown Inaccessible	Inaccessible	No access available at time of inspection. When areas are accessible, confirm status of hazardous materials.	
Internal, walls behind ceramic tiles, membranes	Possible hazardous materials	Unknown	Inaccessible	NA	Not determined	Unknown Inaccessible	Inaccessible	No access available at time of inspection. When areas are accessible, confirm status of hazardous materials.	
Asbestos									
Sub-basement electrical switch room	Electrical backing board	Non-friable	Similar to A12	Assume positive	1 unit	Good Maintenance only	Priority 4: Negligible Risk Level	Remove prior to refurbishment works

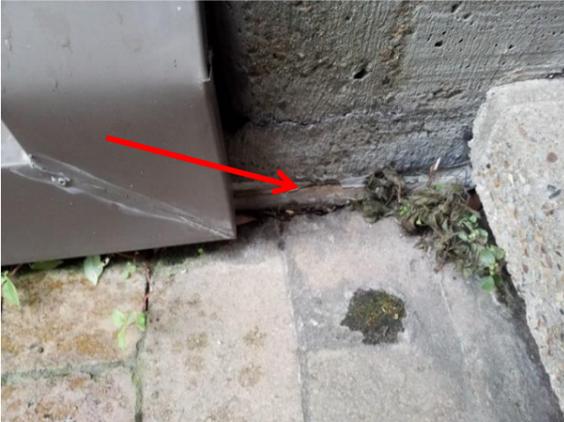
External, sealant between wall and brick path	Sealant	Non-friable	A54	Chrysotile Asbestos Detected	Not determined	Good Maintenance only	Priority 4: Negligible Risk Level	Remove prior to refurbishment works

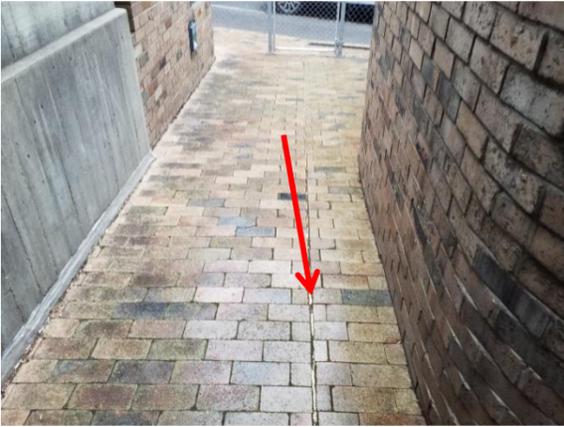
External, western entry path & eastern courtyard, expansion gap	Sealant	Non-friable	A55	No Asbestos Detected	NA	NA	NA	NA

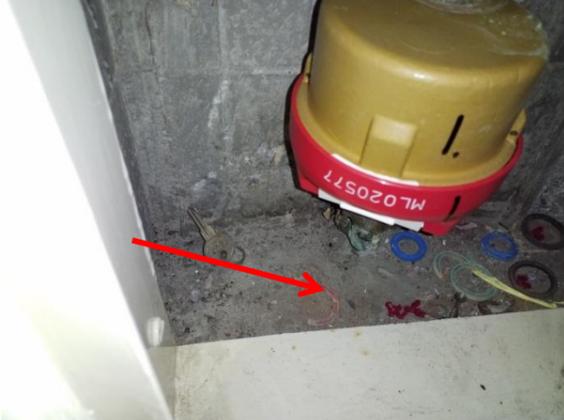
Common are, outside unit 1, water meter riser, redundant gaskets	Gaskets	Friable	Similar to A38	Assume positive	Not determined	Fair Maintenance only	Priority 4: Negligible Risk Level	Remove prior to refurbishment works

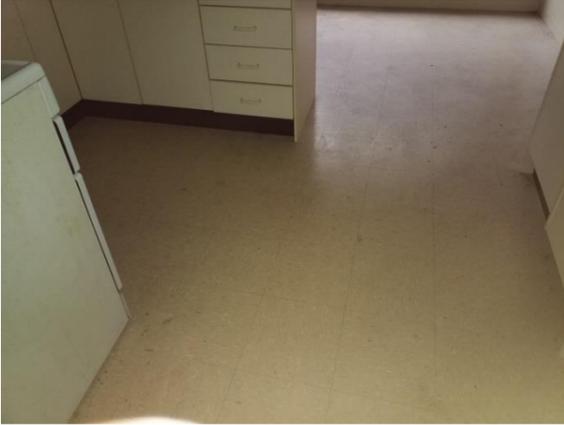
Unit 1, kitchen,	Cream fleck vinyl floor tiles	Non-friable	Similar to A13	Assume negative	NA	NA	NA	NA

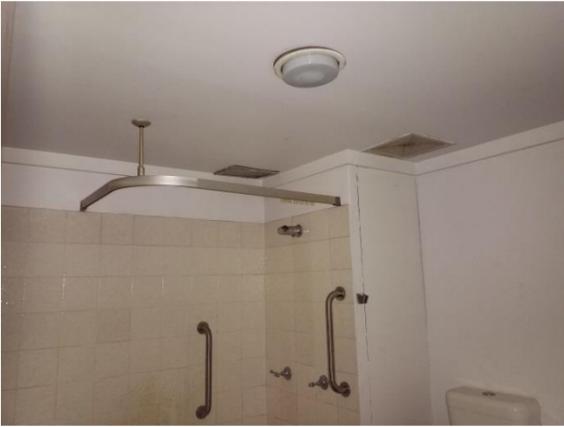
Unit 1, bathroom ceiling	Asbestos cement sheeting	Non-friable	Similar to A47	Assume positive	6m ²	Good Maintenance only	Priority 4: Negligible Risk Level	Remove prior to refurbishment works

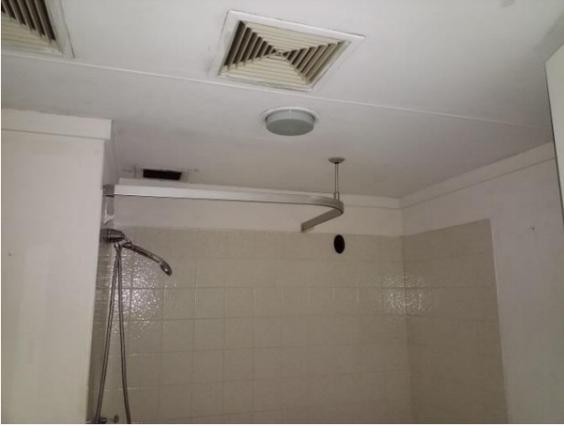
Unit 2, kitchen floor	Tan fleck vinyl floor tiles	Non-friable	A56	No Asbestos Detected	NA	NA	NA	NA	
Unit 2, bathroom	Asbestos cement sheeting	Non-friable	Similar to A47	Assume positive	6m ²	Good Maintenance only	Priority 4: Negligible Risk Level	Remove prior to refurbishment works

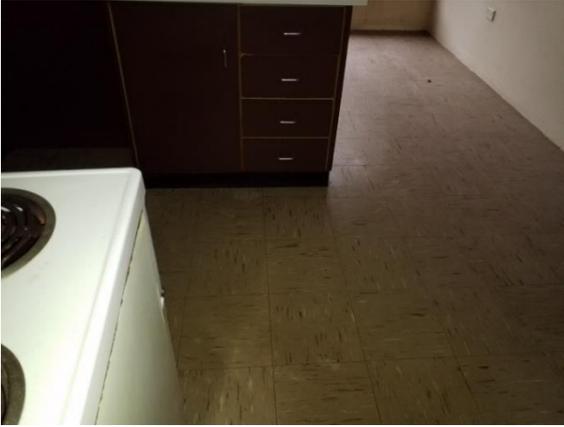
Common are, outside unit 3, water meter riser, packing between frame and wall + redundant material	Asbestos cement sheeting	Non-friable	A57	Chrysotile Asbestos Detected Organic Fibres Detected	Not determined	Good Maintenance only	Priority 4: Negligible Risk Level	Remove prior to refurbishment works	
Unit 3, kitchen, floor	Tan fleck vinyl floor tiles	Non-friable	Similar to A56	Assume negative	NA	NA	NA	NA

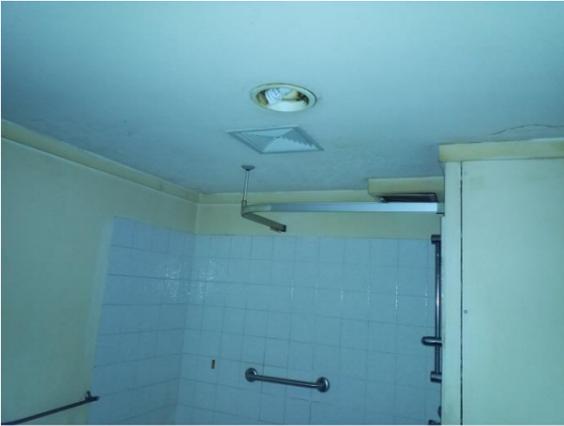
Unit 3 bathroom, ceiling	Asbestos cement sheeting	Non-friable	Similar to A47	Assume positive	6m ²	Good Maintenance only	Priority 4: Negligible Risk Level	Remove prior to refurbishment works

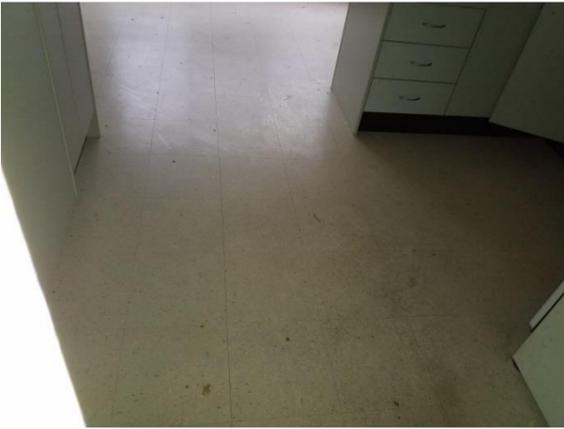
Unit 4, kitchen, floor	Cream and blue speck vinyl floor tiles	Non-friable	Similar to A29	Assume negative	NA	NA	NA	NA

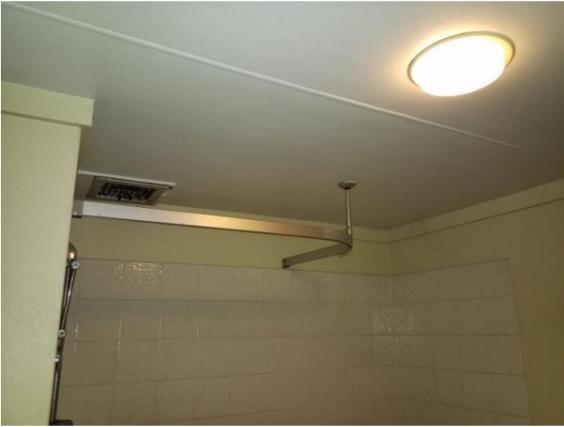
Unit 4 bathroom, ceiling	Asbestos cement sheeting	Non-friable	Similar to A47	Assume positive	6m ²	Good Maintenance only	Priority 4: Negligible Risk Level	Remove prior to refurbishment works

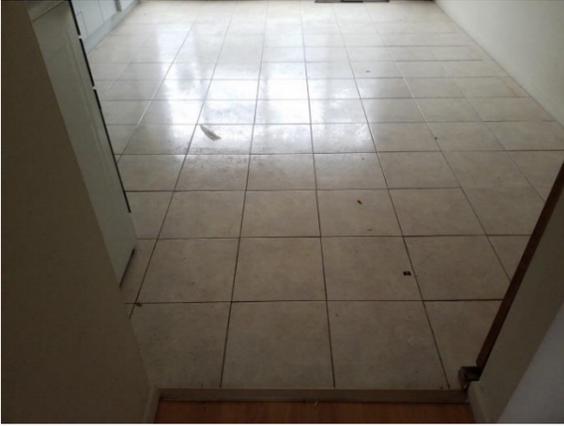
Unit 5, kitchen, floor	Ceramic tiles	NA	Visual Inspection	Assume negative	NA	NA	NA	NA

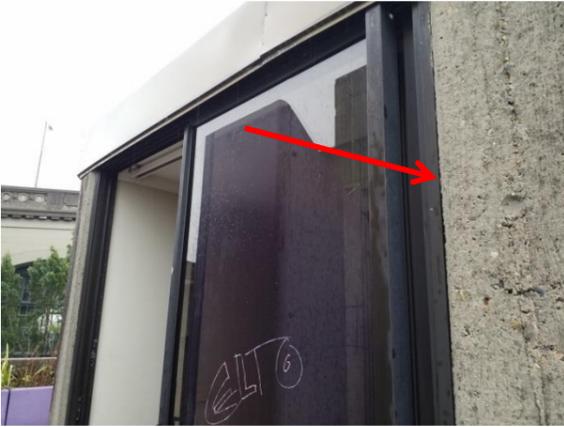
Unit 5 rooftop terrace door, sealant between frame and wall (brown)	Sealant	Non-friable	Similar to A52	Assume positive	Not determined	Good Maintenance only	Priority 4: Negligible Risk Level	Remove prior to refurbishment works

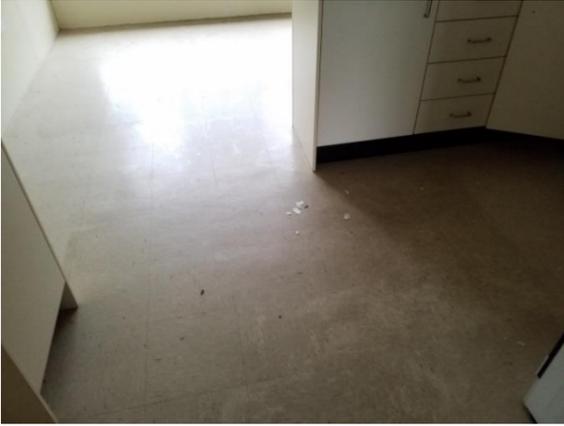
Unit 6, kitchen, floor,	Cream fleck vinyl floor tiles	Non-friable	Similar to A13	Assume negative	NA	NA	NA	NA

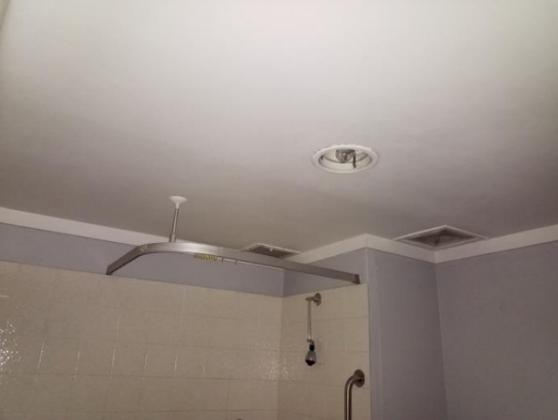
Location	Material Type	Friability	Sample	Analysis Result:	Quantity	Condition and Accessibility	Priority	Recommendations/ Comments	Photograph of material
42 Cumberland Street, The Rocks									
Inaccessible									
Internal, wall cavities	Possible hazardous materials	Unknown	Inaccessible	NA	Not determined	Unknown Inaccessible	Inaccessible	No access available at time of inspection. When areas are accessible, confirm status of hazardous materials.	
Internal, walls behind ceramic tiles, membranes	Possible hazardous materials	Unknown	Inaccessible	NA	Not determined	Unknown Inaccessible	Inaccessible	No access available at time of inspection. When areas are accessible, confirm status of hazardous materials.	
Asbestos									
Bathroom, ceiling	Asbestos cement sheeting	Non-friable	Similar to A47	Assume positive	6m ²	Good Maintenance only	Priority 4: Negligible Risk Level	Remove prior to refurbishment works

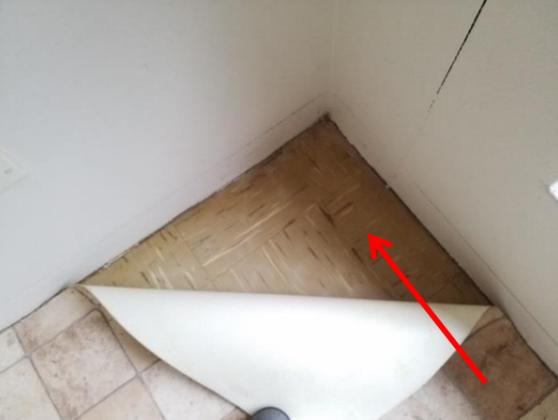
Kitchen, floor under new vinyl sheeting	Grey fleck vinyl floor tiles	Non-friable	Similar to A36	Assume negative	NA	NA	NA	NA

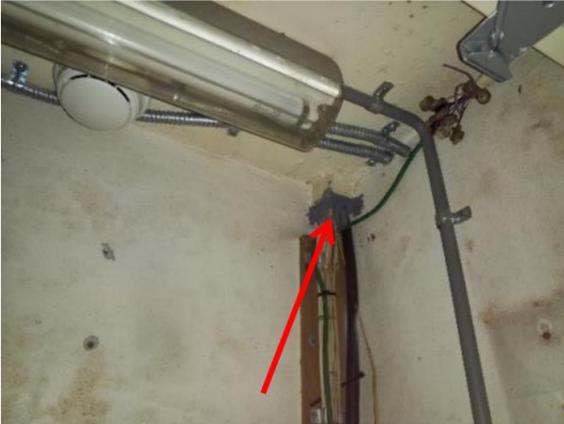
Location	Material Type	Friability	Sample	Analysis Result:	Quantity	Condition and Accessibility	Priority	Recommendations/ Comments	Photograph of material
44 Cumberland Street, The Rocks									
Inaccessible									
Internal, wall cavities	Possible hazardous materials	Unknown	Inaccessible	NA	Not determined	Unknown Inaccessible	Inaccessible	No access available at time of inspection. When areas are accessible, confirm status of hazardous materials.	
Internal, walls behind ceramic tiles, membranes	Possible hazardous materials	Unknown	Inaccessible	NA	Not determined	Unknown Inaccessible	Inaccessible	No access available at time of inspection. When areas are accessible, confirm status of hazardous materials.	
Asbestos									
Carpark									
Car park, communications room, grey fire proofing to cable penetration Used throughout the building	Sealant	Non-friable	A01	No Asbestos Detected	NA	NA	NA	NA

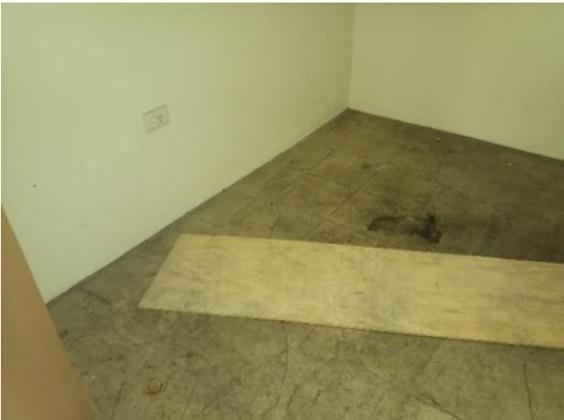
Car park, kitchenette, floor	Cream vinyl floor tiles	Non-friable	A02	No Asbestos Detected	NA	NA	NA	NA

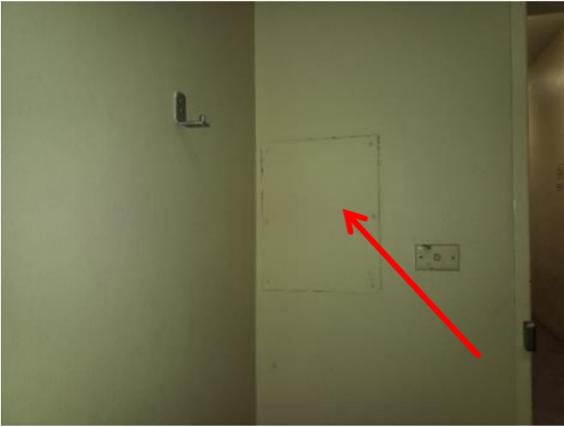
Car park, kitchenette, infill panel behind water meter	Asbestos cement sheeting	Non-friable	A03	Chrysotile Asbestos Detected Organic Fibres Detected	<1m ²	Good Maintenance only	Priority 4: Negligible Risk Level	Remove prior to refurbishment works

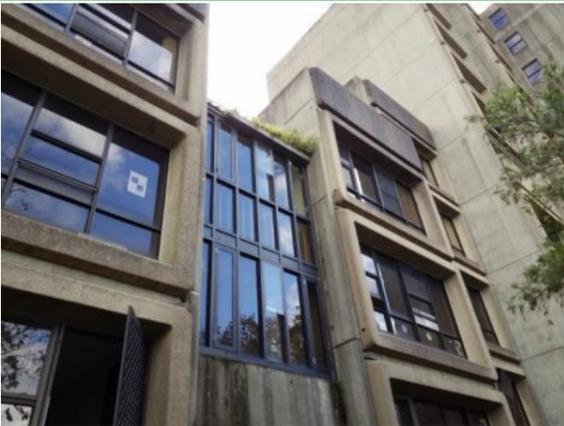
External									
External, expansion gaps to concrete	Sealant	Non-friable	A05	No Asbestos Detected	NA	NA	NA	NA

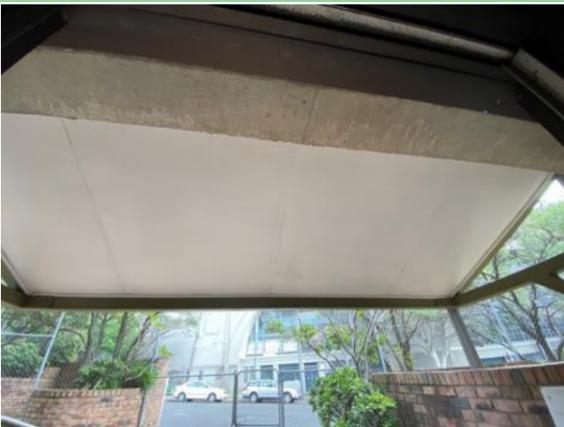
External, awning to main entry	Fibre cement sheeting	Non-friable	A06	No Asbestos Detected Organic Fibres Detected	NA	NA	NA	NA

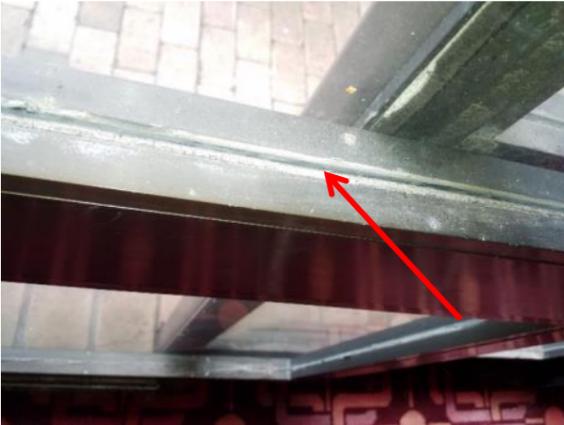
External window mastic	Sealant	Non-friable	A08	Chrysotile Asbestos Detected	Not determined	Good Maintenance only	Priority 4: Negligible Risk Level	Remove prior to refurbishment works

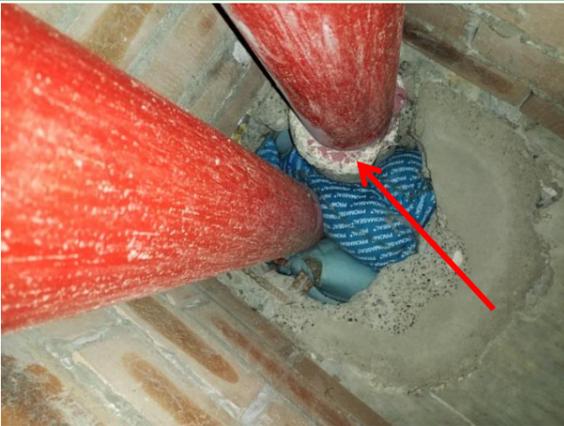
All floors, fire hydrant cupboard, penetration sealant around hydrant pipes	Woven asbestos rope	Friable	A09	Chrysotile Asbestos Detected Organic Fibres Detected	Not determined	Fair Maintenance only	Priority 3: Low Risk Level	Restrict access to hydrant cupboards to essential services only. Remove material prior to undertaking any works on hydrant lines.

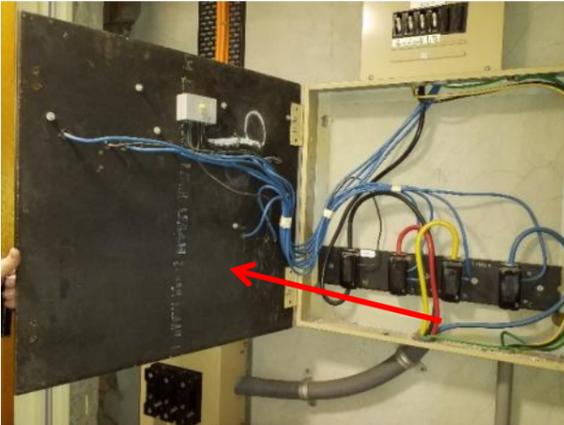
All residential floors, electrical main switchboard	Electrical backing board	Non-friable	A12	Chrysotile Asbestos Detected	2 units per floor	Good Maintenance only	Priority 4: Negligible Risk Level	Remove prior to refurbishment works

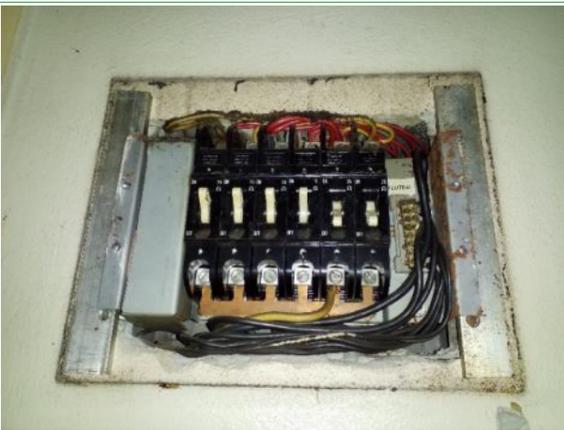
All residential floors, residential units, switchboards	Electrical backing board – not ACM	Non-friable	Not sampled	Assume negative	NA	NA	NA	NA

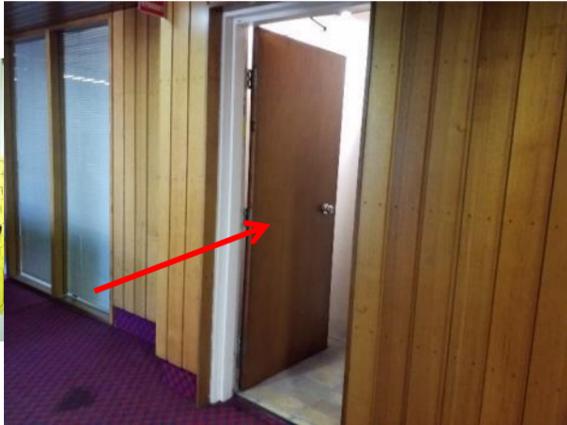
Ground floor, basement access stairs "Padde"	Fire door	Friable	A10	Chrysotile Asbestos Detected Organic Fibres Detected	1 unit	Good Maintenance only	Priority 4: Negligible Risk Level	Remove prior to refurbishment works

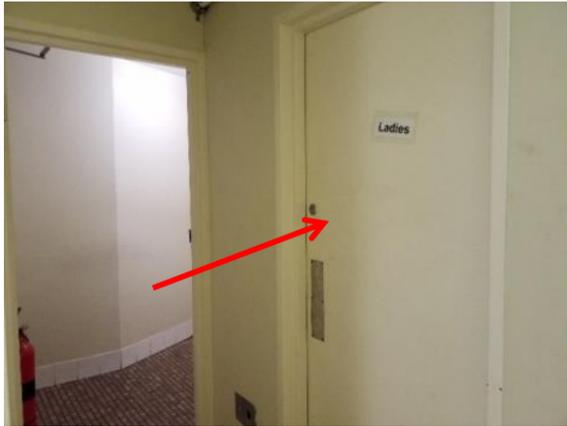
Ground floor, female amenities, door (2009 tag stuck on)	Fire door	Friable	A11	Chrysotile Asbestos Detected Organic Fibres Detected	1 Unit	Good Maintenance only	Priority 4: Negligible Risk Level	Remove prior to refurbishment works. Tag not original to door. All doors are to be assumed to contain asbestos unless certificates with installation dates after 2003 can be obtained.

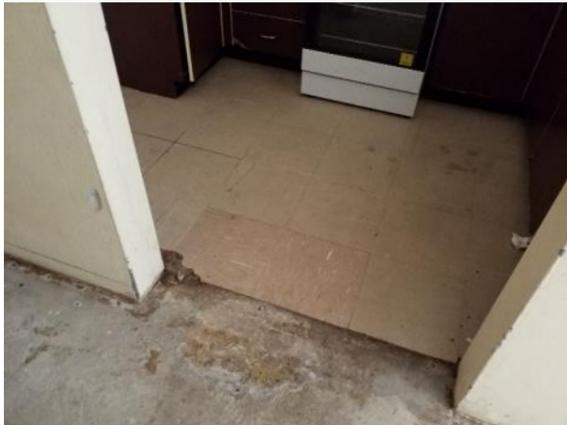
First floor, unit 11, kitchen floor	Cream fleck vinyl floor tiles	Non-friable	A13	No Asbestos Detected	NA	NA	NA	NA
