Hazardous Materials Survey

2-60 Cumberland St, The Rocks NSW

Report Title: Hazardous Materials Survey - 2-60 Cumberland St, The Rocks NSW
Report No: E24614.E10_Rev1

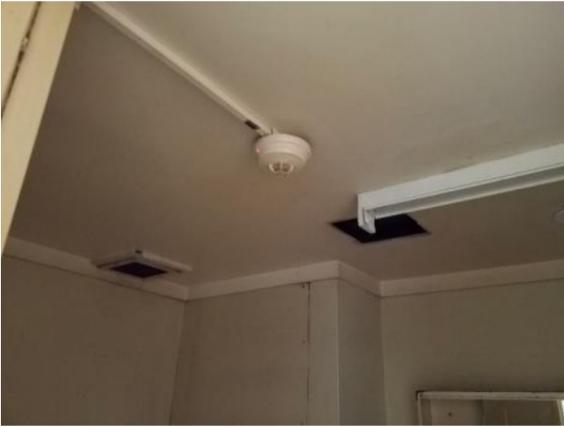
First floor, unit 11, bathroom, ceiling	Asbestos cement sheeting	Non-friable	Similar to A17	Assume positive	6m ²	Good Maintenance only	Priority 4: Negligible Risk Level	Remove prior to refurbishment works

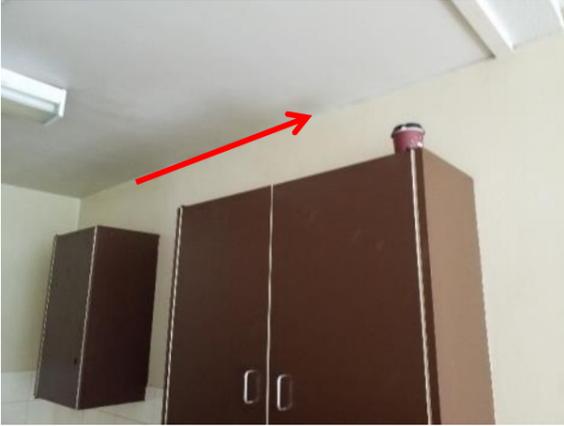
First floor, wall to ceiling joint	Sealant	Non-friable	A15	No Asbestos Detected	NA	NA	NA	NA

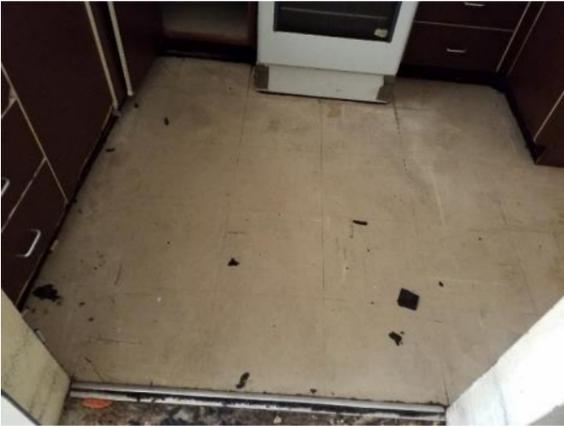
First floor, unit 12, kitchen, floor	Cream vinyl floor tiles	Non-friable	A16	No Asbestos Detected	NA	NA	NA	NA

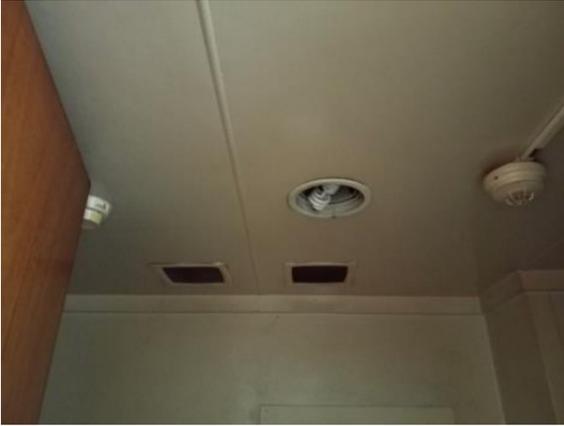
First floor, unit 13, bathroom, ceiling	Asbestos cement sheeting	Non-friable	Similar to A17	Assume positive	6m ²	Good Maintenance only	Priority 4: Negligible Risk Level	Remove prior to refurbishment works

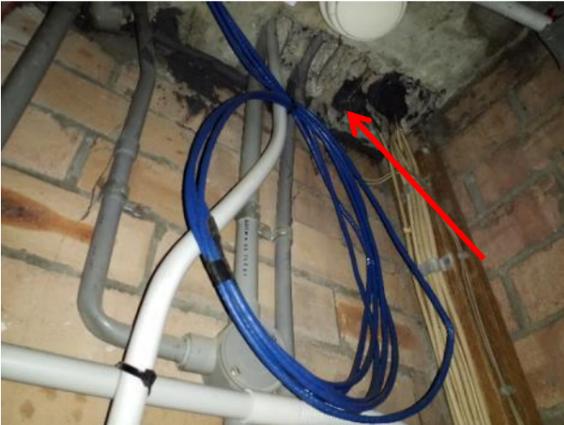
First floor, waste disposal room, services riser, penetrations, fire proofing	Sealant	Non-friable	A18	No Asbestos Detected	NA	NA	NA	NA	NA

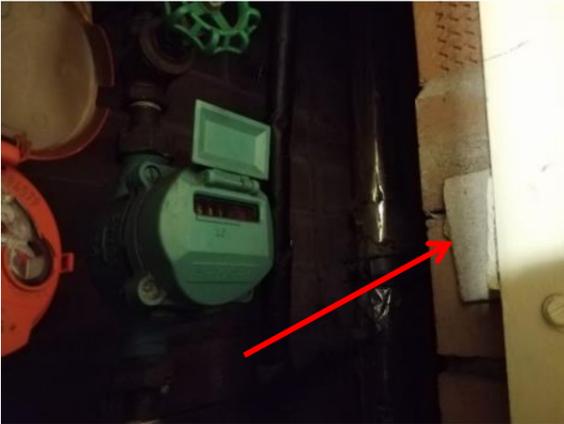
Second floor, common area, water meter risers, packing between metal frame and brick walls	Asbestos cement sheeting	Non-friable	Similar to A20	Assume positive	Not determined	Good Maintenance only	Priority 4: Negligible Risk Level	Remove prior to refurbishment works

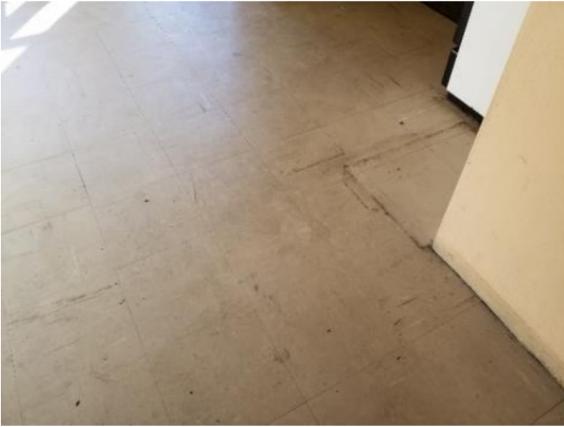
Second floor, unit 22, kitchen and dining room, floor	Cream vinyl floor tiles	Non-friable	Similar to A16	Assume negative	NA	NA	NA	NA

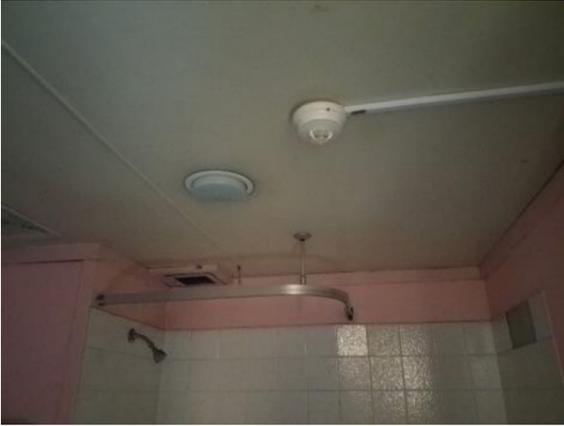
Second floor, unit 22, bathroom, ceiling	Asbestos cement sheeting	Non-friable	Similar to A17	Assume positive	6m ²	Good Maintenance only	Priority 4: Negligible Risk Level	Remove prior to refurbishment works

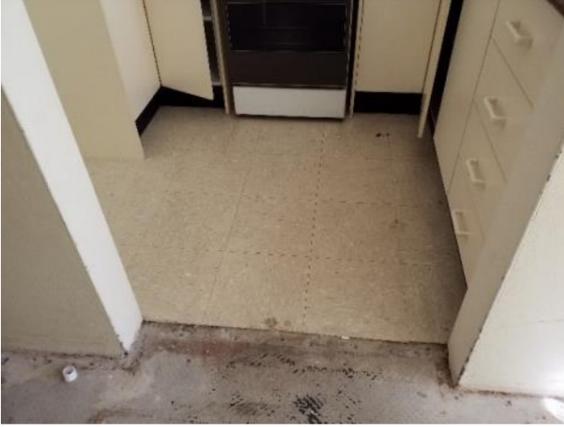
Second floor, unit 23, kitchen floor	Cream fleck vinyl floor tiles	Non-friable	Similar to A13	Assume negative	NA	NA	NA	NA

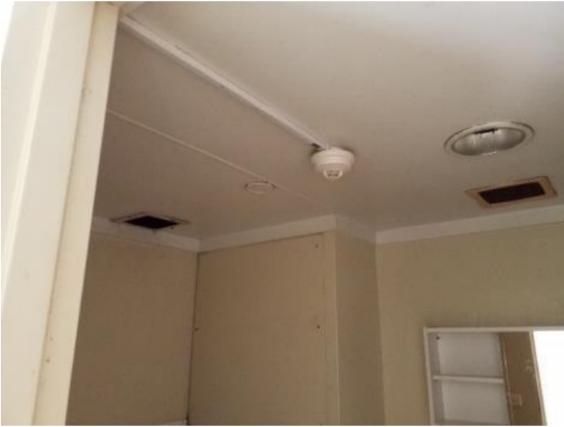
Second floor, unit 23, bathroom ceiling	Asbestos cement sheeting	Non-friable	Similar to A17	Assume positive	6m ²	Good Maintenance only	Priority 4: Negligible Risk Level	Remove prior to refurbishment works

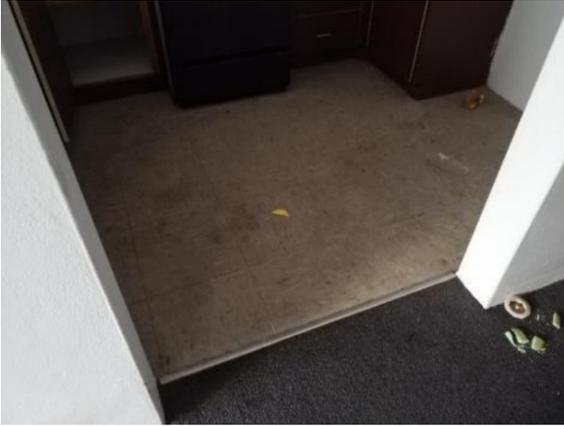
Second floor, unit 24, kitchen, floor,	Grey fleck vinyl floor tiles	Non-friable	A19	No Asbestos Detected	NA	NA	NA	NA

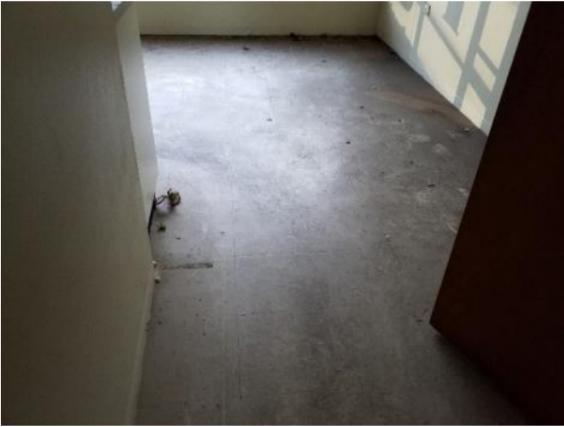
Second floor, unit 25, kitchen and dining, floor	Cream vinyl floor tiles	Non-friable	Similar to A16	Assume negative	NA	NA	NA	NA

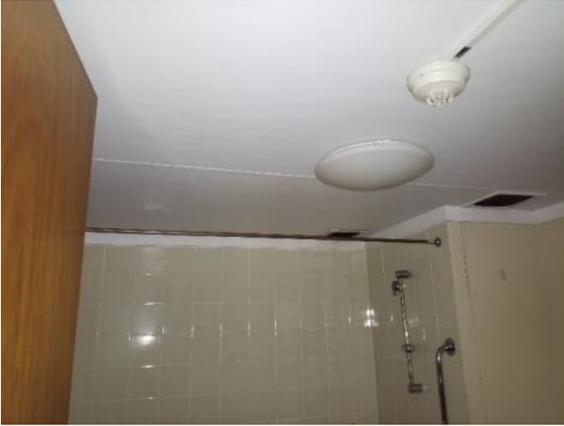
Second floor, unit 25, bathroom ceiling	Asbestos cement sheeting	Non-friable	Similar to A17	Assume positive	6m ²	Good Maintenance only	Priority 4: Negligible Risk Level	Remove prior to refurbishment works

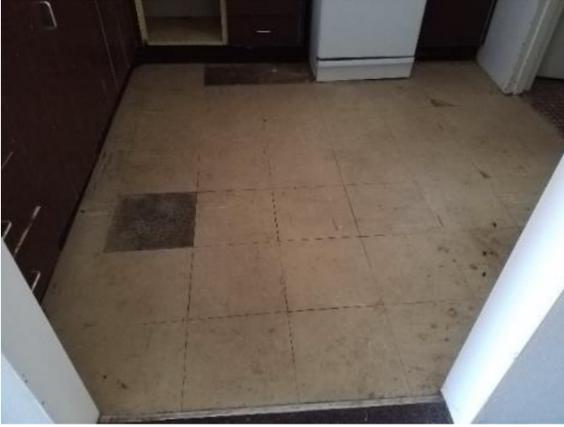
Second floor, unit 26, kitchen floor	Cream vinyl floor tiles	Non-friable	Similar to A16	Assume negative	NA	NA	NA	NA

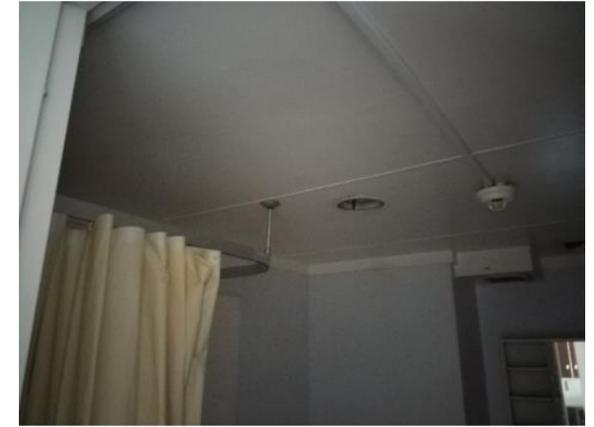
Second floor, unit 26, bathroom, ceiling Asbestos cement sheeting Non-friable Similar to A17 **Assume positive** 6m² Good Maintenance only Priority 4: Negligible Risk Level Remove prior to refurbishment works

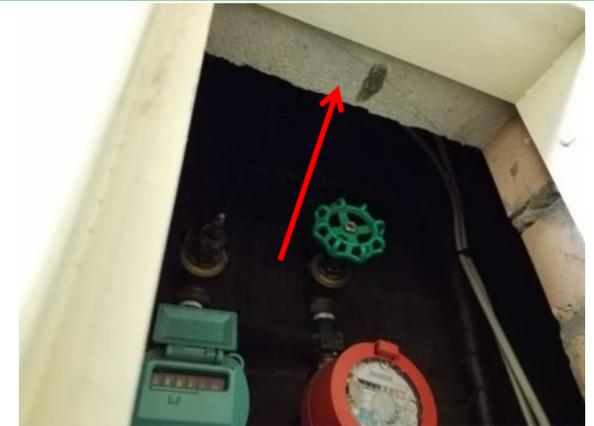
Third floor, common area, water meter risers, packing between metal frame and brick walls Asbestos cement sheeting Non-friable A20 **Chrysotile Asbestos Detected**
Organic Fibres Detected Not determined Good Maintenance only Priority 4: Negligible Risk Level Remove prior to refurbishment works

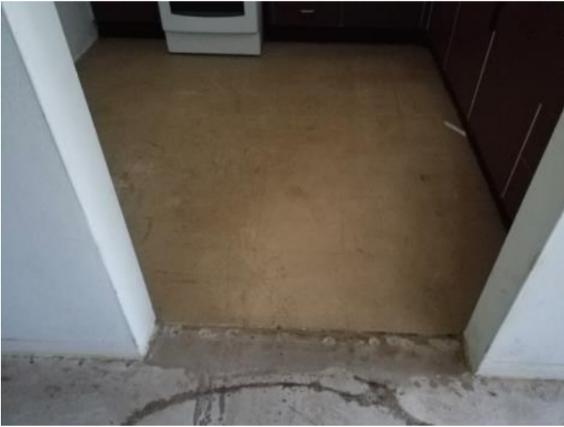
Third floor, unit 31, kitchen, floor	Cream vinyl floor tiles	Non-friable	Similar to A16	Assume negative	NA	NA	NA	NA

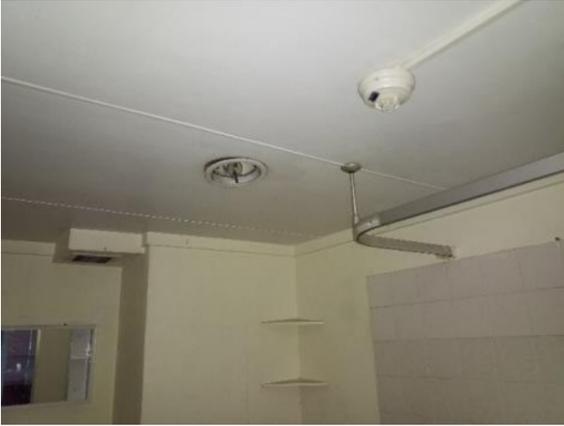
Third floor, unit 31, bathroom ceiling	Asbestos cement sheeting	Non-friable	Similar to A17	Assume positive	6m ²	Good Maintenance only	Priority 4: Negligible Risk Level	Remove prior to refurbishment works

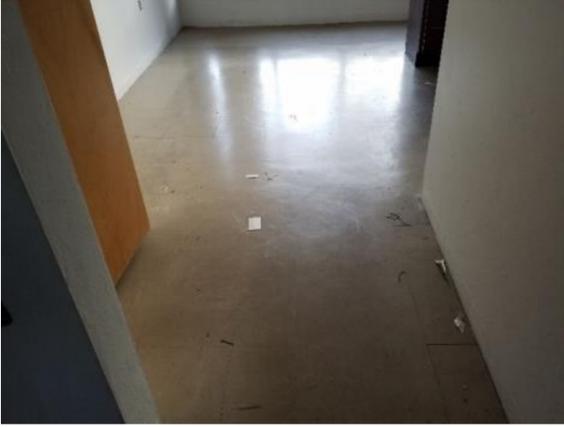
Third floor, unit 32, kitchen, floor	Cream vinyl floor tiles	Non-friable	Similar to A16	Assume negative	NA	NA	NA	NA

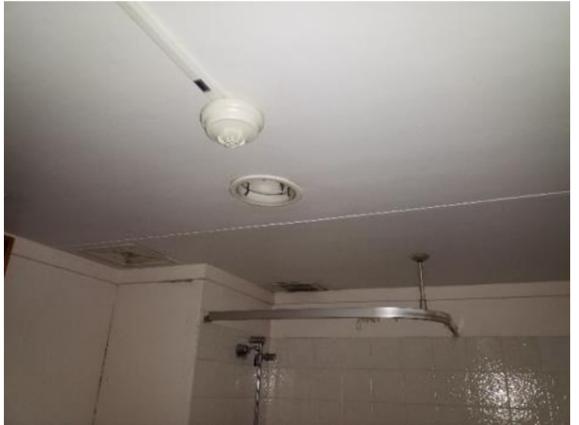
Third floor, unit 32, bathroom, ceiling	Asbestos cement sheeting	Non-friable	Similar to A31	Assume positive	6m ²	Good Maintenance only	Priority 4: Negligible Risk Level	Remove prior to refurbishment works

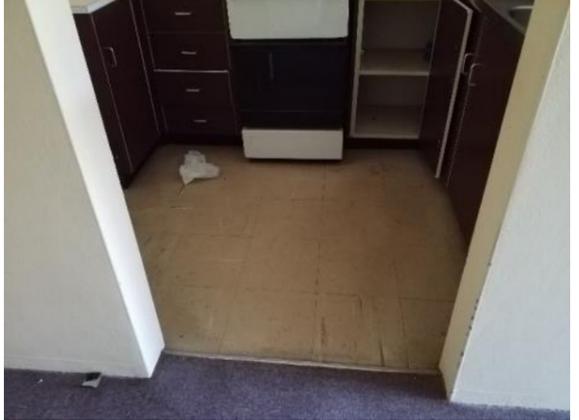
Third floor, unit 33, kitchen, floor	Cream vinyl floor tiles	Non-friable	Similar to A16	Assume negative	NA	NA	NA	NA

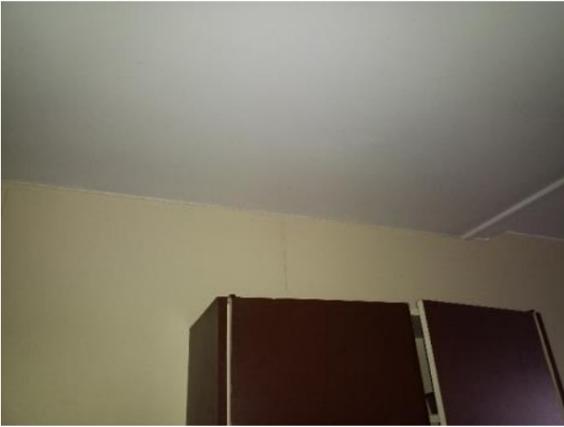
Third floor, unit 33, horizontal slip joint	Sealant	Non-friable	A24	No Asbestos Detected	NA	NA	NA	NA

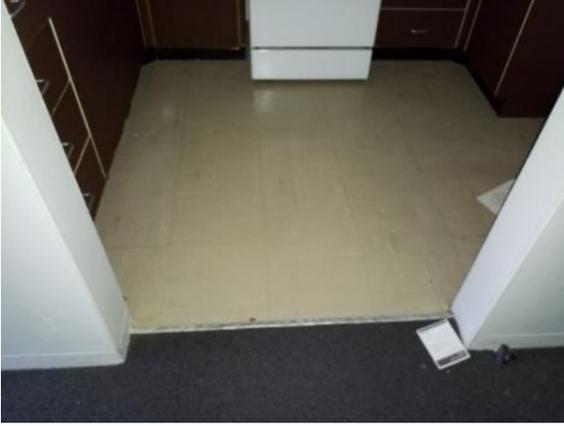
Third floor, unit 34, kitchen, floor	Cream vinyl floor tiles	Non-friable	Similar to A16	Assume negative	NA	NA	NA	NA

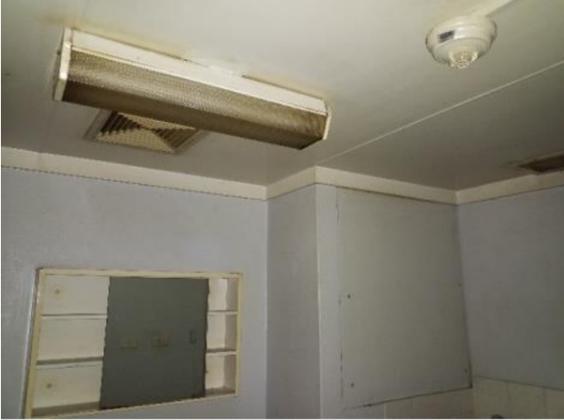
Third floor, unit 34, bathroom, ceiling	Asbestos cement sheeting	Non-friable	Similar to A31	Assume positive	6m ²	Good Maintenance only	Priority 4: Negligible Risk Level	Remove prior to refurbishment works

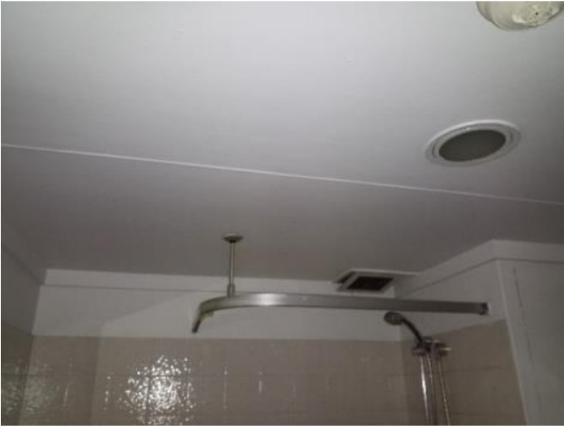
Third floor, unit 35, bathroom ceiling	Asbestos cement sheeting	Non-friable	Similar to A17	Assume positive	6m ²	Good Maintenance only	Priority 4: Negligible Risk Level	Remove prior to refurbishment works

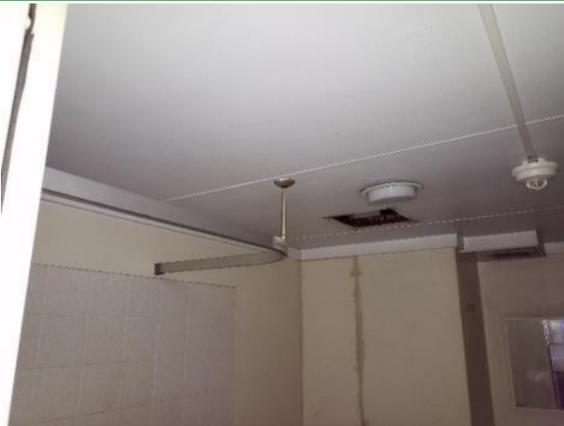
Third floor, unit 36, bathroom ceiling	Asbestos cement sheeting	Non-friable	A25	Chrysotile Asbestos Detected Organic Fibres Detected	6m ²	Good Maintenance only	Priority 4: Negligible Risk Level	Remove prior to refurbishment works

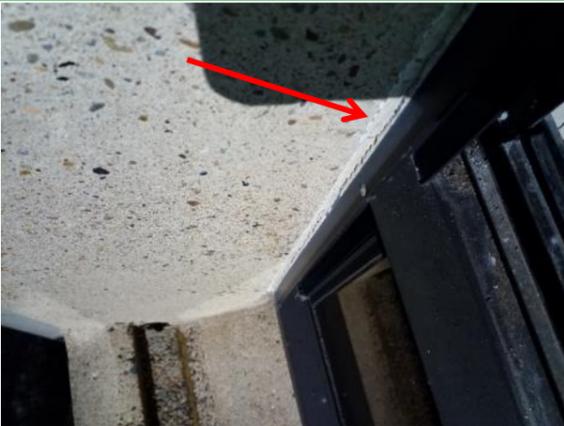
Third floor, unit 36, external window frame to wall	Sealant	Non-friable	A26	No Asbestos Detected	NA	NA	NA	NA

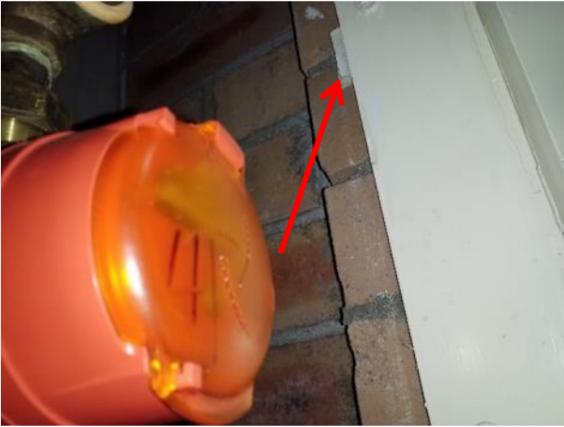
Fourth floor, common area, water meter risers, packing between metal frame and brick walls	Asbestos cement sheeting	Non-friable	Similar to A20	Assume positive	Not determined	Good Maintenance only	Priority 4: Negligible Risk Level	Remove prior to refurbishment works

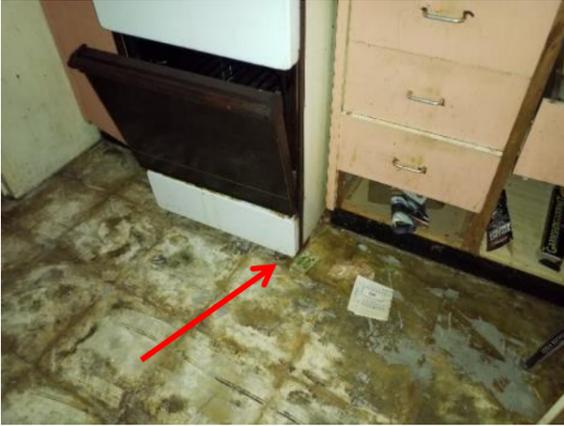
Fourth floor, Fourth floor, unit 41, kitchen, floor underneath stove	Cork print vinyl floor tiles	Non-friable	A27	No Asbestos Detected Organic Fibres Detected	NA	NA	NA	NA

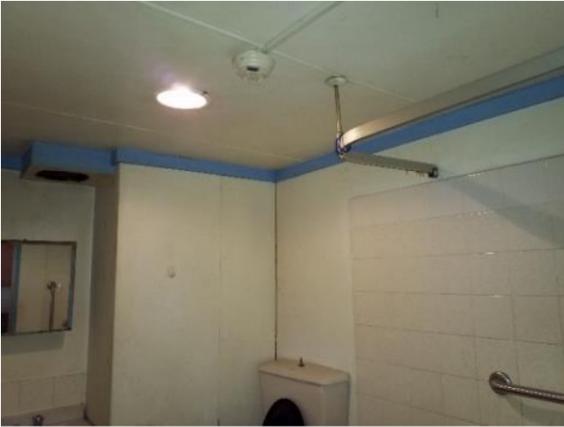
Fourth floor, Fourth floor, unit 41, kitchen, floor underneath stove	Beige vinyl floor tiles	Non-friable	A28	No Asbestos Detected	NA	NA	NA	NA	
Fourth floor, Fourth floor, unit 41, bathroom, ceiling	Asbestos cement sheeting	Non-friable	Similar to A25	Assume positive	6m ²	Good Maintenance only	Priority 4: Negligible Risk Level	Remove prior to refurbishment works

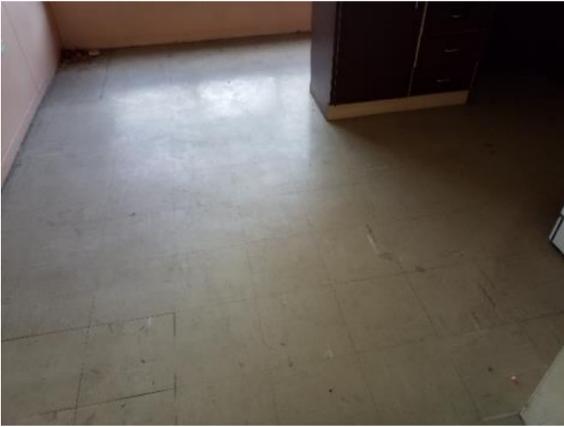
Fourth floor, Fourth floor, unit 42, kitchen/ dining, floor	Cream vinyl floor tiles	Non-friable	Similar to A16	Assume negative	NA	NA	NA	NA

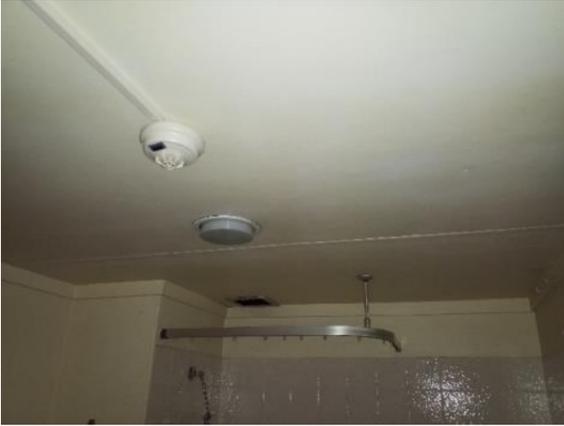
Fourth floor, Fourth floor, unit 42, bathroom, ceiling	Asbestos cement sheeting	Non-friable	Similar to A25	Assume positive	6m ²	Good Maintenance only	Priority 4: Negligible Risk Level	Remove prior to refurbishment works

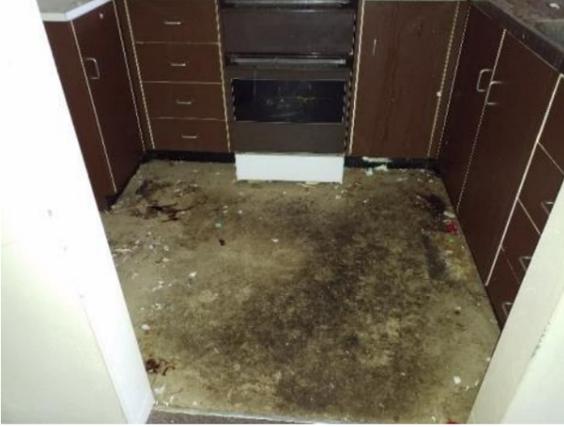
Fourth floor, Fourth floor, unit 43, kitchen, floor	Cream vinyl floor tiles	Non-friable	Similar to A16	Assume negative	NA	NA	NA	NA

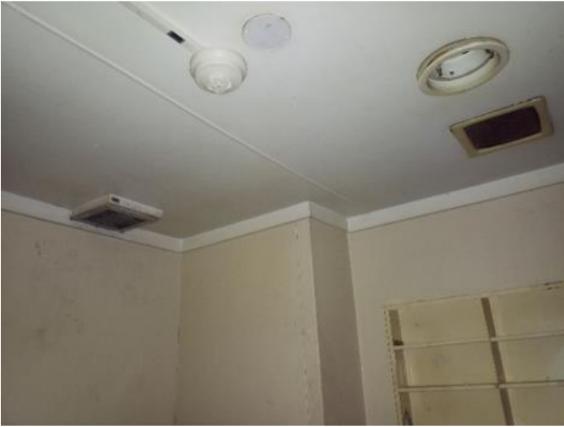
Fourth floor, Fourth floor, unit 43 bathroom, ceiling	Asbestos cement sheeting	Non-friable	Similar to A25	Assume positive	6m ²	Good Maintenance only	Priority 4: Negligible Risk Level	Remove prior to refurbishment works

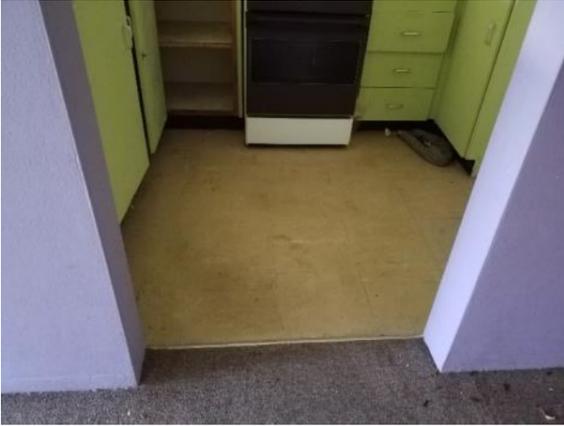
Fourth floor, unit 44, kitchen, floor	Cream vinyl floor tiles	Non-friable	Similar to A16	Assume negative	NA	NA	NA	NA

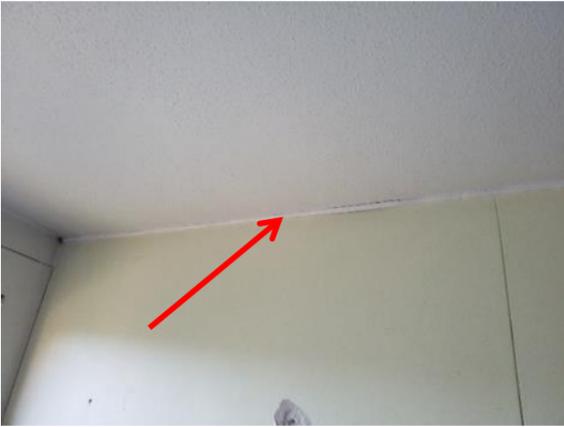
Fourth floor, unit 44, horizontal slip joints	Foam	NA	Visual Inspection	Assume negative	NA	NA	NA	NA

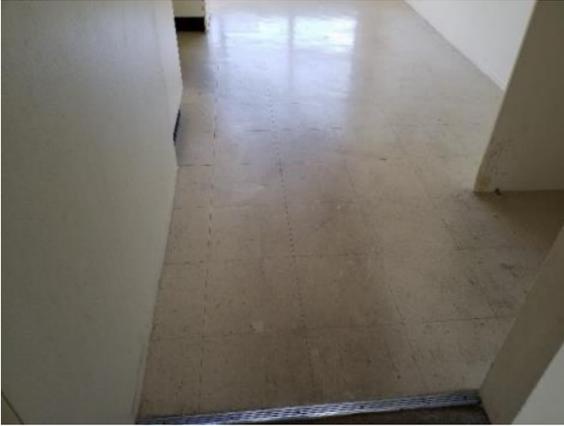
Fourth floor, unit 45, kitchen/dining, floor	Cream and blue speck vinyl floor tiles	Non-friable	A29	No Asbestos Detected	NA	NA	NA	NA

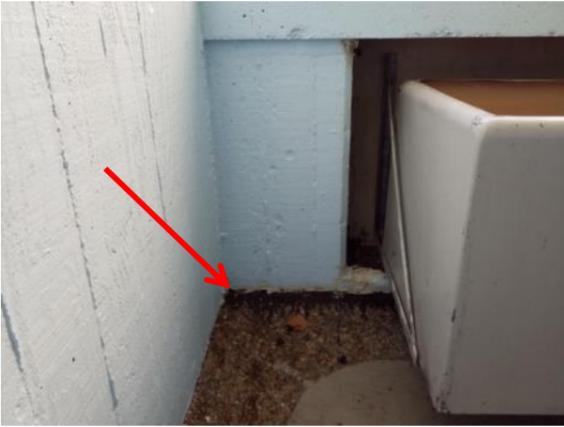
Fourth floor, unit 45, sun room, waterproofing to concrete walls below windows (black)	Sealant	Non-friable	A30	No Asbestos Detected	NA	NA	NA	NA

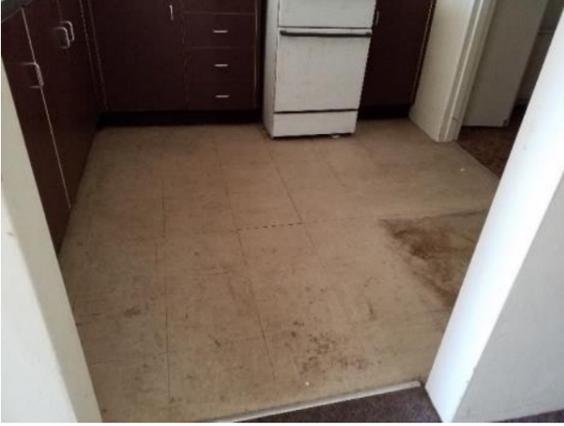
Fourth floor, unit 46, kitchen, floor	Cream vinyl floor tiles	Non-friable	Similar to A16	Assume negative	NA	NA	NA	NA

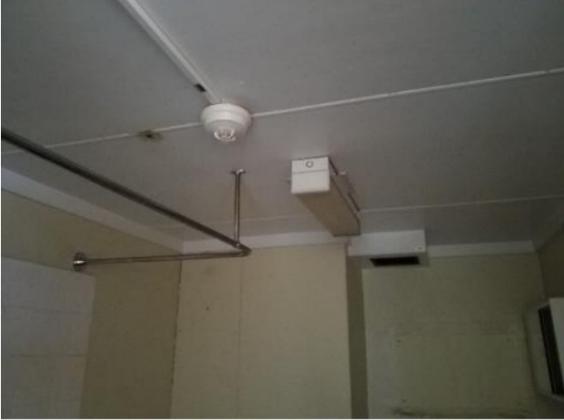
Fourth floor, unit 46, bathroom ceiling	Asbestos cement sheeting	Non-friable	Similar to A25	Assume positive	6m ²	Good Maintenance only	Priority 4: Negligible Risk Level	Remove prior to refurbishment works

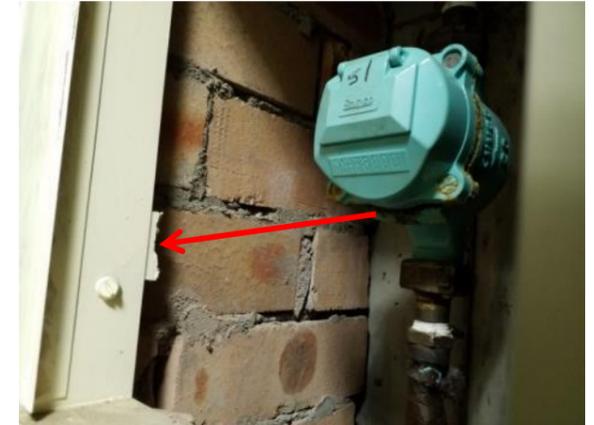
Fifth floor, common area, water meter risers, packing between metal frame and brick walls	Asbestos cement sheeting	Non-friable	Similar to A20	Assume positive	Not determined	Good Maintenance only	Priority 4: Negligible Risk Level	Remove prior to refurbishment works
---	--------------------------	-------------	----------------	------------------------	----------------	-----------------------	-----------------------------------	-------------------------------------

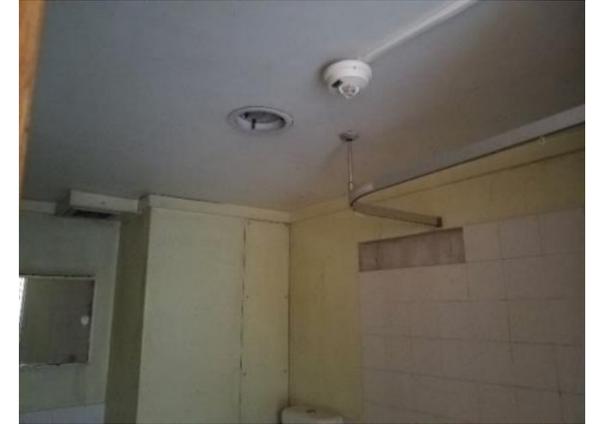
Fifth floor, unit 51, bathroom ceiling	Asbestos cement sheeting	Non-friable	Similar to A17	Assume positive	6m ²	Good Maintenance only	Priority 4: Negligible Risk Level	Remove prior to refurbishment works
--	--------------------------	-------------	----------------	------------------------	-----------------	-----------------------	-----------------------------------	-------------------------------------

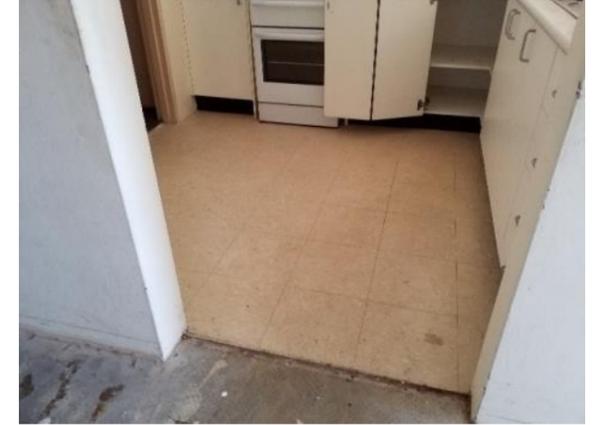
Fifth floor, unit 51, kitchen floor	Cream fleck vinyl floor tiles	Non-friable	Similar to A13	Assume negative	NA	NA	NA	NA
-------------------------------------	-------------------------------	-------------	----------------	-----------------	----	----	----	----

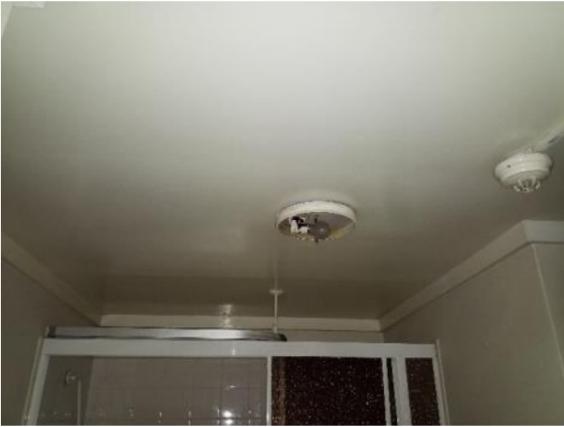
Fifth floor, unit 52, bathroom, ceiling	Asbestos cement sheeting	Non-friable	Similar to A25	Assume positive	6m ²	Good Maintenance only	Priority 4: Negligible Risk Level	Remove prior to refurbishment works

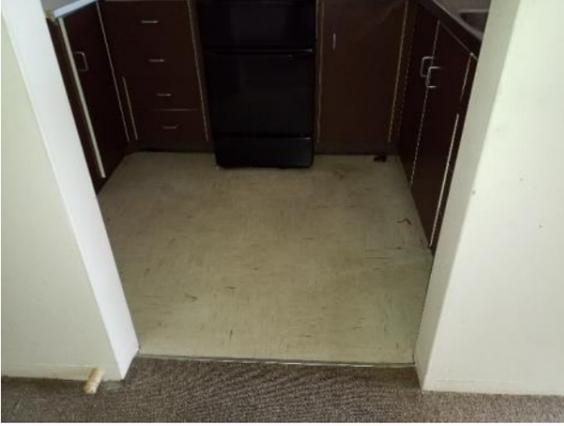
Fifth floor, unit 53, kitchen floor	Cream fleck vinyl floor tiles	Non-friable	Similar to A13	Assume negative	NA	NA	NA	NA

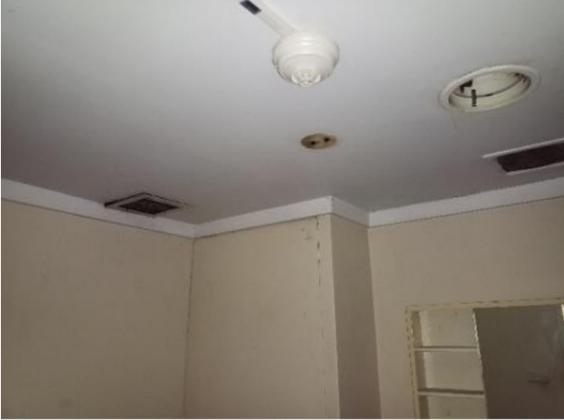
Fifth floor, unit 53, bathroom, ceiling	Asbestos cement sheeting	Non-friable	Similar to A25	Assume positive	6m ²	Good Maintenance only	Priority 4: Negligible Risk Level	Remove prior to refurbishment works

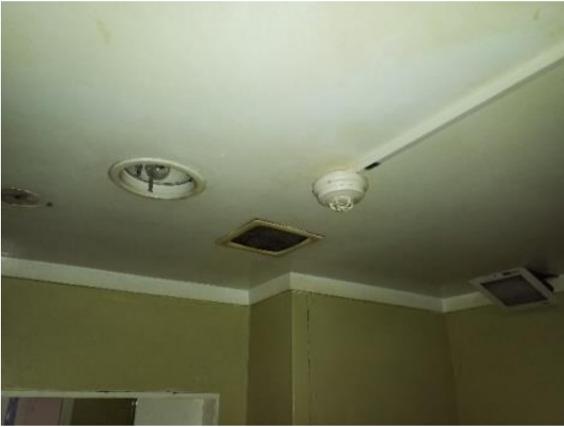
Fifth floor, unit 54, bathroom ceiling	Asbestos cement sheeting	Non-friable	A31	Chrysotile Asbestos Detected Organic Fibres Detected	6m ²	Good Maintenance only	Priority 4: Negligible Risk Level	Remove prior to refurbishment works

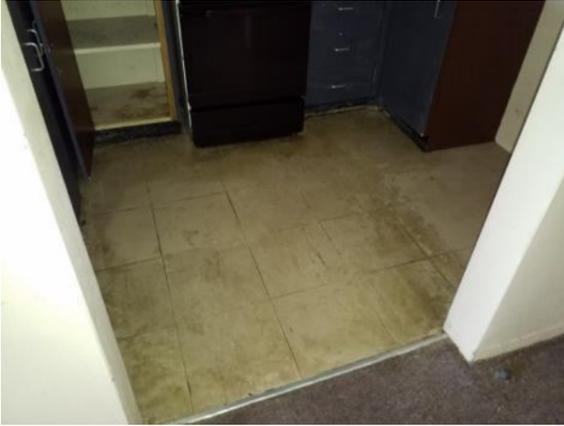
Fifth floor, unit 54, kitchen, floor	Cream vinyl floor tiles	Non-friable	Similar to A16	Assume negative	NA	NA	NA	NA

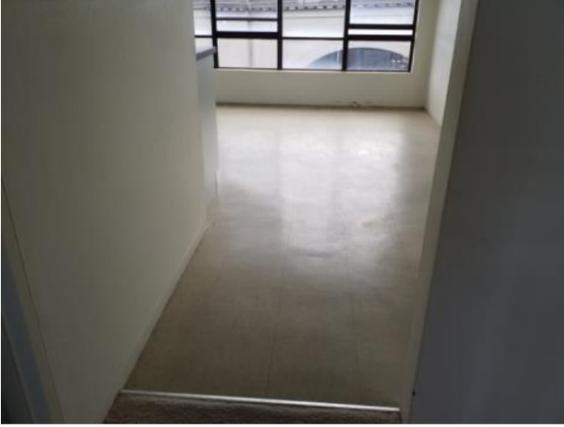
Fifth floor, unit 55, kitchen floor	Cream/ grey fleck vinyl floor tiles	Non-friable	Similar to A35	Assume negative	NA	NA	NA	NA

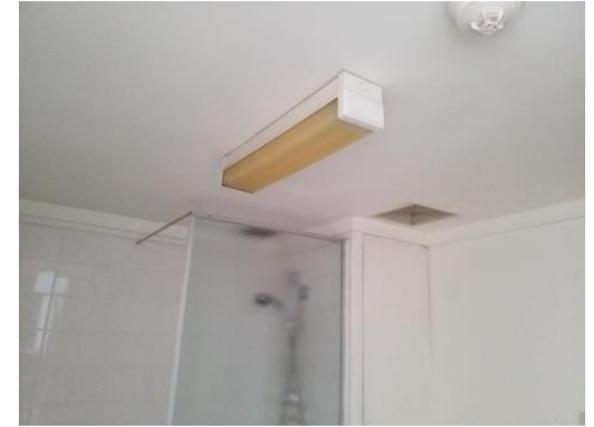
Fifth floor, unit 55, bathroom ceiling Asbestos cement sheeting Non-friable Similar to A31 **Assume positive** 6m² Good Maintenance only Priority 4: Negligible Risk Level Remove prior to refurbishment works

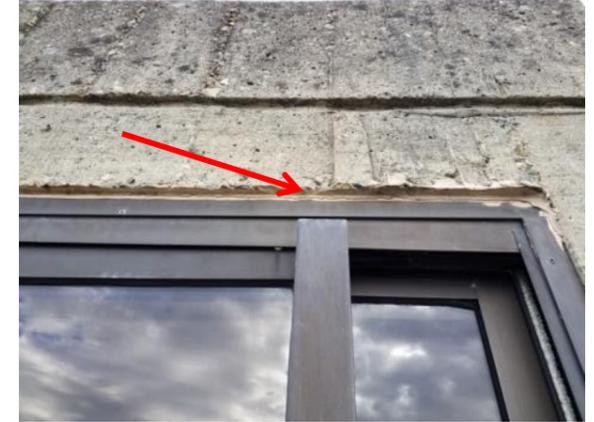
Fifth floor, unit 55, balcony door, frame to wall Sealant Non-friable A32 **Chrysotile Asbestos Detected** Not determined Good Maintenance only Priority 4: Negligible Risk Level Remove prior to refurbishment works

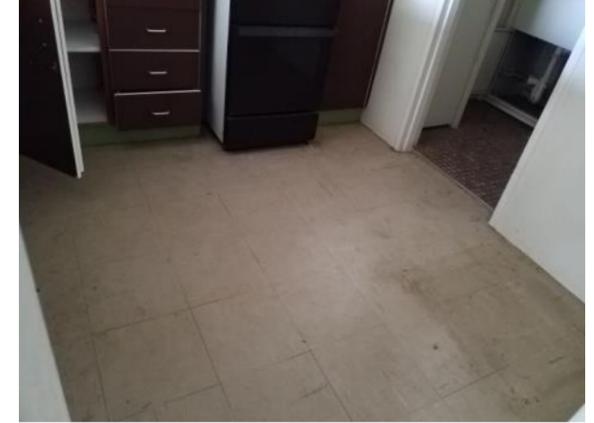
Fifth floor, unit 56, kitchen, floor Cream vinyl floor tiles Non-friable Similar to A16 Assume negative NA NA NA NA

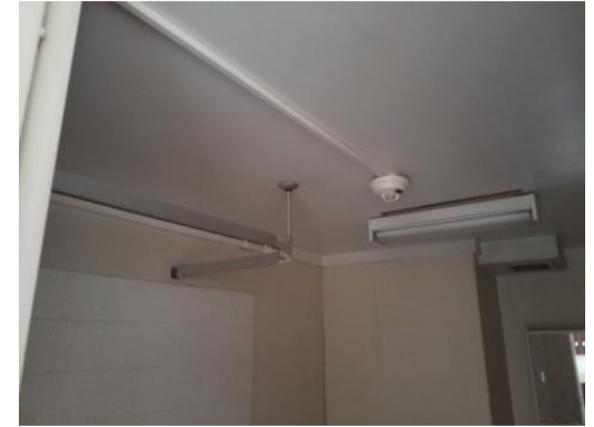
Fifth floor, unit 56, bathroom ceiling Asbestos cement sheeting Non-friable Similar to A31 **Assume positive** 6m² Good Maintenance only Priority 4: Negligible Risk Level Remove prior to refurbishment works

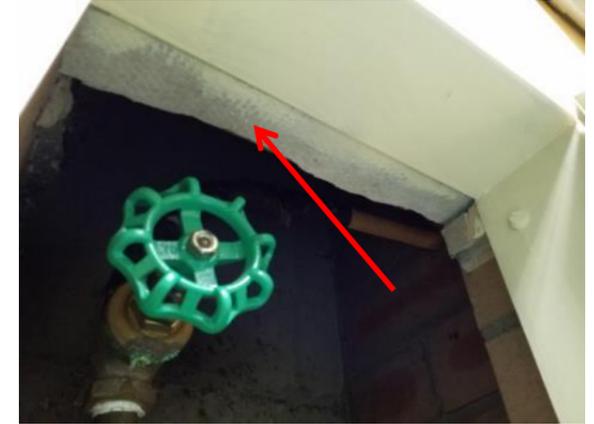
Sixth floor, common area, water meter risers, packing between metal frame and brick walls Asbestos cement sheeting Non-friable Similar to A20 **Assume positive** Not determined Good Maintenance only Priority 4: Negligible Risk Level Remove prior to refurbishment works

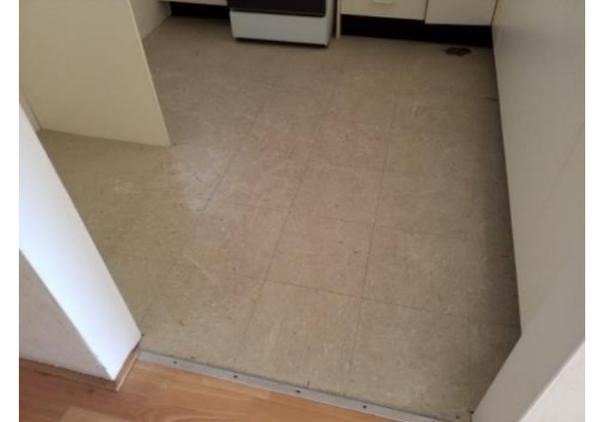
Sixth floor, unit 61, kitchen Cream fleck vinyl floor tiles Non-friable Similar to A13 Assume negative NA NA NA NA

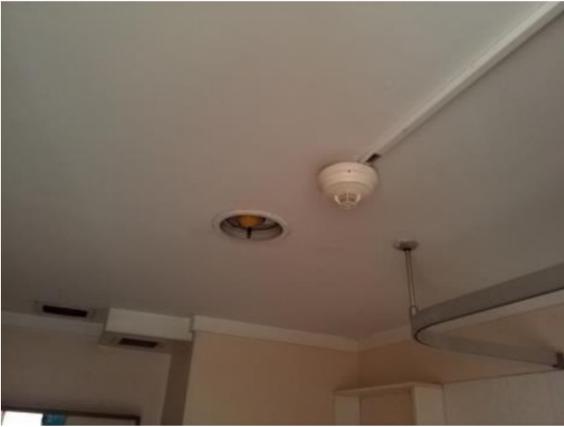
Sixth floor, unit 61, bathroom ceiling	Asbestos cement sheeting	Non-friable	Similar to A31	Assume positive	6m ²	Good Maintenance only	Priority 4: Negligible Risk Level	Remove prior to refurbishment works

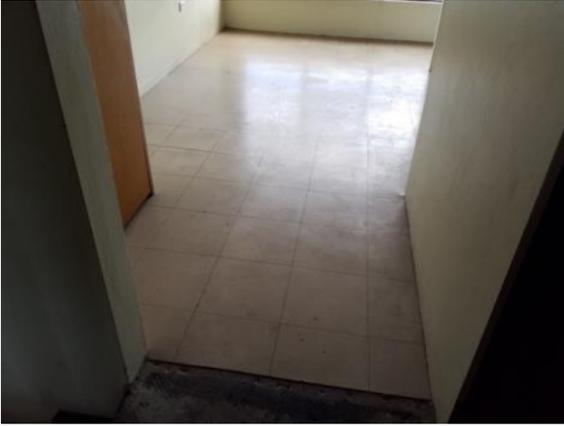
Sixth floor, unit 62, southern room, entry door to balcony, floor	Tan fleck vinyl floor tiles	Non-friable	A33	No Asbestos Detected	NA	NA	NA	NA

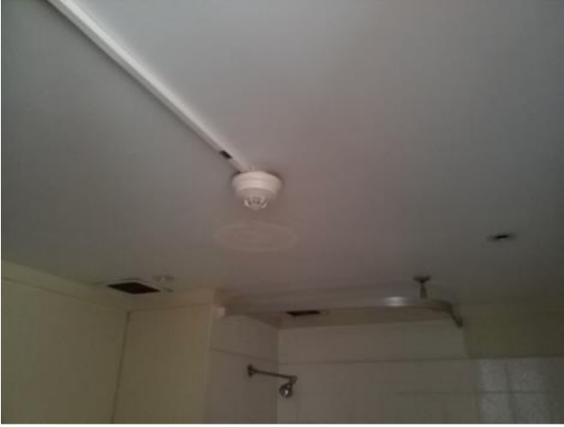
Sixth floor, unit 62, bathroom, ceiling	Asbestos cement sheeting	Non-friable	Similar to A31	Assume positive	6m ²	Good Maintenance only	Priority 4: Negligible Risk Level	Remove prior to refurbishment works

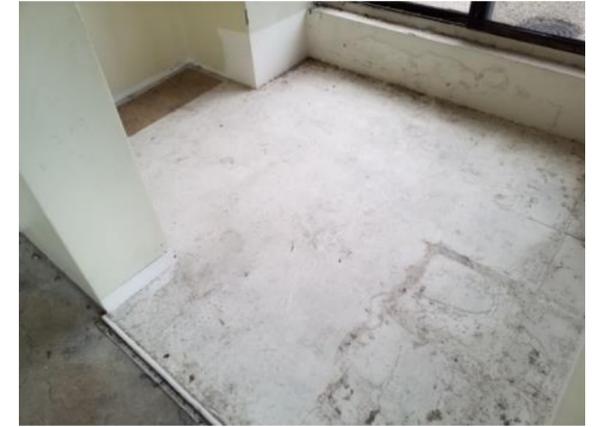
Sixth floor, unit 62, kitchen, floor Cream vinyl floor tiles Non-friable Similar to A16 Assume negative NA NA NA NA

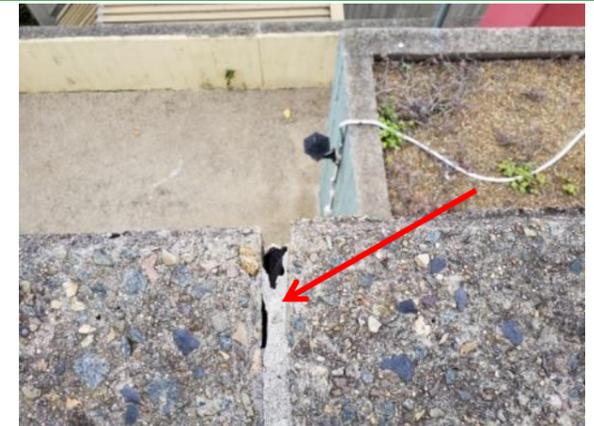
External, expansion gaps Bituminous material Non-friable A34 No Asbestos Detected
Organic Fibres Detected NA NA NA NA

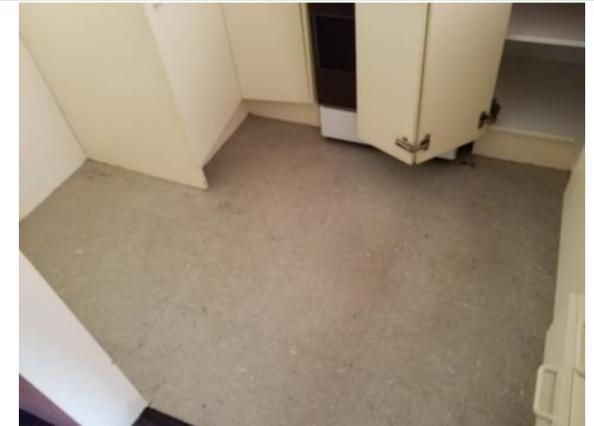
Sixth floor, unit 63, kitchen, floor Cream/ grey fleck vinyl floor tiles Non-friable A35 No Asbestos Detected NA NA NA NA

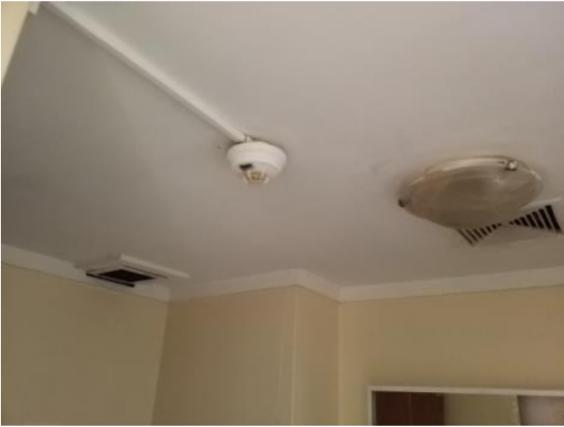
Sixth floor, unit 63, bathroom ceiling	Asbestos cement sheeting	Non-friable	Similar to A31	Assume positive	6m ²	Good Maintenance only	Priority 4: Negligible Risk Level	Remove prior to refurbishment works

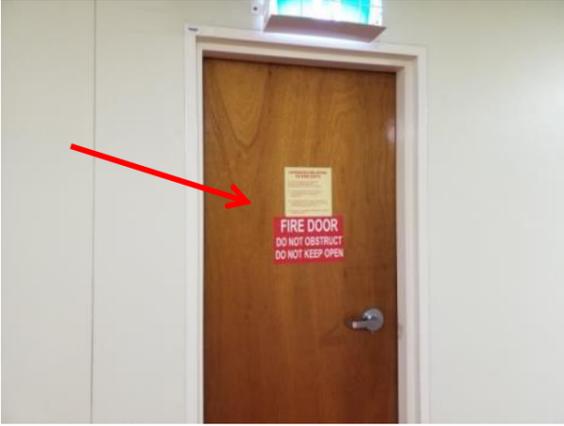
Sixth floor, southern fire door "Padde"	Fire door	Friable	Similar to A10	Assume positive	1 door	Good Maintenance only	Priority 4: Negligible Risk Level	Remove prior to refurbishment works

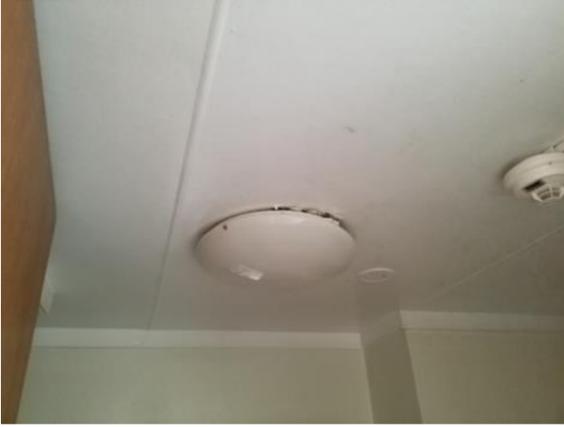
Sixth floor, unit 64, bathroom, ceiling	Asbestos cement sheeting	Non-friable	Similar to A31	Assume positive	6m ²	Good Maintenance only	Priority 4: Negligible Risk Level	Remove prior to refurbishment works

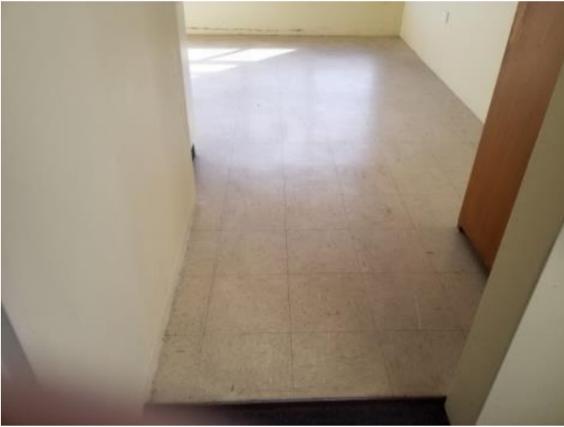
Sixth floor, unit 64, kitchen	Cream fleck vinyl floor tiles	Non-friable	Similar to A13	Assume negative	NA	NA	NA	NA

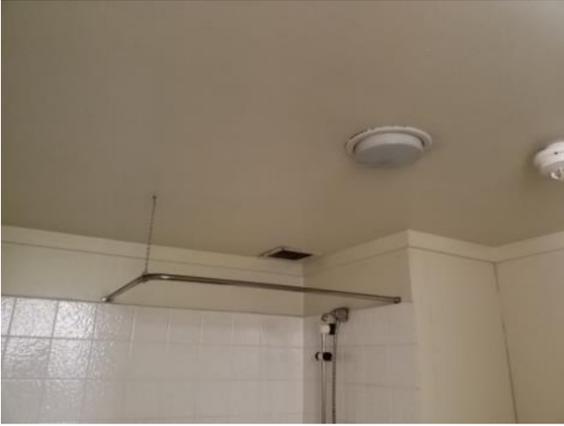
Sixth floor, unit 65, bathroom, ceiling	Asbestos cement sheeting	Non-friable	Similar to A31	Assume positive	6m ²	Good Maintenance only	Priority 4: Negligible Risk Level	Remove prior to refurbishment works

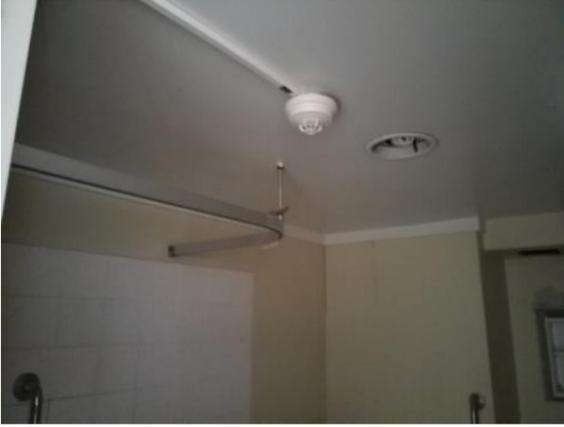
Sixth floor, unit 66, bathroom, ceiling	Asbestos cement sheeting	Non-friable	Similar to A31	Assume positive	6m ²	Good Maintenance only	Priority 4: Negligible Risk Level	Remove prior to refurbishment works

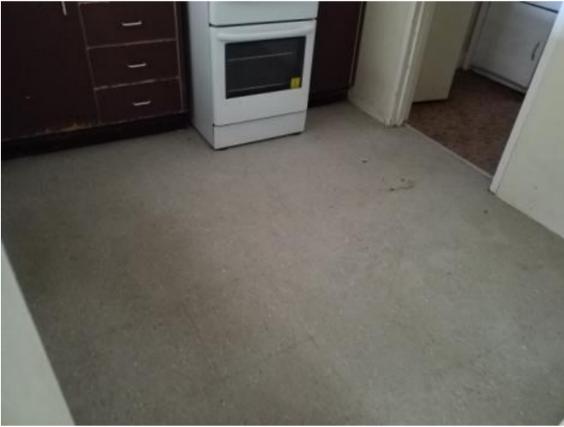
Sixth floor, unit 66, kitchen, floor	Cream/ grey fleck vinyl floor tiles	Non-friable	Similar to A35	Assume negative	NA	NA	NA	NA

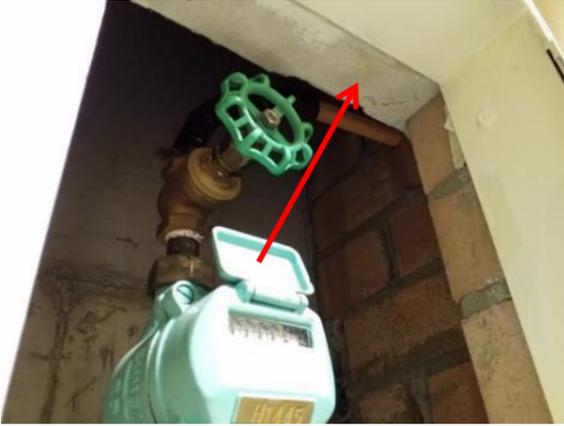
Seventh floor, common area, water meter risers, packing between metal frame and brick walls	Asbestos cement sheeting	Non-friable	Similar to A20	Assume positive	Not determined	Good Maintenance only	Priority 4: Negligible Risk Level	Remove prior to refurbishment works

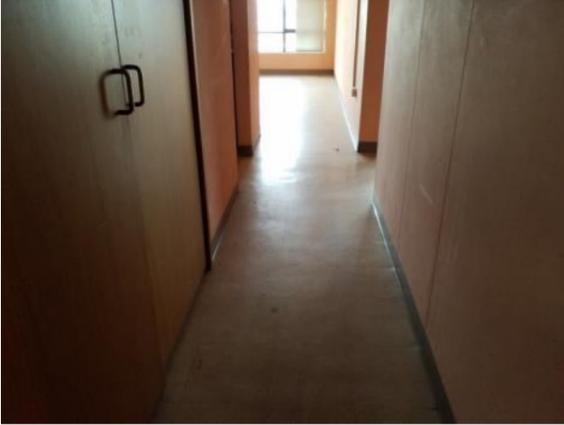
Seventh floor, unit 71, entry, hallway and living areas	Cream fleck vinyl floor tiles	Non-friable	Similar to A13	Assume negative	NA	NA	NA	NA

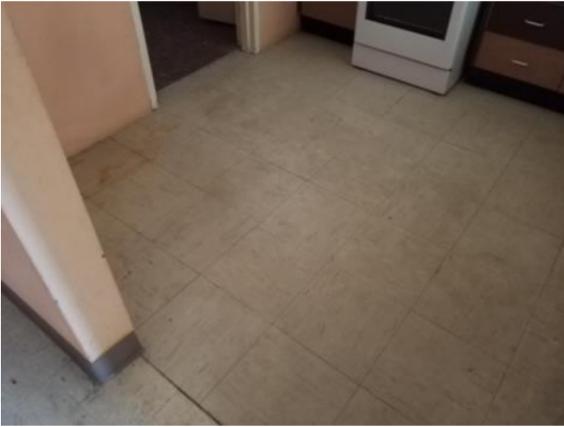
Seventh floor, unit 71, kitchen floor	Grey fleck vinyl floor tiles	Non-friable	A36	No Asbestos Detected	NA	NA	NA	NA

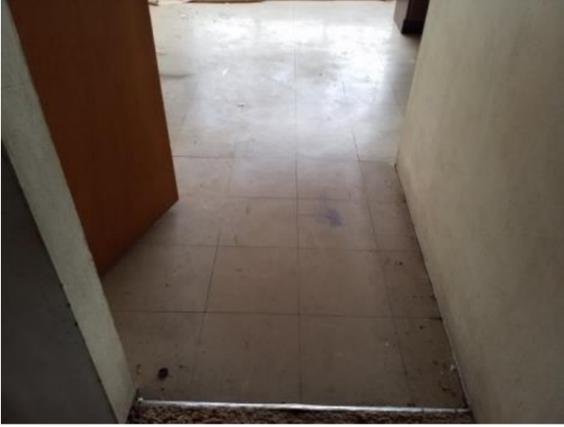
Seventh floor, unit 72, kitchen floor	Cream vinyl floor tiles	Non-friable	Similar to A16	Assume negative	NA	NA	NA	NA

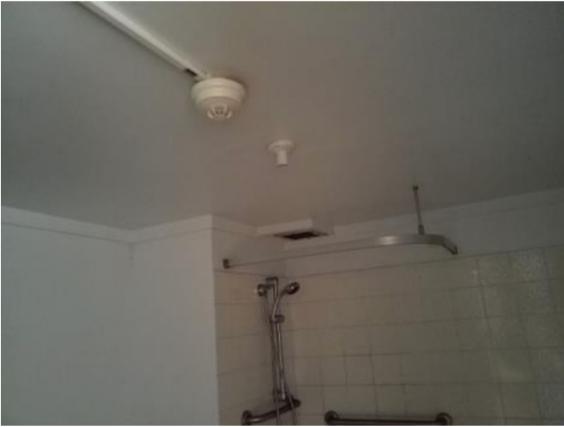
Seventh floor, unit 72, bathroom, ceiling	Asbestos cement sheeting	Non-friable	Similar to A31	Assume positive	6m ²	Good Maintenance only	Priority 4: Negligible Risk Level	Remove prior to refurbishment works

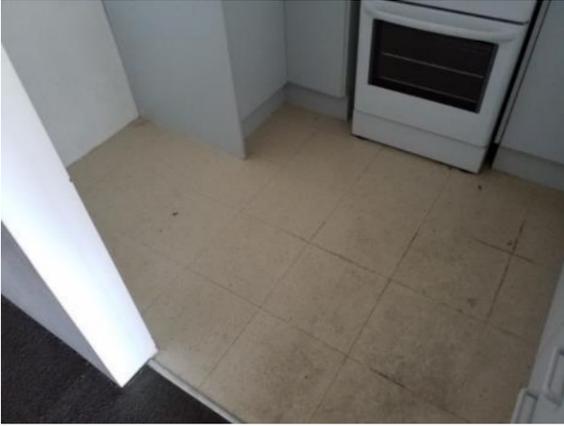
Seventh floor, unit 73, kitchen	Cream and blue speck vinyl floor tiles	Non-friable	Similar to A29	Assume negative	NA	NA	NA	NA

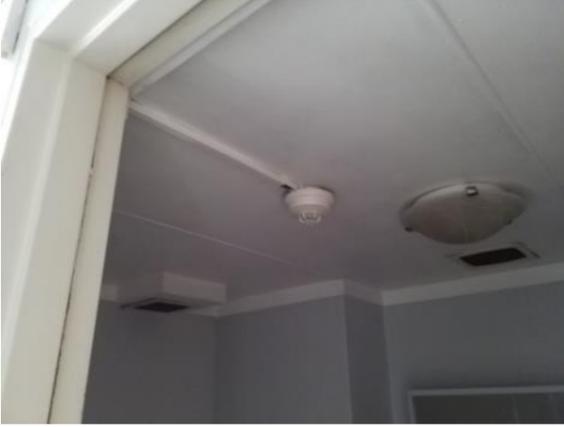
Seventh floor, unit 73, bathroom, ceiling	Asbestos cement sheeting	Non-friable	Similar to A17	Assume positive	6m ²	Good Maintenance only	Priority 4: Negligible Risk Level	Remove prior to refurbishment works

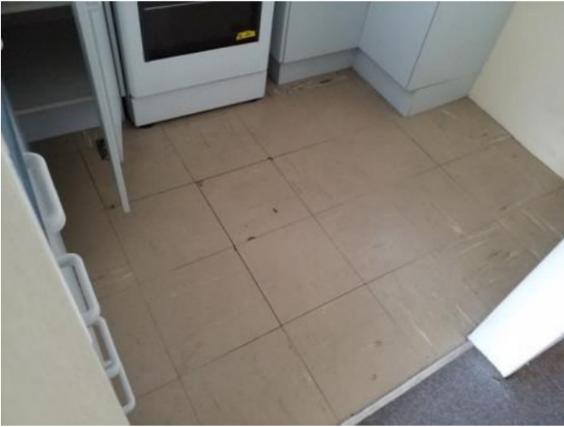
Seventh floor, unit 74, kitchen	Cream vinyl floor tiles	Non-friable	Similar to A16	Assume negative	NA	NA	NA	NA

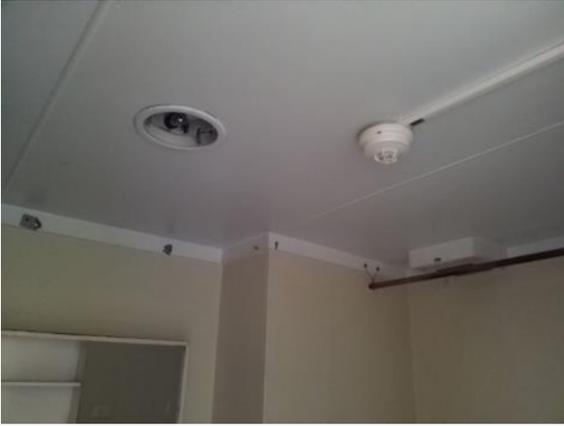
Seventh floor, unit 74, bathroom, ceiling	Asbestos cement sheeting	Non-friable	Similar to A17	Assume positive	6m ²	Good Maintenance only	Priority 4: Negligible Risk Level	Remove prior to refurbishment works

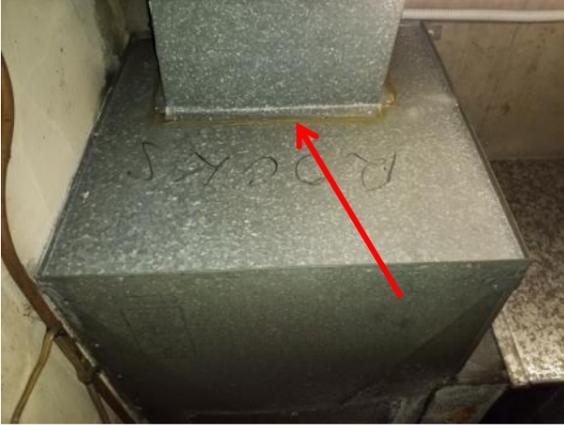
Seventh floor, drying room, lift lobby supply fan, flanges	Green sealant	Non-friable	A37	No Asbestos Detected	NA	NA	NA	NA
