Hazardous Materials Survey

2-60 Cumberland St, The Rocks NSW

Report Title: Hazardous Materials Survey - 2-60 Cumberland St, The Rocks NSW
Report No: E24614.E10_Rev1

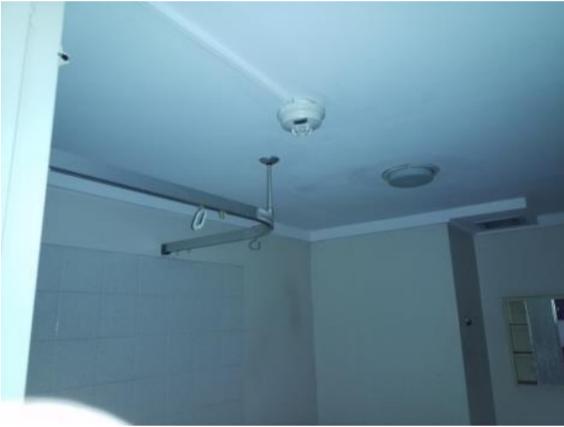
Seventh floor, unit 75, bathroom, ceiling	Asbestos cement sheeting	Non-friable	Similar to A17	Assume positive	6m ²	Good Maintenance only	Priority 4: Negligible Risk Level	Remove prior to refurbishment works

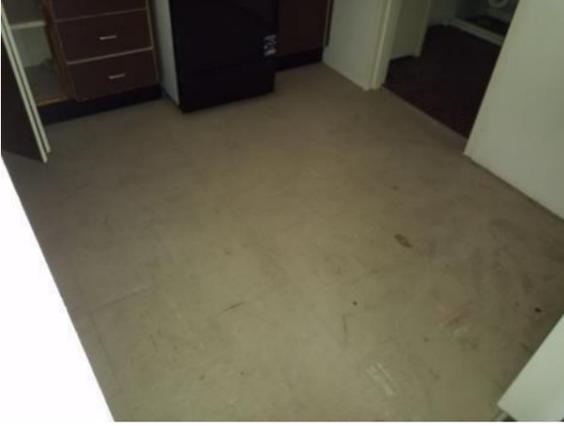
Seventh floor, unit 75, kitchen	Cream vinyl floor tiles	Non-friable	Similar to A16	Assume negative	NA	NA	NA	NA

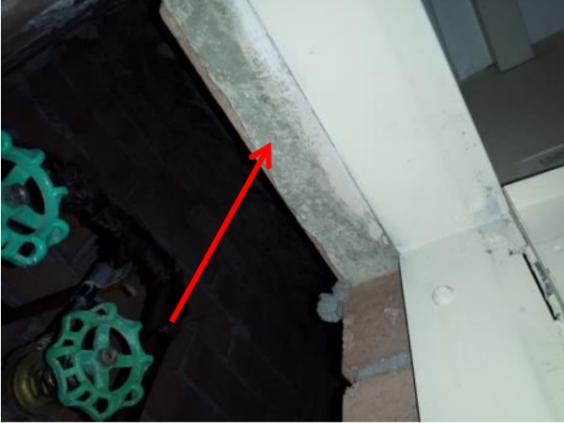
Eight floor, common area, water meter risers, packing between metal frame and brick walls	Asbestos cement sheeting	Non-friable	Similar to A20	Assume positive	Not determined	Good Maintenance only	Priority 4: Negligible Risk Level	Remove prior to refurbishment works

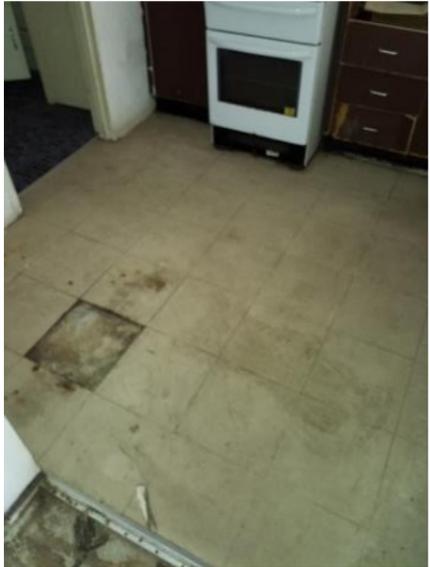
Eighth floor, unit 81, kitchen	Cream vinyl floor tiles	Non-friable	Similar to A16	Assume negative	NA	NA	NA	NA

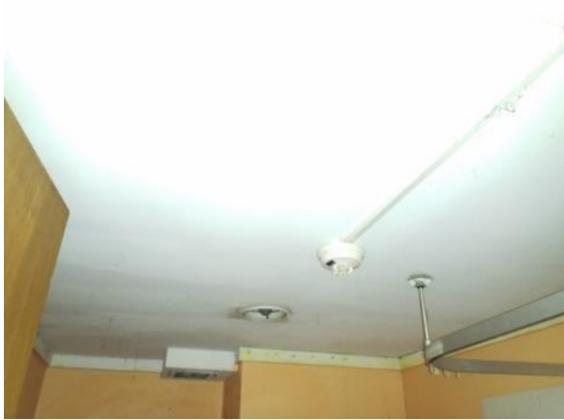
Eighth floor, unit 81, bathroom, ceiling	Asbestos cement sheeting	Non-friable	Similar to A31	Assume positive	6m ²	Good Maintenance only	Priority 4: Negligible Risk Level	Remove prior to refurbishment works

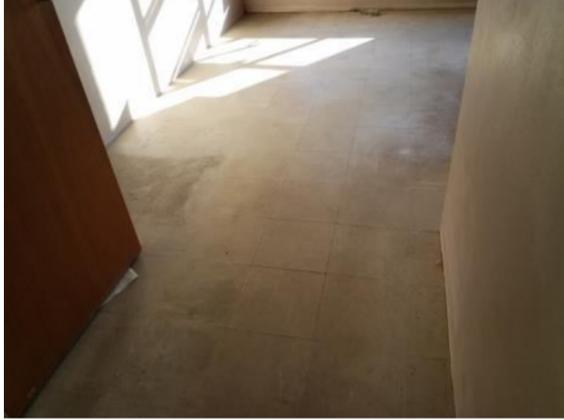
Eighth floor, unit 82, kitchen,	Cream vinyl floor tiles	Non-friable	Similar to A16	Assume negative	NA	NA	NA	NA

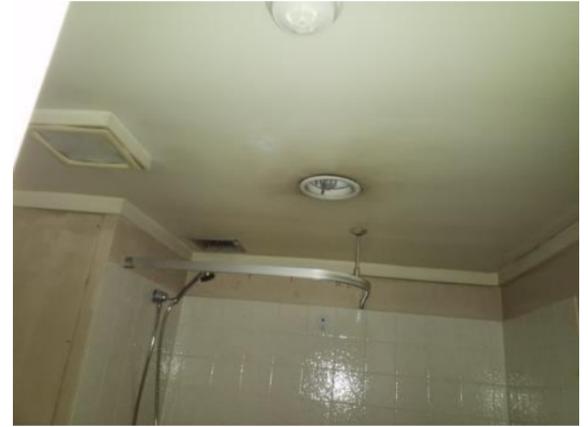
Eighth floor, unit 82, bathroom, ceiling	Asbestos cement sheeting	Non-friable	Similar to A31	Assume positive	6m ²	Good Maintenance only	Priority 4: Negligible Risk Level	Remove prior to refurbishment works

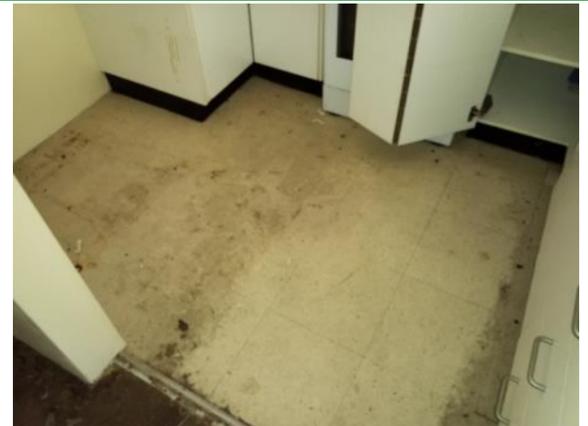
Eighth floor, unit 83, kitchen	Cream and blue speck vinyl floor tiles	Non-friable	Similar to A29	Assume negative	NA	NA	NA	NA

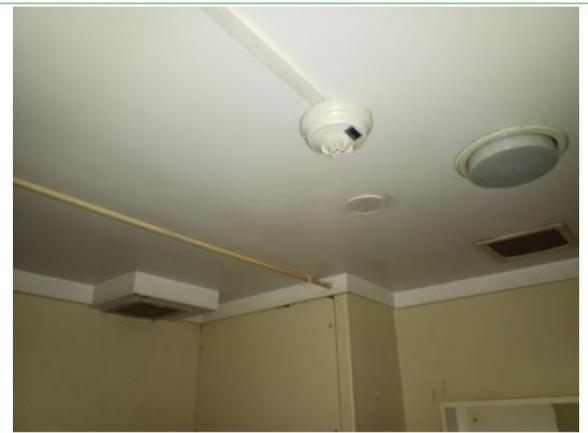
Eighth floor, unit 83, bathroom, ceiling	Asbestos cement sheeting	Non-friable	Similar to A31	Assume positive	6m ²	Good Maintenance only	Priority 4: Negligible Risk Level	Remove prior to refurbishment works

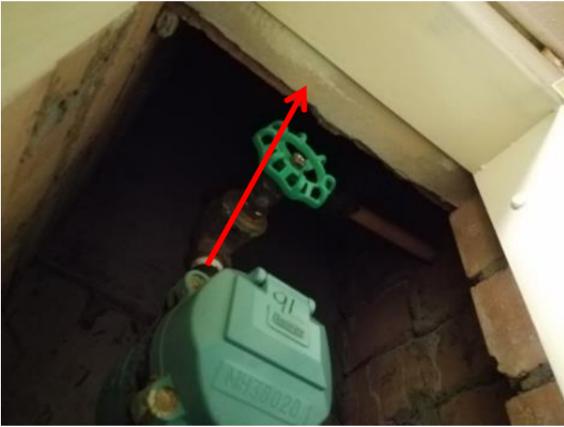
Ninth floor, common area, water meter risers, packing between metal frame and brick walls	Asbestos cement sheeting	Non-friable	Similar to A20	Assume positive	Not determined	Good Maintenance only	Priority 4: Negligible Risk Level	Remove prior to refurbishment works

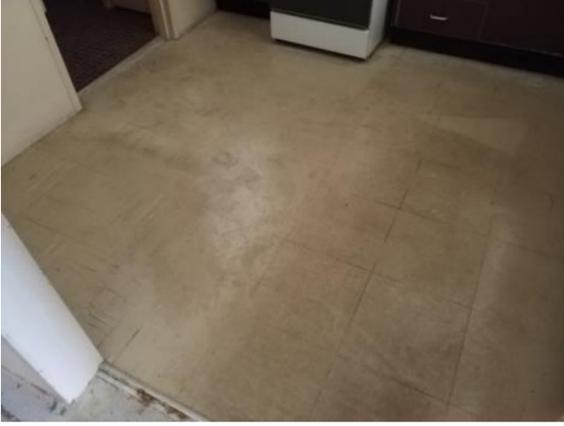
Ninth floor, unit 91, kitchen	Cream vinyl floor tiles	Non-friable	Similar to A16	Assume negative	NA	NA	NA	NA

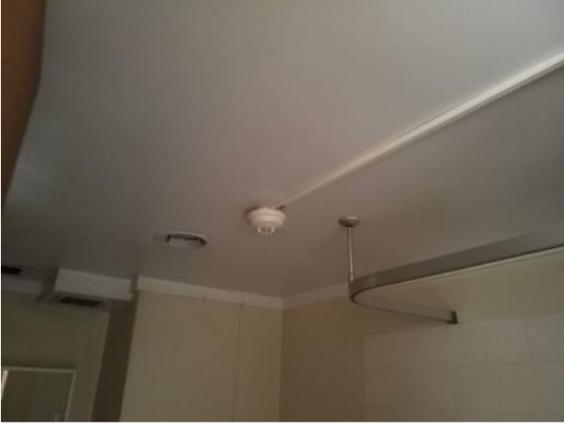
Ninth floor, unit 91, bathroom, ceiling	Asbestos cement sheeting	Non-friable	Similar to A31	Assume positive	6m ²	Good Maintenance only	Priority 4: Negligible Risk Level	Remove prior to refurbishment works

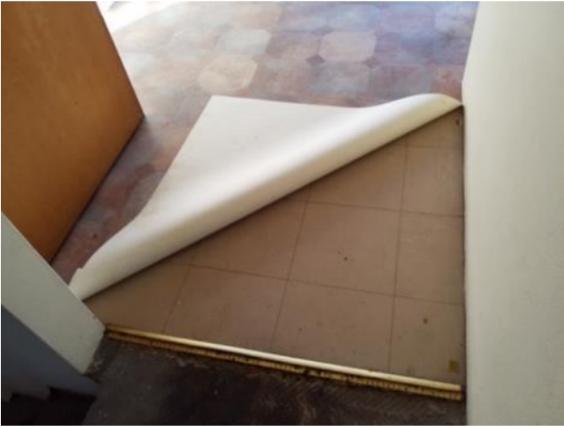
Ninth floor, unit 92, kitchen dining, under vinyl sheeting	Cream vinyl floor tiles	Non-friable	Similar to A16	Assume negative	NA	NA	NA	NA

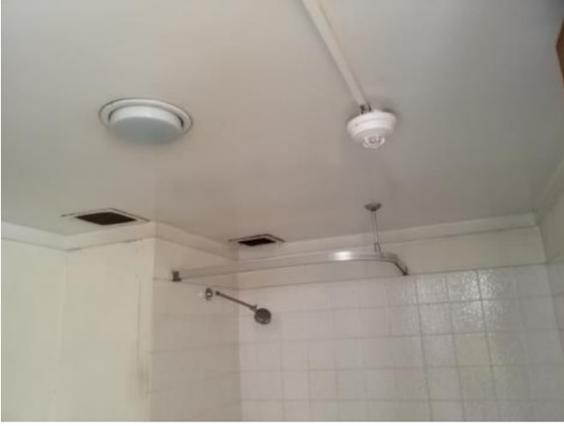
Ninth floor, unit 92, bathroom, ceiling	Asbestos cement sheeting	Non-friable	Similar to A31	Assume positive	6m ²	Good Maintenance only	Priority 4: Negligible Risk Level	Remove prior to refurbishment works

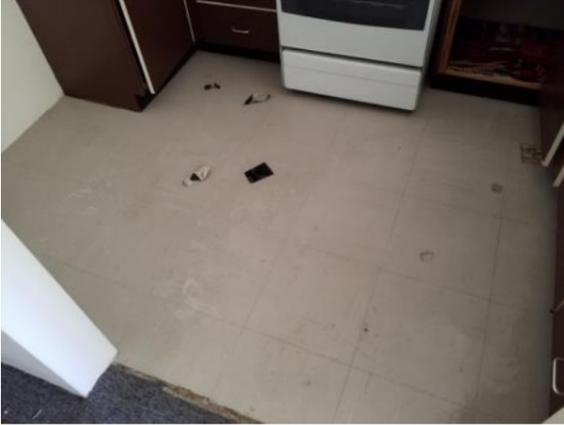
Ninth floor, unit 93, kitchen	Cream vinyl floor tiles	Non-friable	Similar to A16	Assume negative	NA	NA	NA	NA

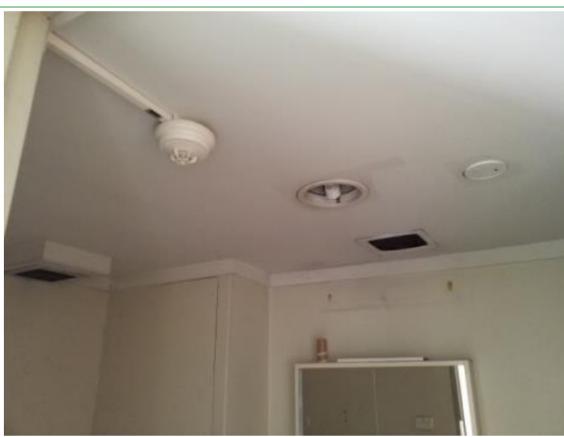
Ninth floor, unit 93, bathroom, ceiling	Asbestos cement sheeting	Non-friable	Similar to A31	Assume positive	6m ²	Good Maintenance only	Priority 4: Negligible Risk Level	Remove prior to refurbishment works

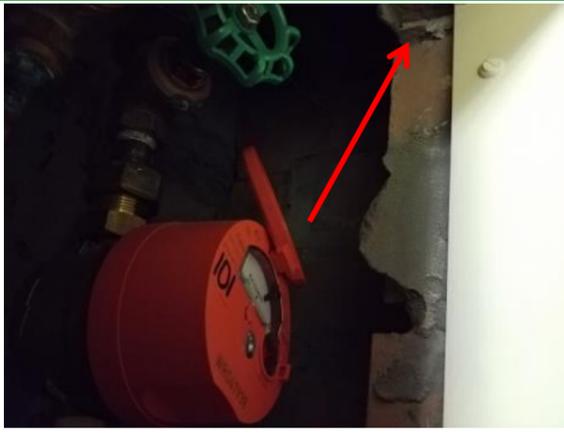
Tenth floor, common area, water meter risers, packing between metal frame and brick walls	Asbestos cement sheeting	Non-friable	Similar to A20	Assume positive	Not determined	Good Maintenance only	Priority 4: Negligible Risk Level	Remove prior to refurbishment works

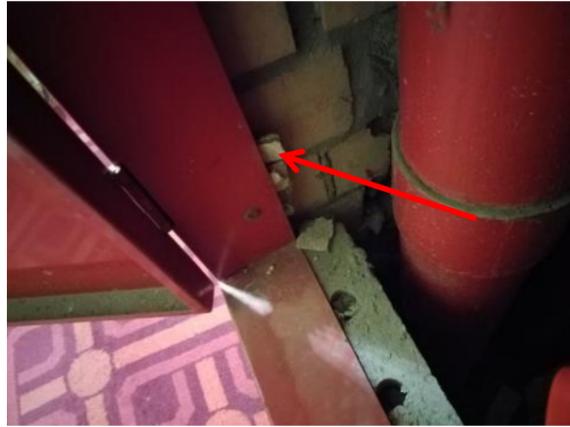
Tenth floor, hydrant riser, packing to door frames	Asbestos cement sheeting	Non-friable	Similar to A20	Assume positive	Not determined	Good Maintenance only	Priority 4: Negligible Risk Level	Remove prior to refurbishment works

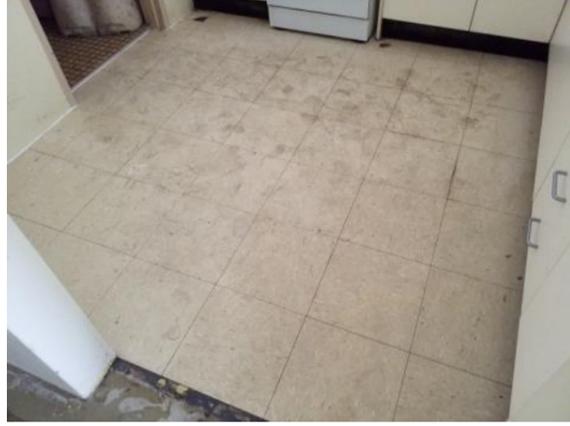
Tenth floor, unit 101, kitchen floor	Cream fleck vinyl floor tiles	Non-friable	Similar to A13	Assume negative	NA	NA	NA	NA

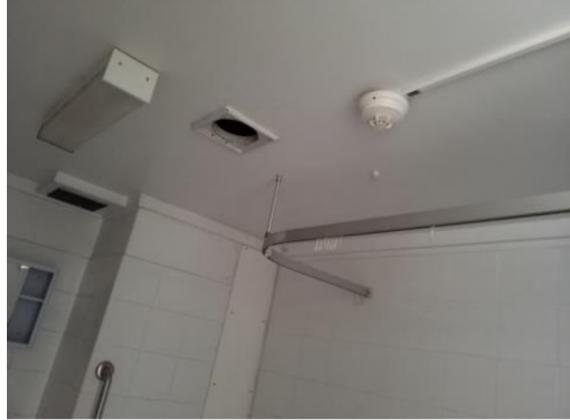
Tenth floor, unit 101, bathroom ceiling	Asbestos cement sheeting	Non-friable	Similar to A31	Assume positive	6m ²	Good Maintenance only	Priority 4: Negligible Risk Level	Remove prior to refurbishment works

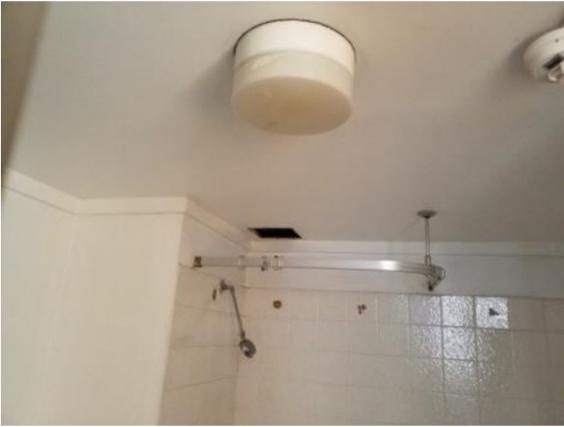
Tenth floor, unit 102, bathroom, ceiling	Asbestos cement sheeting	Non-friable	Similar to A31	Assume positive	6m ²	Good Maintenance only	Priority 4: Negligible Risk Level	Remove prior to refurbishment works

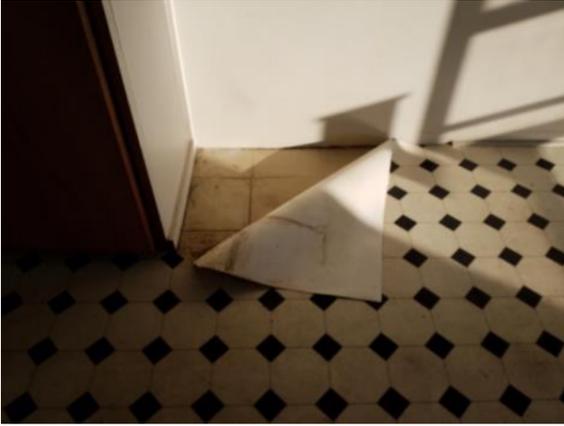
Tenth floor, unit 102, kitchen, under vinyl sheeting	Cream vinyl floor tiles	Non-friable	Similar to A16	Assume negative	NA	NA	NA	NA

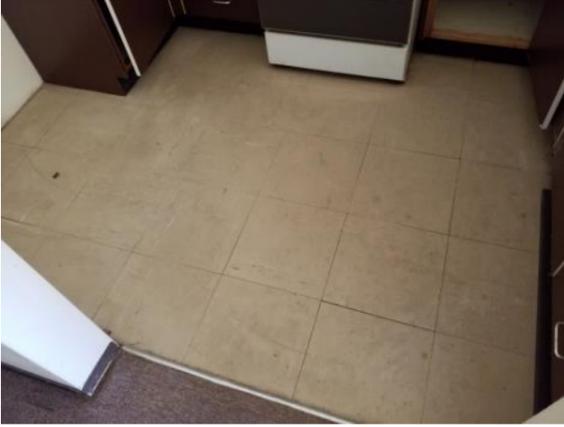
Tenth floor, unit 103, kitchen	Cream vinyl floor tiles	Non-friable	Similar to A16	Assume negative	NA	NA	NA	NA

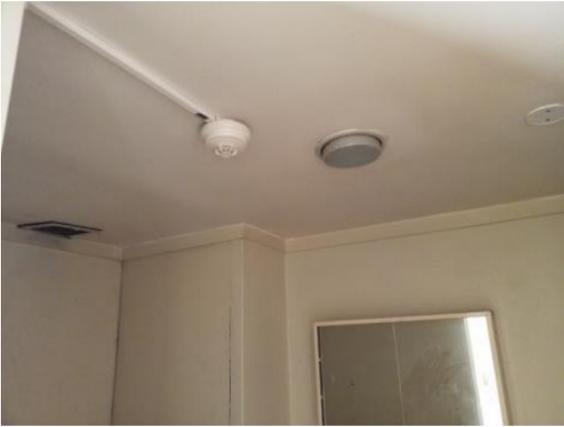
Tenth floor, unit 102, bathroom, ceiling	Asbestos cement sheeting	Non-friable	Similar to A31	Assume positive	6m ²	Good Maintenance only	Priority 4: Negligible Risk Level	Remove prior to refurbishment works

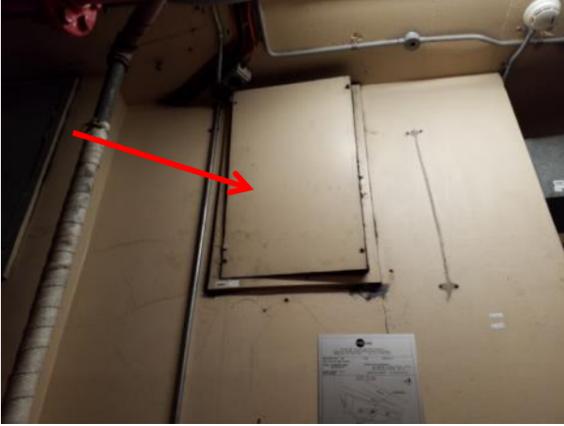
Eleventh floor, lift motor room, lift 1 & 2, copper coil, insulation cover	Woven asbestos rope	Friable	A23	No Asbestos Detected Organic Fibres Detected	NA	NA	NA	NA	
Eleventh floor, hydrant pump room, high level access hatches to void "Padde"	Fire door	Friable	Similar to A10	Assume positive	2 doors	Good Maintenance only	Priority 4: Negligible Risk Level	Remove prior to refurbishment works

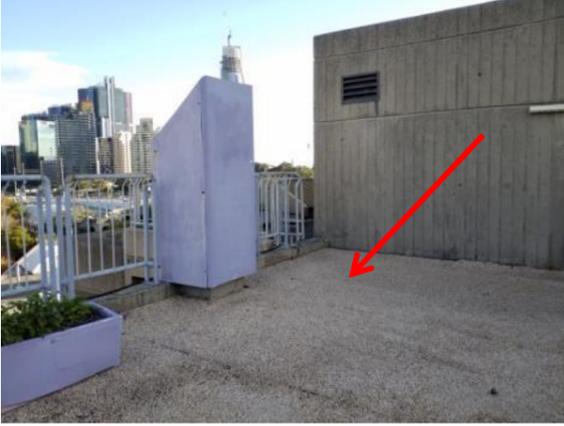
External, roof waterproofing membrane surface	Membrane	Non-friable	A41	No Asbestos Detected	NA	NA	NA	NA

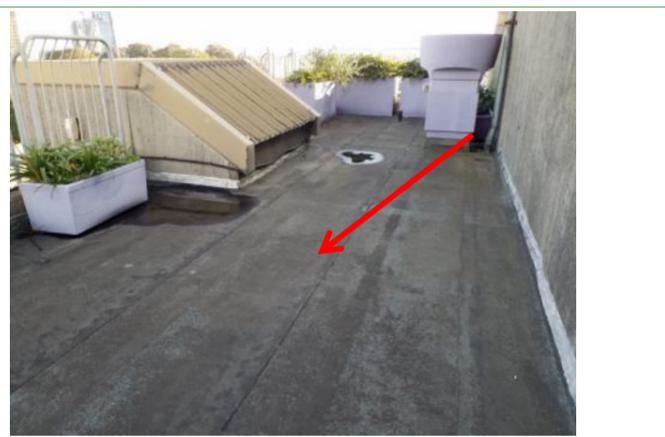
External Eleventh floor, south roof, waterproofing	Membrane	Non-friable	A40	No Asbestos Detected Organic Fibres Detected	NA	NA	NA	NA	NA

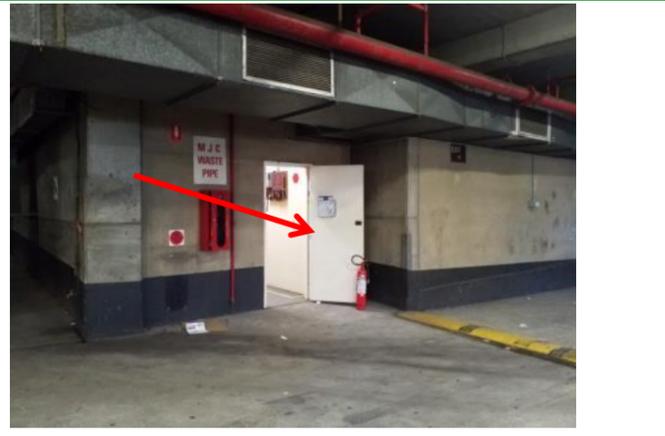
Car park, main switch room, door "Padde"	Fire door	Friable	Similar to A10	Assume positive	1 door	Good Maintenance only	Priority 4: Negligible Risk Level	Remove prior to refurbishment works

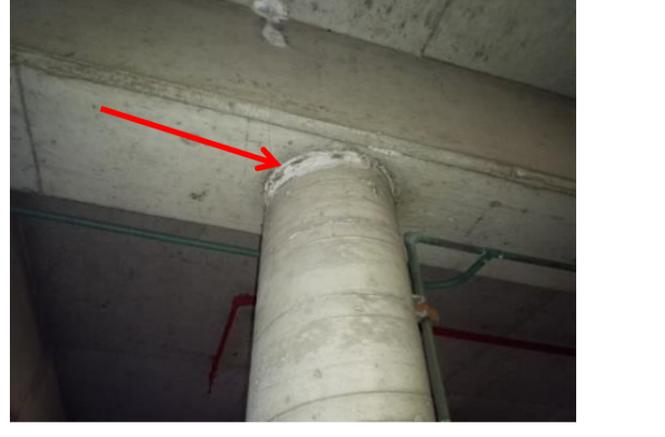
Car park, circular piers (eastern elevation), top of pier, slip joint at slab	Fibre cement sheet	Non-friable	A43	No Asbestos Detected Organic Fibres Detected	NA	NA	NA	NA	NA

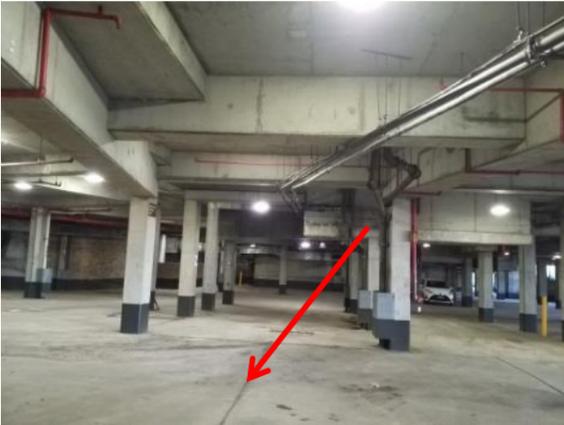
Car park, concrete floor expansion gaps	Sealant	Non-friable	A44	No Asbestos Detected	NA	NA	NA	NA	NA

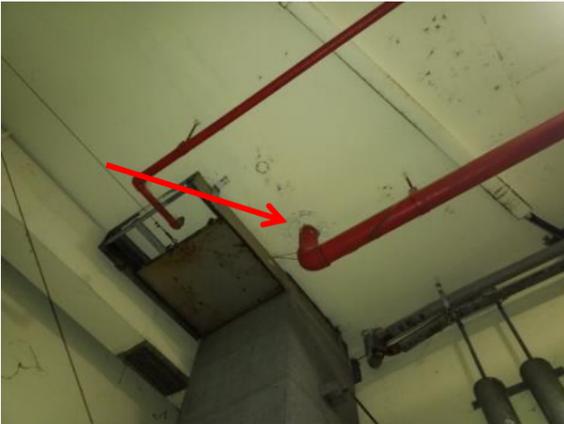
Car park, waste penetrations, randomly around areas, infill panel	Asbestos cement sheeting	Non-friable	Similar to A20	Assume positive	Not determined	Good Maintenance only	Priority 4: Negligible Risk Level	Remove prior to refurbishment works

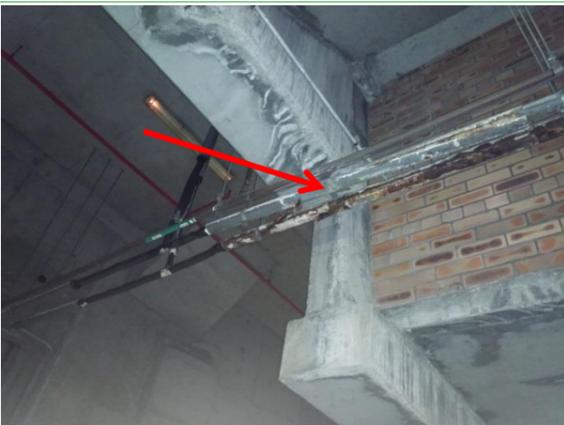
Car park, hot water pipes (metal clad)	Foil backed SMF insulation	Friable	A42	No Asbestos Detected Synthetic Mineral Fibres Detected Organic Fibres Detected	Not determined	Good Maintenance only	Priority 4: Negligible Risk Level	Remove during demolition works

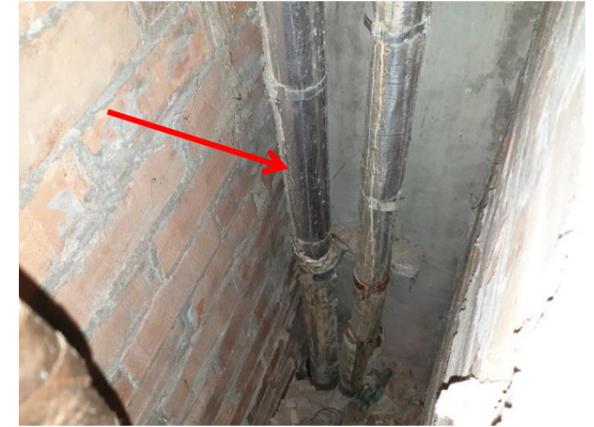
All floors, water risers, insulation to hot water pipes Foil backed SMF insulation Not friable Not sampled **Assume positive** Not determined Good Maintenance only Priority 4: Negligible Risk Level Remove during demolition works

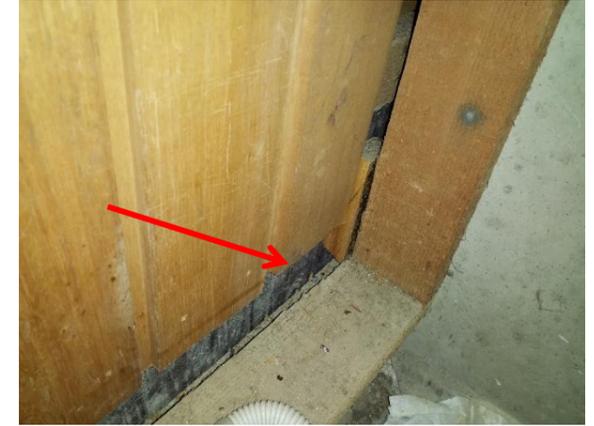
Ground floor, fire panel cupboard, wall cavity, damp proof course Membrane Non-friable A04 No Asbestos Detected
Synthetic Mineral Fibres Detected
Organic Fibres Detected Not determined Good Maintenance only Priority 4: Negligible Risk Level Remove during demolition works

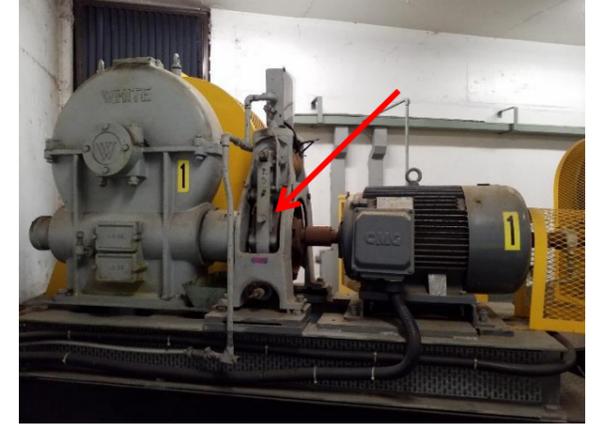
Eleventh floor, lift motor room, lift 2, brakes Brake pads Non-friable A22 No Asbestos Detected
Synthetic Mineral Fibres Detected
Organic Fibres Detected 2 units Good Regular Priority 4: Negligible Risk Level Remove during demolition works

Eleventh floor, lift motor room, lift 1, brakes Brake pads Non-friable A21 No Asbestos Detected
Synthetic Mineral Fibres Detected
Organic Fibres Detected 2 units Good Regular Priority 4: Negligible Risk Level Remove during demolition works

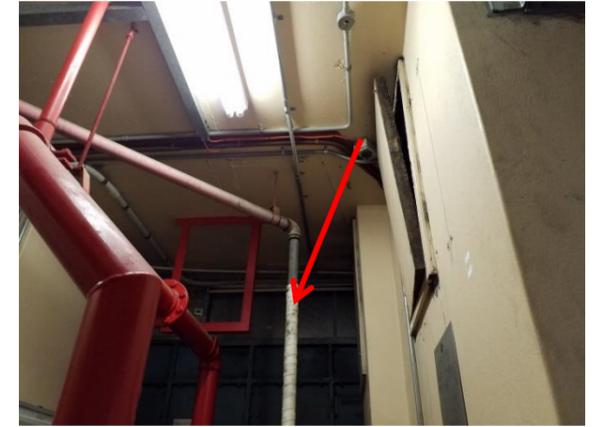
Eleventh floor, exhaust insulation	Woven SMF material	Friable	A39	No Asbestos Detected Synthetic Mineral Fibres Detected	1.5m	Good Maintenance only	Priority 4: Negligible Risk Level	Remove during demolition works
------------------------------------	--------------------	---------	-----	--	------	-----------------------	-----------------------------------	--------------------------------

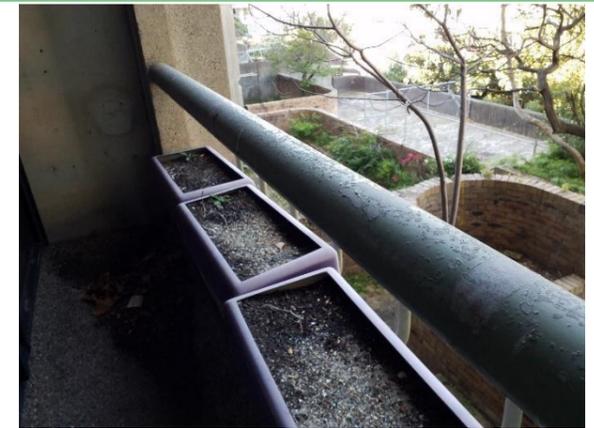
External, balustrades and metal stair rails	Olive Green Paint	NA	P02	0.39% w/w	Not determined	Good Maintenance only	Priority 3: Negligible Risk Level	Minimise abrasive works that will disturb paint during demolition.
---	-------------------	----	-----	------------------	----------------	-----------------------	-----------------------------------	--

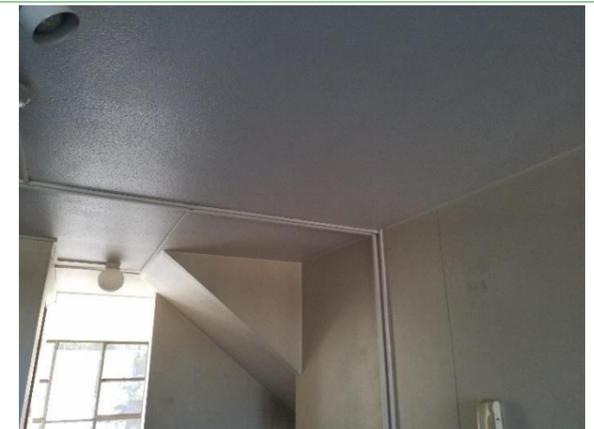
First floor, ceilings (stipple)	White Paint	NA	P01	<0.001% w/w	NA	NA	NA	NA
---------------------------------	-------------	----	-----	-------------	----	----	----	----

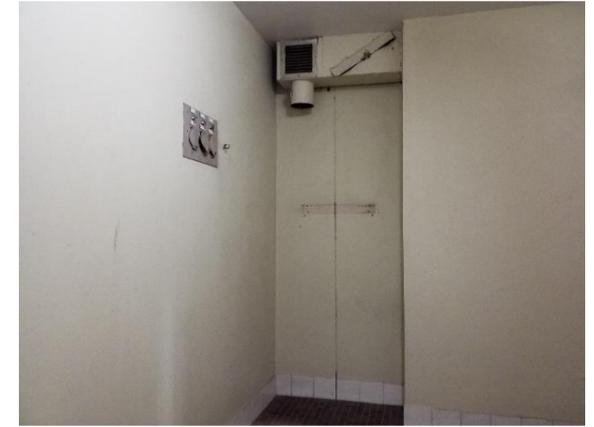
First floor, walls	Cream Paint	NA	P03	0.001% w/w	NA	NA	NA	NA
--------------------	-------------	----	-----	------------	----	----	----	----

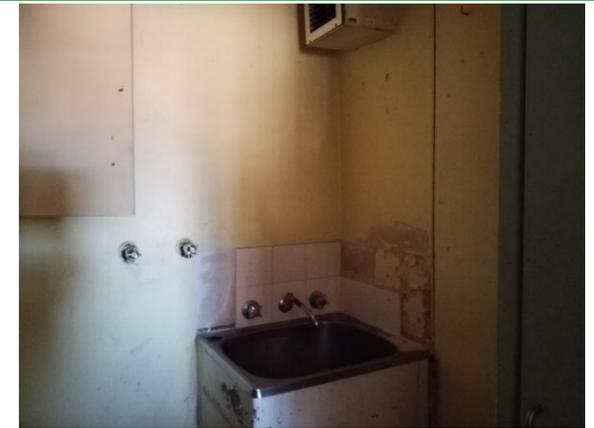
Second floor, unit 21, laundry, walls	Yellow Paint	NA	P04	<0.001% w/w	NA	NA	NA	NA
---------------------------------------	--------------	----	-----	-------------	----	----	----	----

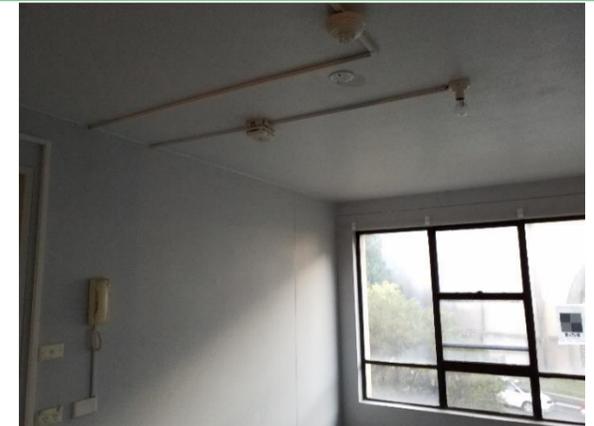
Second floor, unit 24, ceiling and walls	Pale Blue Paint	NA	P05	<0.001% w/w	NA	NA	NA	NA
--	-----------------	----	-----	-------------	----	----	----	----

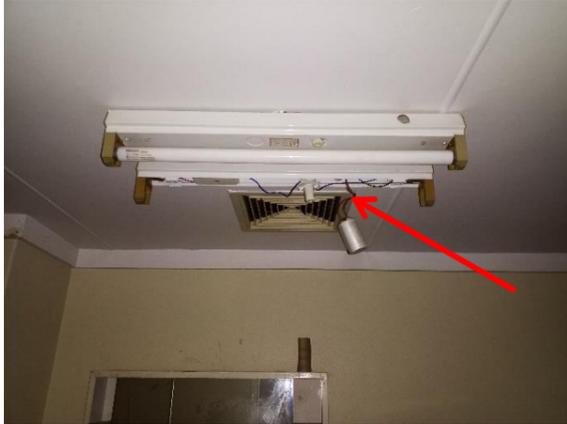
3 rd floor, unit 33, bathroom, ceiling single tube fluorescent light fitting	Ducon, paper capacitor, 3.5uf, apm235r	NA	Visual inspection	Contains PCBs	2 units	Good Maintenance only	Priority 3: Negligible Risk Level	Remove prior to refurbishment works

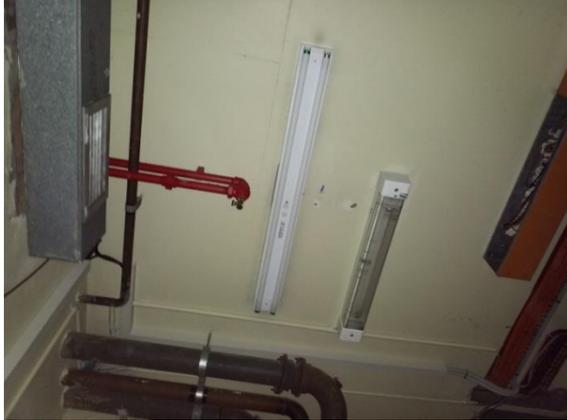
Carpark, above vent 2 board and communications room, single tube fluorescent light fitting	Plessey plastic capacitor	NA	Visual inspection	Does not contain PCBs	NA	NA	NA	NA

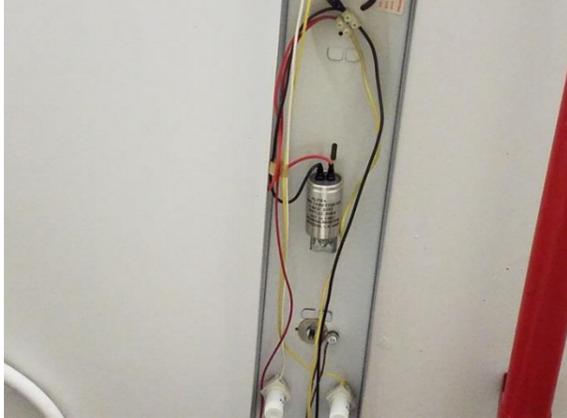
Carpark, store, opposite carpark entry, surface mount (philips screw), two tube fluorescent light fitting	Metal capacitor - Alpha mpp 6uf 250v 50hz	NA	Visual inspection	Does not contain PCBs	NA	NA	NA	NA

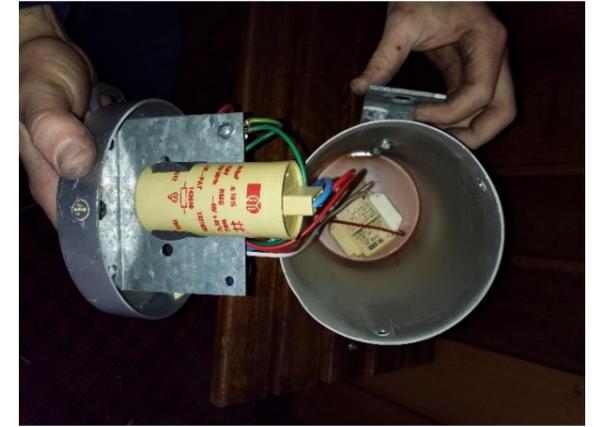
Ground floor, mercury vapour light fitting control Plastic PCB NA Visual inspection Assume negative NA NA NA NA NA

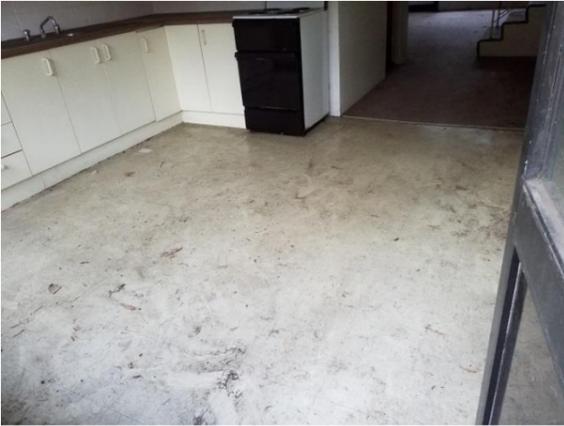
Location	Material Type	Friability	Sample	Analysis Result:	Quantity	Condition and Accessibility	Priority	Recommendations/ Comments	Photograph of material
46 Cumberland Street, The Rocks									
Inaccessible									
Internal, wall cavities	Possible hazardous materials	Unknown	Inaccessible	NA	Not determined	Unknown Inaccessible	Inaccessible	No access available at time of inspection. When areas are accessible, confirm status of hazardous materials.	
Internal, walls behind ceramic tiles, membranes	Possible hazardous materials	Unknown	Inaccessible	NA	Not determined	Unknown Inaccessible	Inaccessible	No access available at time of inspection. When areas are accessible, confirm status of hazardous materials.	
Asbestos									
Kitchen, floor	Cream vinyl floor tiles	Non-friable	Similar to A16	Assume negative	NA	NA	NA	NA

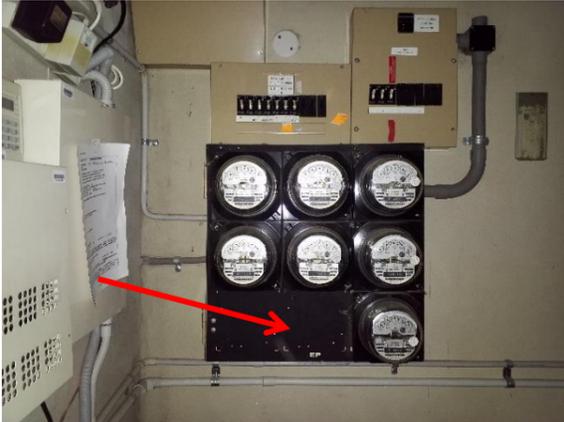
Location	Material Type	Friability	Sample	Analysis Result:	Quantity	Condition and Accessibility	Priority	Recommendations/ Comments	Photograph of material
48 Cumberland Street, The Rocks									
Inaccessible									
Internal, wall cavities	Possible hazardous materials	Unknown	Inaccessible	NA	Not determined	Unknown Inaccessible	Inaccessible	No access available at time of inspection. When areas are accessible, confirm status of hazardous materials.	
Internal, walls behind ceramic tiles, membranes	Possible hazardous materials	Unknown	Inaccessible	NA	Not determined	Unknown Inaccessible	Inaccessible	No access available at time of inspection. When areas are accessible, confirm status of hazardous materials.	
Asbestos									
Sub-basement, electrical switch room	Electrical backing board	Non-friable	Similar to A12	Assume positive	1 unit	Good Maintenance only	Priority 4: Negligible Risk Level	Remove prior to refurbishment works

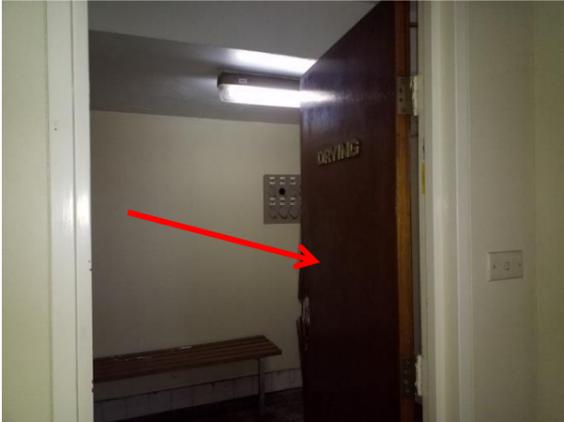
Sub-basement, drying room, door	Fire door	Friable	A61	Amosite & Chrysotile Asbestos Detected	1 unit	Fair Maintenance only		Sealed with black plastic and tape during inspection by 3rd party. Remove prior to refurbishment works

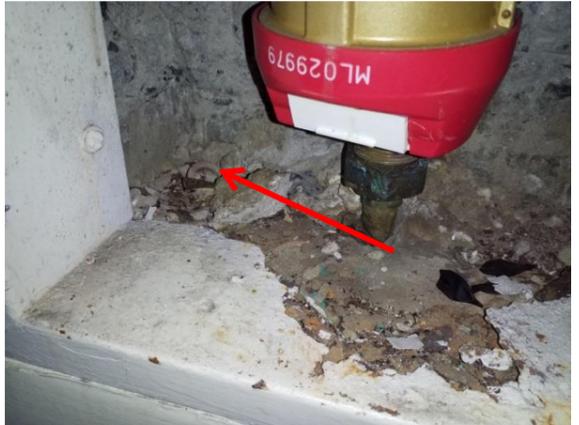
Common areas, outside unit 1, water meter riser, redundant gaskets	Gasket	Friable	Similar to A38	Assume positive	Not determined	Fair Maintenance only	Priority 4: Negligible Risk Level	Remove prior to refurbishment works

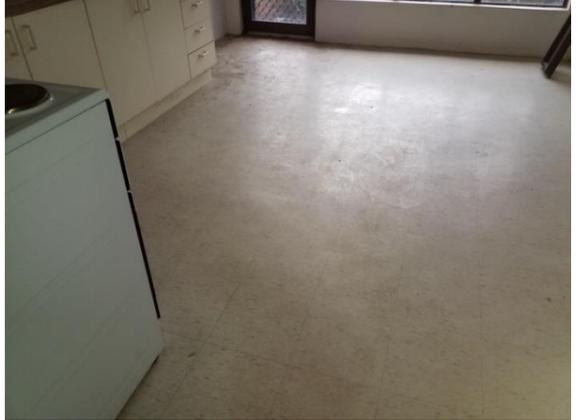
Unit 1, kitchen, floor	Bone fleck vinyl floor tiles	Non-friable	A62	No Asbestos Detected	NA	NA	NA	NA

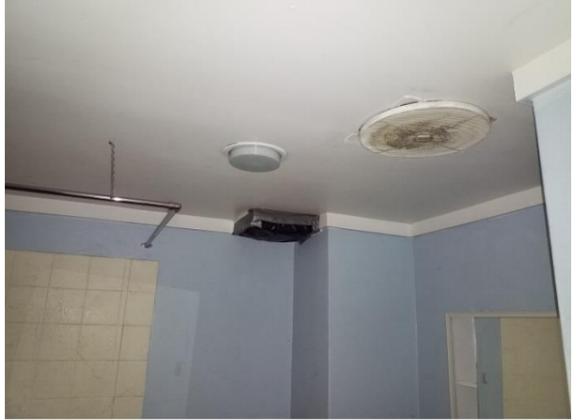
Unit 1, bathroom ceiling	Asbestos cement sheeting	Non-friable	Similar to A47	Assume positive	6m ²	Good Maintenance only	Priority 4: Negligible Risk Level	Remove prior to refurbishment works

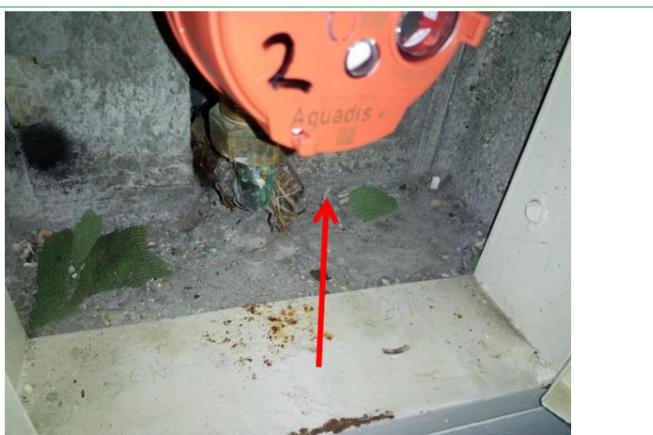
Common areas, outside unit 2, water meter riser, redundant gaskets	Gasket	Friable	Similar to A38	Assume positive	Not determined	Fair Maintenance only	Priority 4: Negligible Risk Level	Remove prior to refurbishment works

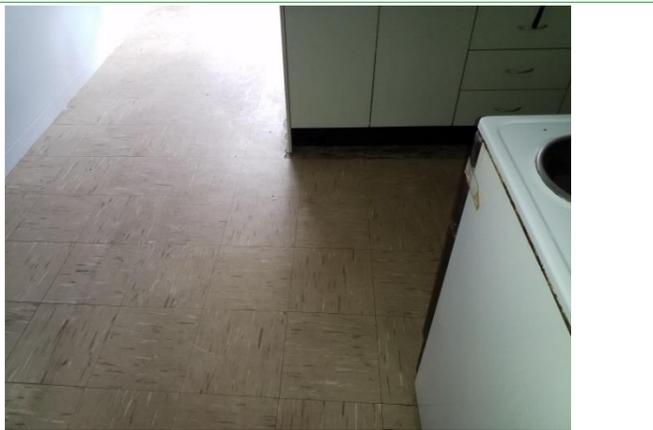
Unit 2, kitchen, floor	Tan fleck vinyl floor tiles	Non-friable	Similar to A56	Assume negative	NA	NA	NA	NA

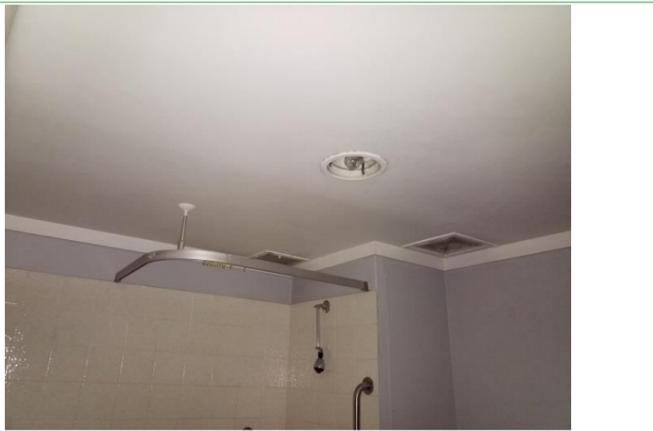
Unit 2, bathroom	Asbestos cement sheeting	Non-friable	Similar to A47	Assume positive	6m ²	Good Maintenance only	Priority 4: Negligible Risk Level	Remove prior to refurbishment works

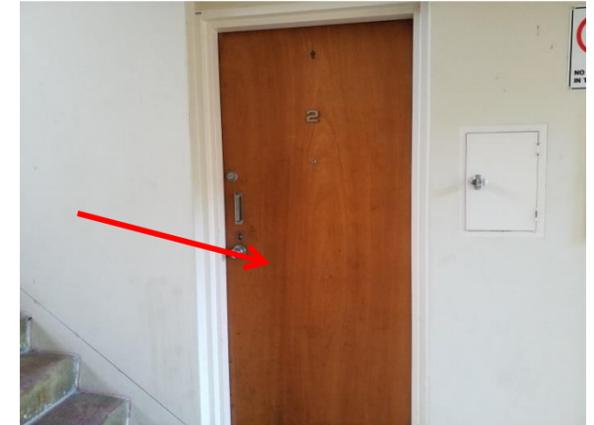
Unit 2, entry door "Padde"	Fire door	Friable	Similar to A10	Assume positive	Not determined	Good Maintenance only	Priority 4: Negligible Risk Level	Remove prior to refurbishment works

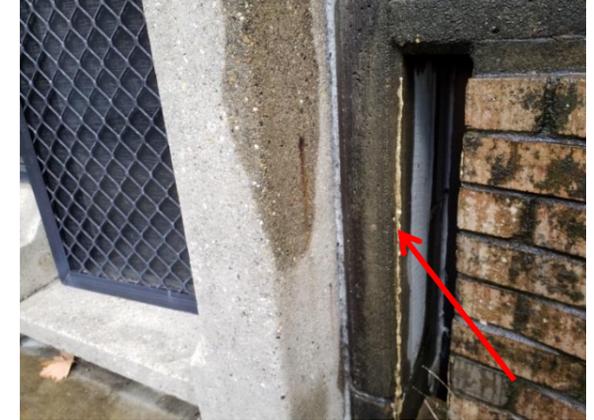
External, eastern elevation, adjacent unit 2, residual mastic on concrete	Sealant	Non-friable	A63	No Asbestos Detected	NA	NA	NA	NA

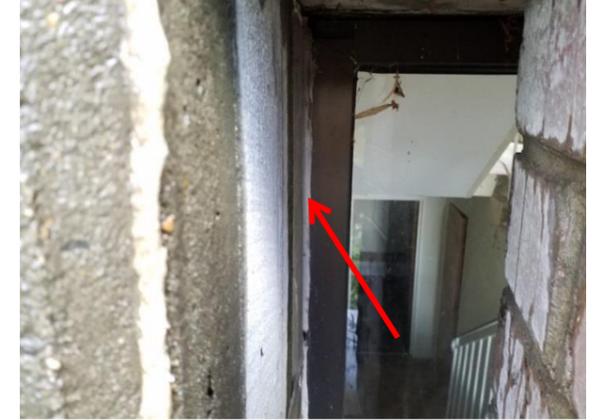
External, eastern elevation adjacent unit 2 courtyard door, mastic between downpipe and wall	Sealant	Non-friable	A64	Chrysotile Asbestos Detected	Not determined	Good Maintenance only	Priority 4: Negligible Risk Level	Remove prior to refurbishment works

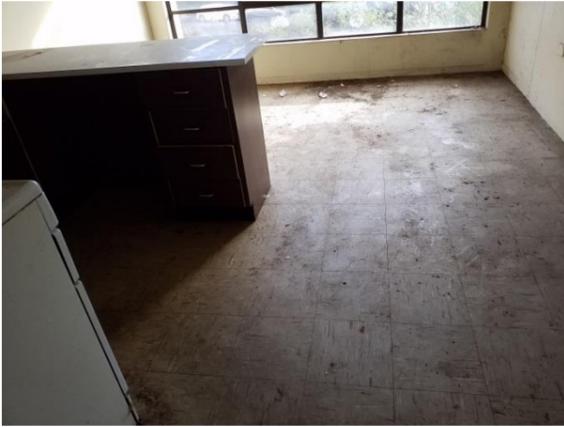
Unit 3, kitchen,	Tan fleck vinyl floor tiles	Non-friable	Similar to A56	No Asbestos Detected	NA	NA	NA	NA

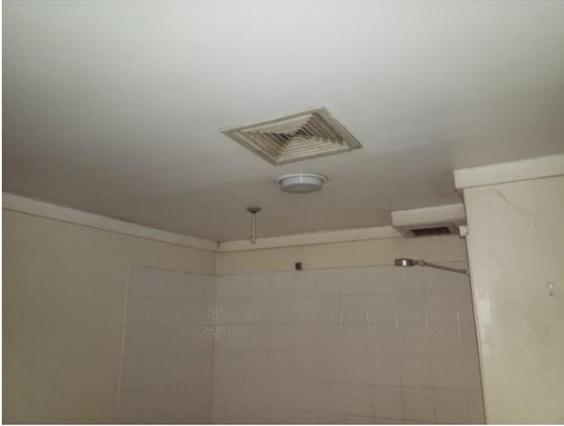
Unit 3, bathroom	Asbestos cement sheeting	Non-friable	Similar to A47	Assume positive	6m ²	Good Maintenance only	Priority 4: Negligible Risk Level	Remove prior to refurbishment works

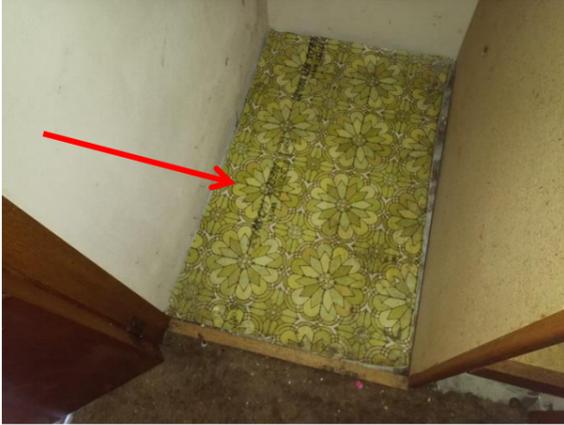
Unit 3, storage cupboard adjacent kitchen, floor	Green geometric vinyl floor sheet	Friable	A65	Chrysotile Asbestos Detected Organic Fibres Detected	Not determined	Good Maintenance only	Priority 4: Negligible Risk Level	Remove prior to refurbishment works

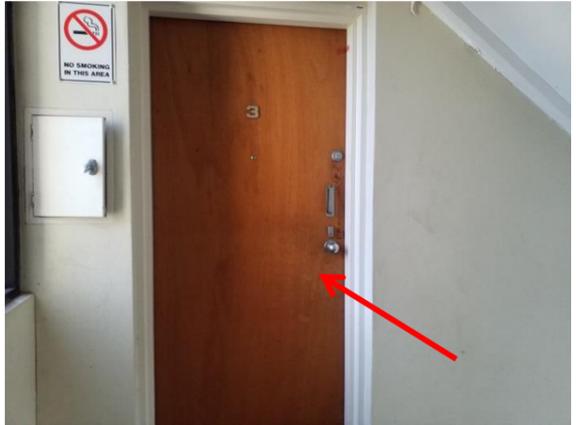
Unit 3, entry door "Padde"	Fire door	Friable	Similar to A10	Assume positive	Not determined	Good Maintenance only	Priority 4: Negligible Risk Level	Remove prior to refurbishment works

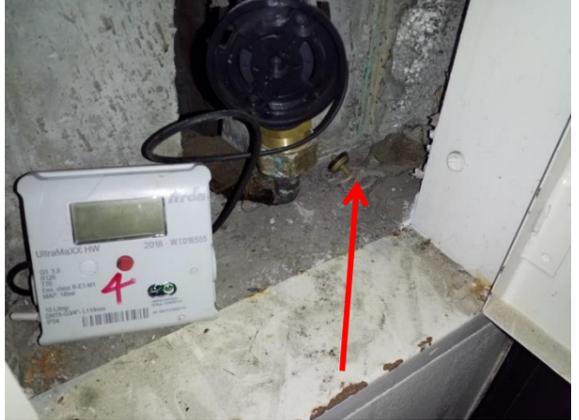
Common areas, outside unit 4, water meter riser, redundant gaskets	Gasket	Friable	Similar to A38	Assume positive	Not determined	Fair Maintenance only	Priority 4: Negligible Risk Level	Remove prior to refurbishment works

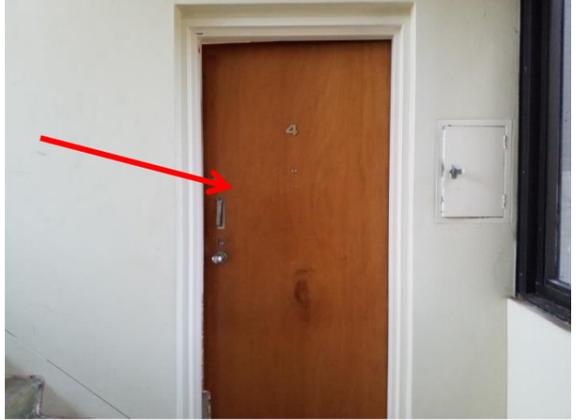
Unit 4, entry door "Padde"	Fire door	Friable	Similar to A10	Assume positive	Not determined	Good Maintenance only	Priority 4: Negligible Risk Level	Remove prior to refurbishment works

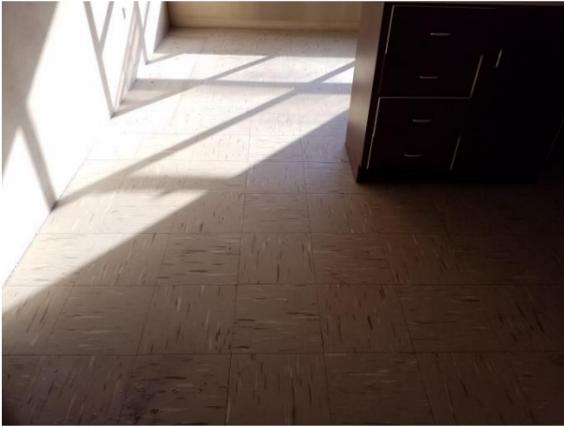
Unit 4, kitchen	Tan fleck vinyl floor tiles	Non-friable	Similar to A56	Assume negative	NA	NA	NA	NA

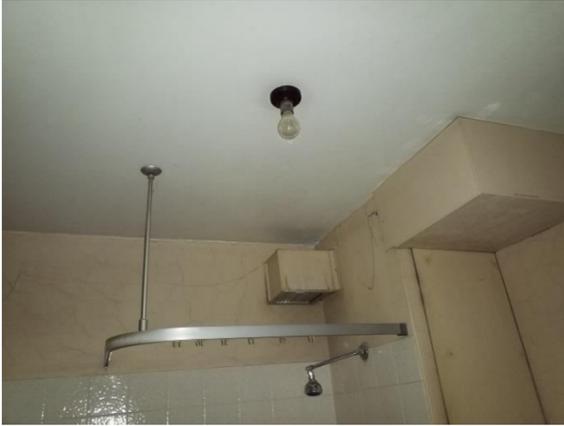
Unit 4, bathroom ceiling	Concrete	NA	Visual Inspection	Assume negative	NA	NA	NA	NA

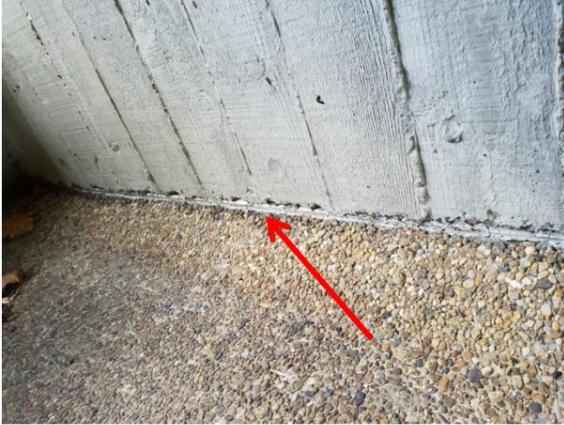
Unit 4 rooftop terrace, mastic to pebble surface and concrete wall	Sealant	Non-friable	Similar to A54	Assume positive	Not determined	Good Maintenance only	Priority 4: Negligible Risk Level	Remove prior to refurbishment works

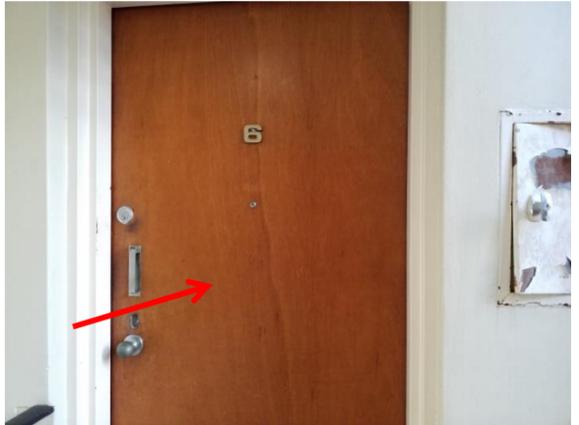
Unit 6, entry door "Padde"	Fire door	Friable	Similar to A10	Assume positive	Not determined	Good Maintenance only	Priority 4: Negligible Risk Level	Remove prior to refurbishment works

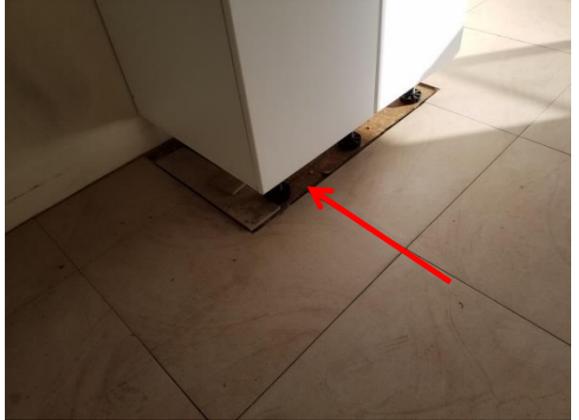
Unit 6, kitchen, underneath cupboard, covered with cork pattern	Cream vinyl floor tiles	Non-friable	Similar to A16	Assume negative	NA	NA	NA	NA

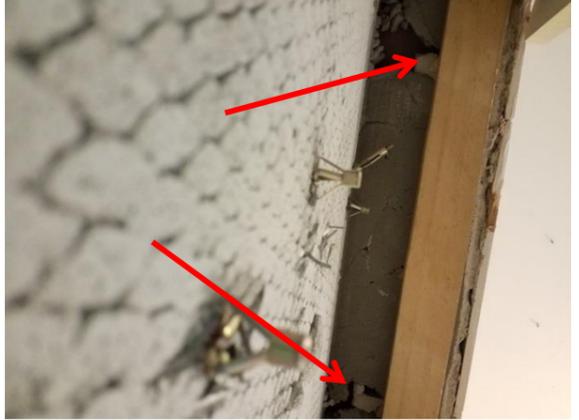
Unit 6, bathroom, wall cavity where shaving cupboard was removed.	Asbestos cement sheeting	Non-friable	Similar to A47	Assume positive	Not determined	Good Maintenance only	Priority 4: Negligible Risk Level	Remove prior to refurbishment works.

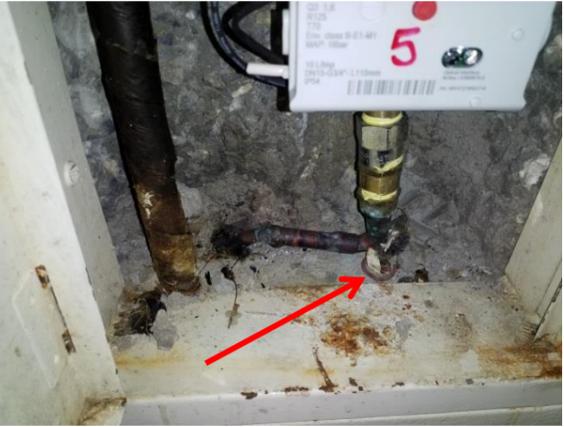
Common areas, outside unit 5, water meter riser, redundant gaskets	Gasket	Friable	Similar to A38	Assume positive	Not determined	Fair Maintenance only	Priority 4: Negligible Risk Level	Remove prior to refurbishment works

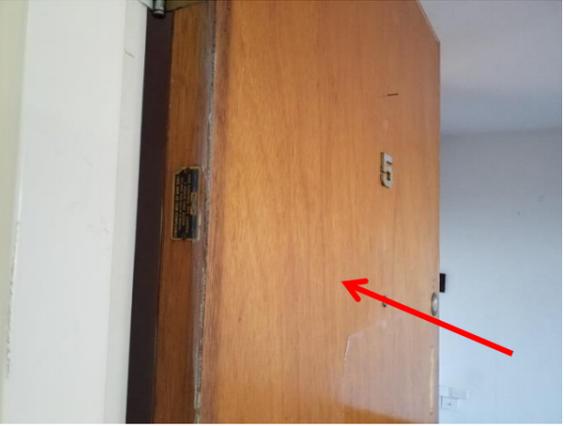
Unit 5, entry door "Padde"	Fire door	Friable	Similar to A10	Assume positive	Not determined	Good Maintenance only	Priority 4: Negligible Risk Level	Remove prior to refurbishment works

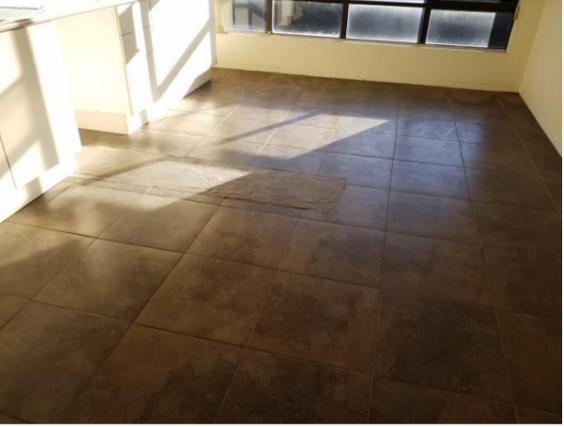
Unit 5, kitchen,	Ceramic tiles	NA	Visual Inspection	Assume negative	NA	NA	NA	NA

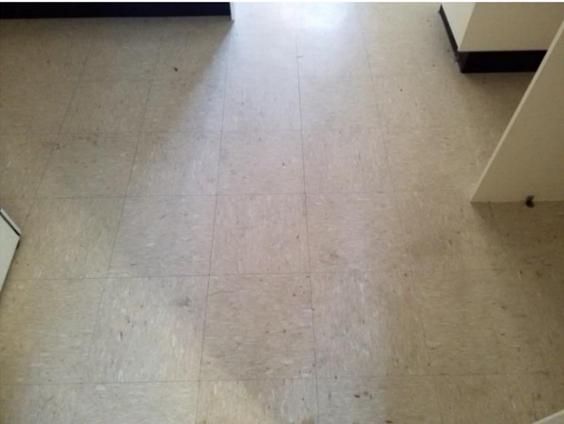
Location	Material Type	Friability	Sample	Analysis Result:	Quantity	Condition and Accessibility	Priority	Recommendations/ Comments	Photograph of material
50 Cumberland Street, The Rocks									
Inaccessible									
Internal, wall cavities	Possible hazardous materials	Unknown	Inaccessible	NA	Not determined	Unknown Inaccessible	Inaccessible	No access available at time of inspection. When areas are accessible, confirm status of hazardous materials.	
Internal, walls behind ceramic tiles, membranes	Possible hazardous materials	Unknown	Inaccessible	NA	Not determined	Unknown Inaccessible	Inaccessible	No access available at time of inspection. When areas are accessible, confirm status of hazardous materials.	
Asbestos									
Kitchen, floor	Cream fleck vinyl floor tiles	Non-friable	Similar to A13	Assume negative	NA	NA	NA	NA
