# Sirius - Tree Removal on Gloucester Walk

**DATE** 21/09/2021  
**TO** Richard Crookes Constructions Pty Ltd  
**ATTN** Ben Wilderink  
**PROJECT** Sirius Building

This letter is prepared to provide comment on the existing Sirius eastern basement retaining walls design and condition and to also comment on the stability of Trees T50 and T51 on Gloucester walk due to the required basement wall structural upgrade and proposed basement construction works.

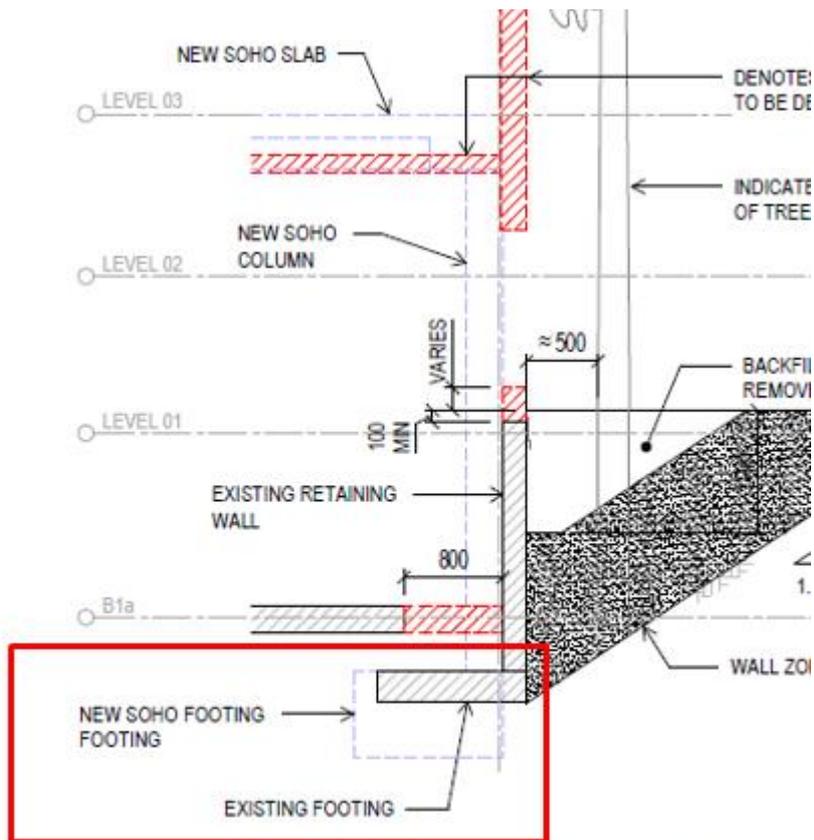
**TREE - T51**  
SCALE 1 : 50

**Typical Wall section North of Grid 108.5 at Tree 51**

With the required removal of the backfill at the tree locations and wall re-construction, the trees would be unstable. Refer to the Arborist report.

To upgrade the building to meet current standards and good building practice (waterproofing, stability etc), which is required in order to structurally certify the completed project, the retaining walls will require removal and re-construction which will impact on the stability of tree 50 and 51.
