Sirius SSD Modification 1 (SSD 10384_Mod 1): proposed tree removal

Sirius - Tree Removal on Gloucester Walk

Re: Sirius Building - Tree numbers 50 and 51 - Basement rectification works.

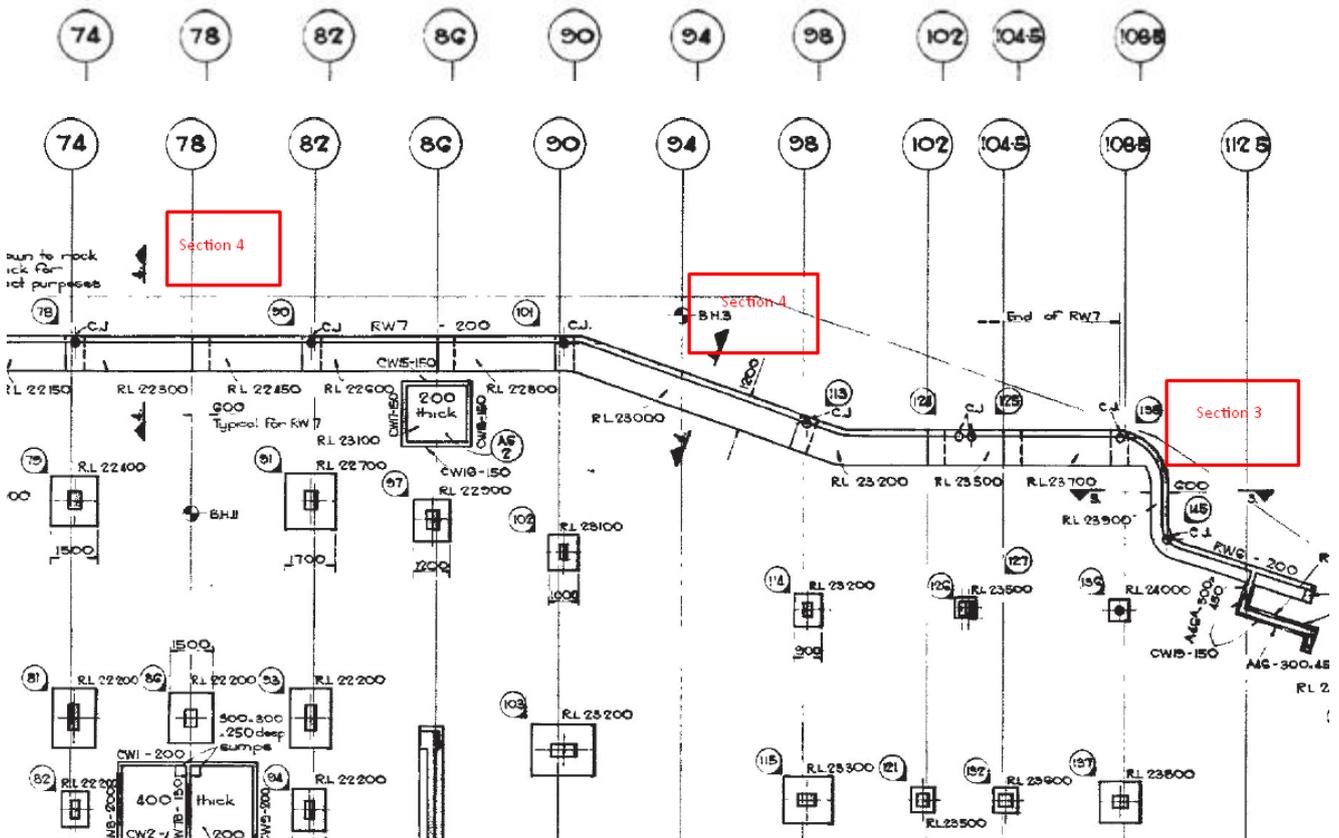
Existing Footing Plan

New Works Plan showing new pad footings clashing with existing RW footings.
