# Dilapidation Report

## LHAP - Multistorey Carpark

**ADCO** / 10 December 2020

LHAP-ST-TTW-RPT-CP-120001

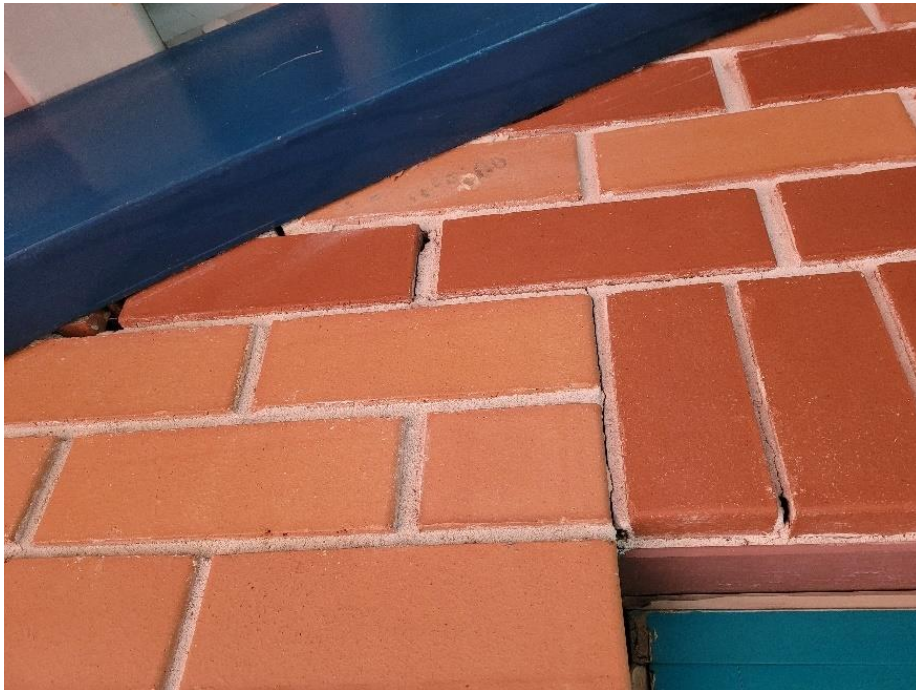
3. Cracks in mortar

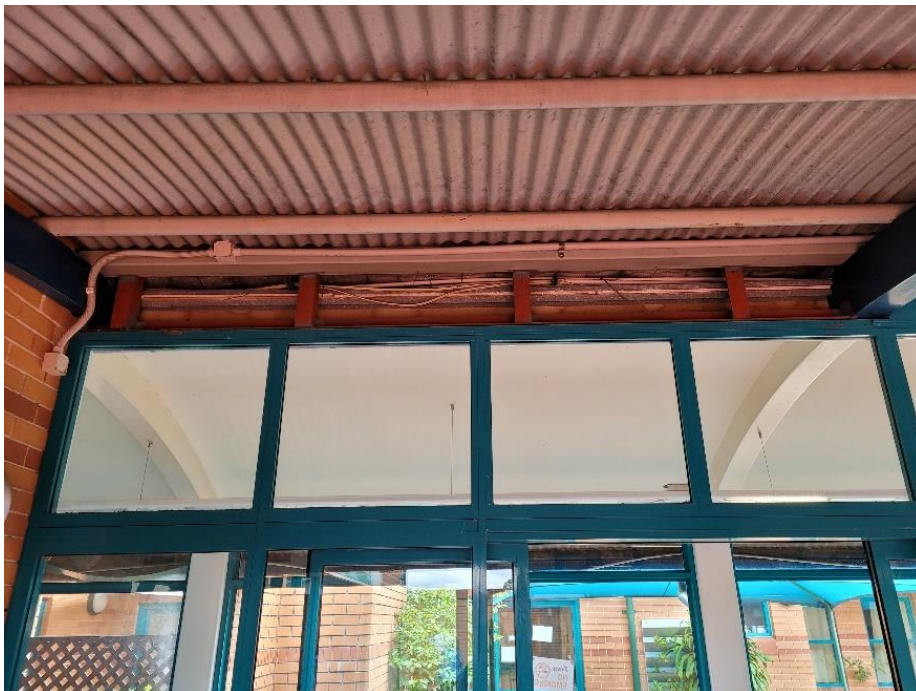
4. Faced panel missing

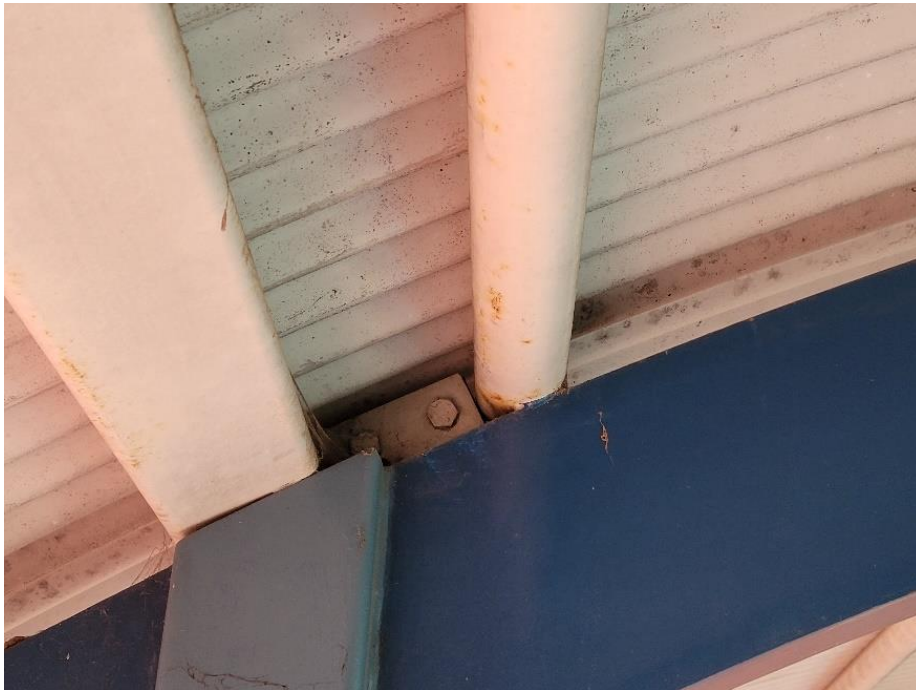
5. Surface rust and  
discolour

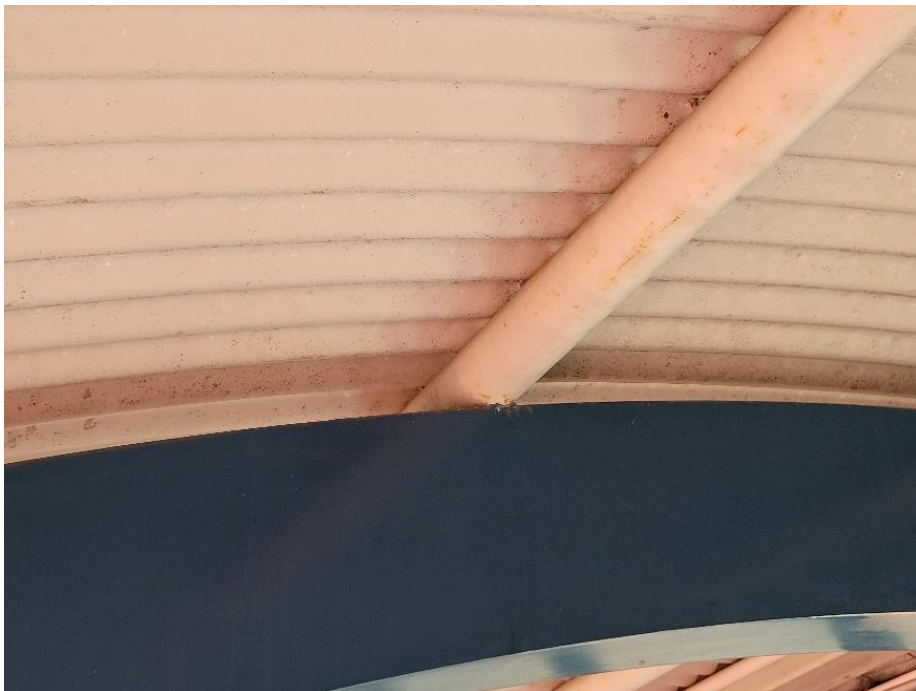
6. Surface rust and  
discolour

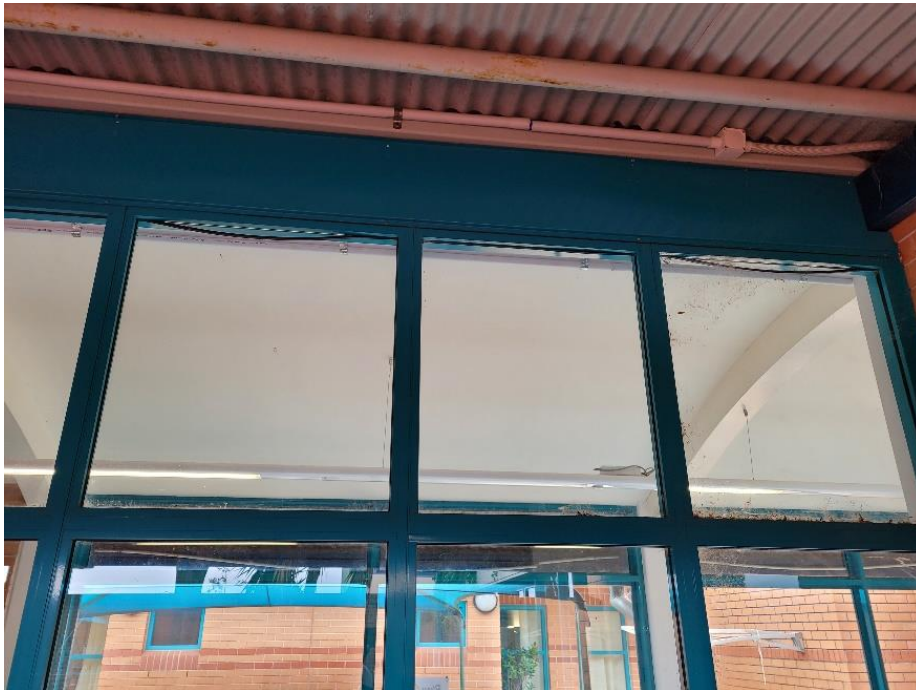
7. Window seals  
damaged

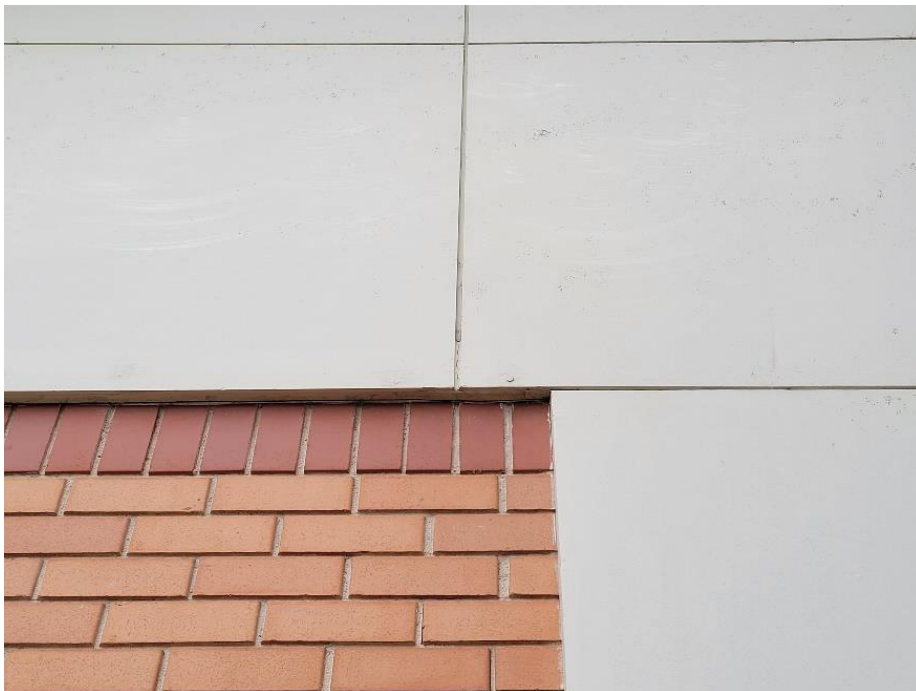
8. Damage to panel

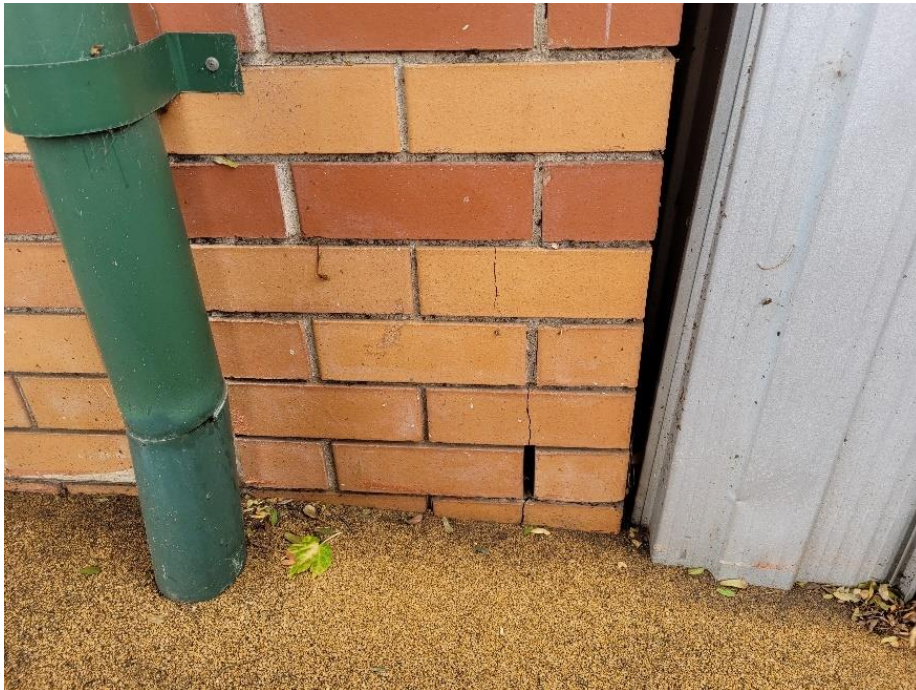
9. Cracks in brickwork

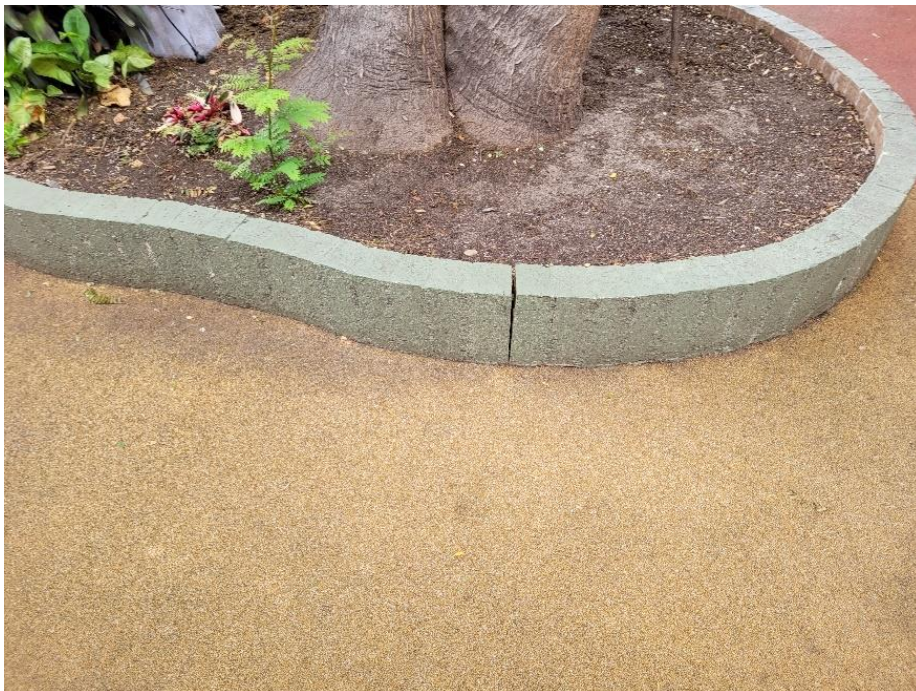
10. Garden bed brickwork damage

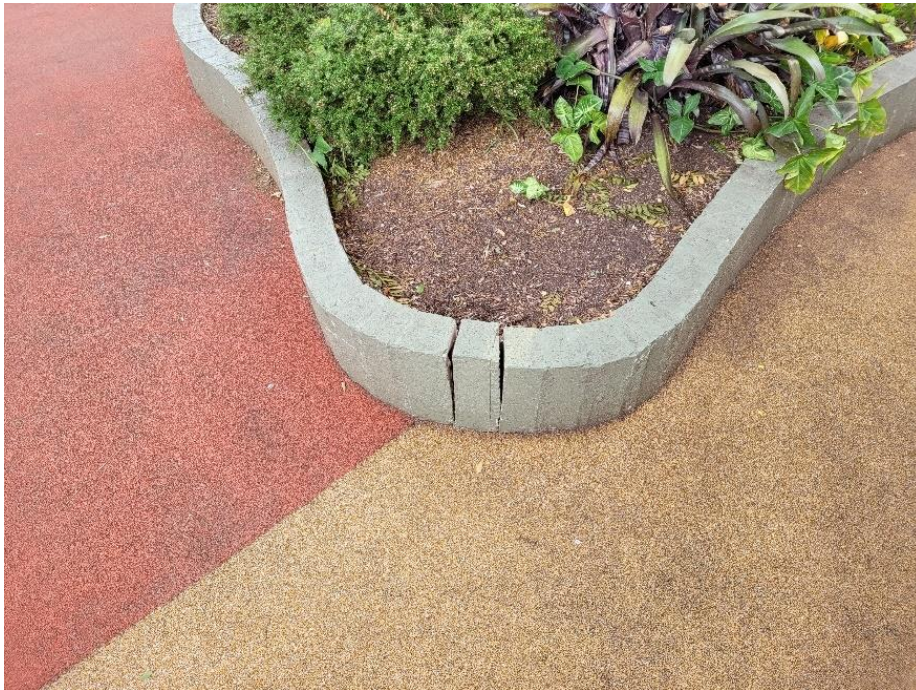
11. Garden bed brickwork damage

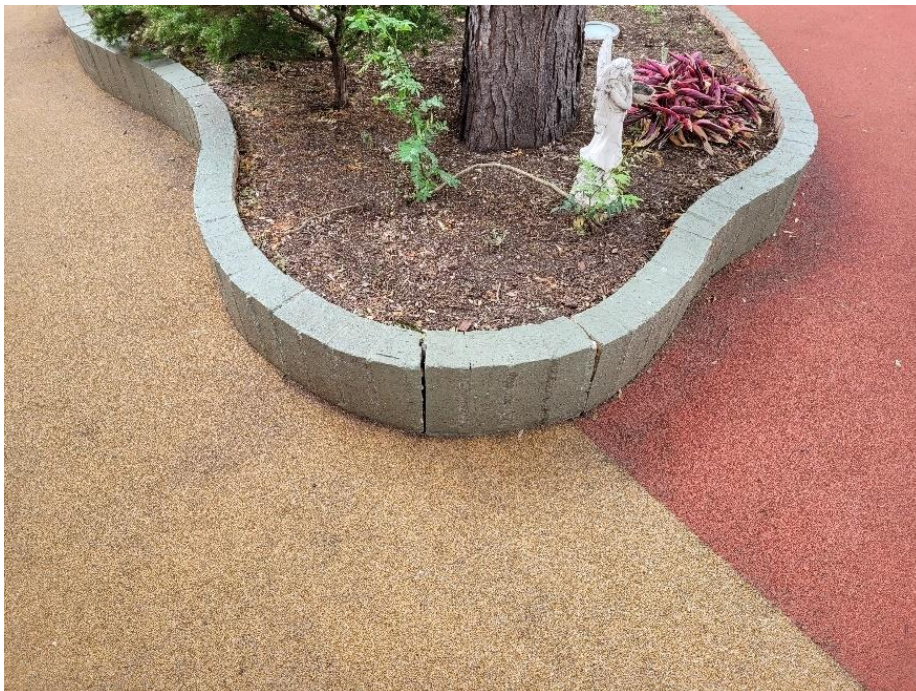
12. Garden bed brickwork damage

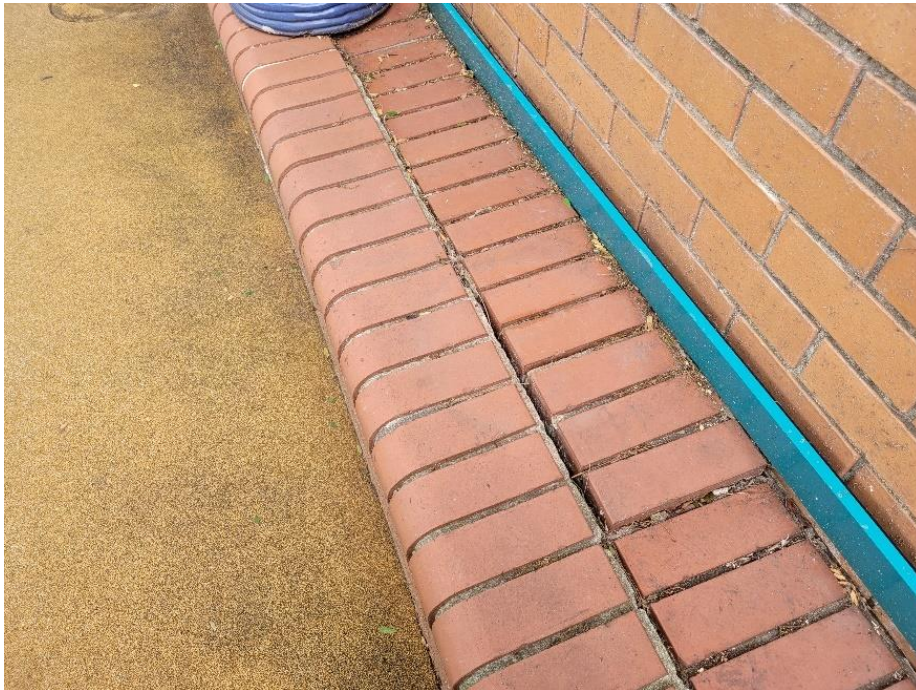
13. Brickwork damage,  
gap between courses

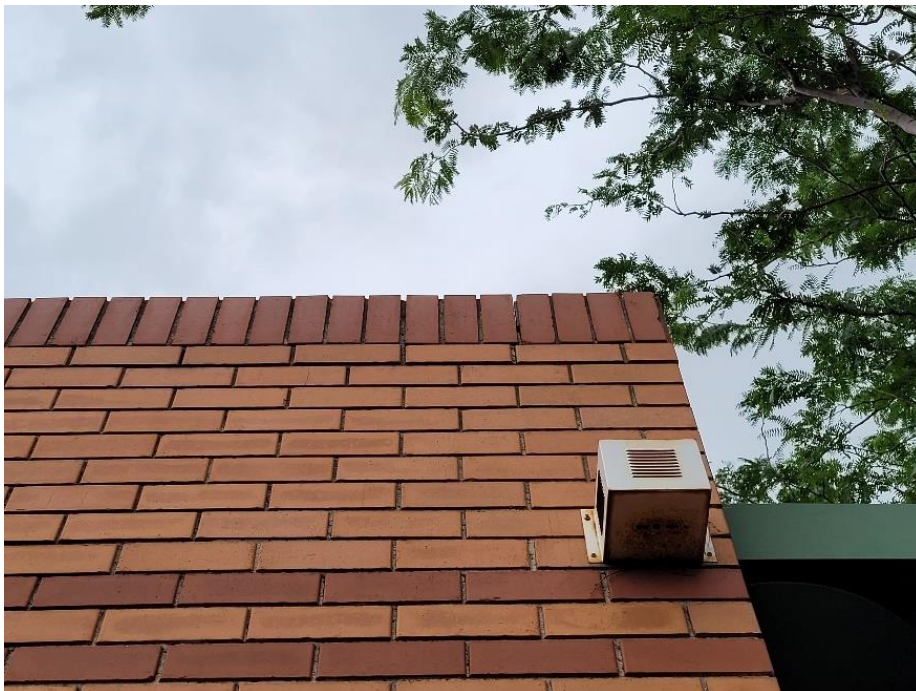
14. Crack to parapet  
brickwork

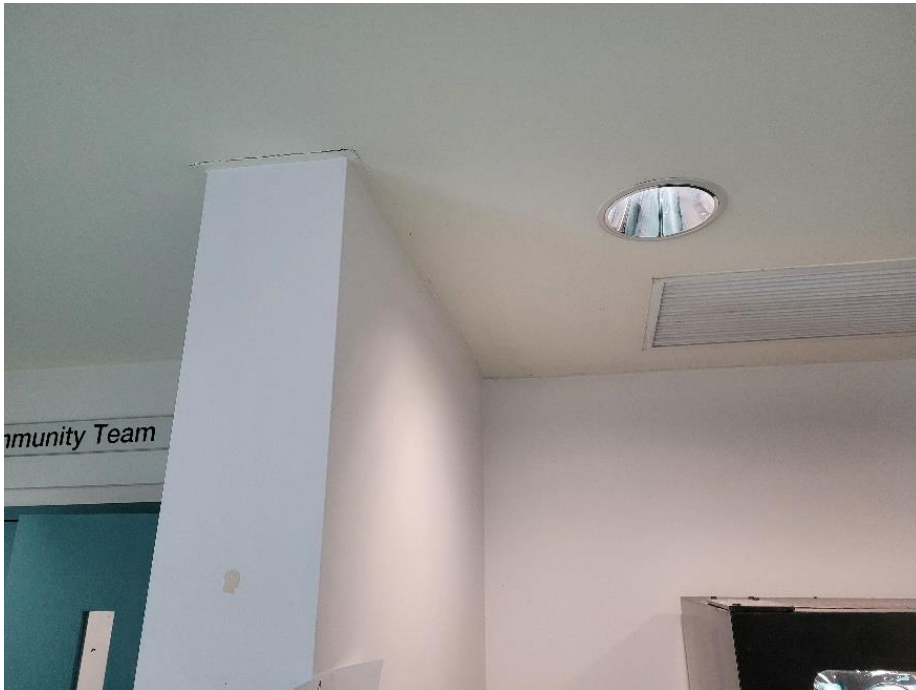
19. Crack in plasterboard  
at wall and ceiling  
junction

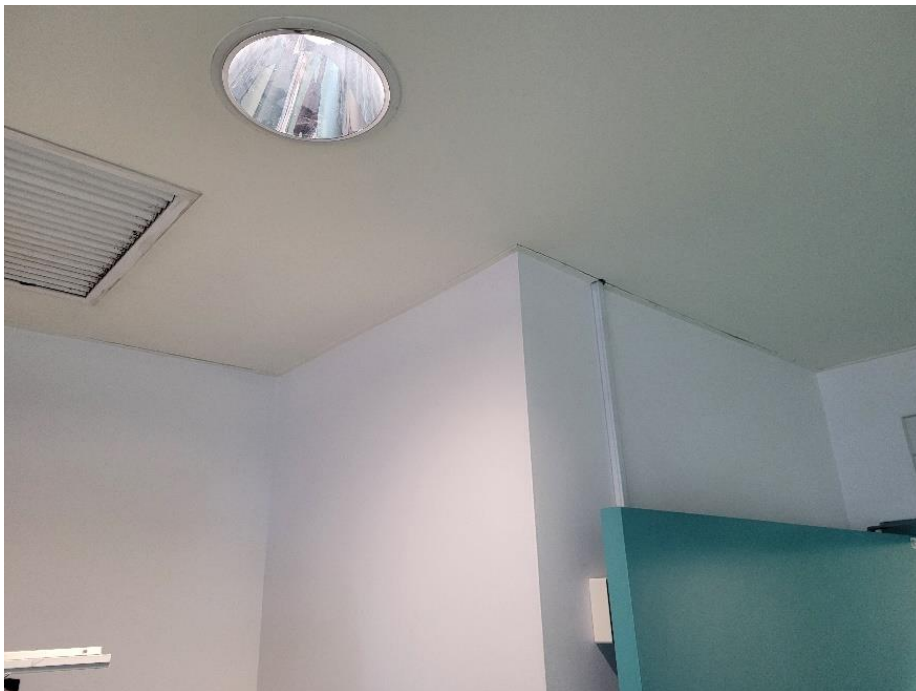
20. Crack in plasterboard  
at wall and ceiling  
junction

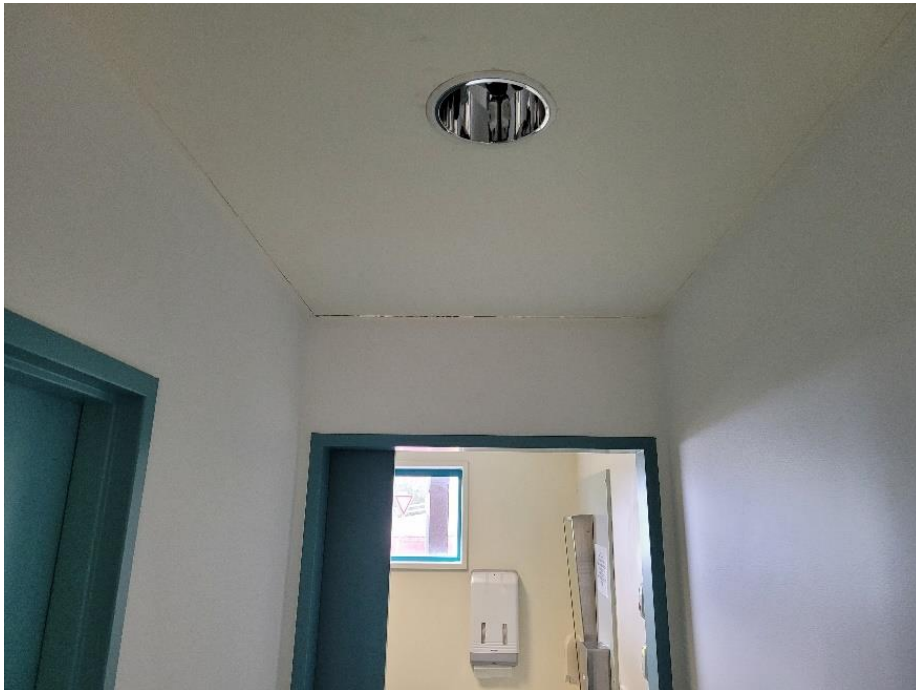
27. Crack in plasterboard  
at wall and ceiling  
junction above door  
opening

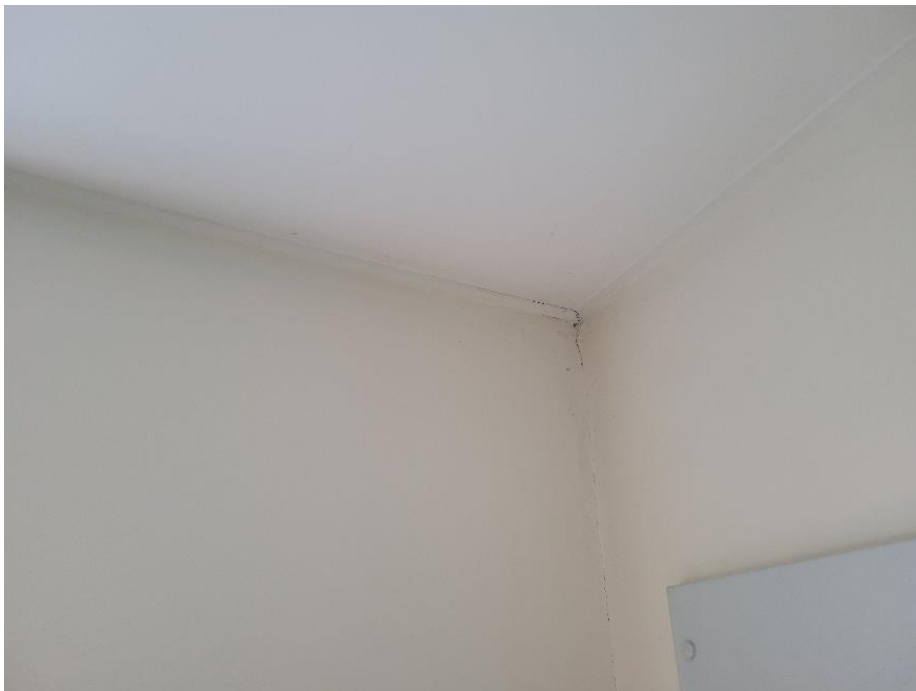
28. Crack in plasterboard  
at wall and ceiling  
junction

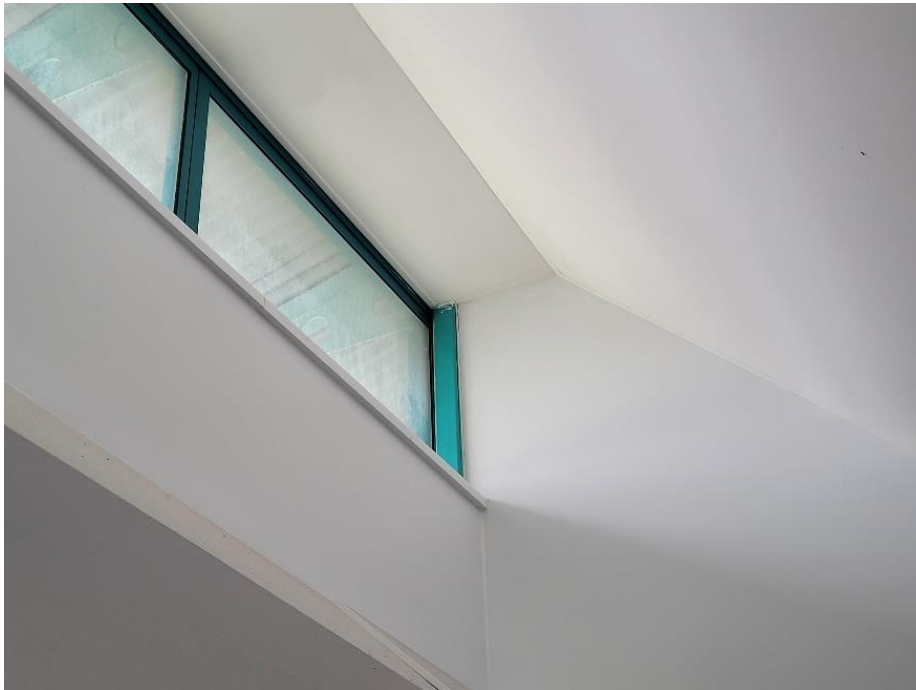
31. Crack in plasterboard  
at wall and ceiling  
junction

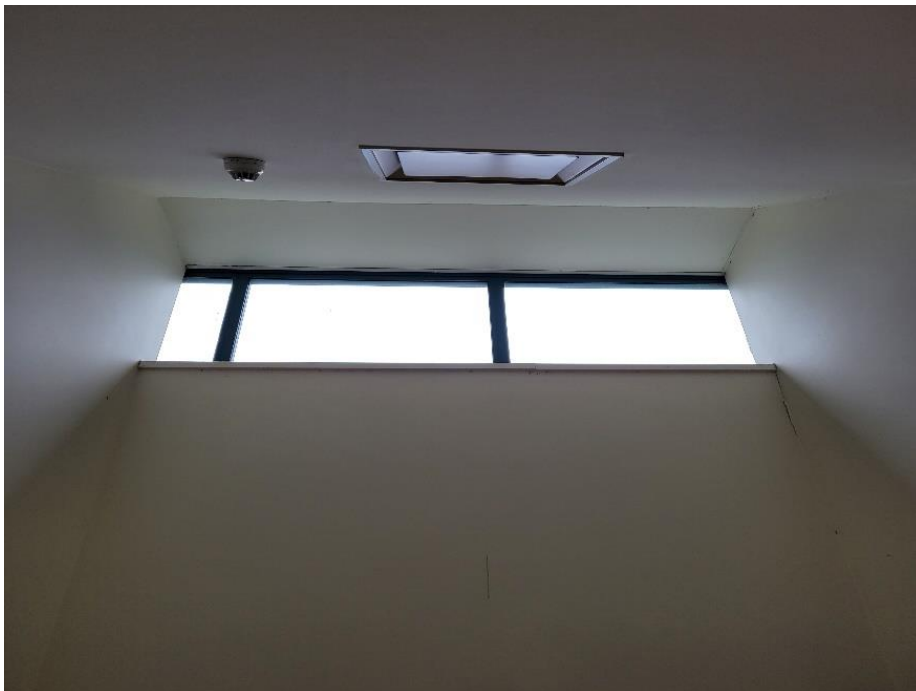
32. Crack in plasterboard  
around window

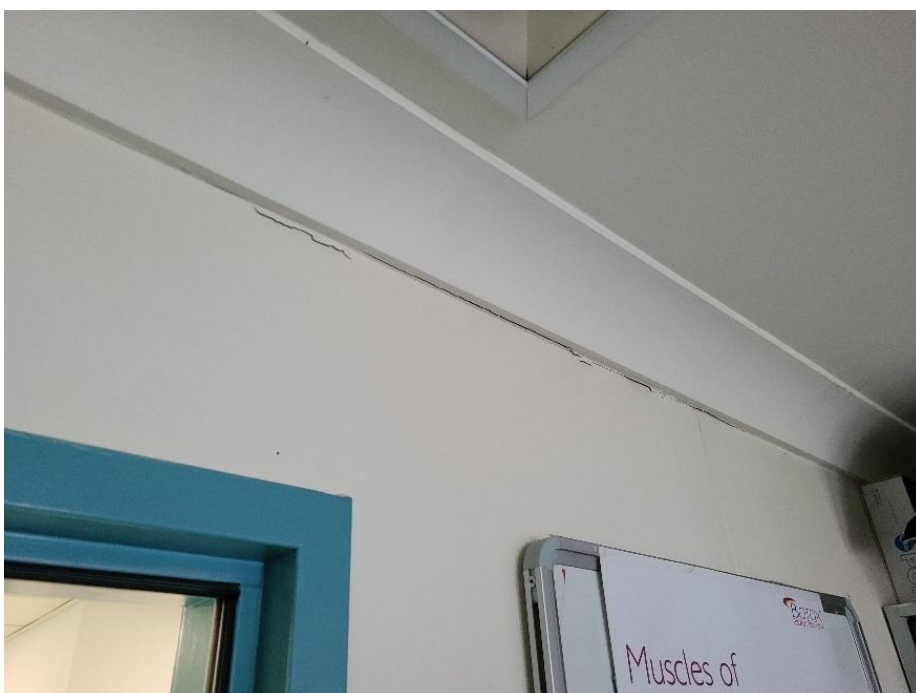
38. Crack in plasterboard at wall and ceiling junction

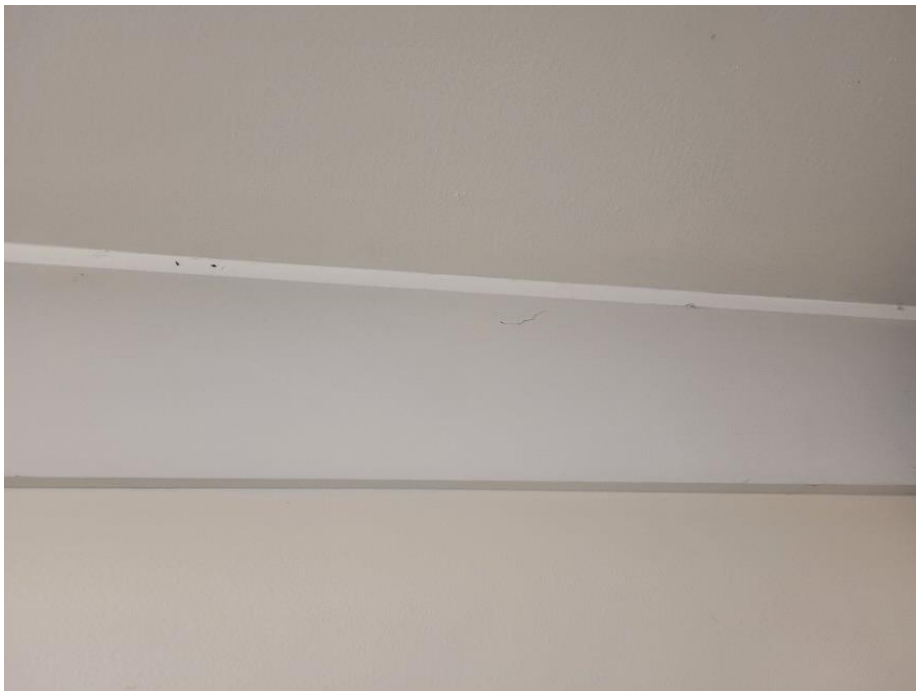
44. Slight damage and cracking in architrave

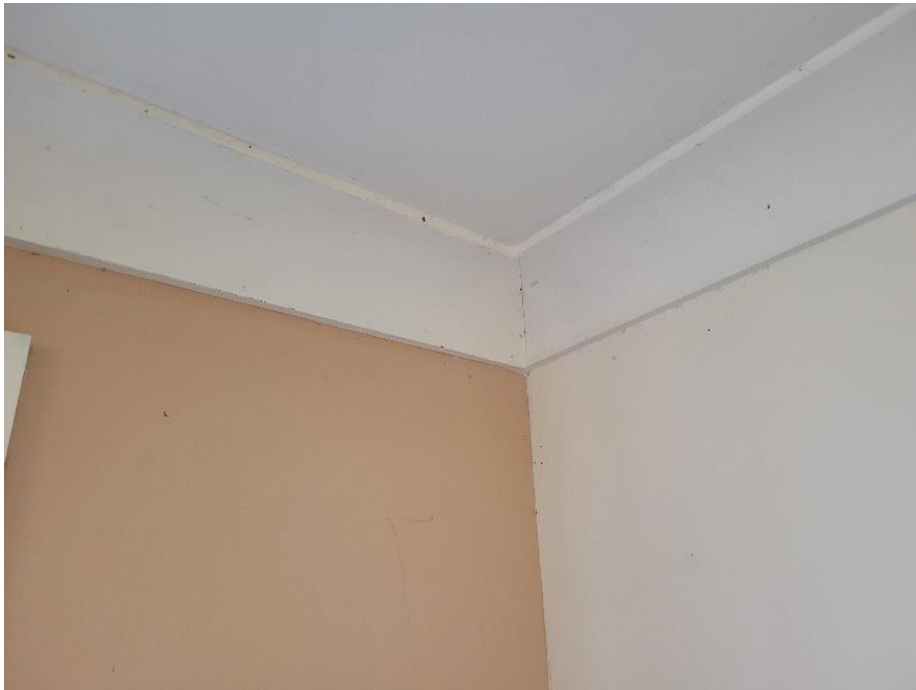
45. Crack in plasterboard  
at wall and ceiling  
junction

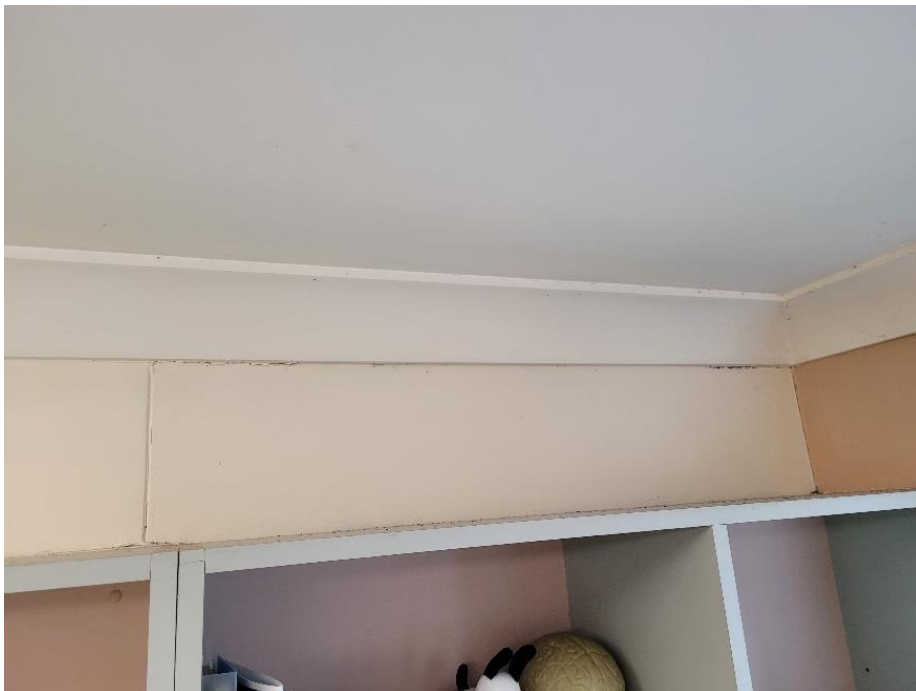
46. Crack in plasterboard  
at wall and ceiling  
junction

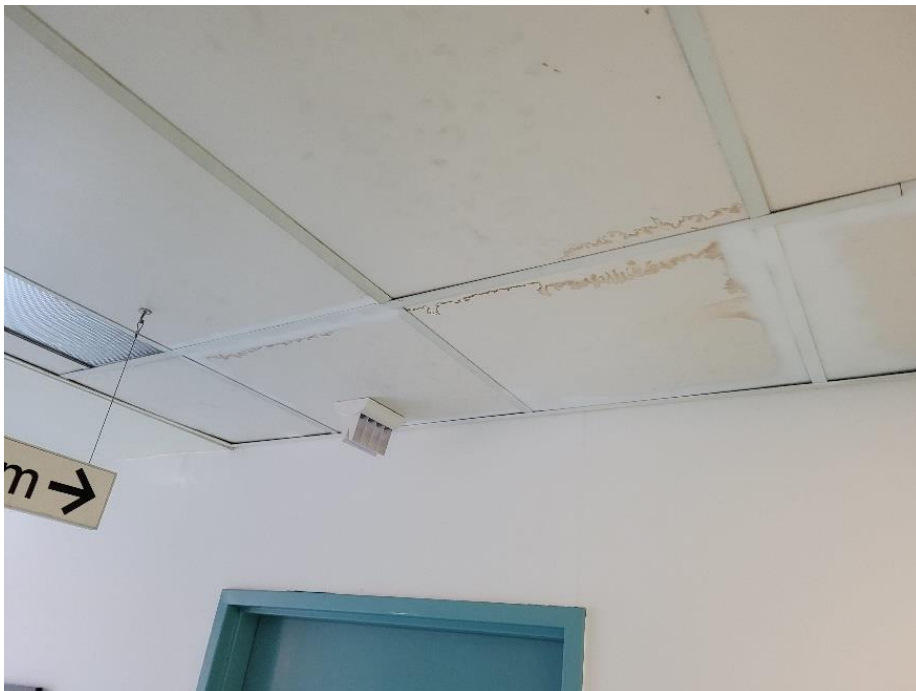
52. Water damage to false ceiling

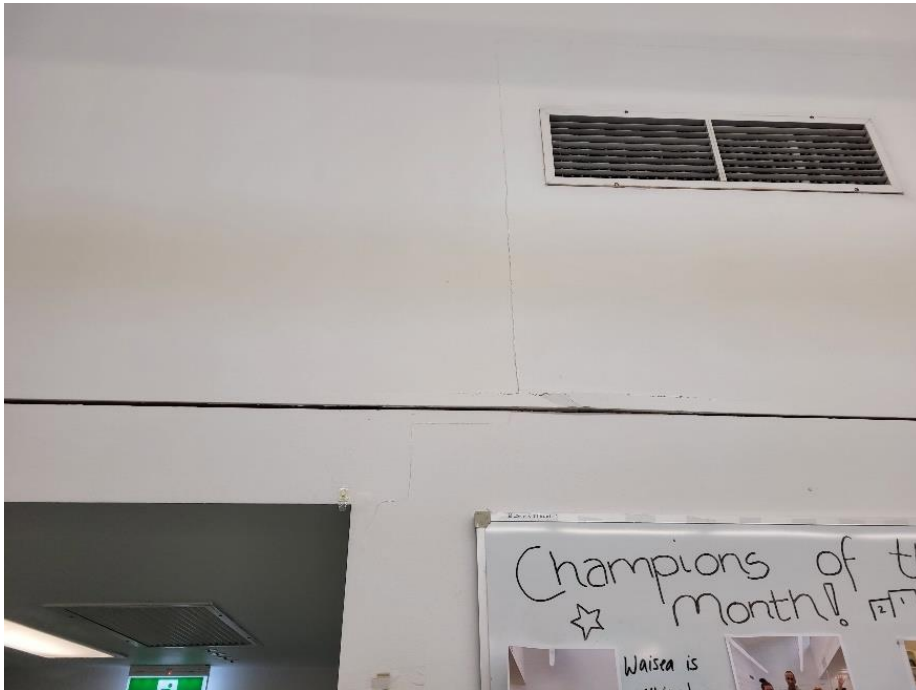
53. Vertical cracks in plasterboard in higher section of wall

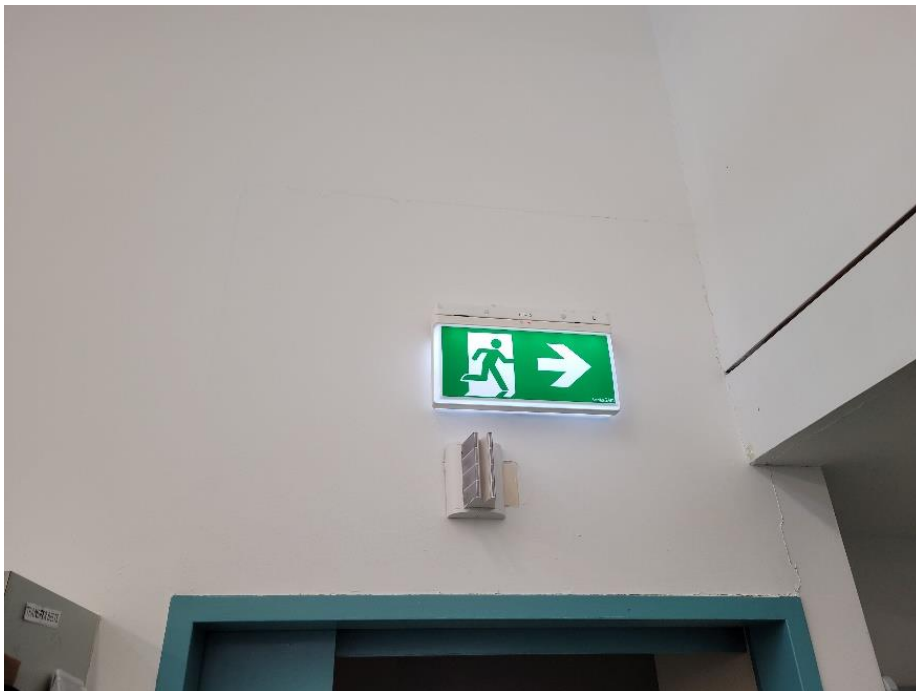
54. Vertical cracking along wall around door frame, continuing up to the higher section of wall

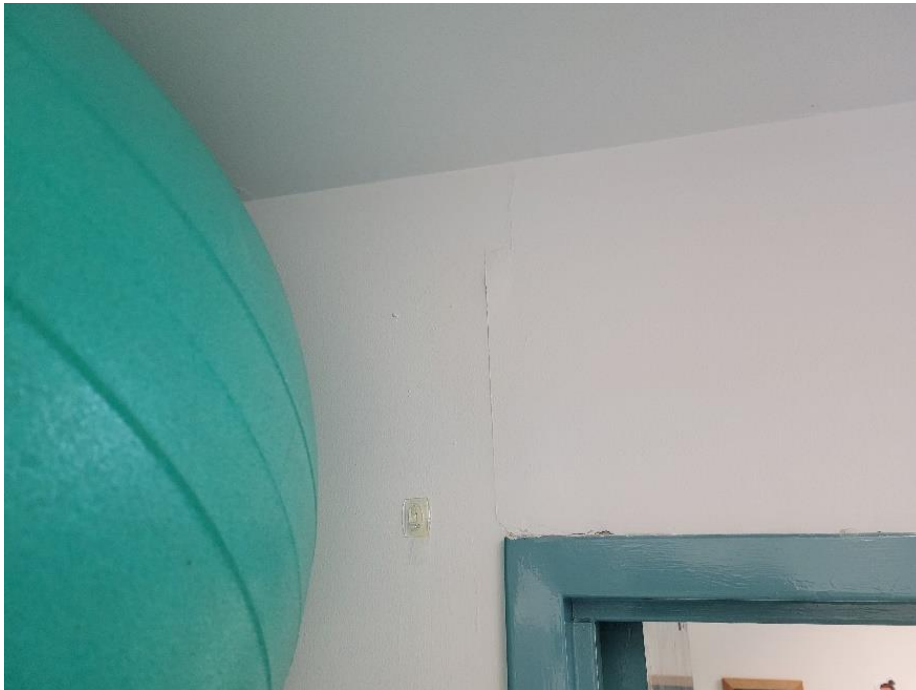
55. Vertical crack in plasterboard from door frame to ceiling

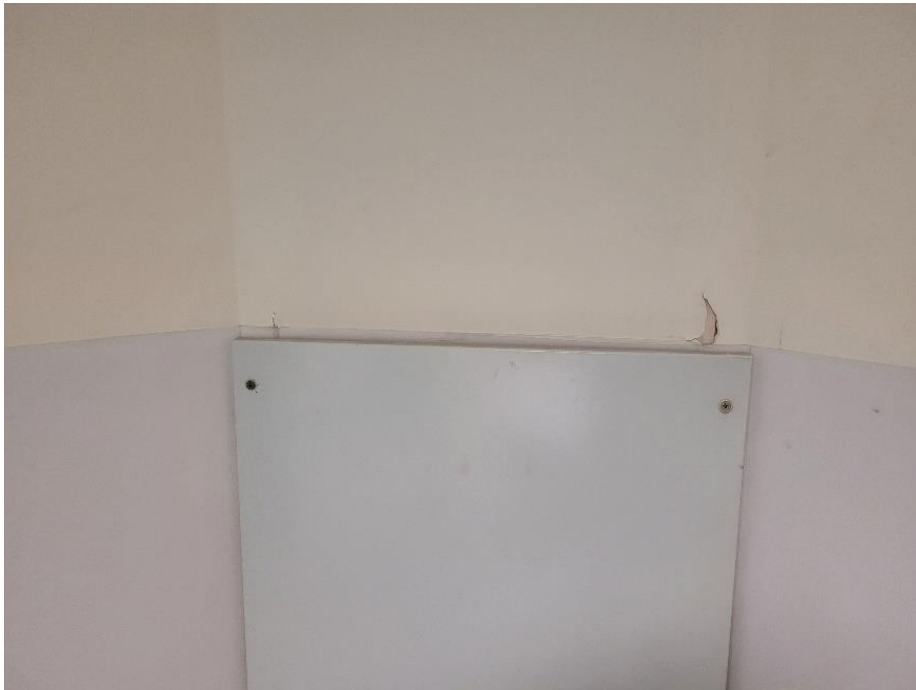
57. Damage to plasterboard around wall patch and anchor points

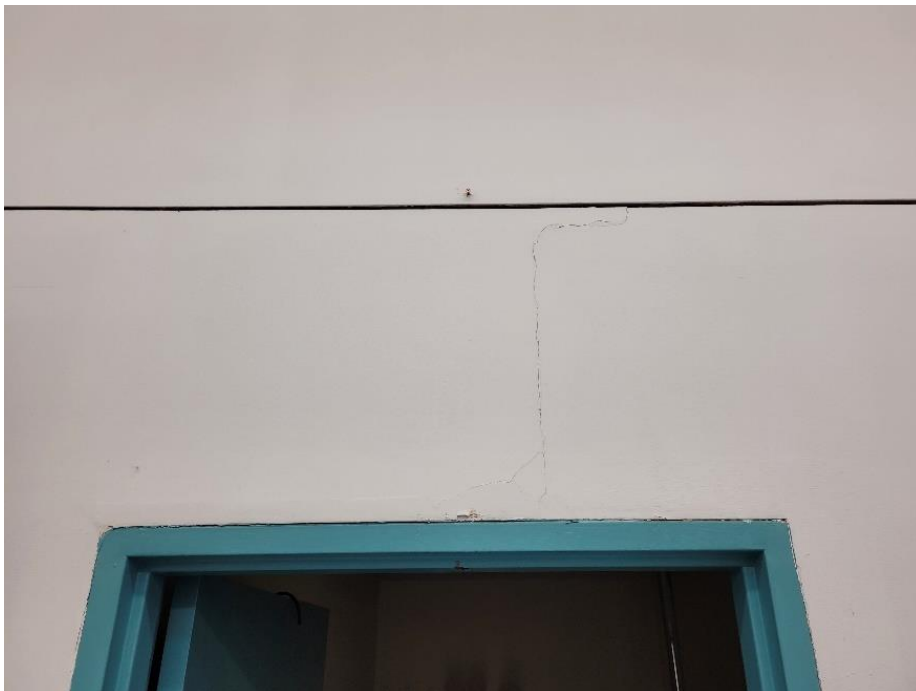
62a. Vertical cracking in higher wall section originating from wall gap

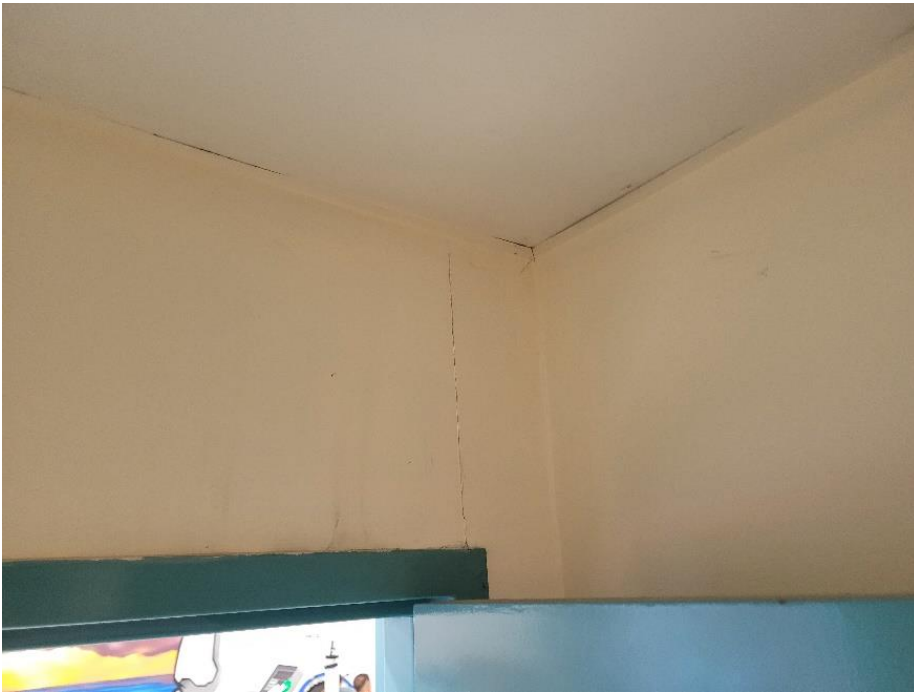
67. Crack in plasterboard at wall and ceiling junction

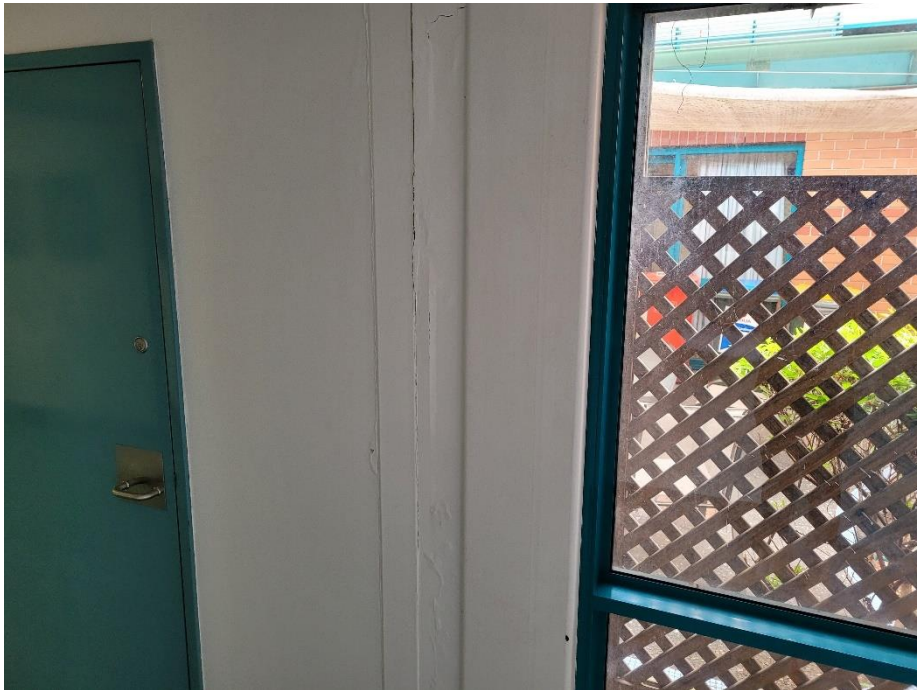
80. Cracking along  
junction with steel post,  
pitched ceiling, wall and  
lower ceiling

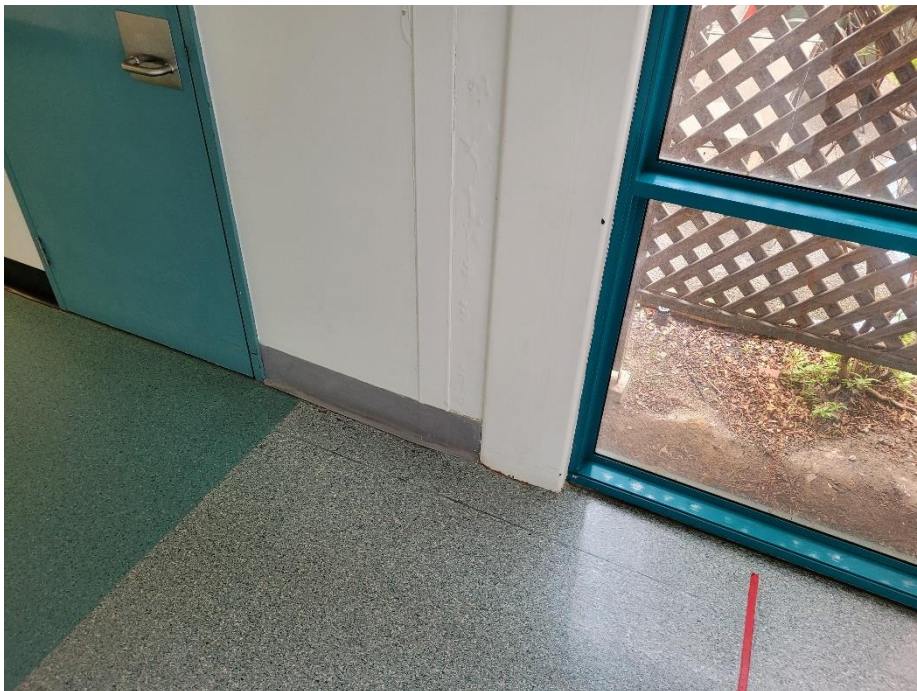
81. Cracking to plasterboard

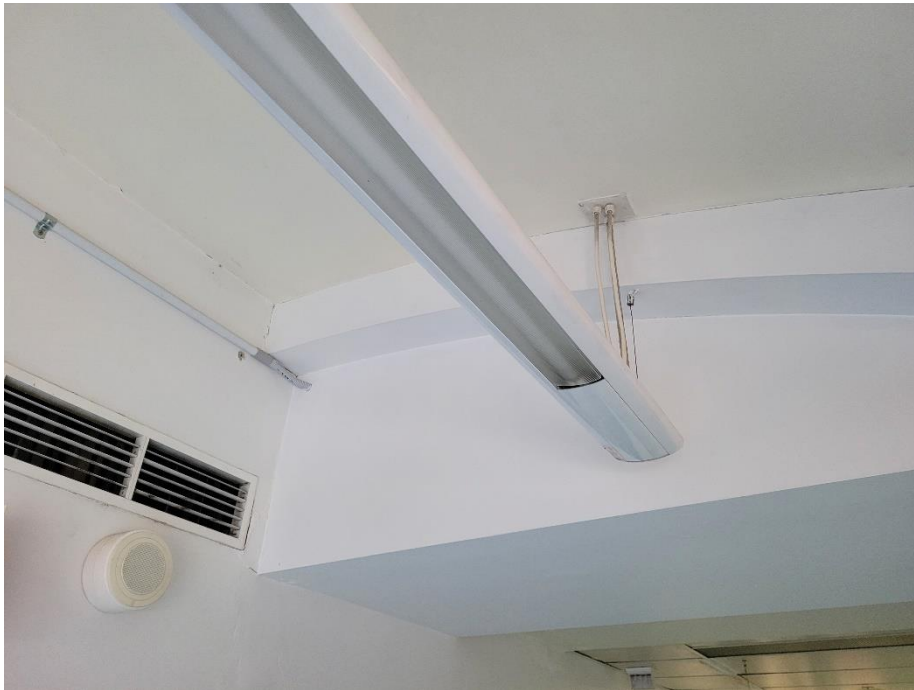
82. Cracking to plasterboard, water damage to wall finish, discolouration and staining to junction with floor finish.

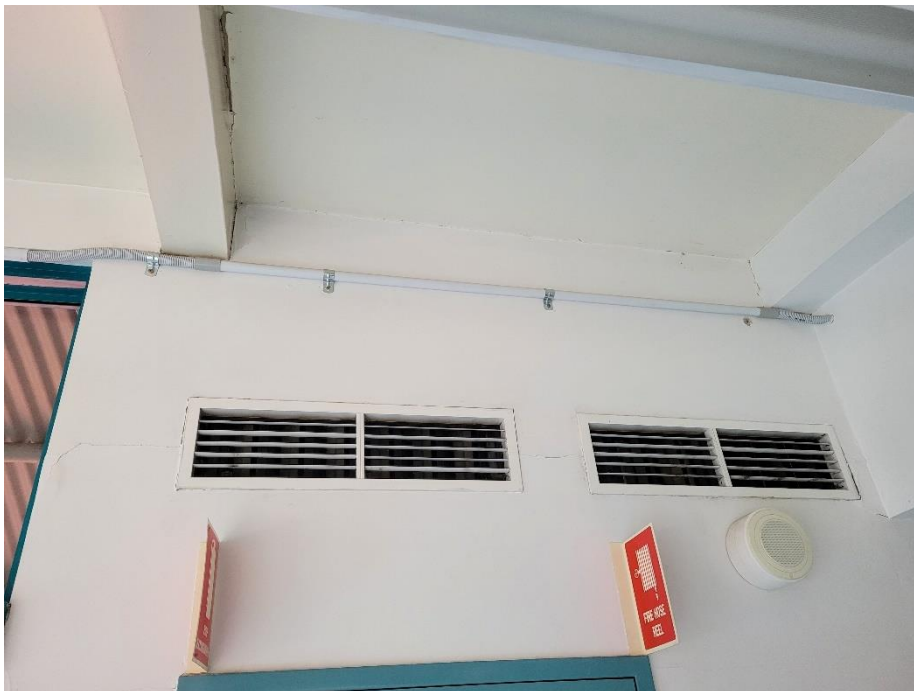
83. Crack in plasterboard  
at wall and ceiling junction

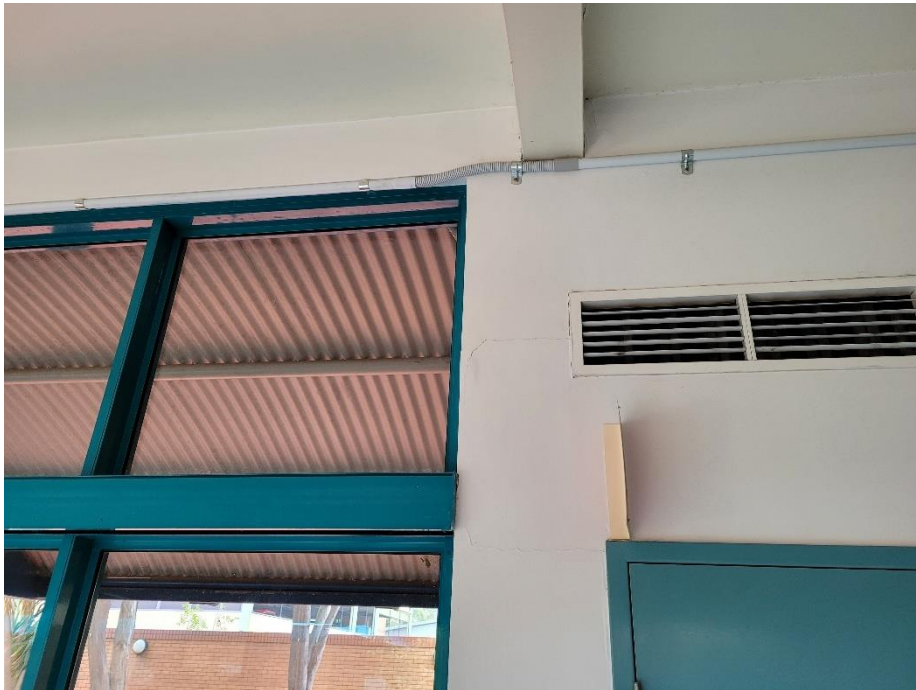
84. Crack in plasterboard  
at wall and ceiling  
junction

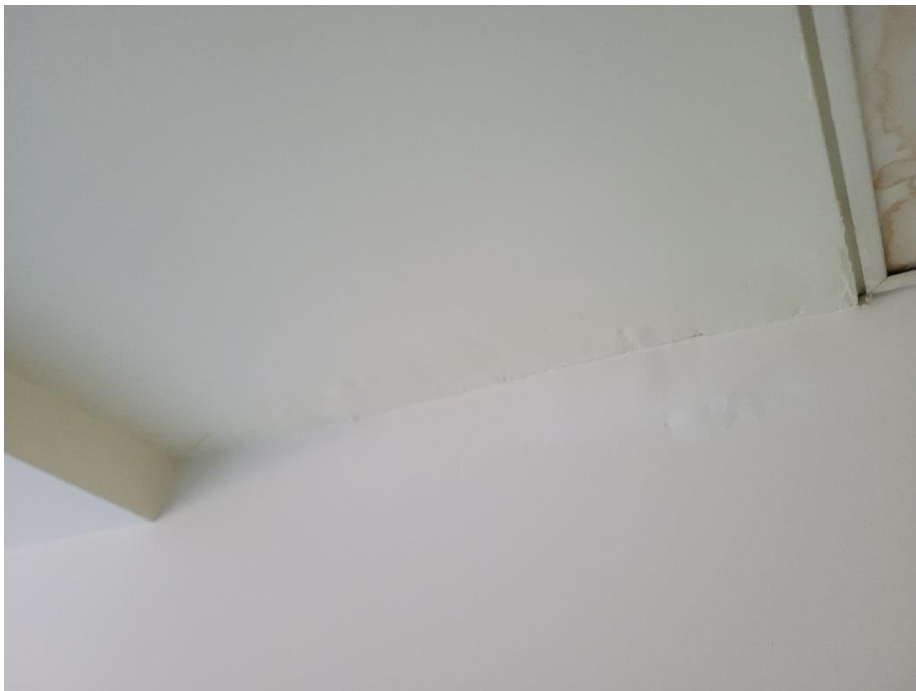
85. Cracking in plasterboard around vent opening

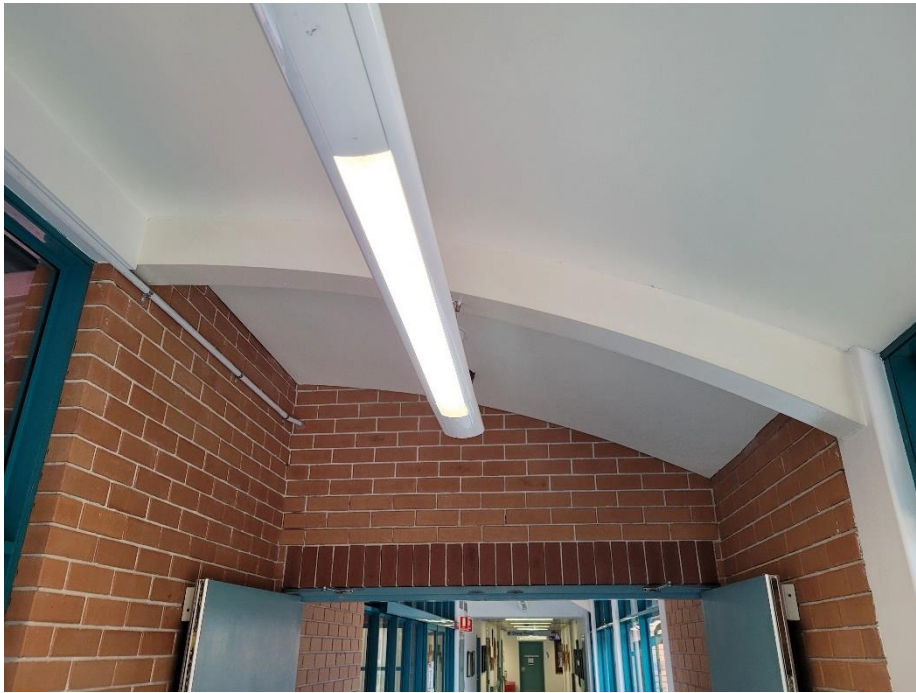
86. Crack in plasterboard at wall and ceiling junction
