# Dilapidation Report

## LHAP - Multistorey Carpark

**ADCO** / 10 December 2020

LHAP-ST-TTW-RPT-CP-120001

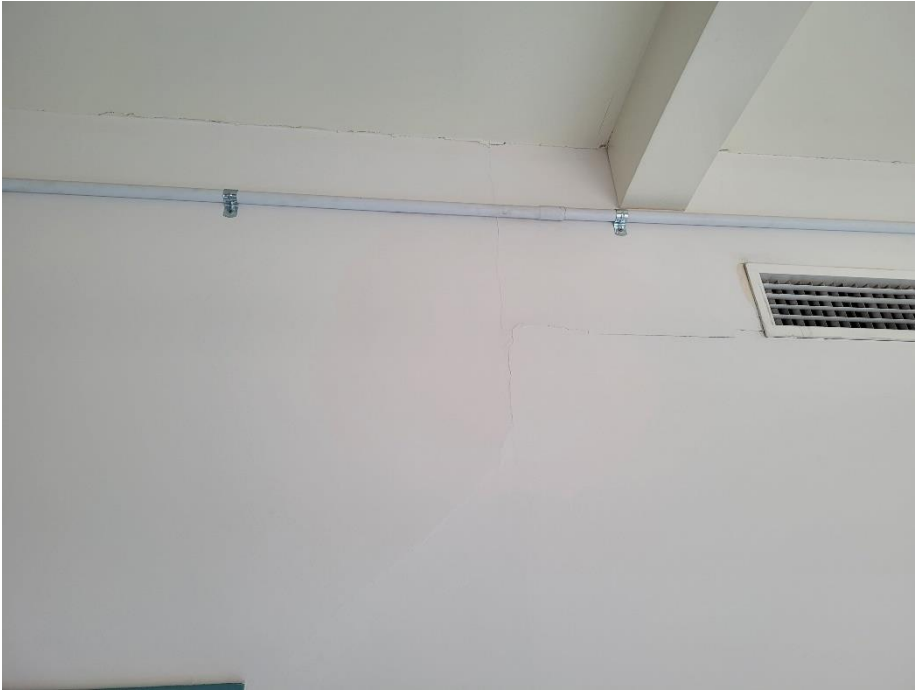
90. Crack in plasterboard at wall and ceiling junction, cracking around vent opening

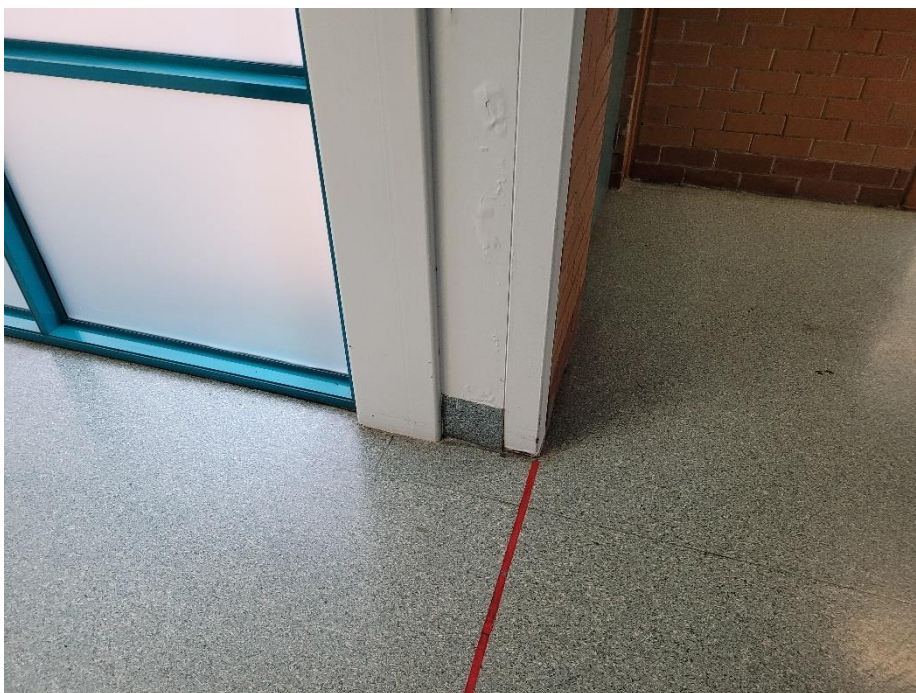
94. Water damage to wall

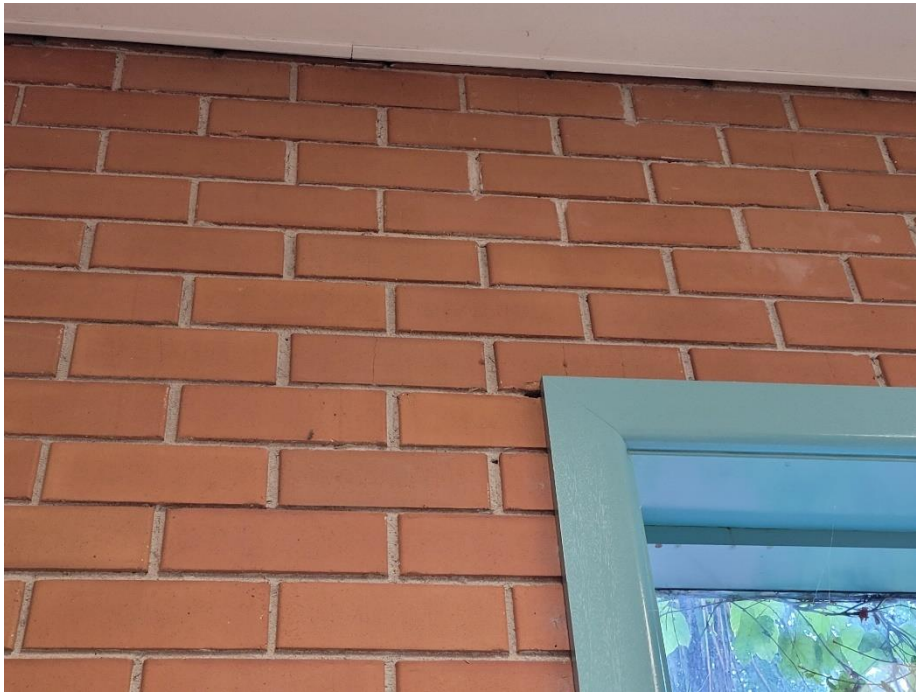
102. Cracking to bricks  
and across mortar joints  
in external wall

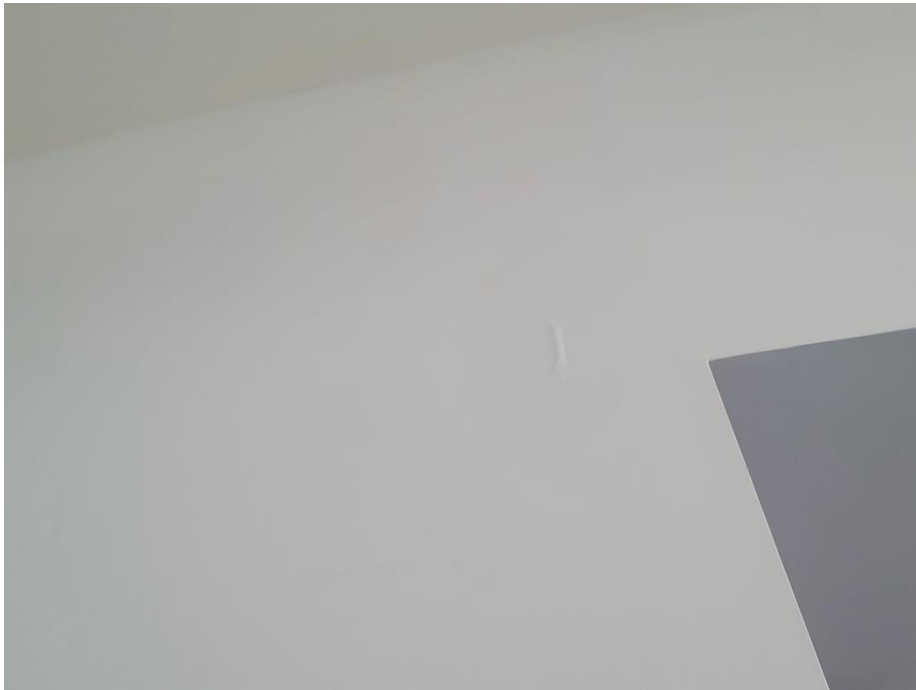
104. Cracking to ceiling finishes

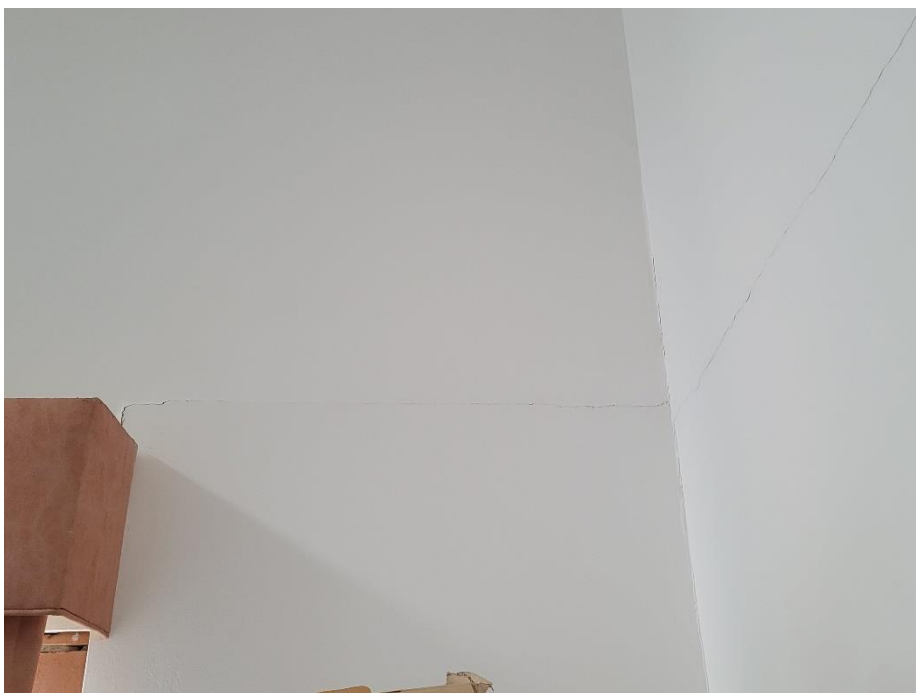
106. Minor cracking next to vent opening

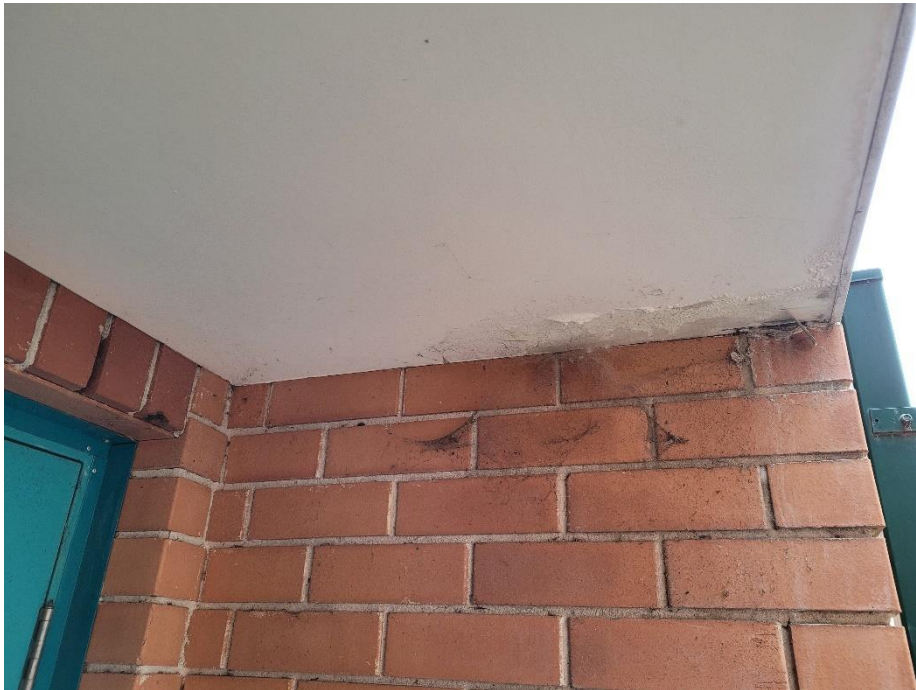
114. Minor cracking to mortar and gaps between soffit and external masonry

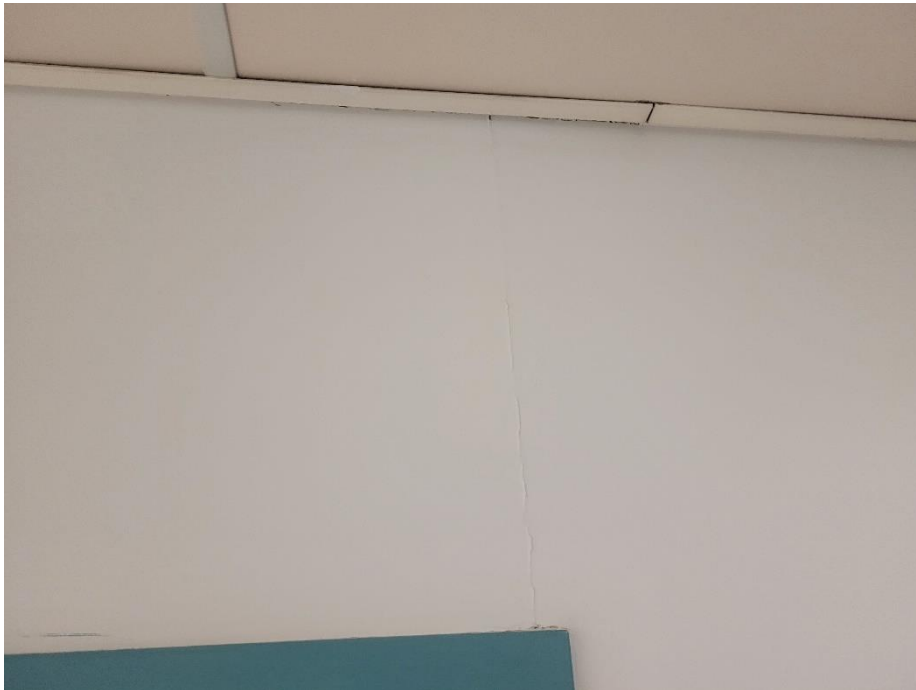
118. Cracking in wall plasterboard in corner and around wall patch

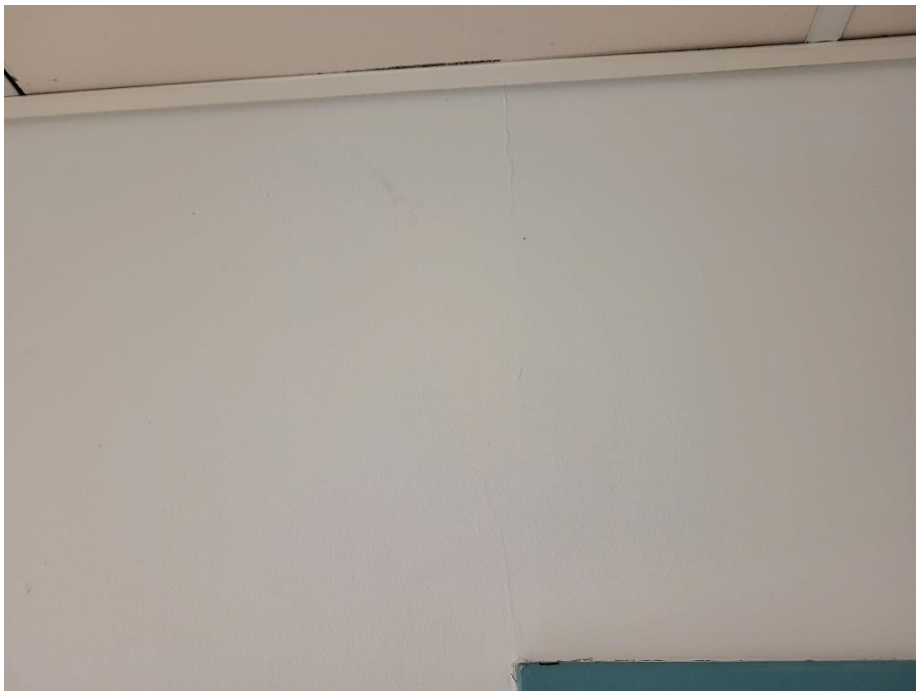
119. Vertical cracking  
from top of door frame to  
false ceiling

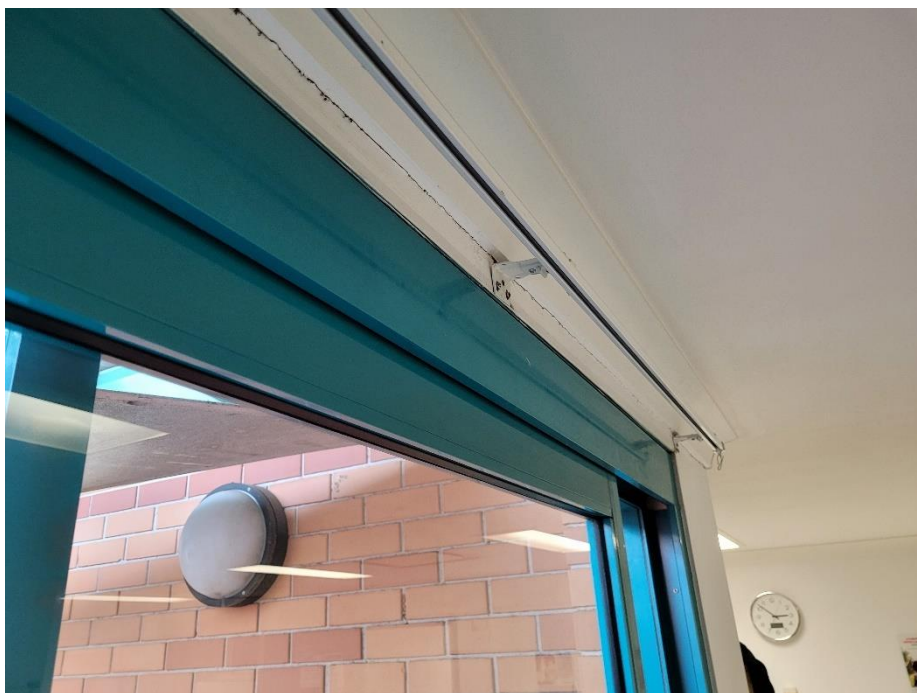
124. Crack in  
plasterboard around  
architrave

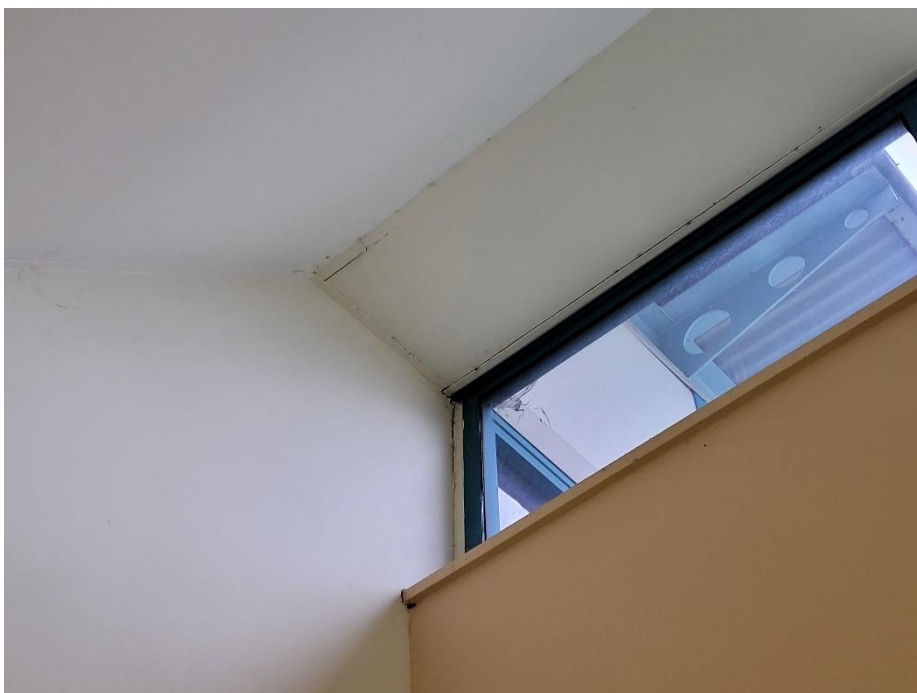
126. Window frame coming away around window opening, crack in plasterboard at wall and ceiling junction

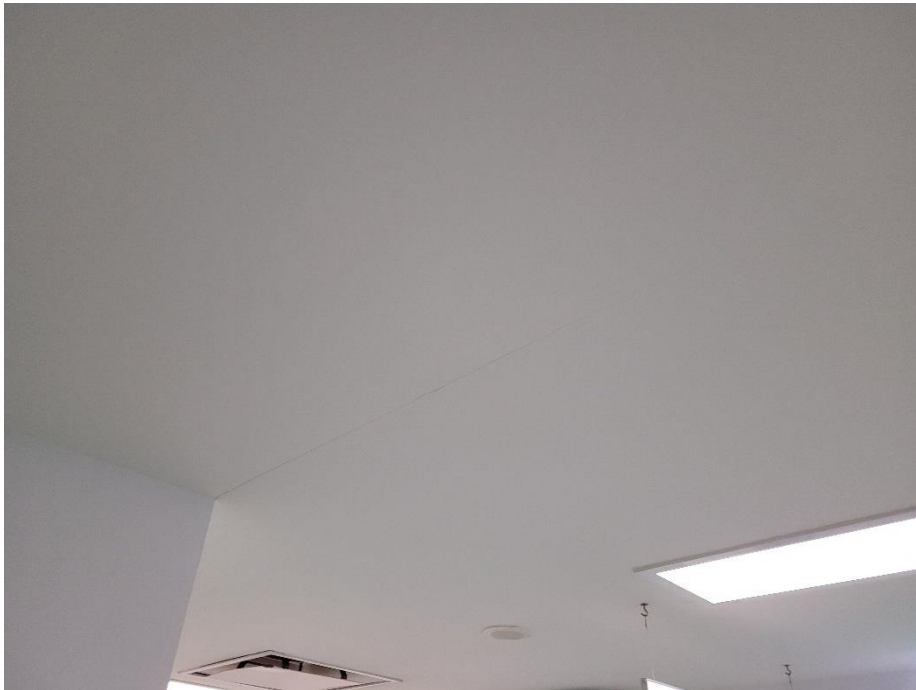
128. Crack in plasterboard at wall and ceiling junction

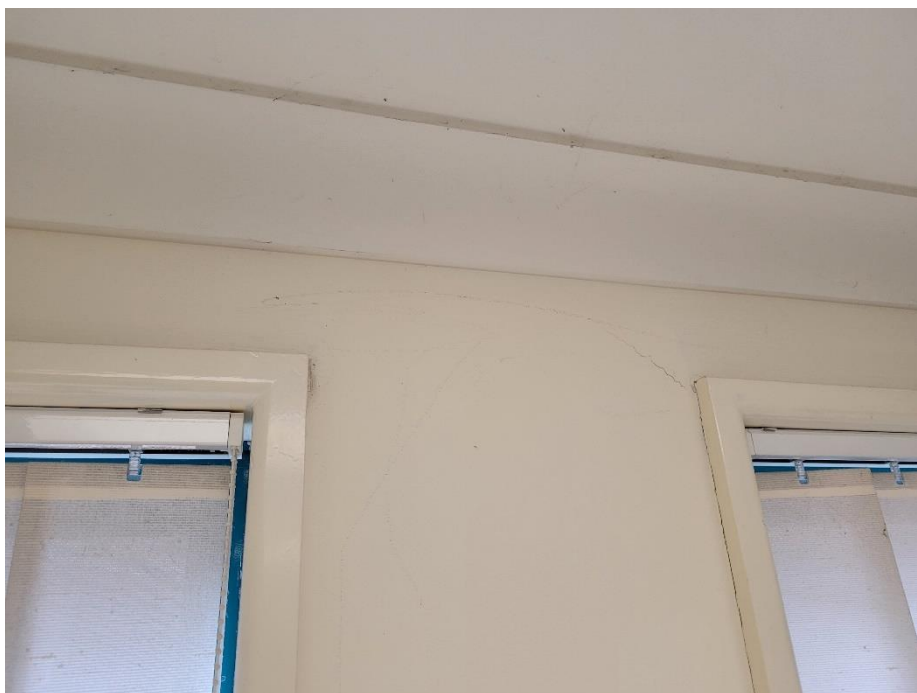
134. Crack in wall  
plasterboard from door  
frame to architrave

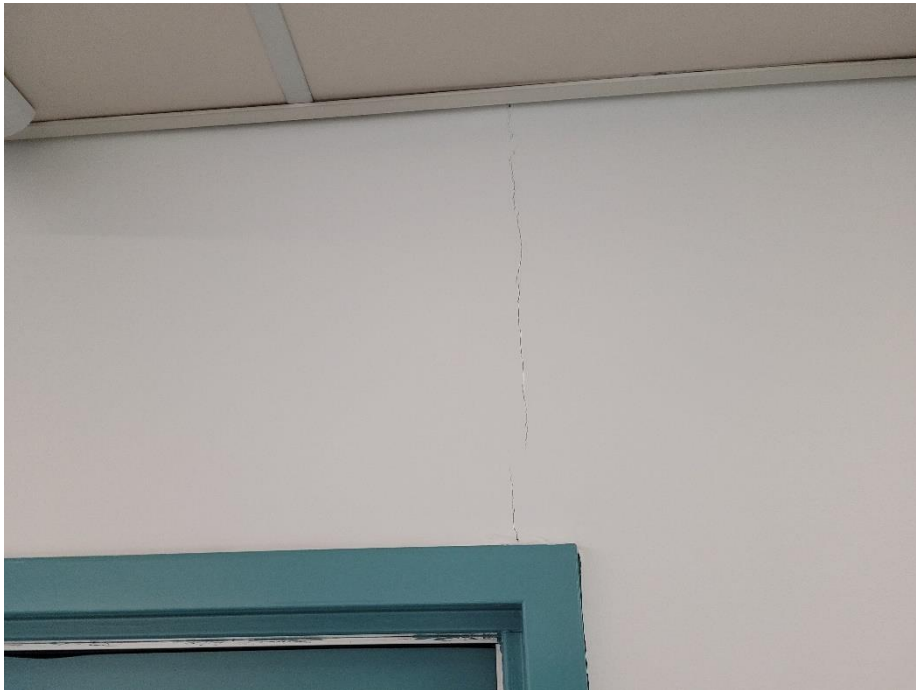
138. Vertical cracking in wall plasterboard from door frame to false ceiling

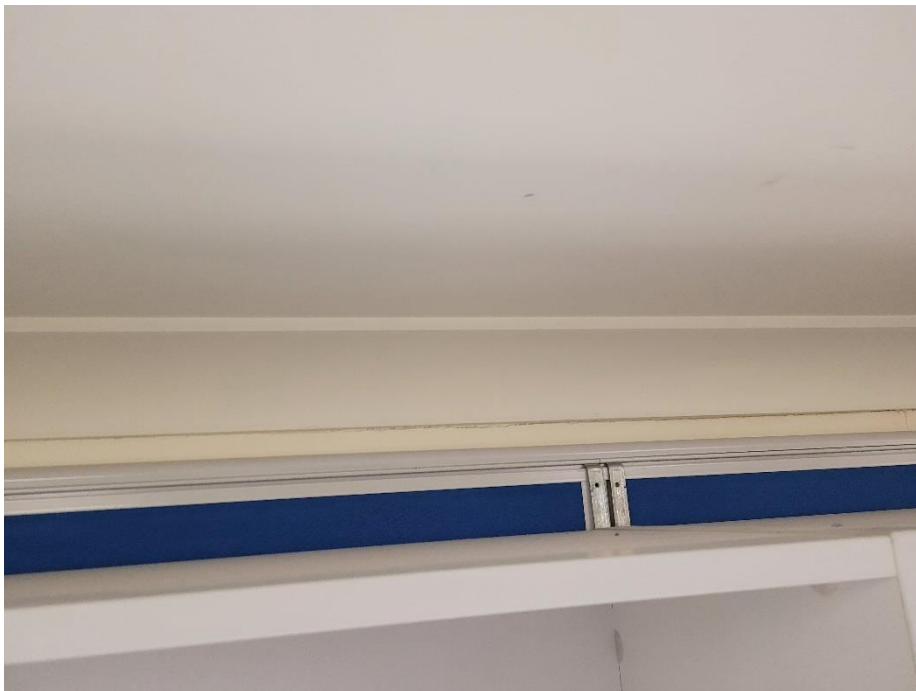
139. Vertical cracking in wall plasterboard from door frame to architrave

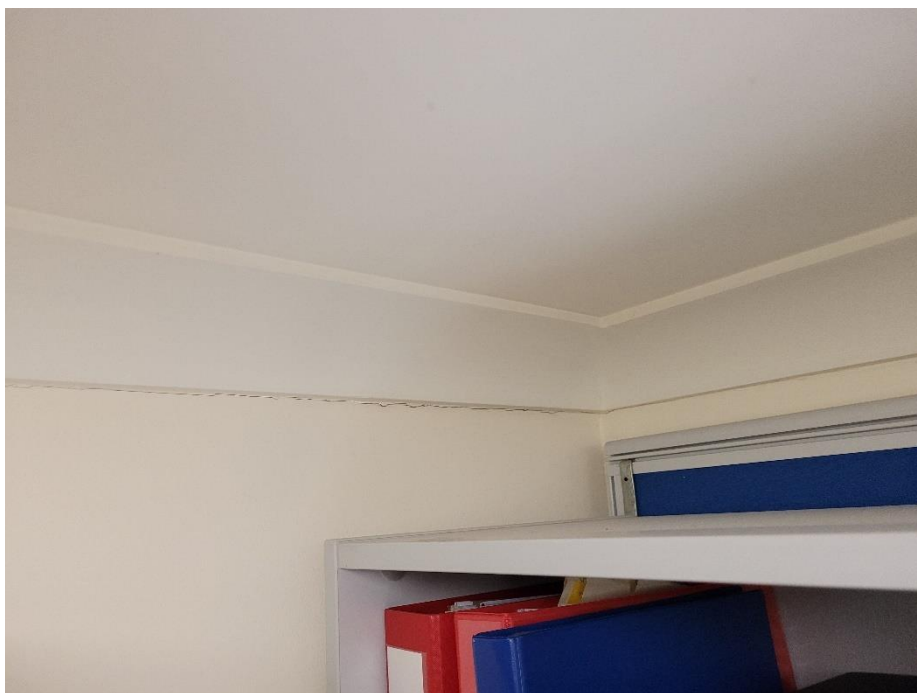
140. Crack in plasterboard at wall and architrave

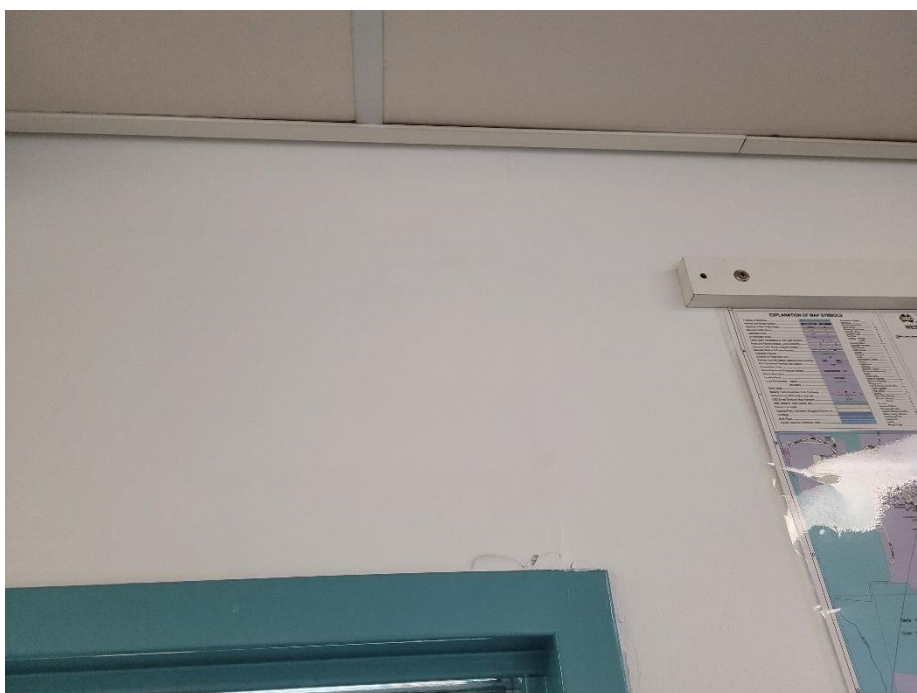
142. Vertical cracking in wall plasterboard from door frame to false ceiling

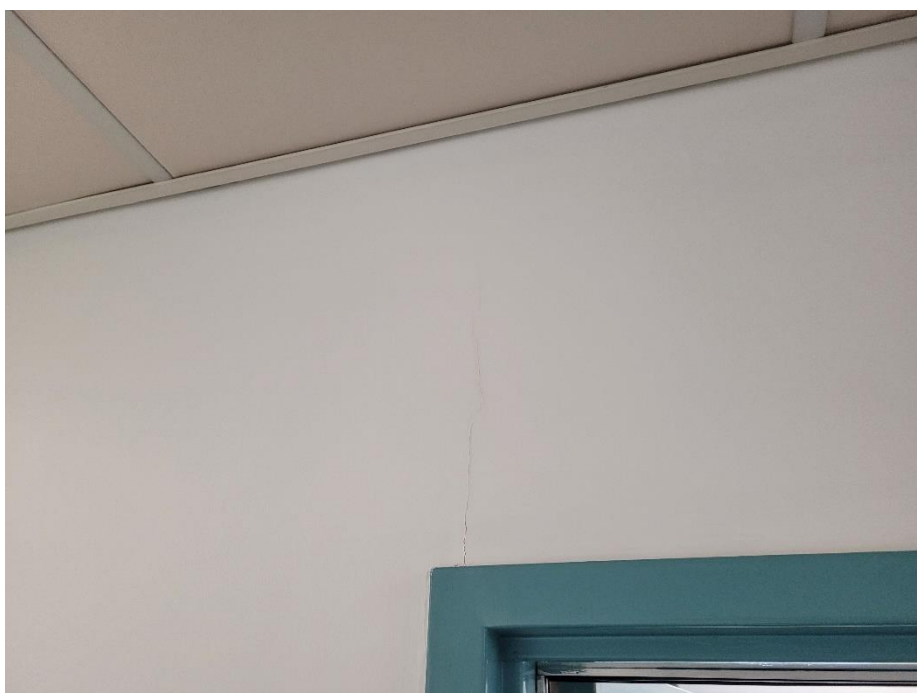
143. Vertical cracking in wall plasterboard from door frame to false ceiling

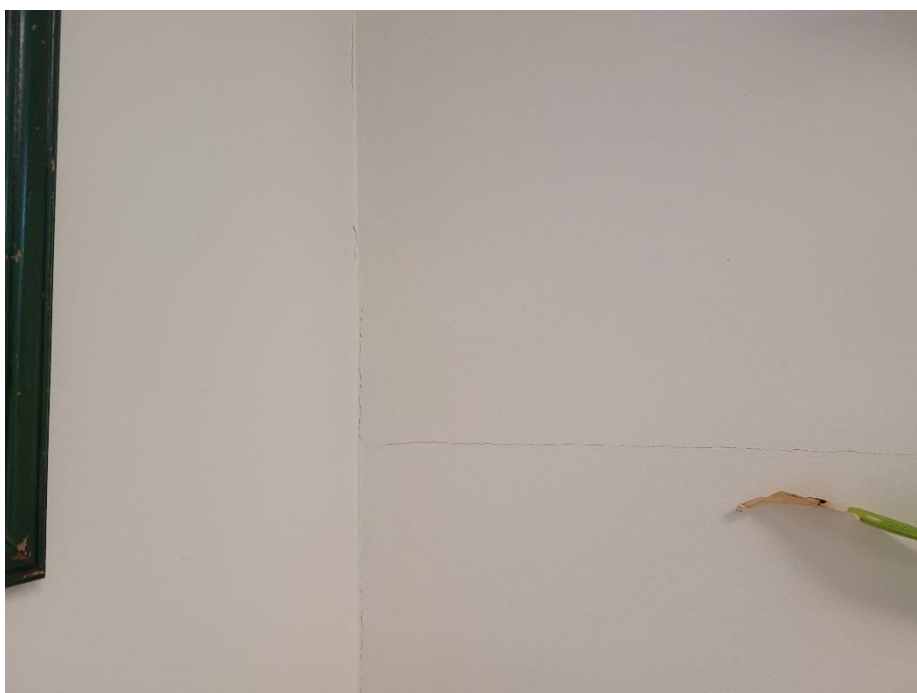
145. Vertical cracking in wall plasterboard from door frame to false ceiling

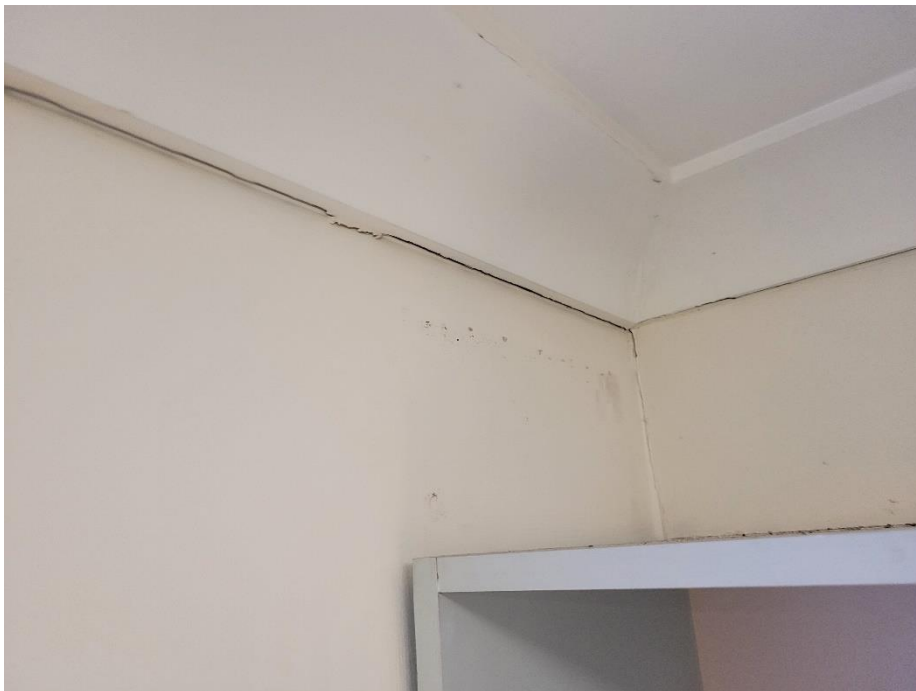
147. Horizontal cracking  
in wall plasterboard  
between window  
openings to external wall

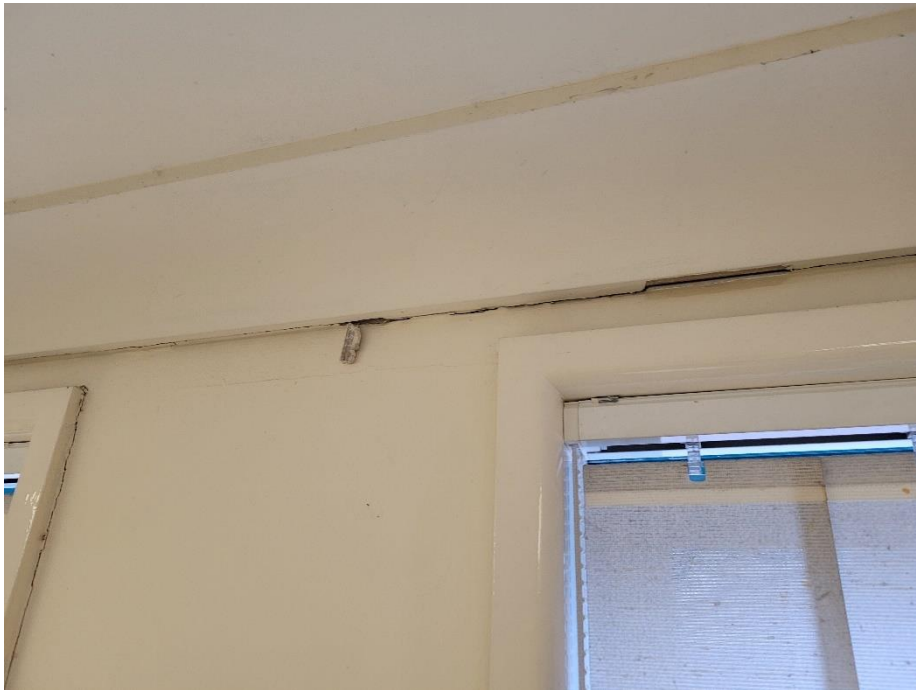
148. Crack in  
plasterboard at wall and  
architrave

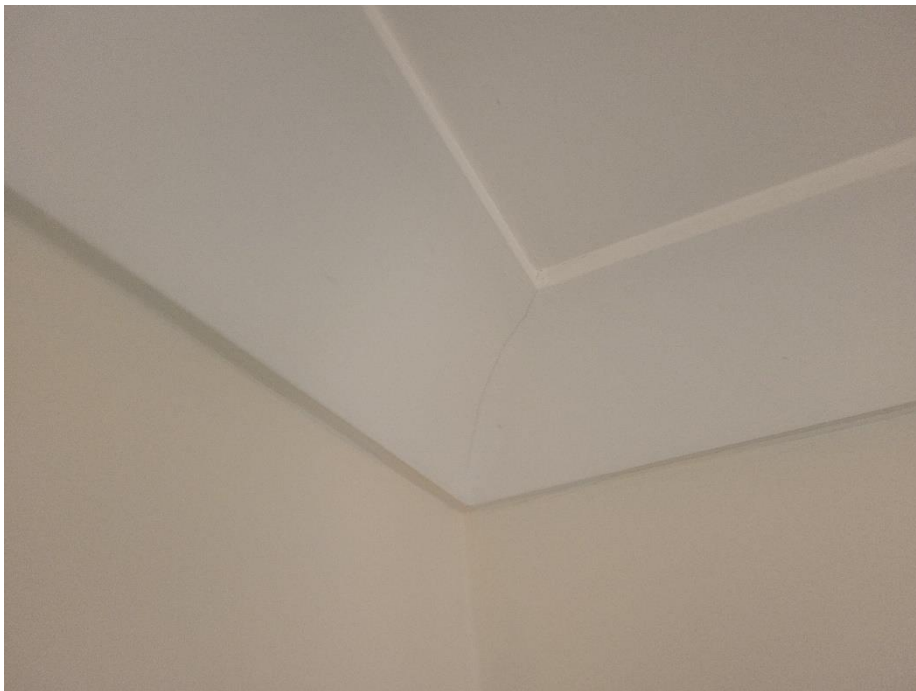
151. Crack in  
plasterboard at wall and  
architrave to external wall

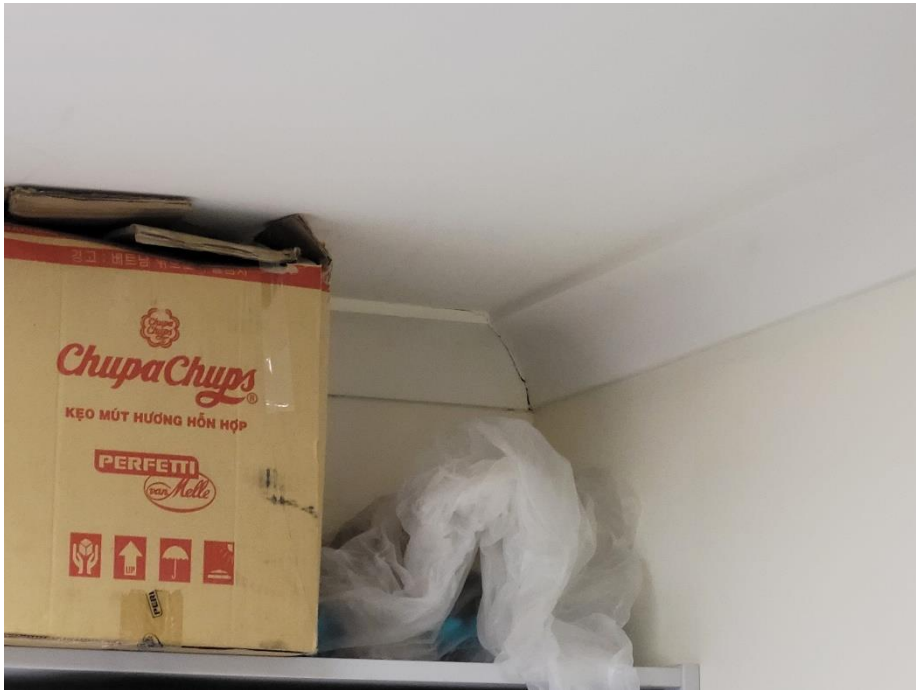
152. Crack in architrave

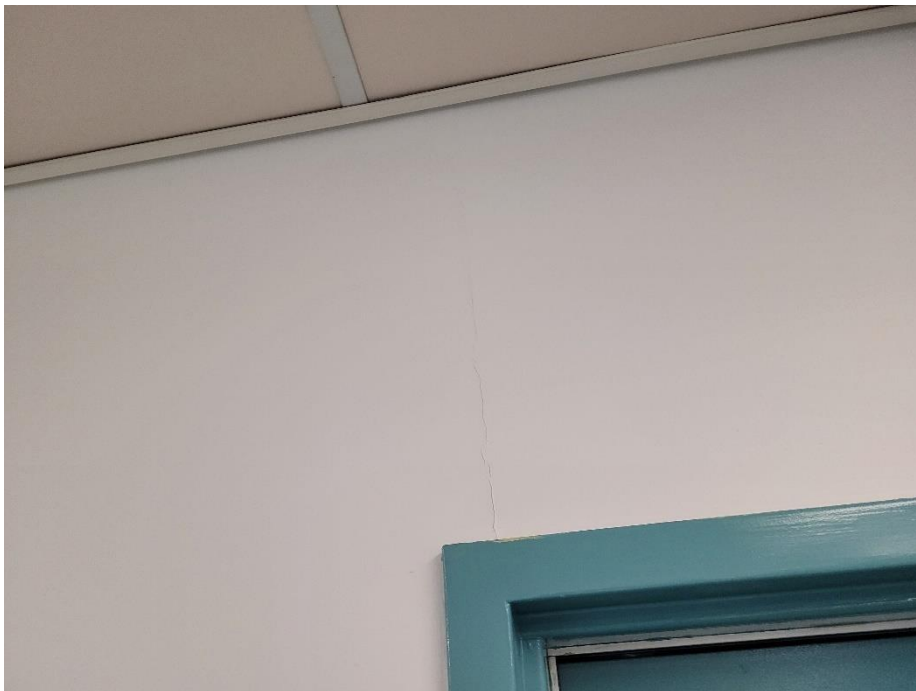
153. Crack in plasterboard at wall and architrave

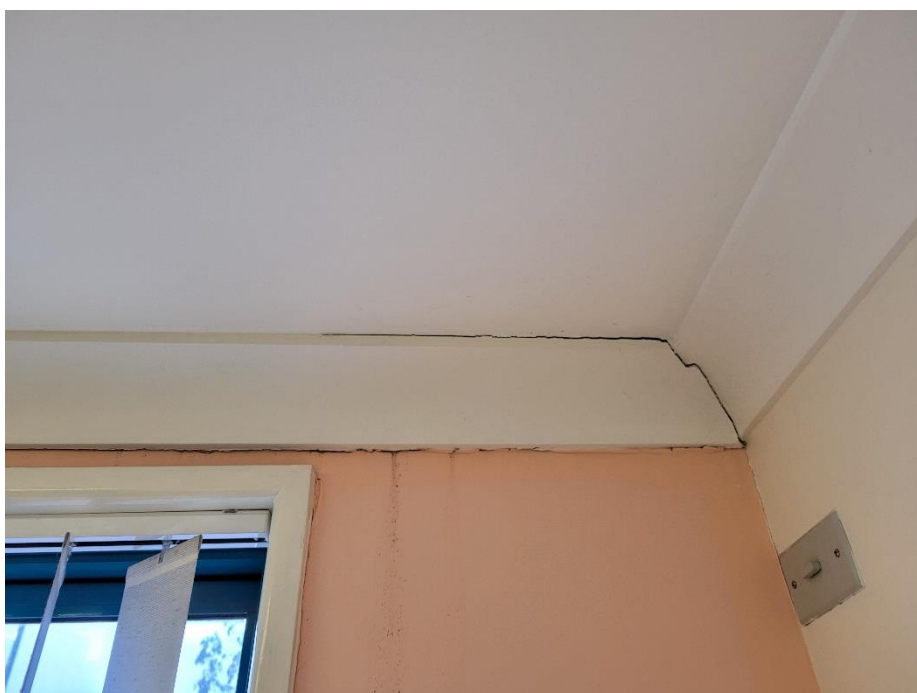
157. Horizontal crack in plasterboard from window opening to corner on external wall

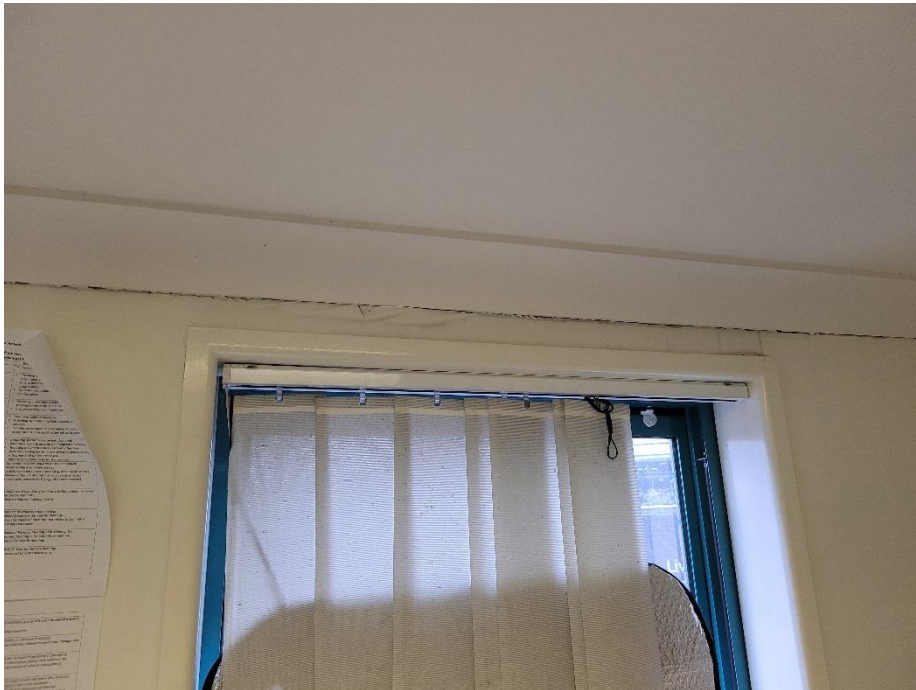
160. Water damage and cracking in plasterboard at wall and architrave around window opening to external wall

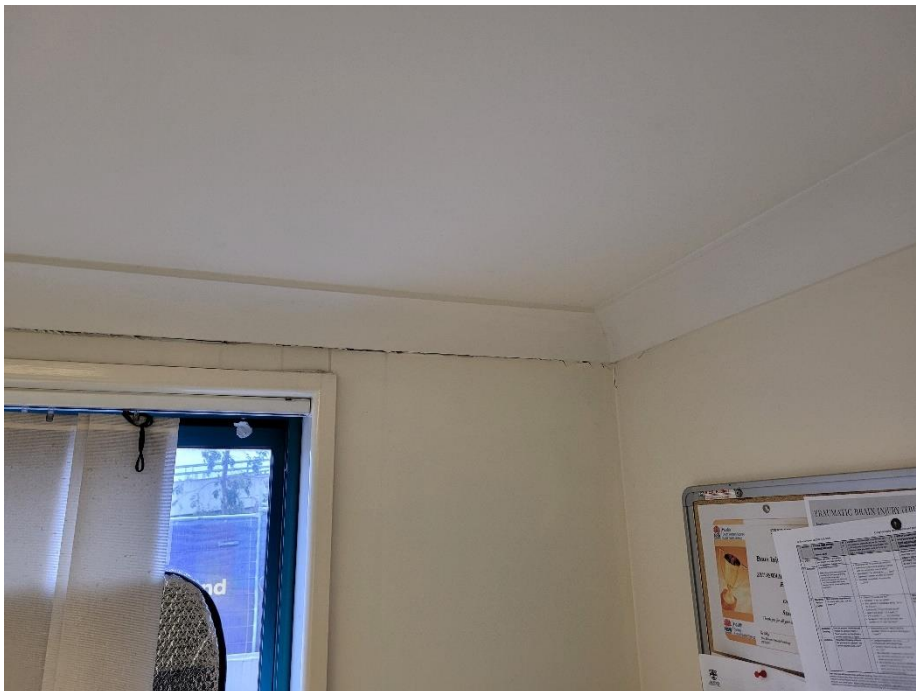
161. Water damage and cracking in plasterboard at wall and architrave around window opening to external wall

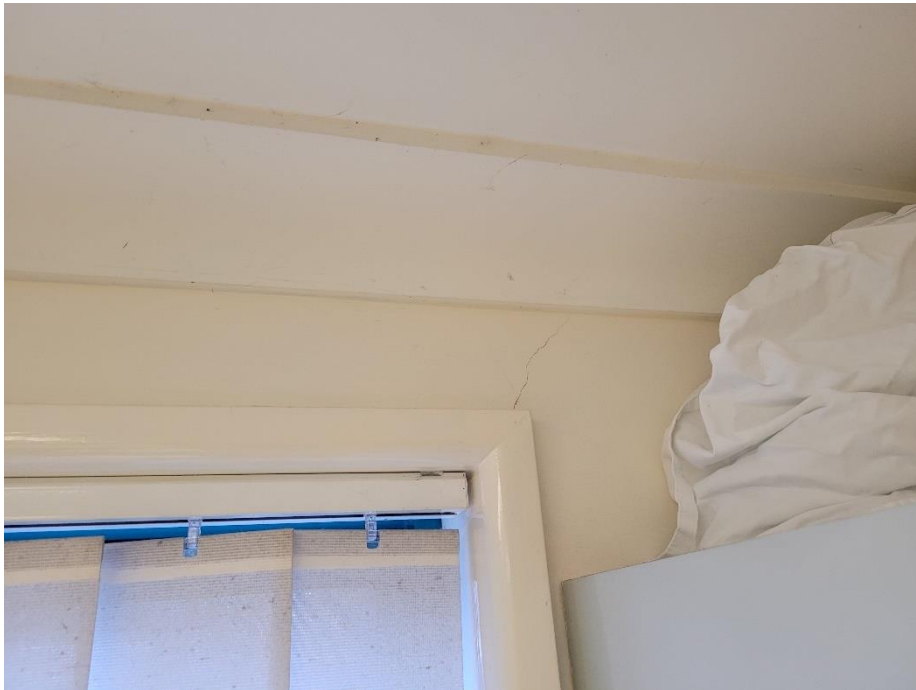
164. Cracking in plasterboard at wall and architrave around window opening to external wall

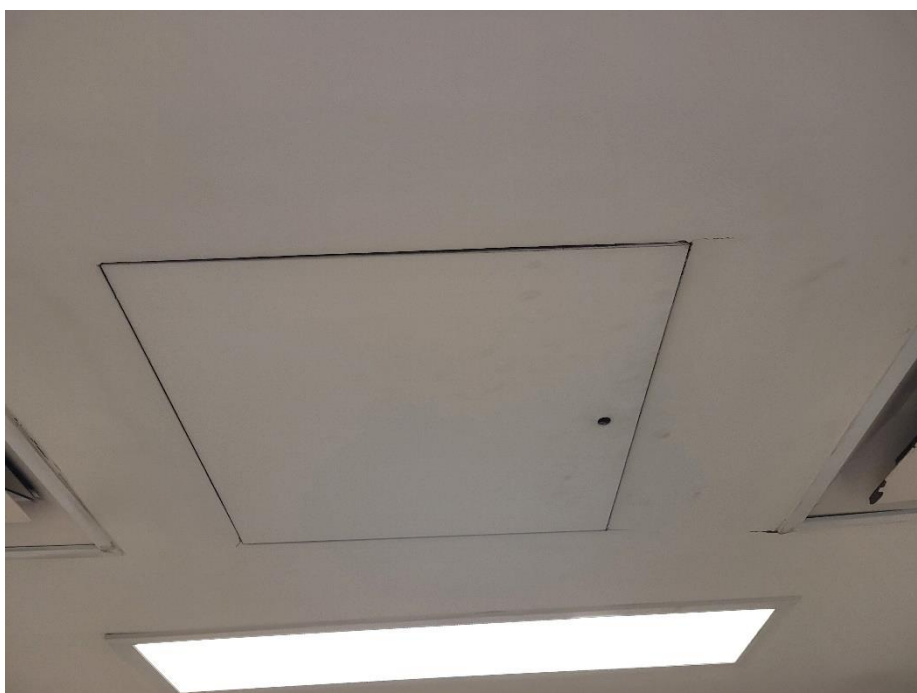
168. Cracking in ceiling around access panel, signs of discolouring

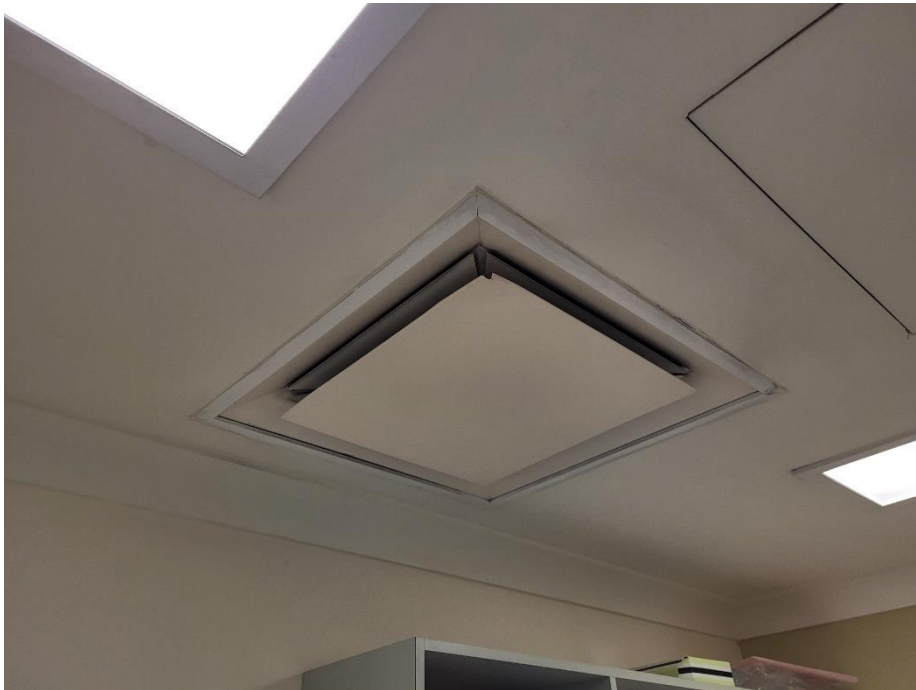
169. Cracking in ceiling around light fitting, signs of discolouring

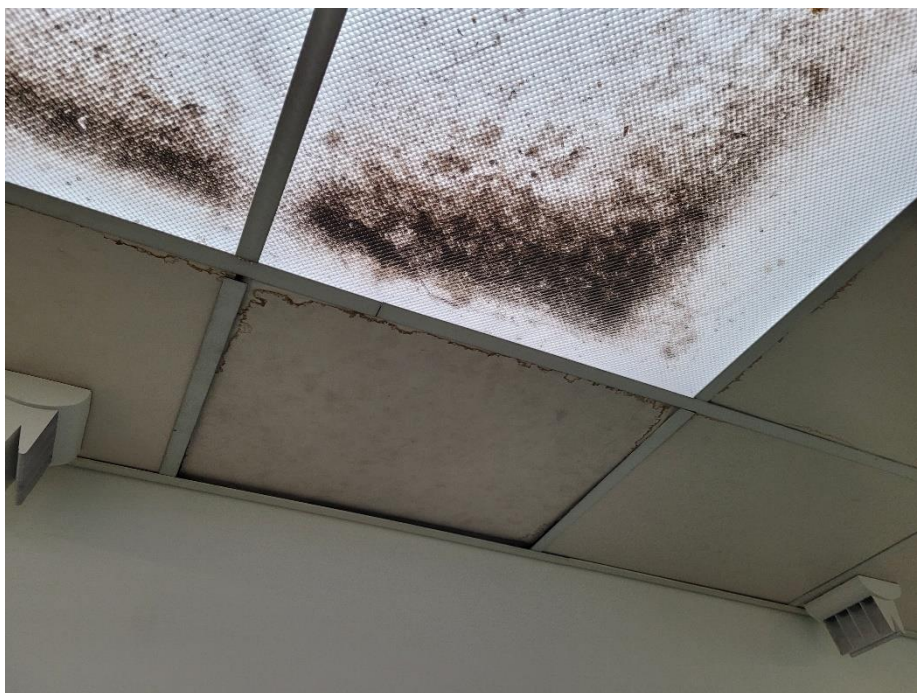
173. Water stains to false ceiling panels and collection of dust/dirt/mess in skylight

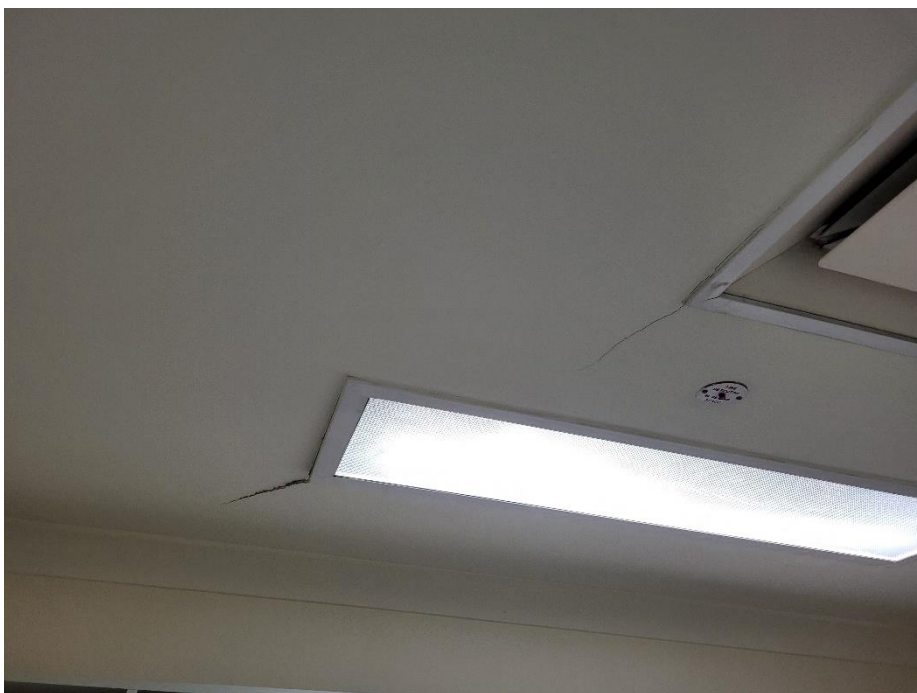
175. Cracking in ceiling  
around light fitting

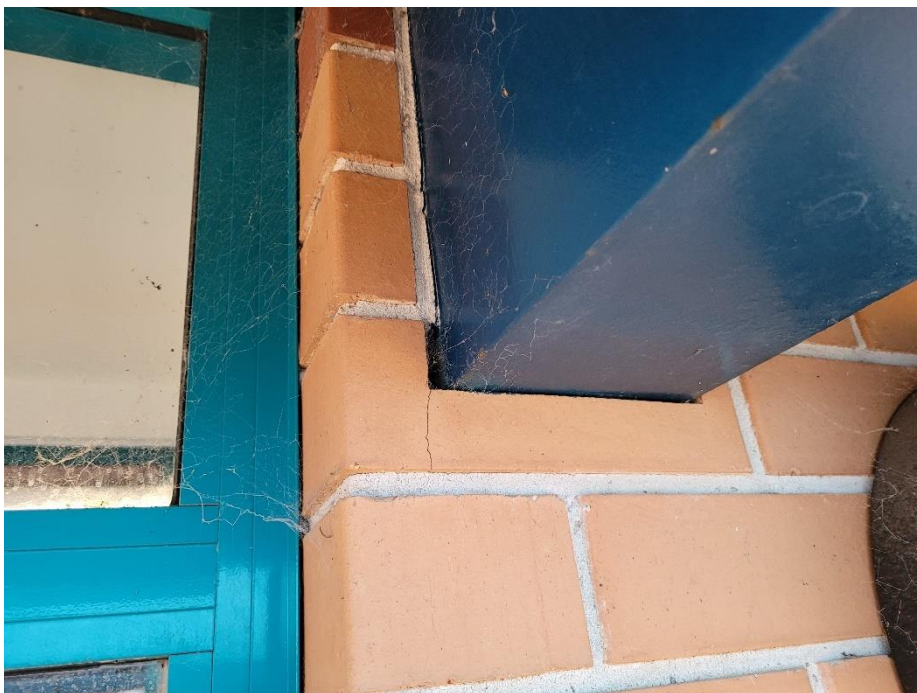
176. Cracking in external  
masonry around steel  
member penetration

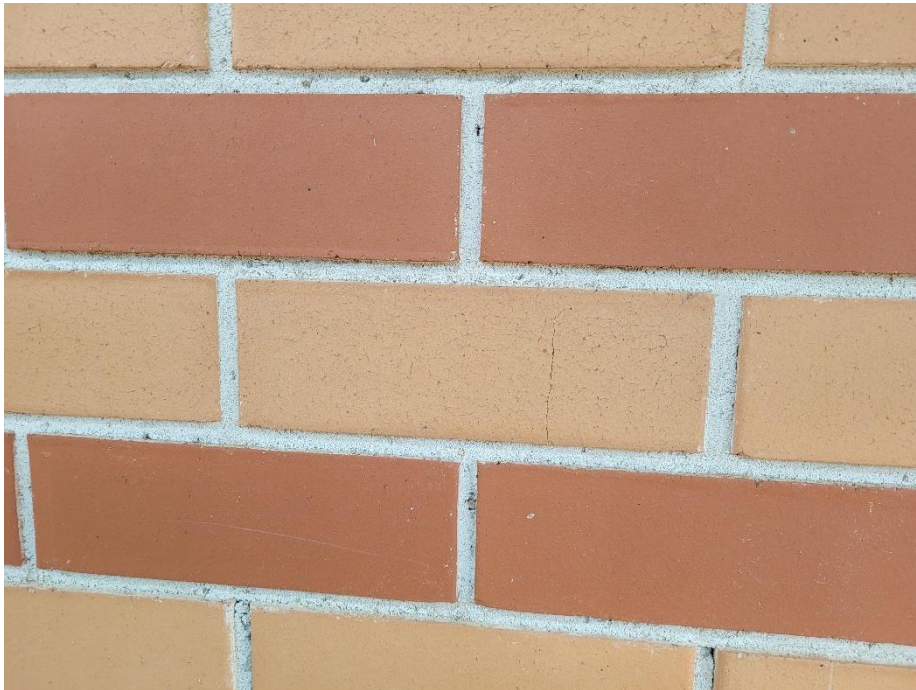
177. Minor cracking in external masonry wall

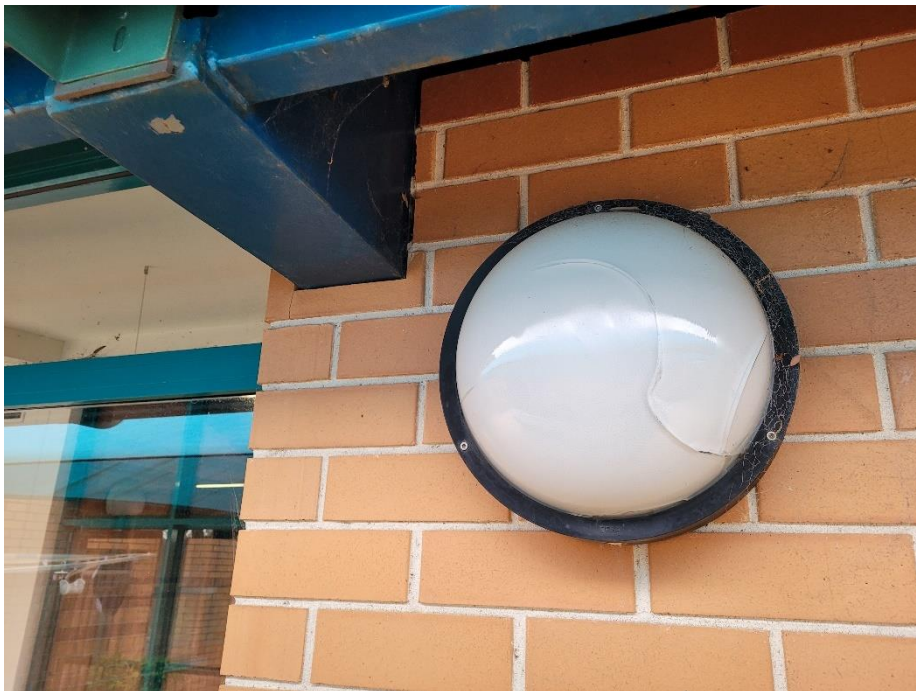
178. Damage to external light fitting

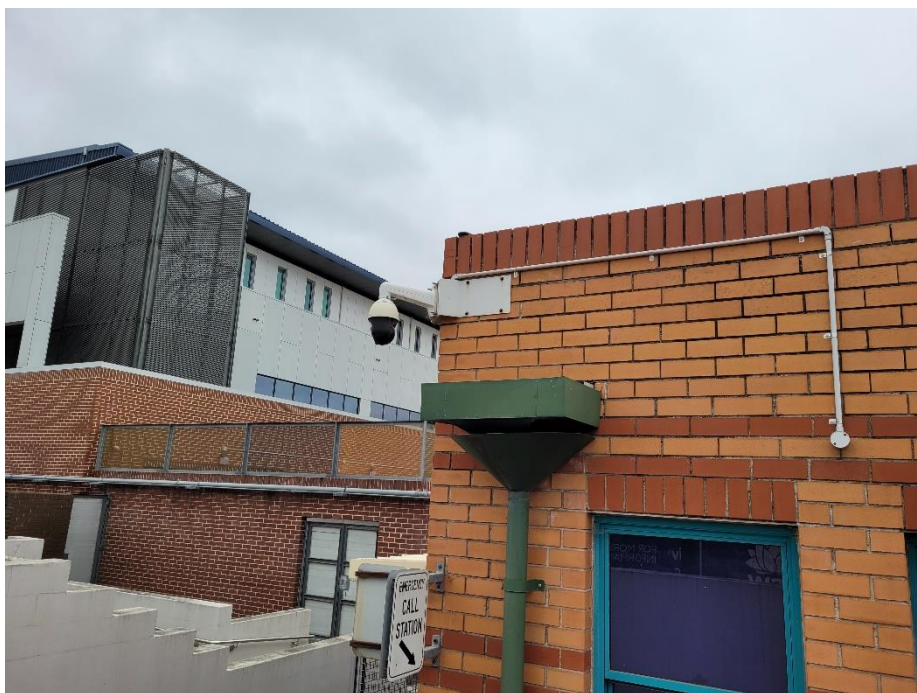
External 1. Cracking around parapet junction and opening for water outlet
