# Dilapidation Report

## LHAP - Multistorey Carpark

**ADCO** / 10 December 2020

LHAP-ST-TTW-RPT-CP-120001

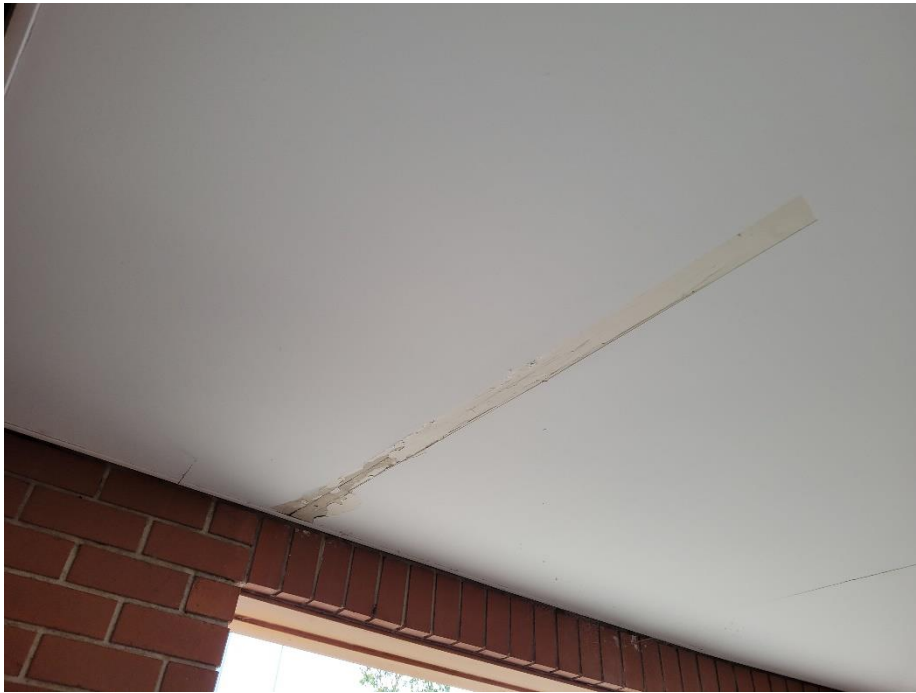
External 5. Damage and staining to external entrance way ceiling

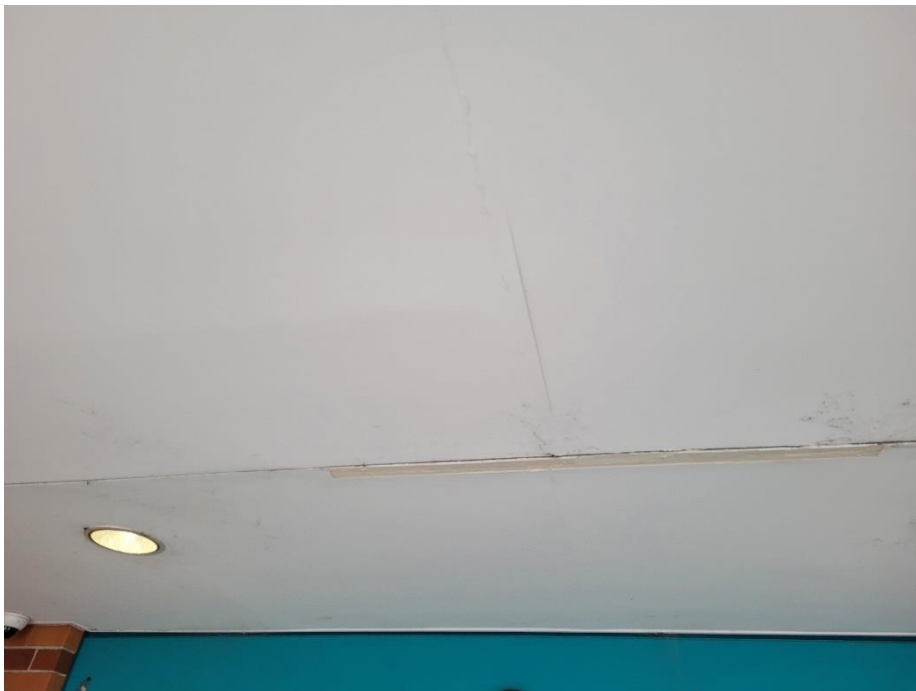
External 6. Damage and staining to external entrance way ceiling

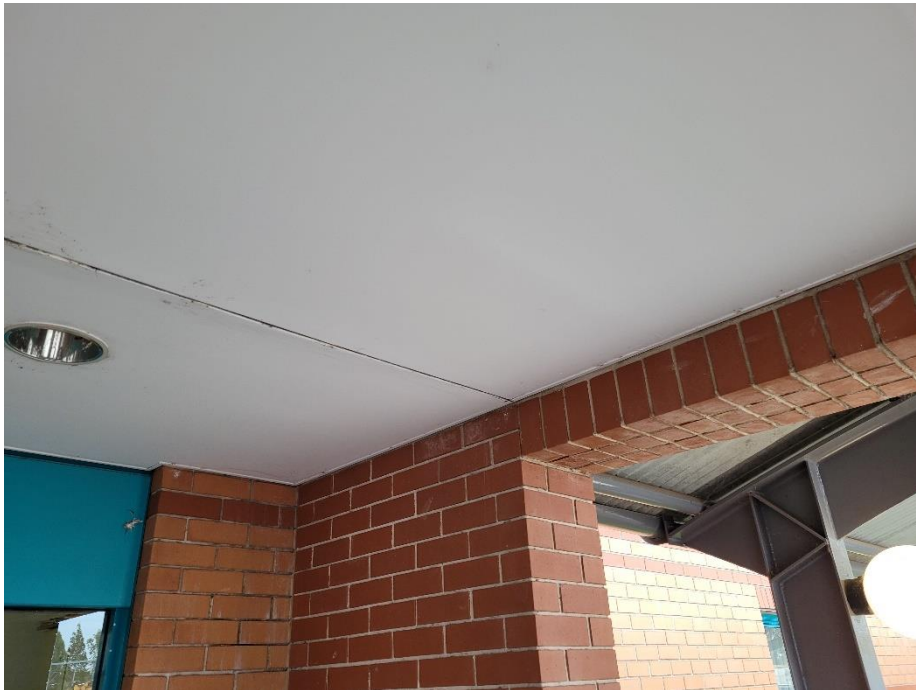
External 7. Damage and staining to external entrance way ceiling

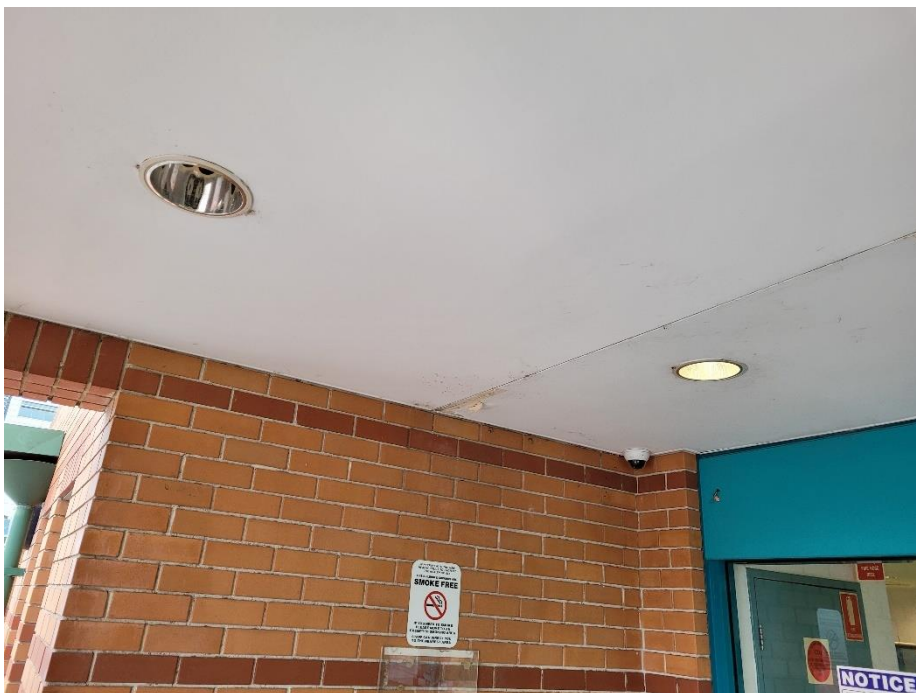
External 8. Damage and staining to external entrance way ceiling

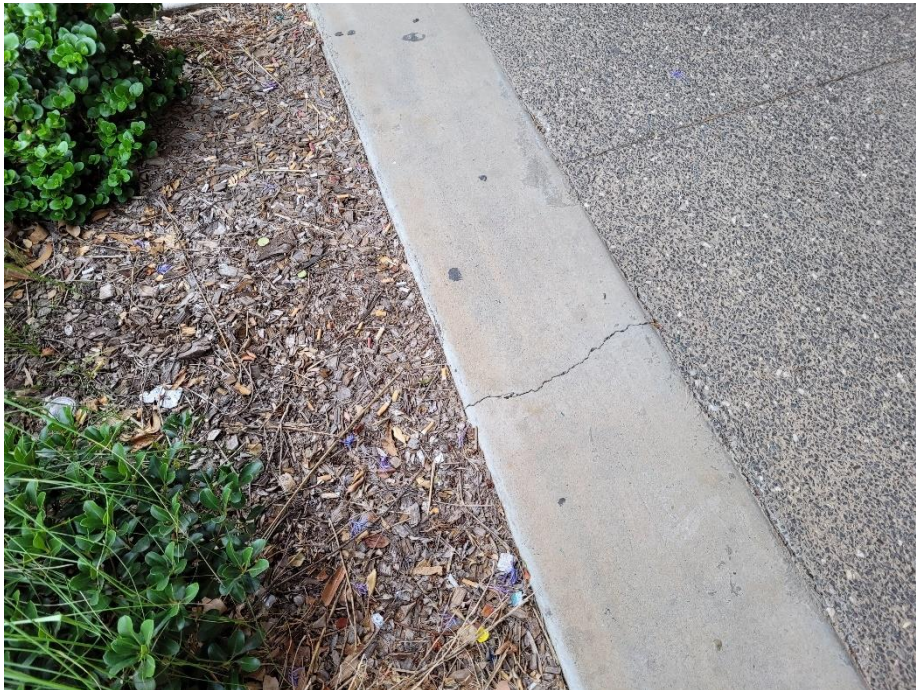
External 5a. Crack in kerb  
along walkway

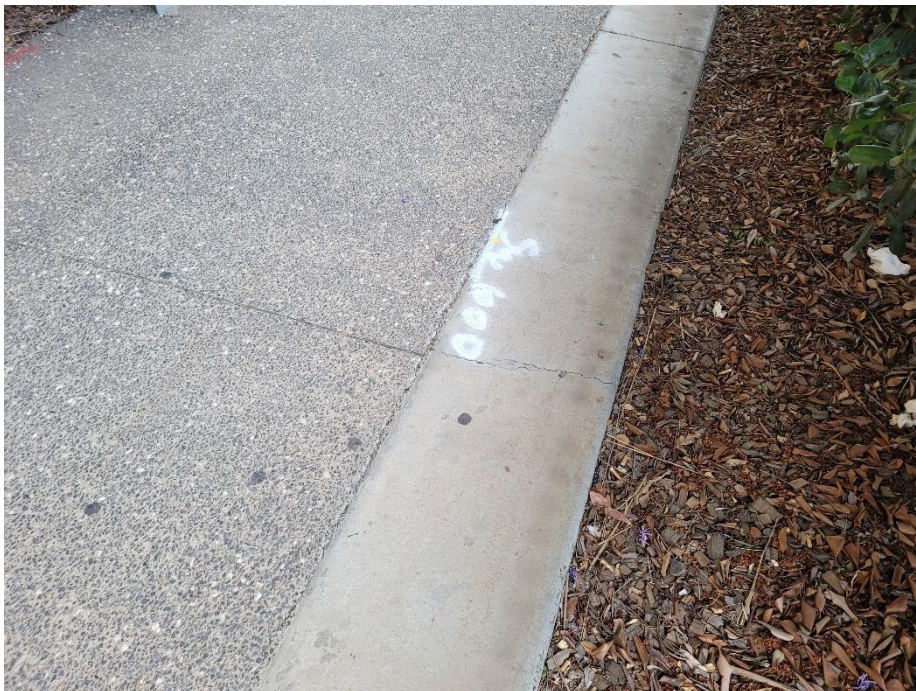
External 6a. Crack in kerb  
along walkway

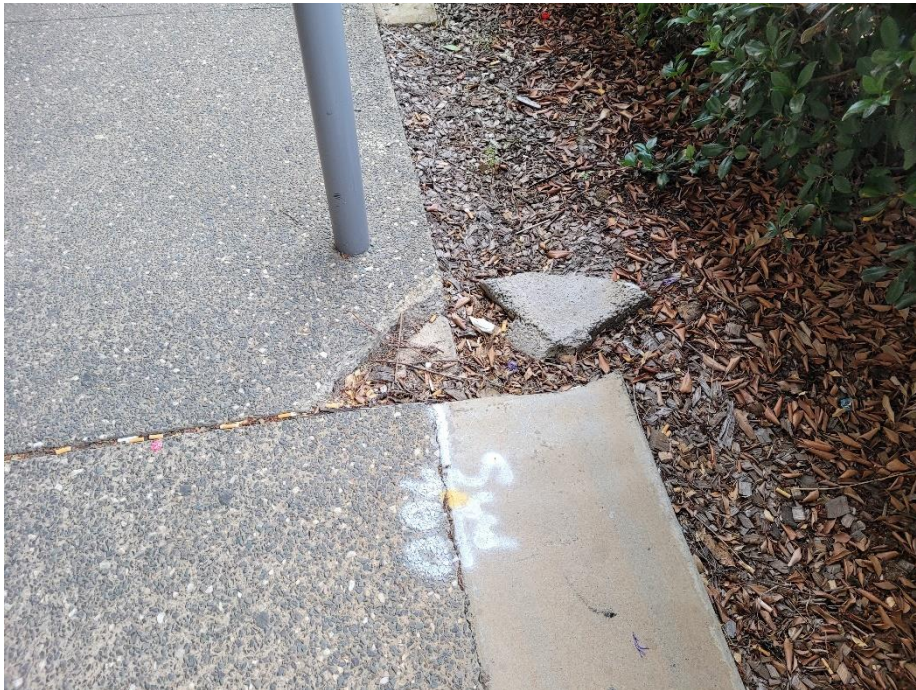
External 7a. Crack in kerb along walkway, parts of walkway surface coming away

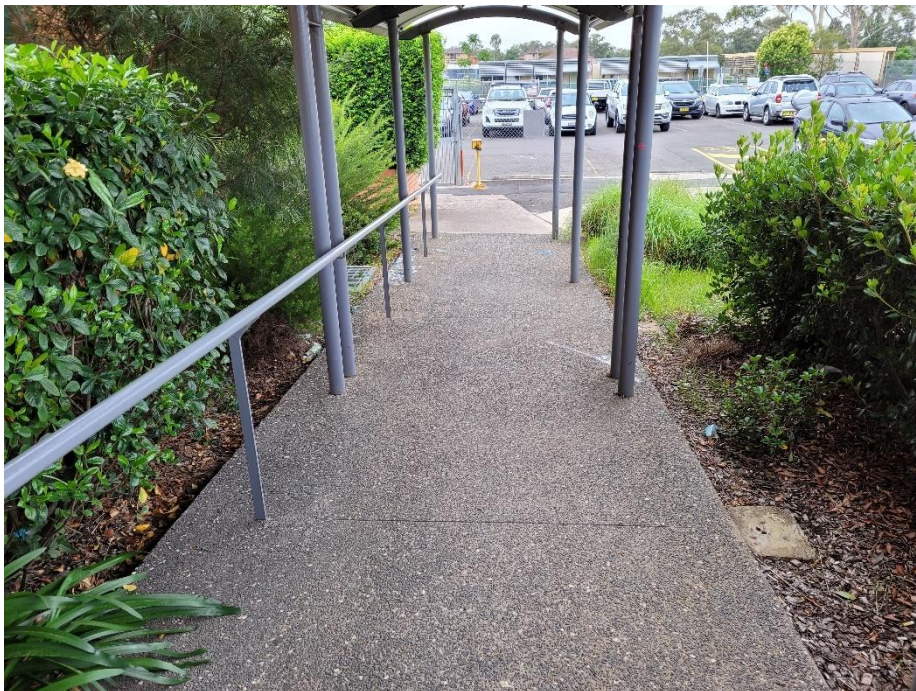
External 8a. General wear and tear of walkway, various minor cracks, and damage to edge along gardens

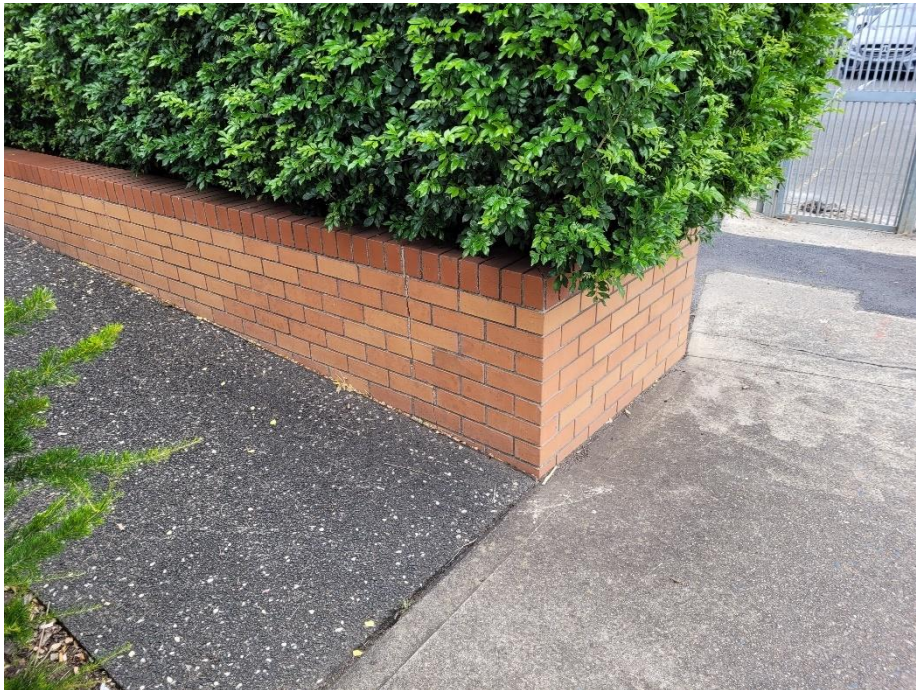
External 9. Minor cracking in planter wall mortar

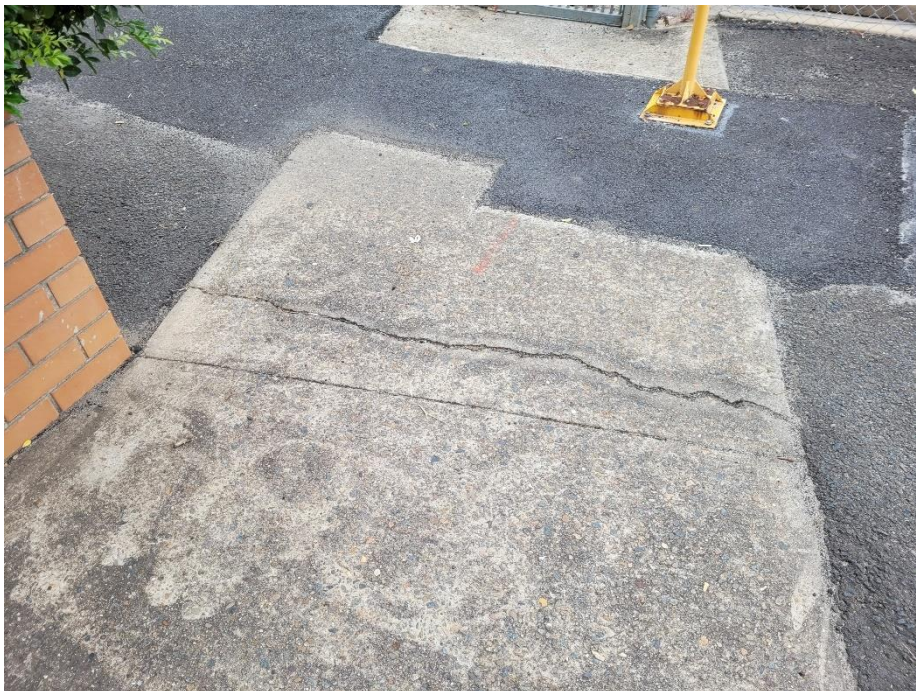
External 10. Cracking in footpath

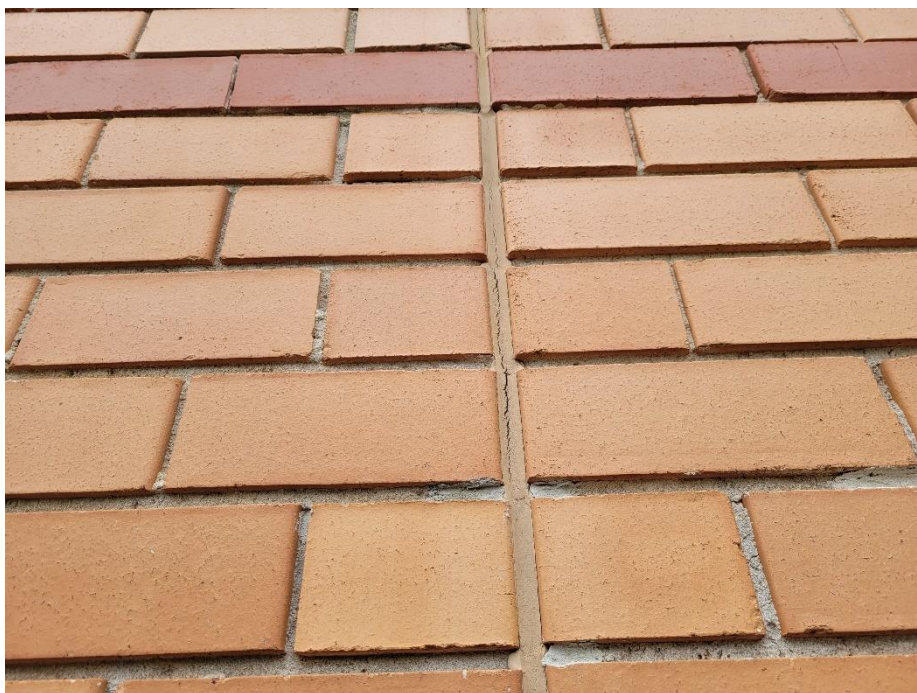
External 13. Cracking in mortar and vertical cracks/sign of wear in building joint

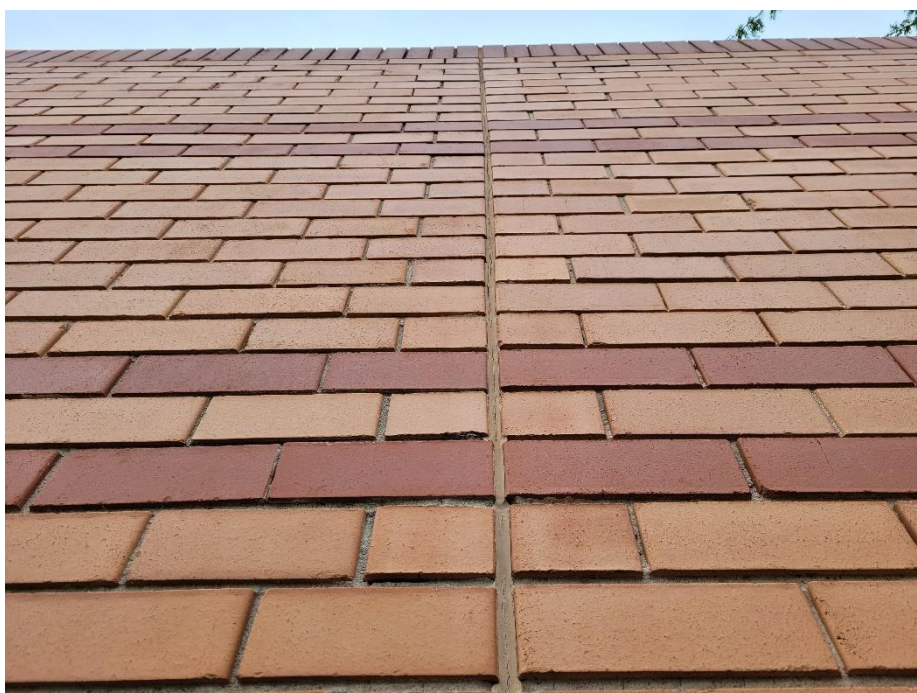
External 14. Cracking in mortar and vertical cracks/sign of wear in building joint

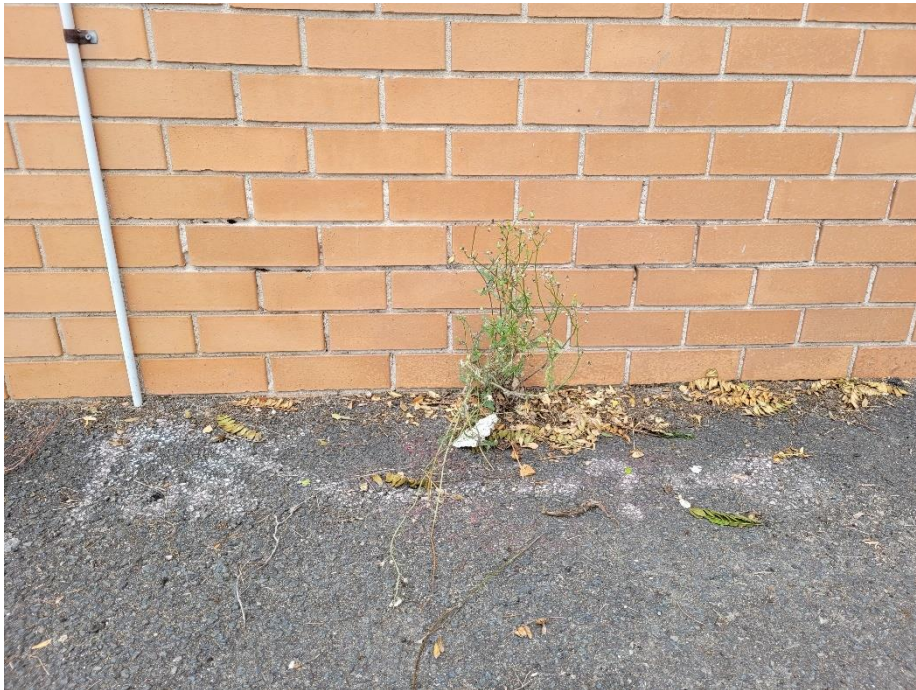
External 15. Cracking to mortar and mortar loss for high external wall

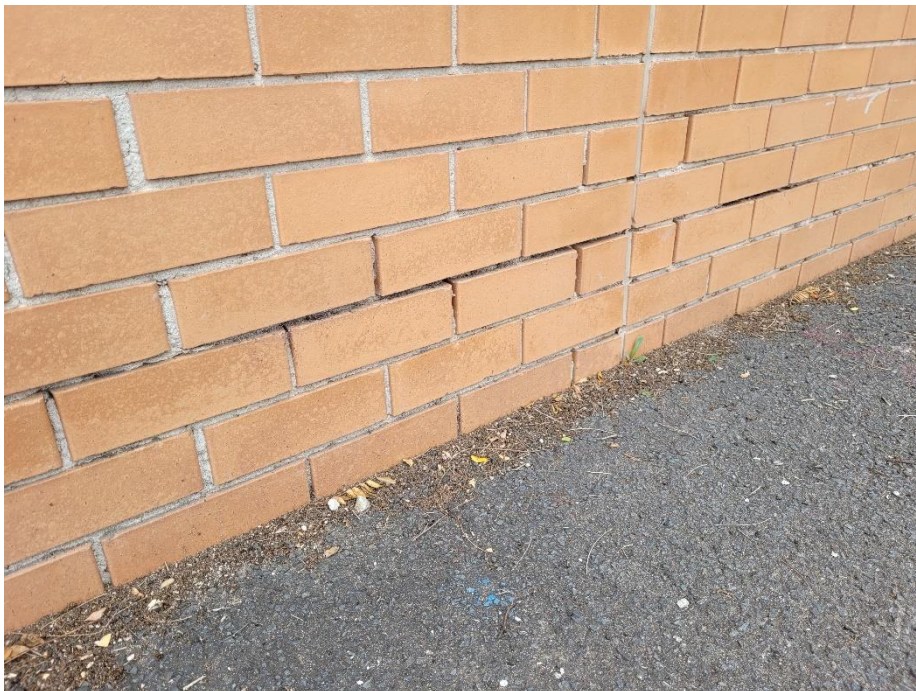
External 16. Cracking to mortar and mortar loss for high external wall

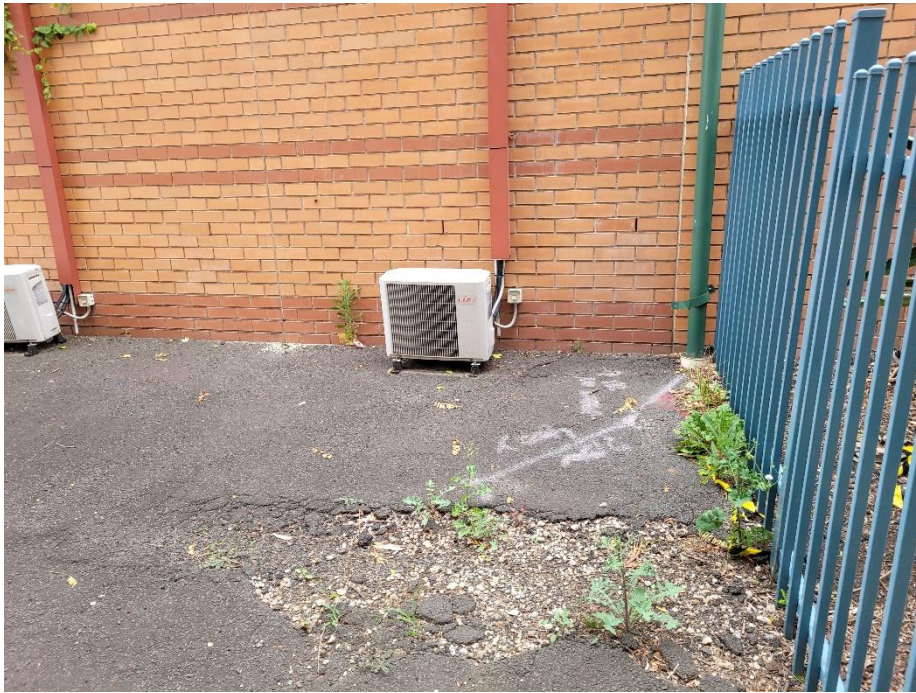
External 19. Damage to external ground bituminous layer, general cracking, and damage across building bounds.

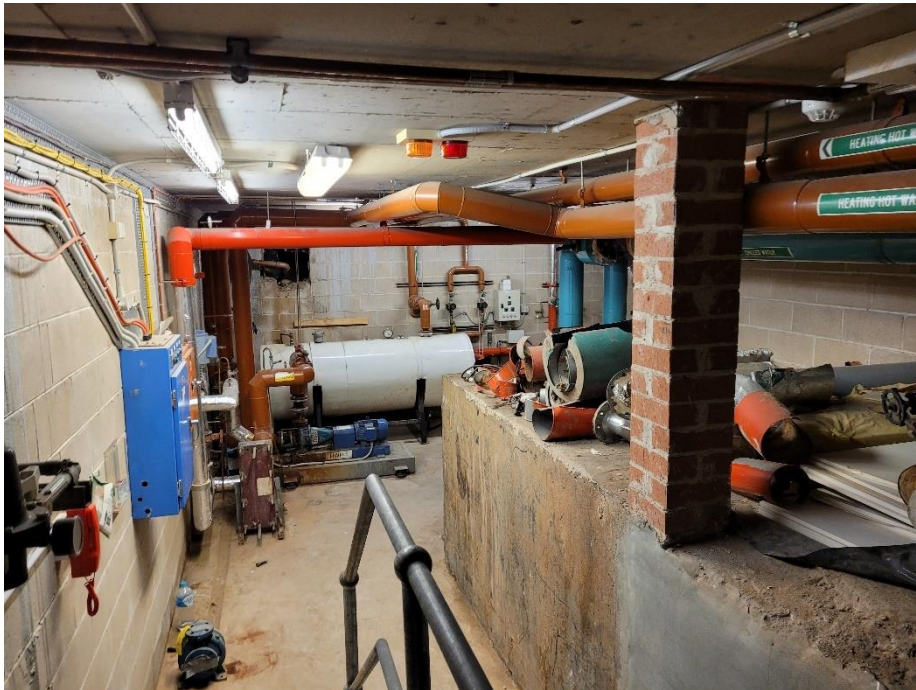
Service Tunnel 2. Access point under BIU, general abrasion or staining to surfaces

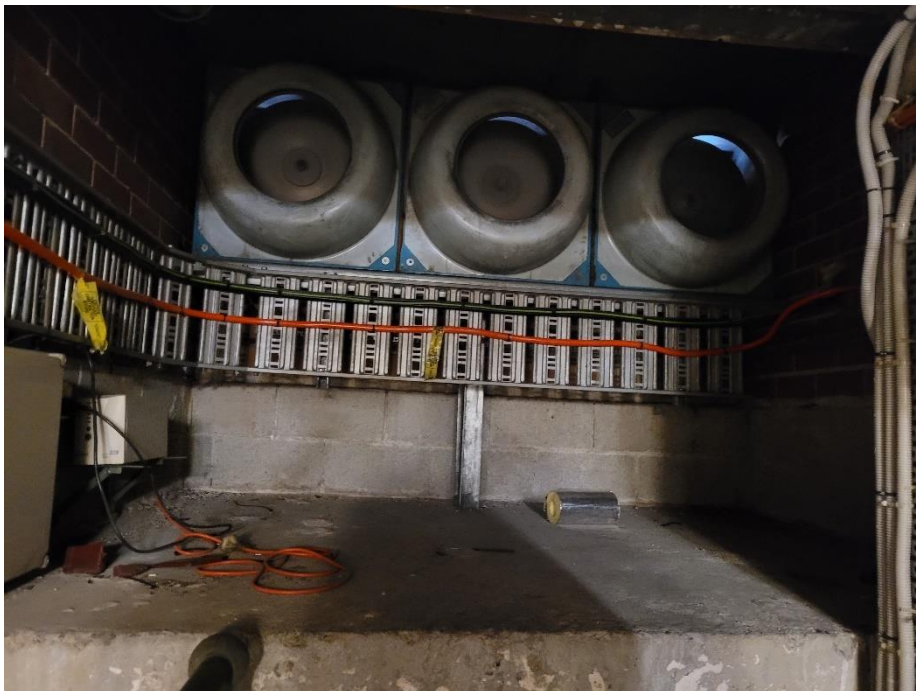
Service Tunnel 3. Air vent access point, general minor damage to concrete edges

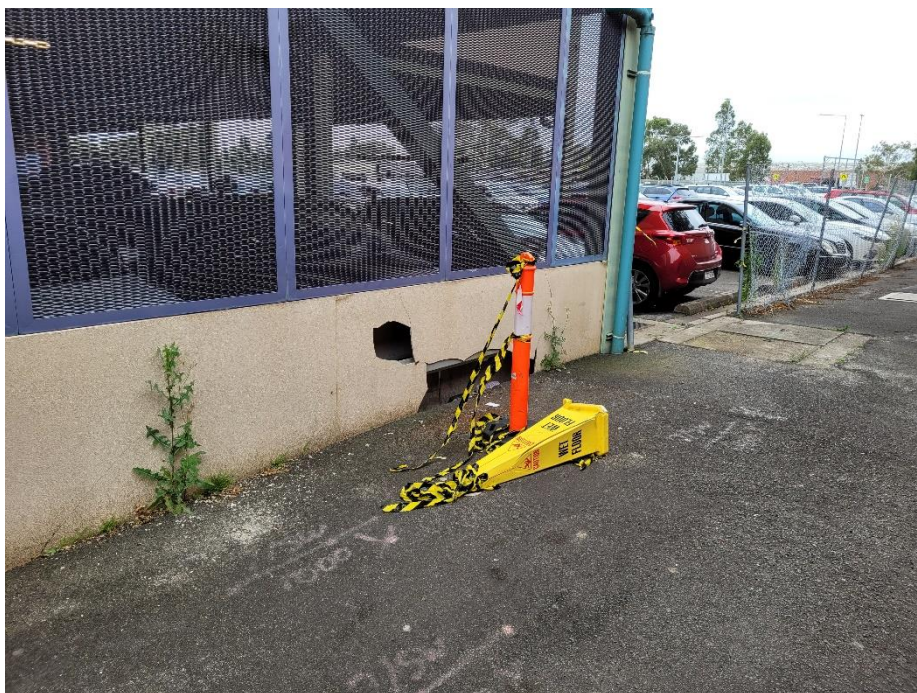
Existing Carpark 1.  
Damage to external  
cladding

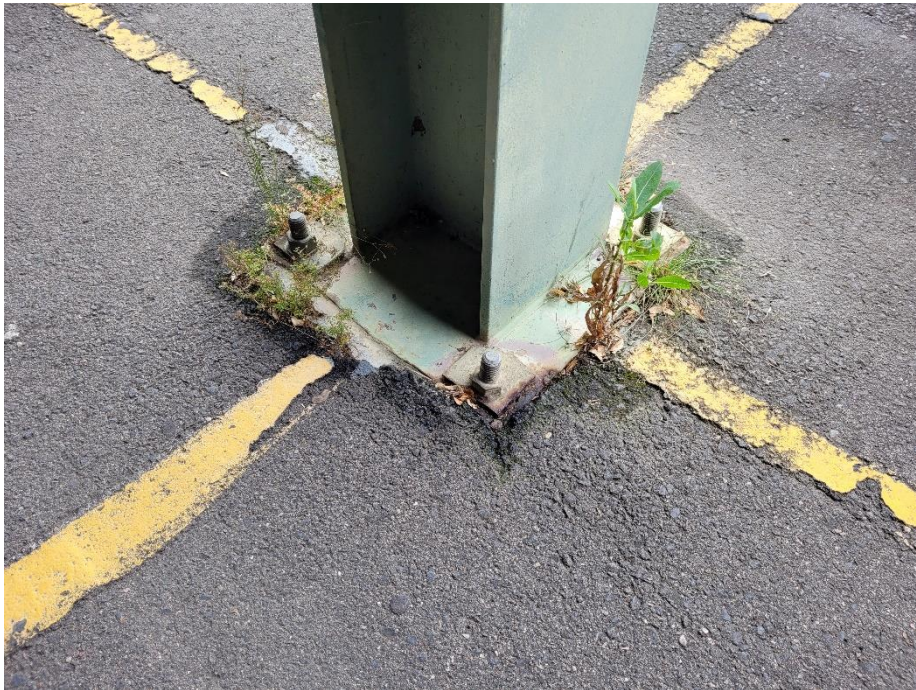
Existing Carpark 3. Signs of minimal ongoing maintenance

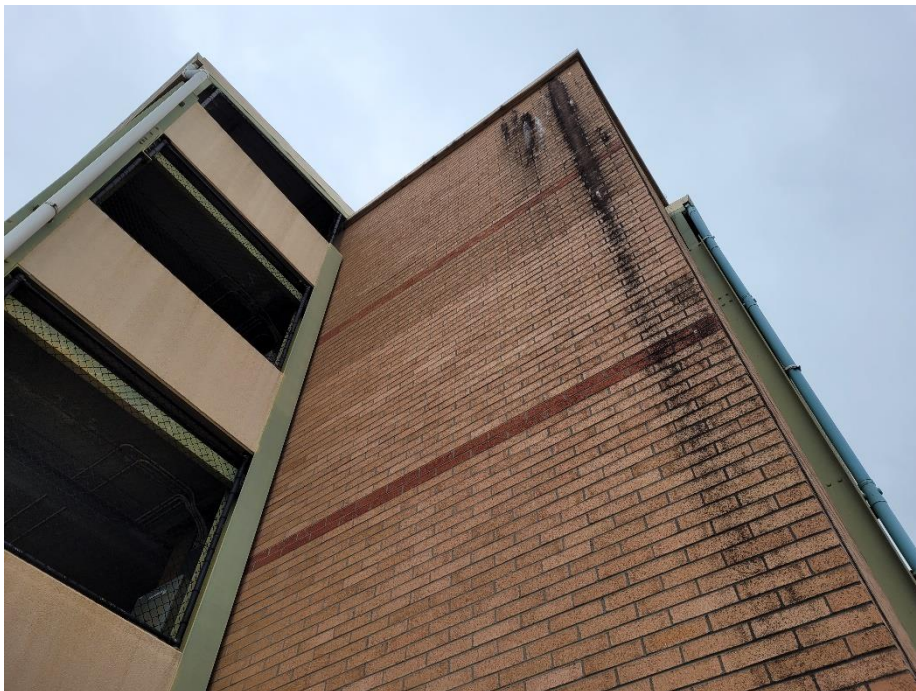
Existing Carpark 6.  
Staining to core structure

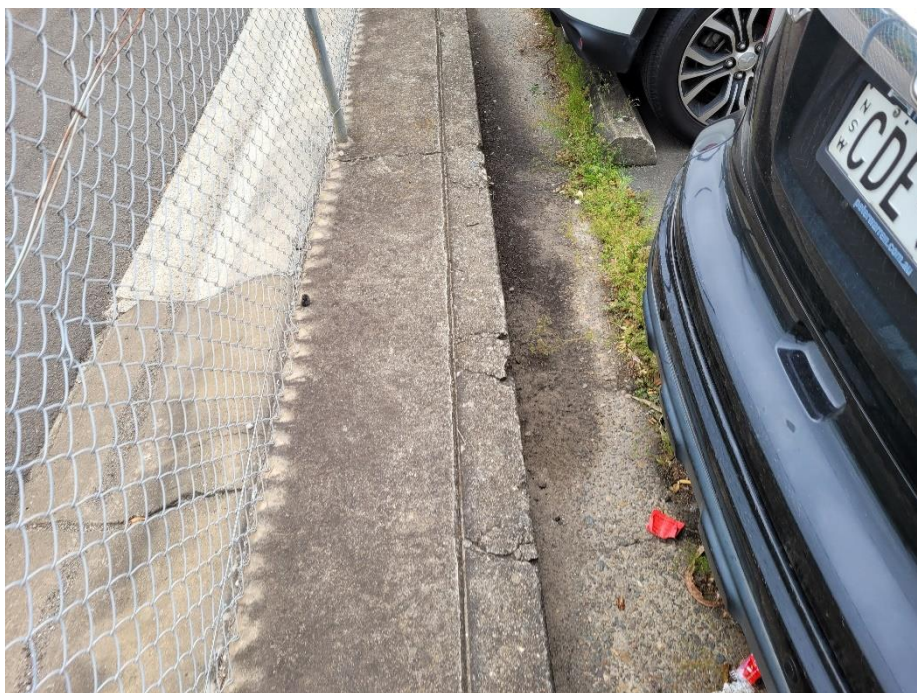
Existing Carpark 7.  
Numerous cracks to  
kerbing

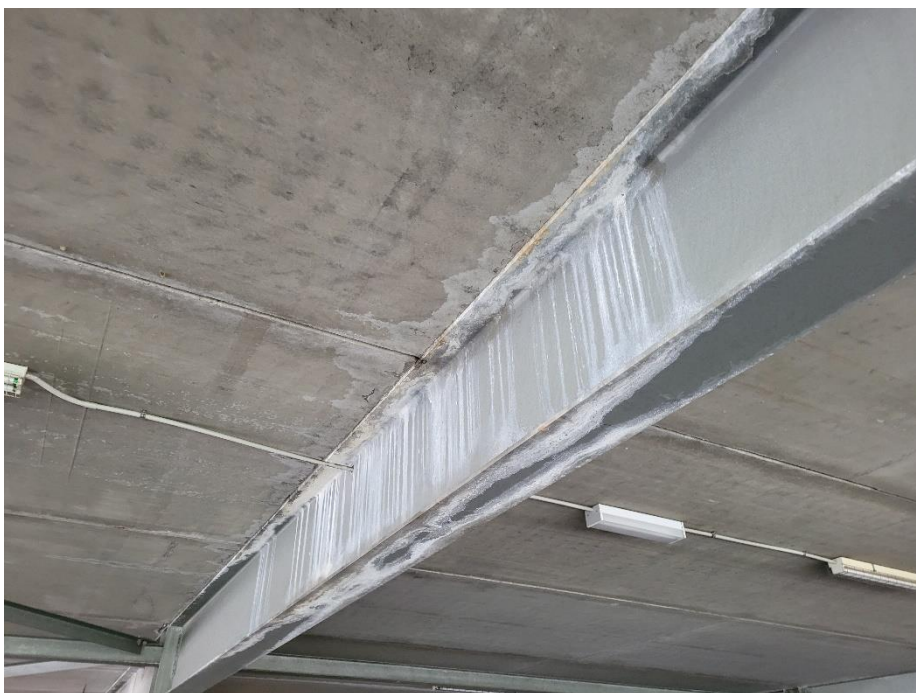
Existing Carpark 9. Water stains and potential surface corrosion to existing steel work

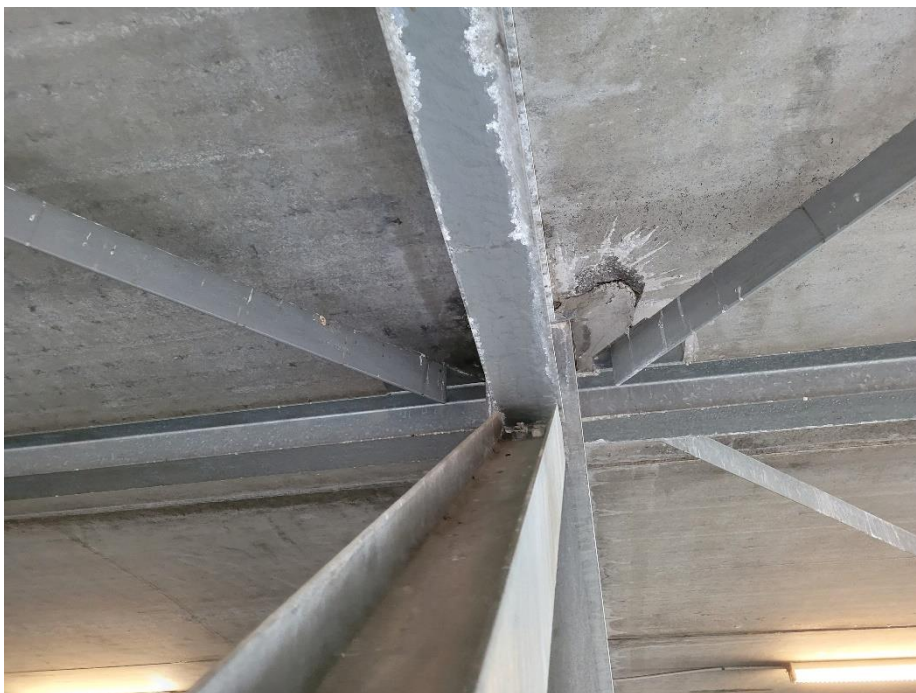
Existing Carpark 10. Water stains and potential surface corrosion to existing steel work

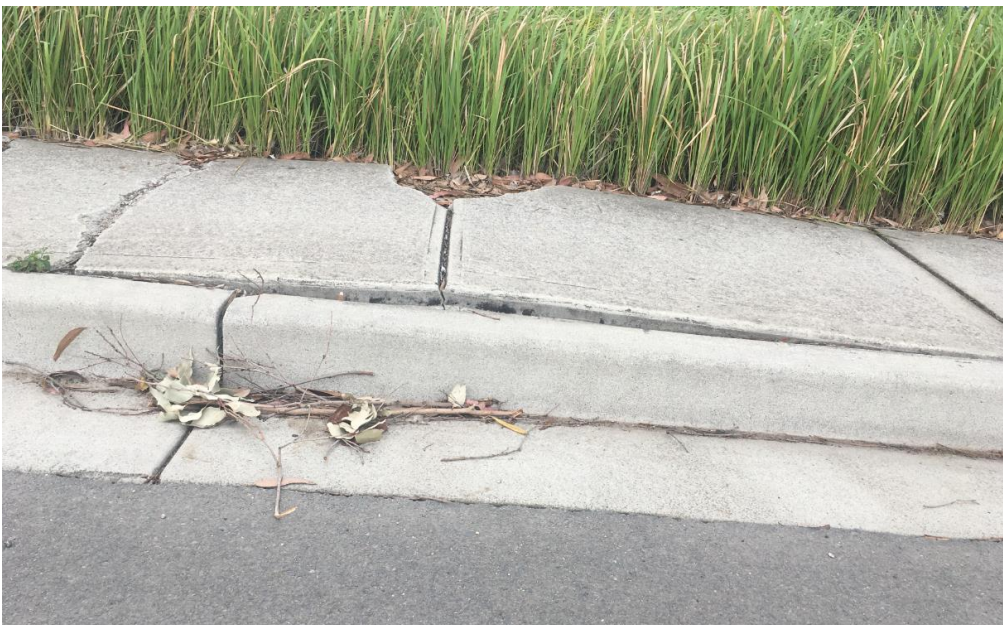
Burnside Drive  
10. Footpath  
deformation
