Re – Arborist Inspection – Tree Risk Assessment

St John of God Richmond Hospital

Tree Risk Assessment

23rd October 2019

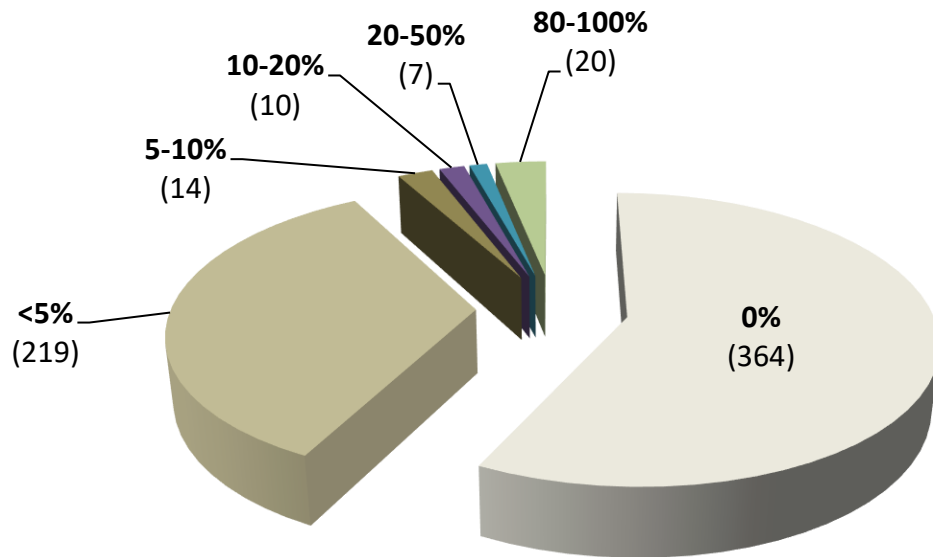
Figure 4: % of Deadwood in Trees - (no. of trees)

- 0% 364 trees
- <5% 219 trees
- 5-10% 14 trees
- 10-20% 10 trees
- 20-50% 7 trees
- 80-100% 20 trees

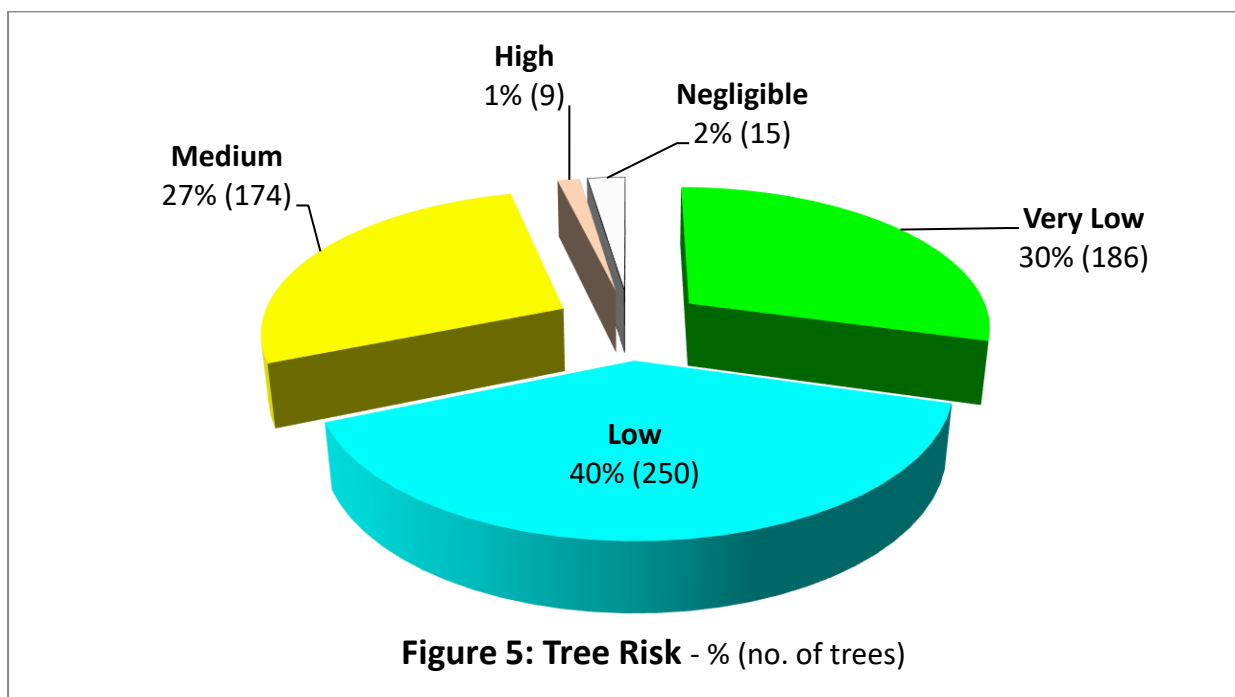
- Negligible Risk 15 trees
- Very Low Risk 186 trees
- Low Risk 250 trees
- Medium Risk 174 trees
- High Risk 9 trees
- Urgent Risk Nil
- Critical Risk Nil

- No (0) trees were assessed as **Critical Risk** or **Urgent Risk**.
- Nine (9) trees were assessed as **High Risk**. These High Risk trees represent approximately 1% of the total tree population and require arboricultural works to reduce the current risk rating as soon as possible.

Specific arboricultural work actions for the trees assessed as **High Risk** is outlined in **RECOMMENDATIONS** in this report and detailed work actions are contained in the electronic excel files.
