# DILAPIDATION REPORT

## Council Assets/Public Infrastructure

**WATERLOO STATION  
COPE STREET**

**24 January 2023**

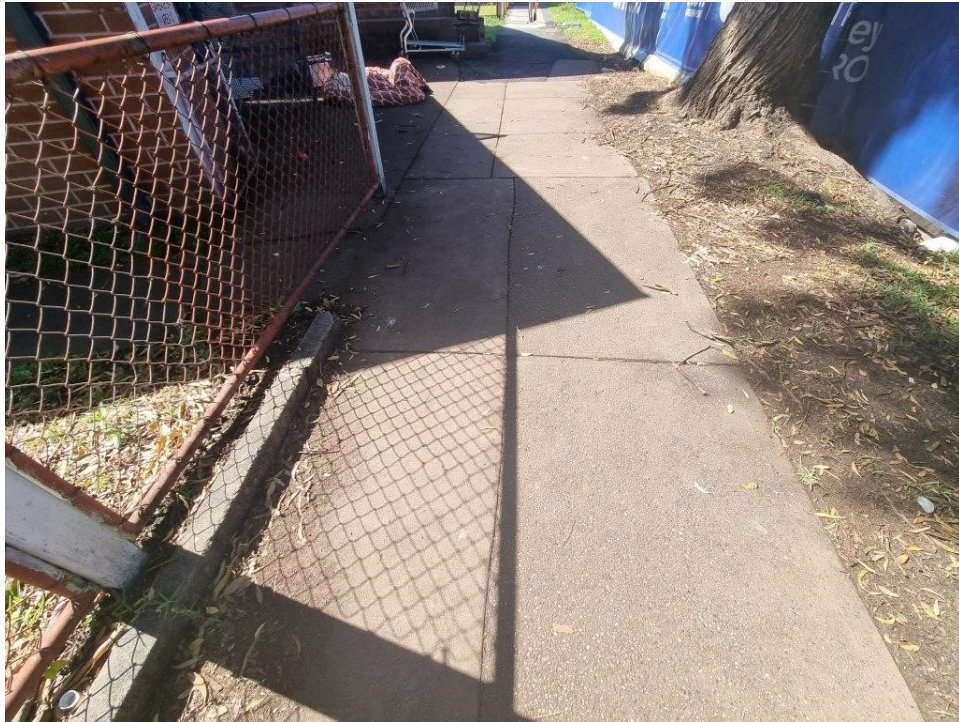
**PHOTO 3**  
(Overview of footpath adjacent 213-215 Cope Street)

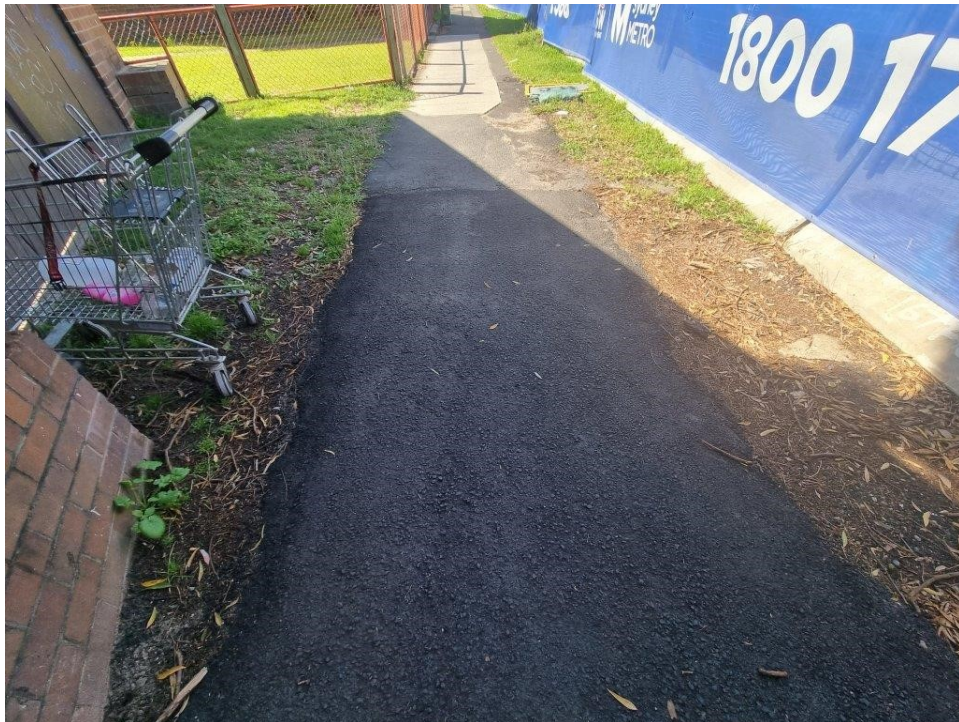
**PHOTO 11**  
(Overview of footpath adjacent 215 Cope Street)

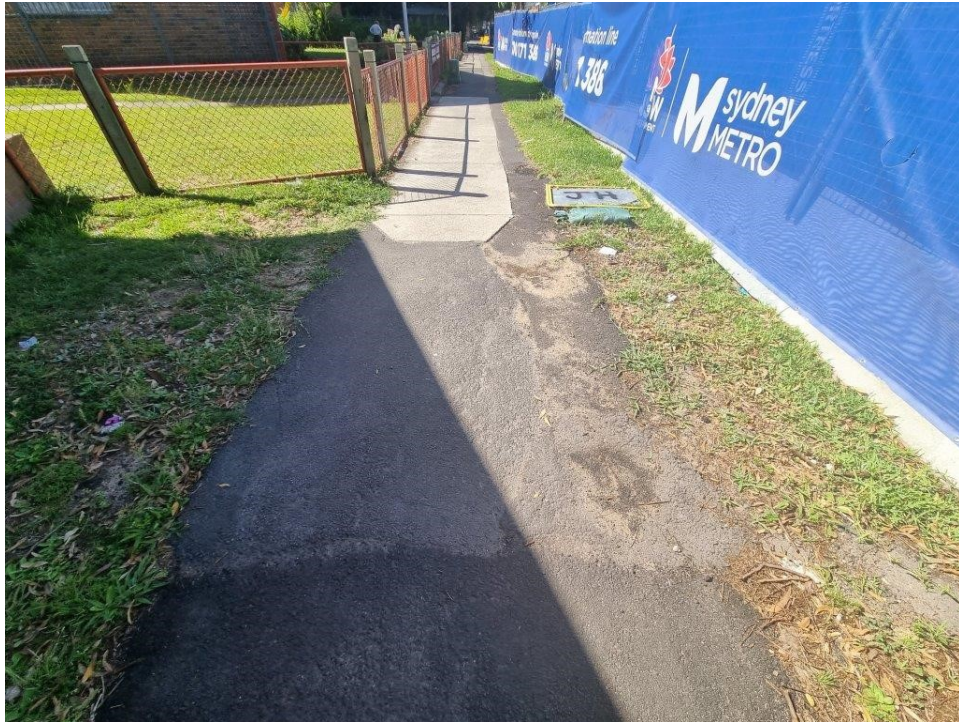
**PHOTO 13**  
(Overview of footpath adjacent 215 Cope Street)

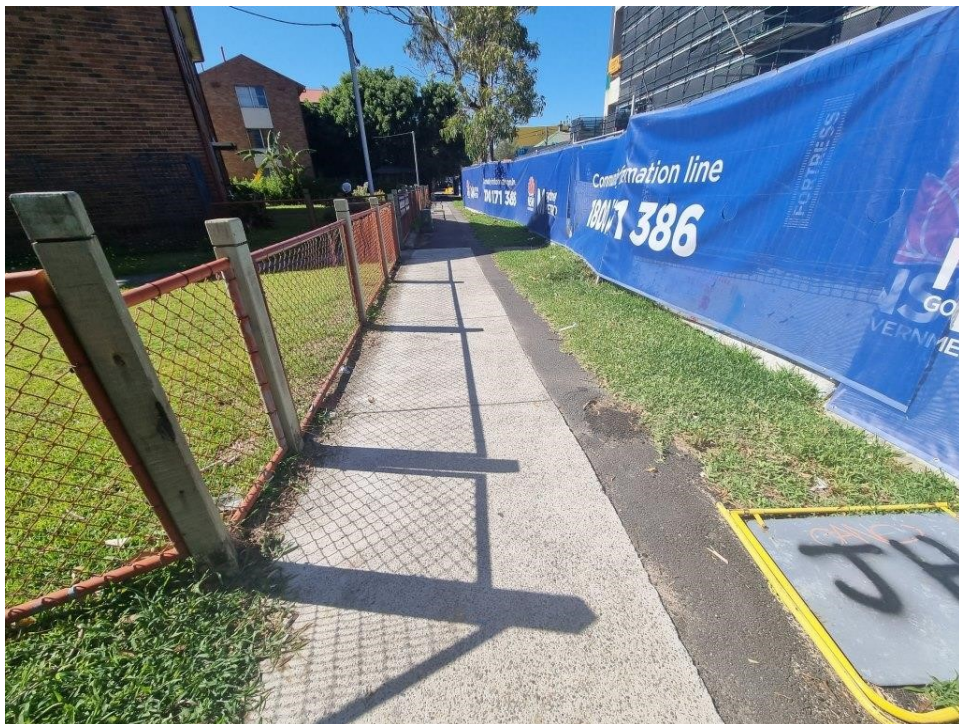
**PHOTO 14**  
(Overview of footpath adjacent 215 Cope Street)

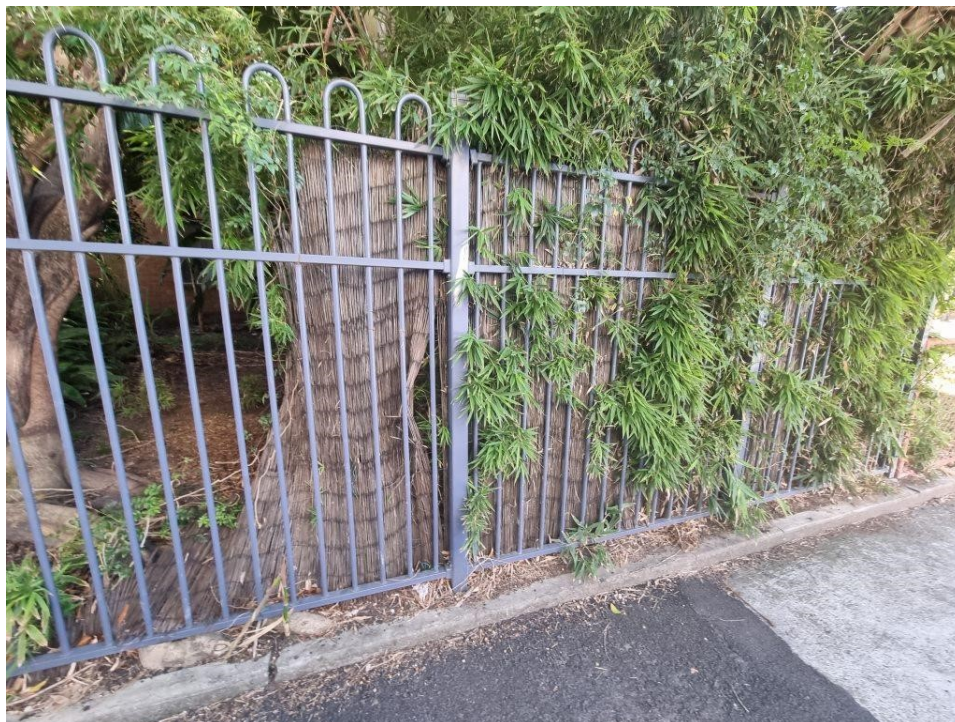
**PHOTO 43**  
(Overview of boundary fence of 113 Wellington Street)

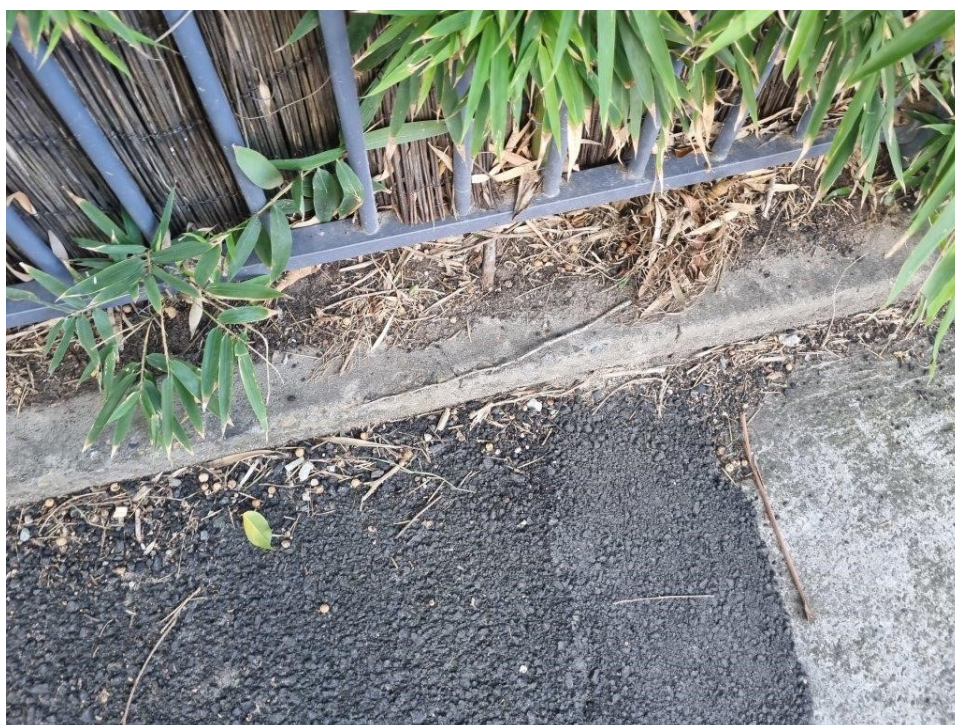
**PHOTO 44**  
(Overview of boundary fence of 113 Wellington Street)

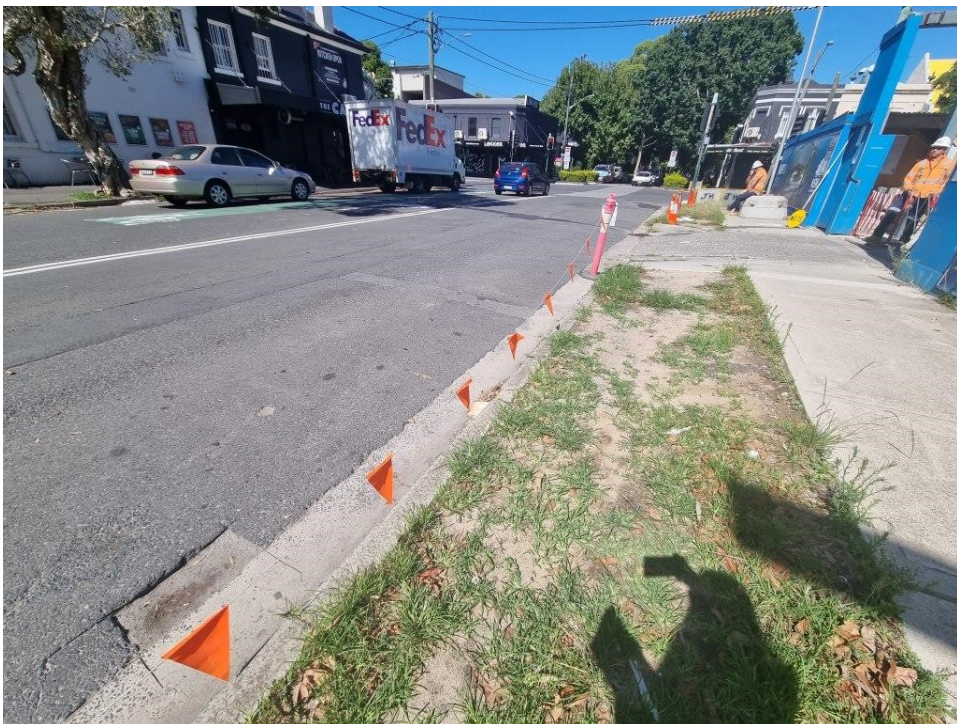
**PHOTO 79**  
(Overview of footpath on Wellington Street)

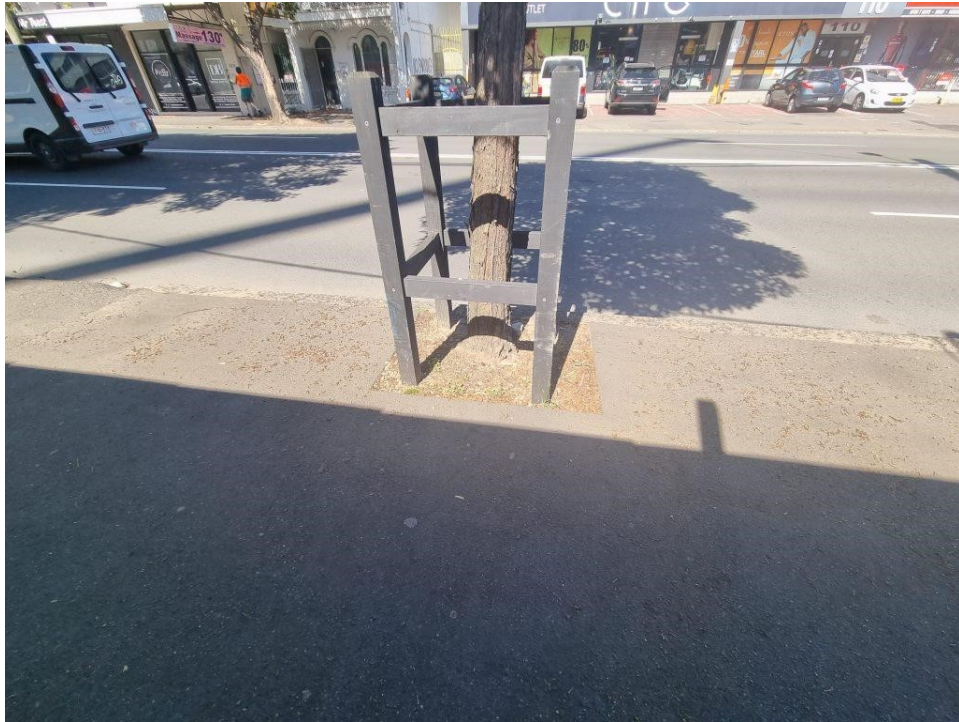
**PHOTO 120**

(Overview of footpath and kerb along Botany Road)

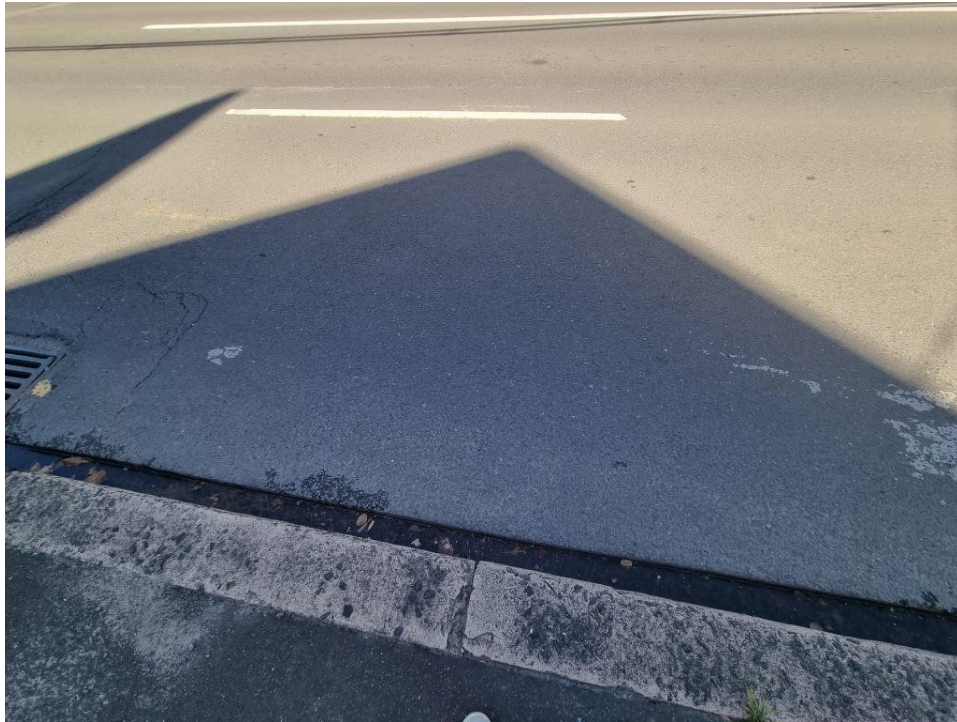
**PHOTO 152**

(Overview of footpath, road, kerb and stormwater inlet pit adjacent church facing South)

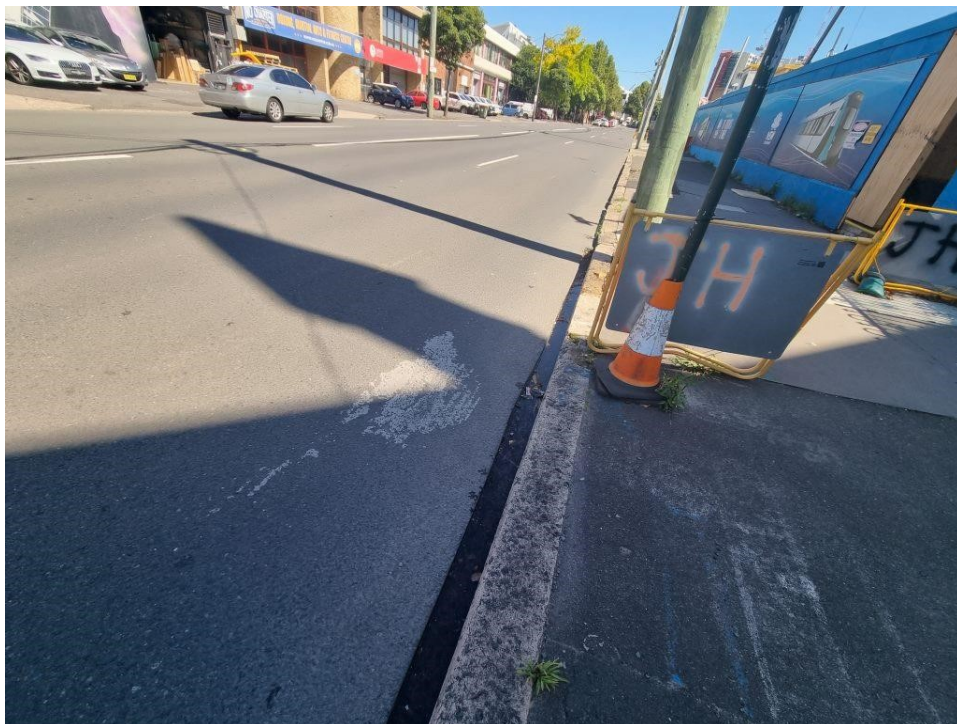
**PHOTO 153**  
(Overview of road adjacent church)
