DILAPIDATION REPORT

Council Assets/Public Infrastructure

**WATERLOO STATION
COPE STREET**

DEMLAKIAN CONSULTING ENGINEERS

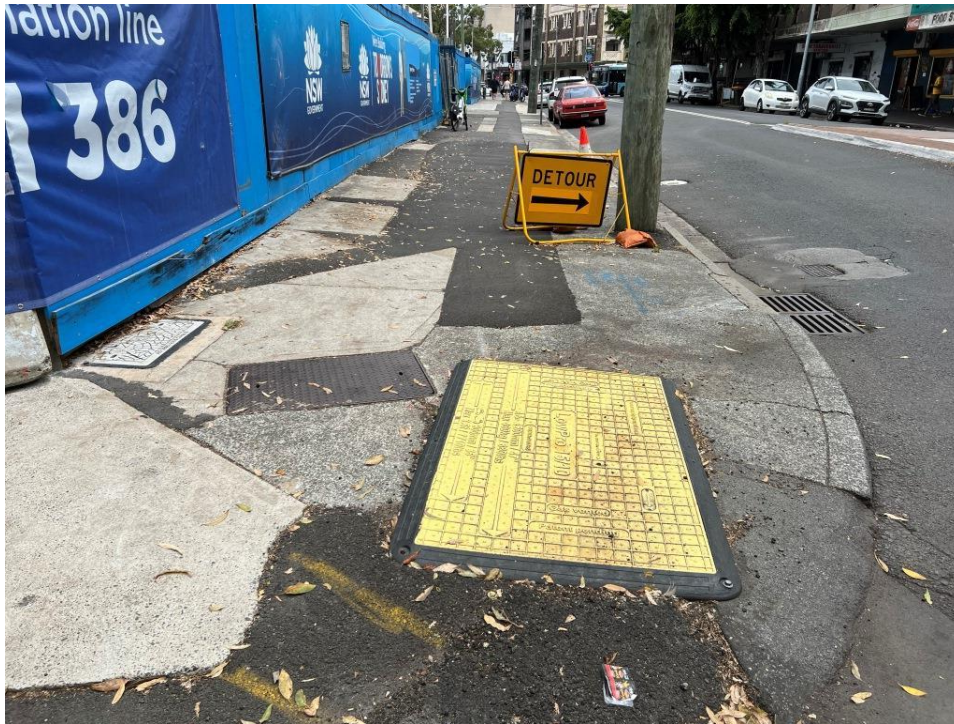
PHOTO 7
(Overview of uneven footpath – Raglan Street)

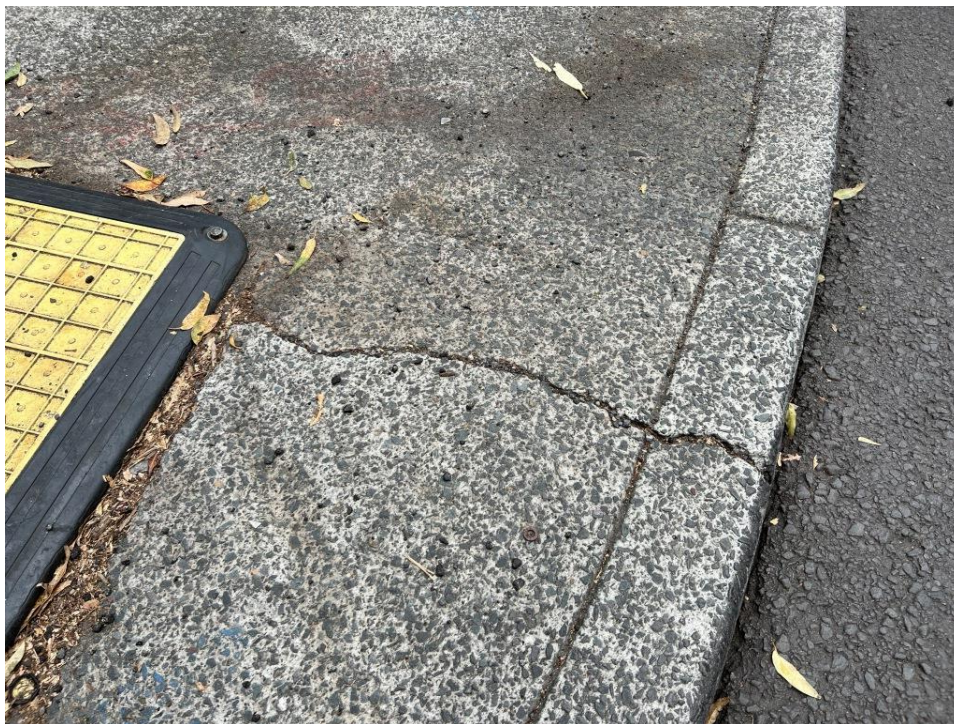
PHOTO 8
(Photo showing crack in footpath and kerb – Raglan Street)

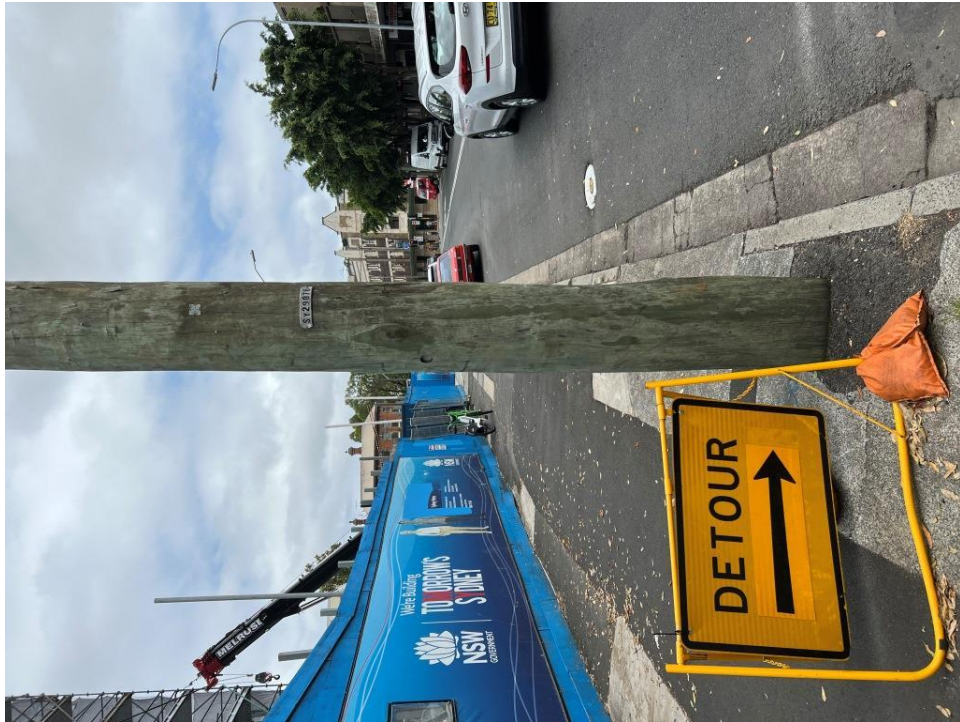
PHOTO 13
(Overview of electricity pole – Raglan Street)

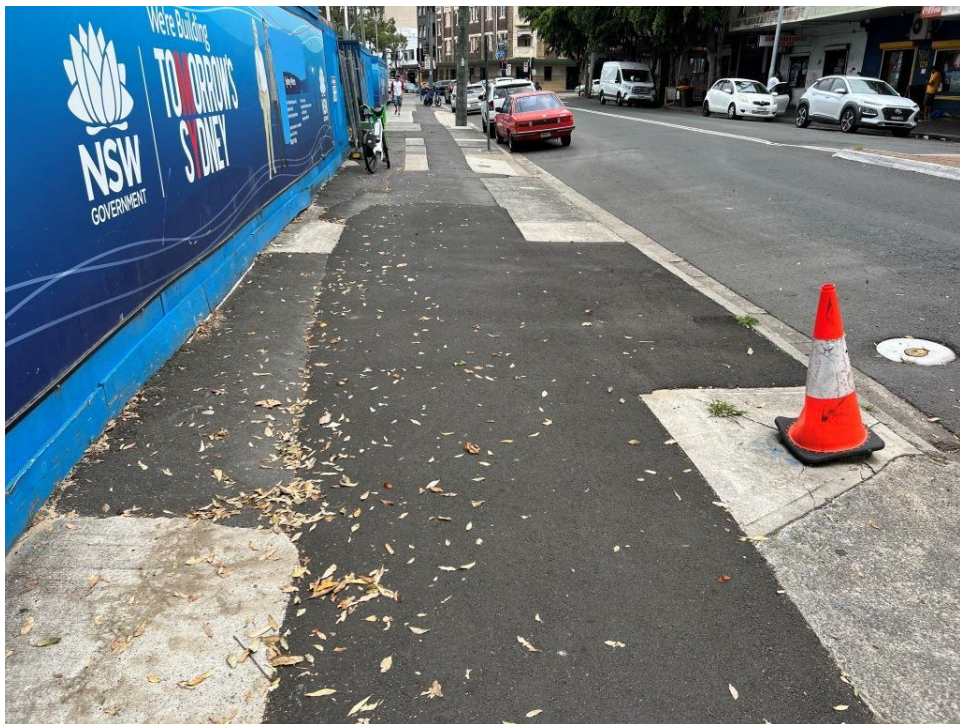
PHOTO 14
(Overview of footpath – Raglan Street)

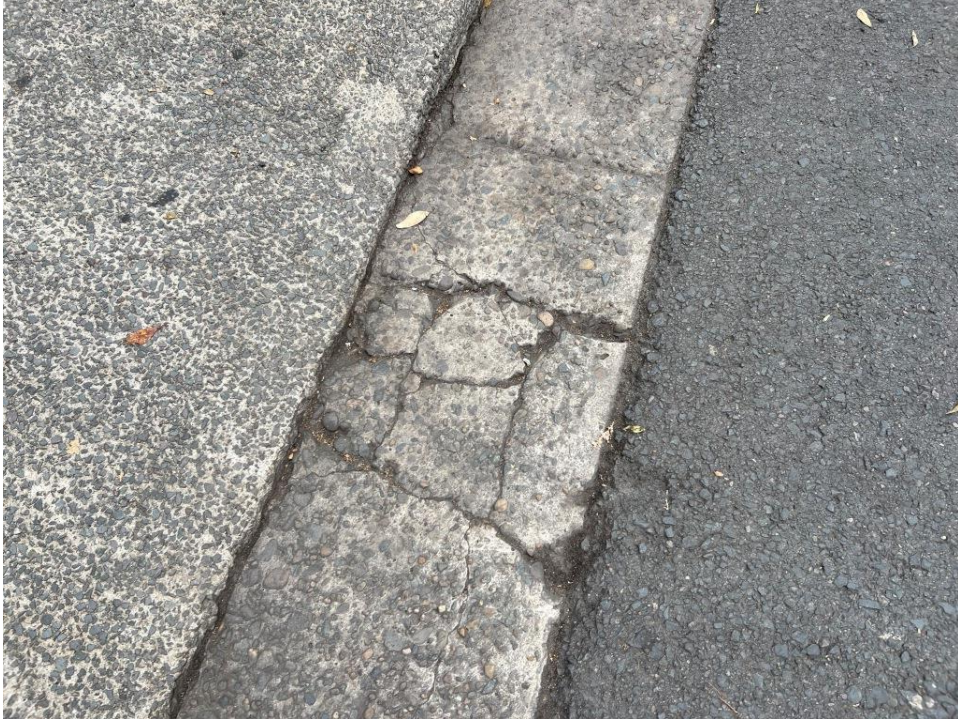
PHOTO 19
(Photo showing cracked gutter – Raglan Street)

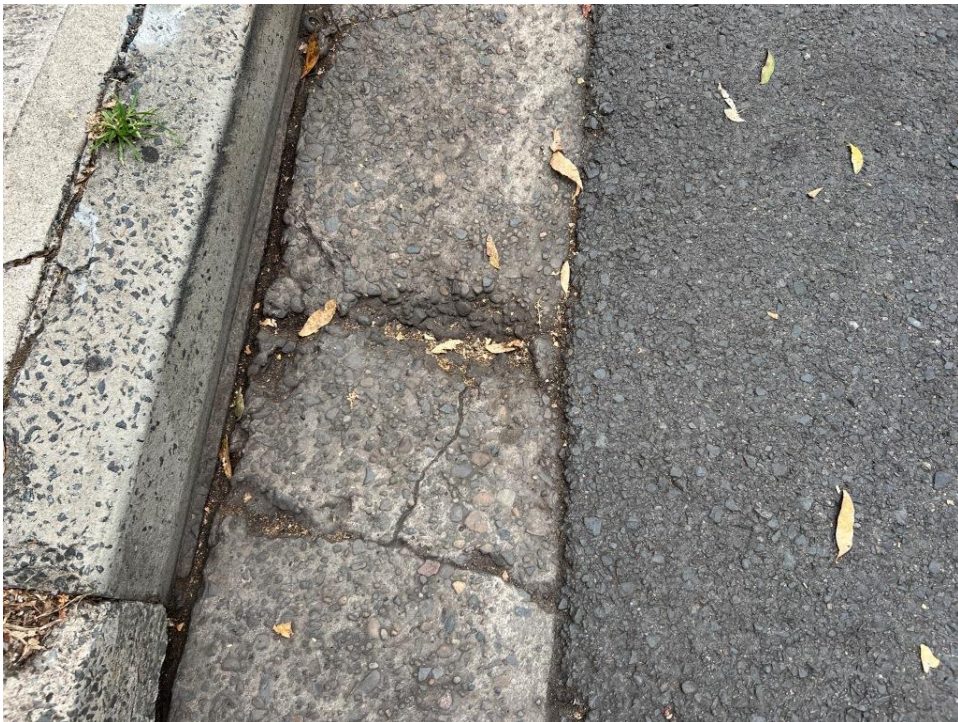
PHOTO 20
(Photo showing cracked kerb and gutter – Raglan Street)

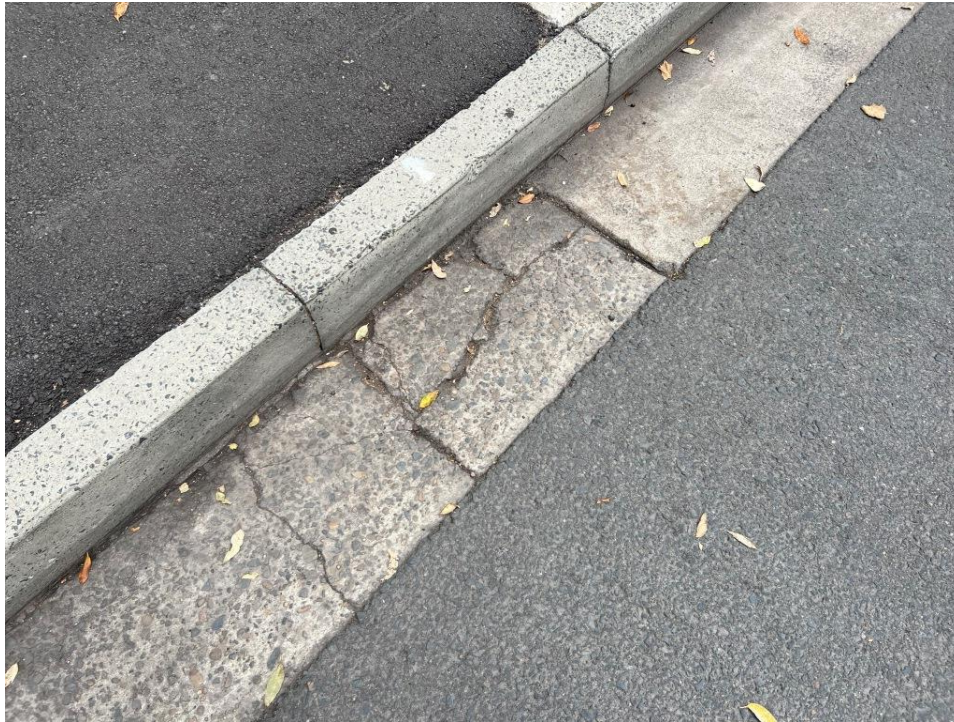
PHOTO 25
(Photo showing cracks in gutter – Raglan Street)

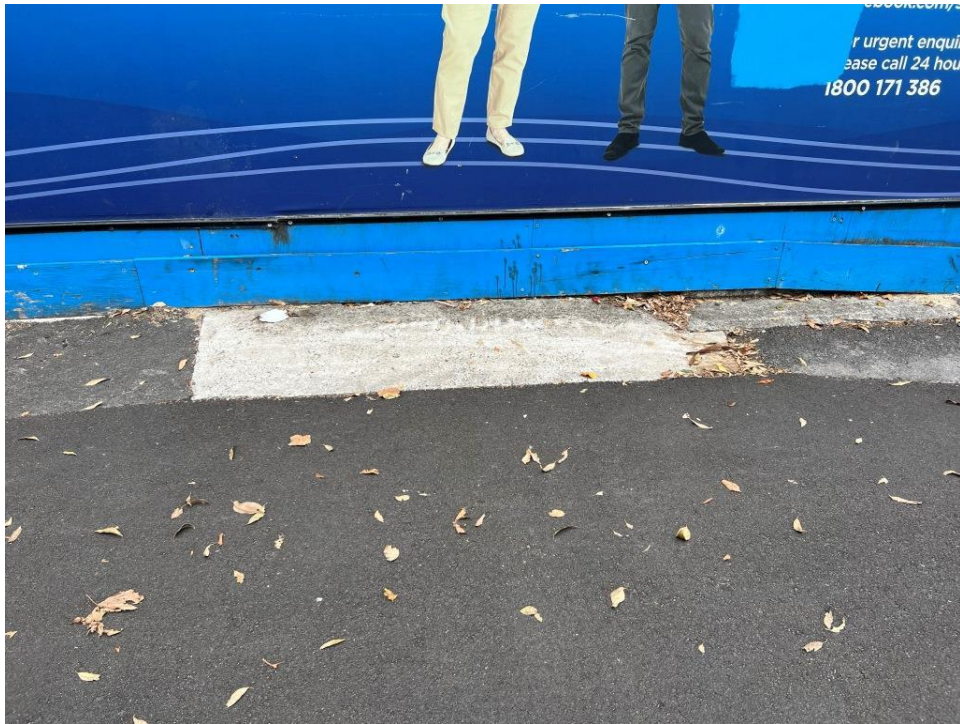
PHOTO 27
(Overview of footpath – Raglan Street)

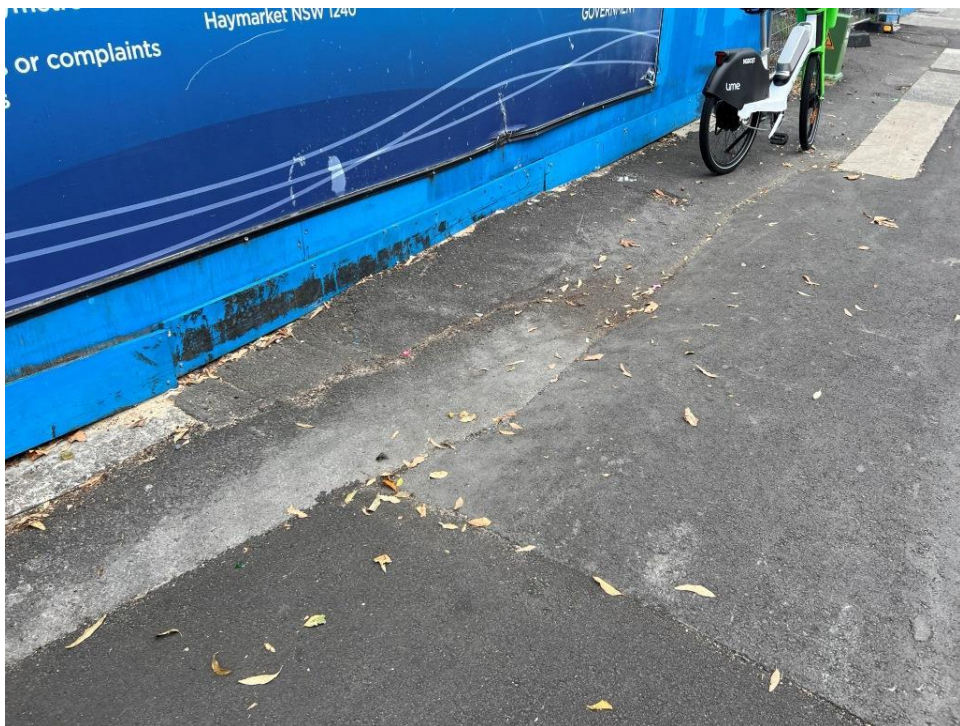
PHOTO 28
(Photo showing uneven footpath – Raglan Street)

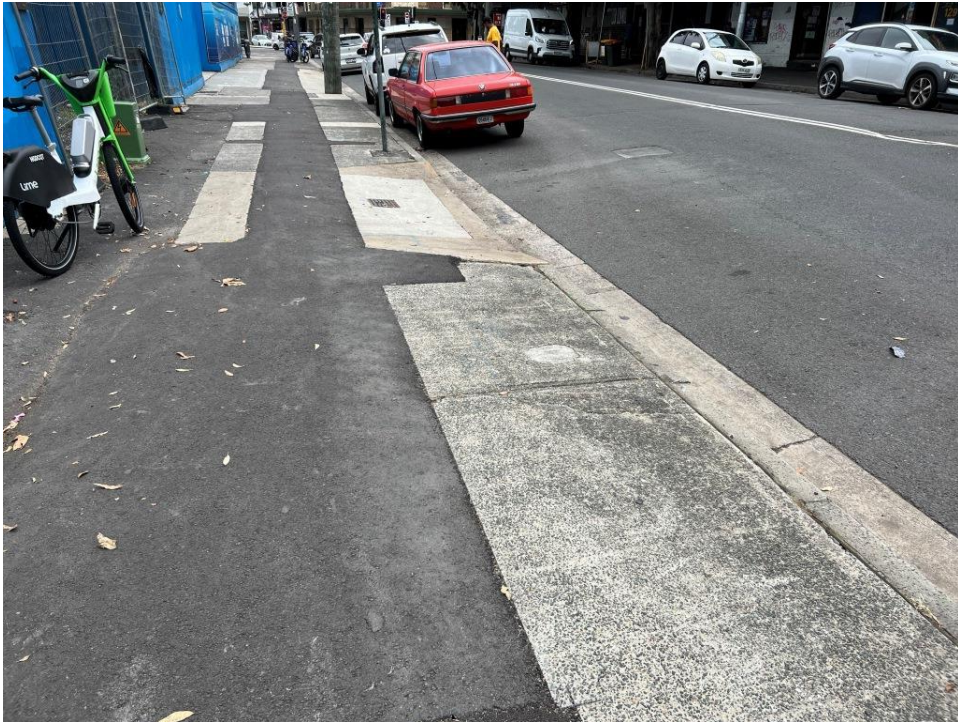
PHOTO 29
(Overview of footpath – Raglan Street)

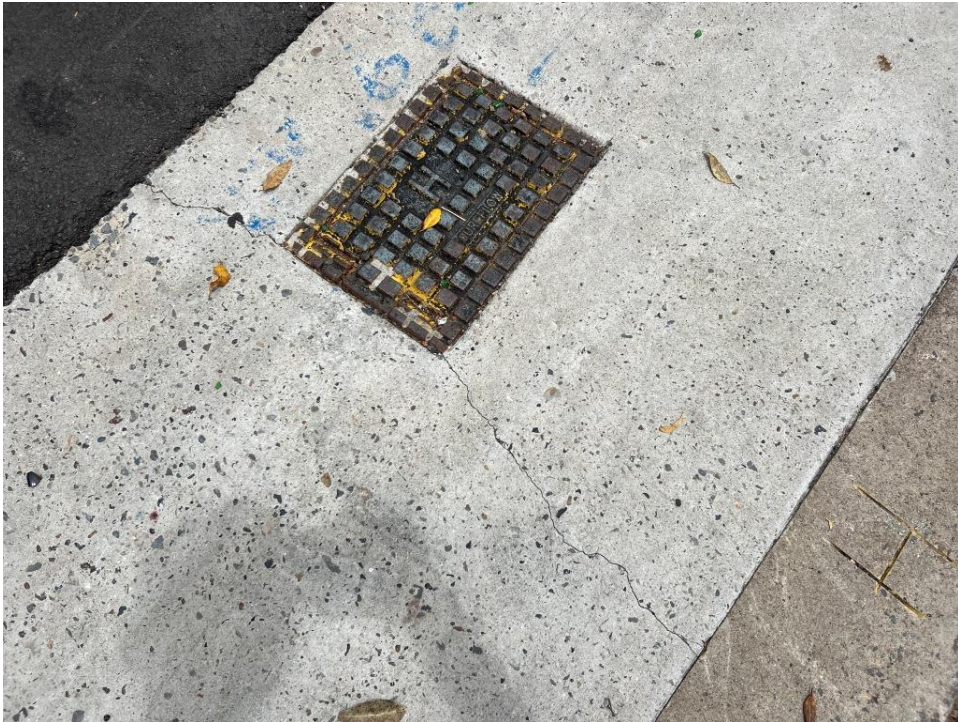
PHOTO 41
(Photo showing cracks in footpath – Raglan Street)

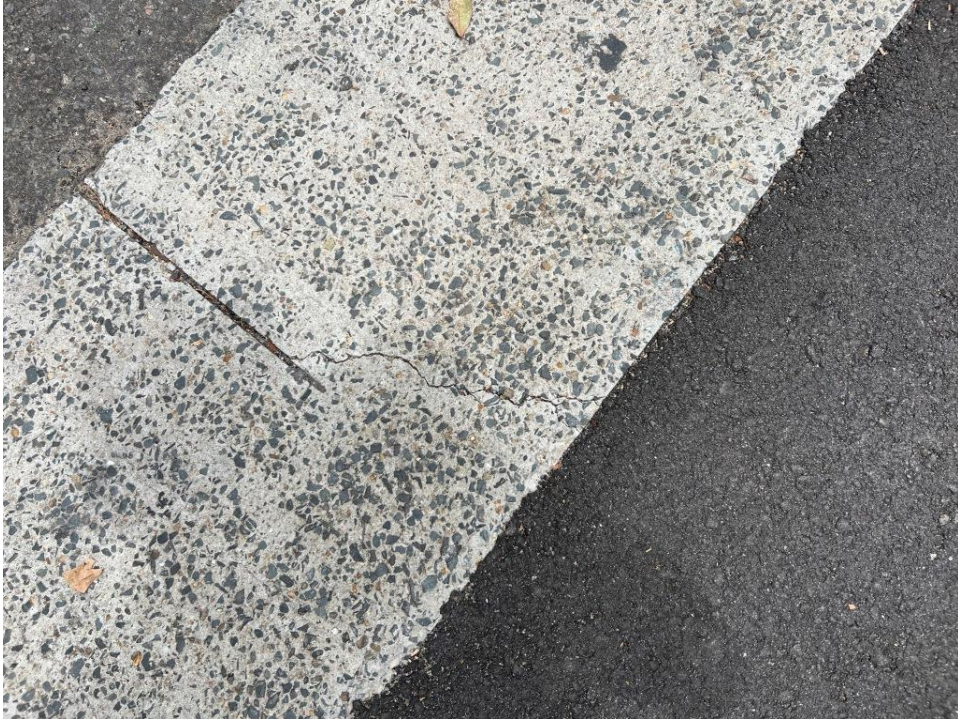
PHOTO 64

(Photo showing crack in footpath – Raglan Street)

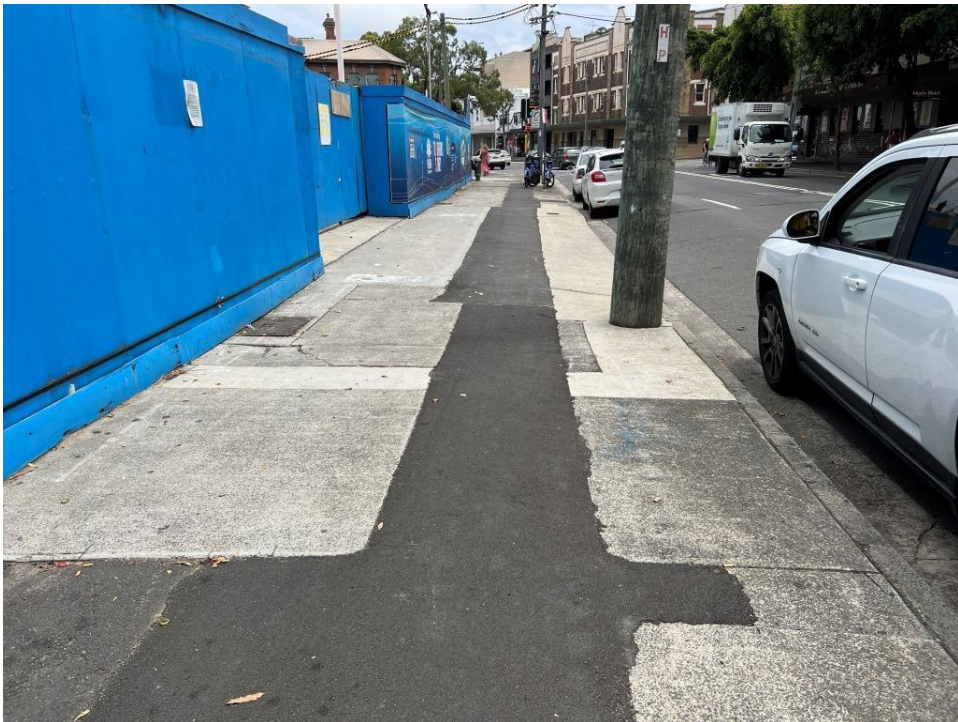
PHOTO 65
(Photo showing crack in footpath – Raglan Street)

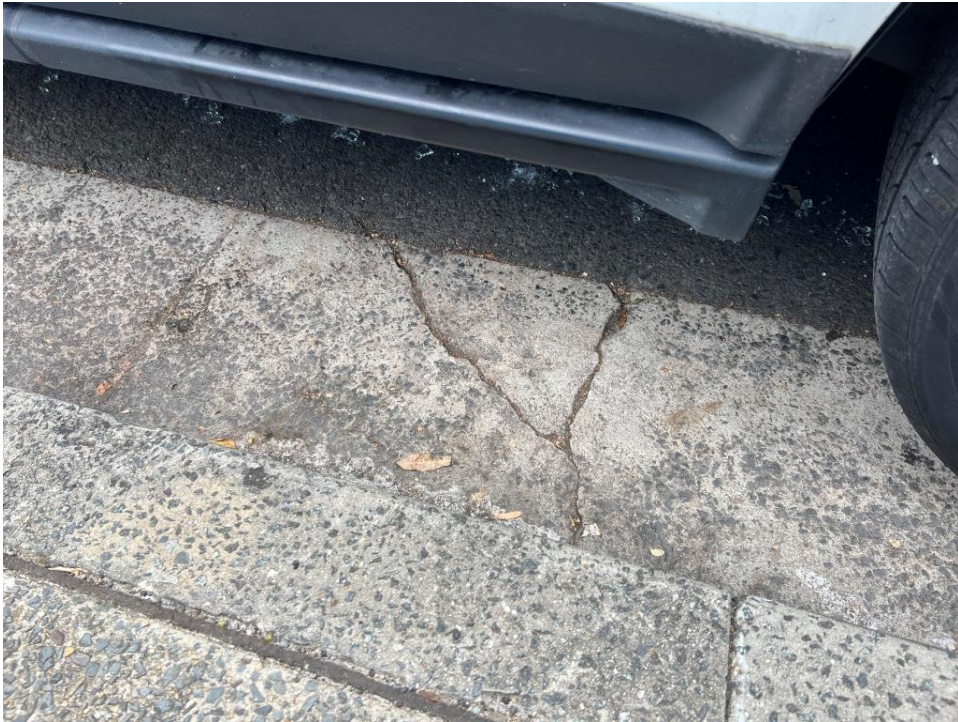
PHOTO 70

(Photo showing cracks in footpath, kerb and gutter – Raglan Street)

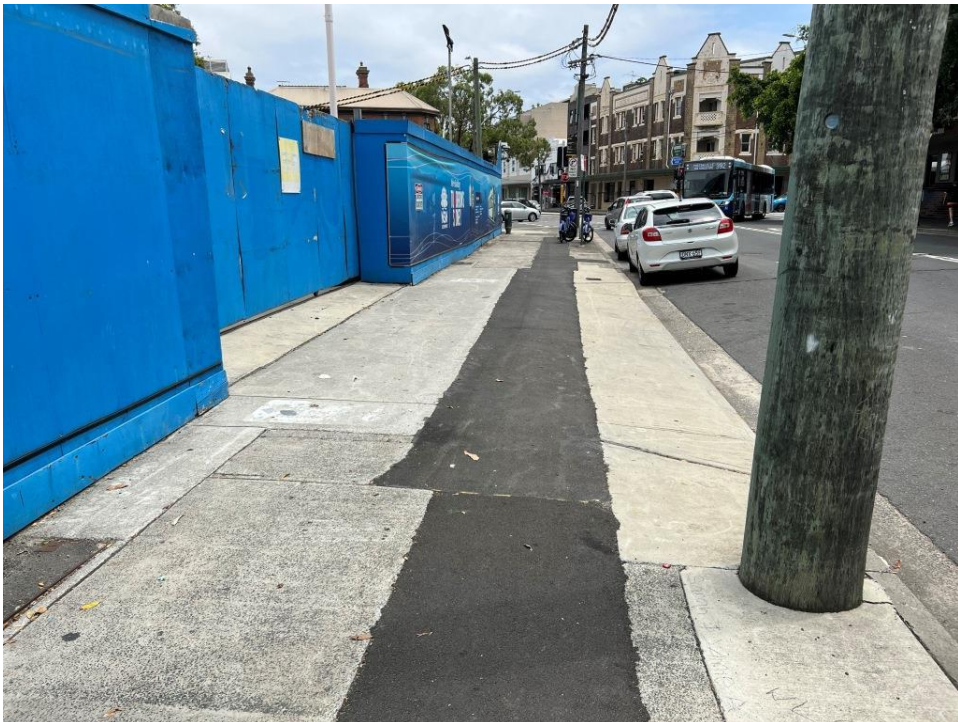
PHOTO 71
(Photo showing cracks in gutter – Raglan Street)

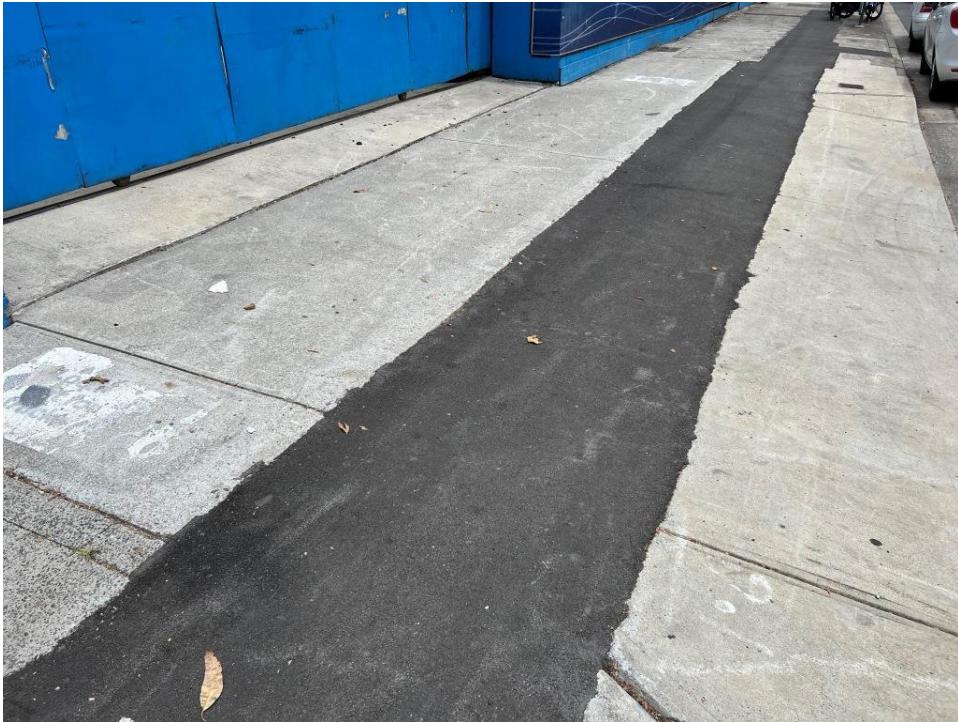
PHOTO 78

(Photo showing cracked gutter adjacent truck driveway – Raglan Street)

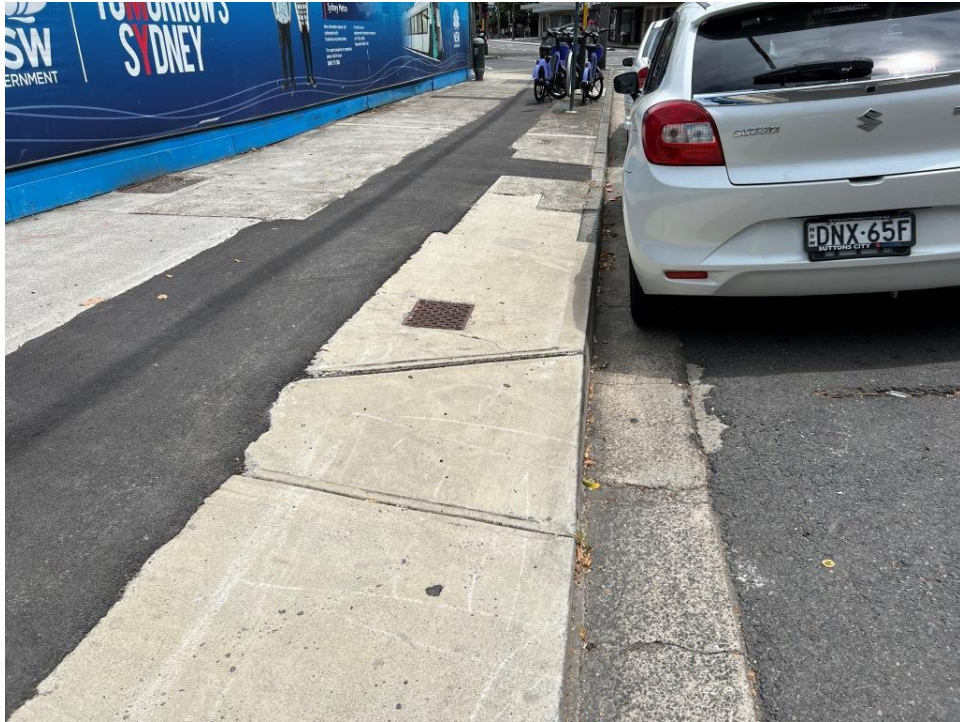
PHOTO 92

(Photo showing footpath's condition adjacent to truck driveway – Raglan Street)

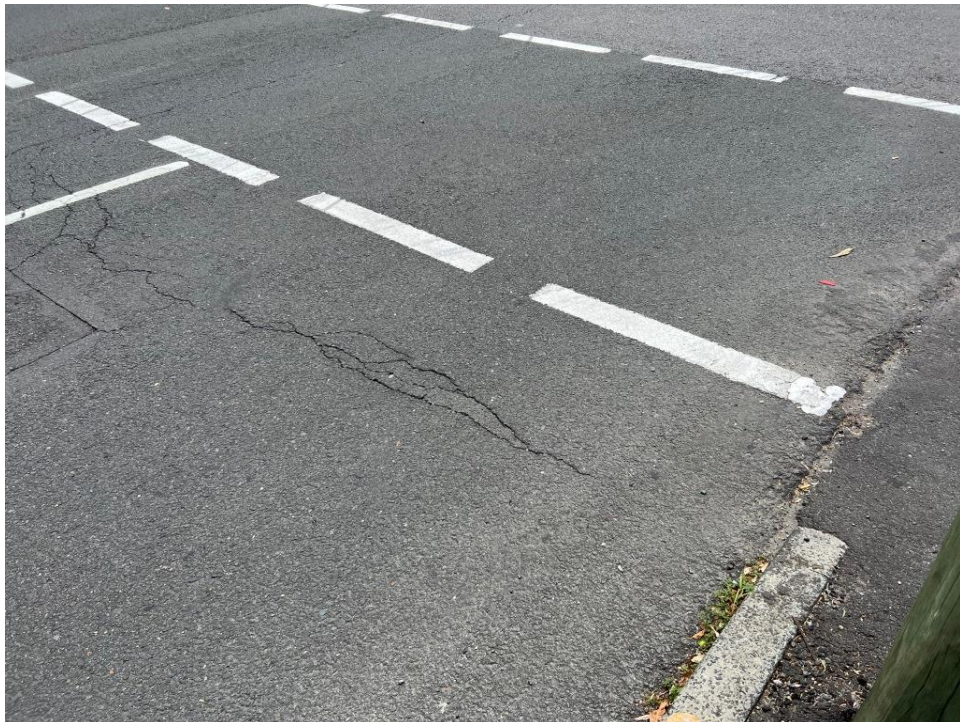
PHOTO 157
(Overview of roadway – Botany Road)

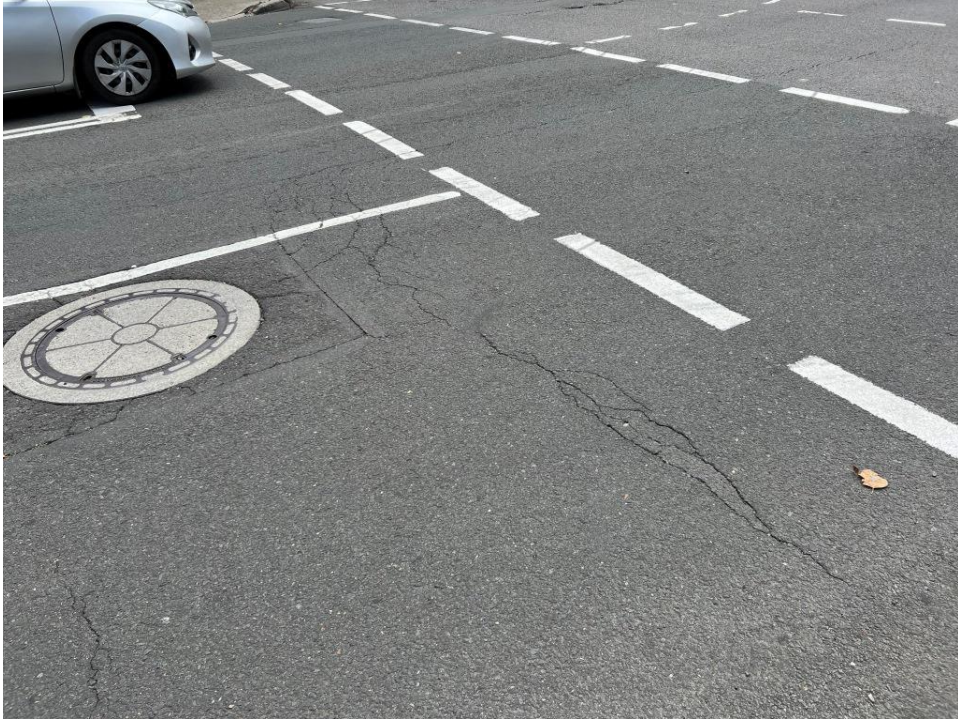
PHOTO 158
(Photo showing cracked asphalt – Botany Road)

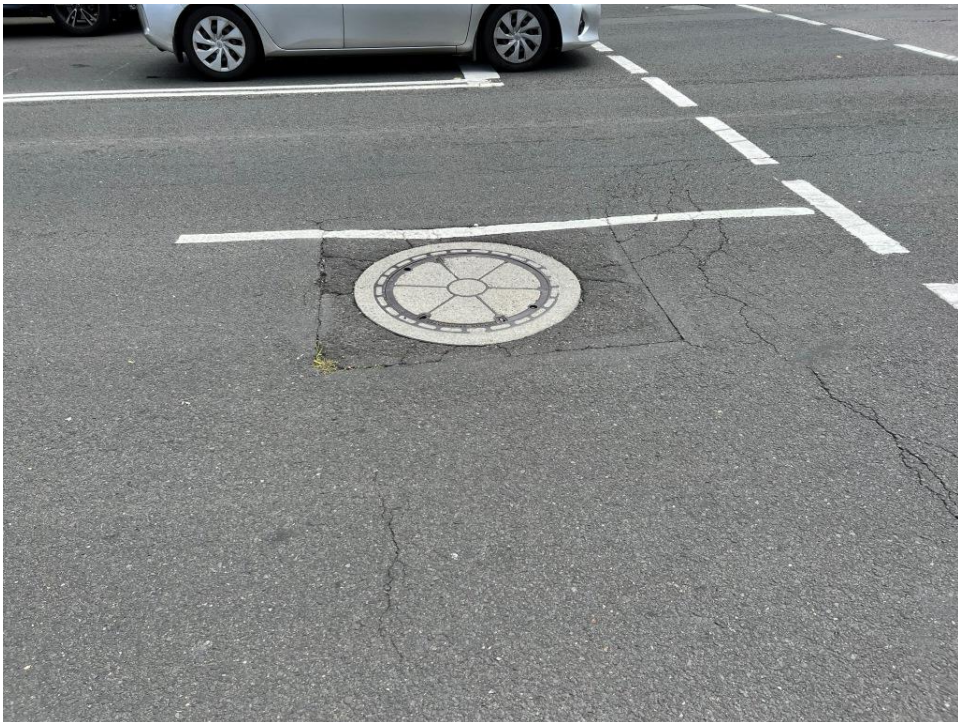
PHOTO 159
(Photo showing cracked asphalt – Botany Road)

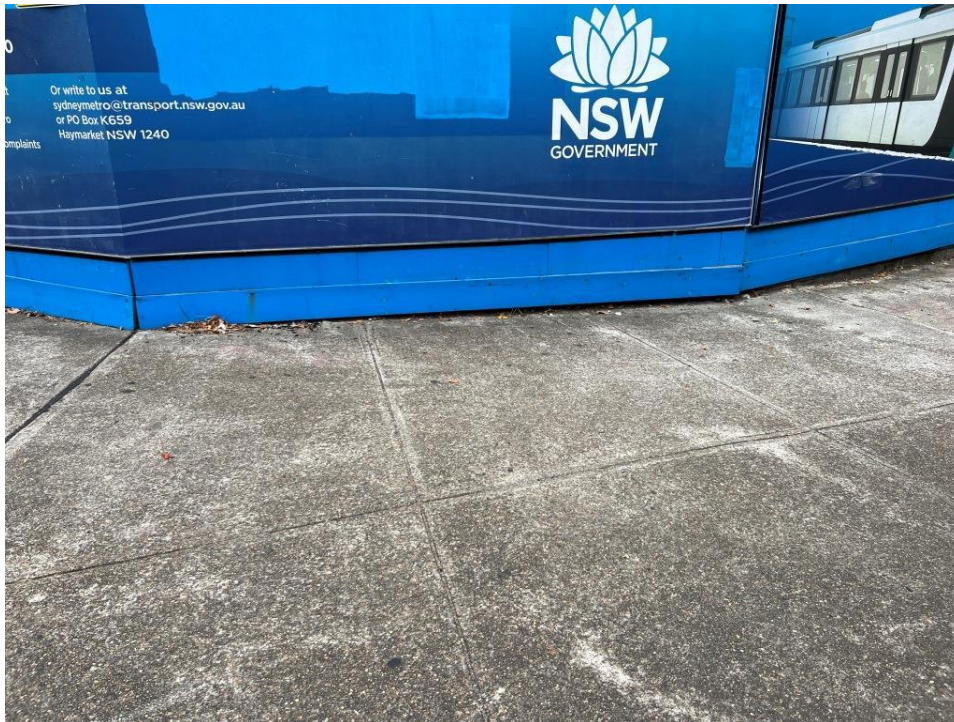
PHOTO 164

(Photo showing crack in footpath – Botany Road)

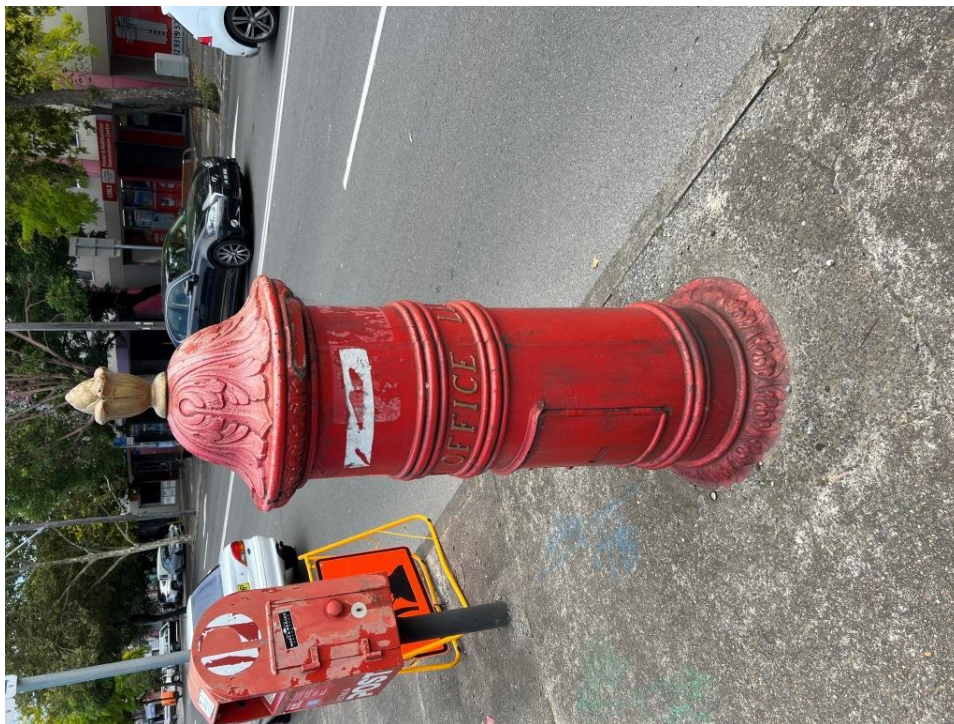
PHOTO 165
(Overview of footpath – Botany Road)

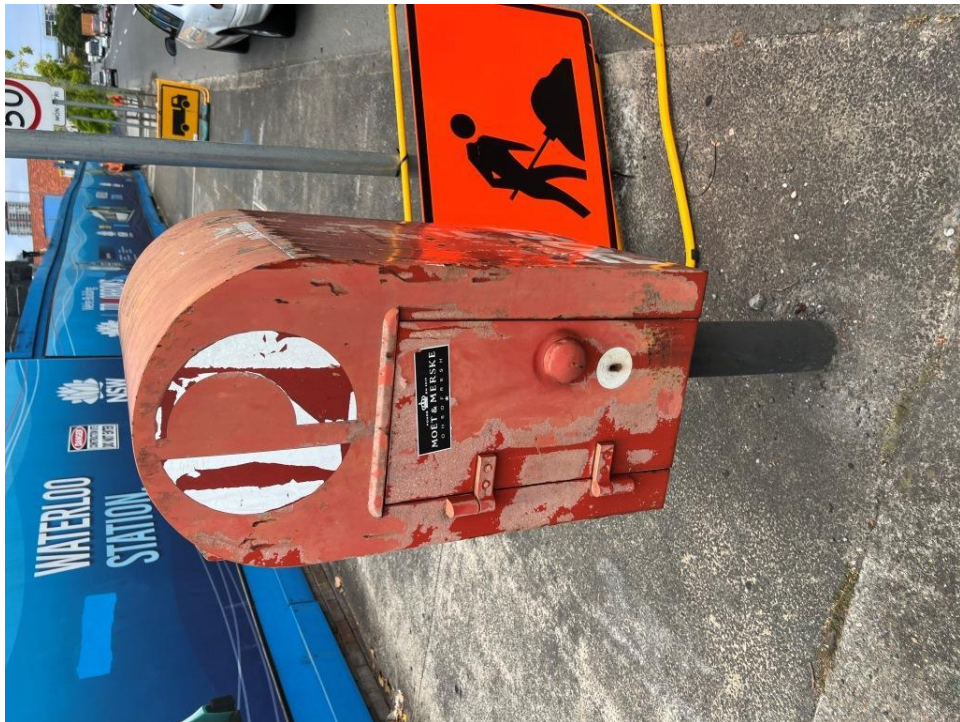
PHOTO 169
(Overview of roadway – Botany Road)

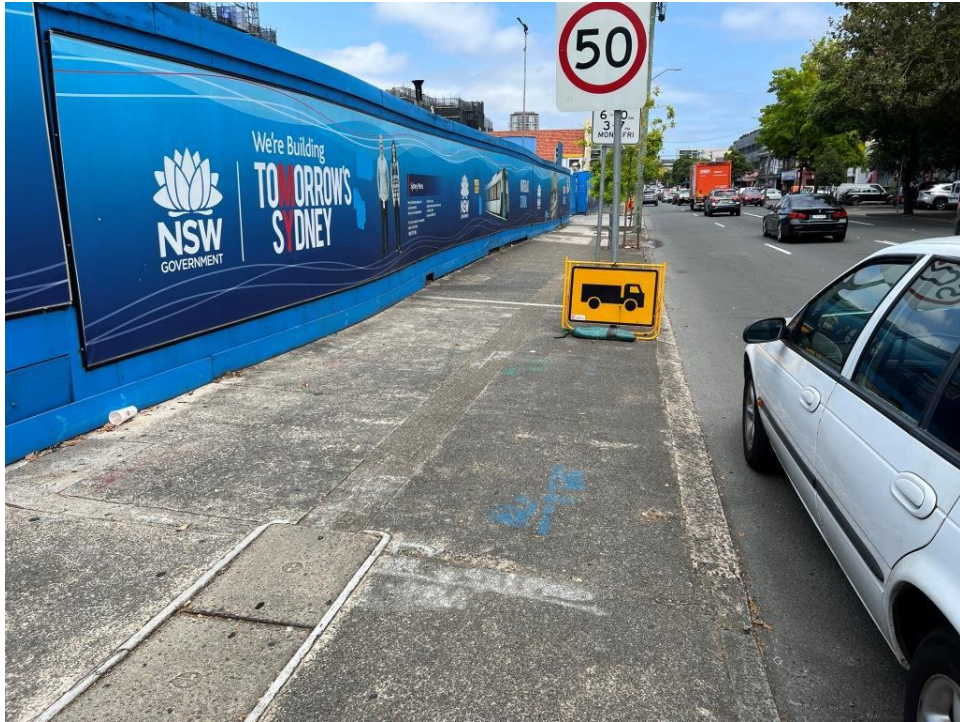
PHOTO 180

(Overview of footpath – Botany Road)

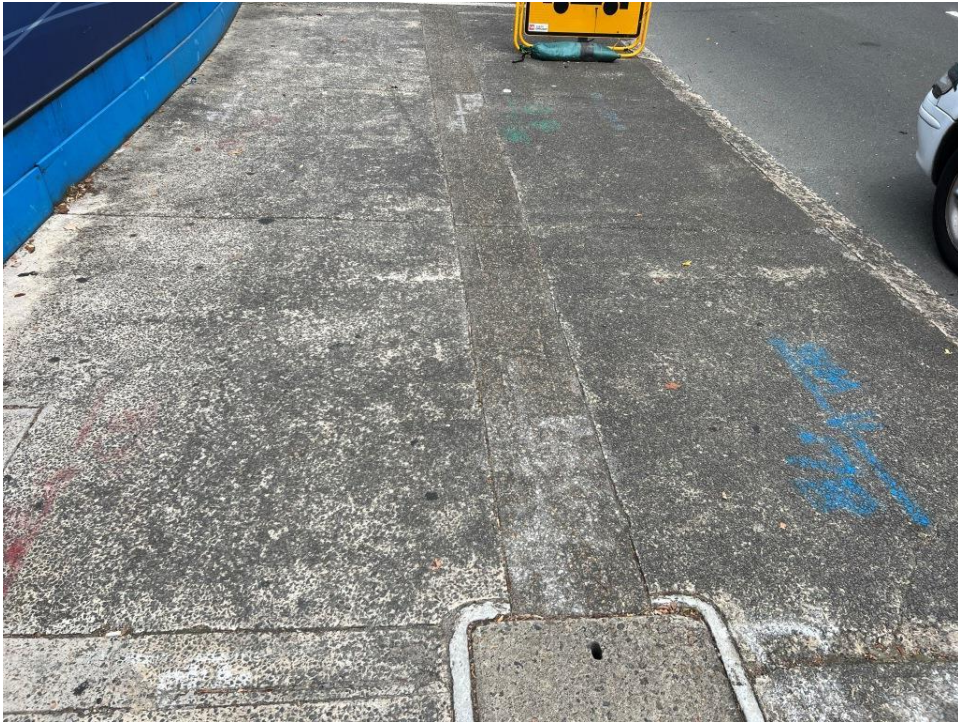
PHOTO 182
(Photo showing crack in footpath – Botany Road)

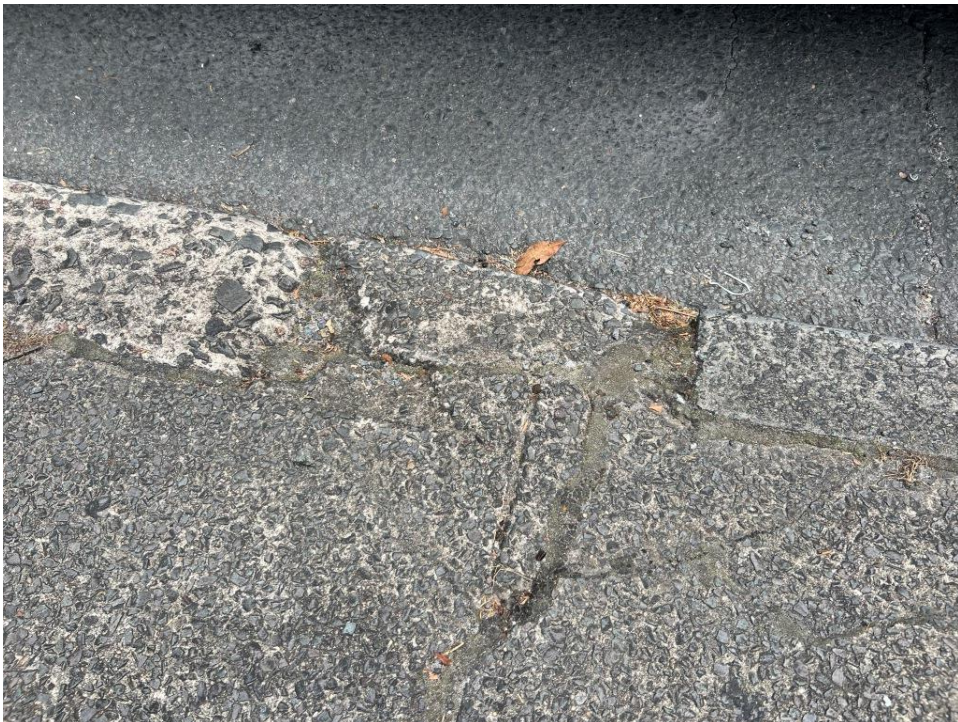
PHOTO 183
(Overview of footpath – Botany Road)

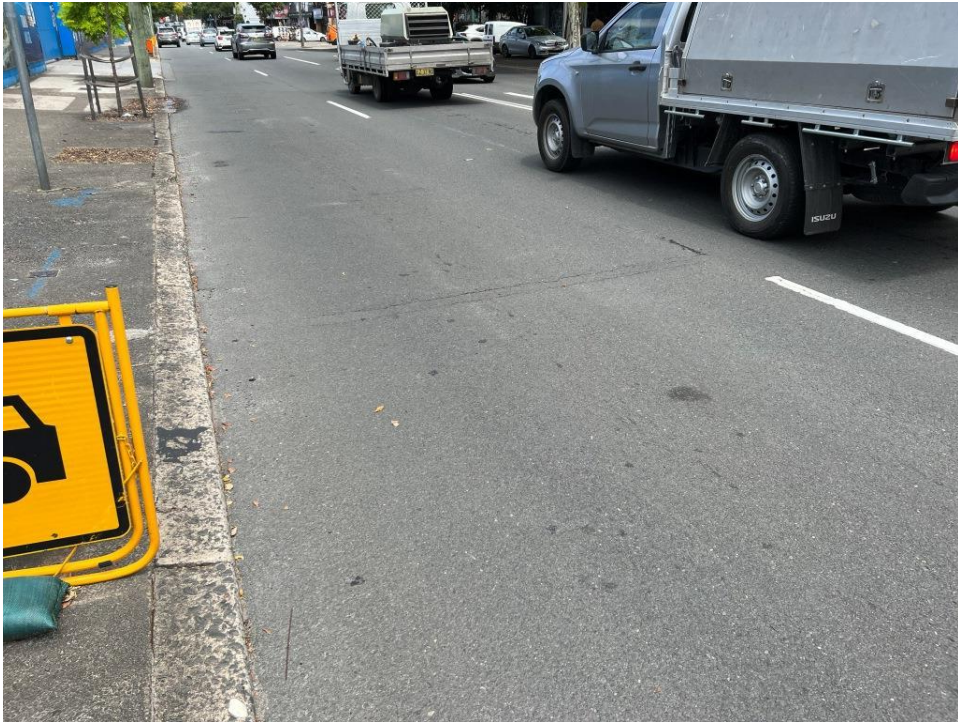
PHOTO 187
(Overview of roadway – Botany Road)

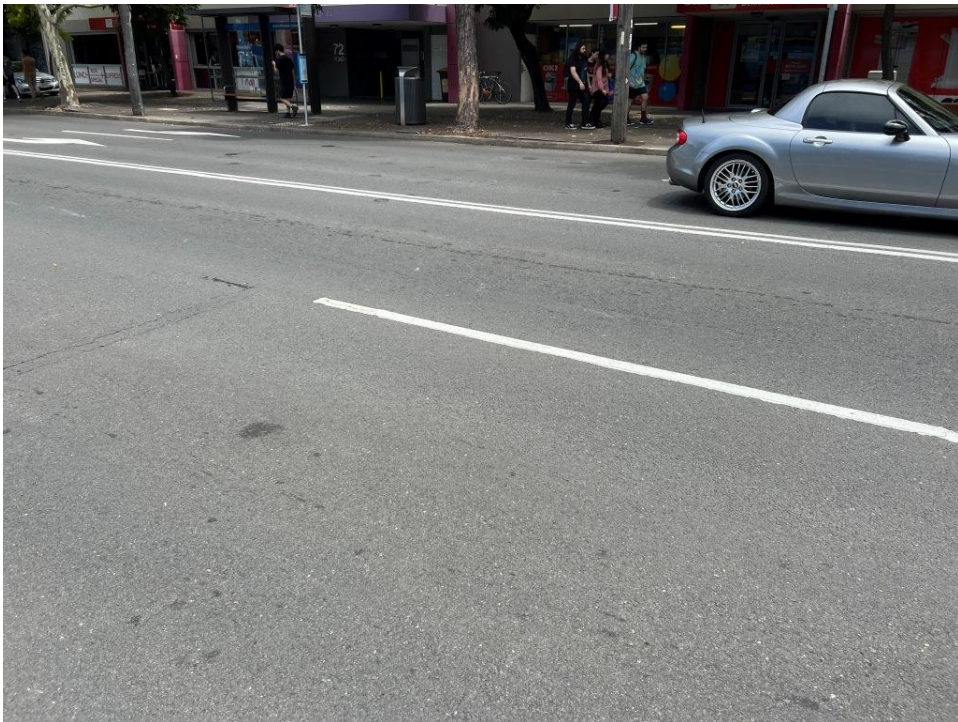
PHOTO 188
(Overview of roadway – Botany Road)

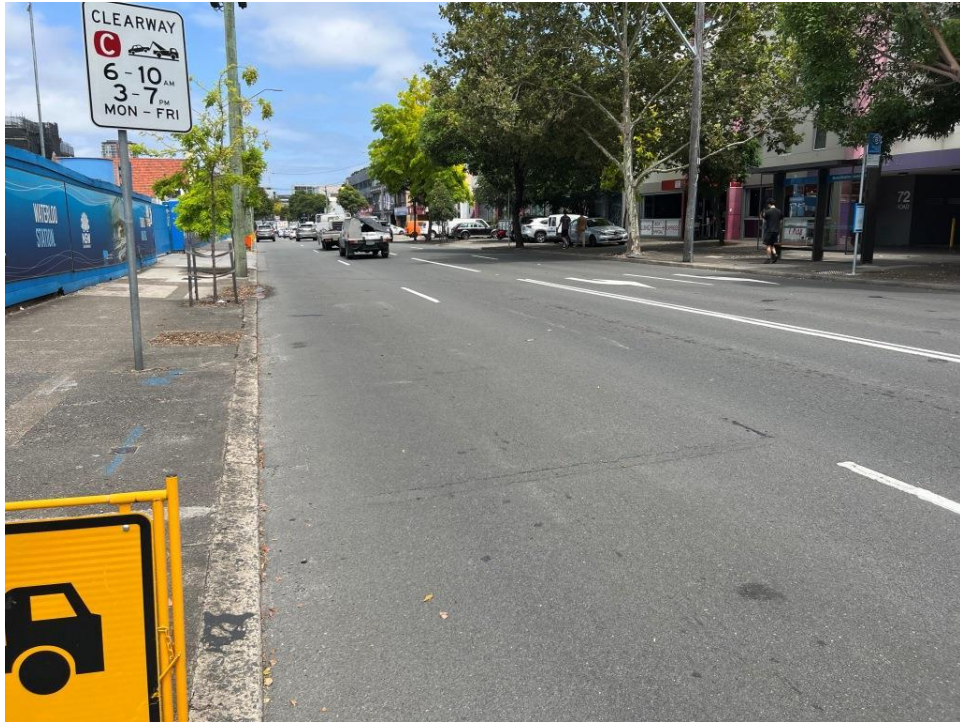
PHOTO 189
(Overview of roadway – Botany Road)

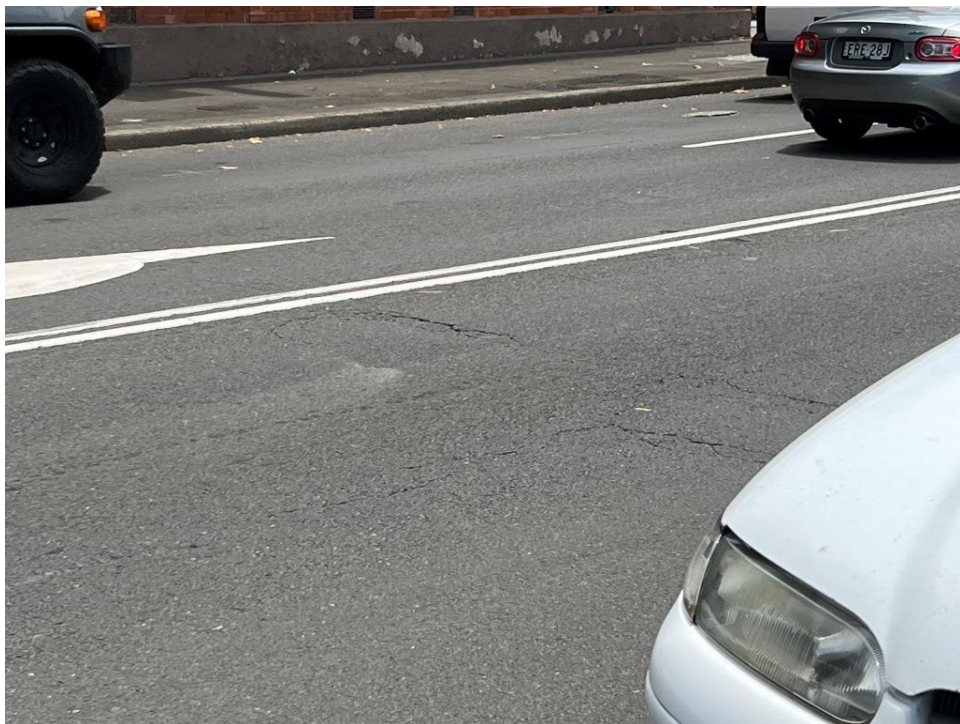
PHOTO 190
(Photo showing cracks in asphalt – Botany Road)

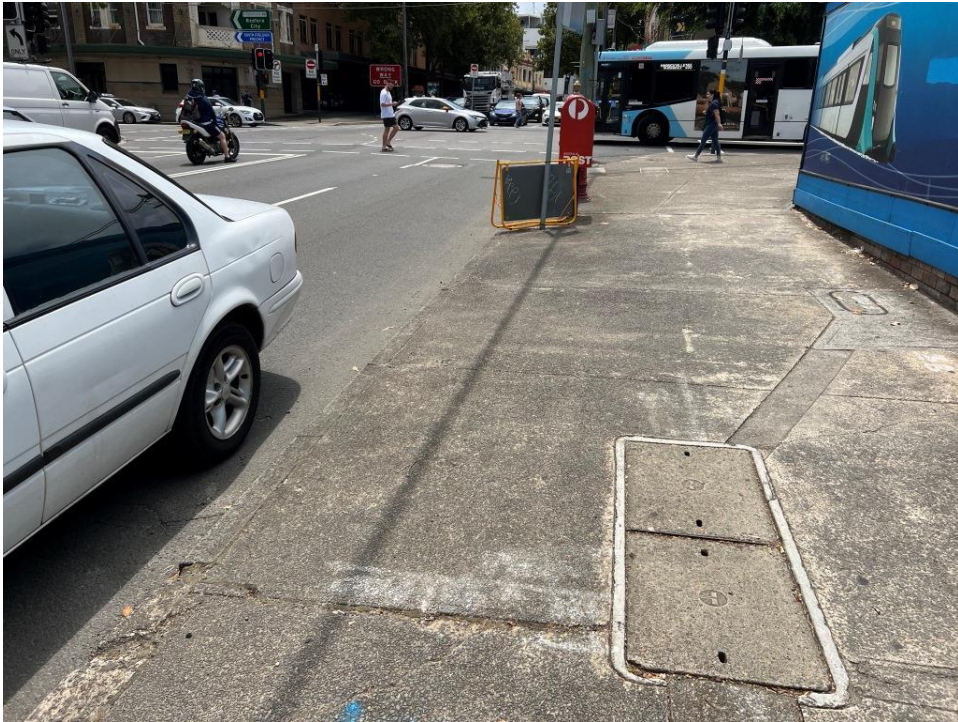
PHOTO 191
(Overview of footpath – Botany Road)

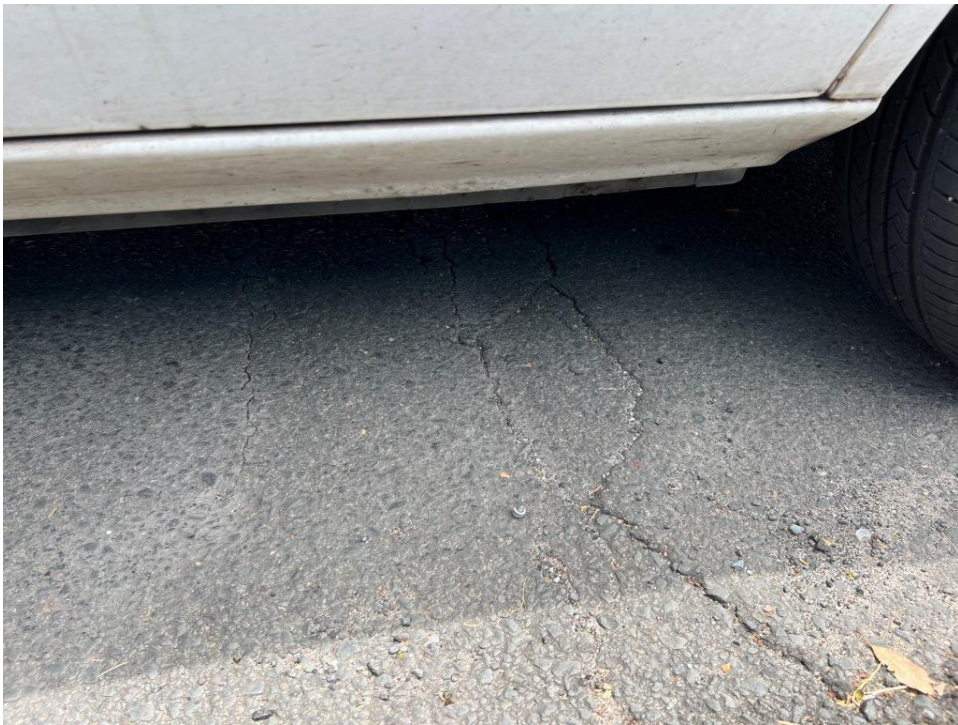
PHOTO 192
(Photo showing cracks in asphalt – Botany Road)

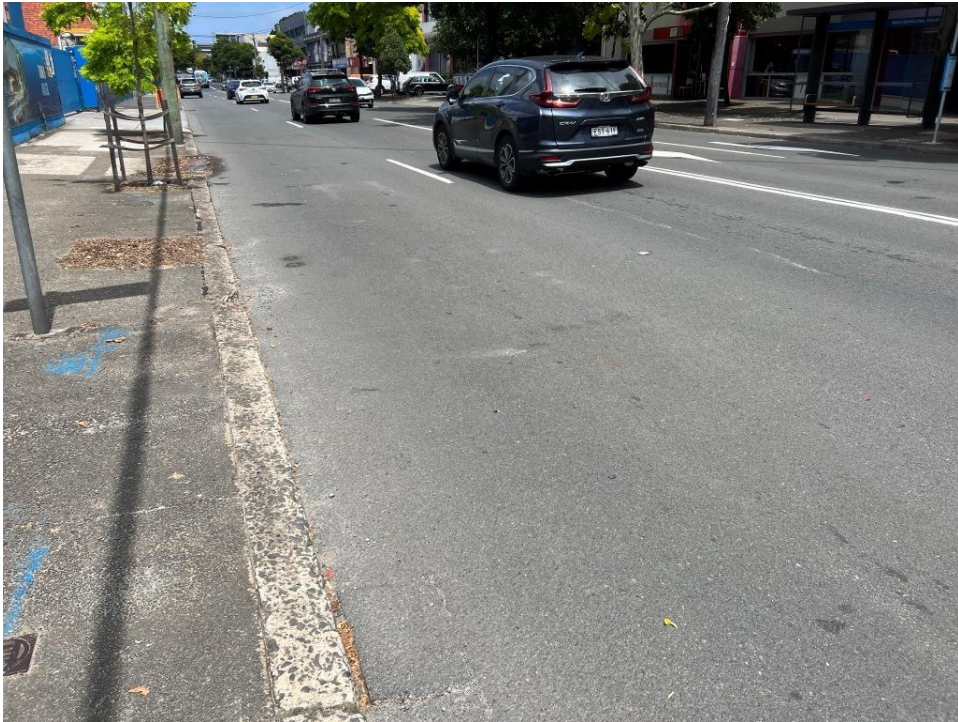
PHOTO 195
(Overview of roadway – Botany Road)
