DILAPIDATION REPORT

Council Assets/Public Infrastructure

**WATERLOO STATION
COPE STREET**

DEMLAKIAN CONSULTING ENGINEERS

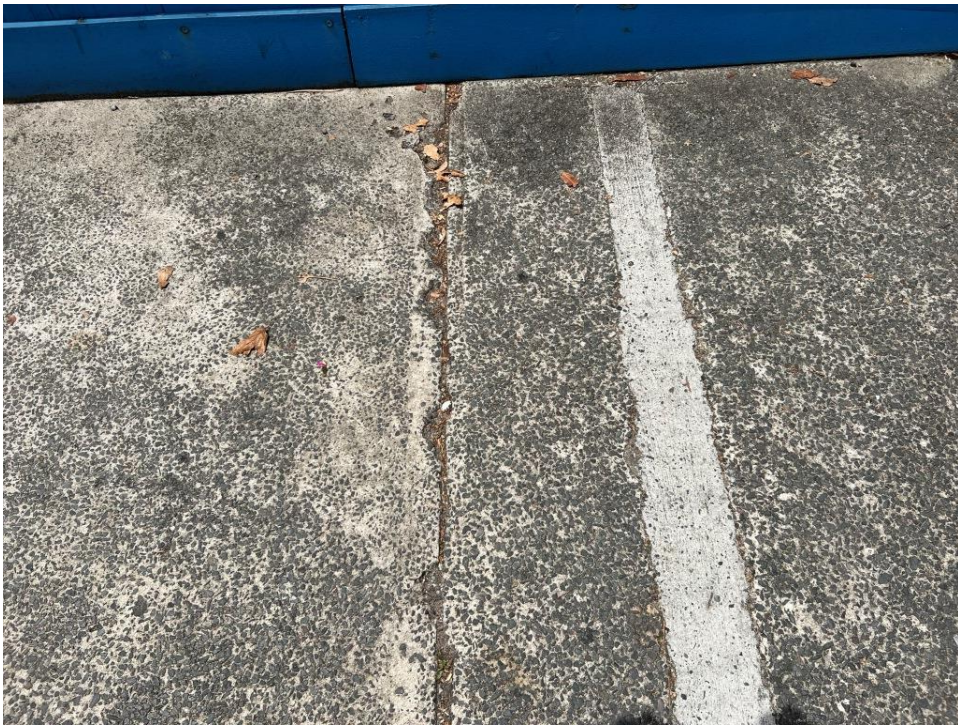
PHOTO 196
(Photo showing chipped concrete along footpath's joint – Botany Road)

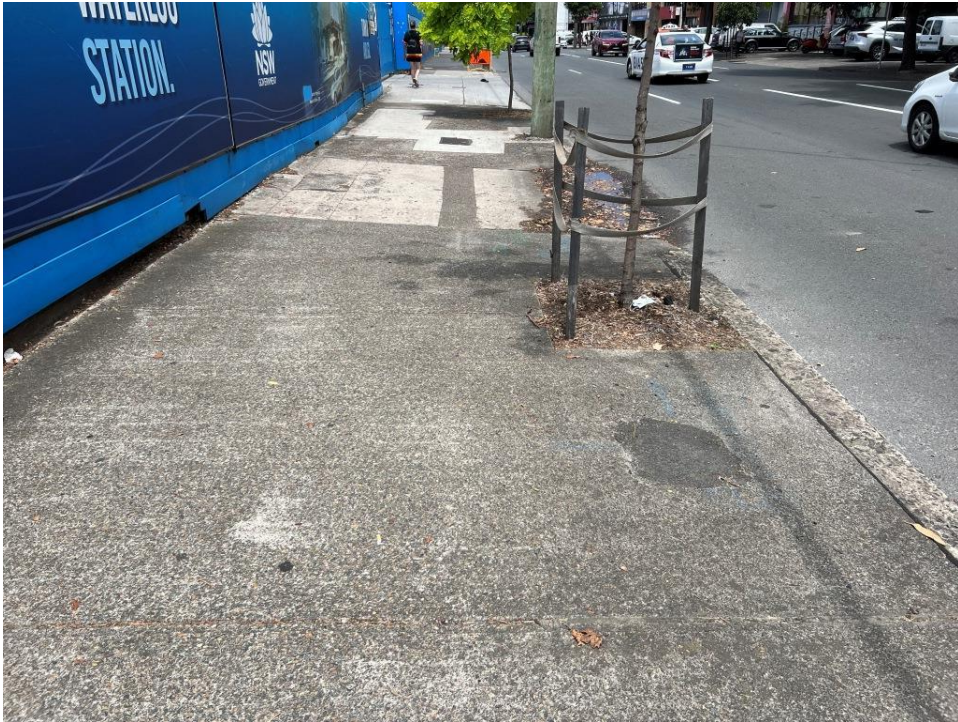
PHOTO 203
(Overview of footpath – Botany Road)

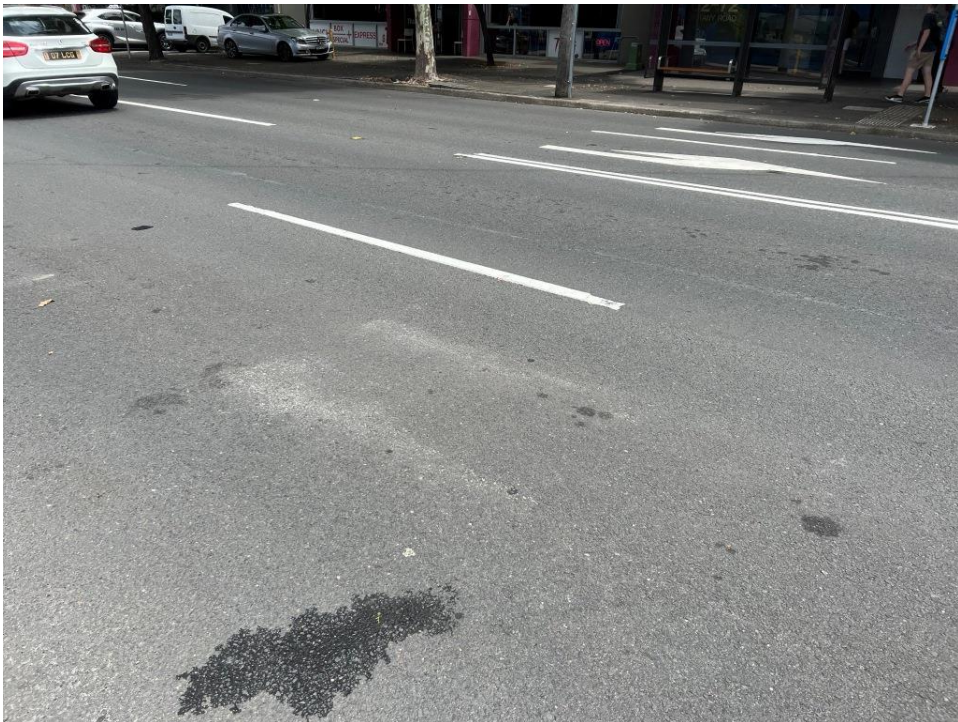
PHOTO 204
(Overview of roadway – Botany Road)

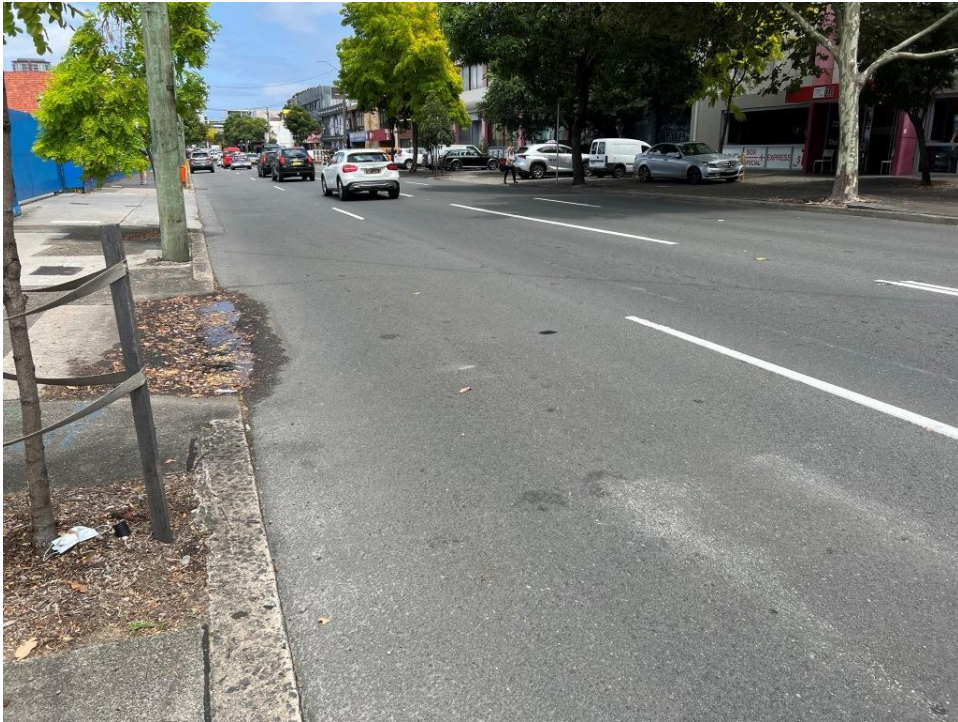
PHOTO 205
(Overview of roadway – Botany Road)

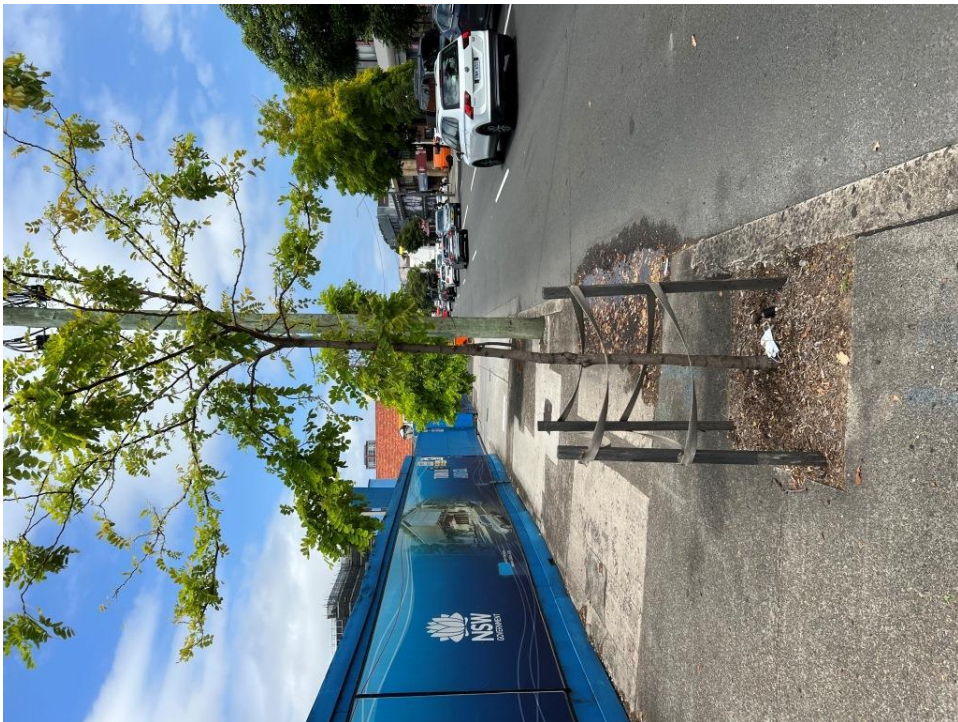
PHOTO 206
(Overview of footpath and tree – Botany Road)

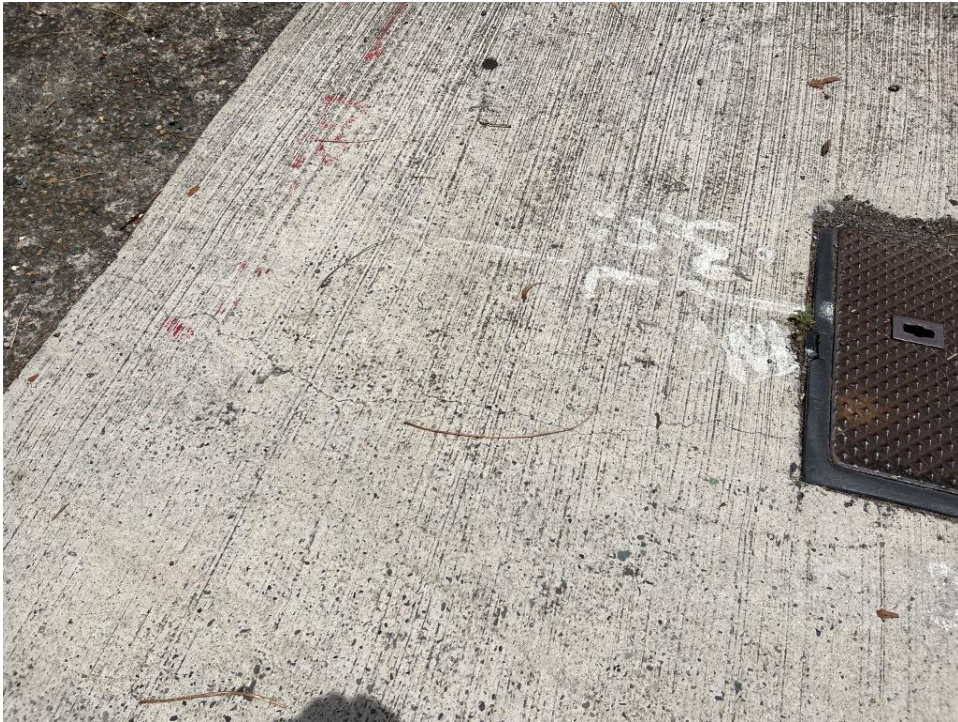
PHOTO 221
(Photo showing crack in footpath – Botany Road)

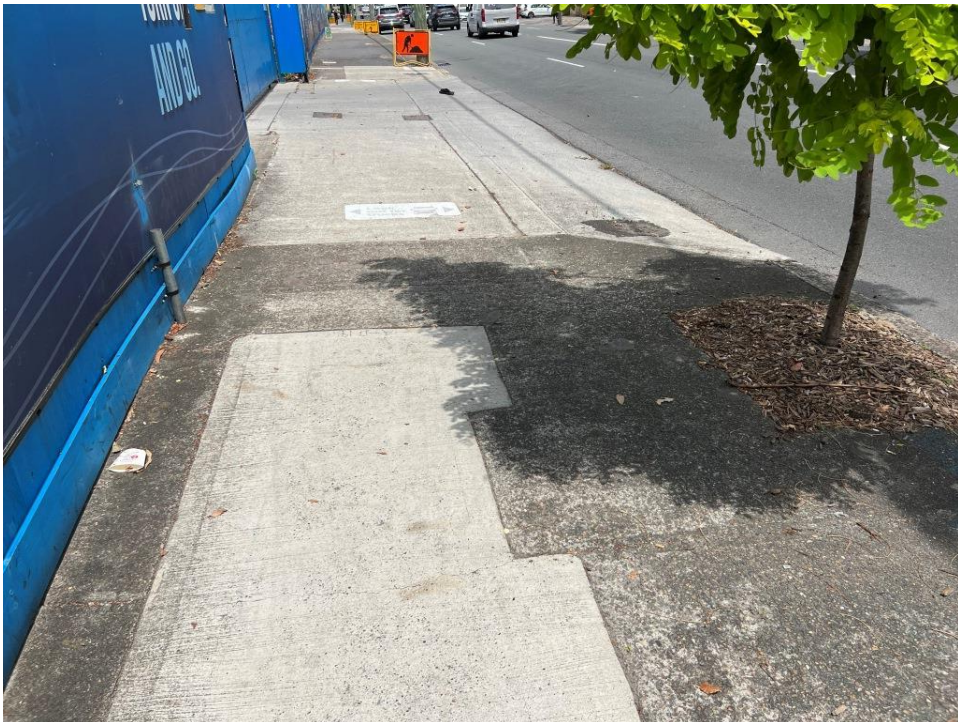
PHOTO 222
(Overview of footpath and tree – Botany Road)

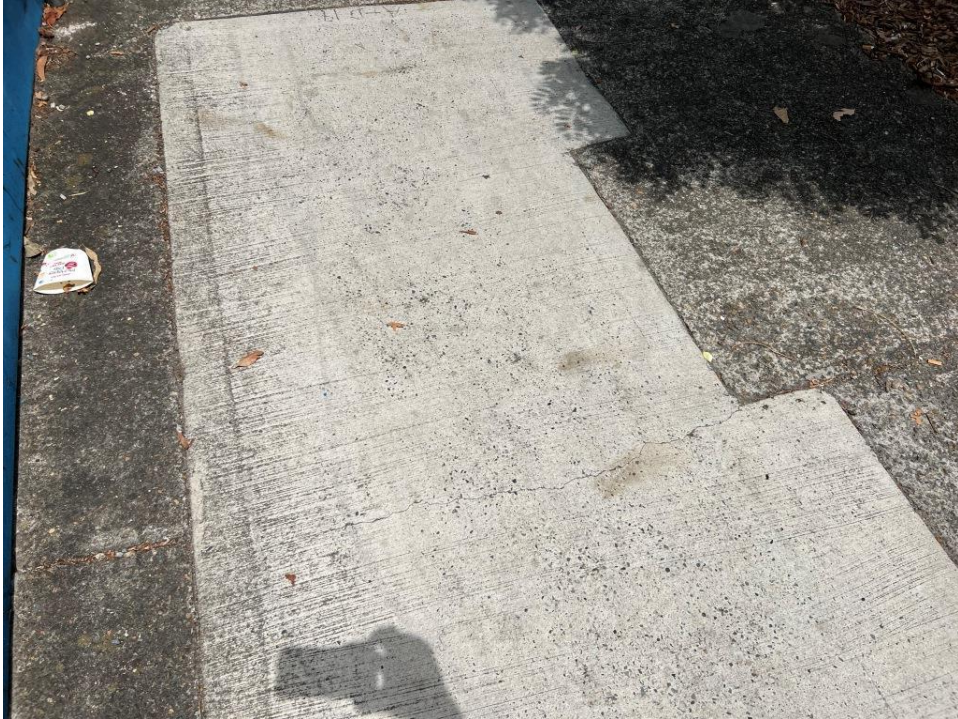
PHOTO 223
(Photo showing crack in footpath – Botany Road)

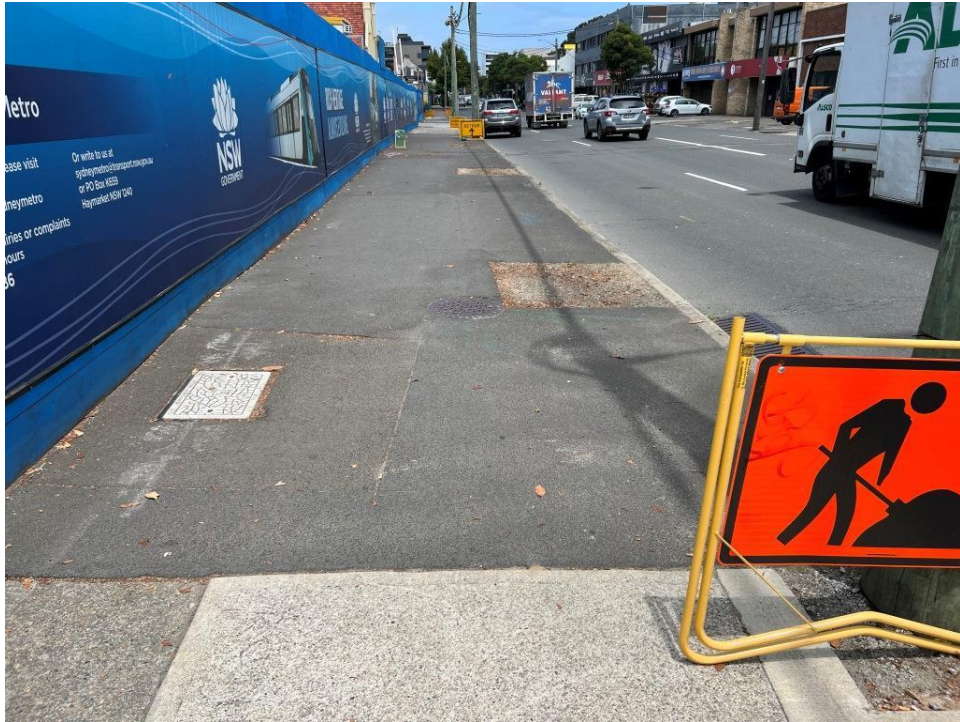
PHOTO 251
(Overview of footpath – Botany Road)

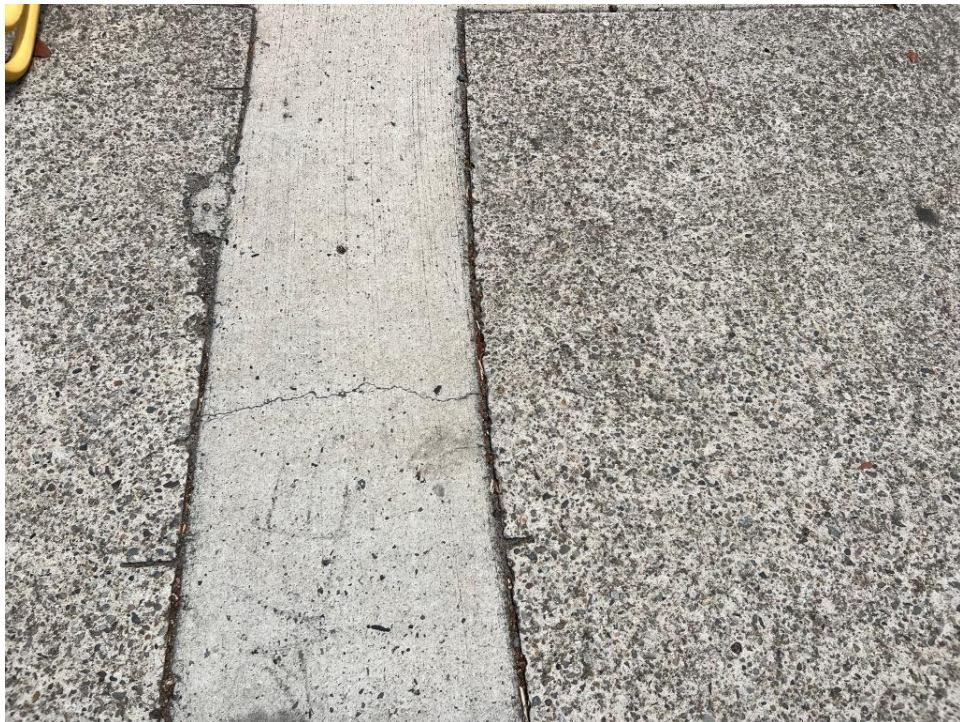
PHOTO 252
(Photo showing crack in footpath – Botany Road)

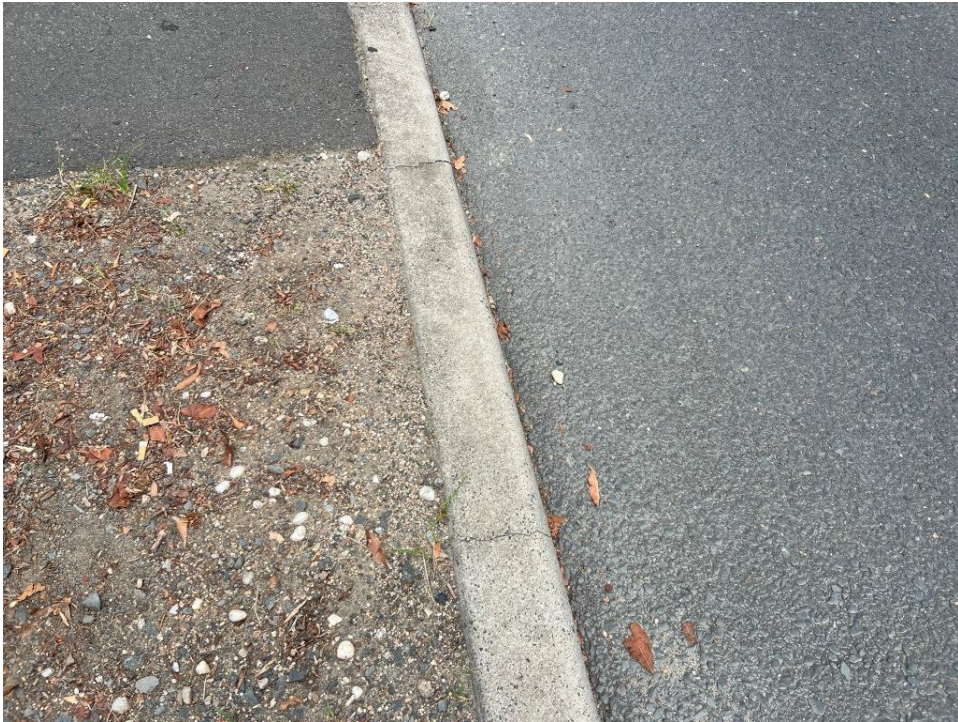
PHOTO 266

(Photo showing crack in kerb – Botany Road)

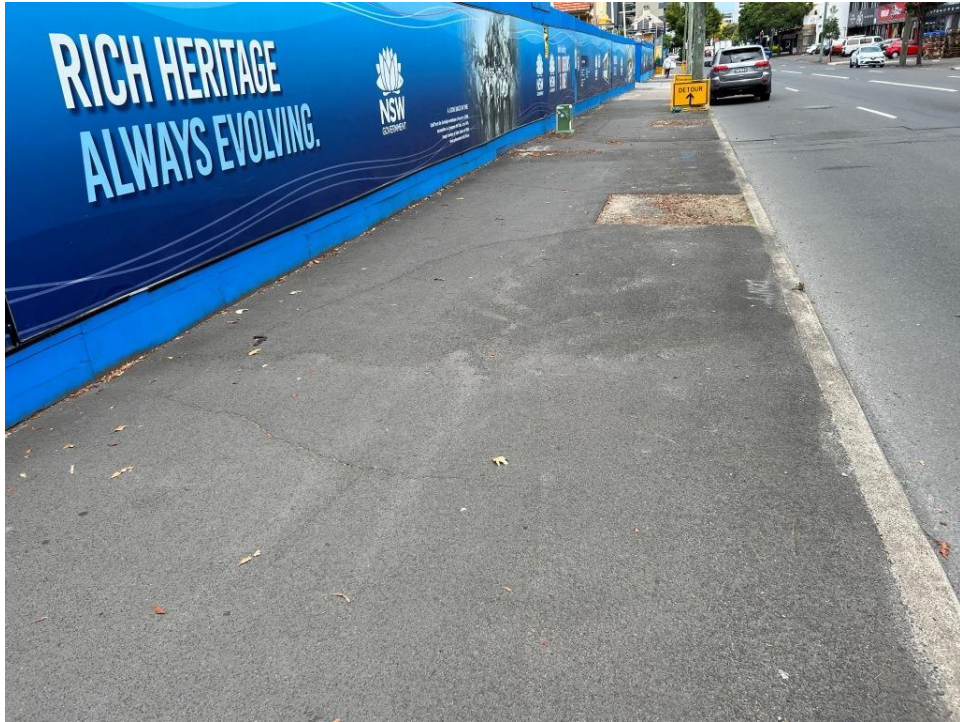
PHOTO 272
(Photo showing cracks in asphalt – Botany Road)

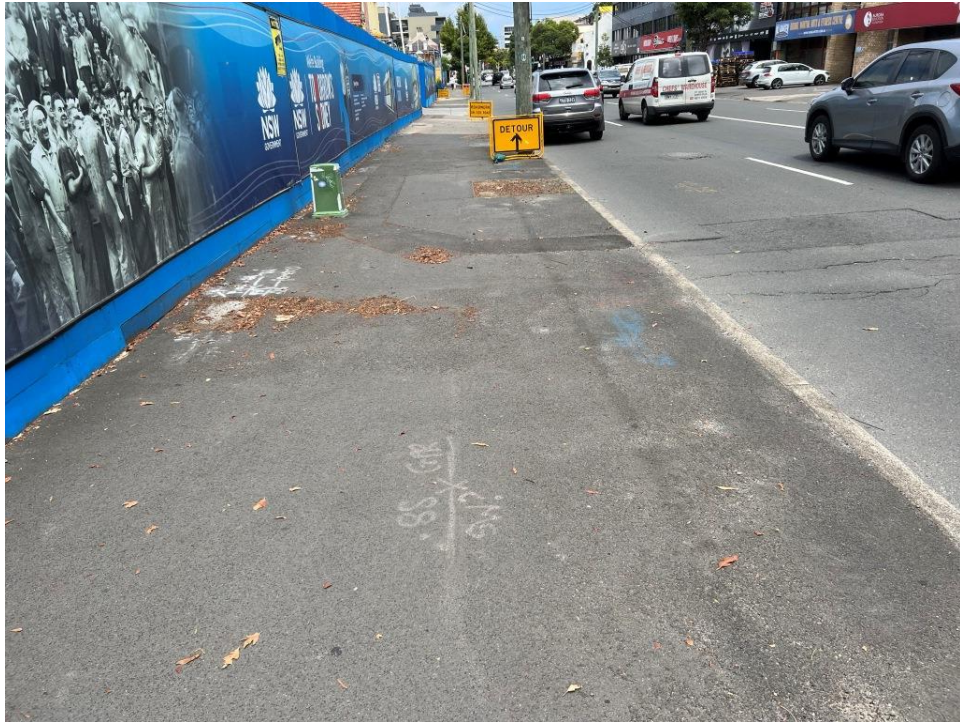
PHOTO 278

(Photo showing crack in footpath – Botany Road)

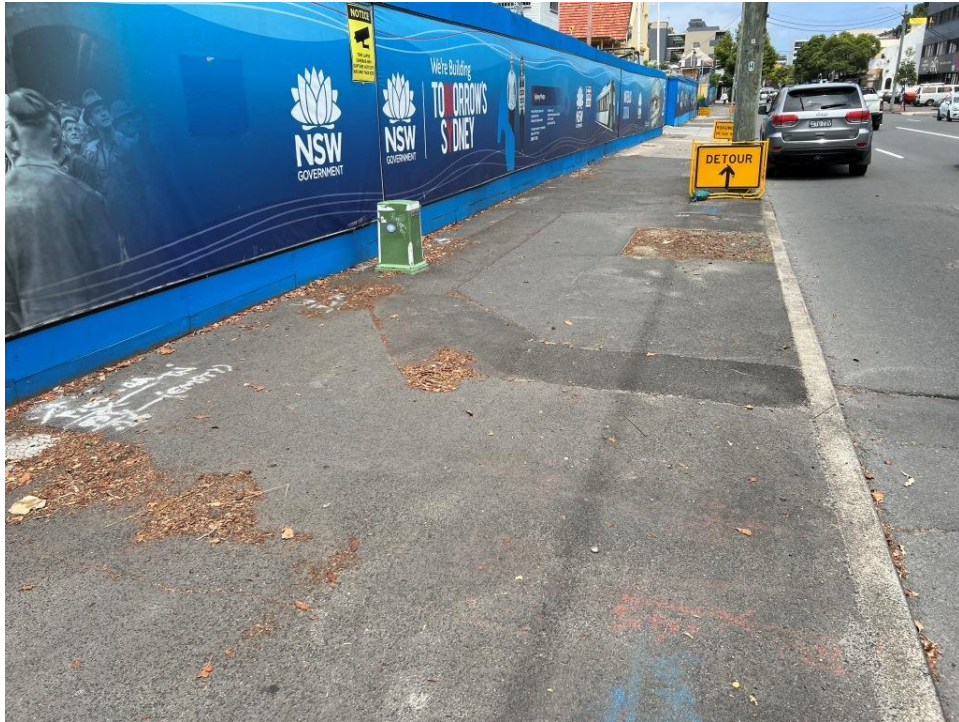
PHOTO 280
(Photo showing cracks in asphalt – Botany Road)

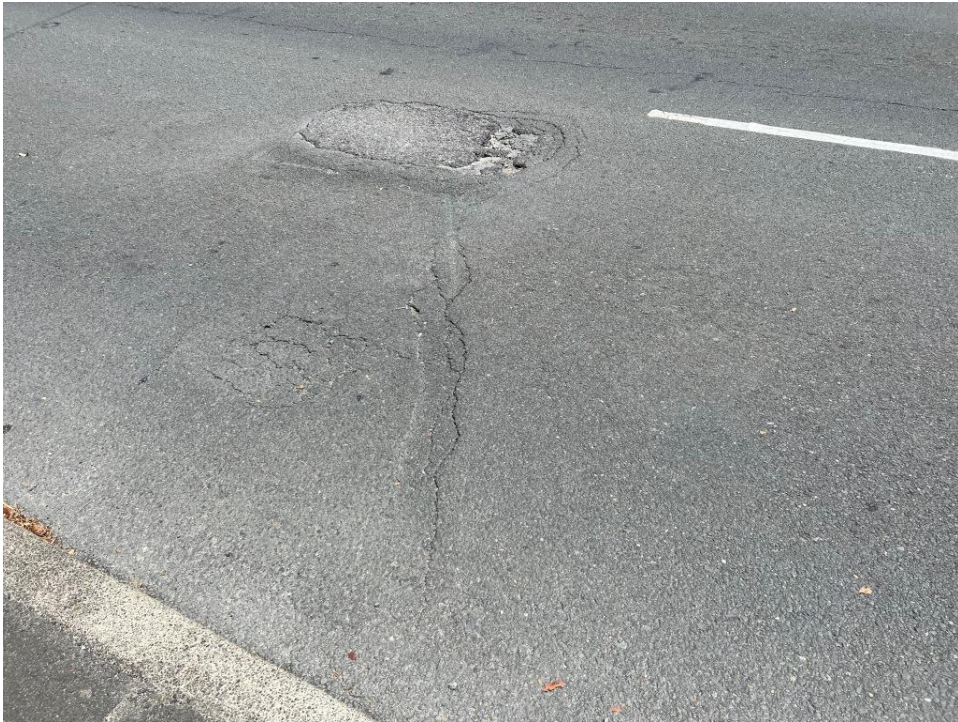
PHOTO 288

(Photo showing crack in footpath – Botany Road)

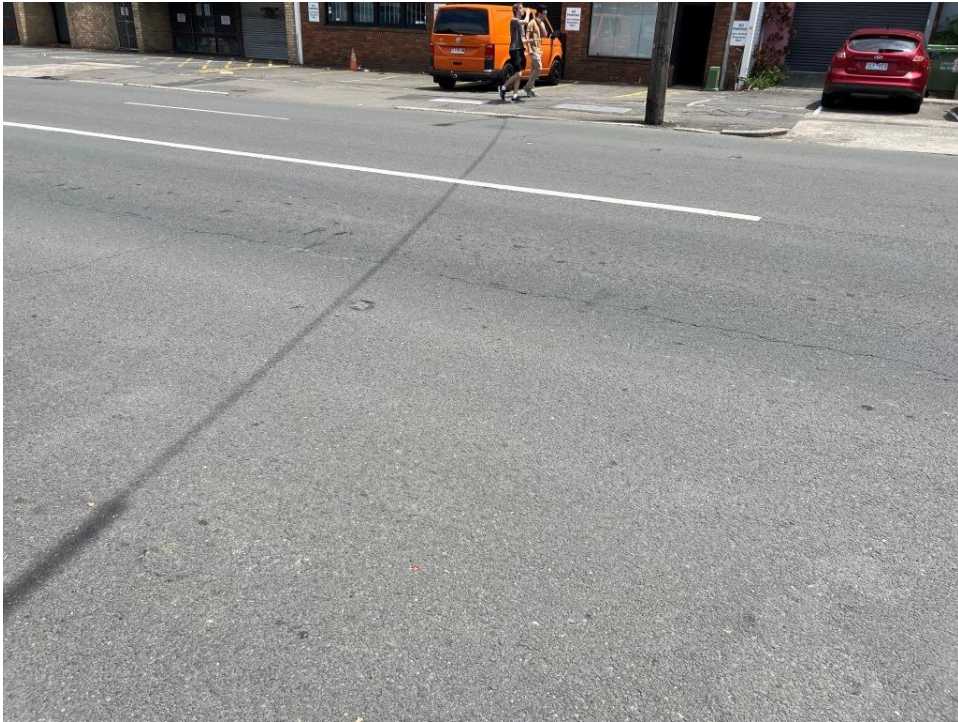
PHOTO 294

(Photo showing crack in asphalt – Botany Road)

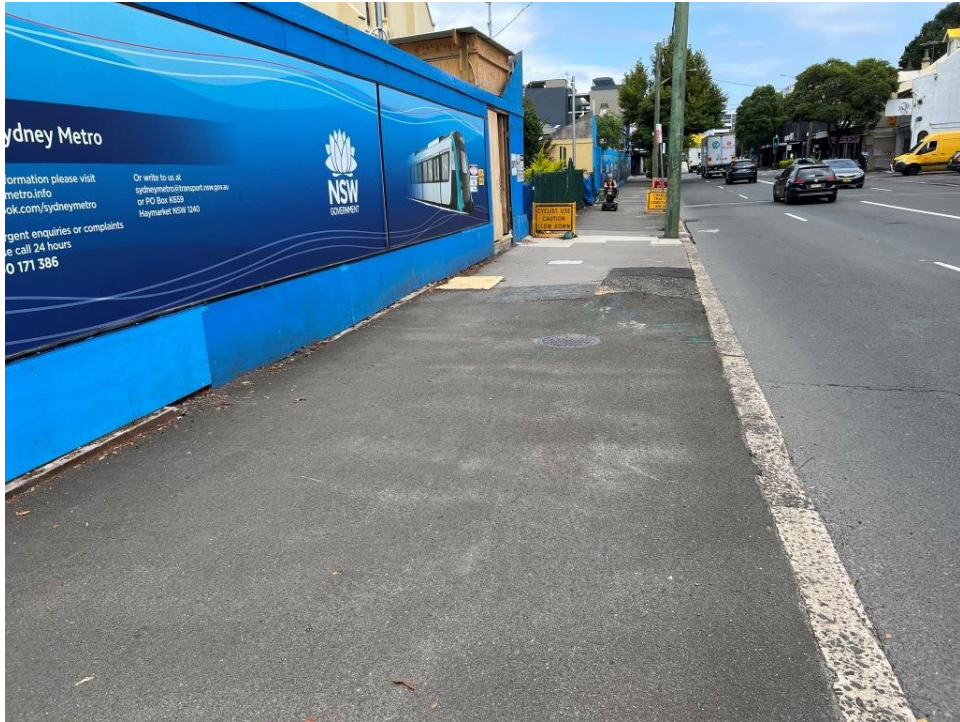
PHOTO 328

(Photo showing crack/missing concrete in kerb at former driveway corner – Botany Road)

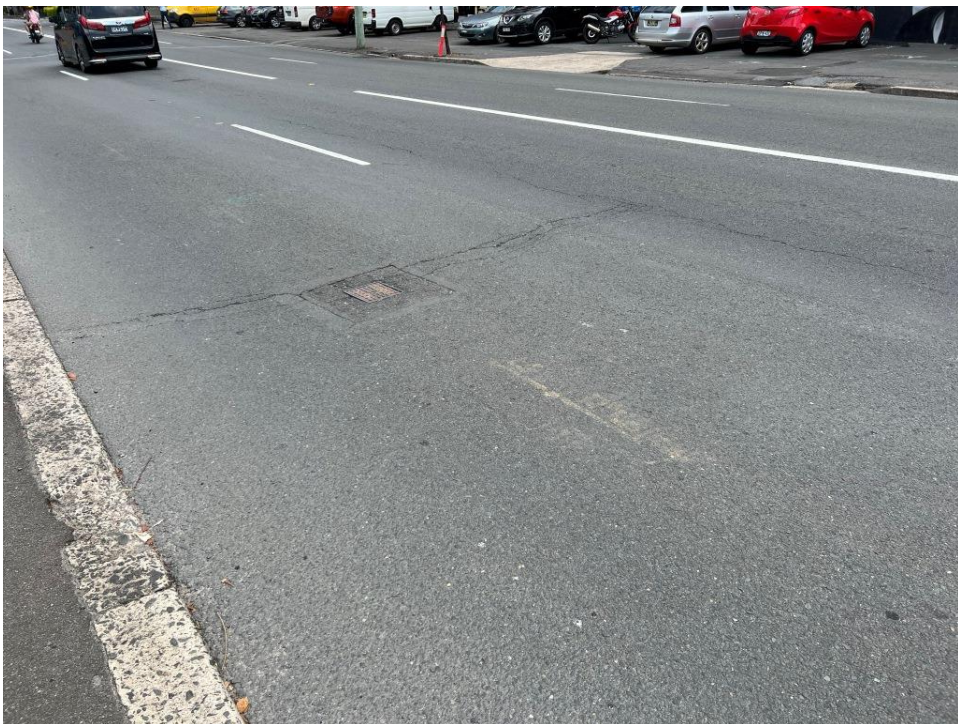
PHOTO 331
(Overview of roadway – Botany Road)

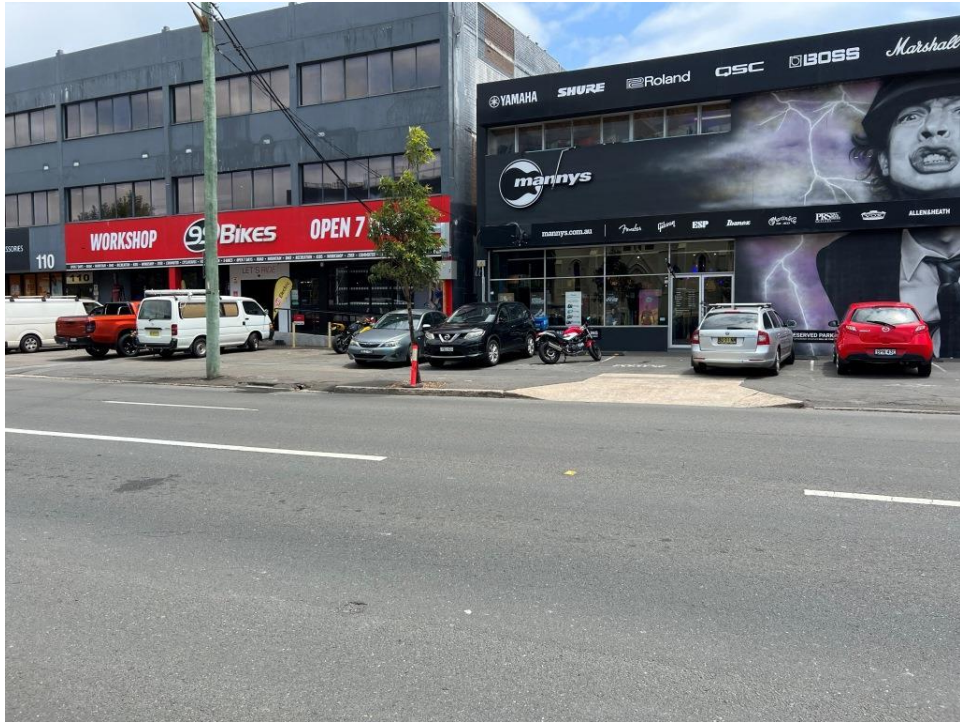
PHOTO 346

(Overview of roadway – Botany Road)

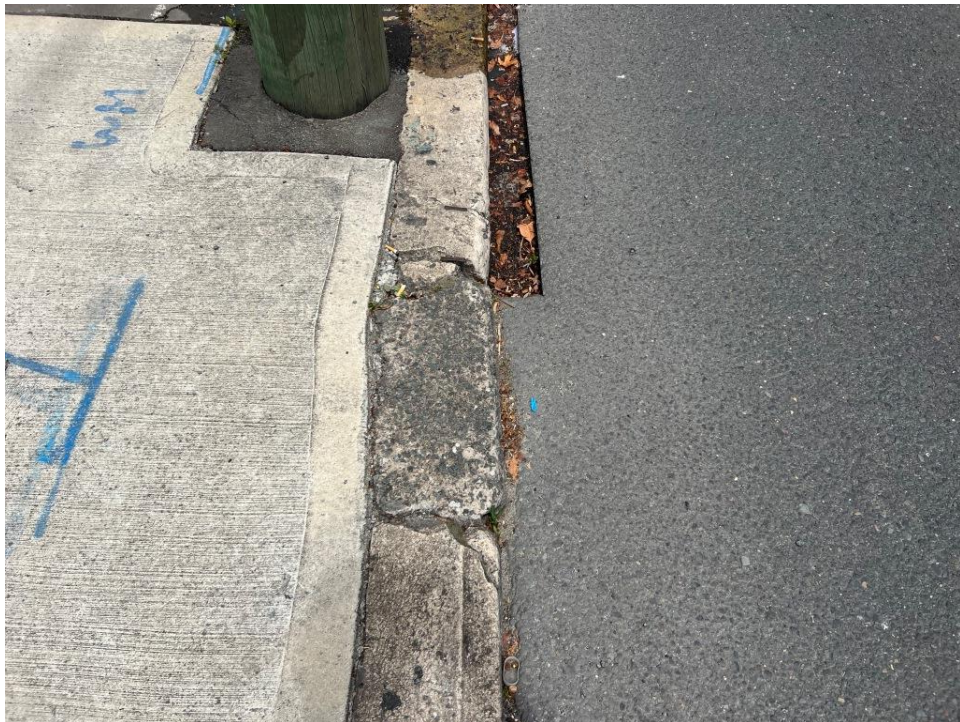
PHOTO 347
(Overview of roadway – Botany Road)
