El Australia

Dilapidation Report

E24783 Bluegum Community School

Report Title: E24783 - Dilapidation Report- DR.01 - Council Assets

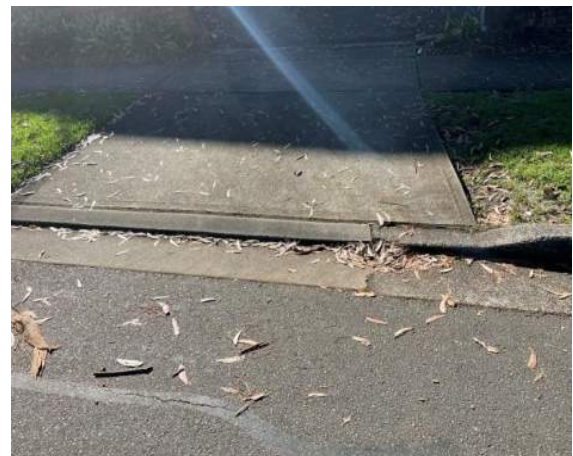
Picture 6

Photo No.	Location	Observational Comment
1	50 William St (Near Lisgar Ln)	Patch repair work conducted along William St.
4	50 William St	Surface cracking along roadway
6	50 William St	Cracks in asphalt outside driveway. Crack in kerb and gutter at entry to driveway
8, 9, 10	55 William St	Patch repair work conducted along William St.
12	55 William St	Minor cracking in asphalt adjacent to stormwater inlet.
17	57 William St	Hairline cracking
22	57 William St	Cracking along roadway
38 -40	59/61 William St	Cracking along roadway (Approx. 1m long)
41 & 42	52 William St	Cracking along roadway (Approx. 1.5m long)
43	52 William St	Cracking in asphalt
52	William St	Minor lipping in pavement slab adjacent to tree. Apparent repair work undertaken.
53, 54	William St	Minor wear and tear to road
55	William St	Repair work undertaken. Minor asphalt deterioration.
57	William St	Minor cracking in asphalt adjacent to kerb and gutter

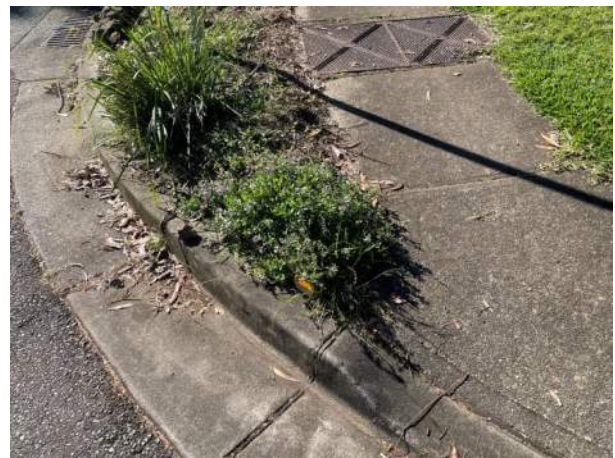
Picture 99

Photo No.	Location	Observational Comment
98	Cnr Rosemead & William St	Minor crack to stormwater inlet
99	Cnr Rosemead & William St	Repair work undertaken.
101, 102	Cnr Rosemead & William St	Visible signs of wear and tear on road.
103	3 Rosemead Rd	Loose rocks above stormwater inlet / gutter
104	3 Rosemead Rd	Hairline cracking (Approx. 1m)
111	3 Rosemead Rd	Hairline cracking in roadway
115	3 Rosemead Rd	Hairline cracking in roadway
124 - 125	4 Rosemead Rd	Moderate crack in driveway slab
128	1A Rosemead Rd	Moderate crack in driveway slab
129 –131, 137 – 140	1A Rosemead Rd	Minor damage to footpath. Lipping evident. Repair work appears to be undertaken
152	Rosemead Rd	Localised repair to road evident.
162	Cnr Rosemead Rd & Dural St	Trench repair work undertaken to road
163, 166, 174	Cnr Rosemead Rd & Dural St	Apparent repair work undertaken to road
176	42 Dural St	Minor concrete spalling on lid
180	42 Dural St	Minor along roadway

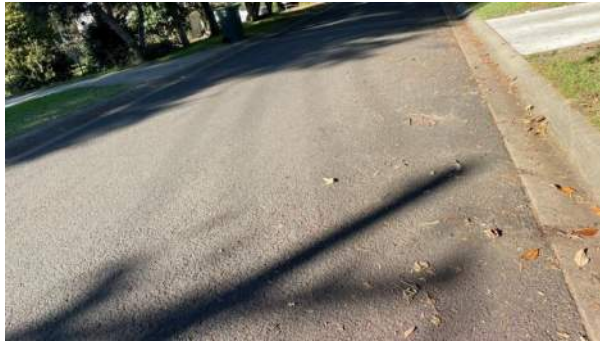
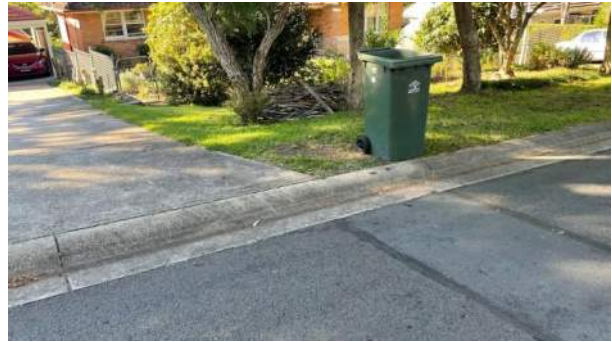
183, 184	42 Dural St	Trench repair work undertaken to road
186	40 Dural St	Minor cracking of spoon drain adjacent to pipes
187	40 Dural St	Soil is beginning to cover lid.
188	40 Dural St	Damage along gutter

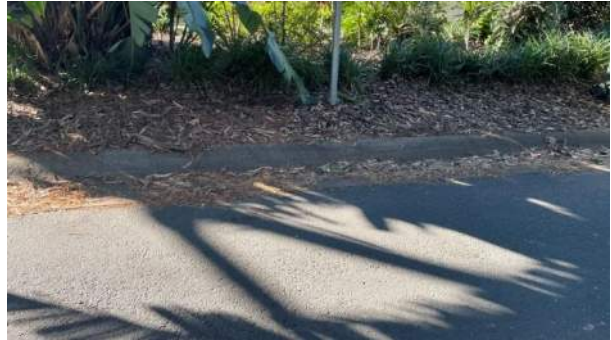
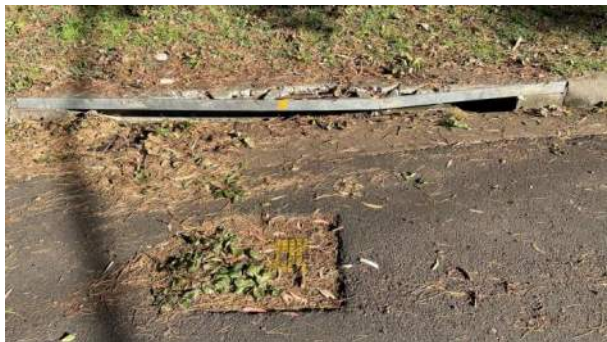
Photo No.	Location	Observational Comment
193 & 194	41 Dural St	Damage to stormwater drain along roadway
202, 205	39 Dural St	Damage in concrete pathway. Lipping of slabs around pit lid
202, 205, 206, 207, 208, 209 & 210	39 Dural St	Damage in brick retaining wall
212 & 213	36 Dural St	Cracking along gutter/driveway
214 & 216, 221	38 Dural St	Cracking along roadway adjacent to repair works
