SCHEDULE OF CONSERVATION AND RESTORATION WORKS

Former Treasury Buildings

MULHPA HOTEL (SYDNEY) PTY LIMITED

25 August 2020

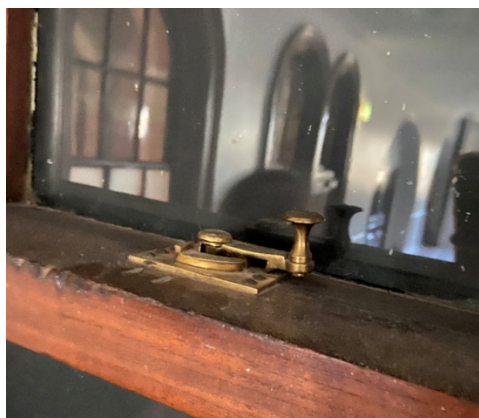
Figure 6 Existing sash fastener to S.17

- Appropriate style of replacement sash fastener for double hung windows pictured below.

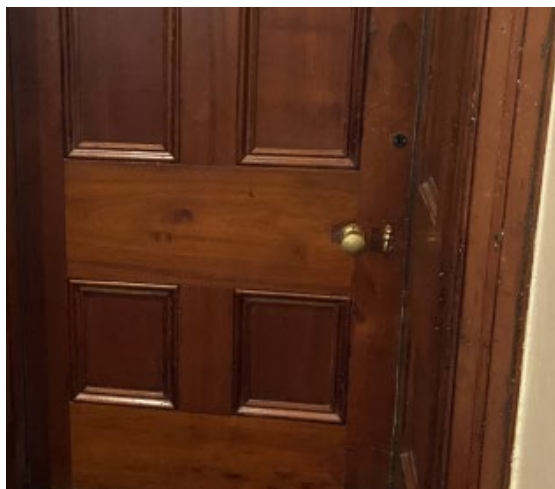
Figure 7 – Door knob to S2.13.

- Any original elements which are presently missing are to be replaced to match original or as close as possible (HC to confirm on site).
- Missing door knobs to Former Treasury Building are to be replaced with appropriate style similar to the below.
