## DILAPIDATION REPORT

MUSEUM DISCOVERY CENTRE

MONDAY, 9 AUGUST 2021

Document Information	
Job Number	210722
Document Number	3
Report Title	Dilapidation Report
Site Address	172 Showground Road and 2 Green Road Castle Hill, NSW, 2154
Lot	1 in DP1066281 & 102 in DP1130271

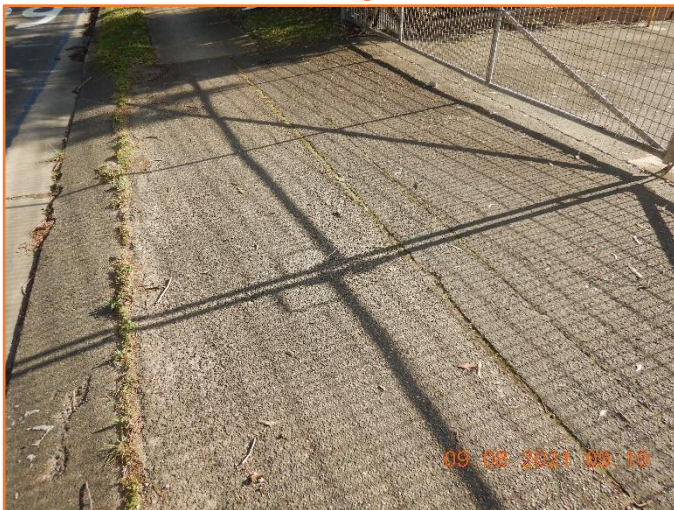
Figure 121: Reasonable - General condition of driveway crossover.  
 Moderate cracking observed.

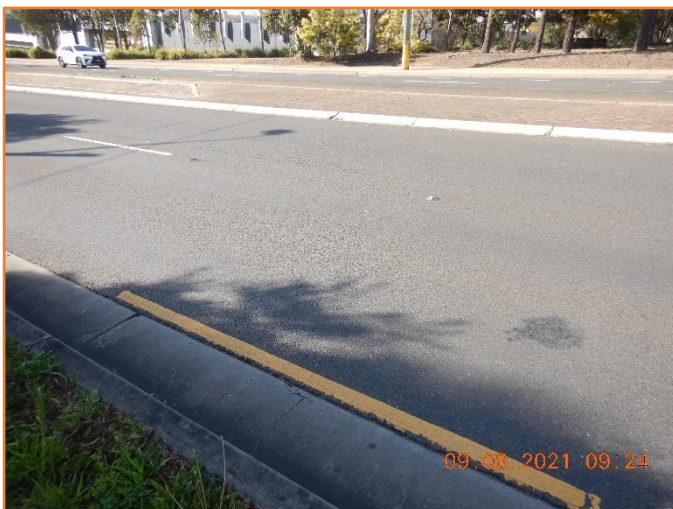
Figure 221: Good - General condition of flexible pavement.

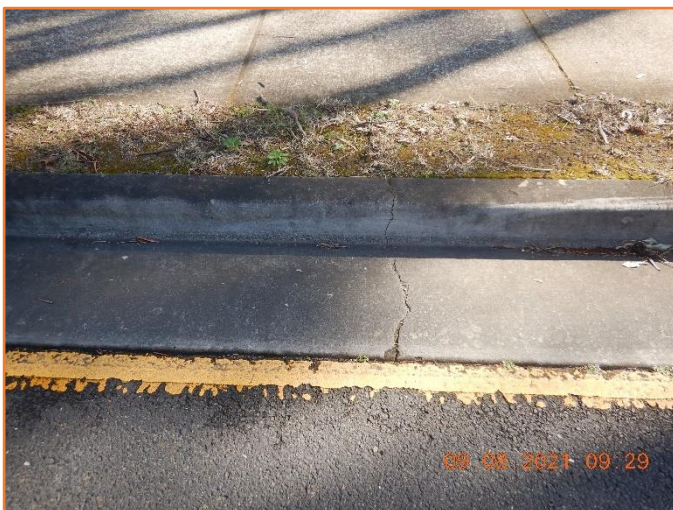
Figure 262: Reasonable - General condition of kerb and gutter.

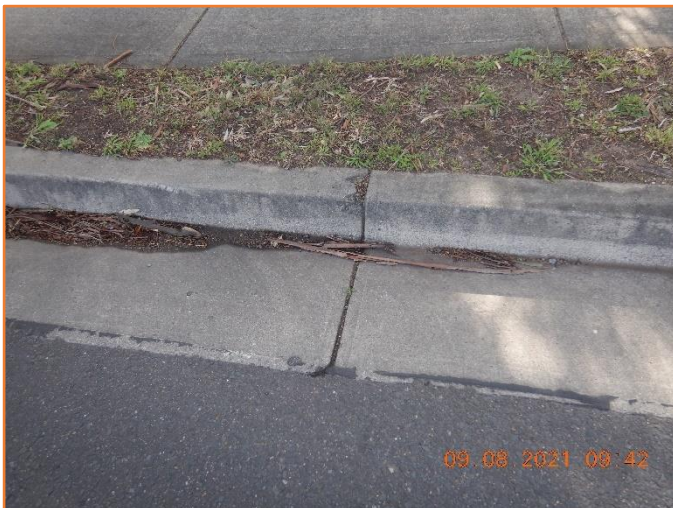
Figure 322: Reasonable - General condition of kerb and gutter.
