Tree Impact Assessment Report and Tree Management Plan

**HammondCare
Greenwich Hospital
River Road,
Greenwich NSW**

Prepared by Mark Bury Consulting

27th September 2021

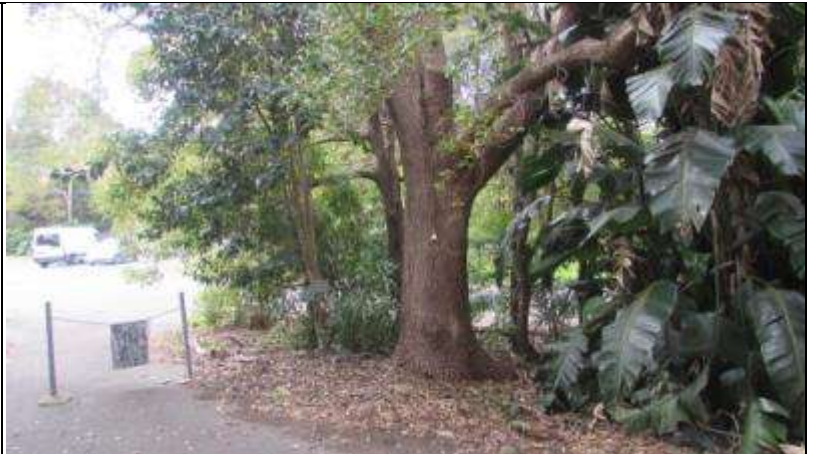
Tree 1
Cinnamomum camphora
Camphorlaurel

- 5.1 **Tree 1** (*Cinnamomum camphora* Camphorlaurel) is a tree in fair condition Appendix 1 gives a description of the tree as per AS-4970-2009 Section 2. Appendix 2 shows a photograph of the tree; Appendix 4 indicates the location of the tree on a survey plan of the site.

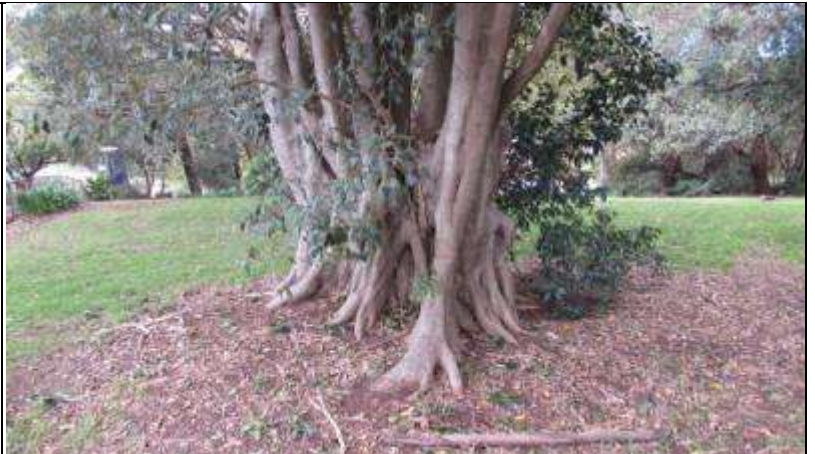
Tree 4
Ficus rubiginosa
Port Jackson Fig

- 5.8 **Tree 3** Tree missing from site, Tree removed since original Tree Survey
- 5.9 **Tree 4** (*Ficus rubiginosa* Port Jackson Fig) is a tree in fair condition Appendix 1 gives a description of the tree as per AS-4970-2009 Section 2. Appendix 2 shows a photograph of the tree; Appendix 4 indicates the location of the tree on a survey plan of the site.

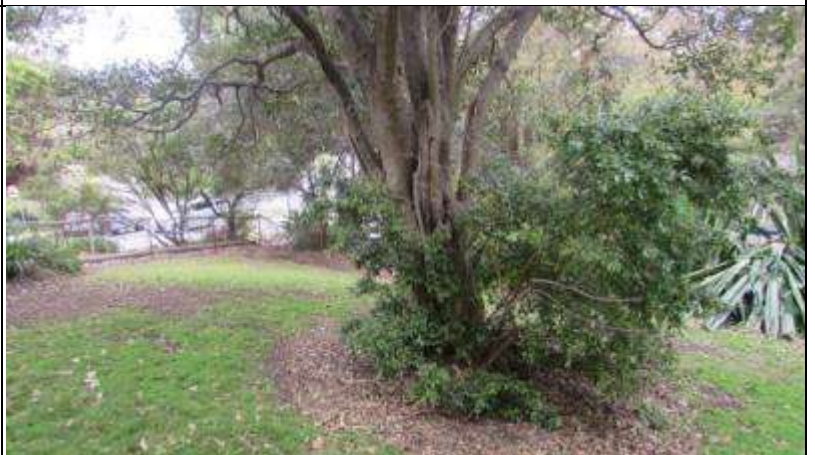
Tree 5
Ficus rubiginosa
Port Jackson Fig

- 5.13 **Tree 5** (*Ficus rubiginosa* Port Jackson Fig) is a tree in fair condition Appendix 1 gives a description of the tree as per AS-4970-2009 Section 2. Appendix 2 shows a photograph of the tree; Appendix 4 indicates the location of the tree

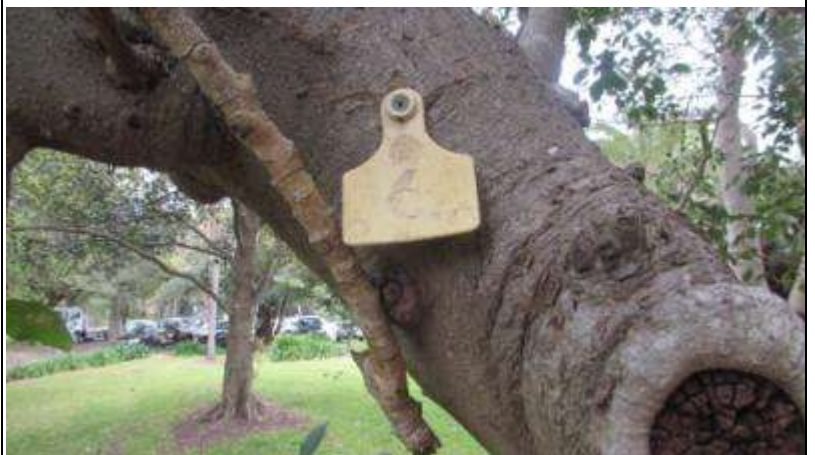
Tree 6
Ficus rubiginosa
Port Jackson Fig

- 5.17 **Tree 6** (*Ficus rubiginosa* Port Jackson Fig) is a tree in fair condition Appendix 1 gives a description of the tree as per AS-4970-2009 Section 2. Appendix 2 shows a photograph of the tree; Appendix 4 indicates the location of the tree on a survey plan of the site.

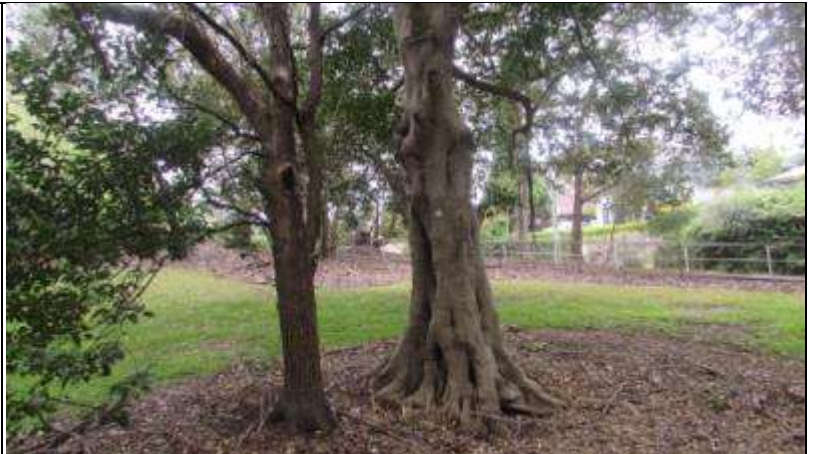
Tree 7
Ficus rubiginosa
Port Jackson Fig

- 5.21 **Tree 7** (*Ficus rubiginosa* Port Jackson Fig) is a tree in fair condition Appendix 1 gives a description of the tree as per AS-4970-2009 Section 2. Appendix 2 shows a photograph of the tree; Appendix 4 indicates the location of the tree on a survey plan of the site.

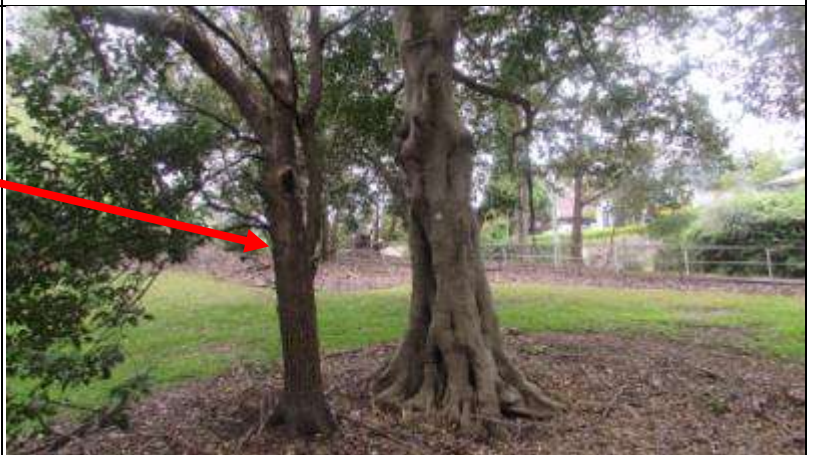
Tree 8
Cinnamomum camphora
Camphorlaurel

- 5.25 **Tree 8** (*Cinnamomum camphora* Camphorlaurel) is a tree that is in fair condition Appendix 1 gives a description of the tree as per AS-4970-2009 Section 2. Appendix 2 shows a photograph of the tree; Appendix 4 indicates the location of the tree on a survey plan of the site.

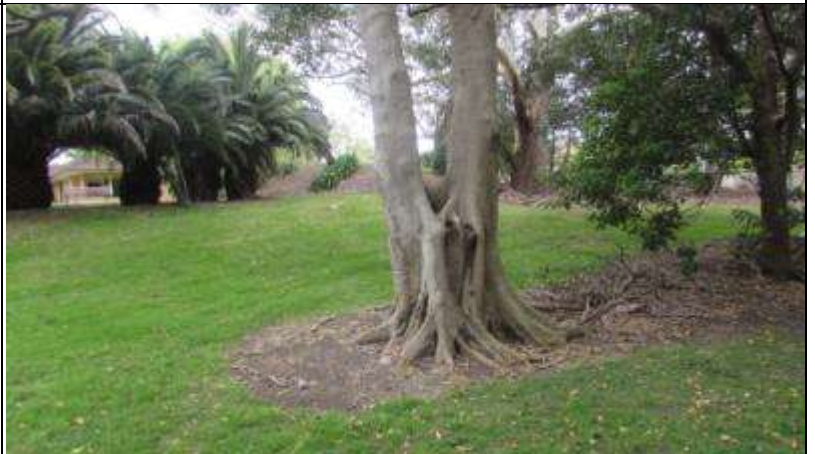
Tree 9
Ficus rubiginosa
Port Jackson Fig

- 5.28 **Tree 9** (*Ficus rubiginosa* Port Jackson Fig) is a tree in fair condition Appendix 1 gives a description of the tree as per AS-4970-2009 Section 2. Appendix 2 shows a photograph of the tree; Appendix 4 indicates the location of the tree on a survey plan of the site.
