**2 MANDALA PARADE, CASTLE HILL
(DORAN DRIVE PRECINCT)
PRE-DILAPIDATION REPORT
Of Sydney Metro and Hills Shire Council Assets
DEICORP PROJECTS SHOWGROUND
PTY LTD.**

Job No. 200124.3
07/07/2021

ACE Structural Services Pty Ltd

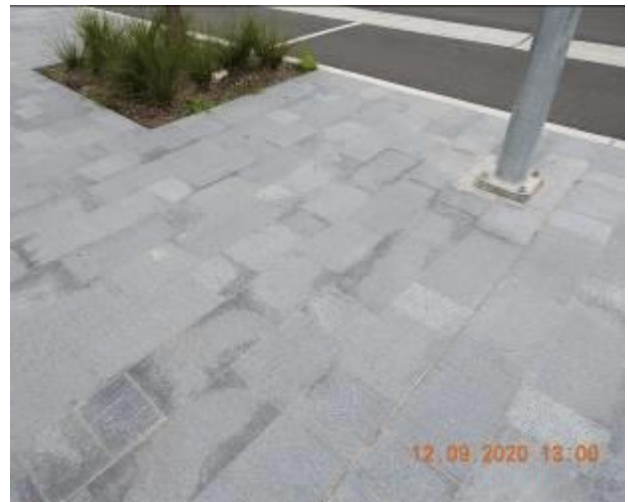
Figure 279 – Hairline cracking and efflorescence through footpath pavement

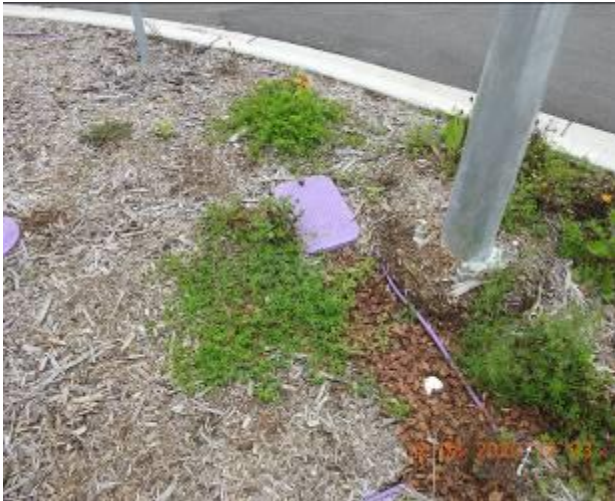
Figure 520 – General condition of service pit

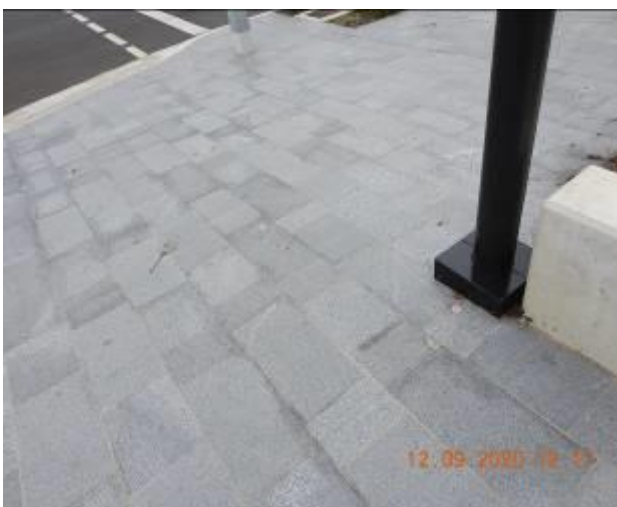
Figure 927 – Hairline crack propagation through footpath pavement

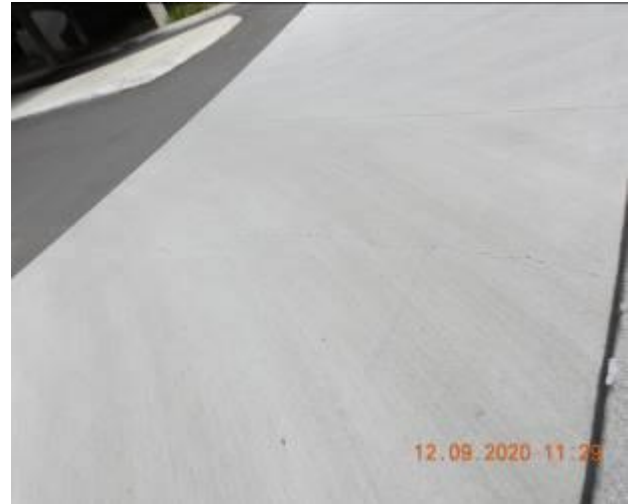
Figure 1131 – General condition of driveway pavement

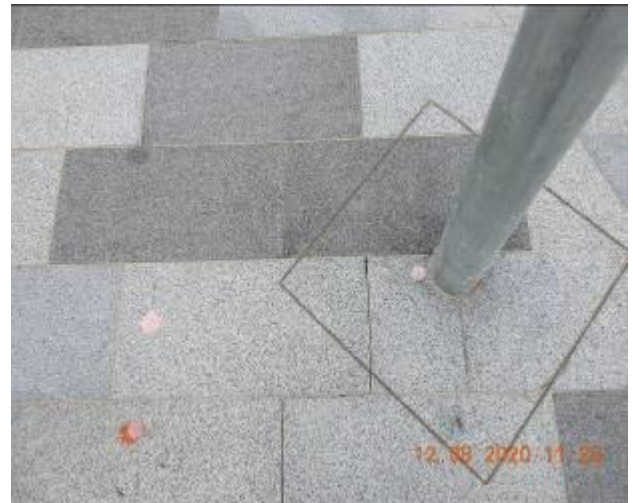
Figure 1579 – Crack propagation and loss of material through footpath pavement

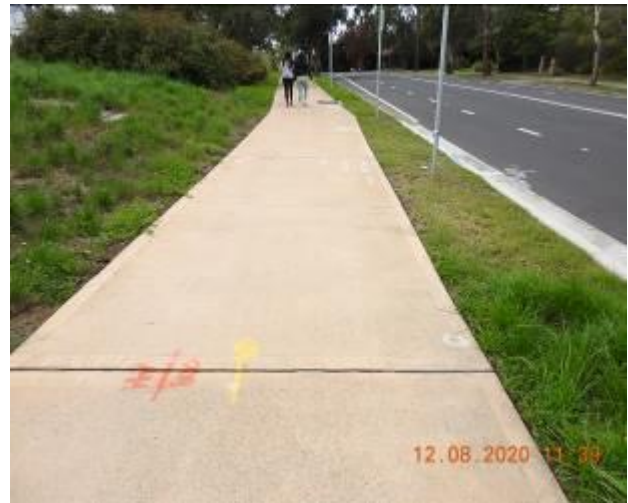
Figure 1663 – General condition of service pits

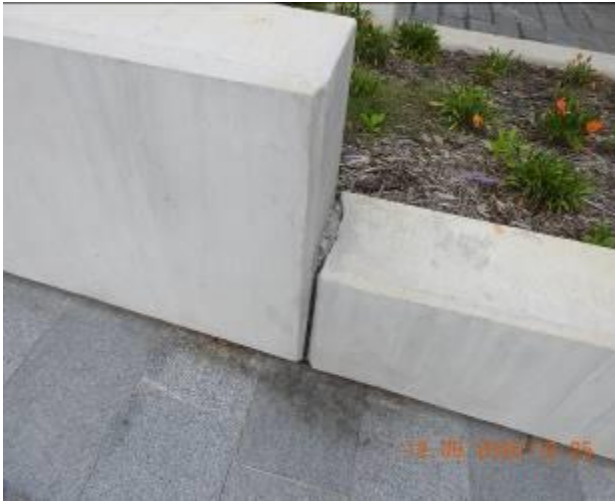
Figure 1983 – Crack propagation through retaining wall

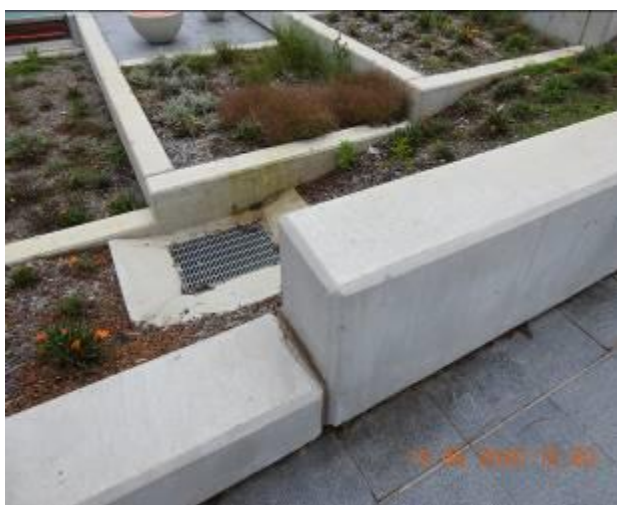
Figure 2102 – General condition of retaining wall

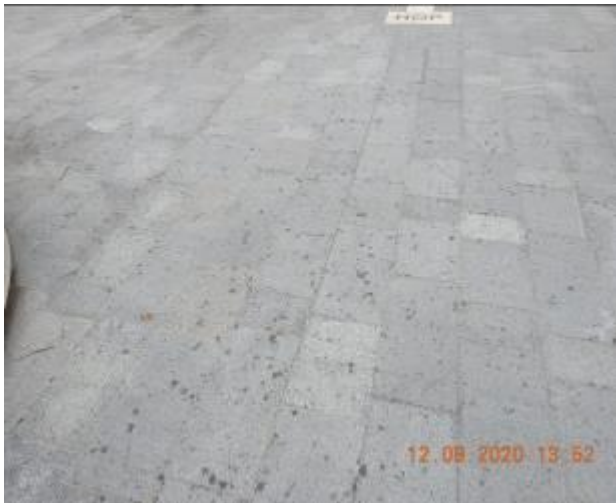
Figure 2463 – Hairline crack propagation through walkway floor
