Report on  
Hazardous Building Materials (HBM) Survey

Lot 100 DP1261496, Maitland Street, Muswellbrook,  
NSW

Prepared for  
Pacific Brook Christian School Ltd

Project 91601.01  
July 2021

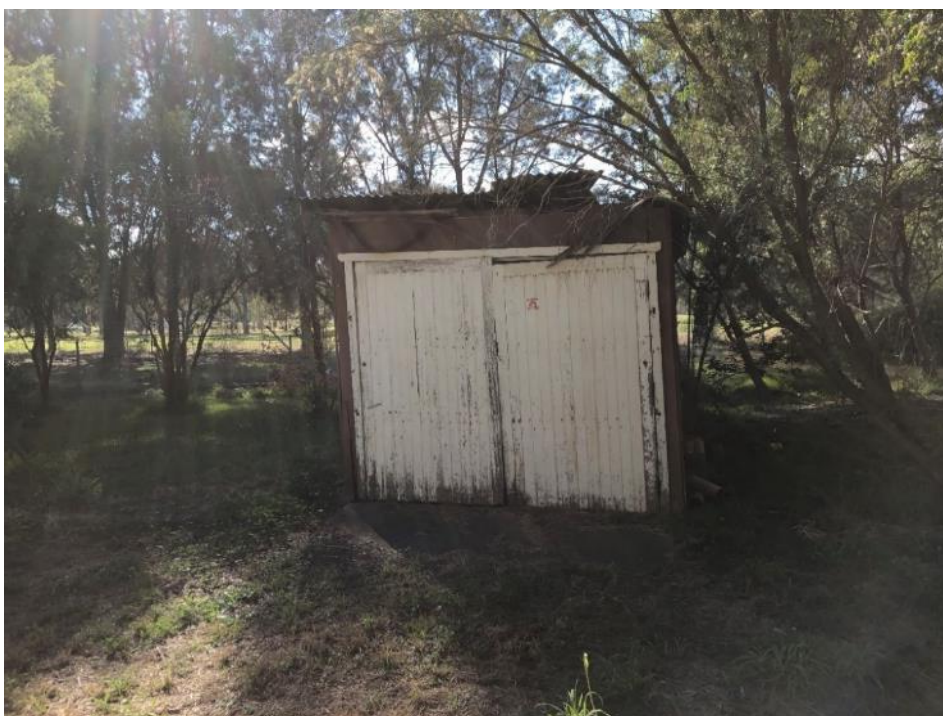
Photograph 17: Timber shed to rear of residential dwelling.

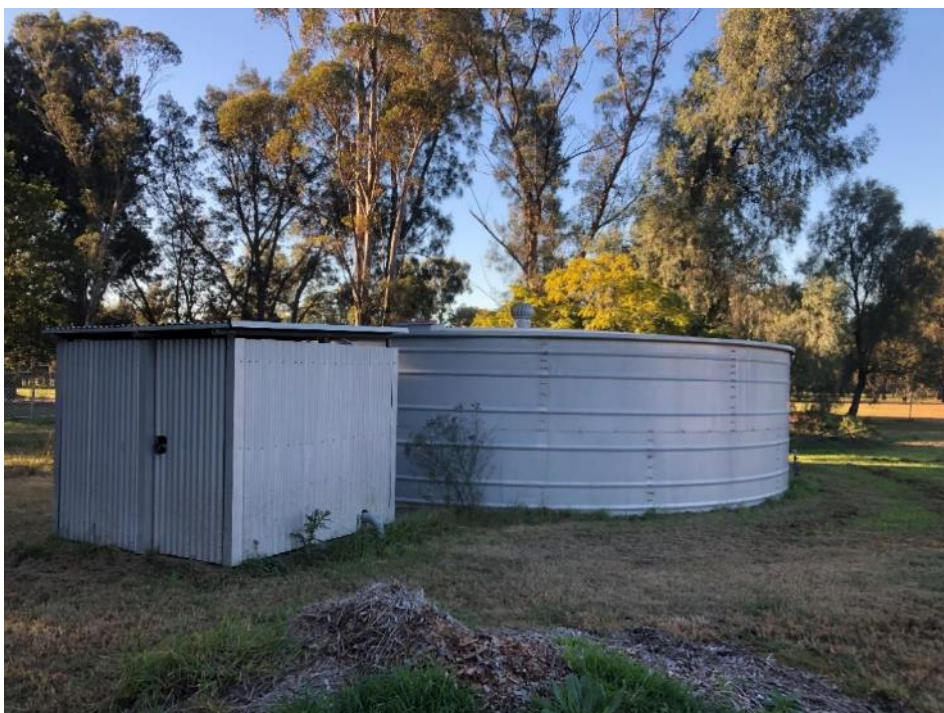
Photograph 19: Galvanised water tank.

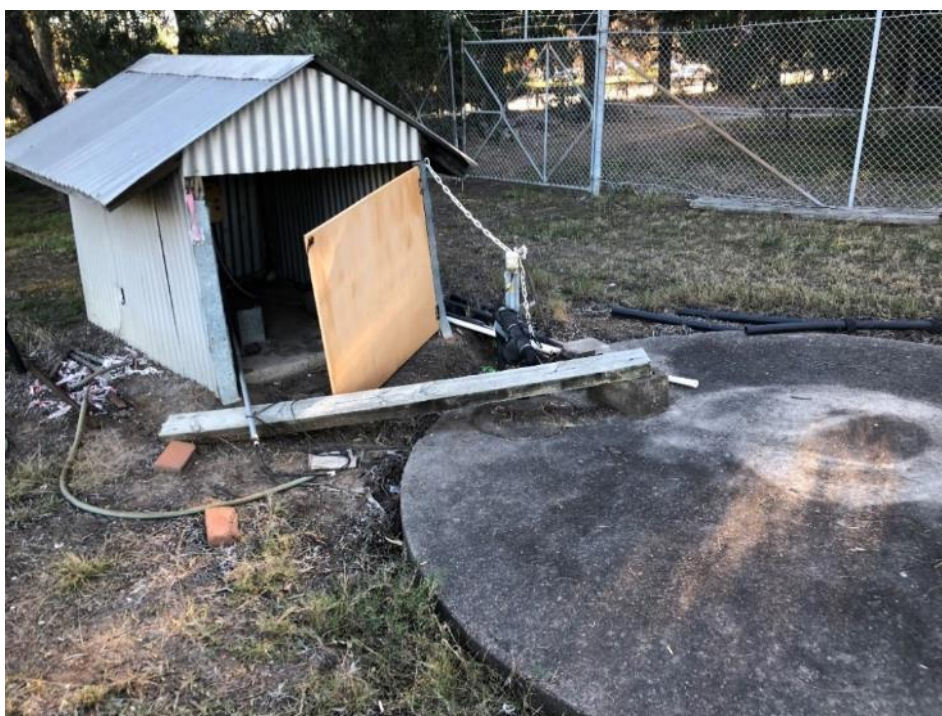
Photograph 20: Concrete water tank (in ground).

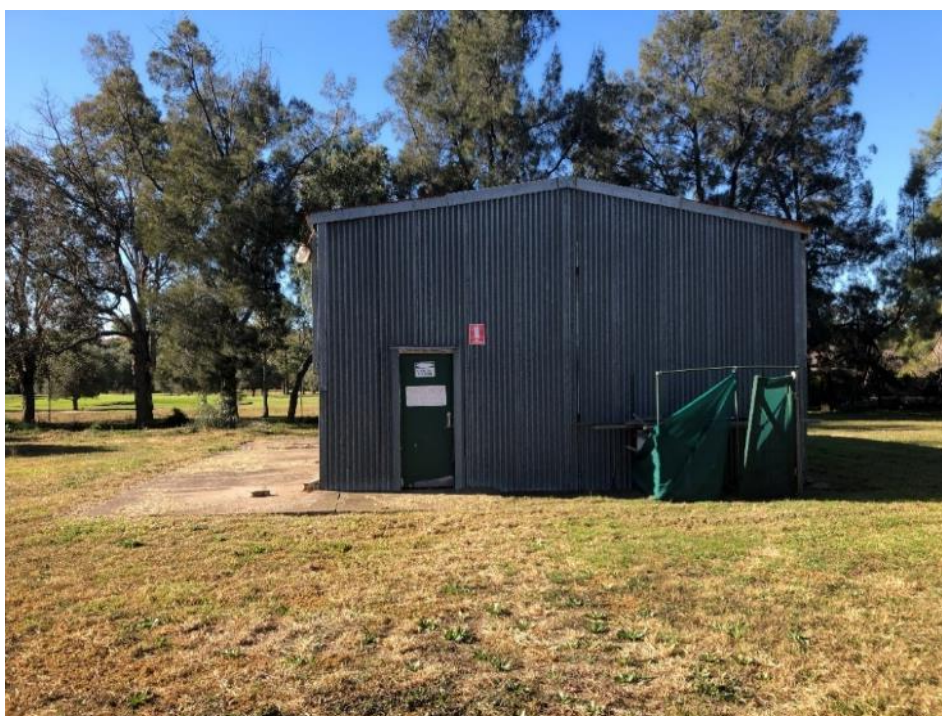
Photograph 62: Machinery and HAZMCHM shed.
