12 October 2021

Arboricultural Impact Assessment Report regarding thirty-one (31) trees located within the vicinity of the Grey House Precinct Project at Pymble Ladies' College, Avon Road, Pymble

Andrew Clark
Consulting Arborist

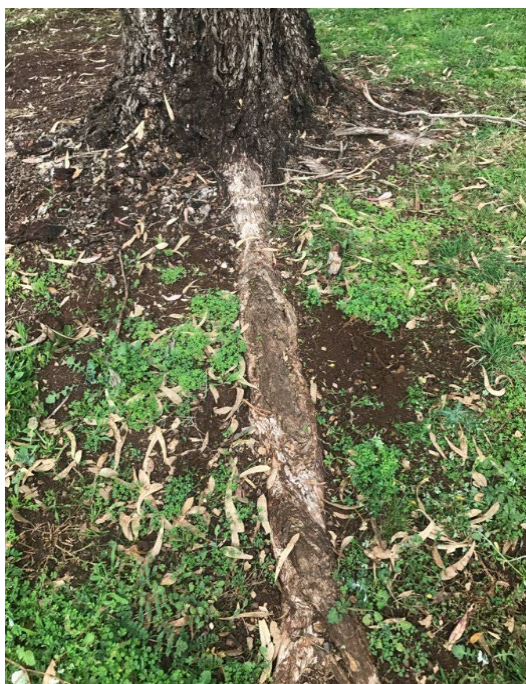
Damage to tree roots (Figure 13 and Figure 14) and the lower portion of a tree's trunk is a common and often unnecessary occurrence that can lead to the entry of decay fungi into a tree's structural framework. Once present, decay may develop in larger structural roots and/or the base of the trunk, which can result in a reduction in tree health and in severe cases even compromise stability.

Figure 13. An example of damage to tree roots caused via mowing. (Luke Dawson, June 2017).

Another advantage to mulching around the trunk and root crown is that it limits damage to both parts from mowing equipment. This in turn reduces mechanical damage and compaction.

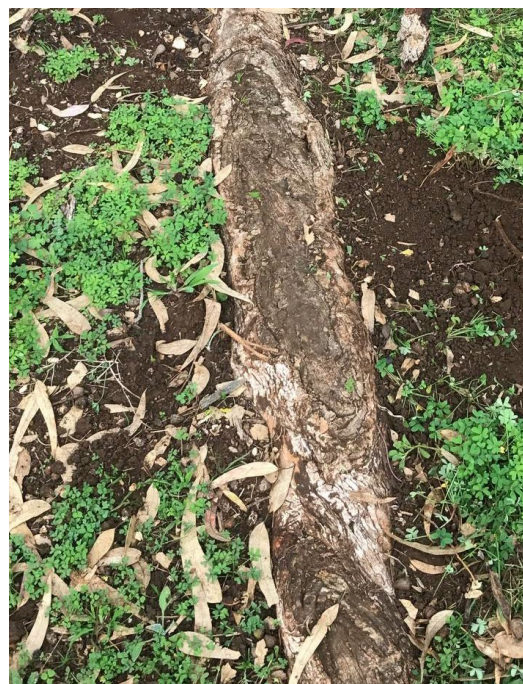
Everyday activities such as grass cutting via mowing or brush cutters can result in serious root damage or wounding to the lower trunk. Young trees with their trunks damaged by machinery often need replacing, while damage to the trunks and/or surface roots of established trees is not only detrimental to tree health but can also result in costly repairs to machinery.

Figure 14. Image showing wound caused to upper portion of surface root by mower. (Luke Dawson, June 2017).
