Arborist Assessment Report

Department of Education NSW

PROJECT: SSD-21854025 Wee Waa High School

Date of Inspection: 27th August 2021

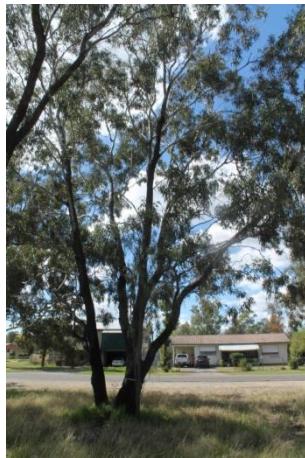
TREE 11

11	Not affected	<i>Eucalyptus microtheca</i> Coolibah	12	50/30	10	Mature good condition, structure good	80	3.0	6.9	A2 HIGH	RETAIN
12	Not affected	<i>Eucalyptus microtheca</i> Coolibah	10	30x3	7	Mature good condition but poor form inclusion @ base	80	3.0	6.2	A2 HIGH	RETAIN

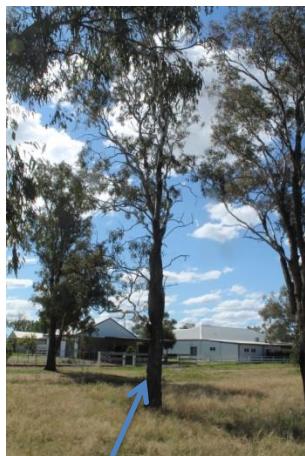
TREE 32A swelling at union
