Hazardous Materials Survey

268 & 278 Catherine Fields Rd, Catherine Field
NSW

Report No: E25586.E10_Rev0

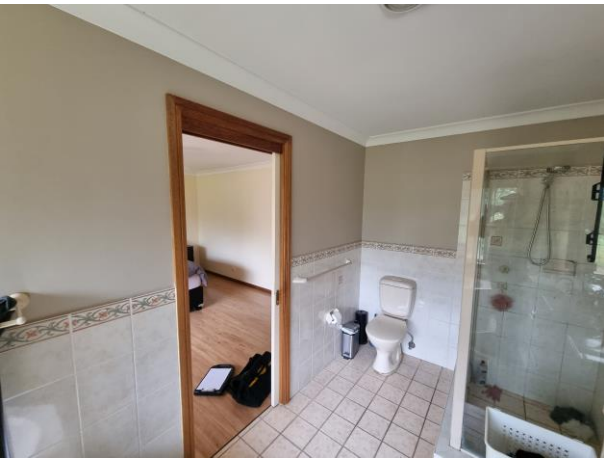
Internal, south-western ensuite bathroom, walls	Fibrous Cement Sheeting	Non-friable	Asb-01	No Asbestos Detected Organic Fibres Detected	NA	NA	NA	NA

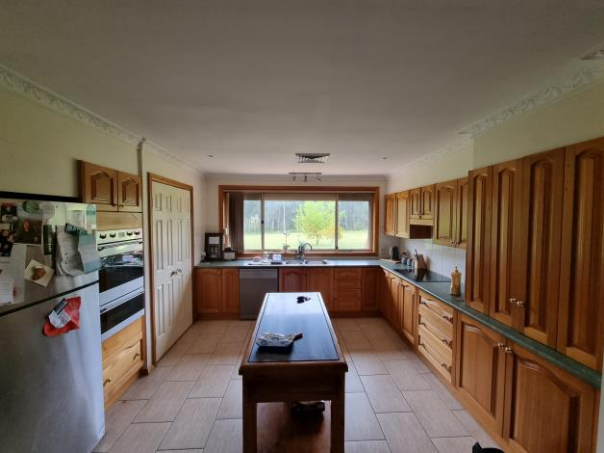
Internal, kitchen, upper walls	Fibrous Cement Sheeting	Non-friable	Asb-02	No Asbestos Detected Organic Fibres Detected	NA	NA	NA	NA

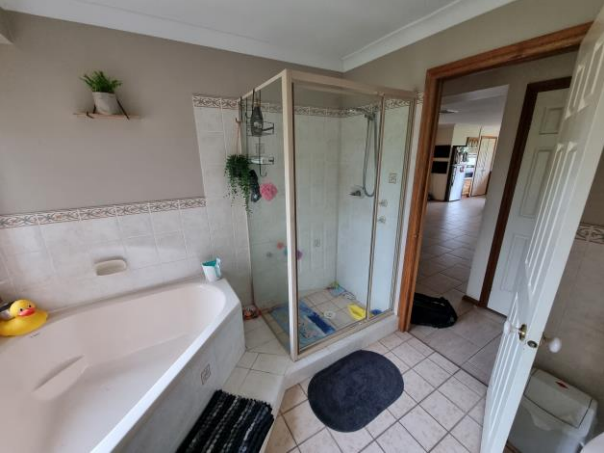
Internal, eastern bathroom, walls	Fibrous Cement Sheeting	Non-friable	Asb-03	No Asbestos Detected Organic Fibres Detected	NA	NA	NA	NA

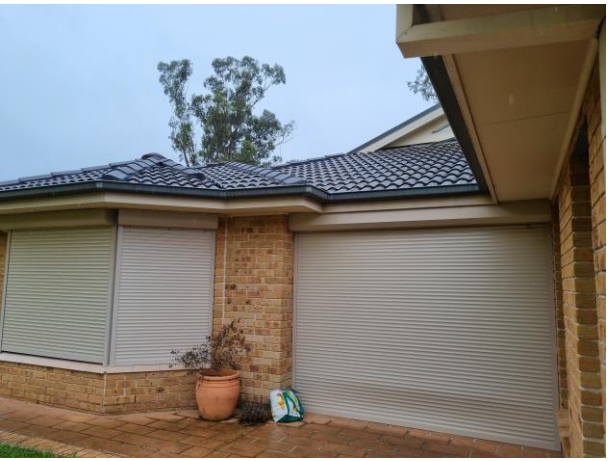
External, eaves	Fibrous Cement Sheeting	Non-friable	Asb-04	No Asbestos Detected Organic Fibres Detected	NA	NA	NA	NA

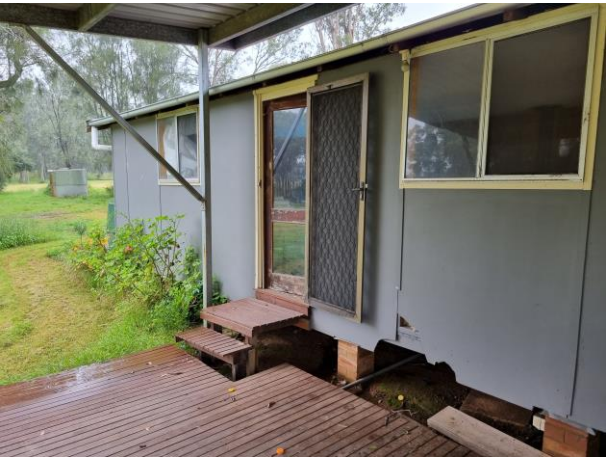
External, northern side, door	Brown paint	NA	Pb-01	0.06% w/w	NA	NA	NA	NA
-------------------------------	-------------	----	-------	-----------	----	----	----	----

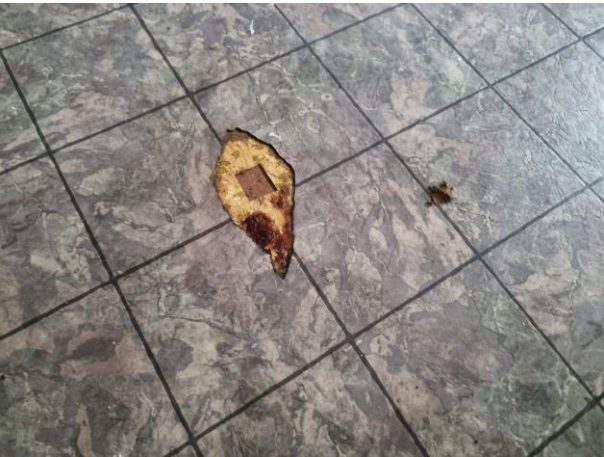
Internal, kitchen, floor, lower layer	Cream Vinyl Floor Sheeting	Sealed	Asb-10	No Asbestos Detected Organic Fibres Detected	NA	NA	NA	NA
---------------------------------------	----------------------------	--------	--------	---	----	----	----	----

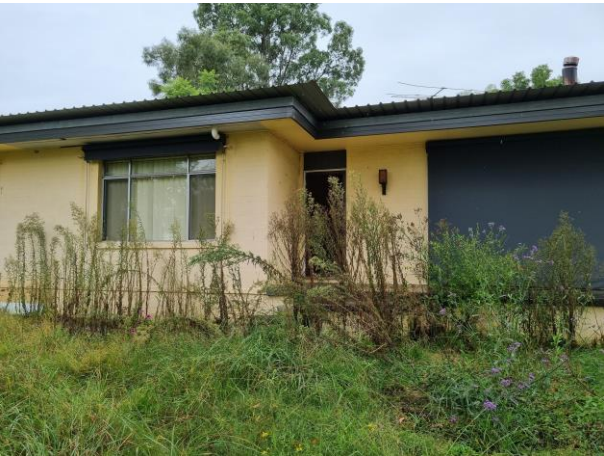
External, throughout	Yellow paint	NA	Pb-02	<0.01% w/w	NA	NA	NA	NA
----------------------	--------------	----	-------	------------	----	----	----	----

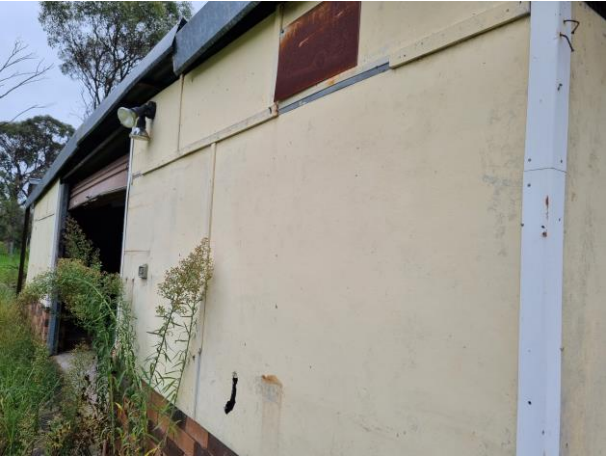
External, walls throughout	Yellow paint	NA	Pb-05	<0.01% w/w	NA	NA	NA	NA

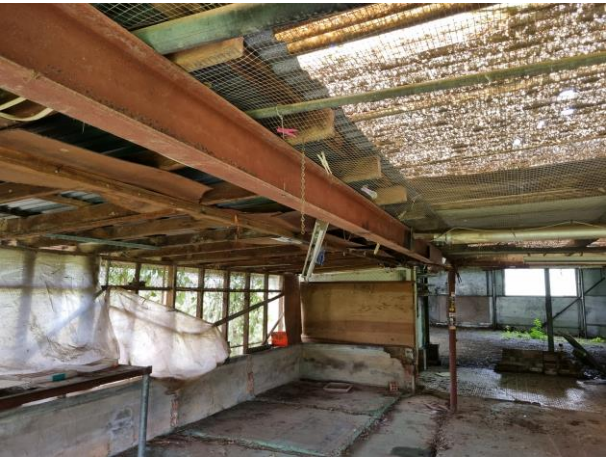
Internal, structural beams throughout	Red/maroon paint	NA	Pb-06	<0.01% w/w	NA	NA	NA	NA
