# **Remediation Validation Report**

42-52 Raymond Avenue, Matraville NSW

Prepared for Perpetual Corporate Trust Limited ATF 42 Matraville Investment Trust November 2021

# **Report Number** J210458 RP#1 Client Perpetual Corporate Trust Limited ATF 42 Matraville Investment Trust Date 16 November 2021 Version v2 Final Prepared by Approved by Lachlan Lewis Victoria Buchanan **Environmental Scientist** National Technical Leader - Contaminated Land 16 November 2021 16 November 2021 EMM Pty Limited (EMM) has prepared this document for the sole use of Perpetual Corporate Trust Limited ATF 42 Matraville Investment Trust

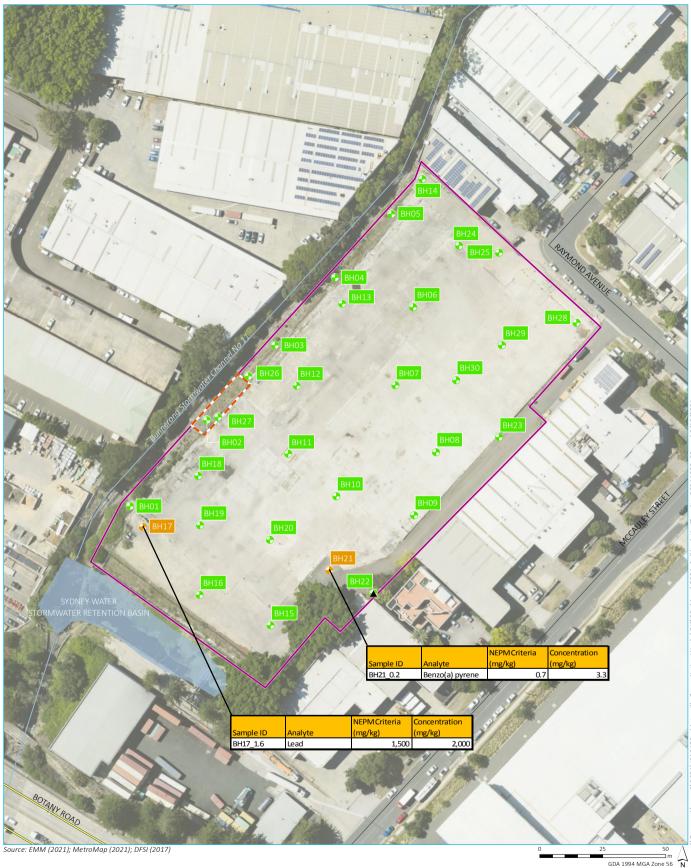
42-52 Raymond Avenue, Matraville NSW Remediation validation report Figure 4.1

A total of 54 primary samples from 30 soil bore locations across the Site (Figure 4.1) were submitted for laboratory analysis for CoPC. The following soil analytical results were reported:

Historical soil data indicated there were petroleum hydrocarbons present in soil in proximity to the former USTs identified along the western boundary the site (ie BH02 and BH03 in Figure 4.1). The hydrocarbon impact was characterised by elevated TRH concentrations of  $C_{16}$ - $C_{34}$  and  $C_{34}$ - $C_{40}$  however concentrations did not exceed the adopted soil assessment criteria. Concentrations of TRH beyond the proximity of the former USTs was reported to be below or slightly above the limit of reporting (EMM, 2020).

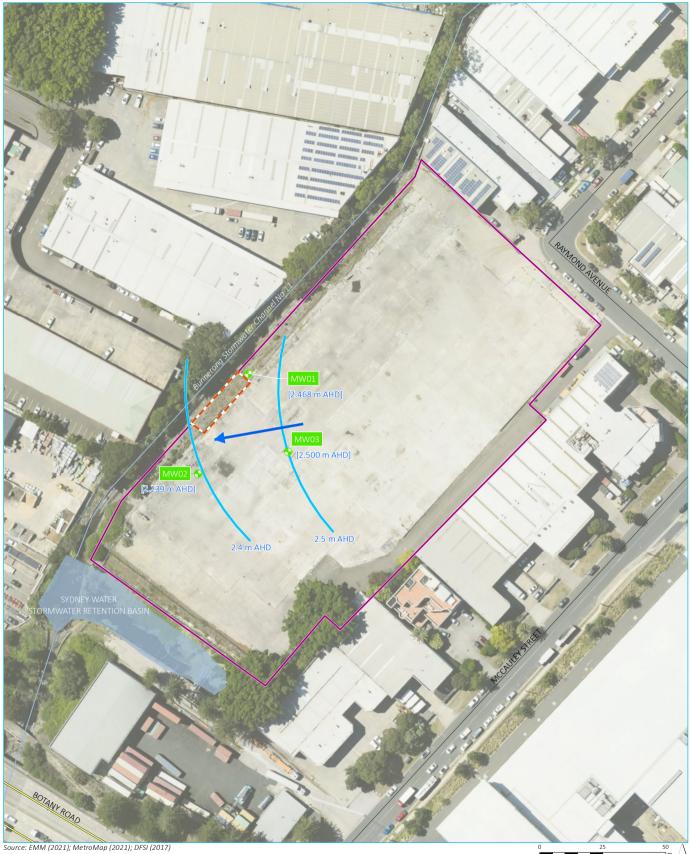
42-52 Raymond Avenue, Matraville NSW Remediation validation report Figure 4.2

Three groundwater wells were installed (MW01, MW02, MW03) with samples collected and analysed for CoPC associated with the identified source of potential contamination (Figure 4.2). The following observations and analytical results were noted:

- groundwater levels at the site ranged from 3.286 to 3.130 m bgl (2.439 to 2.5 m AHD) and the inferred groundwater flow direction was towards the west;
- the three groundwater monitoring wells were installed in accessible locations close to the UPSS, noting steep and uneven terrain along the western Site boundary (between the UPSS and the stormwater channel). Due to these restrictions, the wells were located either up or across hydraulic gradient of the observed UPSS infrastructure;
- there were no odours detected or notable PID results to indicate hydrocarbon impact in groundwater (<2 ppm); and
- there were no exceedances of the adopted criteria for the groundwater assessment. Benzene was reported at a concentration of 3  $\mu$ g/L and TRH C<sub>6</sub>-C<sub>10</sub> was reported at 40  $\mu$ g/L in a groundwater sample collected at MW02.

There have been limited groundwater investigations completed at the Site. Based on data obtained from three wells installed in the south west of the Site in September 2020 (EMM, 2020), there were indications of limited hydrocarbon impacts in the vicinity of the UPSS infrastructure (MW02 and MW03 – Figure 4.2), with contaminant concentrations not reported to be greater than the adopted assessment criteria.
