HAZARDOUS MATERIALS REGISTER

Barker College – 91 Pacific Highway

Project No. 21401 [Rev 1.]

Date: 10/09/20

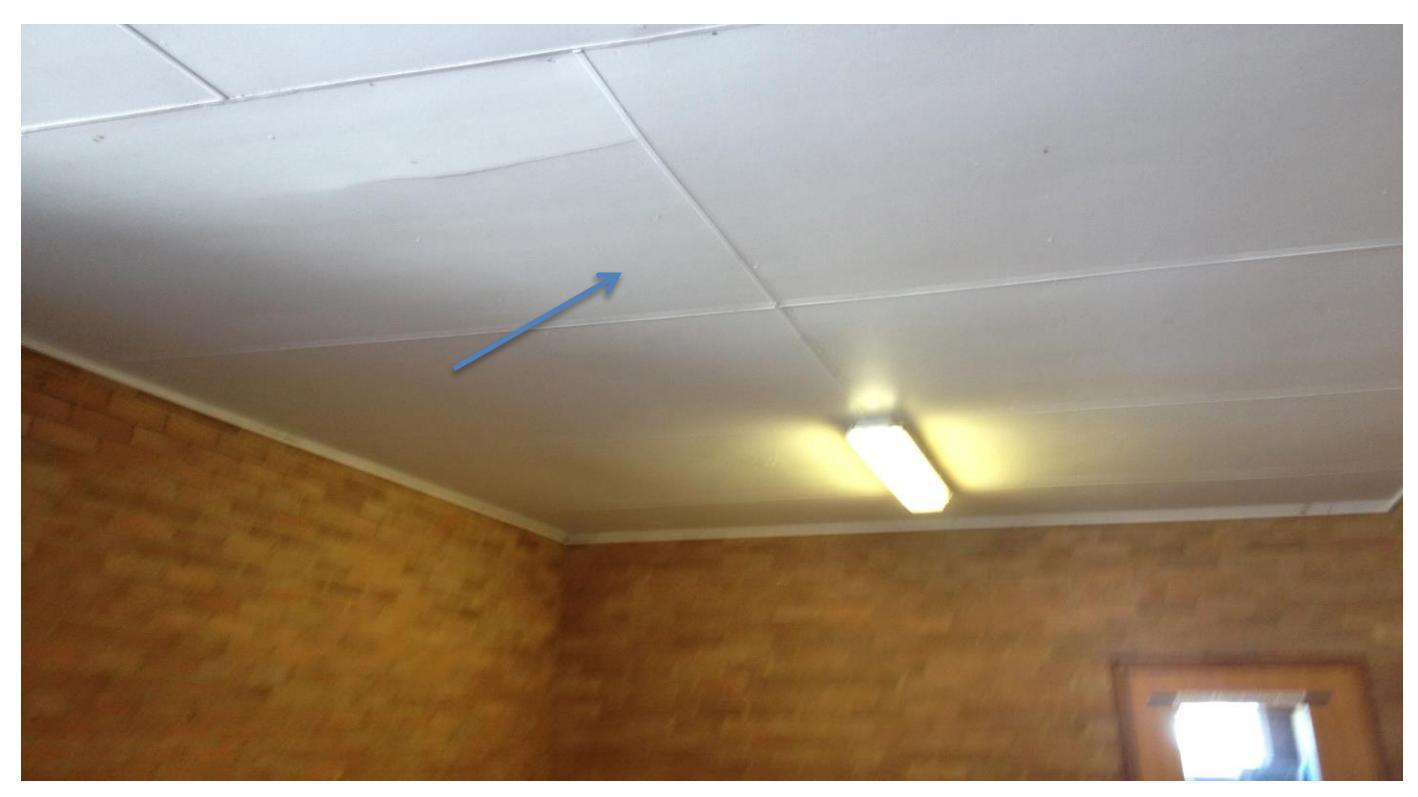
Photo 7: Asbestos cement sheeting on the ceiling lining on Level 3 of the western stairwell of C Block.

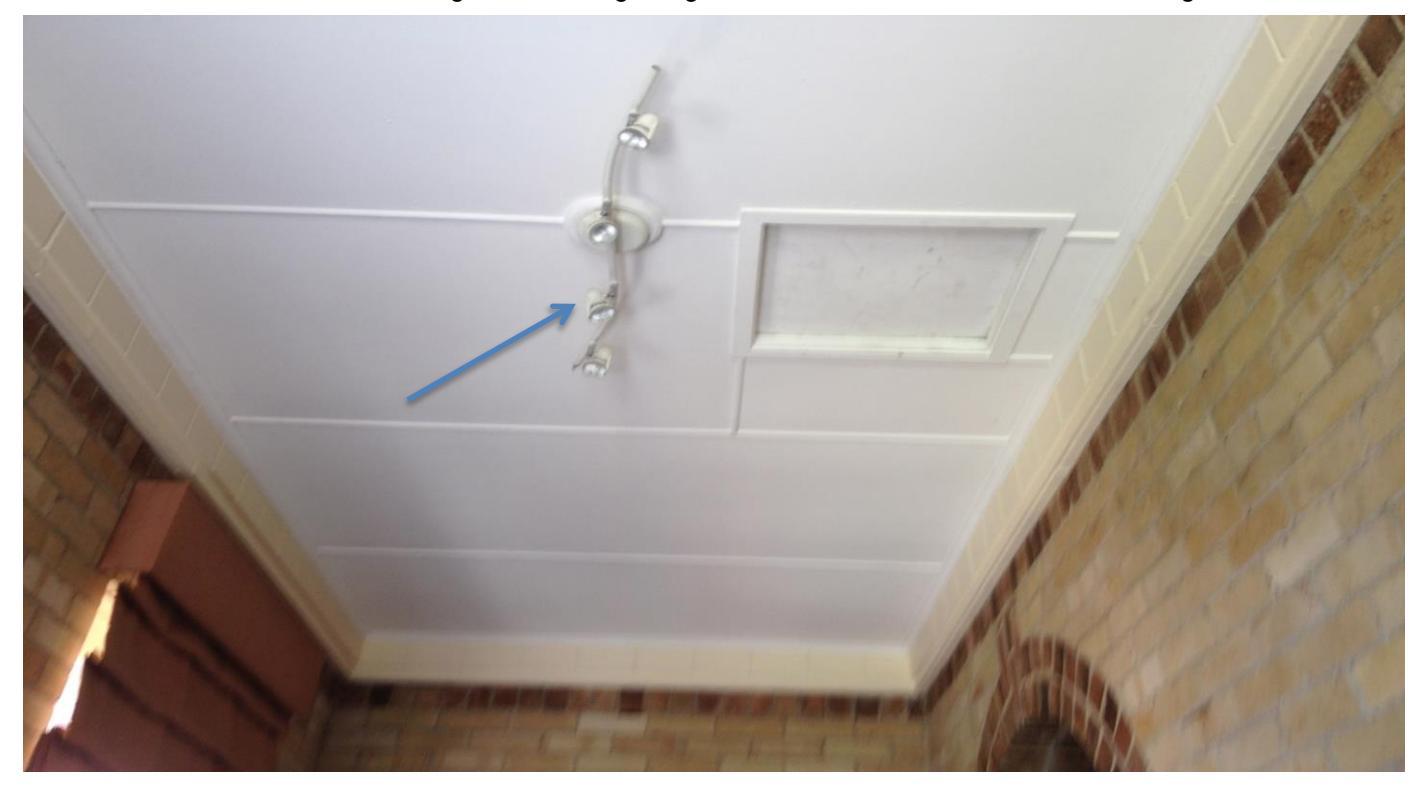
**Photo 14:** Asbestos cement sheeting on the ceiling lining of the eastern internal entrance to the Dining Room/Kitchen.

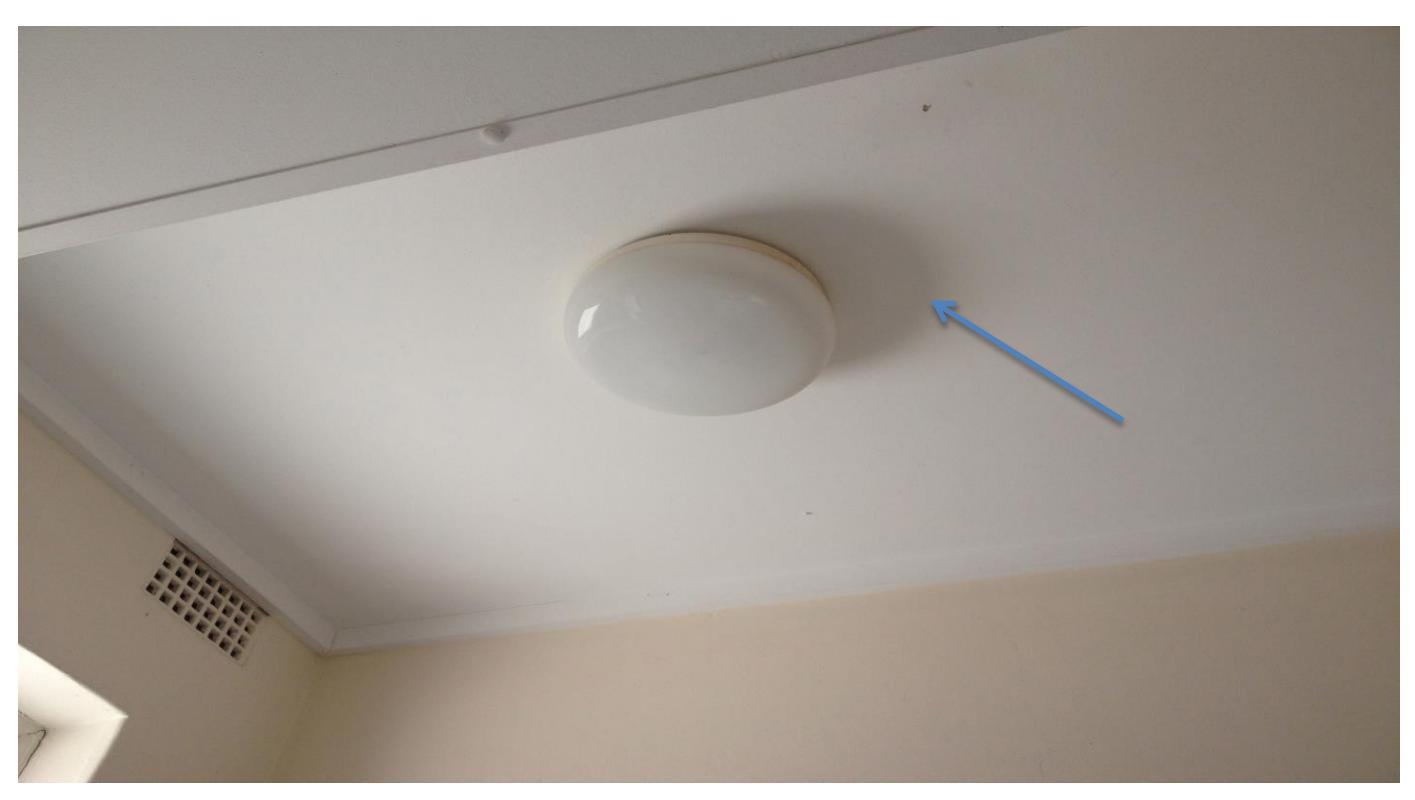
Photo 17: Asbestos cement sheeting on the ceiling lining of the Staff Shower within the Dining Room/Kitchen.

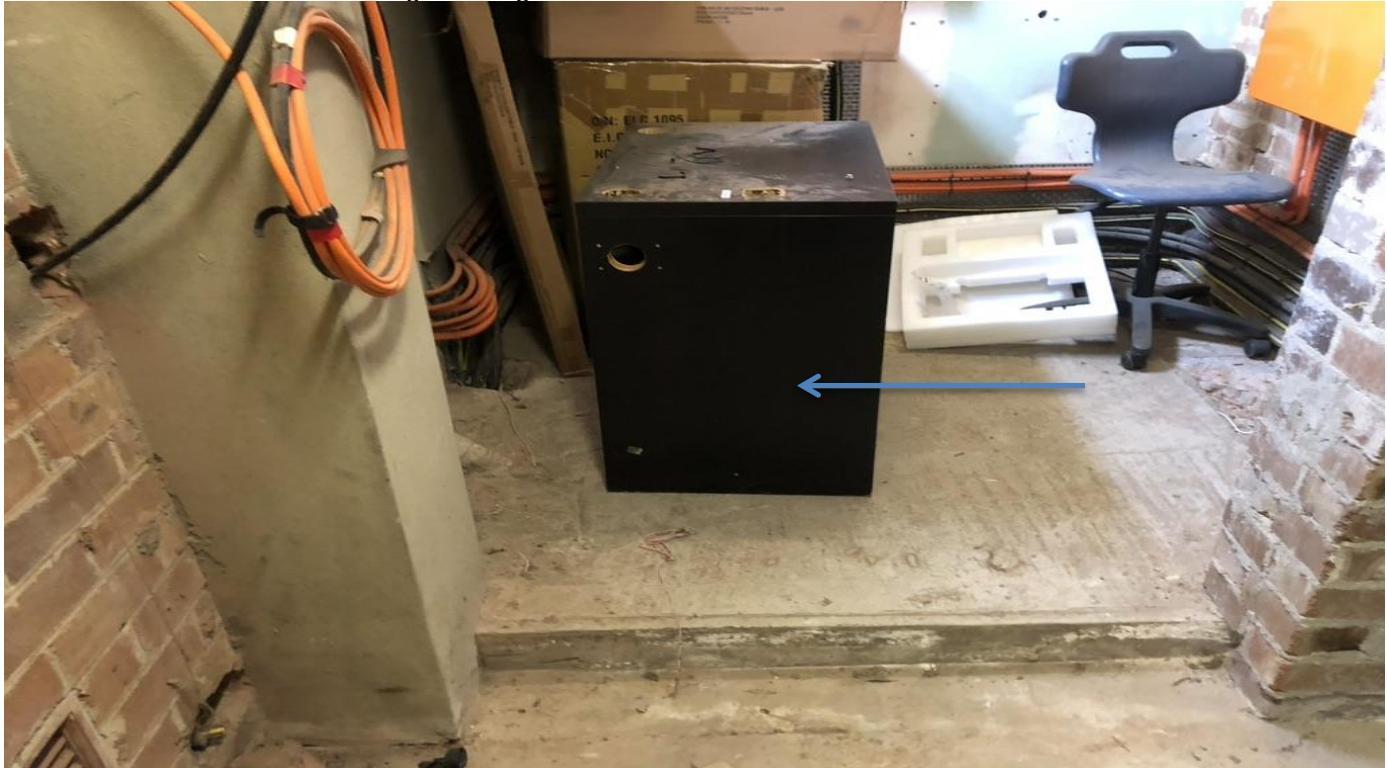
**Photo 20:** Electrical Room within the library on Level 2 (Ground Level) of Junior School – Original Wing following removal of Vinyl floor tiles

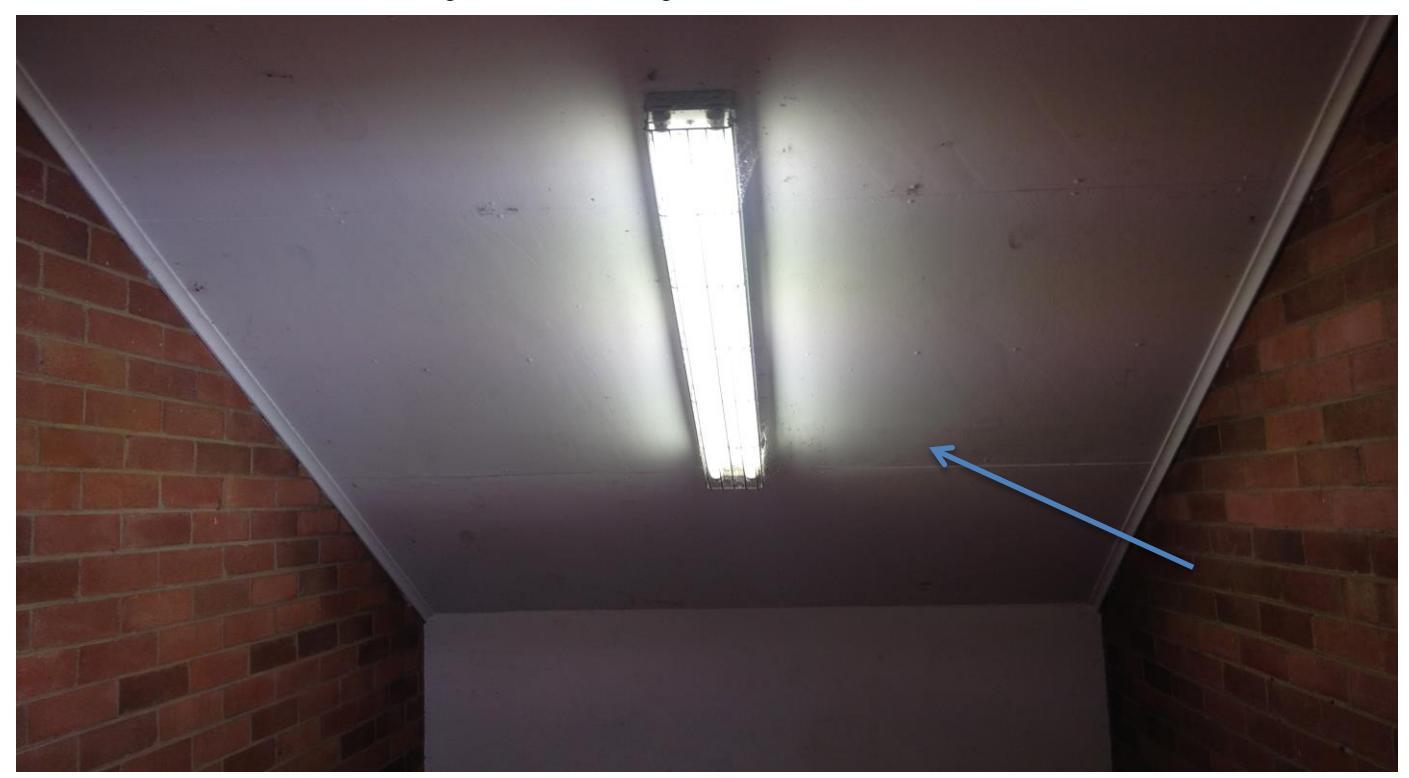
**Photo 22:** Asbestos cement sheeting on the ceiling linings of Stairwell from the Lower Ground Level to Ground Level of Junior School – RW Hall.

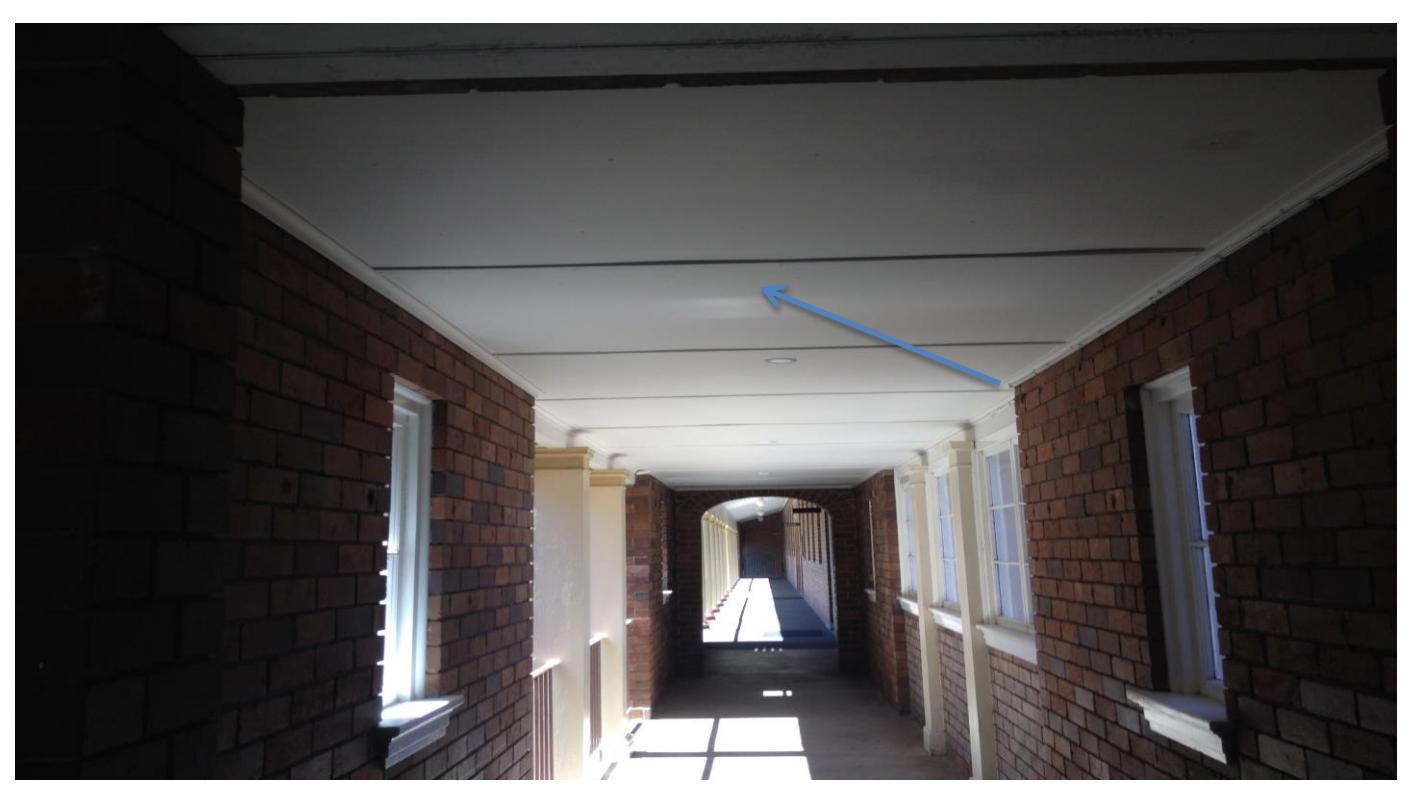
**Photo 25:** Asbestos cement sheeting on the ceiling linings of walkway to Administration adjacent the northern entrance on Level 2 of Boys Boarding – West Wing.

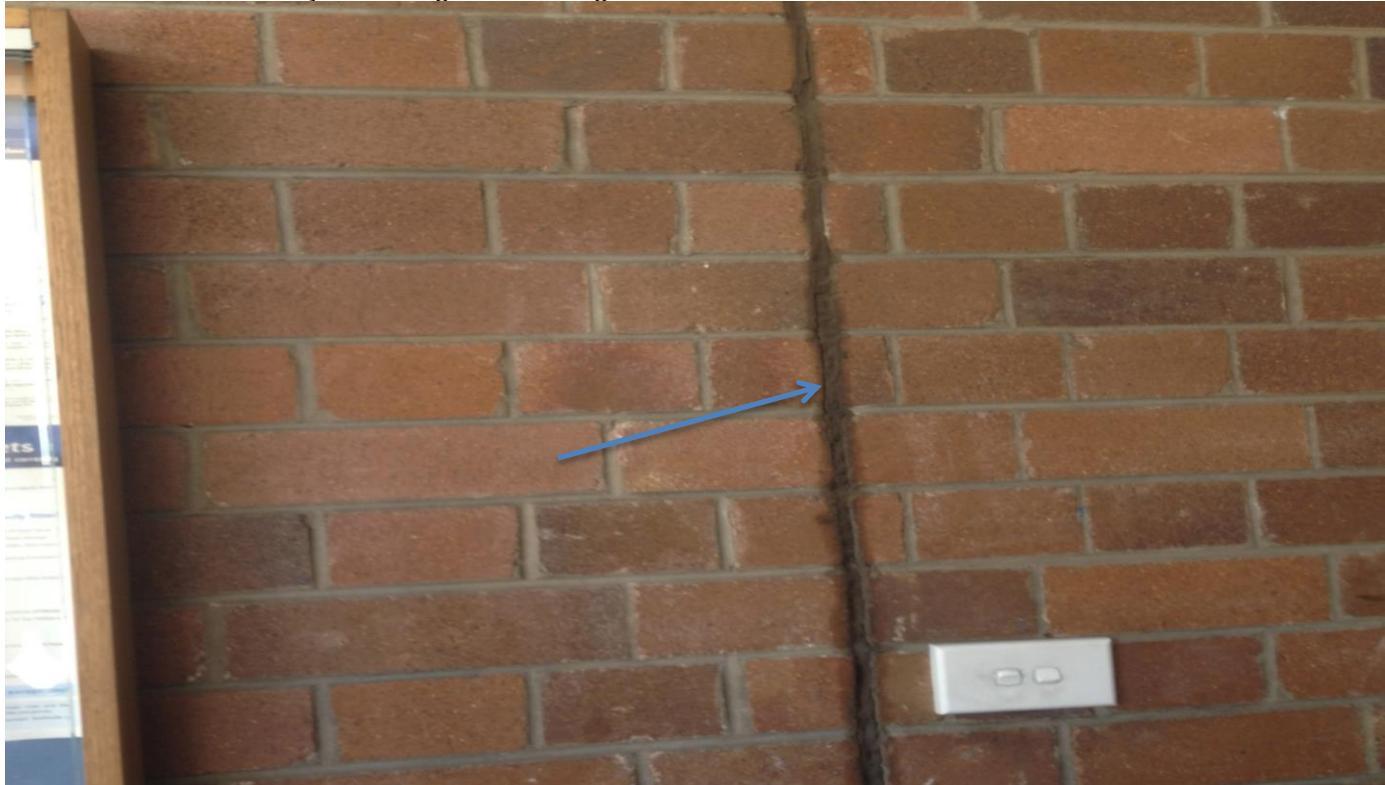
**Photo 326:** Mastic containing asbestos within the expansion joints on the western perimeter wall of Level 1 of Leslie Hall.

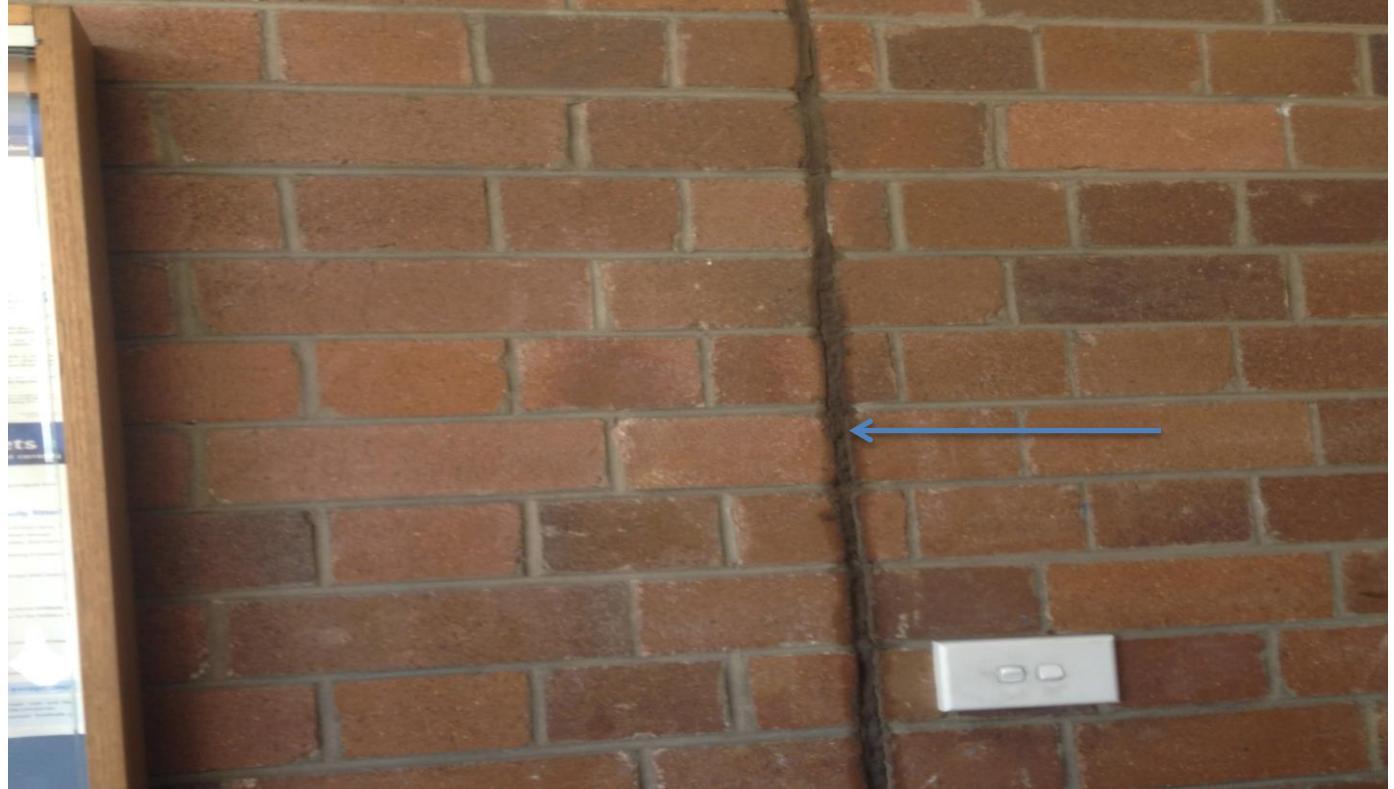
**Photo 45:** Mastic containing asbestos in the expansion joints of the western perimeter wall of the Staffroom in Undercroft Administration.

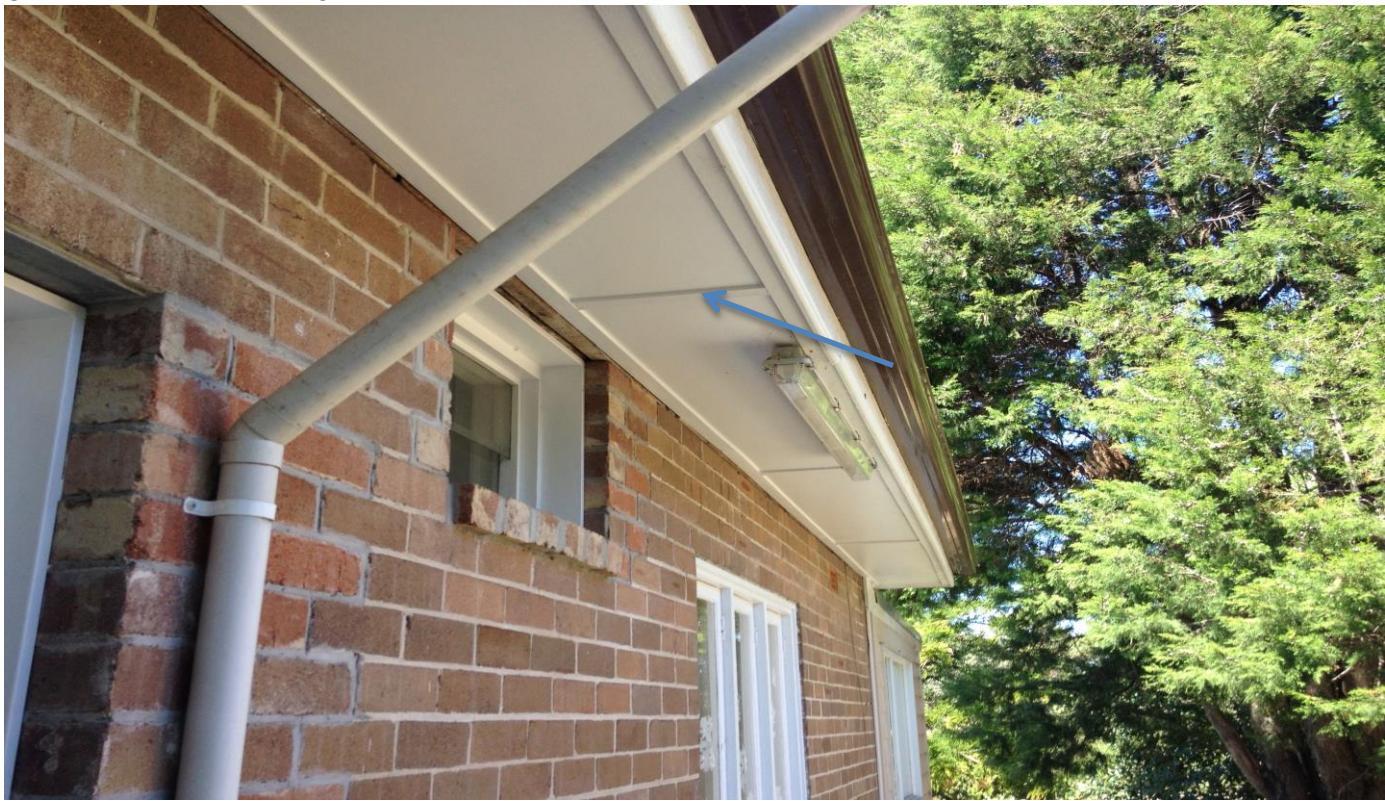
Photo 38: Asbestos cement sheeting on eave linings of OOSH - 7 Clarke Road.

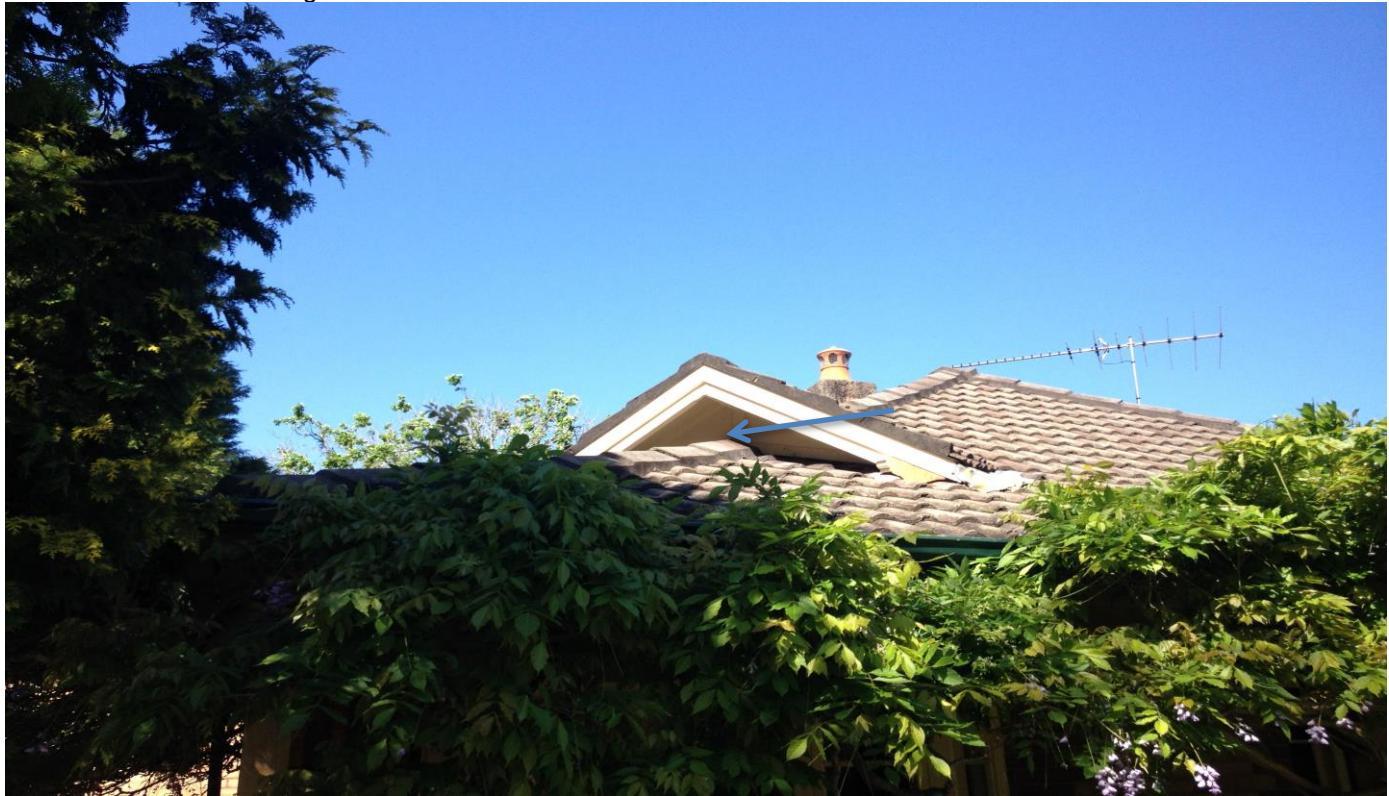
Photo 46: Asbestos cement sheeting on the gable ends of the roof of 9 Clarke Road – Preparatory Administration.

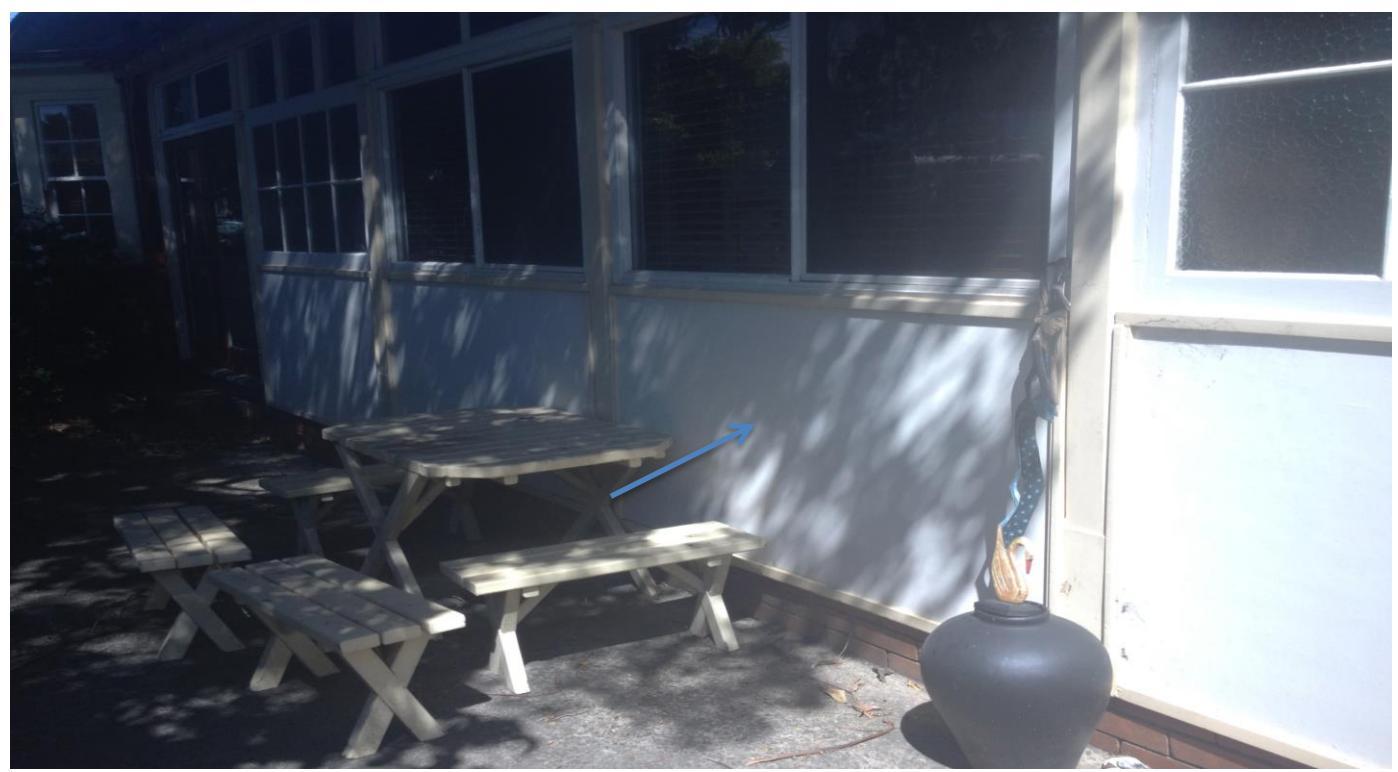
Photo 58: Asbestos cement sheeting beneath the windows on the northern perimeter of Stokeleigh House.

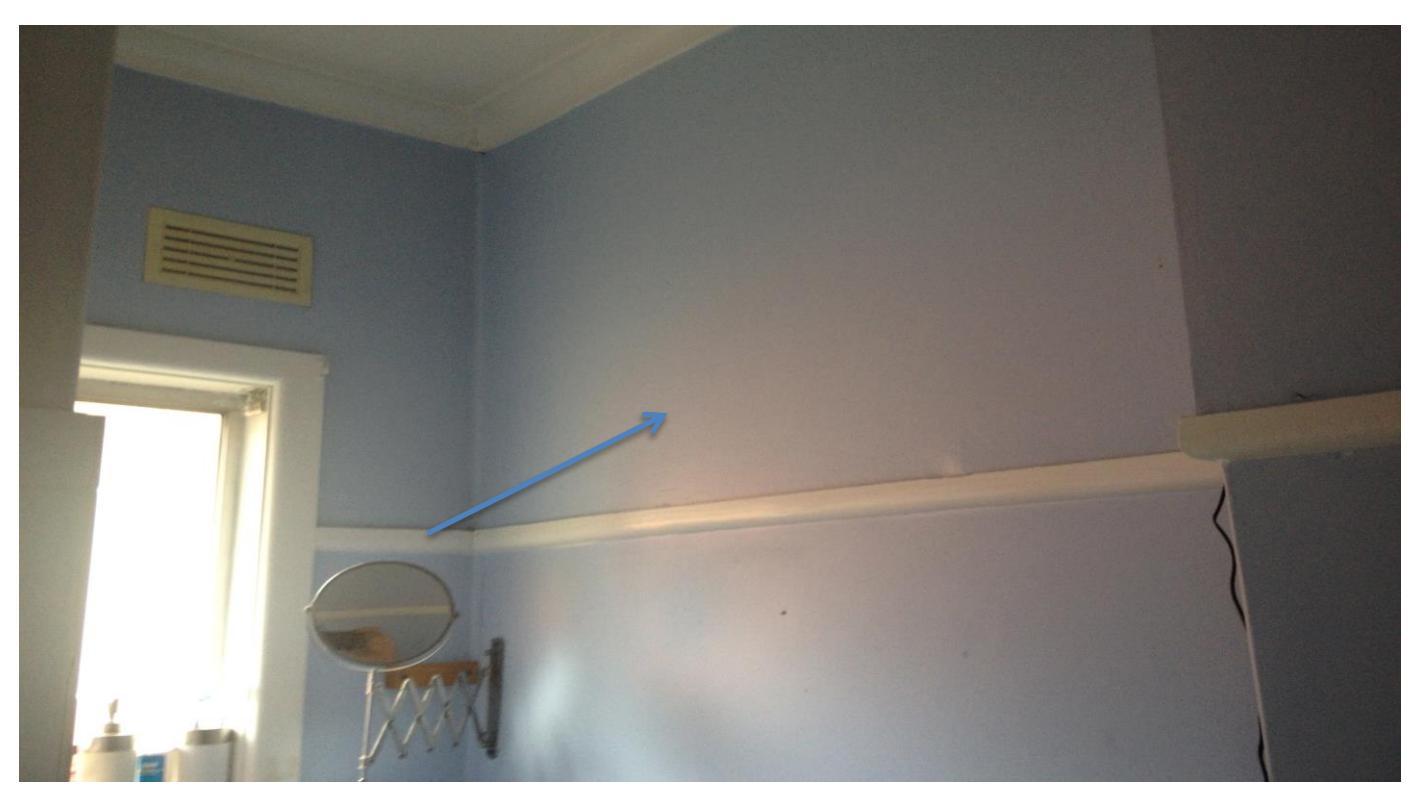
**Photo 67:** Asbestos cement sheeting on the internal wall cladding in the Bathroom of 21 Clarke Road – Male Boarding Accommodation.

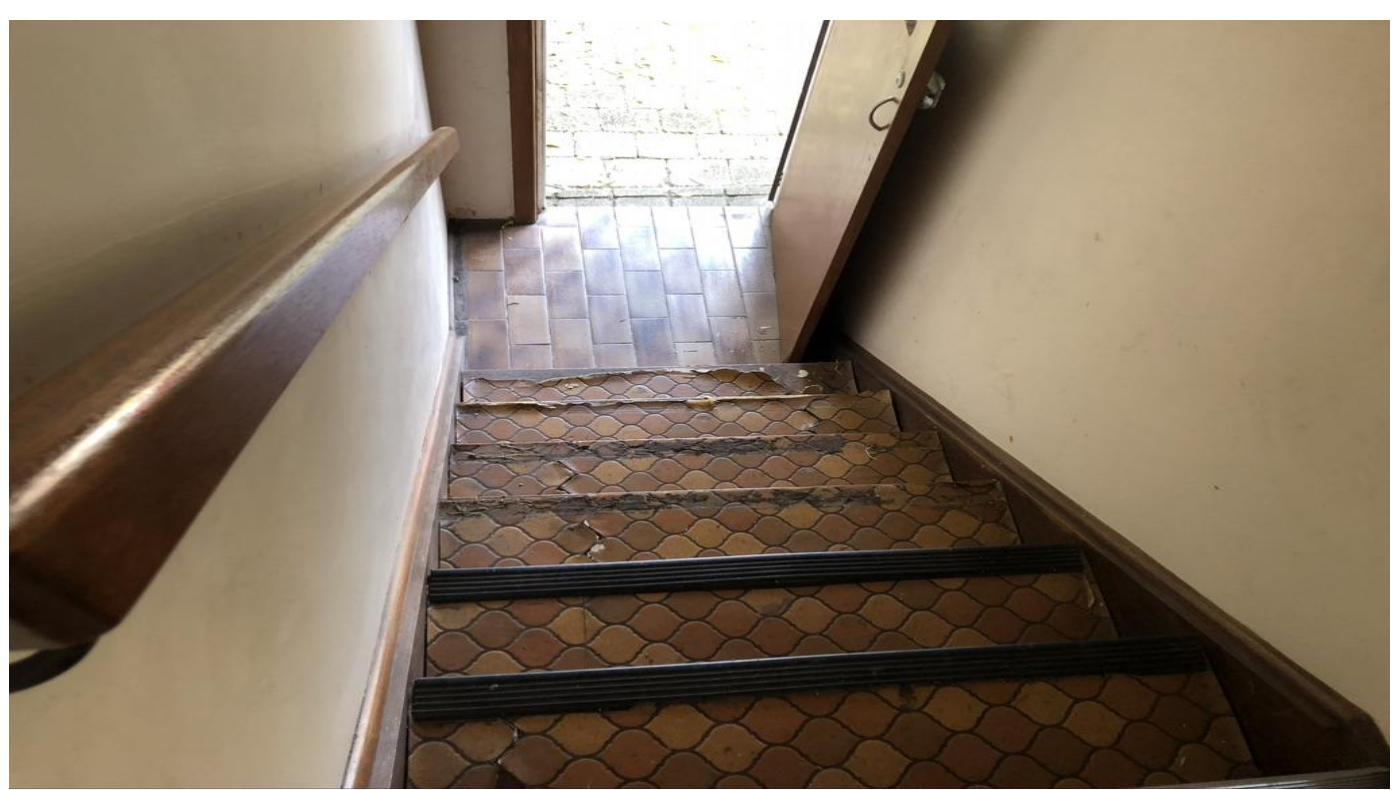
Photo 70: Linoleum floor tiles at rear entrance of 21 Clarke Road. Underside of tiles contain asbestos paper backing

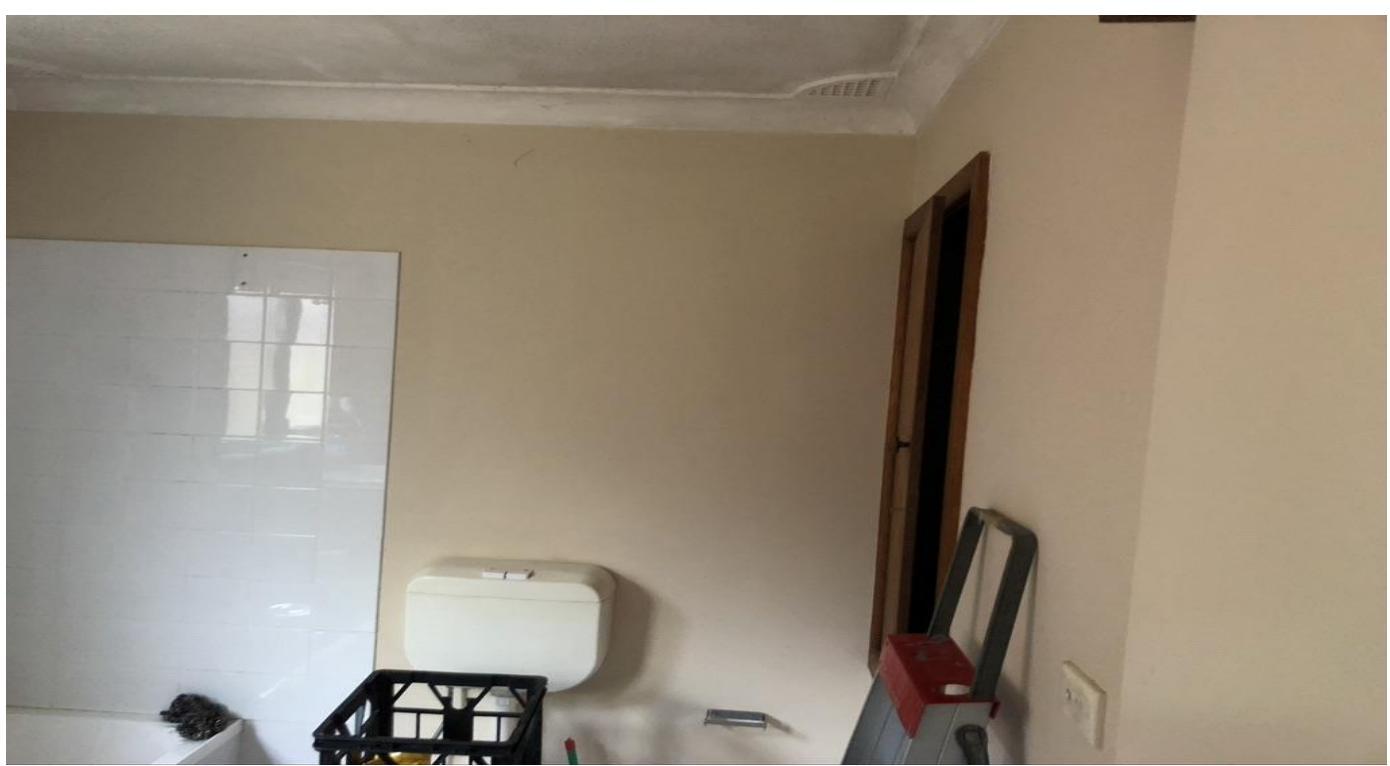
Photo 71: Rear Bathroom at 21 Clarke Road. Asbestos containing wall sheeting

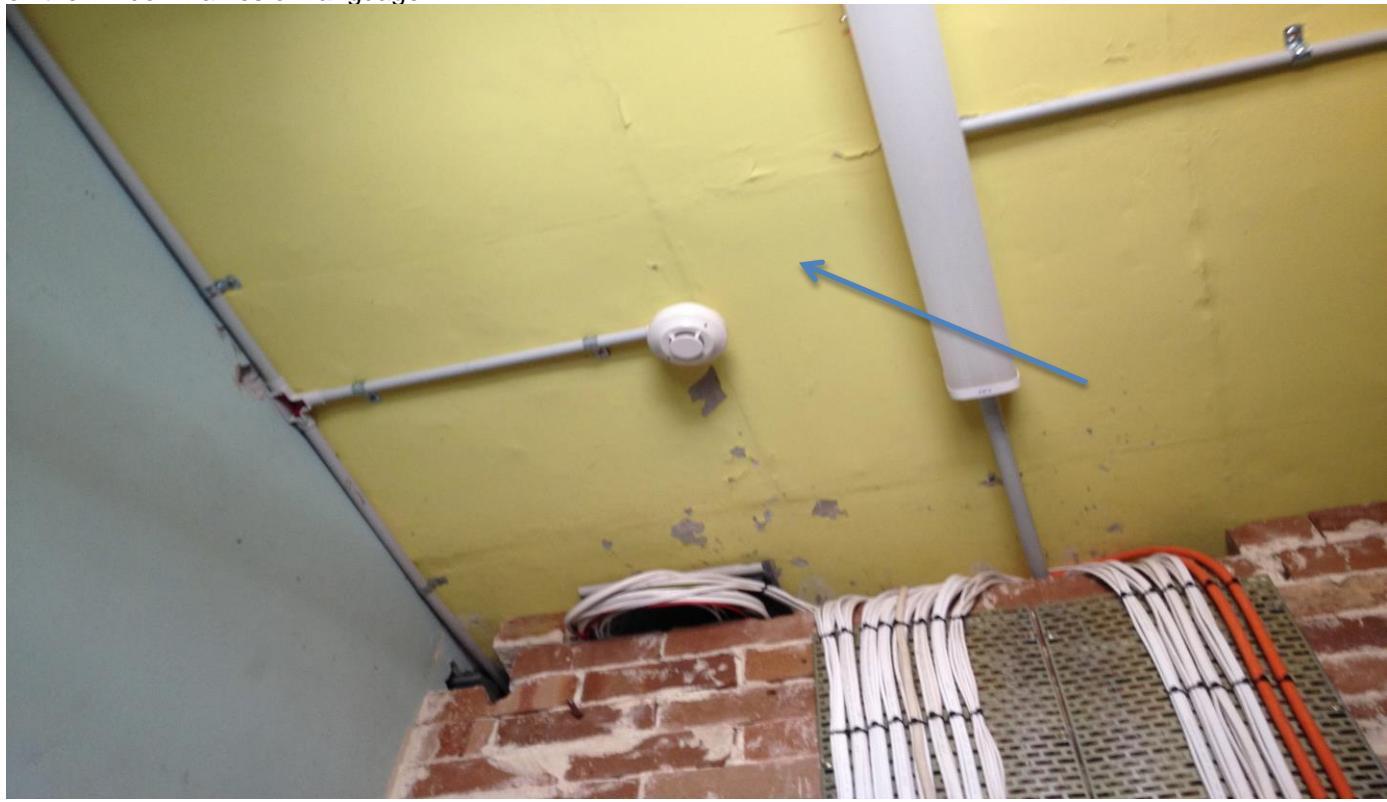
**Photo 76:** Yellow paint containing elevated levels of lead on the soffit lining of the electrical room in the library on Level 2 of the Junior School.
