REPORT FOR GOODMAN PROPERTY
HAZARDOUS MATERIALS ASSESSMENT

AU130 1-3 Burrows Road, Alexandria NSW 2015

Our Ref: J008683-AU130

24 JANUARY 2022

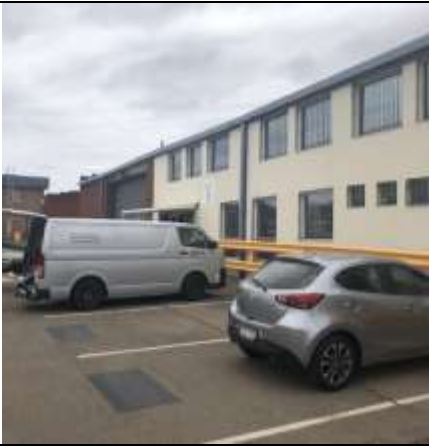
| Location | Photo | Photo |
|---|--|---|
| <p>Photo 10: Unit 3 Exterior</p> | <p>Photo 11: Unit 3 Showing typical columns and perimeter walls with typical interferences-clean 2 meters and below, 1 metre out on floor-before clean</p> | <p>Photo 12: Unit 3 Showing typical columns and perimeter walls with typical interferences-clean 2 meters and below, 1 metre out on floor-after clean</p> |

Lead dust was removed under controlled conditions using hand tools, H-Class HEPA-filtered vacuum cleaner & cloth wiping techniques.
