# ARBORICULTURAL DEVELOPMENT IMPACT AND TREE PROTECTION REPORT

Shoalhaven Hospital –  
**Acute Services Building Project**  
North Street and Scenic Drive  
NOWRA NSW 2541  
Lot 1 DP 1043088, Lot 1 DP 1128  
777, Lot 2 DP 1128777, Part 7300 DP 1132679  
JULY 2022  
FINAL (Updated 30<sup>th</sup> August 2022)

Prepared for: Health Infrastructure  
c/o Johnstaff

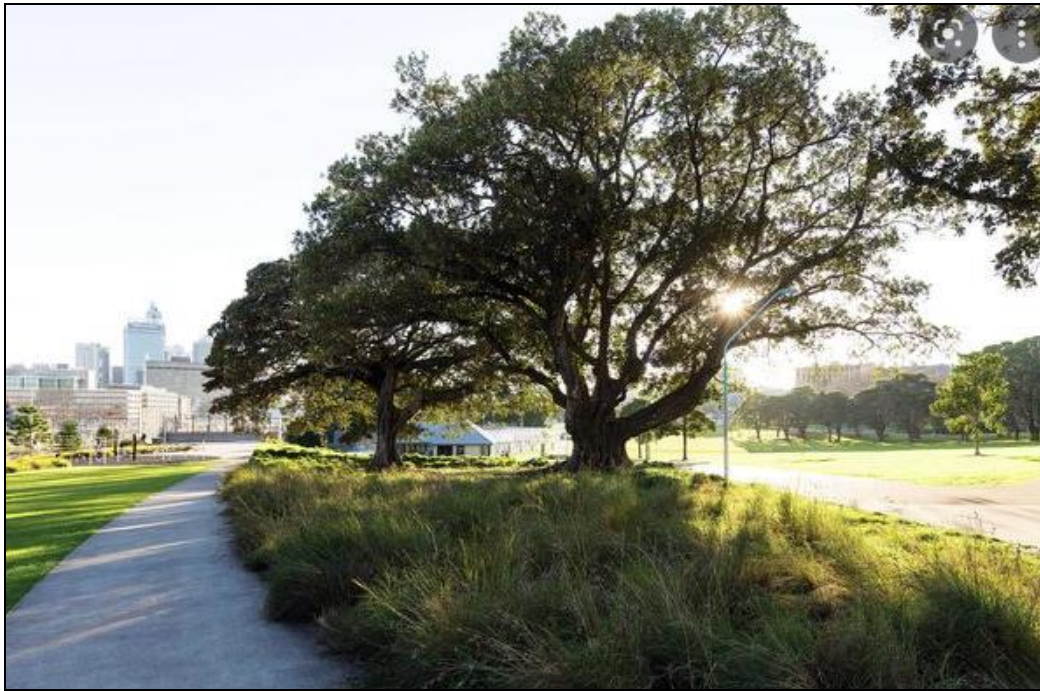
- 4.5** For the purpose of this report, I have categorised Tree 50 as having a high significance rating for its current status. In terms of long term planning this tree may live for another forty (40) years however all trees do not live forever and at some stage this tree will enter senescence where dieback and the shedding of limbs will be part of this senescing process. Level changes and altering the surface hydrology around this tree is likely to speed up this senescing process. It will be important that the existing levels are retained and that the pedestrian path is designed so that water does not pool within the TPZ area (See Note 1, Tree Protection Plan). Potentially this tree could be retained however the entire area under the drip line should be planted out as garden area (Plate 12) in order to

reduce the element of risk from limbs that may fail from a tree of this age. The current plans show the area being turf (See Note 2, Tree Protection Plan).

**Plate 12:** Image showing an example of a planted out garden area below a large mature tree (Architectureau 2022).

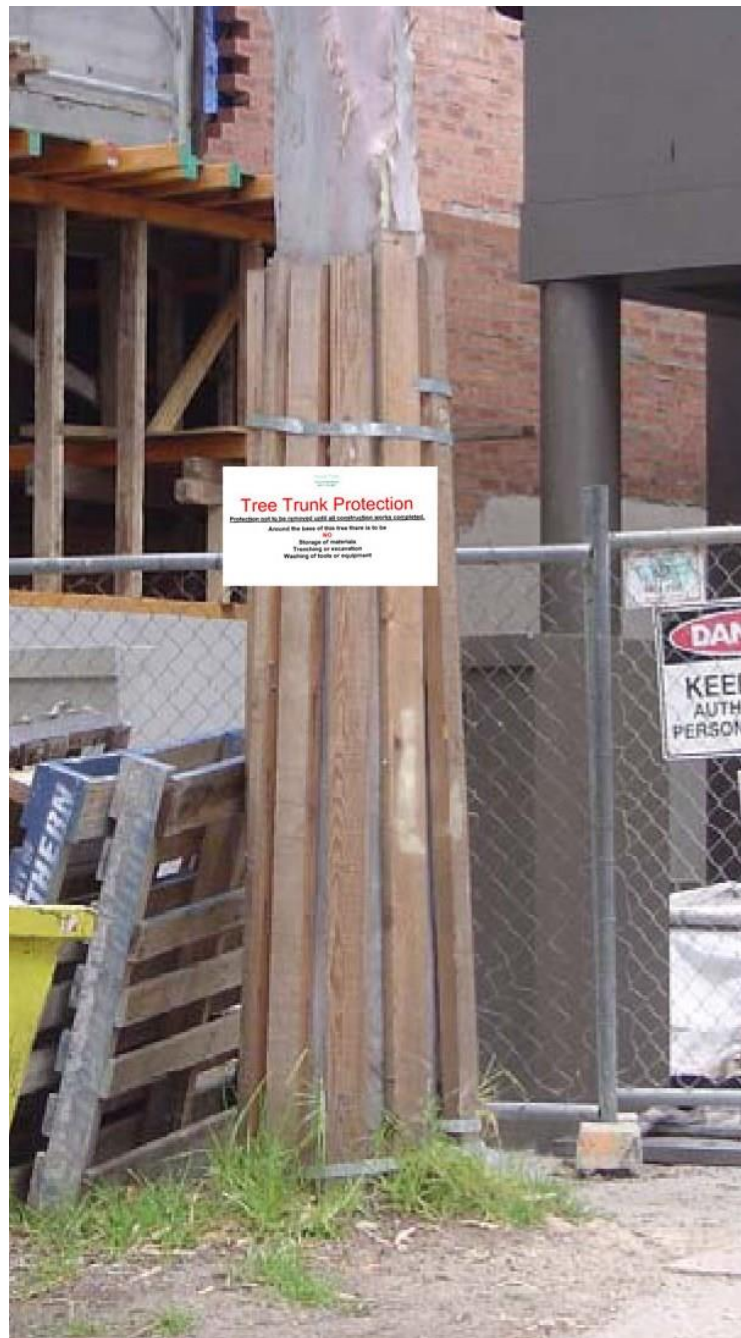
**Plate 12:** Example of trunk protection with sign attached, recommended for the street trees. P. Vezgoff.

- 5.3 Individual trunk protection:** Street trees numbered as 57-60, 62, 74-77 and 101 will require trunk protection to be installed prior to any demolition works occurring. This is achieved by attaching lengths of timber (75mm x 50mm x 2000mm) fastened around the trunk. Geotextile fabric or carpet underlay shall be wrapped around the trunk prior to the timbers being attached. These timbers are to be fastened with hoop iron strapping and not attached directly into the bark of the tree. These timbers are only to be removed when all construction is complete. See Plate 12 for an example of trunk protection. This trunk protection is based on The Australian Standard *Protection of trees on development sites*, AS 4970, 2009.
