## 9. Inventory Sheets

This chapter includes the inventory sheets for each room within the CME Building. Each datasheet includes:

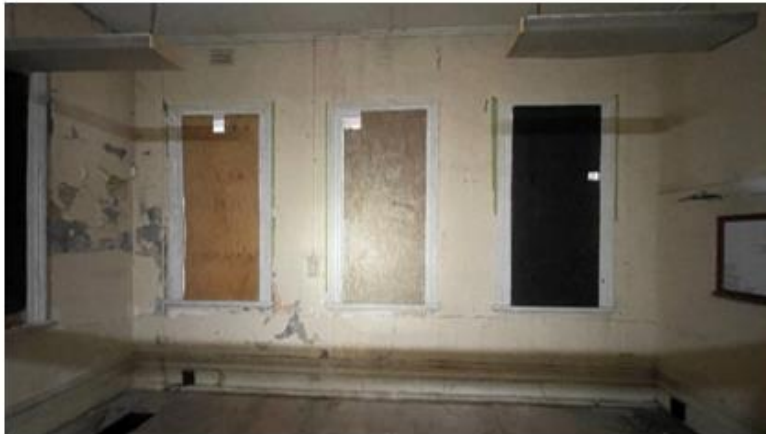
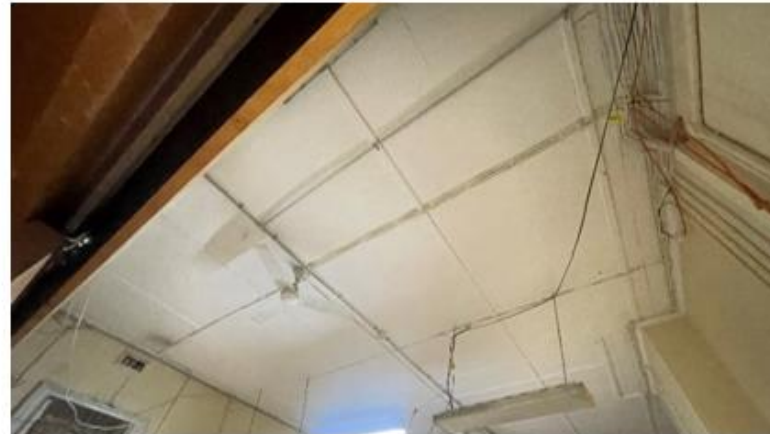
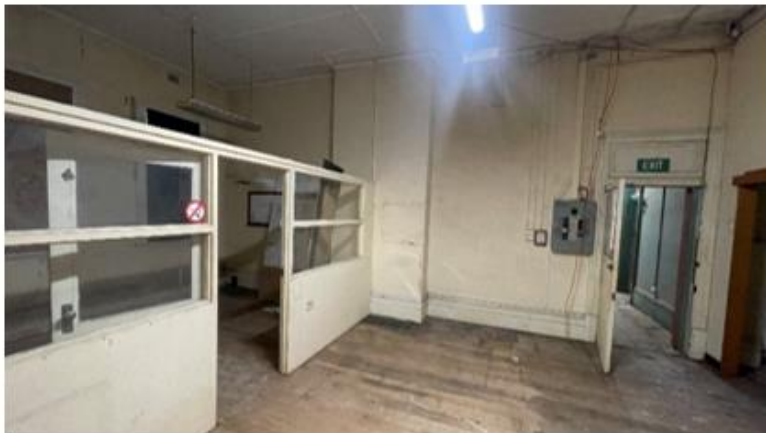
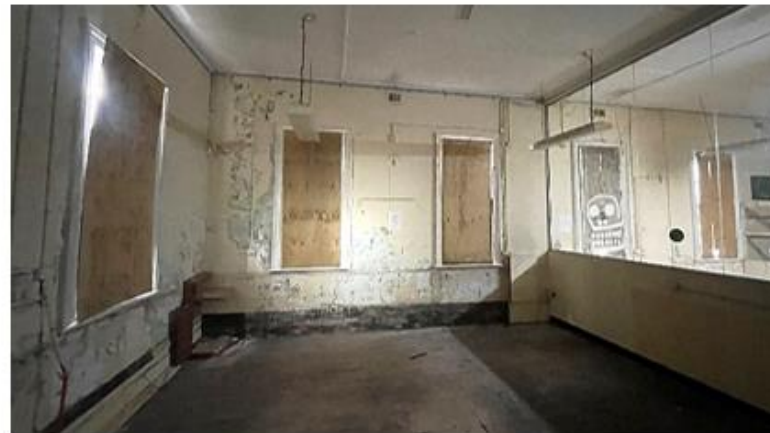
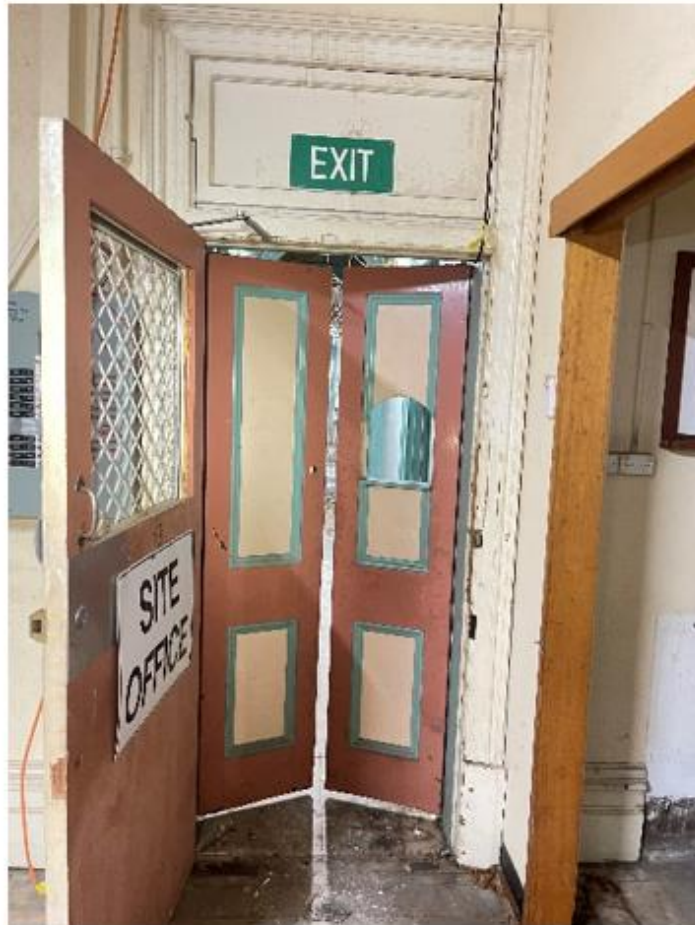
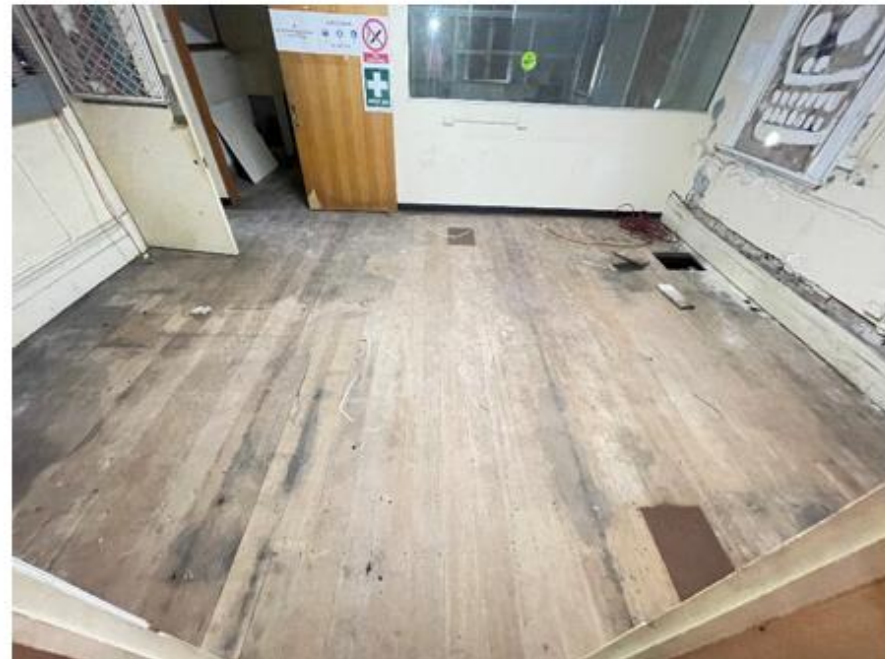
## CME Building – Room G1

Walls	Poor	<p><b>Description:</b> Rising damp at lower levels and falling damp mostly contained to below windows and at NW corner at high level, cracks on western wall, particularly near windows, brick vents are miss matched and some are damaged, paint poor and flaking in places, many surface fixed conduits, fittings and penetrations for services. Intrusive modern partition walls divide this room into 3.</p> <p><b>Recommendation:</b> Remove modern partitions. Paint strip areas of loose or flaking paint, and where the damp has affected it. The rest can be subject to overcoating and or spot repairs as per the guidelines within AS4361.1:2017 <i>Guide to Hazardous Paint Management</i>. Render to be removed up to 1200mm high where rising damp has occurred and wet vacuum wash the brickwork for multiple cycles with a contained head wet system. Allow to dry for min 6 weeks and apply a salt retardant render prior to white set and painting.</p> <p>Also refer to section Walls and Section Painted Surfaces in the <i>Physical Condition and Schedule of Conservation Works</i> report for further treatment recommendations.</p>

Skirting	Very Poor	<p><b>Description:</b> Tall ornate skirtings located sporadically within the room, most are either missing or rotten. The southern and western Skirtings are badly water damaged and rotten</p> <p><b>Recommendation:</b> skirting to be removed to facilitate rising damp repairs and floor removal.</p> <ul style="list-style-type: none"> <li>• Generally, skirtings should remain in their existing positions. Any skirting being replaced due to damage such as water ingress, dry rot and termite damage or that are missing should be reproduced to replicate other skirtings in the same room, or if none at all, should replicate its most likely profile based on the findings of the 1997 CMP.</li> <li>• Ground floor skirtings that are required to be removed for the subfloor excavation works, should have their locations recorded, labelled clearly, carefully removed, de-nailed, cleaned up and reinstated post excavation and subfloor works.</li> </ul>

Fireplace	Very Poor	<p><b>Description:</b> 2 x fireplaces, both sheeted over and missing. Mantles also missing</p> <p><b>Recommendation:</b> as per Section 3.1.8 Fireplaces</p> <p><b>Grading of Significance: Moderate</b></p>

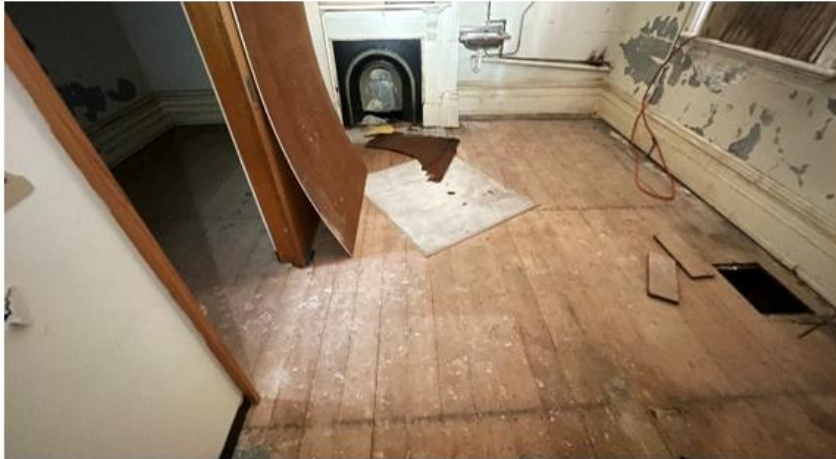
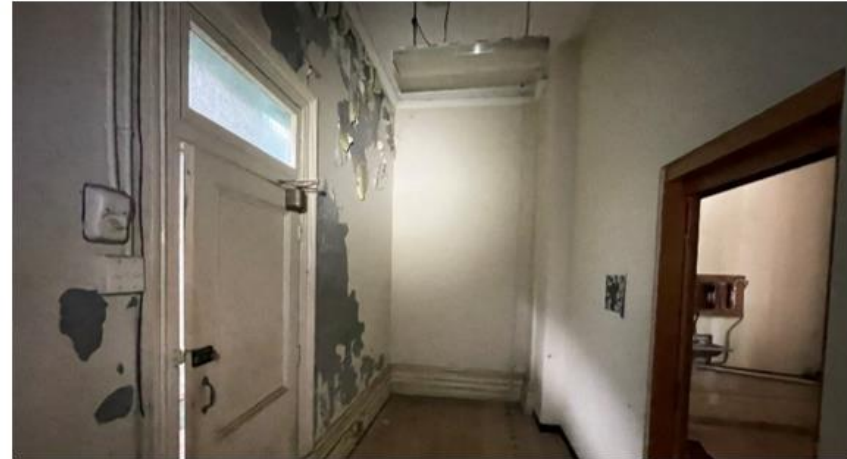
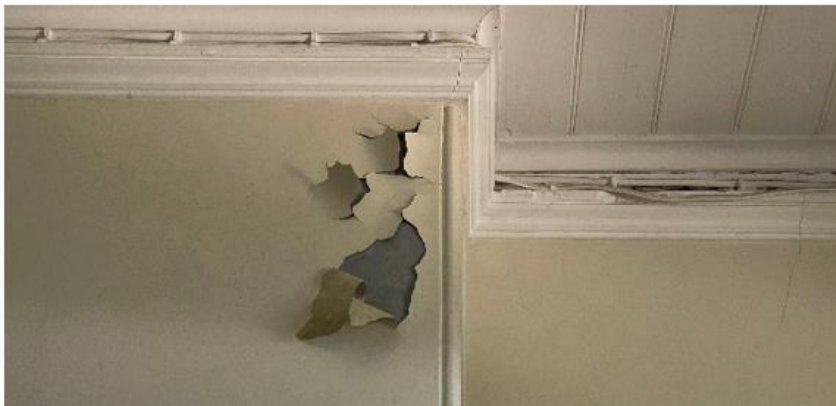
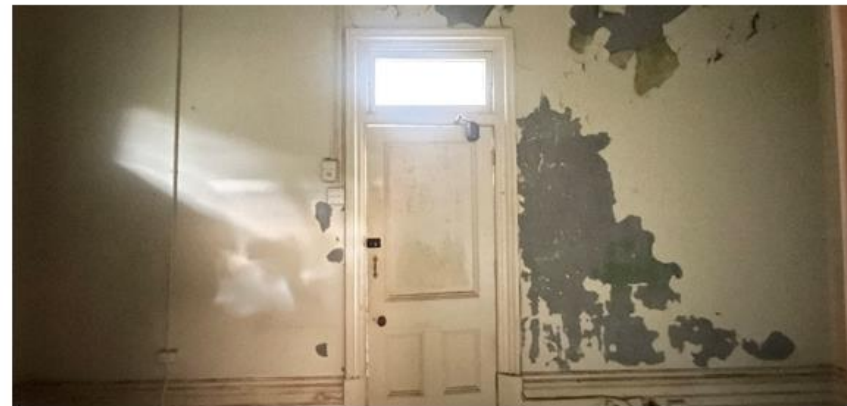
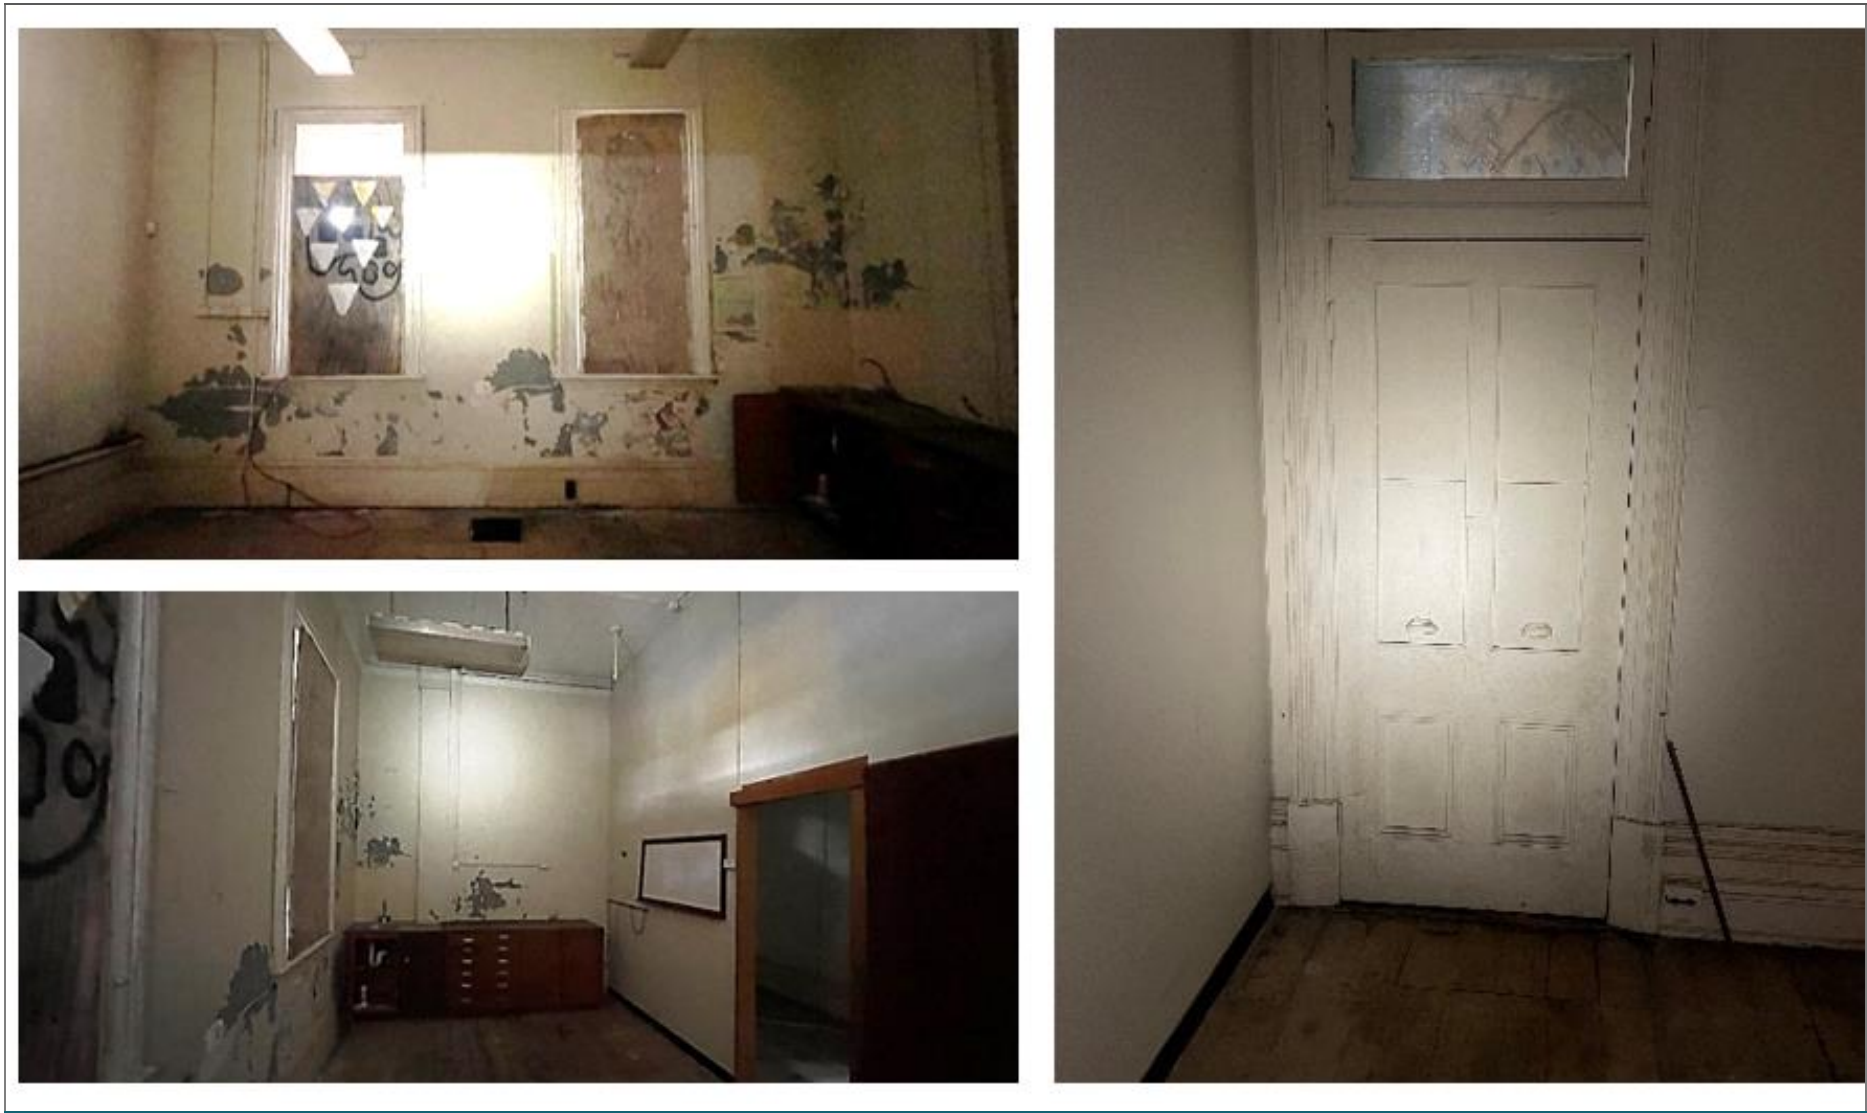
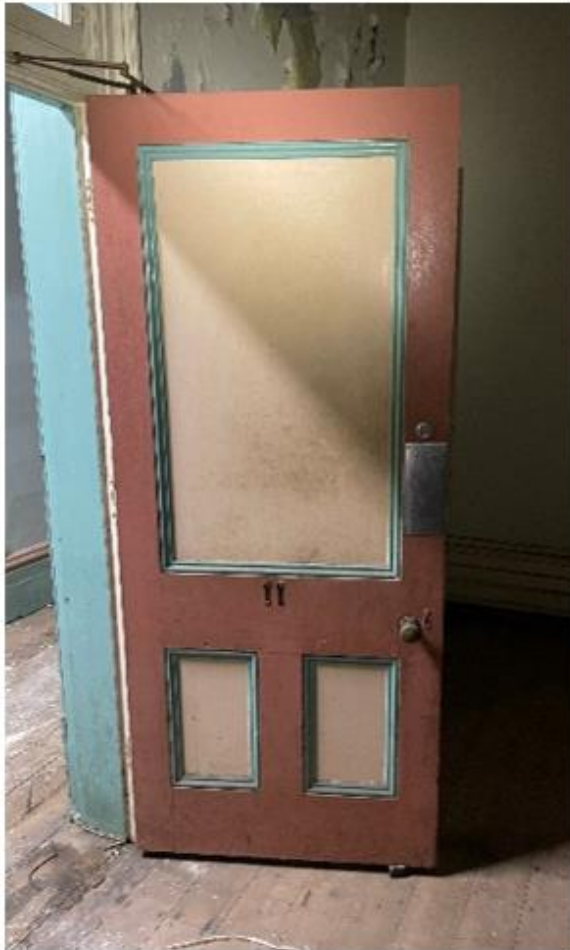
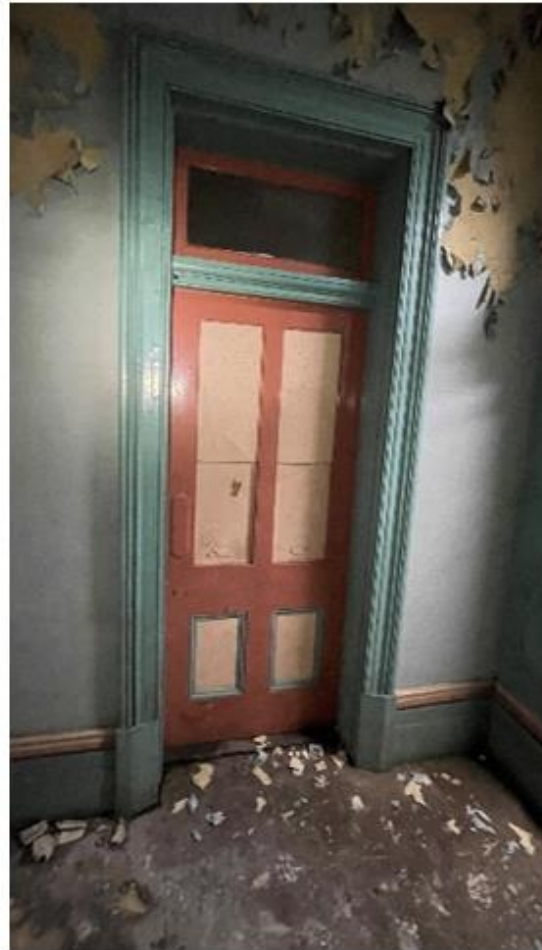
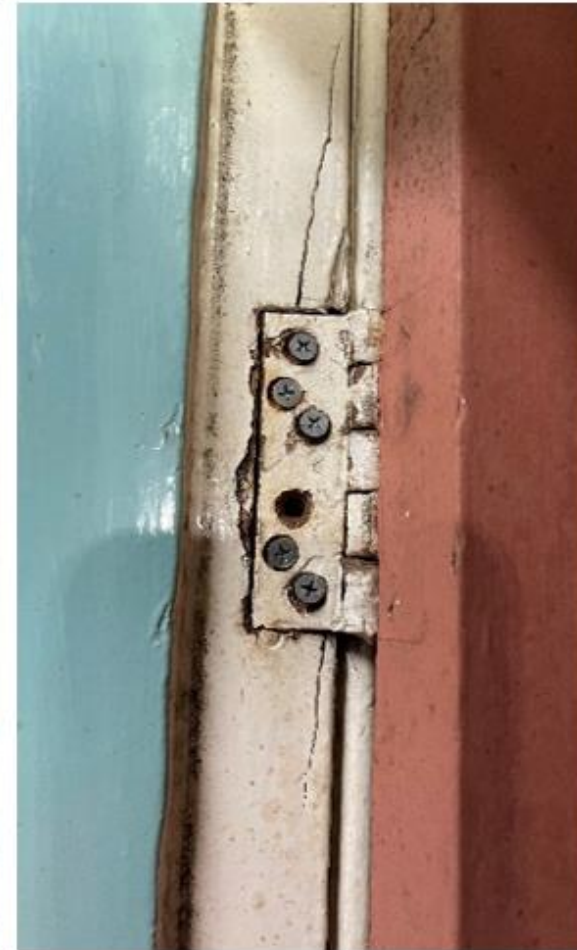
## CME Building – Room G2

CME Building – Room G2		
		Grading of Significance: High
Walls	Poor to Fair	<p><b>Description:</b> Rising damp at lower levels and falling damp mostly contained to North and South walls, cracks on north wall, particularly near windows, brick vents are miss matched and some are damaged by services penetrations or covered over, paint poor and flaking in places, many surface fixed conduits, fittings and penetrations for services. Various poorly chased pipeworks a redundant pipe protruding between the windows on the north wall. An intrusive modern partition wall divide this room into 2. An intrusive joinery cupboard with a sink exists in the north eastern corner</p> <p><b>Recommendation:</b> Remove modern partitions. Paint strip areas of loose or flaking paint, and where the damp has affected it. The rest can be subject to overcoating and or spot repairs as per the guidelines within <i>AS4361.1:2017 Guide to Hazardous Paint Management</i>. Render to be removed up to 1200mm high where rising damp has occurred and wet vacuum wash the brickwork for multiple cycles with a contained head wet system. Allow to dry for min 6 weeks and apply a salt retardant render prior to white set and painting.</p> <p>Also refer to section 3.1.2. Walls and Section 3.1.3. Painted Surfaces in the <i>Physical Condition and Schedule of Conservation Works</i> report for further treatment recommendations.</p> <p>Grading of Significance: High</p>

CME Building – Room G2		
Windows	Poor	<p><b>Description:</b> Windows appear to have been mostly stripped and primed/sealed. Windows are currently boarded up and not accessible for full assessment.</p> <p><b>Recommendation:</b> Remove boarding to expose windows. Strip all lead paint completely from all surfaces and prepare all surfaces under HAZMAT conditions in accordance with <i>AS4361.1:2017 Guide to Hazardous Paint Management</i> prior to commencement of works.</p> <ul style="list-style-type: none"> <li>• Windows should generally be repaired adjusted and cleaned up in their original locations. This could be inclusive of sash cord and weight replacement, glazing putty touch ups or replacement, adjustment and refitting of sashes, rot repairs, broken glass replacement and hardware repairs and or replacement.</li> <li>• Existing heritage hardware should be stripped, polished and reinstated in as close to its original position. Missing hardware should be reinstated with new modern reproduction equivalents.</li> <li>• Locks should be made operational if windows are to be operable. Opening restrictions should be added for both security and code compliance if windows present a climb or fall risk.</li> </ul> <p>See also section 3.1.3. Painted Surfaces and section 3.1.7. Windows in the <i>Physical Condition and Schedule of Conservation Works</i> report for further treatment recommendations.</p> <p><b>Grading of Significance: High</b></p>

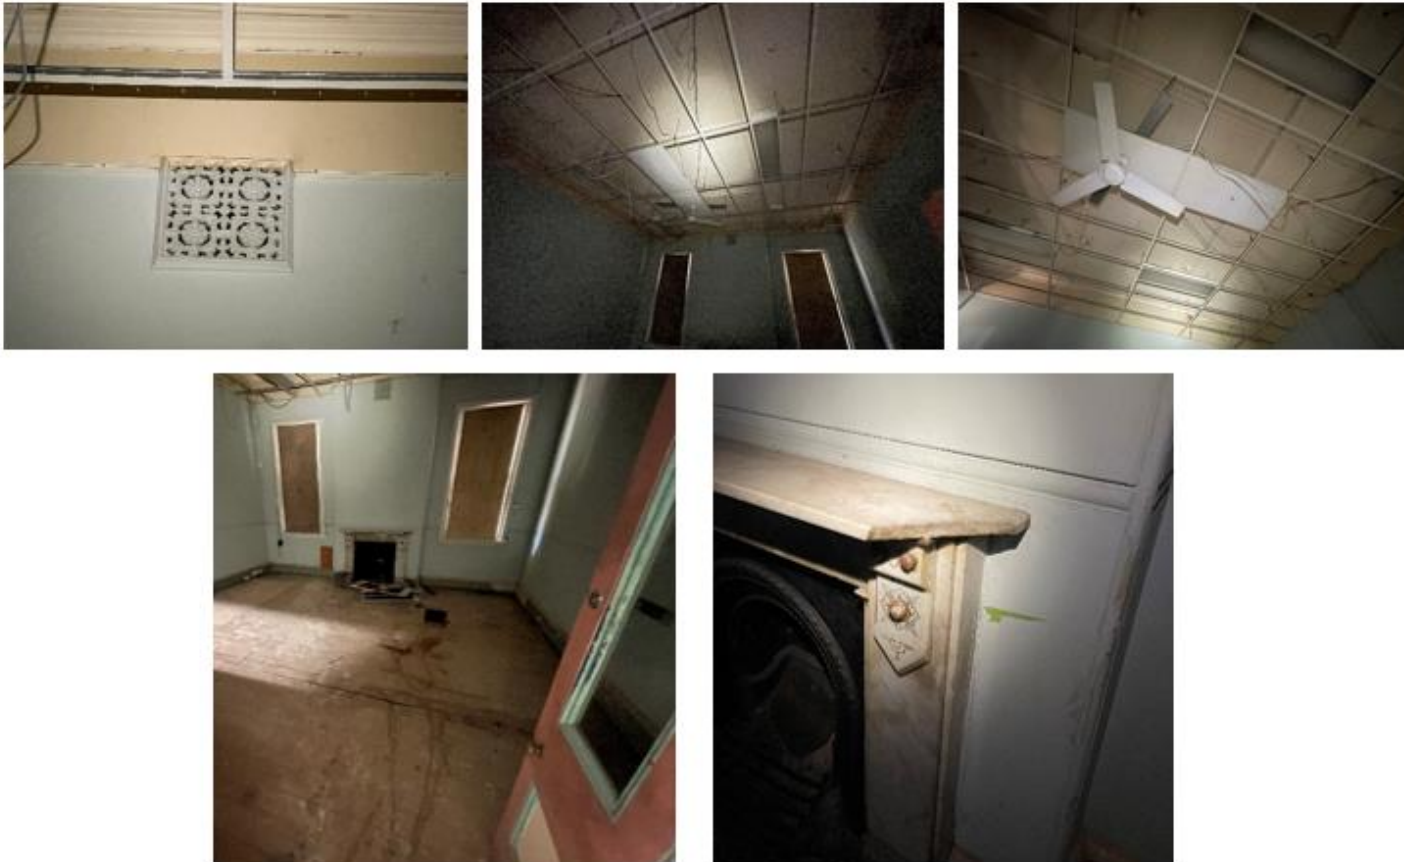
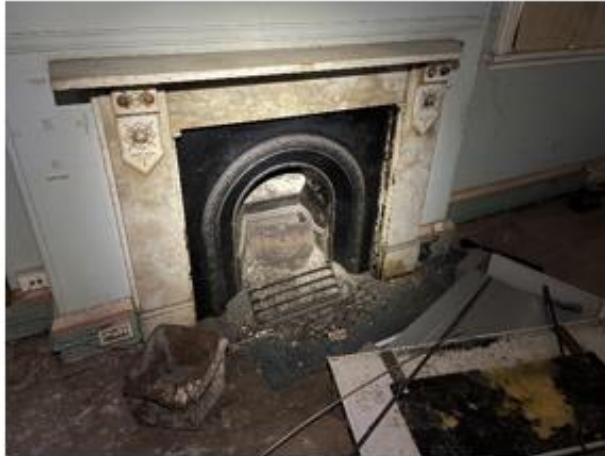
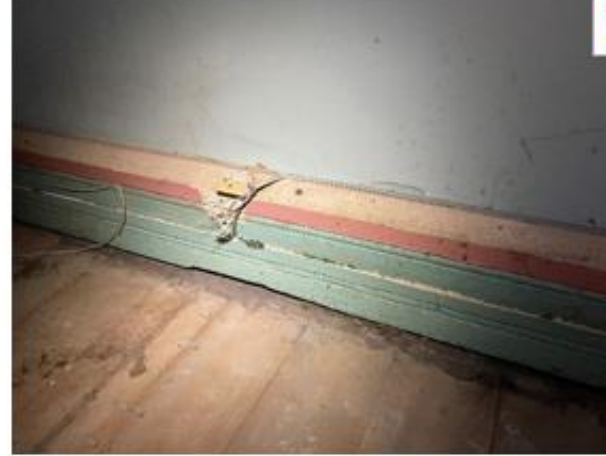
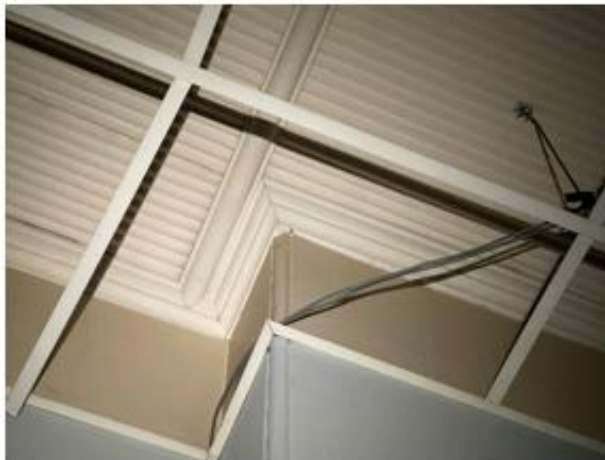
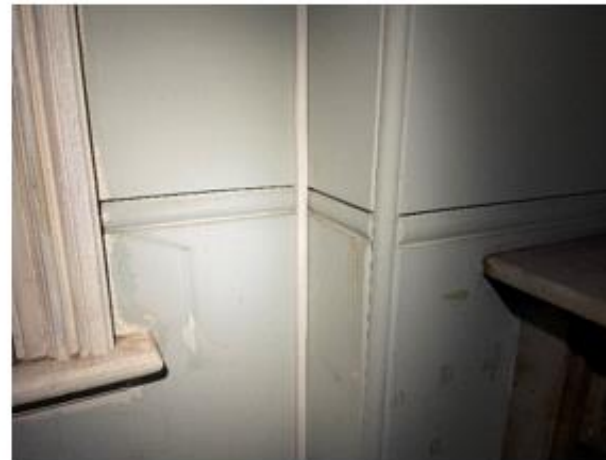
**CME Building – Room G6****Photos**

CME Building – Room G6		
Fabric	Current Condition	Description and Recommendation
Floor	Fair	<p><b>Description:</b> Wide Kauri Pine Floorboards. Generally fair condition besides a few patches.</p> <p><b>Recommendation:</b> All floors on ground floor will need to be temporarily removed to facilitate subfloor works, including installation of concealed services. It is intended to salvage as much as possible of the remnant floorboards for reuse in accordance with Section 3.1.4. in the <i>Physical Condition and Schedule of Conservation Works</i> methodology for floor works. Salvaged flooring from the entire building should collated and graded for condition from best to worst before being re-laid at the completion of subfloor works. Priority should be given to the rooms in key view lines and of most significance to have the floorboards in the best condition as per section 3.1 - 6 General recommendations in the <i>Physical Condition and Schedule of Conservation Works</i></p> <p><b>Grading of Significance: High</b></p>

Walls	Fair	<p><b>Description:</b> Decorative inset moulding at waist height around the room, walls generally sound. Brick vents are miss matched and some are damaged by services penetrations, paint poor with minor flaking in places, many surface fixed conduits, fittings and penetrations for services. Vertical riser panel in south western corner. Decorative vent grill on chimney breast.</p> <p><b>Recommendation:</b> Paint strip areas of loose or flaking paint. The rest can be subject to overcoating and or spot repairs as per the guidelines within AS4361.1:2017 <i>Guide to Hazardous Paint Management</i>. Also refer to section 3.1.2. Walls and Section 3.1.3. Painted Surfaces in the <i>Physical Condition and Schedule of Conservation Works</i> report for further treatment recommendations.</p> <p><b>Grading of Significance: High</b></p>
Ceilings	Good to Fair	<p><b>Description:</b> Corrugated iron ceiling with a large grid of decorative mouldings concealing joints. Surface fixed conduits, fittings and penetrations for services. Existing Tbar grid ceiling system frame in place. Likely original ceiling from 1900 construction.</p> <p><b>Recommendation:</b> Remove Intrusive modern grid ceiling, fixtures fittings and conduits</p>

Cornice	Fair	<p><b>Description:</b> Timber moulding cornice, many surface fixed conduits and wires on cornice.</p> <p><b>Recommendation:</b> Remove intrusive modern fixtures and fittings. Decorative timber mouldings should be repaired in situ if possible. When beyond salvage or if ceilings are replaced, or relocated, timber mouldings should be reinstated with originals salvaged from elsewhere within the building where available or with replicated remakes of the originals should they be beyond salvage. As per section 3.1.1. Ceilings in the <i>Physical Condition and Schedule of Conservation Works</i> report for further treatment recommendations.</p> <p><b>Grading of Significance: High</b></p>

CME Building – Room G6		
Skirting	Poor	<p><b>Description:</b> 1900's addition skirtings with various services, and cabling surface fixed, Skirting may likely show further signs of water damaged and rot upon removal.</p> <p><b>Recommendation:</b> skirting to be removed to facilitate rising damp repairs and floor removal.</p> <ul style="list-style-type: none"> <li>• Generally, skirtings should remain in their existing positions. Any skirting being replaced due to damage such as water ingress, dry rot and termite damage or that are missing should be reproduced to replicate other skirtings in the same room, or if none at all, should replicate its most likely profile based on the findings of the 1997 CMP.</li> <li>• Ground floor skirtings that are required to be removed for the subfloor excavation works, should have their locations recorded, labelled clearly, carefully removed, de-nailed, cleaned up and reinstated post excavation and subfloor works.</li> <li>• Consideration should be put into packing out skirtings with battens to create a void space for wiring prior to reinstallation where they are required to be removed to facilitate other works such as floor replacement, Subfloor excavation or rising damp remediation.</li> <li>• Consideration should be made towards sensitively and sympathetically incorporating a skirting duct into the current skirting profiles to facilitate ease of future services reticulation and to minimize the requirement for future invasive works.</li> </ul> <p>See also section 3.1.7. Skirtings in the <i>Physical Condition Report and Schedule of Conservation Works</i>.</p> <p><b>Grading of Significance: High</b></p>

Doors	Fair	<p><b>Description:</b> 4 panel door in fair condition to south, with glazing to top two panels.</p> <p><b>Recommendation:</b></p> <ul style="list-style-type: none"> <li>• Doors should generally be adjusted, cleaned up, and rehung in their original locations.</li> <li>• -Existing heritage hardware that is non-operational should be stripped, polished, decommissioned and reinstated in as close to its original position provided that it does not interfere with compliance of new door control hardware. New modern hardware that is sympathetic to the heritage aspect of the building yet compliant with relevant Building codes and Australian Standards (AS1428.1) should be installed.</li> </ul>

Fireplace	Fair	<p><b>Description:</b> Ornate Marble Fireplace with damage to eastern end of mantle top. Cast iron is intact, flue flap is dislodged as is grate. Missing ash collector tray.</p> <p><b>Recommendation:</b> repair top of mantle, polish marble. Refix flue flap and reinstate fire grate.</p> <ul style="list-style-type: none"> <li>Generally, intact existing cast iron fireplaces should be conserved and restored. Where they are missing, they should be replaced with recycled salvaged heritage equivalents of the same period in the more significant rooms or boarded up in the less significant rooms. Restored fireplaces should be welded closed or disabled to ensure they cannot be used as functional fireplaces and vermin cannot access them.</li> <li>Cast iron fireplaces in rooms of lesser significance with rusted centres should have a steel plate infill welded over the opening inside the decorative arch to close them off.</li> <li>Existing mantles should be conserved and restored. Missing mantles should be replaced with secondhand heritage mantles or modern reproductions. The type and materiality of replaced mantles should be</li> </ul>

CME Building – Room G6		
		<ul style="list-style-type: none"> <li>Where intact and not at risk of collapse, complete conservation works to reinstate back to original condition. This could be inclusive of patching existing holes, replacing missing, badly damaged sections and in situ cornice template moulding repairs.</li> <li>Where small areas are damaged beyond salvage, replace with salvaged fabric from other rooms of less significance within the building, replace with second hand salvaged material or replace with replicated modern equivalent.</li> <li>Instead of removing large sections of heritage fabric ceilings to facilitate the installation of services or structural repairs, It would be a more preferable heritage outcome to leave any stable remnant ceiling fabric in situ and install a modern ceiling replica of the original ceiling based on existing documentation from the original build or from evidence of remnant fabric. These new ceilings would be installed lower to provide space to conceal services provided that any loss of height does not detract from the overall scale of the rooms or cover necessary ventilation grills or vents. The original ceiling would remain in its current condition concealed above it.</li> </ul> <p>See also Section 3.1.1 Ceilings in the <i>Physical Condition and Schedule of Conservation Works</i> report for further treatment recommendations.</p> <p><b>Grading of Significance: High</b></p>

CME Building – Room G6		
		<p><b>Recommendation:</b> Remove boarding to expose windows. Strip all lead paint completely from all surfaces and prepare all surfaces under HAZMAT conditions in accordance with <i>AS4361.1:2017 Guide to Hazardous Paint Management</i> prior to commencement of works.</p> <ul style="list-style-type: none"> <li>• Windows should generally be repaired adjusted and cleaned up in their original locations. This could be inclusive of sash cord and weight replacement, glazing putty touch ups or replacement, adjustment and refitting of sashes, rot and damage repairs, broken glass replacement and hardware repairs and or replacement.</li> <li>• Existing heritage hardware should be stripped, polished and reinstated in as close to its original position. Missing hardware should be reinstated with new modern reproduction equivalents.</li> <li>• Locks should be made operational if windows are to be operable. Opening restrictions should be added for both security and code compliance if windows present a climb or fall risk.</li> </ul> <p>See also section 3.1.3. Painted Surfaces and section 3.1.5. Windows in the <i>Physical Condition and Schedule of Conservation Works</i> report for further treatment recommendations.</p> <p><b>Grading of Significance: High</b></p>

CME Building – Room G6		
		<ul style="list-style-type: none"> <li>Fanlights should be cleaned up and made good. They should be made to operate if required as part of the HVAC requirements of the building. Existing hardware should be removed, polished and reinstated. Any missing hardware should be replaced with reproduction items to match the existing. Consideration as to make the fanlights operable, fixed open or fixed closed should be made in conjunction with the requirements of the buildings HVAC system and acoustic considerations.</li> <li>Any damage or cut outs to architraves or jambs should be reinstated with timber inlays and reshaped to blend in.</li> <li>Doors that need to be pinned in an open position should be fixed in place with a concealed fixing. Also refer to section 3.1.6. Doors in the <i>Physical Condition Report and Schedule of Conservation Works</i>.</li> </ul> <p><b>Grading of Significance: High</b></p>

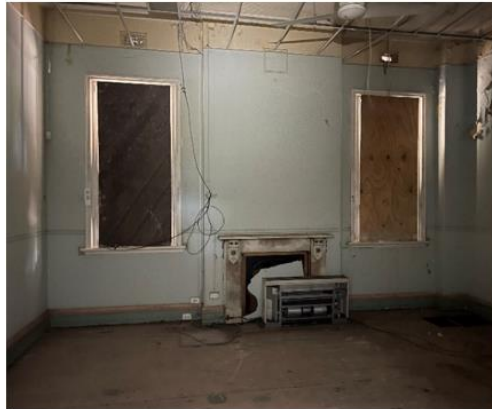
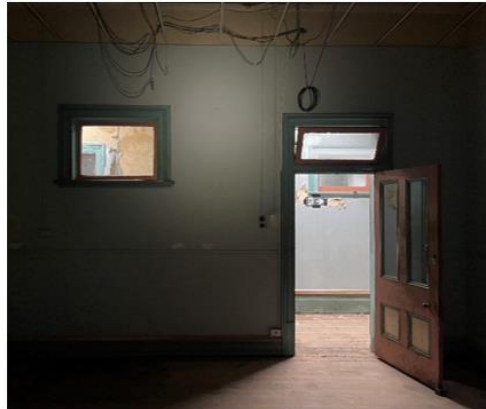
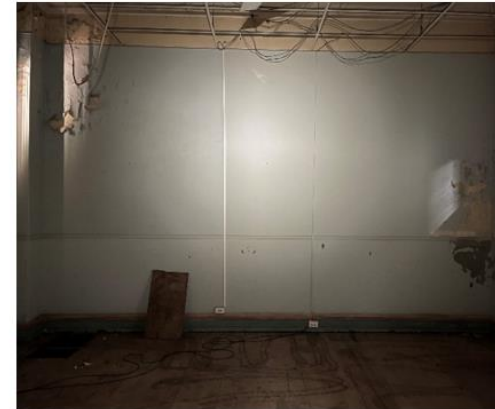
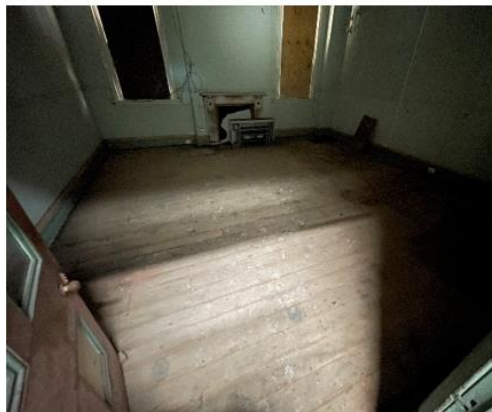
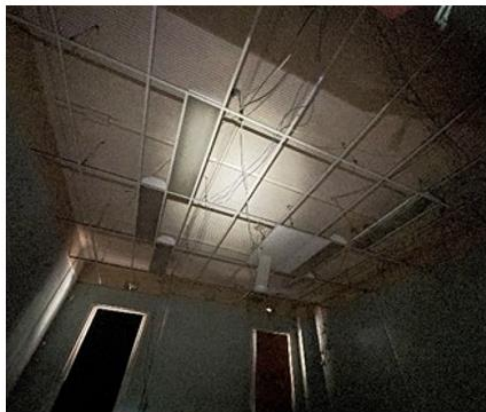
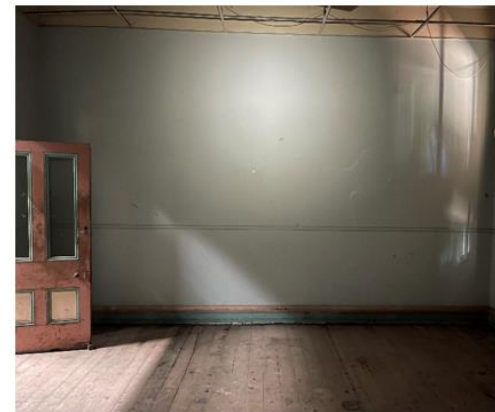
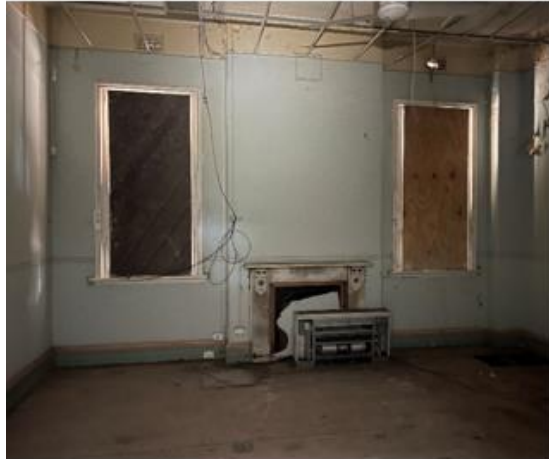
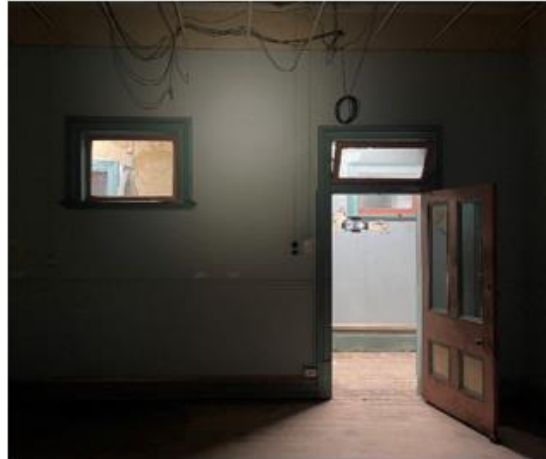
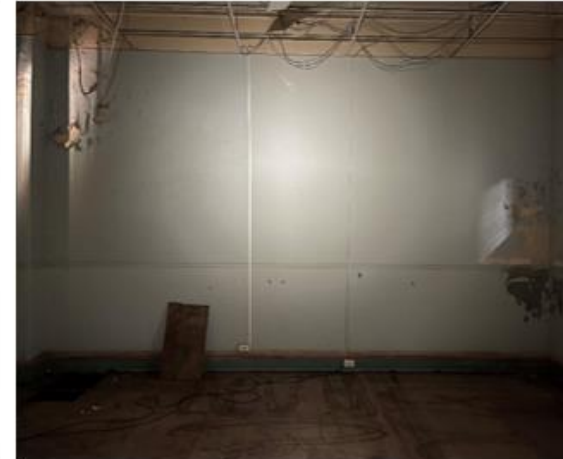
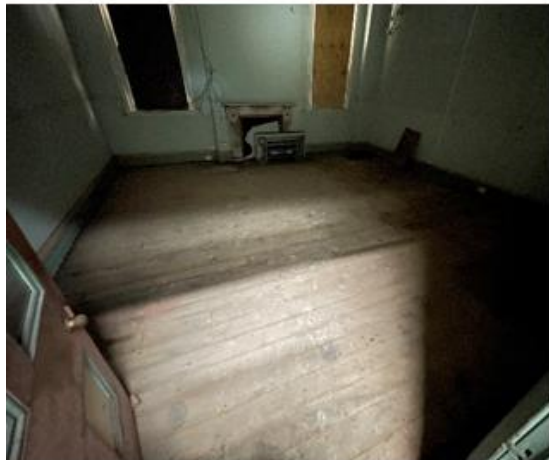
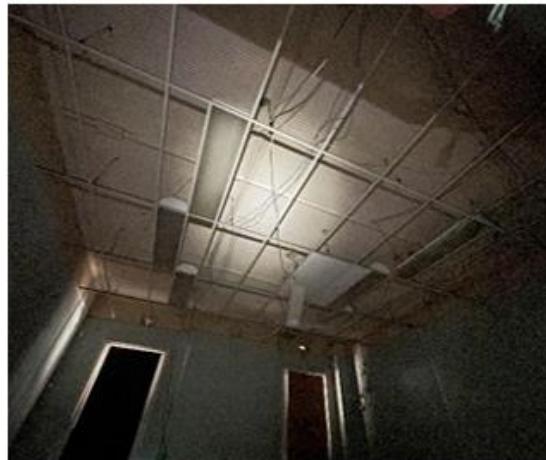
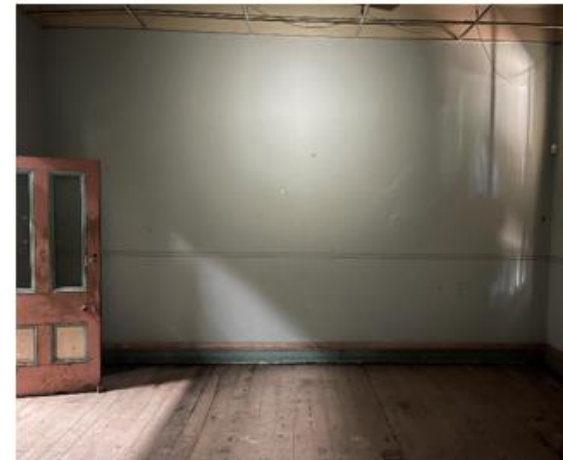
## CME Building – Room G7

CME Building – Room G7		
Fabric	Current Condition	Description and Recommendation
Floor	Fair	<p><b>Description:</b> Wide Kauri Pine Floorboards. Generally fair condition besides a few patches.</p> <p><b>Recommendation:</b> All floors on ground floor will need to be temporarily removed to facilitate subfloor works, including installation of concealed services. It is intended to salvage as much as possible of the remnant floorboards for reuse in accordance with Section 3.1.4. in the <i>Physical Condition and Schedule of Conservation Works</i> methodology for floor works. Salvaged flooring from the entire building should collated and graded for condition from best to worst before being re-laid at the completion of subfloor works. Priority should be given to the rooms in key view lines and of most significance to have the floorboards in the best condition as per section 3.1 - 6 General recommendations in the <i>Physical Condition and Schedule of Conservation Works</i></p> <p><b>Grading of Significance: High.</b></p>

Walls	Fair	<p><b>Description:</b> Decorative inset moulding at waist height around the room, falling damp in the north east and south east corners. There is a square build out in the North east corner. Brick vents are miss matched and some are damaged by services penetrations, paint poor with flaking in places, many surface fixed conduits, fittings and penetrations for services. Vertical riser panel in south western corner. Decorative vent grill on chimney breast has been covered over.</p> <p><b>Recommendation:</b> Paint strip areas of loose or flaking paint. The rest can be subject to overcoating and or spot repairs as per the guidelines within <i>AS4361.1:2017 Guide to Hazardous Paint Management</i>. Also refer to section 3.1.2 Walls and Section 3.1.3. Painted Surfaces in the <i>Physical Condition and Schedule of Conservation Works</i> report for further treatment recommendations.</p> <p><b>Grading of Significance: High</b></p>

Ceilings	Fair	<p><b>Description:</b> Corrugated iron ceiling with a large grid of decorative mouldings concealing joints. Surface fixed conduits, fittings and penetrations for services. Existing Tbar grid ceiling system frame in place. Likely original ceiling from 1900 construction.</p> <p><b>Recommendation:</b> Remove Intrusive modern grid ceiling, fixtures fittings and conduits</p>

Cornice	Fair	<p><b>Description:</b> Timber moulding cornice, many surface fixed conduits and wires on cornice.</p> <p><b>Recommendation:</b> Remove intrusive modern fixtures and fittings. Decorative timber mouldings should be repaired in situ if possible. When beyond salvage or if ceilings are replaced, or relocated, timber mouldings should be reinstated with originals salvaged from elsewhere within the building where available or with replicated remakes of the originals should they be beyond salvage. As per section 3.1.1. Ceilings in the <i>Physical Condition and Schedule of Conservation Works</i> report for further treatment recommendations.</p> <p><b>Grading of Significance: High</b></p>

CME Building – Room G7		
Skirting	Fair	<p><b>Description:</b> 1900's addition skirtings with various services, and cabling surface fixed, Skirting may likely show further signs of water damaged and rot upon removal.</p> <p><b>Recommendation:</b> skirting to be removed to facilitate rising damp repairs and floor removal.</p> <ul style="list-style-type: none"> <li>• Generally, skirtings should remain in their existing positions. Any skirting being replaced due to damage such as water ingress, dry rot and termite damage or that are missing should be reproduced to replicate other skirtings in the same room, or if none at all, should replicate its most likely profile based on the findings of the 1997 CMP.</li> <li>• Ground floor skirtings that are required to be removed for the subfloor excavation works, should have their locations recorded, labelled clearly, carefully removed, de-nailed, cleaned up and reinstated post excavation and subfloor works.</li> <li>• Consideration should be put into packing out skirtings with battens to create a void space for wiring prior to reinstallation where they are required to be removed to facilitate other works such as floor replacement, Subfloor excavation or rising damp remediation.</li> <li>• Consideration should be made towards sensitively and sympathetically incorporating a skirting duct into the current skirting profiles to facilitate ease of future services reticulation and to minimize the requirement for future invasive works.</li> </ul> <p>See also section 3.1.7 Skirtings in the <i>Physical Condition Report and Schedule of Conservation Works</i>.</p> <p><b>Grading of Significance: High</b></p>

Doors	Fair	<p><b>Description:</b> 4 panel door in fair condition to south, with glazing to top two panels.</p> <p><b>Recommendation:</b></p> <ul style="list-style-type: none"> <li>• Doors should generally be adjusted, cleaned up, and rehung in their original locations.</li> <li>• -Existing heritage hardware that is non-operational should be stripped, polished, decommissioned and reinstated in as close to its original position provided that it does not interfere with compliance of new door control hardware. New modern hardware that is sympathetic to the heritage aspect of the building yet compliant with relevant Building codes and Australian Standards (AS1428.1) should be installed.</li> </ul>

Fireplace	Fair	<p><b>Description:</b> Ornate Marble Fireplace with Cast iron intact. Missing ash collector tray and minor damage and rust to fire box.</p> <p><b>Recommendation:</b> Polish marble, fix flue flap closed and reinstate or close off ash collector.</p> <ul style="list-style-type: none"> <li>Generally, intact existing cast iron fireplaces should be conserved and restored. Where they are missing, they should be replaced with recycled salvaged heritage equivalents of the same period in the more significant rooms or boarded up in the less significant rooms. Restored fireplaces should be welded closed or disabled to ensure they cannot be used as functional fireplaces and vermin cannot access them.</li> <li>Cast iron fireplaces in rooms of lesser significance with rusted or missing centres should have a steel plate infill welded over the opening inside the decorative arch to close them off.</li> <li>Existing mantles should be conserved and restored. Missing mantles should be replaced with secondhand heritage mantles or modern reproductions. The type and materiality of replaced mantles should be representative of the room type. The more significant rooms should have marble mantles reinstated whereas</li> </ul>

CME Building – Room G7		
		<ul style="list-style-type: none"> <li>Where intact and not at risk of collapse, complete conservation works to reinstate back to original condition. This could be inclusive of patching existing holes, replacing missing, badly damaged sections and in situ cornice template moulding repairs.</li> <li>Where small areas are damaged beyond salvage, replace with salvaged fabric from other rooms of less significance within the building, replace with second hand salvaged material or replace with replicated modern equivalent.</li> <li>Instead of removing large sections of heritage fabric ceilings to facilitate the installation of services or structural repairs, It would be a more preferable heritage outcome to leave any stable remnant ceiling fabric in situ and install a modern ceiling replica of the original ceiling based on existing documentation from the original build or from evidence of remnant fabric. These new ceilings would be installed lower to provide space to conceal services provided that any loss of height does not detract from the overall scale of the rooms or cover necessary ventilation grills or vents. The original ceiling would remain in its current condition concealed above it.</li> </ul> <p>See also Section 3.1.1. in the <i>Physical Condition and Schedule of Conservation Works</i> report for further treatment recommendations.</p> <p><b>Grading of Significance: High</b></p>

CME Building – Room G7		
		<p><b>Recommendation:</b> Remove boarding to expose windows. Strip all lead paint completely from all surfaces and prepare all surfaces under HAZMAT conditions in accordance with <i>AS4361.1:2017 Guide to Hazardous Paint Management</i> prior to commencement of works.</p> <ul style="list-style-type: none"> <li>• Windows should generally be repaired adjusted and cleaned up in their original locations. This could be inclusive of sash cord and weight replacement, glazing putty touch ups or replacement, adjustment and refitting of sashes, rot and damage repairs, broken glass replacement and hardware repairs and or replacement.</li> <li>• Existing heritage hardware should be stripped, polished and reinstated in as close to its original position. Missing hardware should be reinstated with new modern reproduction equivalents.</li> <li>• Locks should be made operational if windows are to be operable. Opening restrictions should be added for both security and code compliance if windows present a climb or fall risk.</li> </ul> <p>See also section 3.1.3. Painted Surfaces and section 3.1.5. Windows in the <i>Physical Condition and Schedule of Conservation Works</i> report for further treatment recommendations.</p> <p><b>Grading of Significance: High</b></p>

CME Building – Room G7		
		<ul style="list-style-type: none"> <li>Fanlights should be cleaned up and made good. They should be made to operate if required as part of the HVAC requirements of the building. Existing hardware should be removed, polished and reinstated. Any missing hardware should be replaced with reproduction items to match the existing. Consideration as to make the fanlights operable, fixed open or fixed closed should be made in conjunction with the requirements of the buildings HVAC system and acoustic considerations.</li> <li>Any damage or cut outs to architraves or jambs should be reinstated with timber inlays and reshaped to blend in.</li> <li>Doors that need to be pinned in an open position should be fixed in place with a concealed fixing.</li> </ul> <p>Also refer to section 3.1.6. Doors in the <i>Physical Condition Report and Schedule of Conservation Works</i>.</p> <p><b>Grading of Significance: High</b></p>
