## 9. Inventory Sheets

This chapter includes the inventory sheets for each room within the CME Building. Each datasheet includes:

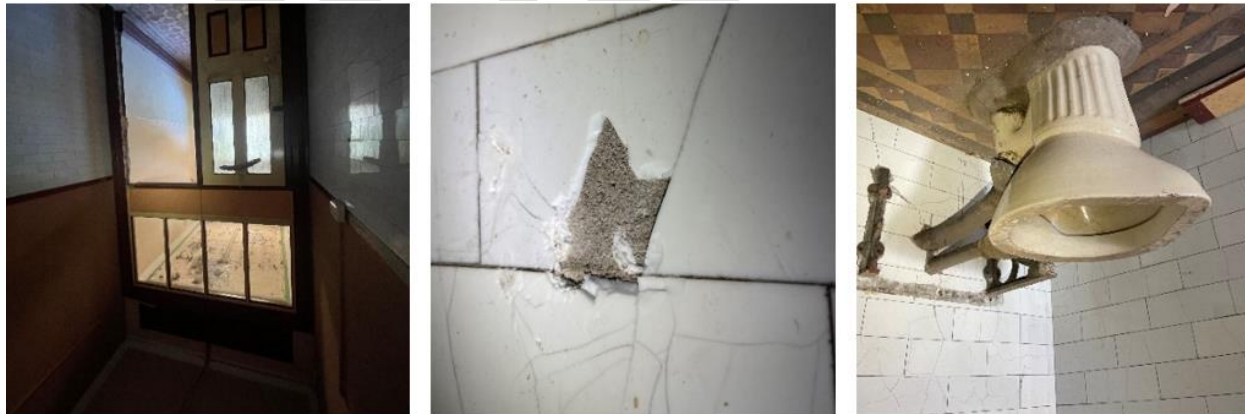
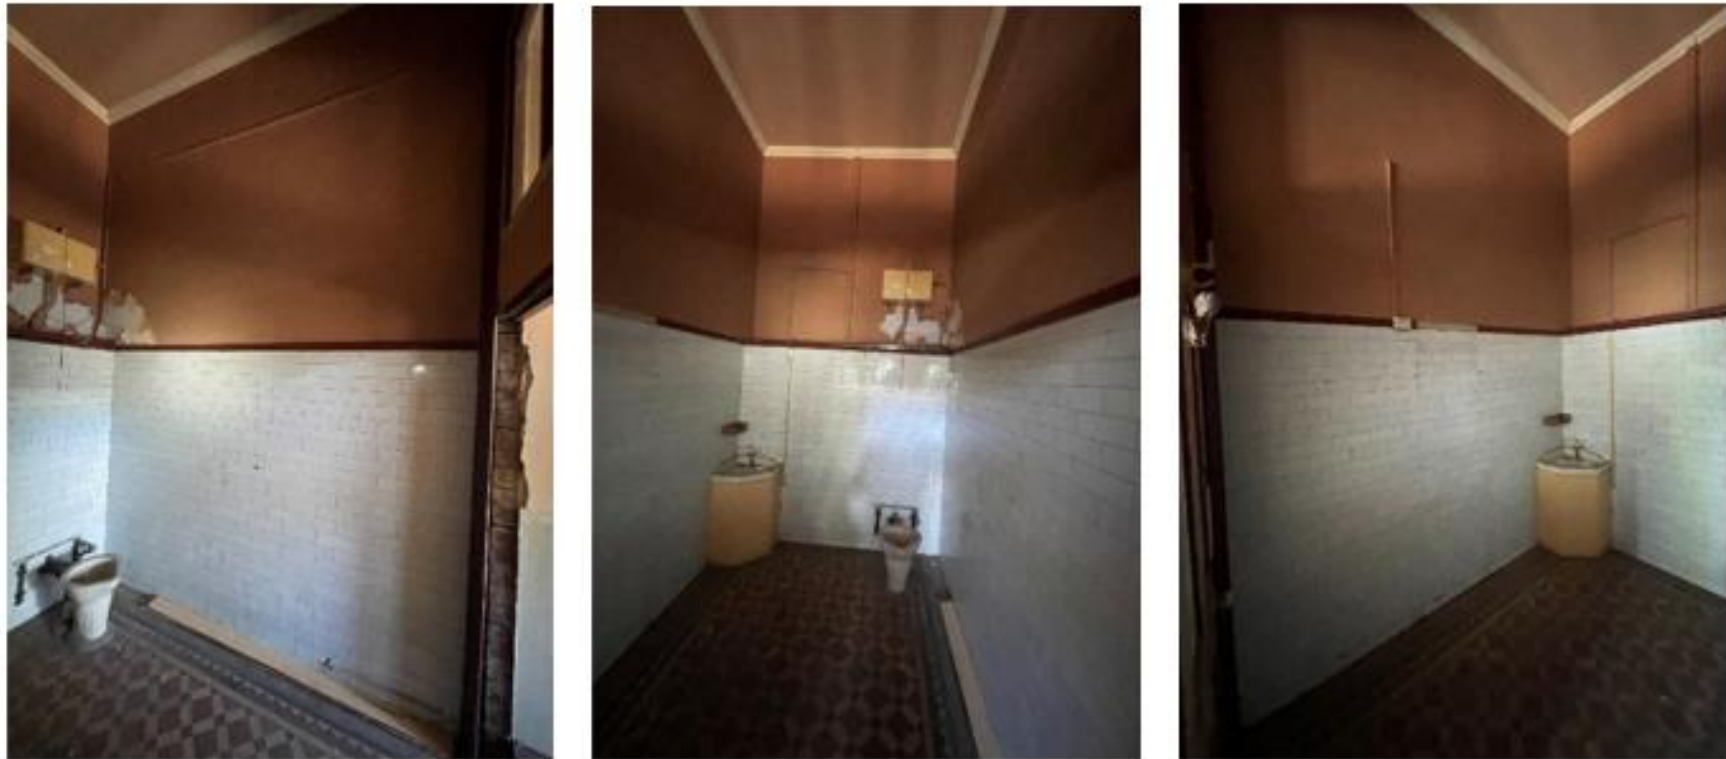
## Photos

CME Building – Room G8		
Fabric	Current Condition	Description and Recommendation
Floor	Good	<p><b>Description:</b> Tesselated tiles, Generally good condition besides a few patches that will be required when redundant WC pan and vanity are removed. WC Pan is listed as an item of moveable heritage</p> <p><b>Recommendation:</b> Floors in this room should be retained and patched as required with matching tiles. Replace patch where centre jamb mullion is removed with contrasting piece to signify that the jamb was once in situ as an interpretive element. The WC Pan is in poor condition and has damage where additional pipes have been fed into the rear trap. As this has a low chance of interpretation or reuse, it should be removed with consideration towards its disposal. Also refer to Section 3.1.4. Floors in the <i>Physical Condition and Schedule of Conservation Works</i> methodology for floor works.</p> <p><b>Grading of Significance: Exceptional</b></p>

Walls	Fair	<p><b>Description:</b> White glass subway style tiles to around 1800 in height around the room to the east, west and south are crazed but sound. Damaged in places with screw holes, cistern brackets, existing services and some impacts. Falling damp in the south east corner. There is a build out on the southern wall to tile height to likely accommodate services. Paint is poor with flaking in places, many surface fixed conduits, fittings and penetrations for services. A timber partition to the north containing inward opening doors, however, the western door and its jamb are not attached. A decorative vertical grill panel sits above the northern partition for ventilation</p> <p><b>Recommendation:</b> Patch repair tiles with best match, Paint strip areas of loose or flaking paint. The rest can be subject to overcoating and or spot repairs as per the guidelines within <i>AS4361.1:2017 Guide to Hazardous Paint Management</i>. Also refer to section 3.1.2. Walls and Section 3.1.3. Painted Surfaces in the <i>Physical Condition and Schedule of Conservation Works</i> report for further treatment recommendations.</p> <p><b>Grading of Significance: High</b></p>

Ceilings	Fair	<p><b>Description:</b> Flat ceiling, unconfirmed materiality. Surface fixed conduits, fittings and penetrations for services. Unlikely to be original ceiling from 1900 construction.</p> <p><b>Recommendation:</b> Confirm materiality is not HAZMAT containing. Remove Intrusive modern fixtures, fittings and conduits.</p>

CME Building – Room G8		
		<ul style="list-style-type: none"> <li>Where intact and not at risk of collapse, complete conservation works to reinstate back to original condition. This could be inclusive of patching existing holes, replacing missing, badly damaged sections and in situ cornice template moulding repairs.</li> <li>Where small areas are damaged beyond salvage, replace with a replicated modern equivalent.</li> <li>Instead of removing large sections of heritage fabric ceilings to facilitate the installation of services or structural repairs, it would be a more preferable heritage outcome to leave any stable remnant ceiling fabric in situ and install a modern ceiling replica of the original ceiling based on existing documentation from the original build or from evidence of remnant fabric. These new ceilings would be installed lower to provide space to conceal services provided that any loss of height does not detract from the overall scale of the rooms or cover necessary ventilation grills or vents. The original ceiling would remain in its current condition concealed above it.</li> </ul> <p>See also Section 3.1.1. Ceilings in the <i>Physical Condition and Schedule of Conservation Works</i> report for further treatment recommendations.</p> <p><b>Grading of Significance: Little</b></p>

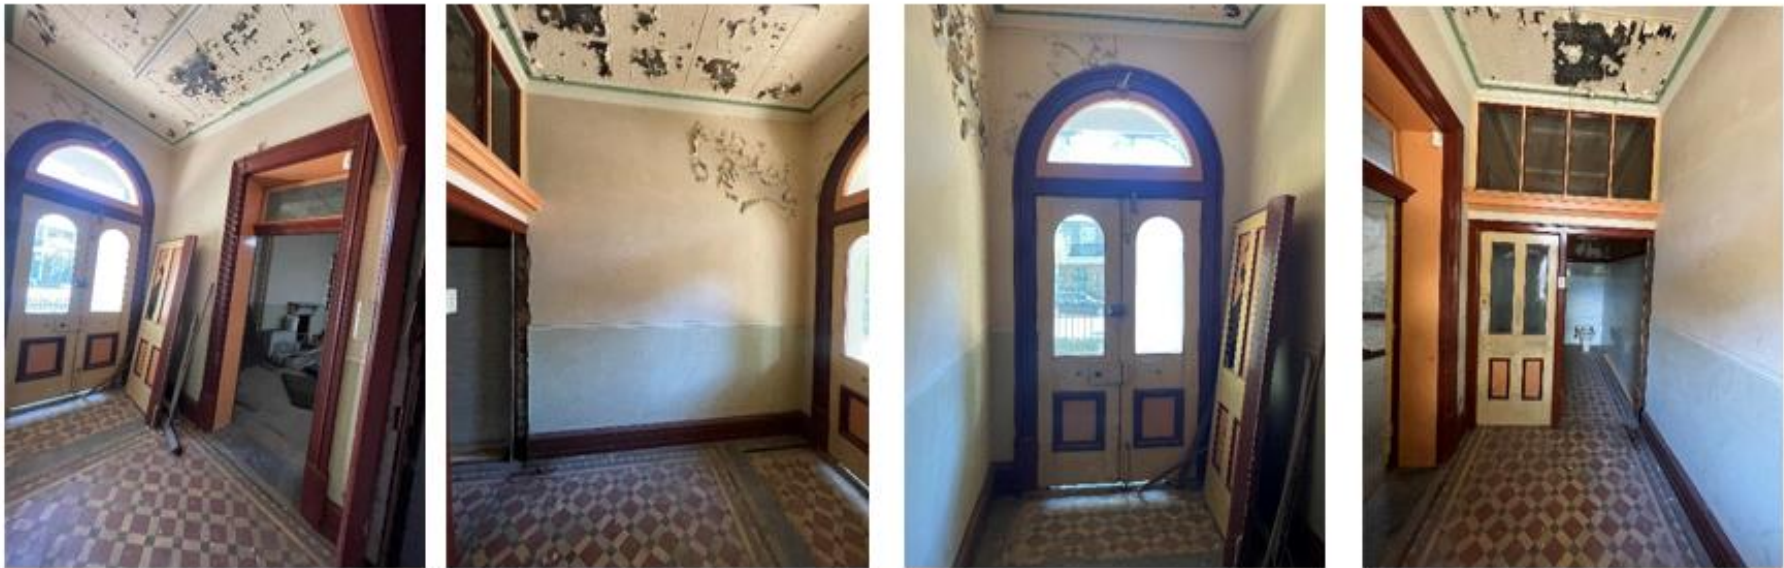
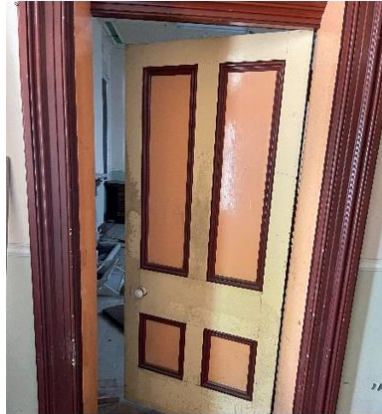
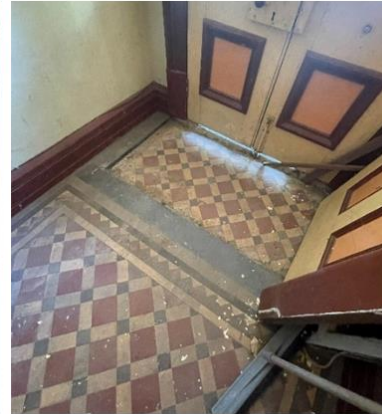
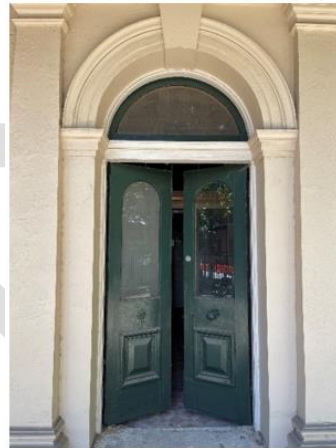
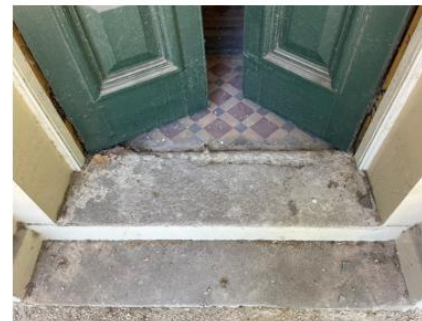
**Photos**

CME Building – Room G9		
Fabric	Current Condition	Description and Recommendation
Floor	Good	<p><b>Description:</b> Tesselated tiles, Generally good condition besides a few patches that will be required, a black granite border around an inset mat recess at the northern entry door and a black granite threshold to the eastern door into room G10. Weathered Sandstone Threshold step to northern entry.</p> <p><b>Recommendation:</b> Floors in this room should be retained and patched as required with matching tiles. Replace patch where centre jamb mullion is removed with contrasting piece to signify that the jamb was once in situ as an interpretive element. Install a mat to the inset recess. Sandstone entry threshold should be exfoliated and dressed. Also refer to Section 3.1.4 Floors in the <i>Physical Condition and Schedule of Conservation Works</i> methodology for floor works.</p> <p><b>Grading of Significance:</b> Exceptional</p>

Walls	Fair	<p><b>Description:</b> Falling damp mostly to the north east. An inset moulding runs around the rendered walls. Paint is poor with flaking in places, surface fixed conduits above the eastern door. A timber partition to the south containing to southward opening doors, however, the western door and its jamb are not attached. Some render patching will be required.</p> <p><b>Recommendation:</b> Paint strip areas of loose or flaking paint. The rest can be subject to overcoating and or spot repairs as per the guidelines within <i>AS4361.1:2017 Guide to Hazardous Paint Management</i>. Also refer to section 3.1.2 Walls and Section 3.1.3. Painted Surfaces in the <i>Physical Condition and Schedule of Conservation Works</i> report for further treatment recommendations.</p> <p><b>Grading of Significance:</b> High</p>
Ceilings	Fair	<p><b>Description:</b> pressed metal patterned ceiling with perimeter border and flaking paint. Surface fixed, fittings and penetrations for services. This room has the same pattern of pressed metal – type 1 as room G10.</p> <p><b>Recommendation:</b> Remove intrusive modern fixtures, fittings and conduits, strip paint as per the guidelines within <i>AS4361.1:2017 Guide to Hazardous Paint Management</i>, patch repair pressed metal and repaint. New fitting and services to be installed sympathetically and symmetrically with the pattern.</p>

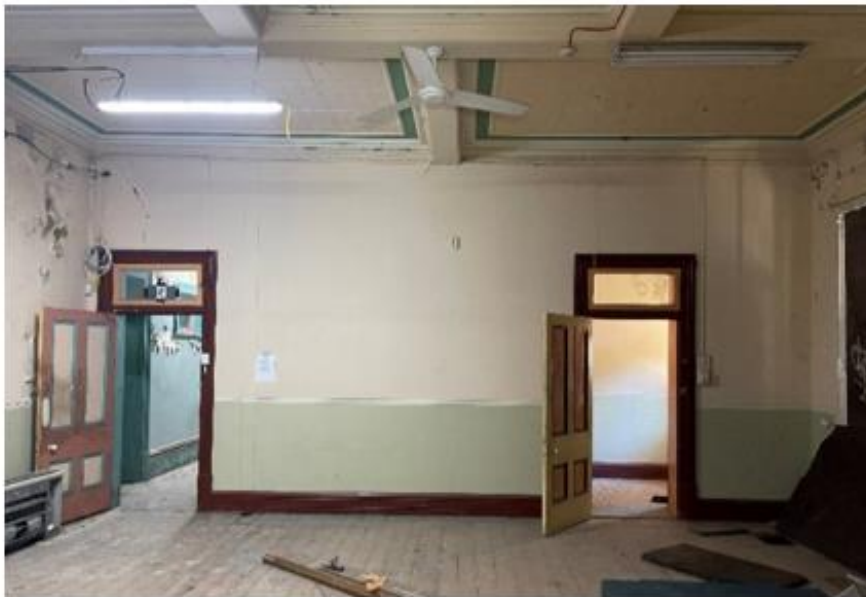
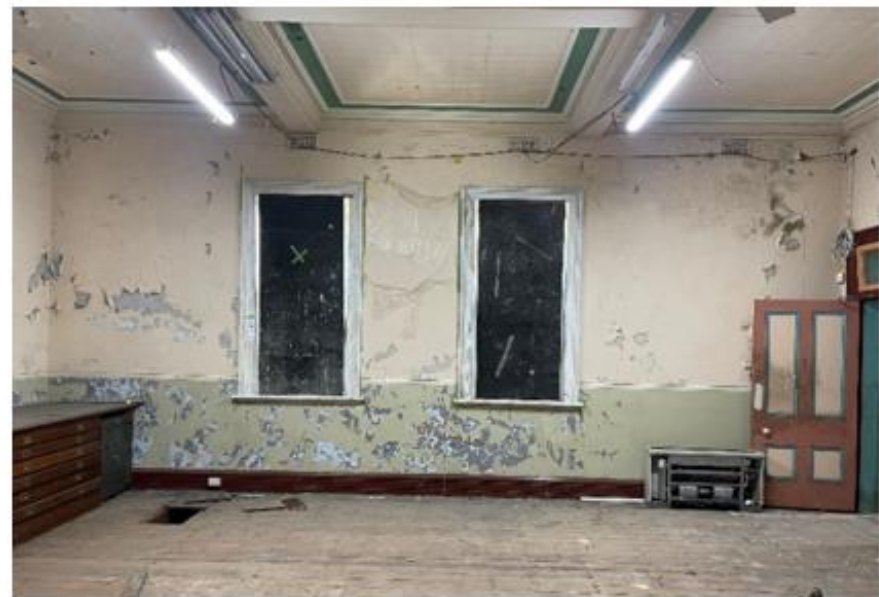
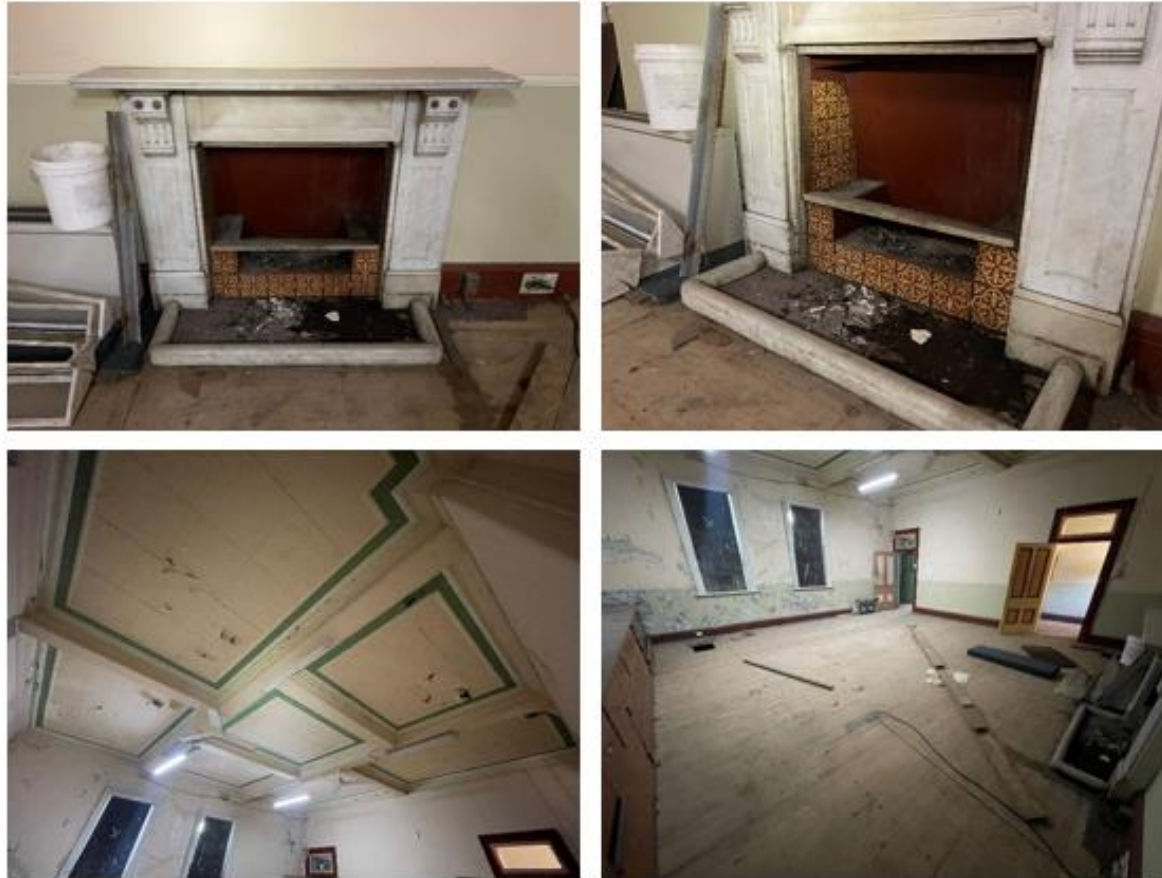
## CME Building – Room G10

CME Building – Room G10		
Fabric	Current Condition	Description and Recommendation
Floor	Poor	<p><b>Description:</b> various cut outs for services, stains, Staples and miss matched boards – Mostly wide boards, likely Kauri Pine.</p> <p><b>Recommendation:</b> All floors on ground floor will need to be temporarily removed to facilitate subfloor works, including installation of concealed services. It is intended to salvage as much as possible of the remnant floorboards for reuse in accordance with Section 3.1.4. in the <i>Physical Condition and Schedule of Conservation Works</i> methodology for floor works. Salvaged flooring from the entire building should collated and graded for condition from best to worst before being re-laid at the completion of subfloor works. Priority should be given to the rooms in key view lines and of most significance to have the floorboards in the best condition as per section 3.1 - 6 General recommendations in the <i>Physical Condition and Schedule of Conservation Works</i></p> <p><b>Grading of Significance: High</b></p>

Walls	Fair to poor	<p><b>Description:</b> Decorative inset moulding at waist height around the room, walls generally sound. Brick vents are in place and good, paint poor with minor flaking in places, many surface fixed conduits, fittings and penetrations for services. Vertical riser panel to the southern end of the western wall. Decorative vent grill on chimney breast has been covered and painted. Bad rising and falling damp to the south and structural cracking in the south western corner above the door. Joinery in place on the eastern wall.</p> <p><b>Recommendation:</b> Paint strip areas of loose or flaking paint, and where the damp has affected it. The rest can be subject to overcoating and or spot repairs as per the guidelines within <i>AS4361.1:2017 Guide to Hazardous Paint Management</i>. Render to be removed up to 1200mm high where rising damp has occurred and wet vacuum wash the brickwork for multiple cycles with a contained head wet system. Allow to dry for min 6 weeks and apply a salt retardant render prior to white set and painting. Structural cracks should be chased out and repaired with a proprietary tie system. Repointing of mortar should be done as per the Mortars: materials, and methods Technical Guide - provided by Heritage NSW. Joinery should be refurbished, large file cabinet metal drawer sections (bay of six and bay of four) should be removed as they are modern and intrusive. The safe in the southeastern corner of the room which is considered an item of moveable heritage and the joinery in this room should be utilized as an interpretive element. This is further detailed in the <i>Chief Mechanical engineers Building Heritage Interpretation Plan</i></p>

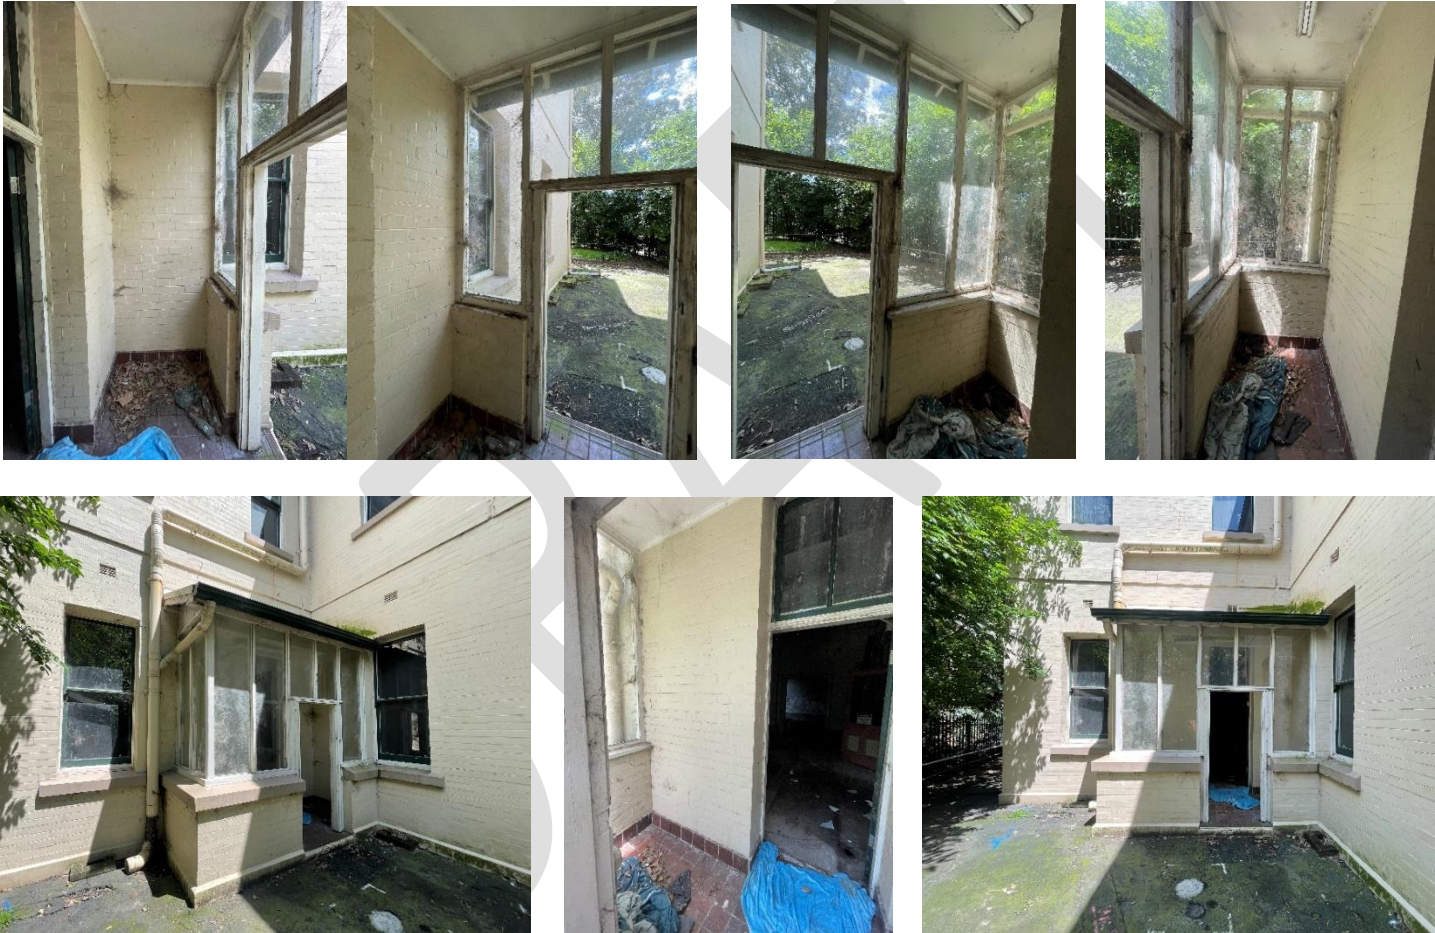
## CME Building – Room G11

CME Building – Room G11		
Fabric	Current Condition	Description and Recommendation
Floor	Good	<p><b>Description:</b> Modern tiles, Generally good condition</p> <p><b>Recommendation:</b> Tiled floors in this room should be removed and replaced with sympathetic modern tiles. Also refer to Section 3.1.1 Floors . in the <i>Physical Condition and Schedule of Conservation Works</i> methodology for floor works.</p> <p><b>Grading of Significance:</b> Little</p>
Walls	Fair	<p><b>Description:</b> Painted face brick low height walls to east and south. North and west walls are the external brick walls of the building.</p> <p><b>Recommendation:</b> Paint strip areas of loose or flaking paint. The rest can be subject to overcoating and or spot repairs as per the guidelines within <i>AS4361.1:2017 Guide to Hazardous Paint Management</i>. Also refer to section 3.1.2. Walls and Section 3.1.3. Painted Surfaces in the <i>Physical Condition and Schedule of Conservation Works</i> report for further treatment recommendations.</p> <p><b>Grading of Significance:</b> Little</p>

Ceilings	Fair	<p><b>Description:</b> Assumed cement sheet or fibro ceiling potential for HAZMAT Asbestos</p> <p><b>Recommendation:</b> Test for Hazmat, if safe leave intact and paint. See also Section 3.1.1. Ceilings in the <i>Physical Condition and Schedule of Conservation Works</i> report for further treatment recommendations</p> <p><b>Grading of Significance:</b> Little</p>
Cornice	Fair	<p><b>Description:</b> Timber scotia moulding</p> <p><b>Recommendation:</b> Remove intrusive modern fixtures and fittings. Decorative timber mouldings should be repaired in situ if possible. When beyond salvage or if ceilings are replaced, or relocated, timber mouldings should be reinstated with originals salvaged from elsewhere within the building where available or with replicated remakes of the originals should they be beyond salvage. As per section 3.1.1. Ceilings in the <i>Physical Condition and Schedule of Conservation Works</i> report for further treatment recommendations.</p> <p><b>Grading of Significance:</b> Little</p>

CME Building – Room G11		
Skirting	Fair	<p><b>Description:</b> Modern tile skirting matching floor</p> <p><b>Recommendation:</b> Remove and replace with sympathetic modern tiles</p> <p><b>Grading of Significance:</b> Neutral</p>
Windows	Poor	<p><b>Description:</b> Fixed pane windows on top of low height brickwork up to soffit to East inclusive of above the door and to the south.</p> <p><b>Recommendation:</b> Strip all lead paint completely from all surfaces and prepare all surfaces under HAZMAT conditions in accordance with <i>AS4361.1:2017 Guide to Hazardous Paint Management</i> prior to commencement of works.</p> <ul style="list-style-type: none"> <li>Windows should generally be repaired and cleaned up in their original locations. This could be inclusive of glazing putty touch ups or replacement, rot and damage repairs and broken glass replacement.</li> </ul> <p>See also section 3.1.3 Painted Surfaces and section 3.1.5. Windows in the <i>Physical Condition and Schedule of Conservation Works</i> report for further treatment recommendations.</p> <p><b>Grading of Significance:</b> Little</p>

Doors	Fair	<p><b>Description:</b> Eastern door is a modern two panel door with clear glazing. Currently unattached and located in room G12. western door is a solid core modern door</p> <p><b>Recommendation.</b> Replace both doors with heritage doors salvaged from within the building. If unsuitable, replace with modern solid timber four panel doors.</p> <ul style="list-style-type: none"> <li>Doors should generally be adjusted, cleaned up, and rehung in their original locations.</li> <li>-Existing heritage hardware that is non-operational should be stripped, polished, decommissioned and reinstated in as close to its original position provided that it does not interfere with compliance of new door control hardware. New modern hardware that is sympathetic to the heritage aspect of the building yet compliant with relevant Building codes and Australian Standards (AS1428.1) should be installed.</li> </ul>

CME Building – Room G11		
		<ul style="list-style-type: none"> <li>Fanlights should be cleaned up and made good. They should be made to operate if required as part of the HVAC requirements of the building. Existing hardware should be removed, polished and reinstated. Any missing hardware should be replaced with reproduction items to match the existing. Consideration as to make the fanlights operable, fixed open or fixed closed should be made in conjunction with the requirements of the buildings HVAC system and acoustic considerations.</li> <li>Any damage or cut outs to architraves or jambs should be reinstated with timber inlays and reshaped to blend in.</li> </ul> <p>Also refer to section 3.1.6. Doors in the <i>Physical Condition Report and Schedule of Conservation Works</i>.</p> <p><b>Grading of Significance: Intrusive</b></p>
Fireplace	Fair	<p>Description: N/A</p> <p>Recommendation: N/A</p> <p>Grading of Significance: N/A</p>

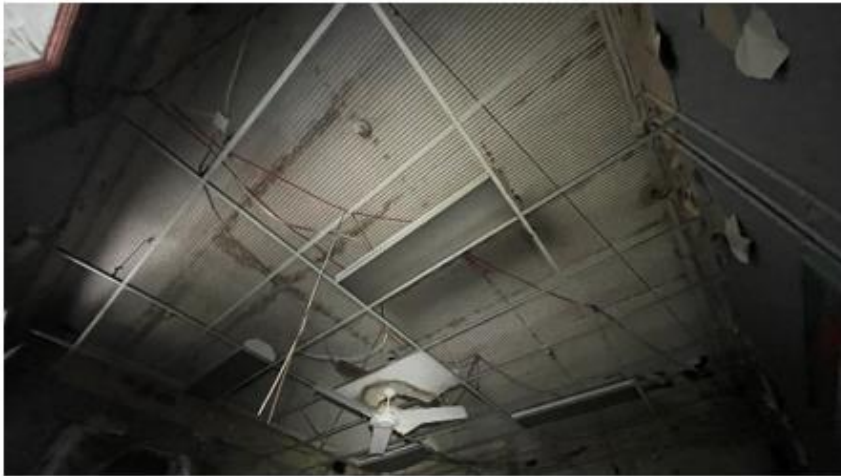
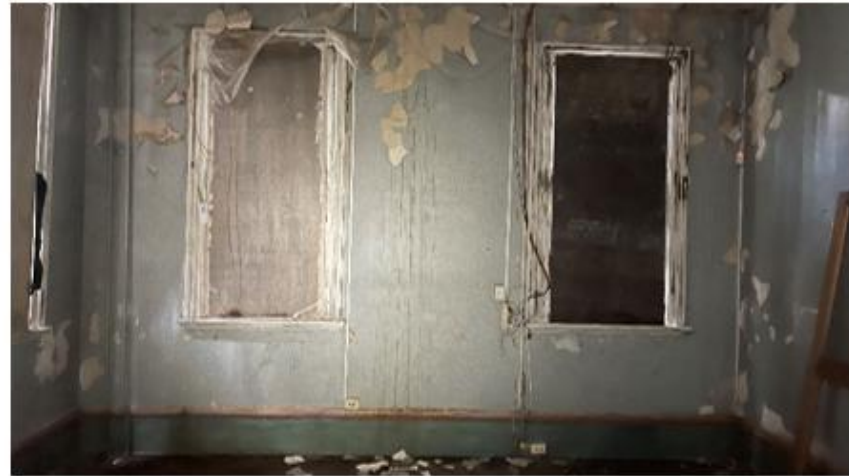
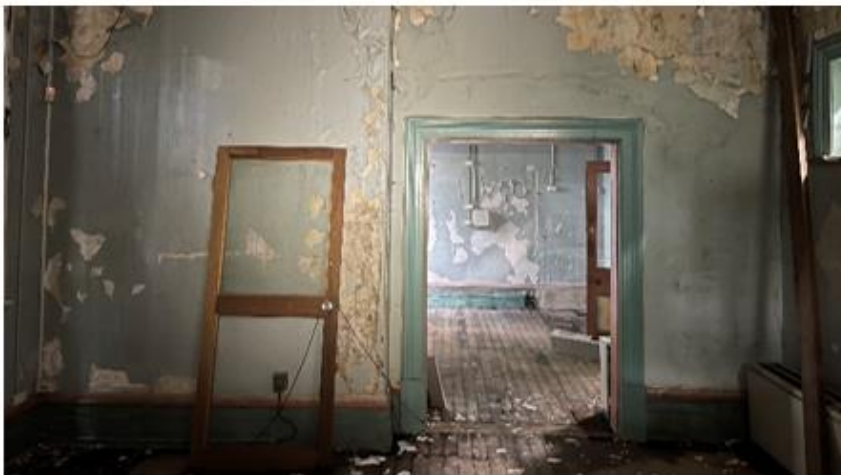
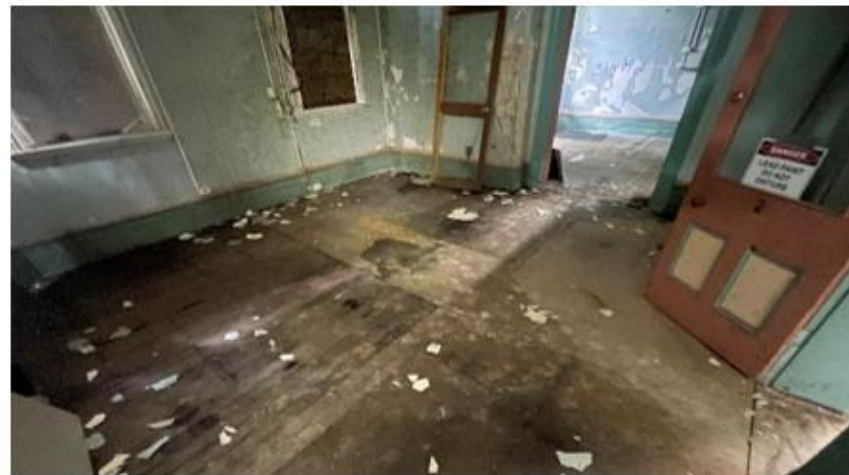
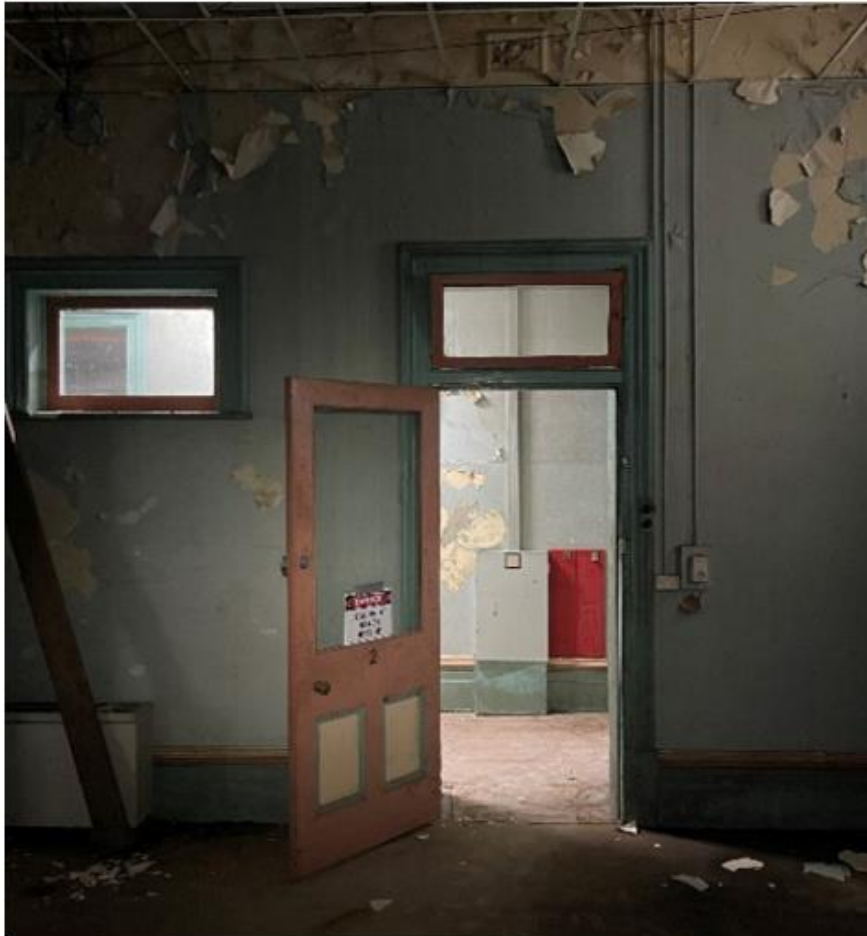
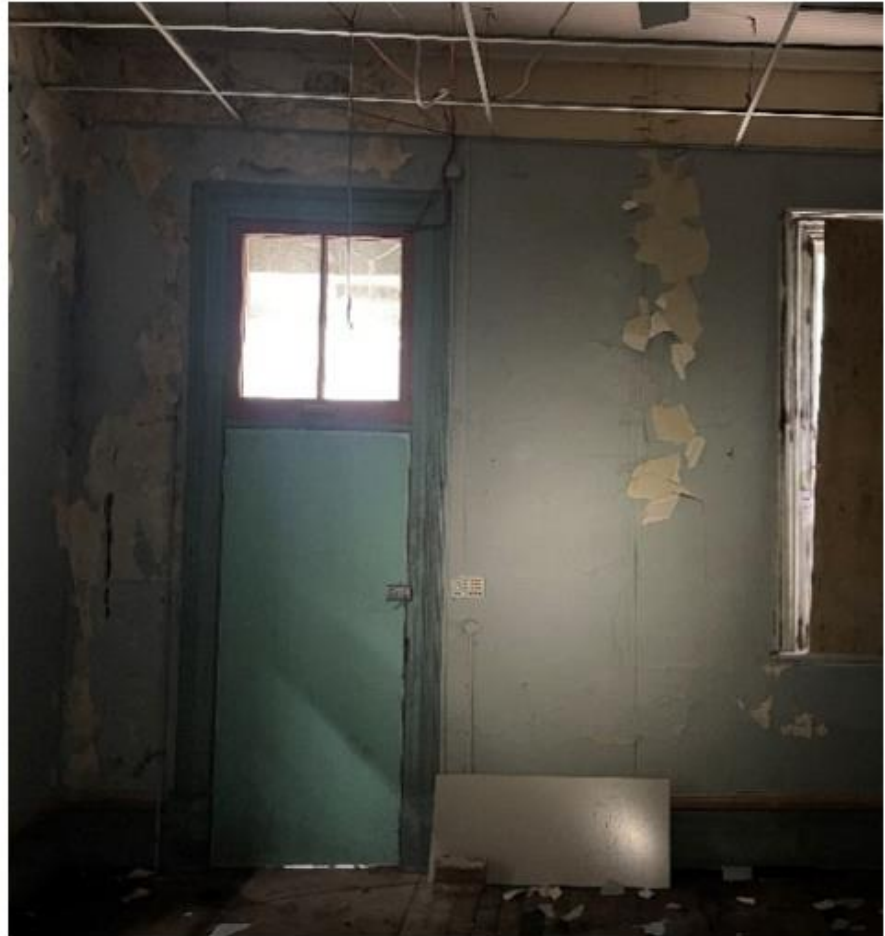
## CME Building – Room G12

CME Building – Room G12		
Fabric	Current Condition	Description and Recommendation
Floor	Very Poor	<p><b>Description:</b> Large missing sections of floorboards infilled with water damaged yellow tongue particleboard, narrow hardwood floorboards to the rest with water damage. Masonry infill threshold between rooms G12 and G13.</p> <p><b>Recommendation:</b> All floors on ground floor will need to be temporarily removed to facilitate subfloor works, including installation of concealed services. It is intended to salvage as much as possible of the remnant floorboards for reuse in accordance with Section 3.1.4. Floors in the <i>Physical Condition and Schedule of Conservation Works</i> methodology for floor works. Salvaged flooring from the entire building should collated and graded for condition from best to worst before being re-laid at the completion of subfloor works. Priority should be given to the rooms in key view lines and of most significance to have the floorboards in the best condition as per section 3.1 - 6 General recommendations in the <i>Physical Condition and Schedule of Conservation Works</i></p> <p>The threshold should be dressed and maintained or replaced with a more suitable finish. It should remain as an interpretive feature as evidence of the wall that was originally there.</p> <p><b>Grading of Significance:</b> High</p>

CME Building – Room G12		
Walls	Poor	<p><b>Description :</b> Bad falling damp in most of the room. An opening dressed with a reveal and architrave has been created through to room G13. There is a square built out chimney breast in the south west corner that has had the fire place removed and bricked in. Brick vents are miss matched, missing or damaged by services penetrations, paint poor with flaking in places, many surface fixed conduits, fittings and penetrations for services.</p> <p><b>Recommendation:</b> Paint strip areas of loose or flaking paint, and where the damp has affected it. The rest can be subject to overcoating and or spot repairs as per the guidelines within <i>AS4361.1:2017 Guide to Hazardous Paint Management</i>. Render to be removed up to 1200mm high where rising damp has occurred and wet vacuum wash the brickwork for multiple cycles with a contained head wet system. Allow to dry for min 6 weeks and apply a salt retardant render prior to white set and painting. Structural cracks should be chased out and repaired with a proprietary tie system. Repointing of mortar should be done as per the Mortars: materials, and methods Technical Guide - provided by Heritage NSW. Also refer to section 3.1.2.Walls and Section 3.1.3. Painted Surfaces in the <i>Physical Condition and Schedule of Conservation Works</i> report for further treatment recommendations.</p> <p><b>Grading of Significance: High</b></p>

Ceilings	Poor	<p><b>Description:</b> Corrugated iron ceiling with a large grid of decorative mouldings concealing joints that have been removed revealing joints .Surface fixed conduits, fittings and penetrations for services. Existing Tbar grid ceiling system frame in place. Likely original ceiling from 1920 construction.</p> <p><b>Recommendation:</b> Remove Intrusive modern grid ceiling, fixtures fittings and conduits</p> <ul style="list-style-type: none"> <li>Where intact and not at risk of collapse, complete conservation works to reinstate back to original condition. This could be inclusive of patching existing holes, replacing missing, badly damaged sections, mouldings and in situ cornice template moulding repairs.</li> <li>Where small areas are damaged beyond salvage, replace with salvaged fabric from other rooms of less significance within the building, replace with second hand salvaged material or replace with replicated modern equivalent.</li> </ul>

Cornice	Fair	<p><b>Description:</b> Timber moulding cornice, some surface fixed conduits and wires on cornice.</p> <p><b>Recommendation:</b> Remove intrusive modern fixtures and fittings. Decorative timber mouldings should be repaired in situ if possible. When beyond salvage or if ceilings are replaced, or relocated, timber mouldings should be reinstated with originals salvaged from elsewhere within the building where available or with replicated remakes of the originals should they be beyond salvage. As per section 3.1.1. Ceilings in the <i>Physical Condition and Schedule of Conservation Works</i> report for further treatment recommendations.</p> <p><b>Grading of Significance: High</b></p>
Skirting	Fair	<p><b>Description:</b> 1920's addition skirtings with various services, and cabling surface fixed, Skirting may likely show further signs of water damaged and rot upon removal.</p> <p><b>Recommendation:</b> Skirting to be removed to facilitate rising damp repairs and floor removal.</p> <ul style="list-style-type: none"> <li>Generally, skirtings should remain in their existing positions. Any skirting being replaced due to damage such as water ingress, dry rot and termite damage or that are missing should be reproduced to replicate other skirtings in the same room, or if none at all, should replicate its most likely profile based on the findings of the 1997 CMP.</li> </ul>

Windows	Poor	<p><b>Description:</b> windows to the east and south have been stripped and primed/sealed. A singular fixed sash window to the north wall is at high level and contains a fixed single sash. Eastern and southern windows are currently boarded up and not accessible for full assessment.</p> <p><b>Recommendation:</b> Remove boarding to expose windows. Strip all lead paint completely from all surfaces and prepare all surfaces under HAZMAT conditions in accordance with <i>AS4361.1:2017 Guide to Hazardous Paint Management</i> prior to commencement of works.</p> <ul style="list-style-type: none"> <li>Windows should generally be repaired adjusted and cleaned up in their original locations. This could be inclusive of sash cord and weight replacement, glazing putty touch ups or replacement, adjustment and refitting of sashes, rot and damage repairs, broken glass replacement and hardware repairs and or replacement.</li> <li>Existing heritage hardware should be stripped, polished and reinstated in as close to its original position. Missing hardware should be reinstated with new modern reproduction equivalents.</li> </ul>

Fireplace	Fair	<p><b>Description:</b> Fireplace has been bricked in and skirting run through</p> <p><b>Recommendation:</b> Reinstate salvage heritage mantle,</p> <ul style="list-style-type: none"> <li>• Rooms with fireplaces bricked in or sheeted over should at least have a mantle installed as an interpretive element.</li> <li>• Hearths should be restored where they are relatively intact. Damaged or bare hearths should be either tiled, overlayed with stone or painted.</li> <li>• Chimneys breasts should remain as an expressed feature of a room. In places where services risers are placed beside them, new partition walls beside chimney breasts should sit back at least 50mm to ensure that the chimney breasts are retained as a defined expression into the room and that staff moulded rises on the corners of the breasts are not lost.</li> <li>• Chimney tops should have over flashing caps installed to ensure the building is protected from water and pest ingress.</li> <li>• Chimneys can be reutilised for services runs within the building were possible.</li> </ul> <p>Also refer to Section 3.1.8. Fireplaces in the <i>Physical Condition Report and Schedule of Conservation Works</i>.</p> <p><b>Grading of Significance:</b> Intrusive</p>

CME Building – Room G12		
		<ul style="list-style-type: none"> <li>Instead of removing large sections of heritage fabric ceilings to facilitate the installation of services or structural repairs, It would be a more preferable heritage outcome to leave any stable remnant ceiling fabric in situ and install a modern ceiling replica of the original ceiling based on existing documentation from the original build or from evidence of remnant fabric. These new ceilings would be installed lower to provide space to conceal services provided that any loss of height does not detract from the overall scale of the rooms or cover necessary ventilation grills or vents. The original ceiling would remain in its current condition concealed above it.</li> </ul> <p>See also Section 3.1.1.in the <i>Physical Condition and Schedule of Conservation Works</i> report for further treatment recommendations.</p> <p><b>Grading of Significance: High</b></p>

CME Building – Room G12		
		<ul style="list-style-type: none"> <li>Ground floor skirtings that are required to be removed for the subfloor excavation works, should have their locations recorded, labelled clearly, carefully removed, de-nailed, cleaned up and reinstated post excavation and subfloor works.</li> <li>Consideration should be put into packing out skirtings with battens to create a void space for wiring prior to reinstallation where they are required to be removed to facilitate other works such as floor replacement, Subfloor excavation or rising damp remediation.</li> <li>Consideration should be made towards sensitively and sympathetically incorporating a skirting duct into the current skirting profiles to facilitate ease of future services reticulation and to minimize the requirement for future invasive works.</li> </ul> <p>See also section 3.1.7. Skirtings in the <i>Physical Condition Report and Schedule of Conservation Works</i>.</p> <p><b>Grading of Significance: High</b></p>

CME Building – Room G12		
		<ul style="list-style-type: none"> <li>Locks should be made operational if windows are to be operable. Opening restrictions should be added for both security and code compliance if windows present a climb or fall risk.</li> </ul> <p>See also section 3.1.3. Painted Surfaces and section 3.1.5. Windows in the <i>Physical Condition and Schedule of Conservation Works</i> report for further treatment recommendations.</p> <p><b>Grading of Significance: High</b></p>
Doors	Fair	<p><b>Description:</b> Modern plain door to the east with a tall highlight with a single vertical muntin. 3 panel door to the north with glazing to top panel.</p> <p><b>Recommendation:</b></p> <ul style="list-style-type: none"> <li>Doors should generally be adjusted, cleaned up, and rehung in their original locations.</li> <li>-Existing heritage hardware that is non-operational should be stripped, polished, decommissioned and reinstated in as close to its original position provided that it does not interfere with compliance of new door control hardware. New modern hardware that is sympathetic to the heritage aspect of the building yet compliant with relevant Building codes and Australian Standards (AS1428.1) should be installed.</li> <li>Fanlights should be cleaned up and made good. They should be made to operate if required as part of the HVAC requirements of the building. Existing hardware should be removed, polished and reinstated. Any missing hardware should be replaced with reproduction items to match the existing. Consideration as to make the fanlights operable, fixed open or fixed closed should be made in conjunction with the requirements of the buildings HVAC system and acoustic considerations.</li> <li>Any damage or cut outs to architraves or jambs should be reinstated with timber inlays and reshaped to blend in.</li> <li>Doors that need to be pinned in an open position should be fixed in place with a concealed fixing.</li> </ul> <p>Also refer to section 3.1.6. Doors in the <i>Physical Condition Report and Schedule of Conservation Works</i>.</p> <p><b>Grading of Significance: High</b></p>
