## 9. Inventory Sheets

This chapter includes the inventory sheets for each room within the CME Building. Each datasheet includes:

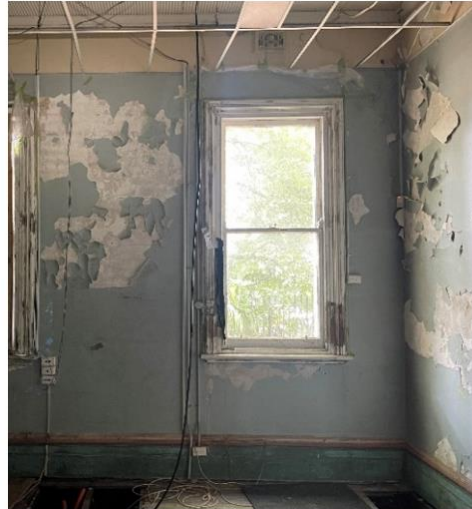
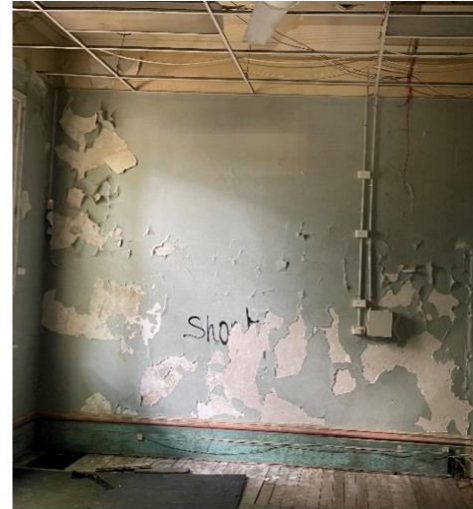
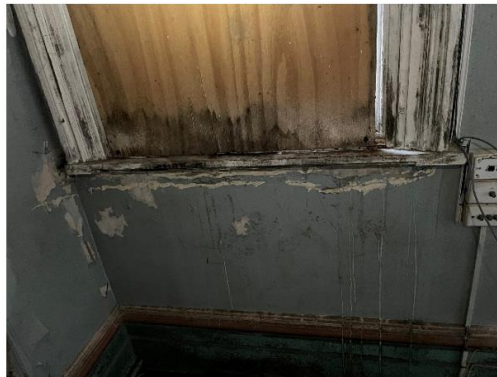
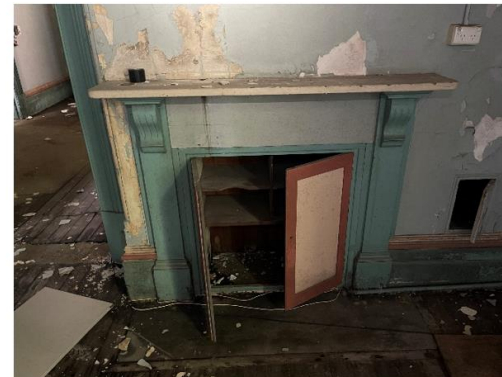
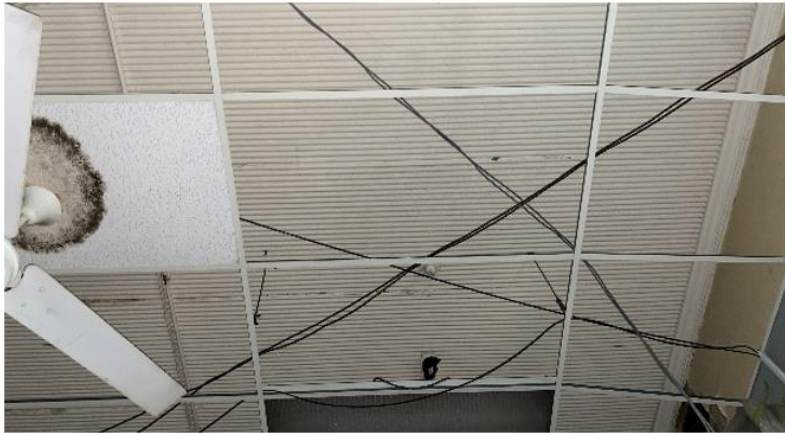
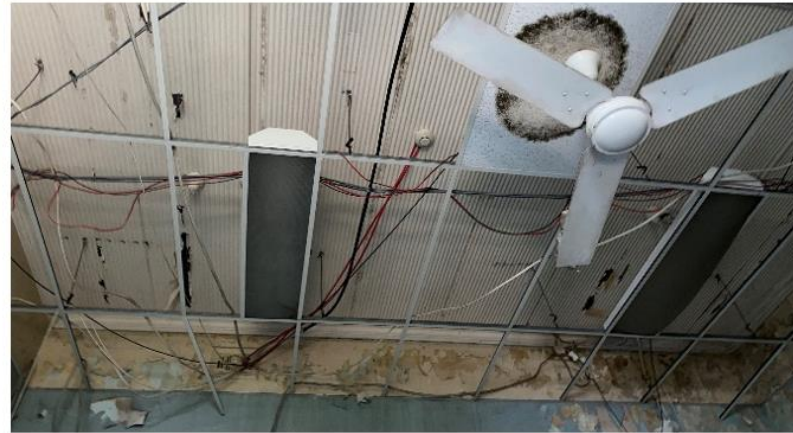
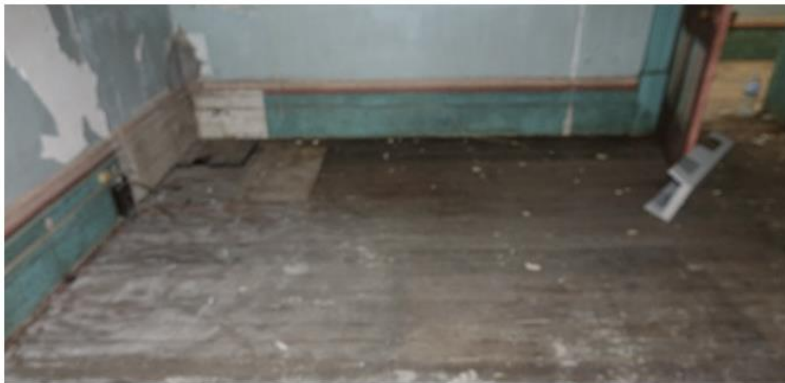
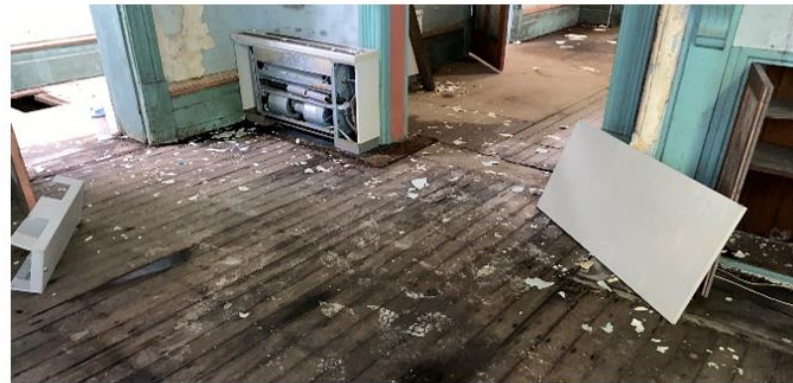
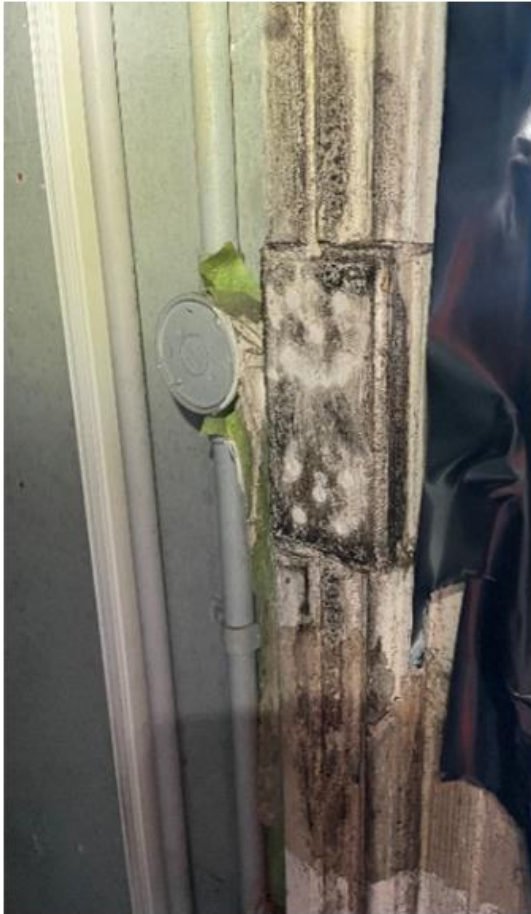
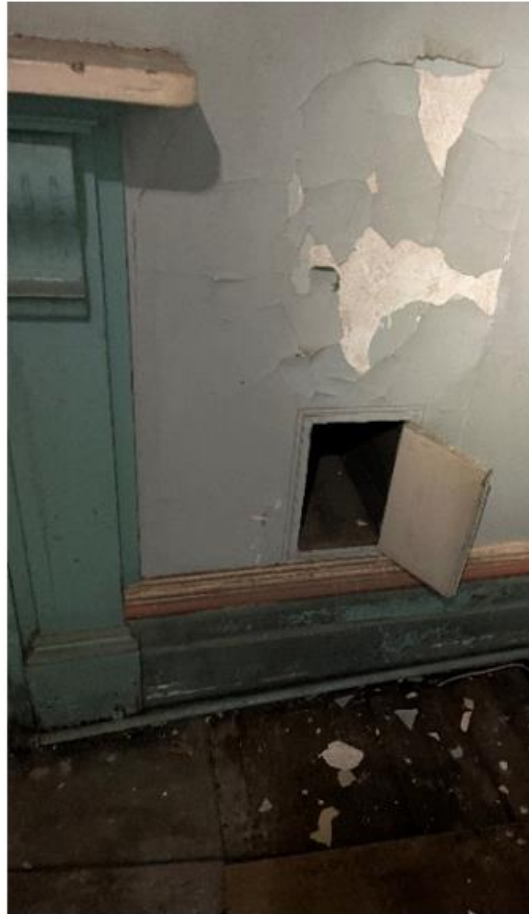
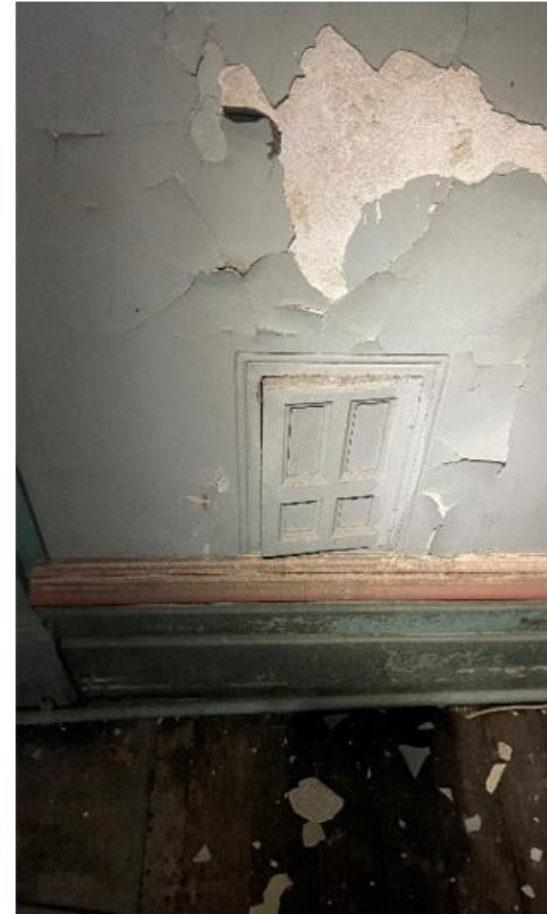
## CME Building – Room G13

CME Building – Room G13		
Fabric	Current Condition	Description and Recommendation
Floor	Poor	<p><b>Description:</b> Narrow hardwood floorboards with water damage. Several damaged boards and infill repairs. Masonry infill threshold between rooms G12 and G13.</p> <p><b>Recommendation:</b> All floors on ground floor will need to be temporarily removed to facilitate subfloor works, including installation of concealed services. It is intended to salvage as much as possible of the remnant floorboards for reuse in accordance with Section 3.1.4. Floors in the <i>Physical Condition and Schedule of Conservation Works</i> methodology for floor works. Salvaged flooring from the entire building should collated and graded for condition from best to worst before being re-laid at the completion of subfloor works. Priority should be given to the rooms in key view lines and of most significance to have the floorboards in the best condition as per section 3.1 - 6 General recommendations in the <i>Physical Condition and Schedule of Conservation Works</i></p> <p>The threshold should be dressed and maintained or replaced with a more suitable finish. It should remain as an interpretive feature as evidence of the wall that was originally there.</p> <p><b>Grading of Significance: High</b></p>

Walls	Poor	<p><b>Description:</b> Bad falling and rising damp in most of the room. An opening to the east is dressed with a reveal and architrave has been created through to room G12. There is a square built out chimney breast in the south east corner that has the mantle in place, however the cast iron fireplace has been retrofitted with a timber cupboard. Brick vents are miss matched, missing or damaged by services penetrations, paint poor with flaking in places, many surface fixed conduits, fittings and penetrations for services. A small penetration with a 4 panel timber door is located low in the south eastern corner beside the fireplace. Minor cracking in places and patch repair evident in north east corner.</p> <p><b>Recommendation:</b> Paint strip areas of loose or flaking paint, and where the damp has affected it. The rest can be subject to overcoating and or spot repairs as per the guidelines within <i>AS4361.1:2017 Guide to Hazardous Paint Management</i>. Render to be removed up to 1200mm high where rising damp has occurred and wet vacuum wash the brickwork for multiple cycles with a contained head wet system. Allow to dry for min 6 weeks and apply a salt retardant render prior to white set and painting. Structural cracks should be chased out and repaired with a proprietary tie system. Repointing of mortar should be done as per the Mortars: materials, and methods Technical Guide - provided by Heritage NSW. Fireplace cupboard should be left in place and either refurbished or sheeted</p>

CME Building – Room G13		
Cornice	Fair	<p><b>Description:</b> Timber moulding cornice, some surface fixed conduits and wires on cornice.</p> <p><b>Recommendation:</b> Remove intrusive modern fixtures and fittings. Decorative timber mouldings should be repaired in situ if possible. When beyond salvage or if ceilings are replaced, or relocated, timber mouldings should be reinstated with originals salvaged from elsewhere within the building where available or with replicated remakes of the originals should they be beyond salvage. As per section 3.1.1. Ceilings in the <i>Physical Condition and Schedule of Conservation Works</i> report for further treatment recommendations.</p> <p><b>Grading of Significance:</b> High</p>
Skirting	Poor	<p><b>Description:</b> 1920's addition skirtings with various services, and cabling surface fixed, Skirting may likely show further signs of water damaged and rot upon removal.</p> <p><b>Recommendation:</b> skirting to be removed to facilitate rising damp repairs and floor removal.</p> <ul style="list-style-type: none"> <li>• Generally, skirtings should remain in their existing positions. Any skirting being replaced due to damage such as water ingress, dry rot and termite damage or that are missing should be reproduced to replicate other skirtings in the same room, or if none at all, should replicate its most likely profile based on the findings of the 1997 CMP.</li> <li>• Ground floor skirtings that are required to be removed for the subfloor excavation works, should have their locations recorded, labelled clearly, carefully removed, de-nailed, cleaned up and reinstated post excavation and subfloor works.</li> <li>• Consideration should be put into packing out skirtings with battens to create a void space for wiring prior to reinstallation where they are required to be removed to facilitate other works such as floor replacement, Subfloor excavation or rising damp remediation.</li> <li>• Consideration should be made towards sensitively and sympathetically incorporating a skirting duct into the current skirting profiles to facilitate ease of future services reticulation and to minimize the requirement for future invasive works.</li> </ul>

CME Building – Room G13		
		<p>See also section 3.1.7. Skirtings in the <i>Physical Condition Report and Schedule of Conservation Works</i>.</p> <p><b>Grading of Significance: High</b></p>
Windows	Poor	<p><b>Description:</b> windows to the south have been stripped and primed/sealed. A singular fixed sash window to the north wall is at high level and contains a fixed single sash. One of the southern windows is currently boarded up and not accessible for full assessment. The south western has a cut out in the architrave. The south eastern window has had the front of the sill cut back</p> <p><b>Recommendation:</b> Remove boarding to expose windows. Strip all lead paint completely from all surfaces and prepare all surfaces under HAZMAT conditions in accordance with <i>AS4361.1:2017 Guide to Hazardous Paint Management</i> prior to commencement of works. The south western window will require an infill to be inserted into the architrave and reshaped. The south eastern window will require the sill to be repaired and reshaped.</p> <ul style="list-style-type: none"> <li>• Windows should generally be repaired adjusted and cleaned up in their original locations. This could be inclusive of sash cord and weight replacement, glazing putty touch ups or replacement, adjustment and refitting of sashes, rot and damage repairs, broken glass replacement and hardware repairs and or replacement.</li> <li>• Existing heritage hardware should be stripped, polished and reinstated in as close to its original position. Missing hardware should be reinstated with new modern reproduction equivalents.</li> <li>• Locks should be made operational if windows are to be operable. Opening restrictions should be added for both security and code compliance if windows present a climb or fall risk.</li> </ul> <p>See also section 3.1.3. Painted Surfaces and section 3.1.5. Windows in the <i>Physical Condition and Schedule of Conservation Works</i> report for further treatment recommendations.</p> <p><b>Grading of Significance: High</b></p>

Doors	Fair	<p><b>Description:</b> 3 panel door to the north with glazing to top panel.</p> <p><b>Recommendation:</b></p> <ul style="list-style-type: none"> <li>• Doors should generally be adjusted, cleaned up, and rehung in their original locations.</li> </ul>

CME Building – Room G13		
		<p>over. Also refer to section 3.1.2. Walls and Section 3.1.3. Painted Surfaces in the <i>Physical Condition and Schedule of Conservation Works</i> report for further treatment recommendations.</p> <p><b>Grading of Significance: High</b></p>
Ceilings	Very Poor	<p><b>Description:</b> Corrugated iron ceiling, rusty in places. Surface fixed conduits, fittings and penetrations for services. Existing Tbar grid ceiling system frame in place. Likely original ceiling from 1920 construction.</p> <p><b>Recommendation:</b> Remove Intrusive modern grid ceiling, fixtures fittings and conduits</p> <ul style="list-style-type: none"> <li>• Where intact and not at risk of collapse, complete conservation works to reinstate back to original condition. This could be inclusive of patching existing holes, replacing missing, badly damaged sections, mouldings and in situ cornice template moulding repairs.</li> <li>• Where small areas are damaged beyond salvage, replace with salvaged fabric from other rooms of less significance within the building, replace with second hand salvaged material or replace with replicated modern equivalent.</li> <li>• Instead of removing large sections of heritage fabric ceilings to facilitate the installation of services or structural repairs, It would be a more preferable heritage outcome to leave any stable remnant ceiling fabric in situ and install a modern ceiling replica of the original ceiling based on existing documentation from the original build or from evidence of remnant fabric. These new ceilings would be installed lower to provide space to conceal services provided that any loss of height does not detract from the overall scale of the rooms or cover necessary ventilation grills or vents. The original ceiling would remain in its current condition concealed above it.</li> </ul> <p>See also Section 3.1.1. in the <i>Physical Condition and Schedule of Conservation Works</i> report for further treatment recommendations.</p> <p><b>Grading of Significance: High</b></p>

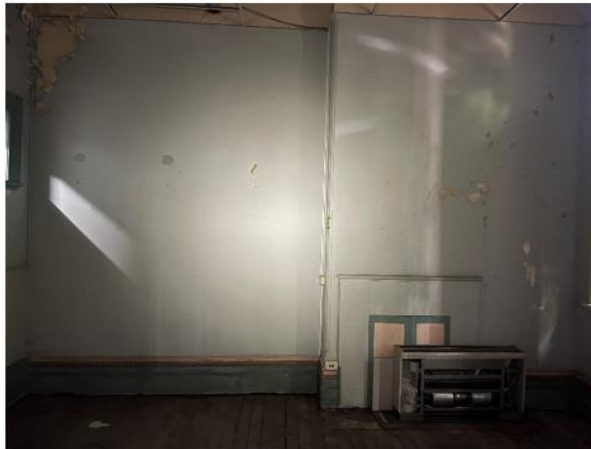
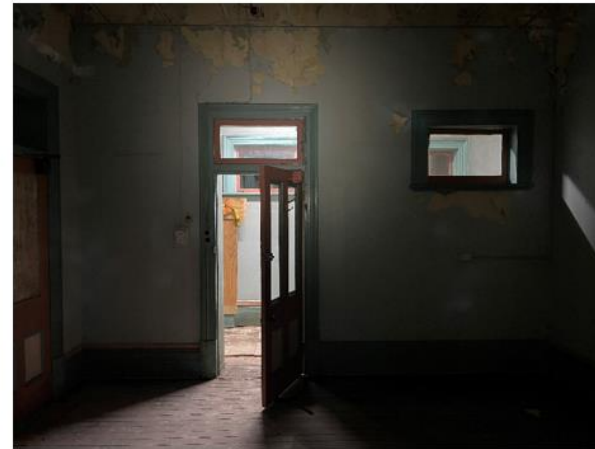
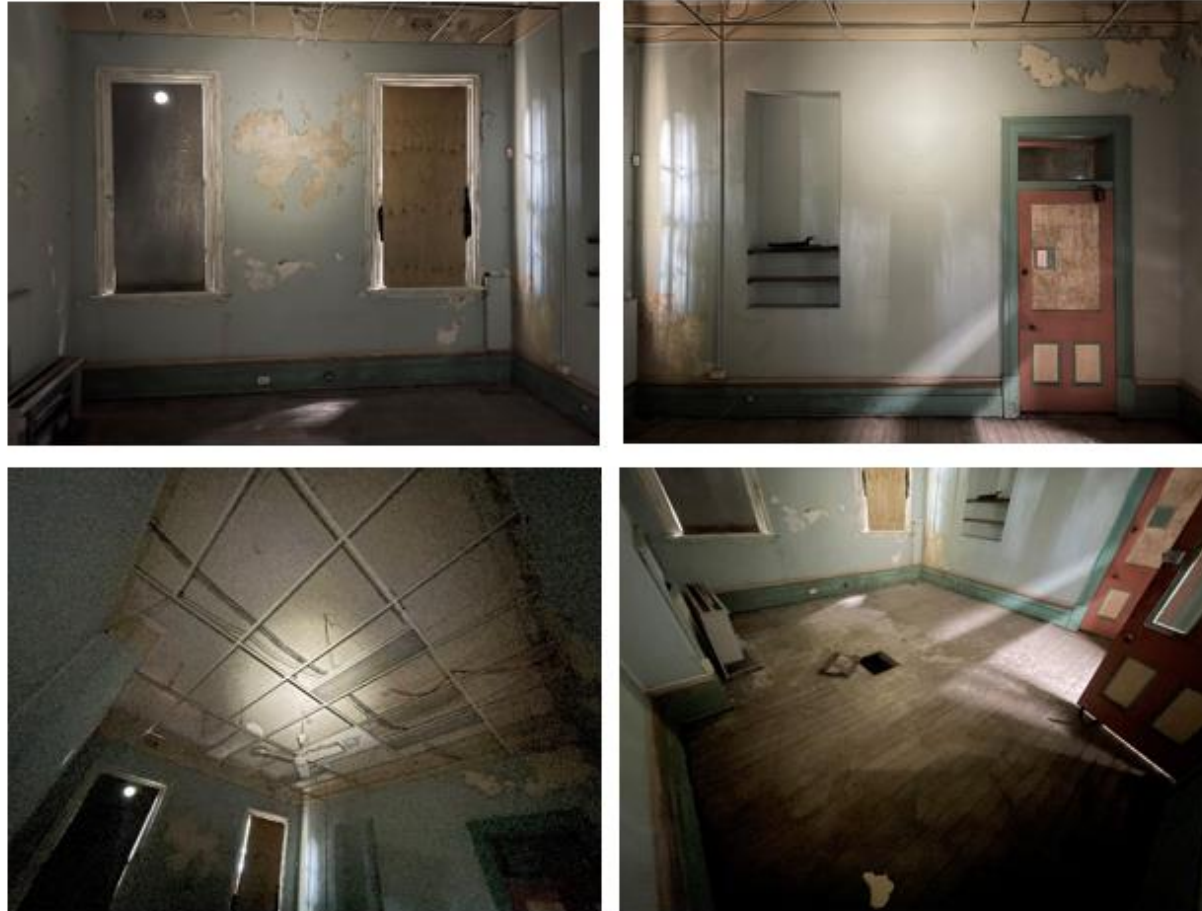
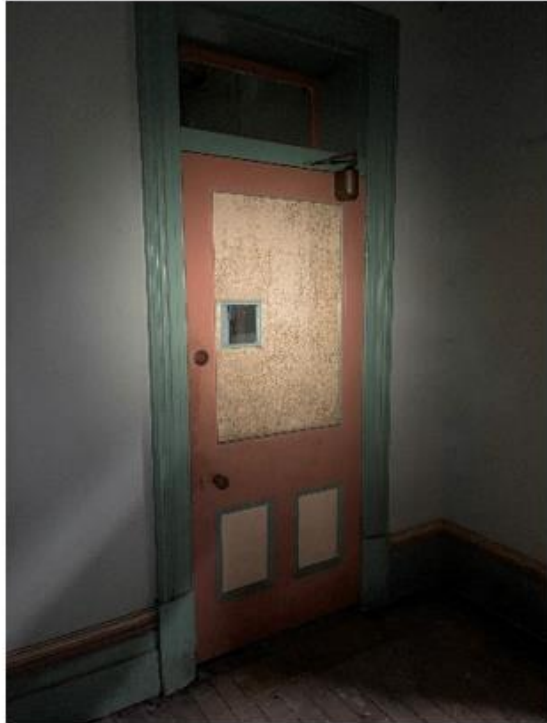
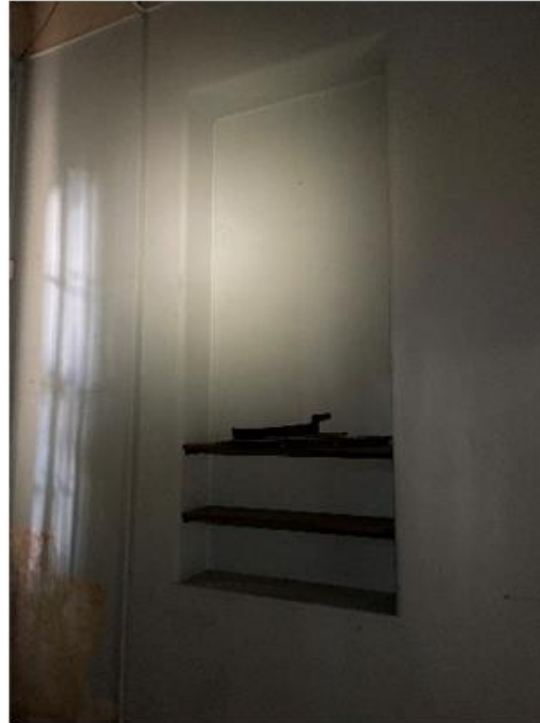
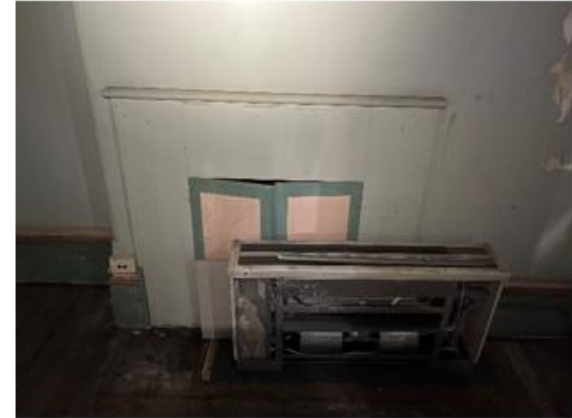
### CME Building – Room G14

CME Building – Room G14		
Fabric	Current Condition	Description and Recommendation
Floor	Poor	<p><b>Description:</b> Wide Kauri floorboards. A few damaged boards and infill repairs.</p> <p><b>Recommendation:</b> All floors on ground floor will need to be temporarily removed to facilitate subfloor works, including installation of concealed services. It is intended to salvage as much as possible of the remnant floorboards for reuse in accordance with Section 3.1.4. Floors in the <i>Physical Condition and Schedule of Conservation Works</i> methodology for floor works. Salvaged flooring from the entire building should collated and graded for condition from best to worst before being re-laid at the completion of subfloor works. Priority should be given to the rooms in key view lines and of most significance to have the floorboards in the best condition as per section 3.1 - 6 General recommendations in the <i>Physical Condition and Schedule of Conservation Works</i></p> <p><b>Grading of Significance: High</b></p>

Walls	Poor	<p><b>Description :</b> Falling and rising damp in parts of the room. There is a square built out chimney breast in the south east corner that has a buildout to enclose the fireplace that has been retrofitted with a timber cupboard. Brick vents are miss matched and damaged by services penetrations, paint poor with flaking in places, many surface fixed conduits, fittings and penetrations for services. A redundant window that was part of the original 1887 Building façade that now makes up the eastern wall has an infilled window converted into timber shelves.</p> <p><b>Recommendation:</b> Paint strip areas of loose or flaking paint, and where the damp has affected it. The rest can be subject to overcoating and or spot repairs as per the guidelines within <i>AS4361.1:2017 Guide to Hazardous Paint Management</i>. Render to be removed up to 1200mm high where rising damp has occurred and wet vacuum wash the brickwork for multiple cycles with a contained head wet system. Allow to dry for min 6 weeks and apply a salt retardant render prior to white set and painting. Fireplace cupboard should be sheeted over and a salvaged heritage mantle installed. Also refer to section 3.1.2. Walls and Section 3.1.3. Painted Surfaces in the <i>Physical Condition and Schedule of Conservation Works</i> report for further treatment recommendations.</p> <p><b>Grading of Significance: High</b></p>

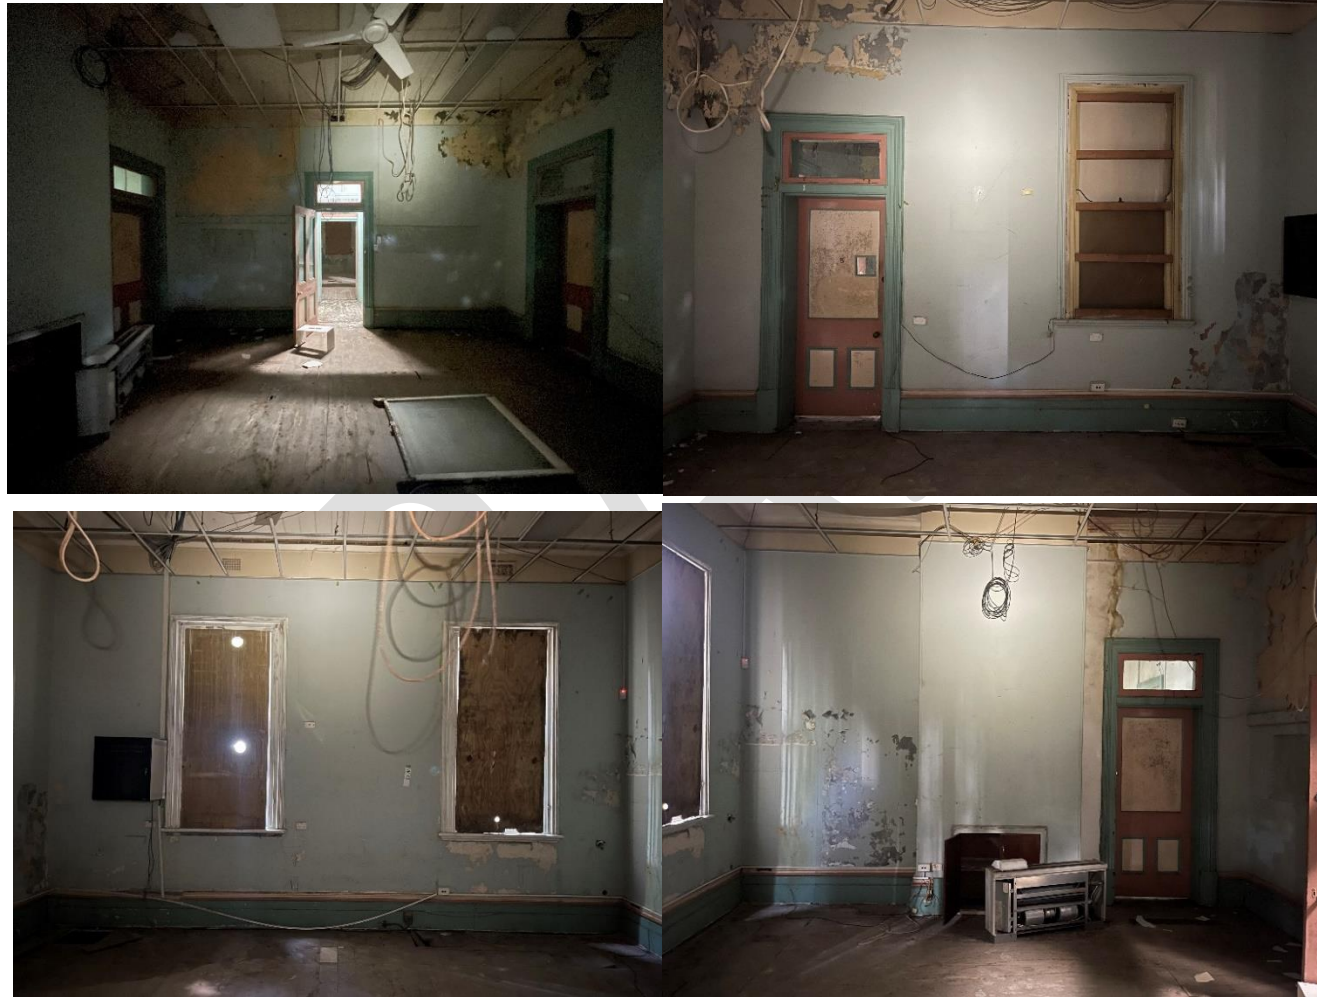
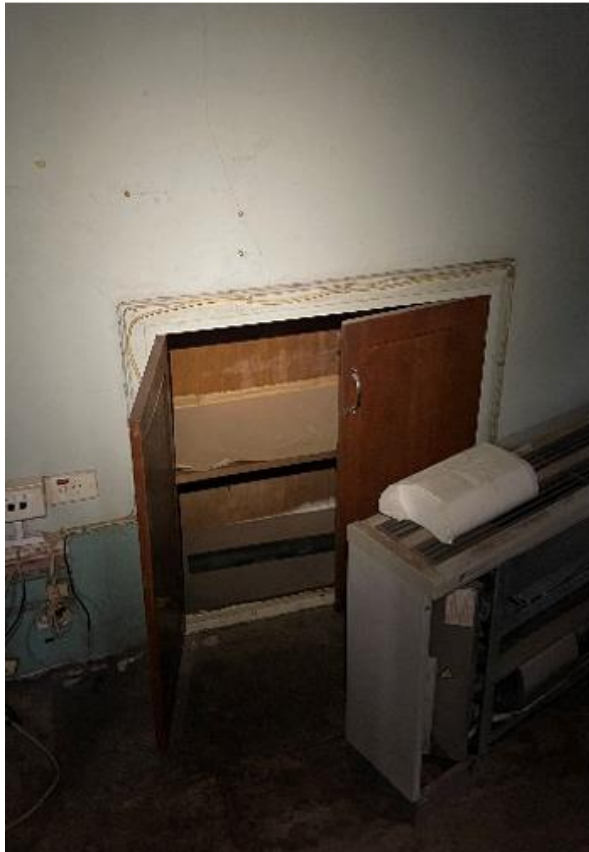
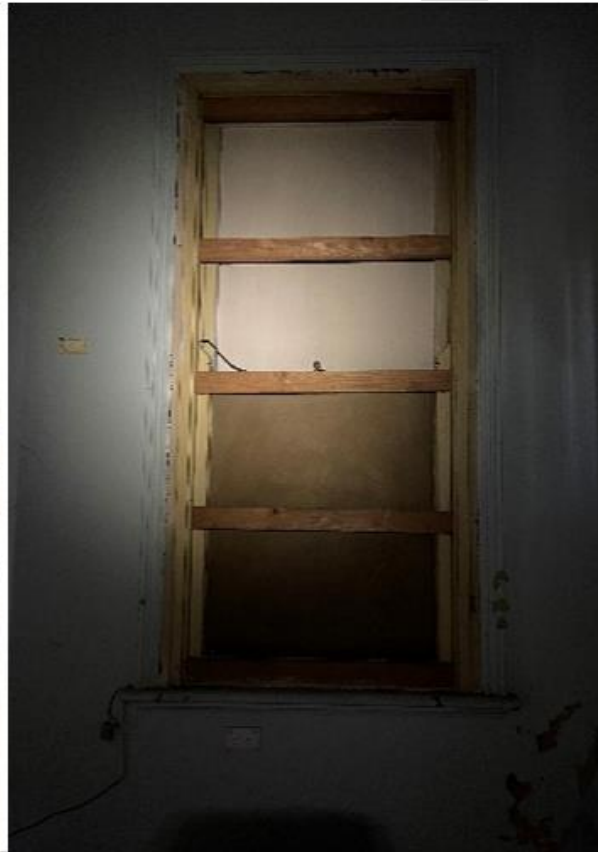
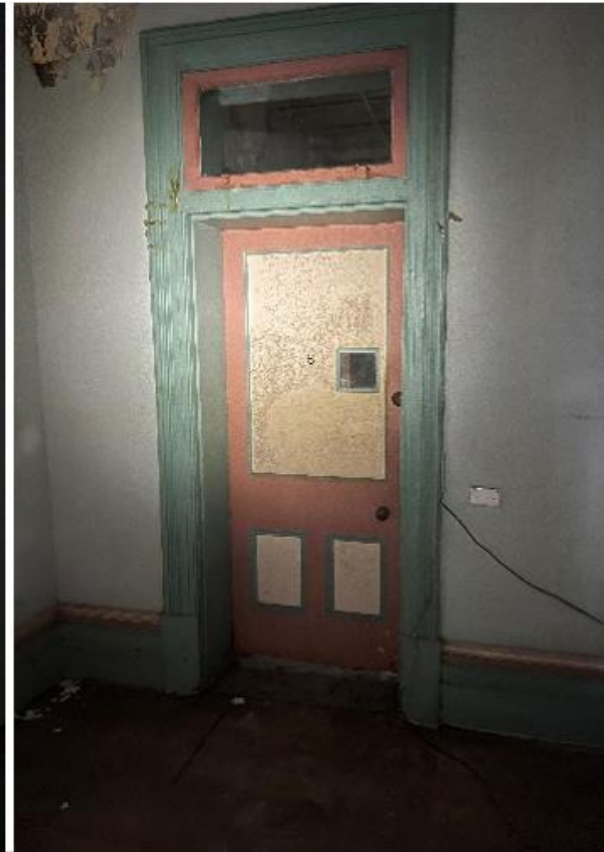
## CME Building – Room G15

CME Building – Room G15		
Fabric	Current Condition	Description and Recommendation
Floor	Poor	<p><b>Description:</b> Wide Kauri floorboards. Several damaged boards and infill repairs.</p> <p><b>Recommendation:</b> All floors on ground floor will need to be temporarily removed to facilitate subfloor works, including installation of concealed services. It is intended to salvage as much as possible of the remnant floorboards for reuse in accordance with Section 3.1.4. Floors in the <i>Physical Condition and Schedule of Conservation Works</i> methodology for floor works. Salvaged flooring from the entire building should collated and graded for condition from best to worst before being re-laid at the completion of subfloor works. Priority should be given to the rooms in key view lines and of most significance to have the floorboards in the best condition as per section 3.1 - 6 General recommendations in the <i>Physical Condition and Schedule of Conservation Works</i></p> <p><b>Grading of Significance: High</b></p>

Walls	Poor	<p><b>Description:</b> Falling and rising damp in parts of the room. There is a built out chimney breast in the middle of the western wall that has been retrofitted with a timber cupboard. Brick vents are miss matched and damaged by services penetrations, paint poor with flaking in places, many surface fixed conduits, fittings and penetrations for services. A redundant window that was part of the original 1887 Building that now makes up the eastern wall has been infilled with the back side in room G14 converted into timber shelves.</p> <p><b>Recommendation:</b> Paint strip areas of loose or flaking paint, and where the damp has affected it. The rest can be subject to overcoating and or spot repairs as per the guidelines within <i>AS4361.1:2017 Guide to Hazardous Paint Management</i>. Render to be removed up to 1200mm high where rising damp has occurred and wet vacuum wash the brickwork for multiple cycles with a contained head wet system. Allow to dry for min 6 weeks and apply a salt retardant render prior to white set and painting. Fireplace cupboard should be sheeted over and a salvaged heritage mantle installed. Also refer to section 3.1.2. Walls and Section 3.1.3. Painted Surfaces in the <i>Physical Condition and Schedule of Conservation Works</i> report for further treatment recommendations.</p> <p><b>Grading of Significance: High</b></p>

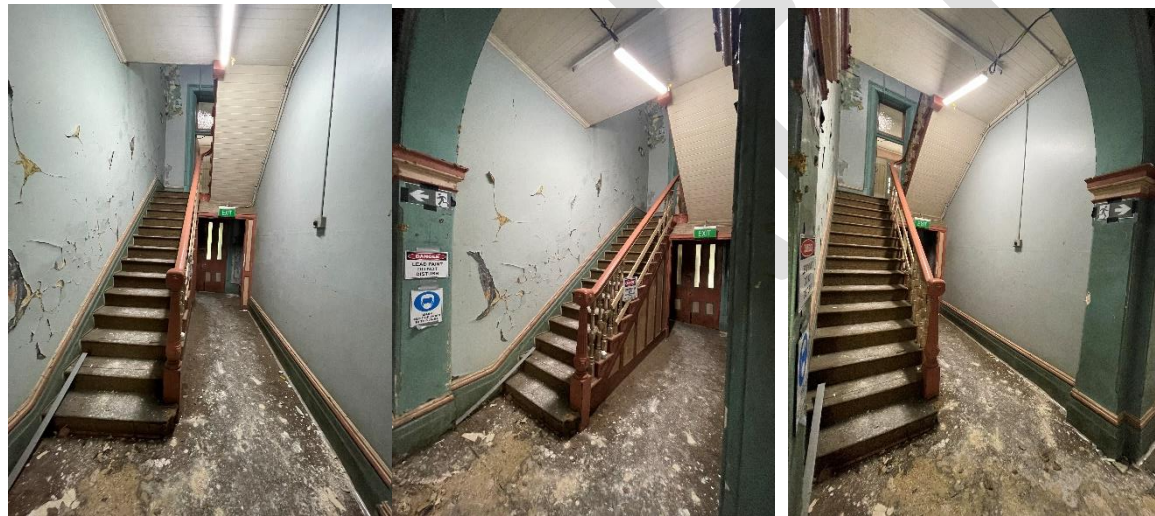
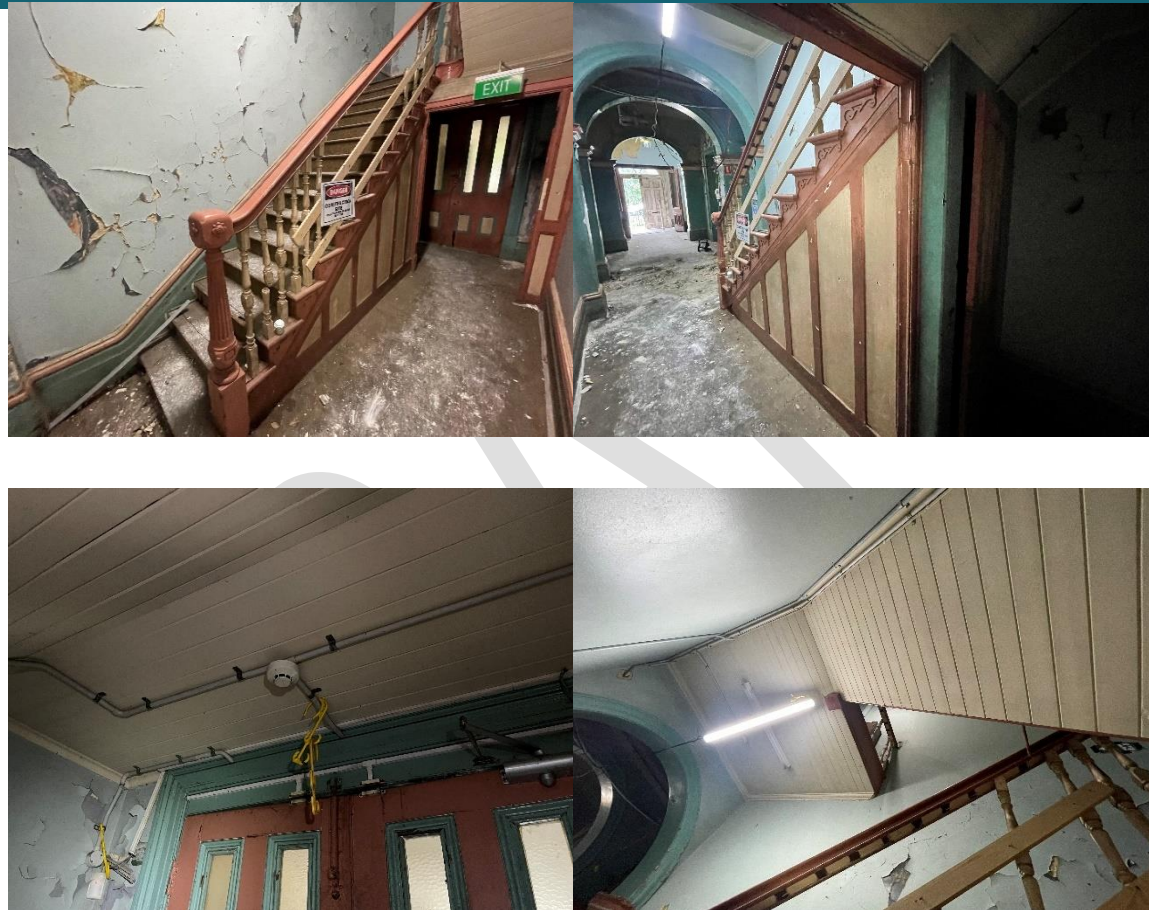
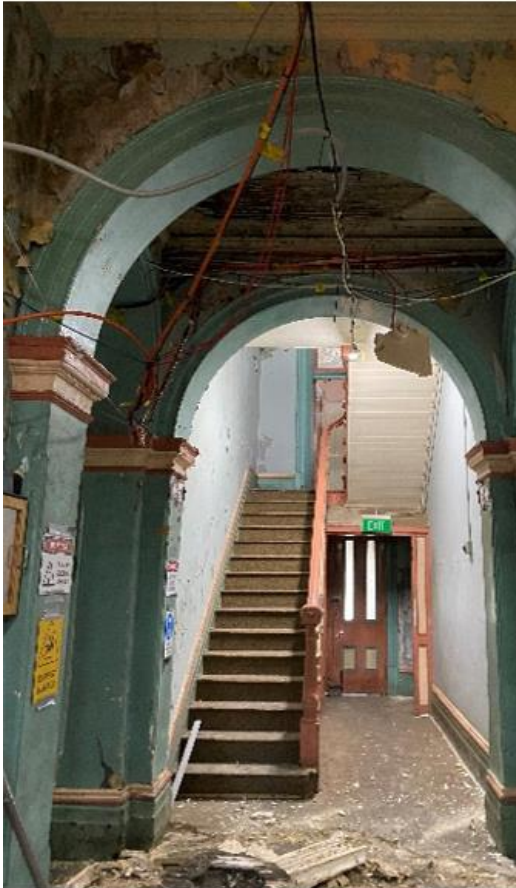
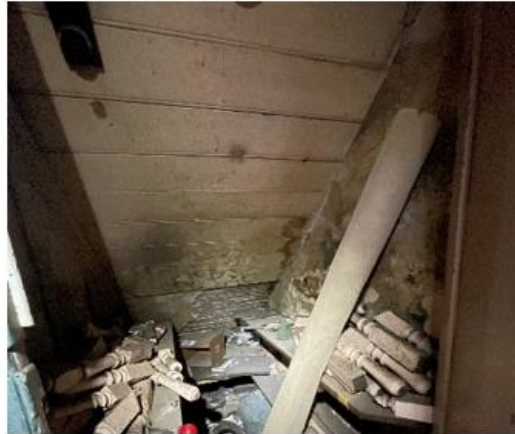
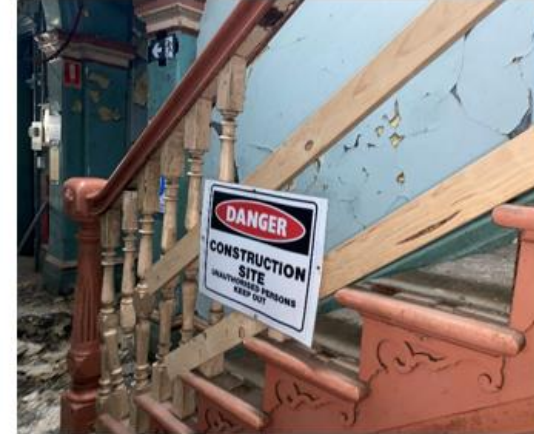
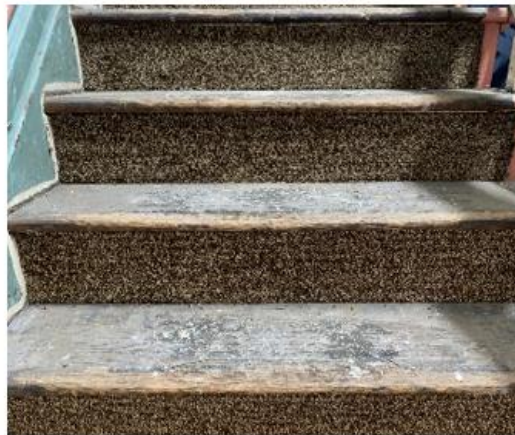
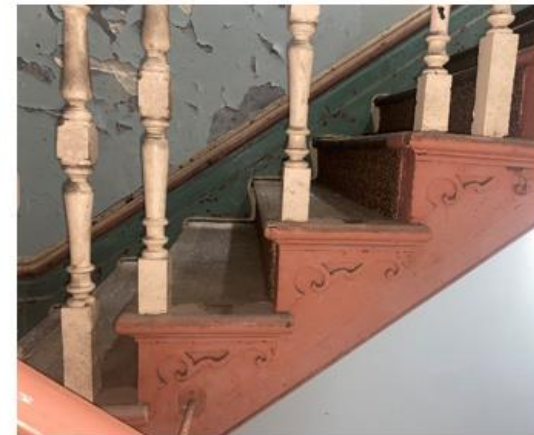
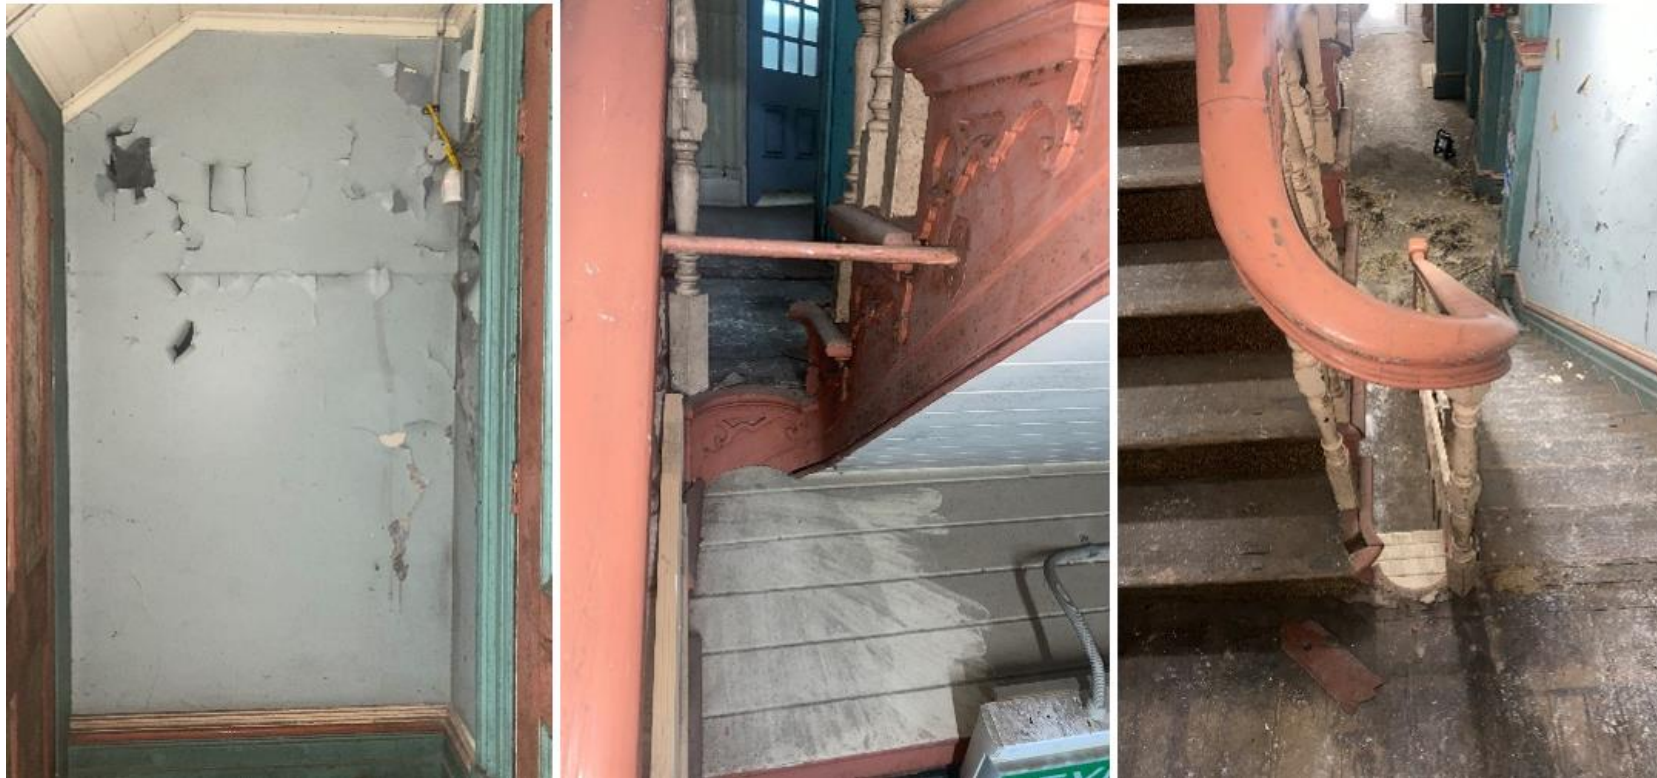
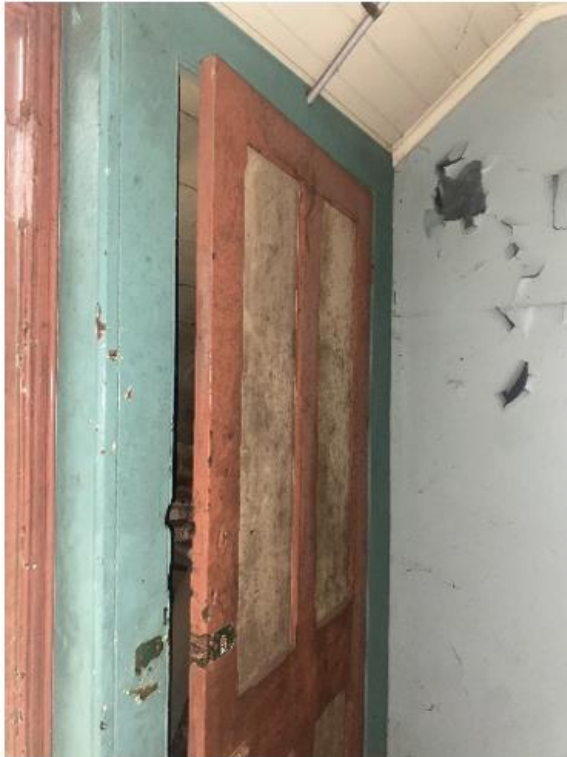
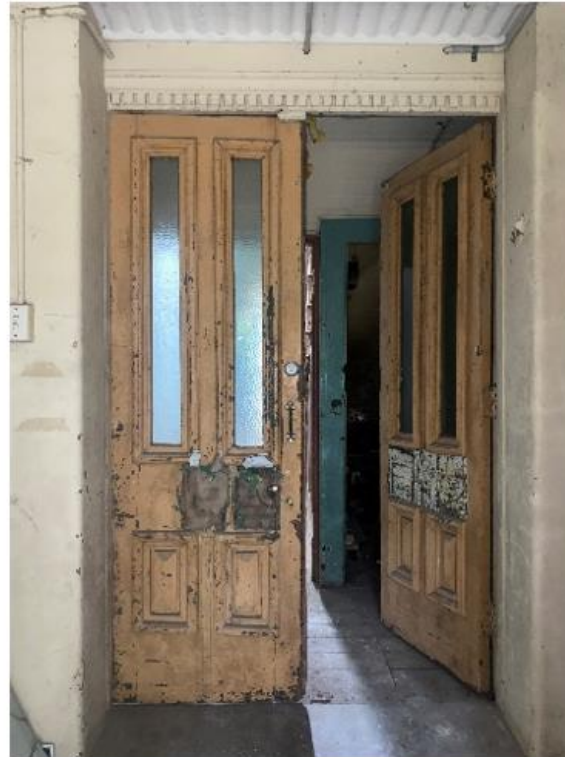
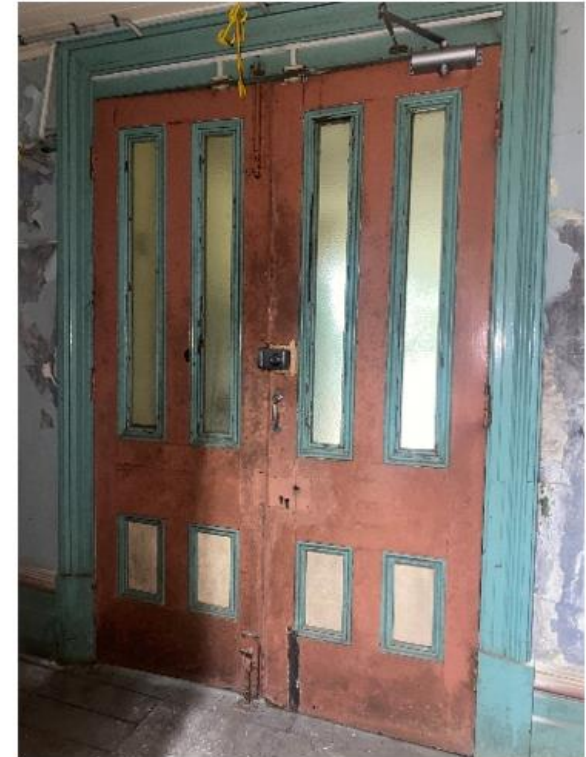
**CME Building – Room G17**

CME Building – Room G17		
Fabric	Current Condition	Description and Recommendation
Floor	Poor	<p><b>Description:</b> Wide Kauri floorboards, some water damage. Several damaged boards and infill repairs. The stair treads are in a poor state with considerable wear and splitting.</p> <p><b>Recommendation:</b> All floors on ground floor will need to be temporarily removed to facilitate subfloor works, including installation of concealed services. It is intended to salvage as much as possible of the remnant floorboards for reuse in accordance with Section 3.1.4. Floors in the <i>Physical Condition and Schedule of Conservation Works</i> methodology for floor works. Salvaged flooring from the entire building should collated and graded for condition from best to worst before being re-laid at the completion of subfloor works. Priority should be given to the rooms in key view lines and of most significance to have the floorboards in the best condition as per section 3.1 - 6 General recommendations in the <i>Physical Condition and Schedule of Conservation Works</i></p> <p><b>Grading of Significance: High</b></p>

Walls	Poor	<p><b>Description :</b> Falling and rising damp in parts of the room, paint poor with flaking in places, many surface fixed conduits, fittings and penetrations for services. Various cracks.</p> <p><b>Recommendation:</b> Paint strip areas of loose or flaking paint, and where the damp has affected it. The rest can be subject to overcoating and or spot repairs as per the guidelines within <i>AS4361.1:2017 Guide to Hazardous Paint Management</i>. Render to be removed where rising and falling damp has occurred and wet vacuum wash the brickwork for multiple cycles with a contained head wet system. Allow to dry for min 6 weeks and apply a salt retardant render prior to white set and painting. Also refer to section 3.1.2.Walls and Section 3.1.1. Painted Surfaces in the <i>Physical Condition and Schedule of Conservation Works</i> report for further treatment recommendations.</p> <p><b>Grading of Significance: High</b></p>

Ceilings	Poor	<p><b>Description:</b> Lining board ceiling, surface fixed conduits, fittings and penetrations for services. Some water damage in places</p> <p>Fires at the CME in 1902 caused extensive damage to the ceilings which resulted in the replacement of original lath and plaster ceilings in several rooms. Further fires at the CME in 1908 saw more fire damaged ceilings replaced,</p>

CME Building – Room G17		
		<p>this time with timber tongue-and- groove lining board ceilings. It was likely that the lining boards were used for economic reasons.</p> <p><b>Recommendation:</b> Remove Intrusive modern fixtures, fittings and conduits.</p> <ul style="list-style-type: none"> <li>• Where intact and not at risk of collapse, complete conservation works to reinstate back to original condition. This could be inclusive of patching existing holes, replacing missing, badly damaged sections.</li> <li>• Where small areas are damaged beyond salvage, replace with salvaged Fabric from other rooms of less significance within the building, replace with second hand salvaged material or replace with replicated modern equivalent.</li> <li>• Instead of removing large sections of heritage fabric ceilings to facilitate the installation of services or structural repairs, It would be a more preferable heritage outcome to leave any stable remnant ceiling fabric in situ and install a modern ceiling replica of the original ceiling based on existing documentation from the original build or from evidence of remnant fabric. These new ceilings would be installed lower to provide space to conceal services provided that any loss of height does not detract from the overall scale of the rooms or cover necessary ventilation grills or vents. The original ceiling would remain in its current condition concealed above it.</li> </ul> <p>See also Section 3.1.1. Ceilings in the <i>Physical Condition and Schedule of Conservation Works</i> report for further treatment recommendations.</p> <p><b>Grading of Significance: High</b></p>

Cornice	Fair	<p><b>Description:</b> Timber scotia cornice.</p> <p><b>Recommendation:</b> Remove intrusive modern fixtures and fittings. Decorative timber mouldings should be repaired in situ if possible. When beyond salvage or if ceilings are replaced, or relocated, timber mouldings should be reinstated with originals salvaged from elsewhere within the building where available or with replicated remakes of the originals should they be beyond salvage. As per section 3.1.1. Ceilings in the <i>Physical Condition and Schedule of Conservation Works</i> report for further treatment recommendations.</p>

CME Building – Room G17		
		Grading of Significance: High
Skirting	Poor	<p><b>Description:</b> 1887 original tall ornate skirtings with various services, and cabling surface fixed, Skirting may likely show further signs of water damaged and rot upon removal.</p> <p><b>Recommendation:</b> Skirting to be removed to facilitate rising damp repairs and floor removal.</p> <ul style="list-style-type: none"> <li>• Generally, skirtings should remain in their existing positions. Any skirting being replaced due to damage such as water ingress, dry rot and termite damage or that are missing should be reproduced to replicate other skirtings in the same room, or if none at all, should replicate its most likely profile based on the findings of the 1997 CMP.</li> <li>• Ground floor skirtings that are required to be removed for the subfloor excavation works, should have their locations recorded, labelled clearly, carefully removed, de-nailed, cleaned up and reinstated post excavation and subfloor works.</li> <li>• Consideration should be put into packing out skirtings with battens to create a void space for wiring prior to reinstallation where they are required to be removed to facilitate other works such as floor replacement, Subfloor excavation or rising damp remediation.</li> <li>• Consideration should be made towards sensitively and sympathetically incorporating a skirting duct into the current skirting profiles to facilitate ease of future services reticulation and to minimize the requirement for future invasive works.</li> </ul> <p>See also section 3.1.7. Skirtings in the <i>Physical Condition Report and Schedule of Conservation Works</i>.</p> <p>Grading of Significance: High</p>

Doors	Poor	<p><b>Description:</b> 4 panel door to the south beneath the lower flight encloses a storage room beneath the stairs. A pair of four panel double doors with obscure glazing to the upper panels open into G17 from G19. There appears to be a set of double swung doors that would have created an airlock type arrangement missing. These doors were hung from a timber jamb and nib wall that would have closed off the area beneath the landing of the stairs.</p> <p><b>Recommendation.</b> Paint strip and French polish the storage door and its jamb and the jamb and nib from the missing doors to match the rest of the staircase. The southernmost double doors should be either pinned open or retrofitted with automated openers to facilitate access.</p> <ul style="list-style-type: none"> <li>• Doors should generally be adjusted, cleaned up, and rehung in their original locations.</li> <li>• Doors and jambs that need to be replaced for fire rating, should be replaced with compliant metal jambs and fire doors. Existing architraves should be reinstated, and sympathetic bolection mouldings should be installed onto the fire doors to recreate the appearance of the original panel doors.</li> <li>• -Existing heritage hardware that is non-operational should be stripped, polished, decommissioned and reinstated in as close to its original position provided that it does not interfere with compliance of new door control hardware. New modern hardware that is sympathetic to the heritage aspect of the building yet compliant with relevant Building codes and Australian Standards (AS1428.1) should be installed.</li> <li>• Fanlights should be cleaned up and made good. They should be made to operate if required as part of the HVAC requirements of the building. Existing hardware should be removed, polished and reinstated. Any missing hardware should be replaced with reproduction items to match the existing. Consideration as to make the fanlights operable, fixed open or fixed closed should be made in conjunction with the requirements of the buildings HVAC system and acoustic considerations.</li> <li>• Any damage or cut outs to architraves or jambs should be reinstated with timber inlays and reshaped to blend in.</li> <li>• Doors that need to be pinned in an open position should be fixed in place with a concealed fixing.</li> </ul> <p><b>Grading of Significance:</b> High</p>

CME Building – Room G17		
Fireplace	N/A	<p><b>Description:</b> N/A- No fireplaces in this area.</p> <p><b>Recommendation:</b> N/A</p> <p><b>Grading of Significance:</b> N/A</p>
Staircase	Poor	<p><b>Description:</b> The stair treads are in a poor state with considerable wear and splitting. End return nosings are loose in places. Risers are currently carpeted. Everything besides the treads has been painted. Balusters are nearly all broken, knewel posts and railings are attached. Decorative fretwork to the stringers and panelling below is intact. An enclosed space below the lower flight is currently used as storage with shelving.</p> <ul style="list-style-type: none"> <li>• <b>Recommendation:</b> Floors in this area will be removed in part to facilitate subfloor works. Stair treads should be repaired where possible. Treads damaged beyond salvage will need to be replaced. Also refer to Section 3.1.4. Floors in the <i>Physical Condition Report and Schedule of Conservation Works</i>. Balusters should be replaced with replicated copies of the original design. Handrails, Knewel posts, stringers, fretwork and panelling should be stripped and french polished as per original. Code compliant handrails should be retrofitted. They should be fabricated from brass and be sympathetic in both design and attachment to the existing balustrade. The storage space below the lower flight should be used to house services. Sprinklers required to be fitted under the upper flight should be concealed within the lining boards or installed as side throw from the underside of the upper landing to minimise adding intrusive elements to the otherwise undisturbed lining boards. Fixing of the Knewel posts to the existing timber structure should be assessed for adequacy and fixings should be added to maintain rigidity.</li> <li>• Stair balustrades should be repaired and reinstated. Additional sympathetic and complimentary metal handrails should be added to achieve compliance with relevant codes and standards.</li> <li>• Consideration should be put towards a central carpet runner with brass rod retainers and code compliant tread nosing's to provide slip ratings and luminance contrast for the main staircase.</li> <li>• Contrasting stone inlays or carborundum inlays should be considered for luminance contrast strips on the nosing's of existing stone or masonry steps. Carborundum is suggested due to its non-slip qualities</li> </ul>
