## 9. Inventory Sheets

This chapter includes the inventory sheets for each room within the CME Building. Each datasheet includes:

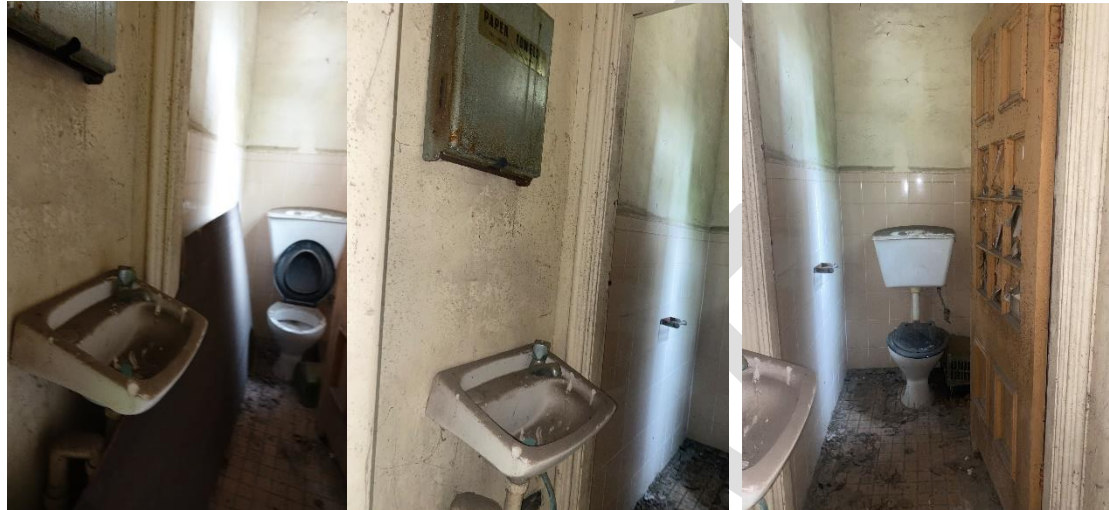
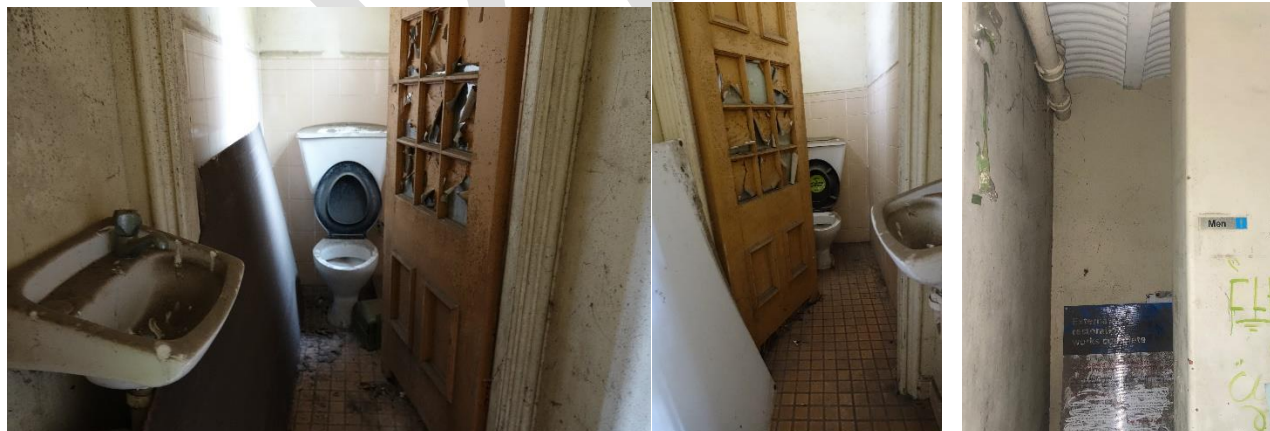
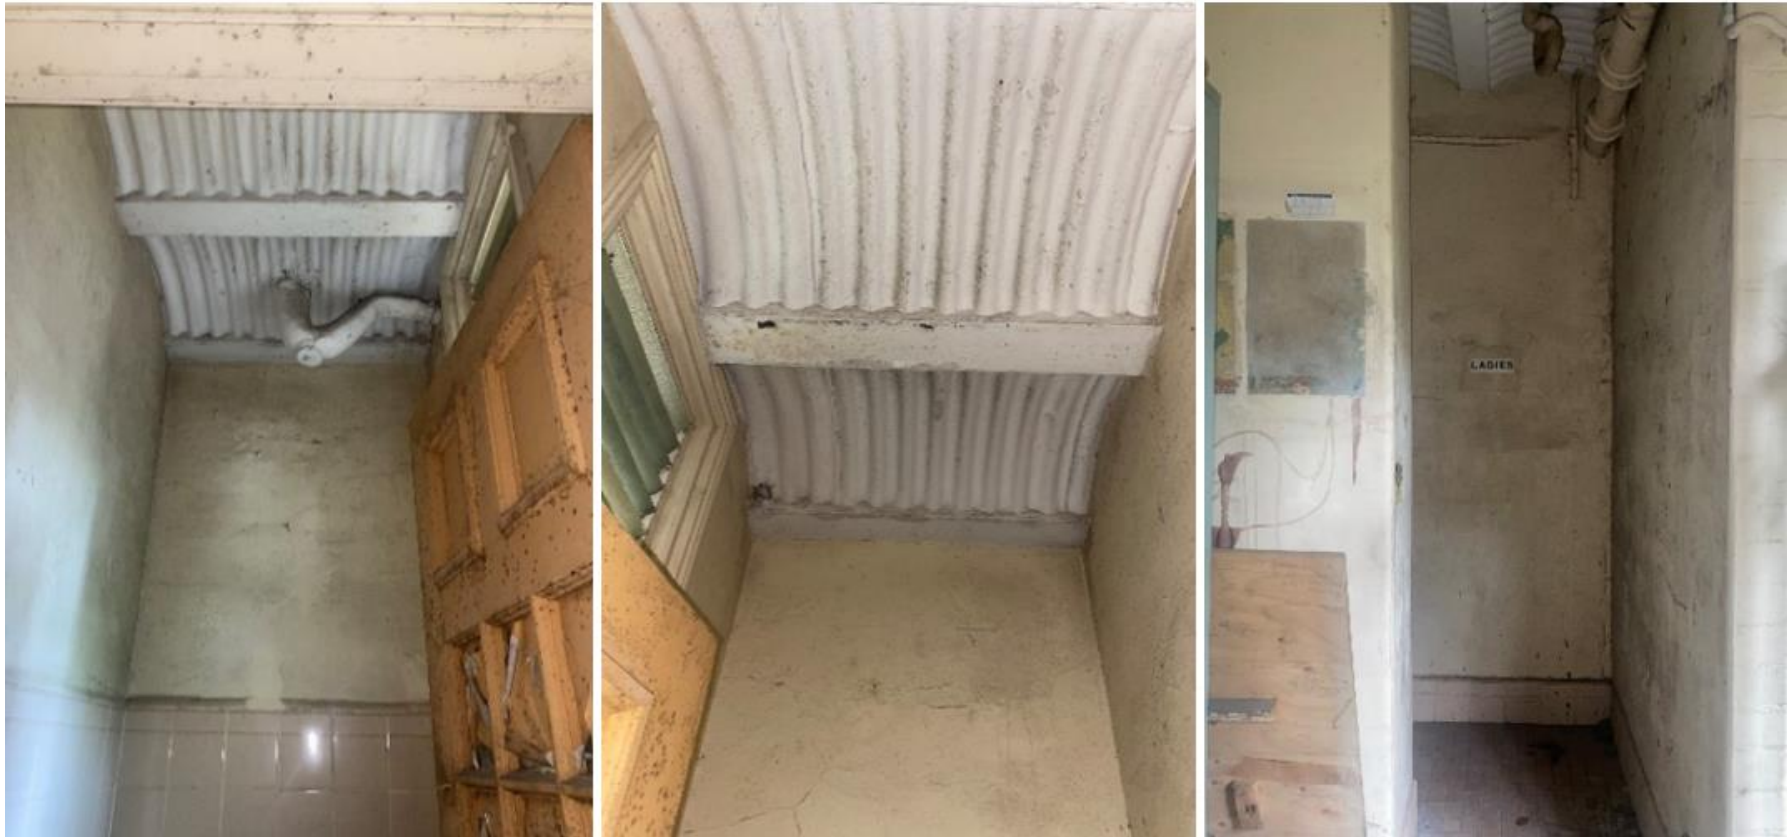
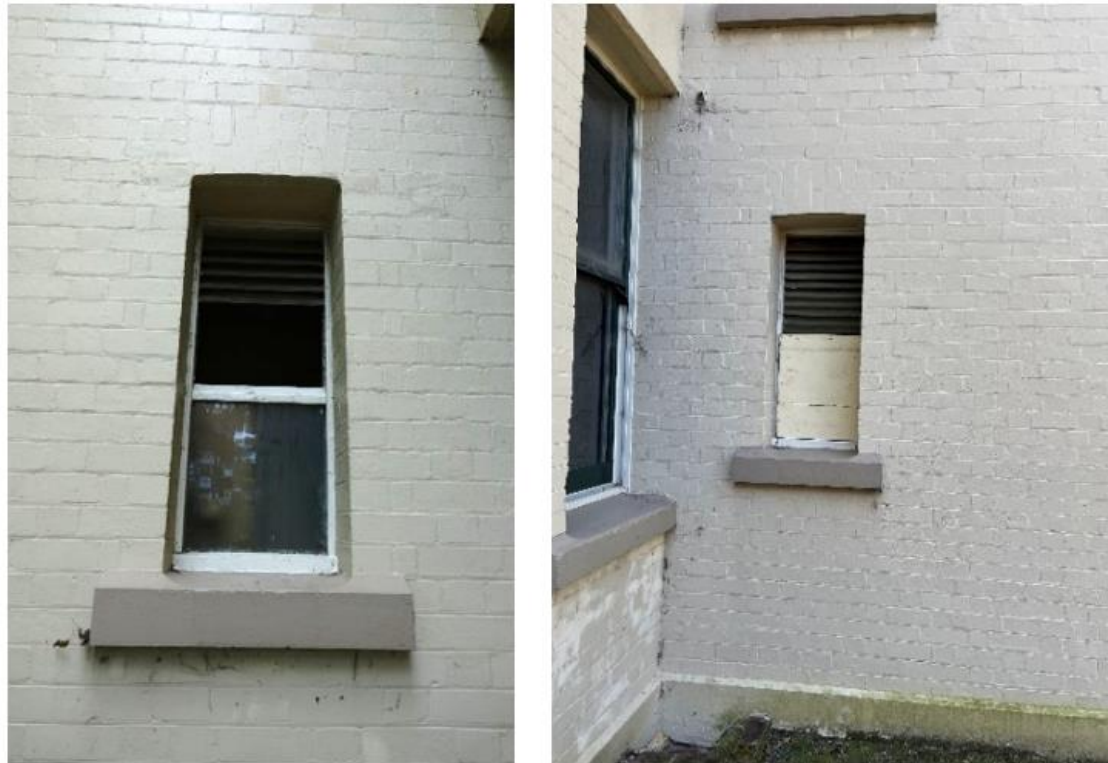
### CME Building – Room G18 & G20

CME Building – Room G18 & G20		
Fabric	Current Condition	Description and Recommendation
Floor	Fair	<p><b>Description:</b> Tiled Floor, currently in fair condition</p> <p><b>Recommendation:</b> Tile Floors in this room will be removed in part to facilitate Hydraulic upgrades, waterproofing and re-tiling See section 3.1.4 Floors in the <i>Physical Condition and Schedule of Conservation Works</i> methodology for floor works.</p> <p><b>Grading of Significance: Moderate</b></p>
Walls	Poor	<p><b>Description :</b> Paint poor with flaking in places, mould and various cracks. Northern half of the room in toilet cubicle is tiled to approx. 1500mm High. Toilet located at Northern end of the room and hand basin and paper towel dispenser to entry.</p> <p><b>Recommendation:</b> Remove toilet, basin and paper towel dispenser, paint strip areas of loose or flaking paint, The rest can be subject to overcoating and or spot repairs as per the guidelines within <i>AS4361.1:2017 Guide to Hazardous Paint Management</i>. Wall tiles to be removed. If rising damp has occurred, wet vacuum wash the brickwork for multiple cycles with a contained head wet system. Allow to dry for min 6 weeks and apply a salt retardant render prior to white set and painting. Also refer to section 3.1.2. Walls and Section 3.1.3. Painted Surfaces in the <i>Physical Condition and Schedule of Conservation Works</i> report for further treatment recommendations.</p> <p><b>Grading of Significance: Moderate</b></p>

Ceilings	Fair	<p><b>Description:</b> Jack arch ceiling, surface fixed conduits, fittings and penetrations for services. Some water damage in places</p> <p><b>Recommendation:</b> Remove redundant services, patch and Paint strip areas of loose or flaking paint and patch redundant penetrations. The rest can be subject to overcoating and or spot repairs as per the guidelines within <i>AS4361.1:2017 Guide to Hazardous Paint Management</i>. Assess for water damage. See also Section 3.1.1.Ceilings and Section 3.1.3. Painted Surfaces in the <i>Physical Condition and Schedule of Conservation Works</i> report for further treatment recommendations.</p> <p><b>Grading of Significance: Moderate</b></p>

CME Building – Room G18 & G20		
Cornice	N/A	<p><b>Description:</b> N/A</p> <p><b>Recommendation:</b> N/A</p> <p><b>Grading of Significance:</b> N/A</p>
Skirting	Fair	<p><b>Description:</b> Tiled border skirting, currently in fair condition</p> <p><b>Recommendation:</b> Tile Floors in this room will be removed in part to facilitate Hydraulic upgrades, waterproofing and re-tiling See section 3.1.4. Floors in the <i>Physical Condition and Schedule of Conservation Works</i> report for further treatment recommendations.</p> <p><b>Grading of Significance:</b> Little</p>
Windows	Poor	<p><b>Description:</b> Upper glass louvres with lower fixed sash with obscure glass. Partially boarded up and not accessible for full inspection</p> <p><b>Recommendation:</b> Remove boarding to expose windows. Strip all lead paint completely from all surfaces and prepare all surfaces under HAZMAT conditions in accordance with <i>AS4361.1:2017 Guide to Hazardous Paint Management</i> prior to commencement of works.</p> <ul style="list-style-type: none"> <li>• Windows should generally be repaired adjusted and cleaned up in their original locations. This could be inclusive of sash cord and weight replacement, glazing putty touch ups or replacement, adjustment and refitting of sashes, rot and damage repairs, broken glass replacement and hardware repairs and or replacement.</li> <li>• Existing heritage hardware should be stripped, polished and reinstated in as close to its original position. Missing hardware should be reinstated with new modern reproduction equivalents.</li> <li>• Locks should be made operational if windows are to be operable. Opening restrictions should be added for both security and code compliance if windows present a climb or fall risk.</li> </ul> <p>See also section 3.1.3. Painted Surfaces and section 3.1.5 Windows in the <i>Physical Condition and Schedule of Conservation Works</i> report for further treatment recommendations.</p> <p><b>Grading of Significance:</b> Moderate</p>

CME Building – Room G18 & G20		
Doors	Poor	<p><b>Description:</b> 13 panel doors enclose the toilet cubicle with 2 solid panels at the top and two solid panels at the bottom with array of 9 obscure glass panels mid-height. An arched cutout provides a large central undercut.</p> <p><b>Recommendation:</b></p> <ul style="list-style-type: none"> <li>• Doors should generally be adjusted, cleaned up, and rehung in their original locations.</li> <li>• Doors and jambs that need to be replaced for fire rating, should be replaced with compliant metal jambs and fire doors. Existing architraves should be reinstated, and sympathetic bolection mouldings should be installed onto the fire doors to recreate the appearance of the original panel doors.</li> <li>• -Existing heritage hardware that is non-operational should be stripped, polished, decommissioned and reinstated in as close to its original position provided that it does not interfere with compliance of new door control hardware. New modern hardware that is sympathetic to the heritage aspect of the building yet compliant with relevant Building codes and Australian Standards (AS1428.1) should be installed.</li> <li>• Fanlights should be cleaned up and made good. They should be made to operate if required as part of the HVAC requirements of the building. Existing hardware should be removed, polished and reinstated. Any missing hardware should be replaced with reproduction items to match the existing. Consideration as to make the fanlights operable, fixed open or fixed closed should be made in conjunction with the requirements of the buildings HVAC system and acoustic considerations.</li> <li>• Any damage or cut outs to architraves or jambs should be reinstated with timber inlays and reshaped to blend in.</li> <li>• Doors that need to be pinned in an open position should be fixed in place with a concealed fixing.</li> </ul> <p>Also refer to section 3.1.6 Doors in the <i>Physical Condition Report and Schedule of Conservation Works</i>.</p> <p><b>Grading of Significance: Moderate</b></p>

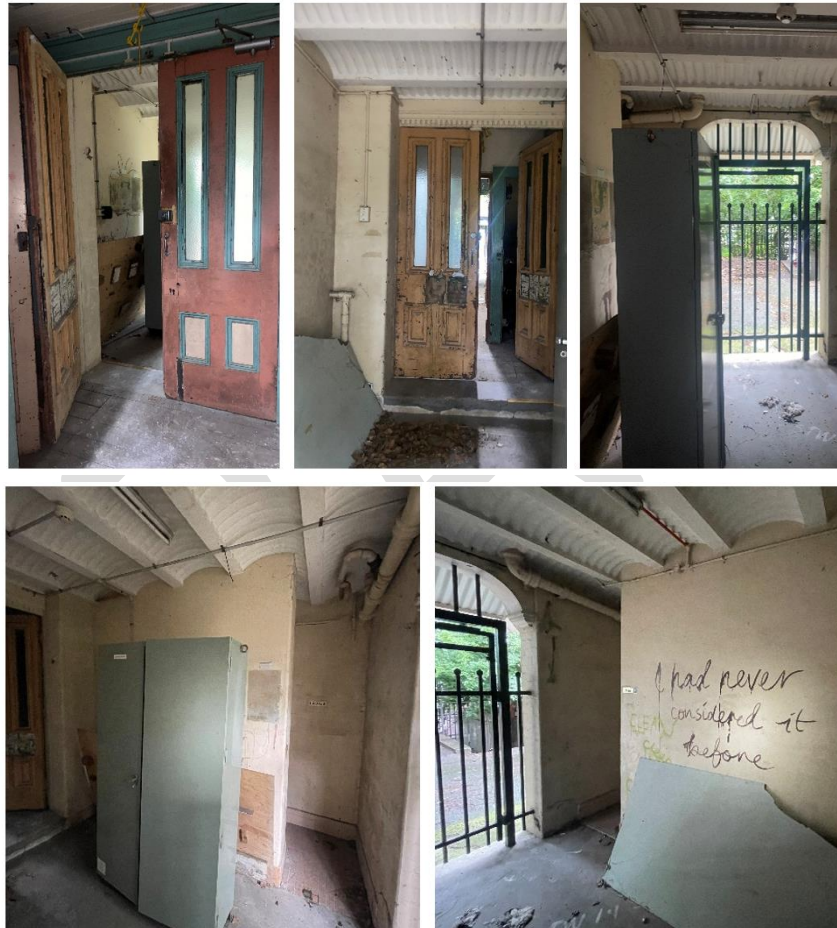
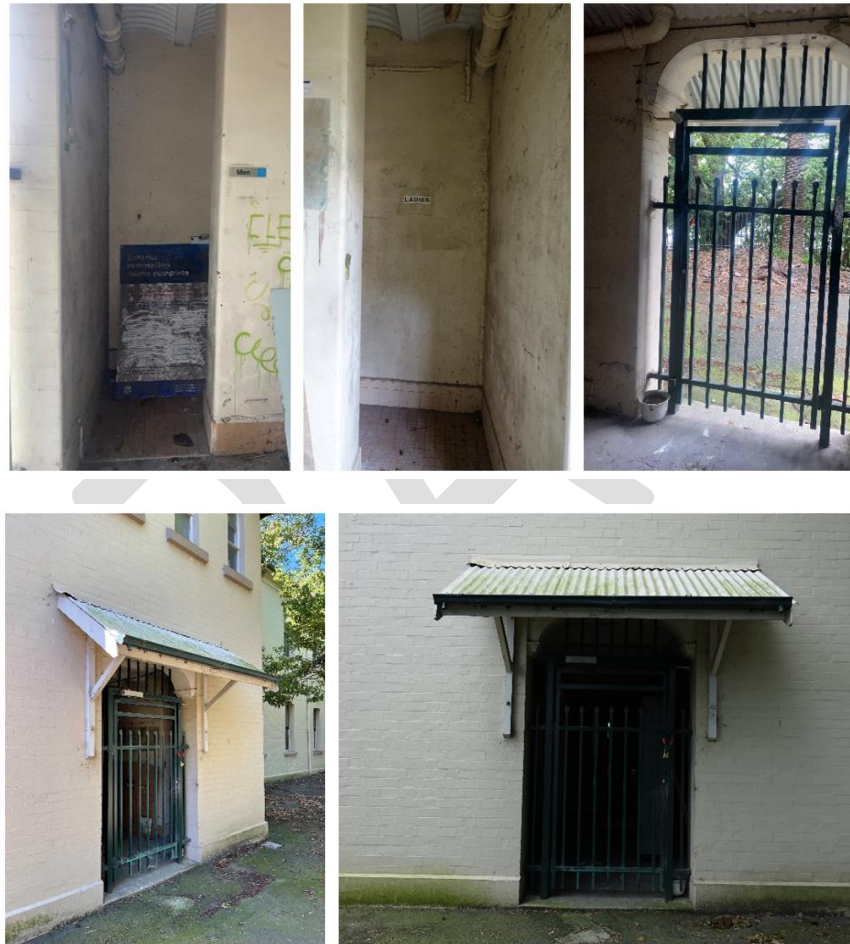
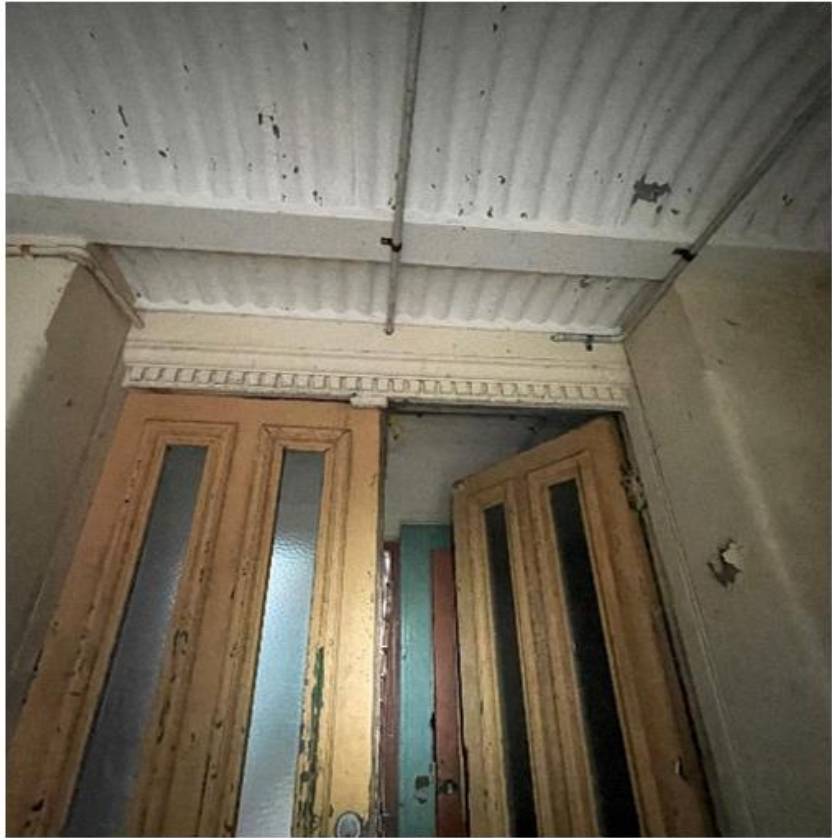
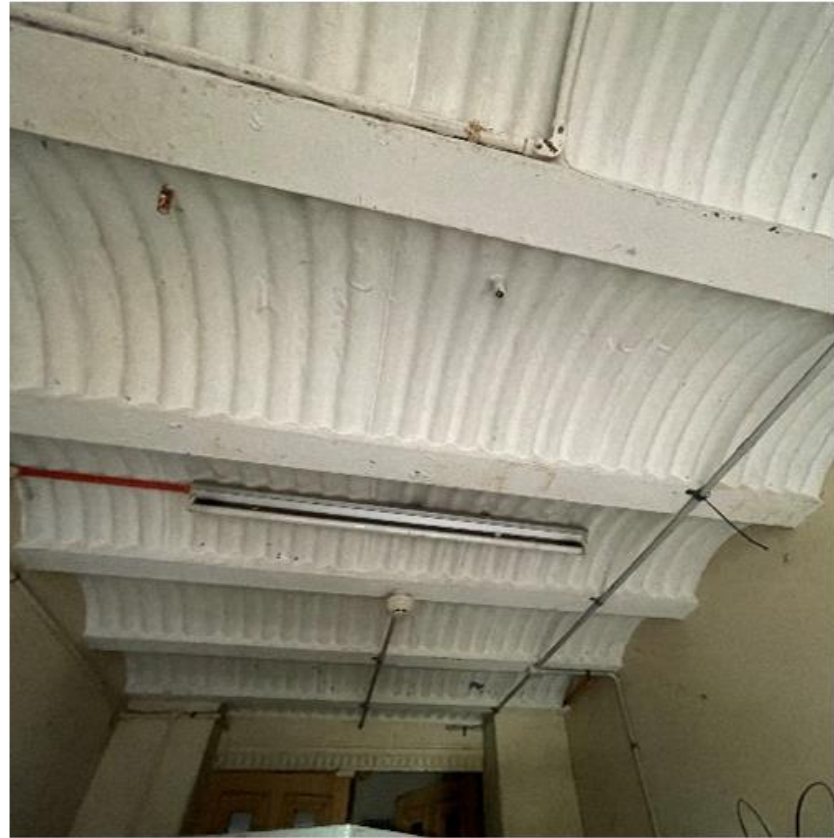
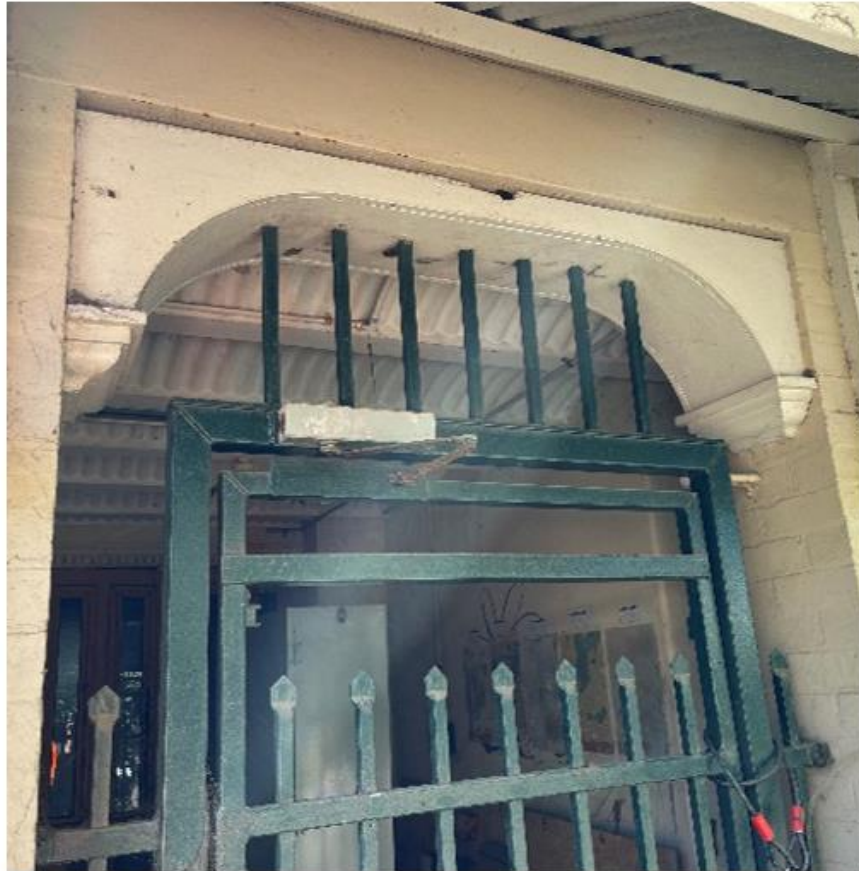
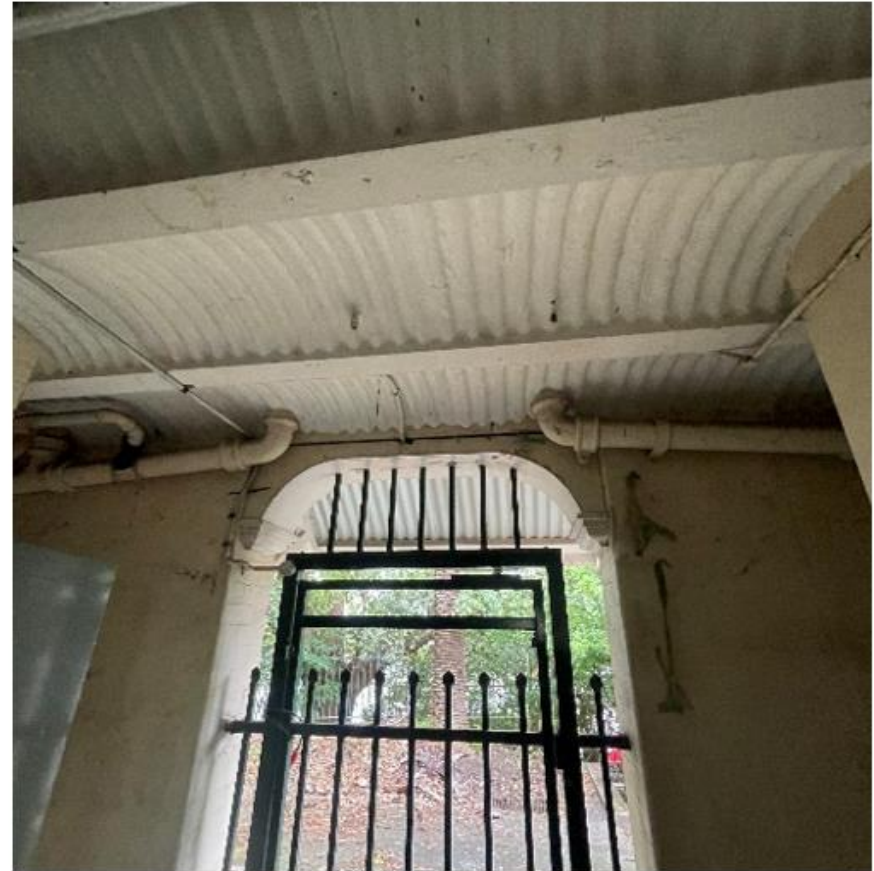
## CME Building – Room G19

CME Building – Room G19		
Fabric	Current Condition	Description and Recommendation
Floor	poor	<p><b>Description:</b> Concrete floor, currently in poor condition with minor cracking and a section with a cementitious residue. A stone indent has been placed onto the threshold step into G17.</p> <p><b>Recommendation:</b> Pressure clean, spot repair any damage with matching. Suggest grinding or honing cementitious residue and lightly dress remainder of floor prior to the application of an appropriate non slip sealer. See section 3.1.4. Floors in the <i>Physical Condition and Schedule of Conservation Works</i> methodology for floor works.</p> <p><b>Grading of Significance: Moderate</b></p>
Walls	Poor	<p><b>Description :</b> Paint poor with flaking in places. Graffiti and paint removal samples evident.</p> <p><b>Recommendation:</b> Remove redundant services, paint strip areas of loose or flaking paint, The rest can be subject to overcoating and or spot repairs as per the guidelines within <i>AS4361.1:2017 Guide to Hazardous Paint Management</i>. Wall tiles to be removed. If rising damp has occurred, remove render and wet vacuum wash the brickwork for multiple cycles with a contained head wet system. Allow to dry for min 6 weeks and apply a salt retardant render prior to painting. Also refer to section 3.1.2. Walls and Section 3.1.3. Painted Surfaces in the <i>Physical Condition and Schedule of Conservation Works</i> report for further treatment recommendations.</p> <p><b>Grading of Significance: Moderate</b></p>

Ceilings	Fair	<p><b>Description:</b> Jack arch ceiling, surface fixed conduits, fittings and penetrations for services. Some water damage in places</p> <p><b>Recommendation:</b> Remove redundant services, patch and Paint strip areas of loose or flaking paint and patch redundant penetrations. The rest can be subject to overcoating and or spot repairs as per the guidelines within <i>AS4361.1:2017 Guide to Hazardous Paint Management</i>. Assess for water damage. See also Section 3.1.1. Ceilings and Section 3.1.3. Painted Surfaces in the <i>Physical Condition and Schedule of Conservation Works</i> report for further treatment recommendations.</p> <p><b>Grading of Significance: Moderate</b></p>

CME Building – Room G19		
Cornice	N/A	<p>Description: N/A- No cornice in this area.</p> <p>Recommendation: N/A</p> <p>Grading of Significance: N/A</p>
Skirting	N/A	<p>Description: N/A – Noskirting in this area.</p> <p>Recommendation: N/A</p> <p>Grading of Significance: N/A</p>
Windows	N/A	<p>Description: N/A – No windows in this area.</p> <p>Recommendation: N/A</p> <p>Grading of Significance: N/A</p>
Doors	Poor	<p>Description: A Pair of double four panel doors with obscure glazed top panels and heavy bolection mouldings to the north with an ornate decorative header above. The doors are in worn condition with paint removal trials having been undertaken on them in the past. There is a single steel security gate to the south with a decorative arch detail above. The gate is a modern addition.</p> <p>Recommendation: Repair damage and automate or fix them in an open position. Gate- Remove and replace with modern glass automated door.</p> <ul style="list-style-type: none"> <li>• Doors should generally be adjusted, cleaned up, and rehung in their original locations.</li> <li>• Doors and jambs that need to be replaced for fire rating, should be replaced with compliant metal jambs and fire doors. Existing architraves should be reinstated, and sympathetic bolection mouldings should be installed onto the fire doors to recreate the appearance of the original panel doors.</li> <li>• -Existing heritage hardware that is non-operational should be stripped, polished, decommissioned and reinstated in as close to its original position provided that it does not interfere with compliance of new door</li> </ul>

CME Building – Room G19		
		<p>control hardware. New modern hardware that is sympathetic to the heritage aspect of the building yet compliant with relevant Building codes and Australian Standards (AS1428.1) should be installed.</p> <ul style="list-style-type: none"> <li>Fanlights should be cleaned up and made good. They should be made to operate if required as part of the HVAC requirements of the building. Existing hardware should be removed, polished and reinstated. Any missing hardware should be replaced with reproduction items to match the existing. Consideration as to make the fanlights operable, fixed open or fixed closed should be made in conjunction with the requirements of the buildings HVAC system and acoustic considerations.</li> <li>Any damage or cut outs to architraves or jambs should be reinstated with timber inlays and reshaped to blend in.</li> <li>Doors that need to be pinned in an open position should be fixed in place with a concealed fixing.</li> </ul> <p>Also refer to section 3.1.6. Doors in the <i>Physical Condition Report and Schedule of Conservation Works</i>.</p> <p><b>Grading of Significance: High</b></p>

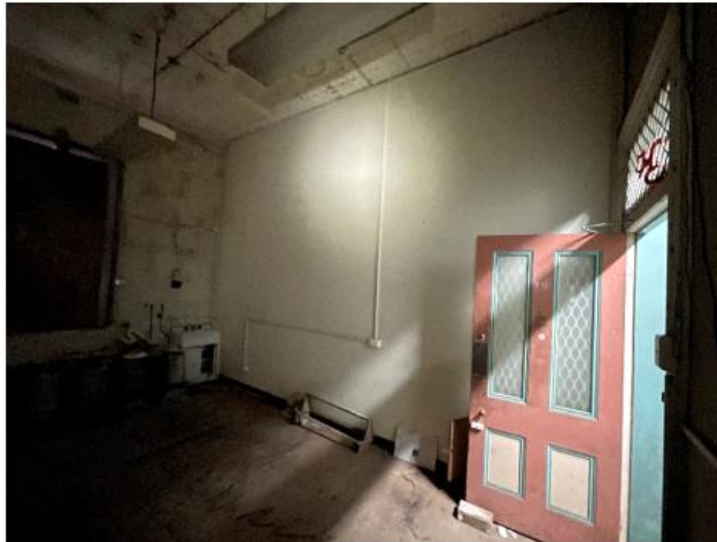
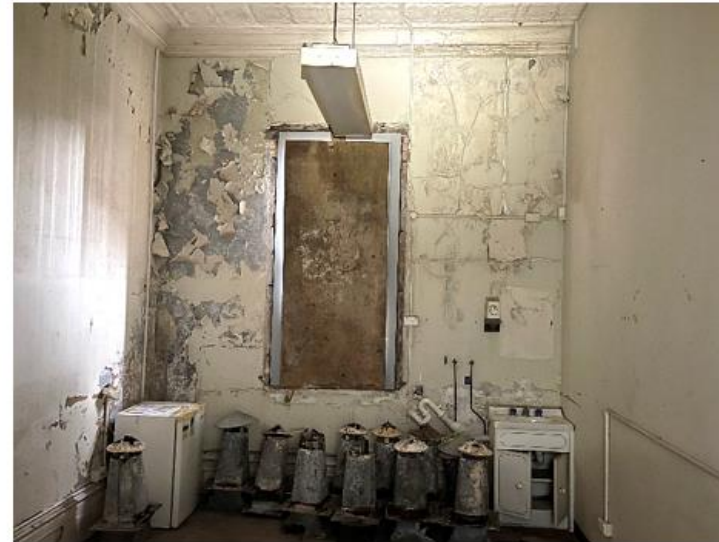
## CME Building - Room G21

CME Building – Room G21		
Fabric	Current Condition	Description and Recommendation
Floor	Fair	<p><b>Description:</b>– Wide boards, likely Kauri Pine. Generally fair condition besides a few patches. Two concrete pads are located adjacent to the fireplace in the north and south east of the room</p> <p><b>Recommendation:</b> All floors on ground floor will need to be temporarily removed to facilitate subfloor works, including installation of concealed services. It is intended to salvage as much as possible of the remnant floorboards for reuse in accordance with Section 3.1.4. Floors in the <i>Physical Condition and Schedule of Conservation Works</i> methodology for floor works. Salvaged flooring from the entire building should collated and graded for condition from best to worst before being re-laid at the completion of subfloor works. Priority should be given to the rooms in key view lines and of most significance to have the floorboards in the best condition as per section 3.1 - 6 General recommendations in the <i>Physical Condition and Schedule of Conservation Works</i></p> <p><b>Grading of Significance: High</b></p>

Walls	Poor	<p><b>Description:</b> Rising and falling damp, cracks on south wall, particularly near windows, brick vents are miss matched and some are damaged by services penetrations, paint poor and flaking in places, many surface fixed conduits, fittings and penetrations for services. An intrusive modern partition wall running north-south divides this room into two. An intrusive joinery cupboard with a sink exists in the south western corner.</p> <p><b>Recommendation:</b> Remove modern partition and intrusive joinery item. Paint strip areas of loose or flaking paint, and where the damp has affected it. The rest can be subject to overcoating and or spot repairs as per the guidelines within <i>AS4361.1:2017 Guide to Hazardous Paint Management</i>. Render to be removed up to 1200mm high where rising damp has occurred and other areas where falling damp is evident. Wet vacuum wash the brickwork for multiple cycles with a contained head wet system. Allow to dry for min 6 weeks and apply a salt retardant render prior to white set and painting. Render will also need repairs around the eastern most window. Also refer to section 3.1.2. Walls and Section 3.1.3. Painted Surfaces in the <i>Physical Condition and Schedule of Conservation Works</i> report for further treatment recommendations.</p> <p><b>Grading of Significance: High</b></p>

CME Building – Room G21		
Ceilings	Poor	<p><b>Description:</b> Pressed metal in poor and rusty condition. Many surface fixed conduits, fittings and penetrations for services. A decorative pressed metal ceiling rose in the centre of the room. This room has a different pattern of pressed metal to rooms G9 &amp; G10 – type 2</p> <p><b>Recommendation:</b> Remove intrusive modern fixtures, fittings and conduits, strip paint as per the guidelines within <i>AS4361.1:2017 Guide to Hazardous Paint Management</i>, patch repair pressed metal and repaint. New fitting and services to be installed sympathetically and symmetrically with the pattern.</p> <ul style="list-style-type: none"> <li>Where intact and not at risk of collapse, complete conservation works to reinstate back to original condition. This could be inclusive of patching existing holes, replacing missing, badly damaged or rusted sections with new fabric replicated to match the existing patterns.\</li> <li>If the entire room is beyond salvage, remove any unstable remnant fabric and install a modern plywood ceiling substrate with new pressed metal fabric replicated to match the existing patterns. Should heritage cornices in these rooms need to be replaced due to damage, they are to be replaced with cornice replicated to match the existing heritage cornice. The ceilings could potentially be installed lower to provide space to conceal services provided that any loss of height does not detract from the overall scale of the rooms or cover necessary ventilation grills or vents.</li> <li>Instead of removing large sections of heritage fabric ceilings to facilitate the installation of services or structural repairs, It would be a more preferable heritage outcome to leave any stable remnant ceiling fabric in situ and install a modern ceiling replica of the original ceiling based on existing documentation from the original build or from evidence of remnant fabric. These new ceilings would be installed lower to provide space to conceal services provided that any loss of height does not detract from the overall scale of the rooms or cover necessary ventilation grills or vents. The original ceiling would remain in its current condition concealed above it. See also section Room by Room Schedule 3.1.1 Ceilings in the <i>Physical Condition and Schedule of Conservation Works</i> report for further treatment recommendations.</li> </ul> <p><b>Grading of Significance:</b> High</p>

CME Building – Room G21		
Cornice	Fair to Poor	<p><b>Description:</b> fair to poor condition decorative ornate plaster cornice, many surface fixed conduits and wires on cornice.</p> <p><b>Recommendation:</b> Remove intrusive modern fixtures and fittings. Decorative plaster cornices should be repaired in situ if possible. When beyond salvage or if ceilings are replaced, or relocated, cornices should be reinstated with originals salvaged from elsewhere within the building where available or with replicated castings / remakes of the originals should they be beyond salvage. As per section 3.1.1. Ceilings in the <i>Physical Condition and Schedule of Conservation Works</i> report for further treatment recommendations.</p> <p><b>Grading of Significance:</b> High</p>
Skirting	Poor	<p><b>Description:</b> Tall ornate skirtings within the room, the southern skirting is water damaged. Both northern and eastern skirtings may likely show further signs of water damaged and rot upon removal.</p> <p><b>Recommendation:</b> Skirting to be removed to facilitate rising damp repairs and floor removal.</p> <ul style="list-style-type: none"> <li>• Generally, skirtings should remain in their existing positions. Any skirting being replaced due to damage such as water ingress, dry rot and termite damage or that are missing should be reproduced to replicate other skirtings in the same room, or if none at all, should replicate its most likely profile based on the findings of the 1997 CMP.</li> <li>• Ground floor skirtings that are required to be removed for the subfloor excavation works, should have their locations recorded, labelled clearly, carefully removed, de-nailed, cleaned up and reinstated post excavation and subfloor works.</li> <li>• Consideration should be put into packing out skirtings with battens to create a void space for wiring prior to reinstallation where they are required to be removed to facilitate other works such as floor replacement, Subfloor excavation or rising damp remediation.</li> <li>• Consideration should be made towards sensitively and sympathetically incorporating a skirting duct into the current skirting profiles to facilitate ease of future services reticulation and to minimize the requirement for future invasive works.</li> </ul>

CME Building – Room G21		
		<p>See also section 3.1.7 Skirtings in the <i>Physical Condition Report and Schedule of Conservation Works</i>.</p> <p><b>Grading of Significance: High</b></p>
Windows	Poor	<p><b>Description:</b> Two Poor condition windows in the southern wall. The western most window appears to have been stripped and primed/sealed, however has a missing sill. The Eastern most window has been replaced and currently has no architrave. Windows are currently boarded up and not accessible for full assessment</p> <p><b>Recommendation:</b> Remove boarding to expose windows. Strip all lead paint completely from all surfaces and prepare all surfaces under HAZMAT conditions in accordance with <i>AS4361.1:2017 Guide to Hazardous Paint Management</i> prior to commencement of works. Replace architrave to Eastern window with salvaged or replicated fabric.</p> <ul style="list-style-type: none"> <li>• Windows should generally be repaired adjusted and cleaned up in their original locations. This could be inclusive of sash cord and weight replacement, glazing putty touch ups or replacement, adjustment and refitting of sashes, rot and damage repairs, broken glass replacement and hardware repairs and or replacement.</li> <li>• Existing heritage hardware should be stripped, polished and reinstated in as close to its original position. Missing hardware should be reinstated with new modern reproduction equivalents.</li> <li>• Locks should be made operational if windows are to be operable. Opening restrictions should be added for both security and code compliance if windows present a climb or fall risk.</li> </ul> <p>See also section 3.1.3 Painted Surfaces and section 3.1.5 Windows in the <i>Physical Condition and Schedule of Conservation Works</i> report for further treatment recommendations.</p> <p><b>Grading of Significance: High</b></p>

CME Building – Room G21		
Doors	Fair	<p><b>Description:</b> 4 panel door glazed with obscure glass top panels in fair condition to north. An obtrusive aluminium mesh security grill is installed to the inside face of the door and high light. A four panel solid door through to room G1 is in the southern end of the western wall. It has no highlight.</p> <p><b>Recommendation:</b> The northern door should have the security grill removed and cut outs in the architrave infilled.</p> <ul style="list-style-type: none"> <li>• Doors should generally be adjusted, cleaned up, and rehung in their original locations.</li> <li>• Doors and jambs that need to be replaced for fire rating, should be replaced with compliant metal jambs and fire doors. Existing architraves should be reinstated, and sympathetic bolection mouldings should be installed onto the fire doors to recreate the appearance of the original panel doors.</li> <li>• -Existing heritage hardware that is non-operational should be stripped, polished, decommissioned and reinstated in as close to its original position provided that it does not interfere with compliance of new door control hardware. New modern hardware that is sympathetic to the heritage aspect of the building yet compliant with relevant Building codes and Australian Standards (AS1428.1) should be installed.</li> <li>• Fanlights should be cleaned up and made good. They should be made to operate if required as part of the HVAC requirements of the building. Existing hardware should be removed, polished and reinstated. Any missing hardware should be replaced with reproduction items to match the existing. Consideration as to make the fanlights operable, fixed open or fixed closed should be made in conjunction with the requirements of the buildings HVAC system and acoustic considerations.</li> <li>• Any damage or cut outs to architraves or jambs should be reinstated with timber inlays and reshaped to blend in.</li> <li>• Doors that need to be pinned in an open position should be fixed in place with a concealed fixing.</li> </ul> <p>Also refer to section 3.1.6.</p> <p><b>Grading of Significance:</b> High</p>

CME Building – Room G21		
Fireplace	Poor	<p><b>Description:</b> fireplace and timber mantle intact. Cast iron centre covered over and is rusted. Fireplace was partly covered and could not be assessed in detail.</p> <p><b>Recommendation:</b></p> <ul style="list-style-type: none"> <li>• Generally, intact existing cast iron fireplaces should be conserved and restored. Where they are missing, they should be replaced with recycled salvaged heritage equivalents of the same period in the more significant rooms or boarded up in the less significant rooms. Restored fireplaces should be welded closed or disabled to ensure they cannot be used as functional fireplaces and vermin cannot access them.</li> <li>• Cast iron fireplaces in rooms of lesser significance with rusted or missing centres should have a steel plate infill welded over the opening inside the decorative arch to close them off.</li> <li>• Existing mantles should be conserved and restored. Missing mantles should be replaced with secondhand heritage mantles or modern reproductions. The type and materiality of replaced mantles should be representative of the room type. The more significant rooms should have marble mantles reinstated whereas the less significant rooms should have more basic timber examples installed. Rooms with fireplaces bricked in or sheeted over should at least have a mantle installed as an interpretive element.</li> <li>• Hearths should be restored where they are relatively intact. Damaged or bare hearths should be either tiled, overlayed with stone or painted.</li> <li>• Cast iron and other metal componentry should be painted with satin black paint.</li> <li>• Chimneys breasts should remain as an expressed feature of a room. In places where services risers are placed beside them, new partition walls beside chimney breasts should sit back at least 50mm to ensure that the chimney breasts are retained as a defined expression into the room and that staff moulded rises on the corners of the breasts are not lost.</li> </ul>

Look to either replace the cast iron insert or cover over. Also refer to Section 3.1.8. Fireplaces in the *Physical Condition Report and Schedule of Conservation Works*.

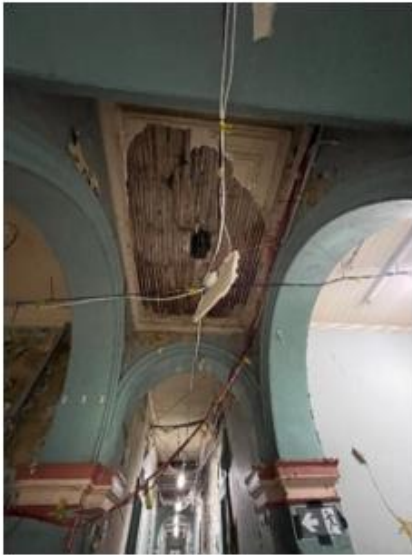
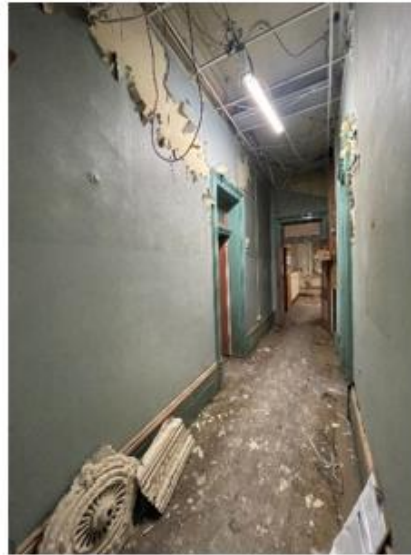
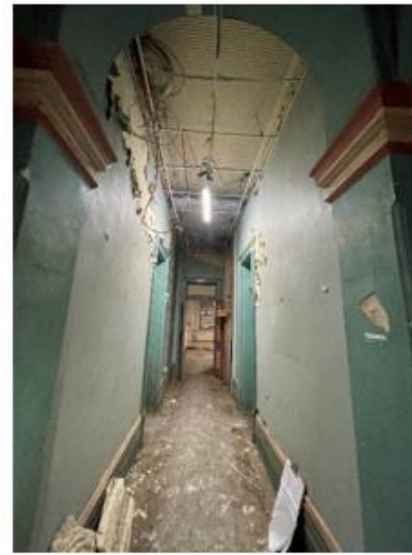
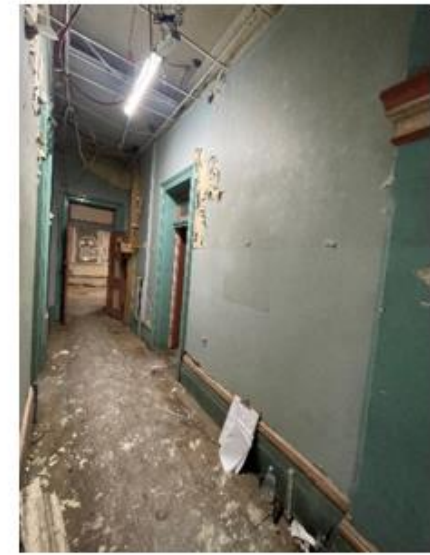
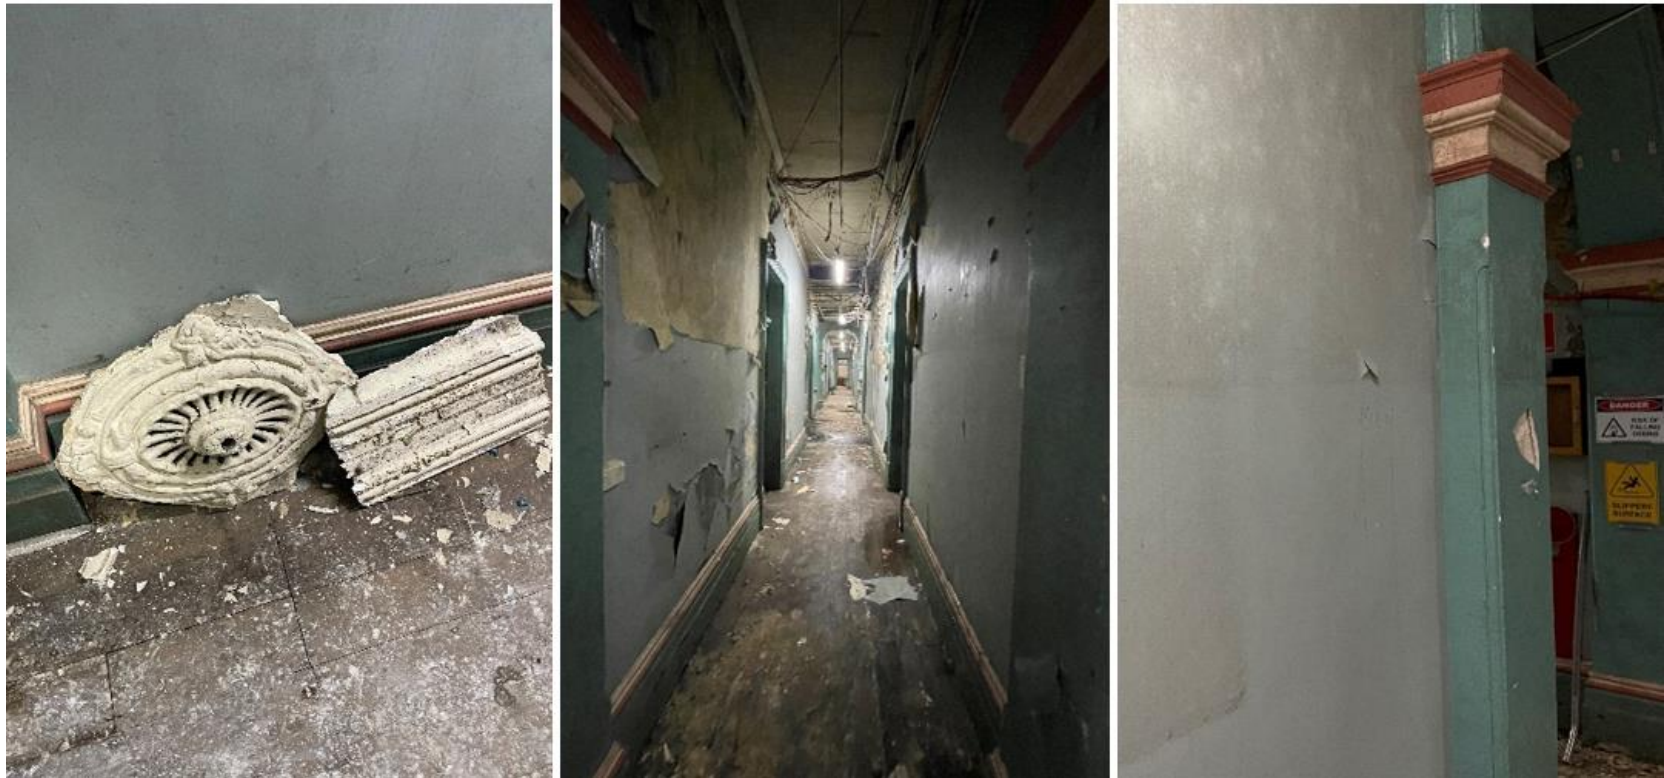
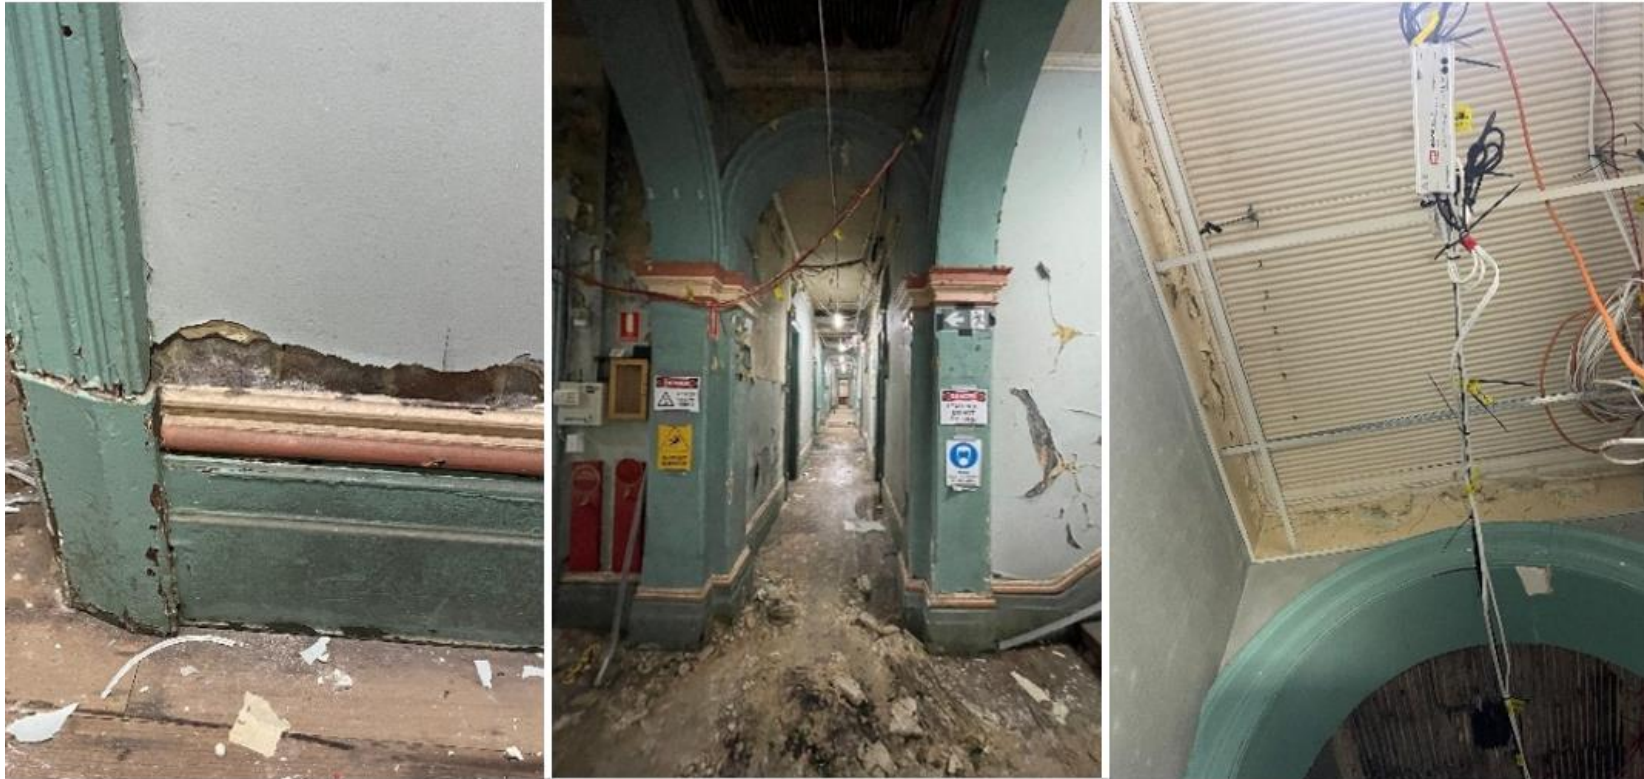
**CME Building – Room G22, G23 & G24****Photos**

CME Building – Room G22, G23 & G24		
Fabric	Current Condition	Description and Recommendation
Floor	Fair to Poor	<p><b>Description:</b> fair condition timber floor, Kauri pine wide boards to the western sections -G23 with various cut outs for services and stains. Water damage likely to the crossover section of the hallway at G3. G24 eastern end is also east-west wide boards,</p> <p><b>Recommendation:</b> All floors on ground floor will need to be temporarily removed to facilitate subfloor works, including installation of concealed services. It is intended to salvage as much as possible of the remnant floorboards for reuse in accordance with Section 3.1.4. Floors in the <i>Physical Condition and Schedule of Conservation Works</i> methodology for floor works. Salvaged flooring from the entire building should collated and graded for condition from best to worst before being re-laid at the completion of subfloor works. Priority should be given to the rooms in key view lines and of most significance to have the floorboards in the best condition as per section 3.1 - 6 General recommendations in the <i>Physical Condition and Schedule of Conservation Works</i></p> <p><b>Grading of Significance: High</b></p>

Walls	Poor	<p><b>Description:</b> Rising damp at lower levels and falling damp at high level, damp is particularly bad to the more eastern end of the hallway. Very poor paint that is flaking in places, many surface fixed fittings and penetrations for services. This section of the hallway is divided in to three sections with decorative arches. These arches have ornate in situ formed plaster arch mouldings and a plaster crown moulding to the columns at either side. Flaking paint has revealed two tone previous colour schemes with a contrasting pinstripe detail below the colour change at mid-height</p> <p><b>Recommendation:</b> Paint strip areas of loose or flaking paint, and where the damp has affected it. The rest can be subject to overcoating and or spot repairs as per the guidelines within <i>AS4361.1:2017 Guide to Hazardous Paint Management</i>. Render to be removed up to 1200mm high where rising damp has occurred and in other areas of badly affected falling damp and wet vacuum wash the brickwork for multiple cycles with a contained head wet system. Allow to dry for min 6 weeks and apply a salt retardant render prior to white set and painting.</p> <p>Also refer to section 3.1.2. Walls and Section 3.1.3. Painted Surfaces in the <i>Physical Condition and Schedule of Conservation Works</i> report for further treatment recommendations.</p> <p><b>Grading of Significance: High</b></p>

Ceilings	Fair	<p><b>Description:</b> Intrusive modern ceiling grid framework to the eastern and western sections below Corrugated metal ceilings. The centre hallway crossover at G23 has remnant lath and plaster that has collapsed with only the lath remaining. Many surface fixed conduits, fittings and penetrations for services. Rooms in the original section of the building later damaged by a fire (assumed) in 1902 were retrofitted with corrugated iron in lieu of Lath and Plaster.</p> <p><b>Recommendation:</b> Remove intrusive modern grid ceiling, Fixtures and fittings.</p> <ul style="list-style-type: none"> <li>Where intact and not at risk of collapse, undertake conservation works to reinstate back to original condition. This could be inclusive of patching existing holes, replacing missing, badly damaged or rusted sections.</li> <li>Where areas are damaged beyond salvage, to replace with salvaged corrugated iron from other rooms of less significance within the building, replace with second hand salvaged material or replace with replicated modern equivalent.</li> <li>Instead of removing large sections of heritage fabric ceilings to facilitate the installation of services or structural repairs, It would be a more preferable heritage outcome to leave any stable remnant ceiling fabric in situ and install a modern ceiling replica of the original ceiling based on existing documentation from the original build or from evidence of remnant fabric. These new ceilings would be installed lower to provide space to conceal services provided that any loss of height does not detract from the overall scale of the rooms or cover necessary ventilation grills or vents. The original ceiling would remain in its current condition concealed above it.</li> </ul> <p>See also section Room by Room Schedule 3.1.1. Ceilings in the <i>Physical Condition and Schedule of Conservation Works</i> report for further treatment recommendations.</p> <p><b>Grading of Significance:</b> High</p>

CME Building – Room G22, G23 & G24		
Cornice	Fair	<p><b>Description:</b> Timber moulding to the eastern and western sections below Corrugated metal ceilings. The centre hallway crossover at G23 has remnant decorative ornate cornice that has partially collapsed. Many surface fixed conduits, fittings throughout.</p> <p><b>Recommendation:</b> Remove intrusive modern fixtures and fittings. Decorative plaster cornices and timber mouldings should be repaired in situ if possible. When beyond salvage or if ceilings are replaced, or relocated, cornices and timber mouldings should be reinstated with originals salvaged from elsewhere within the building where available or with replicated castings / remakes of the originals should they be beyond salvage. As per section 3.1.1. Ceilings in the <i>Physical Condition and Schedule of Conservation Works</i> report for further treatment recommendations.</p> <p><b>Grading of Significance:</b> High</p>

Skirting	Fair to Poor	<p><b>Description:</b> Tall ornate skirtings, likely rotten at the western end due to rising damp.</p> <p><b>Recommendation:</b> Skirting to be removed to facilitate rising damp repairs and floor removal.</p> <ul style="list-style-type: none"> <li>Generally, skirtings should remain in their existing positions. Any skirting being replaced due to damage such as water ingress, dry rot and termite damage or that are missing should be reproduced to replicate other skirtings in the same room, or if none at all, should replicate its most likely profile based on the findings of the 1997 CMP.</li> <li>Ground floor skirtings that are required to be removed for the subfloor excavation works, should have their locations recorded, labelled clearly, carefully removed, de-nailed, cleaned up and reinstated post excavation and subfloor works.</li> <li>Consideration should be put into packing out skirtings with battens to create a void space for wiring prior to reinstallation where they are required to be removed to facilitate other works such as floor replacement, Subfloor excavation or rising damp remediation.</li> </ul>

CME Building – Room G22, G23 & G24		
		<ul style="list-style-type: none"> <li>Consideration should be made towards sensitively and sympathetically incorporating a skirting duct into the current skirting profiles to facilitate ease of future services reticulation and to minimize the requirement for future invasive works.</li> </ul> <p>See also section 3.1.7. Skirtings in the <i>Physical Condition Report and Schedule of Conservation Works</i>.</p> <p><b>Grading of Significance: High</b></p>
Windows	N/A	<p><b>Description:</b> No windows in this area</p> <p><b>Recommendation:</b> N/A</p> <p><b>Grading of Significance:</b> N/A</p>
Doors	N/A	<p><b>Description:</b> Door descriptions noted in room descriptions.</p> <p><b>Recommendation:</b> N/A</p> <p><b>Grading of Significance:</b> N/A</p>
Fireplace	N/A	<p><b>Description:</b> No fireplaces in this area</p> <p><b>Recommendation:</b> N/A</p> <p><b>Grading of Significance:</b> N/A</p>
