## 9. Inventory Sheets

This chapter includes the inventory sheets for each room within the CME Building. Each datasheet includes:

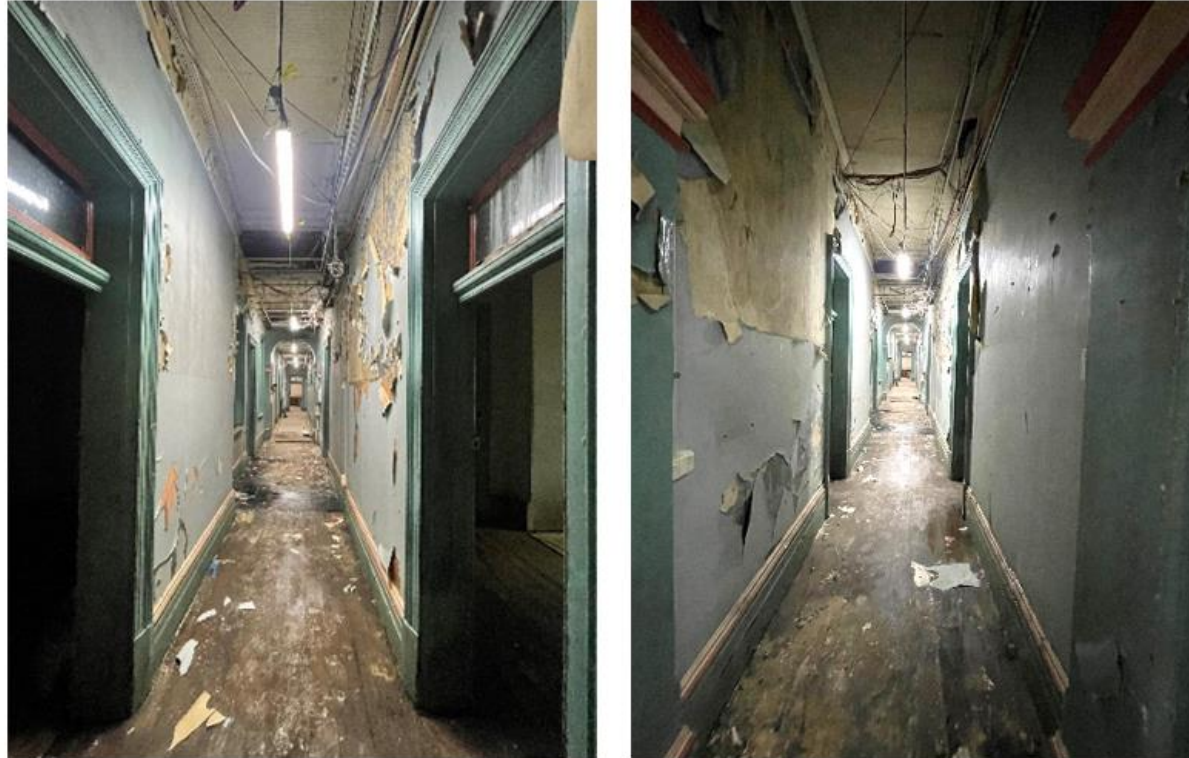
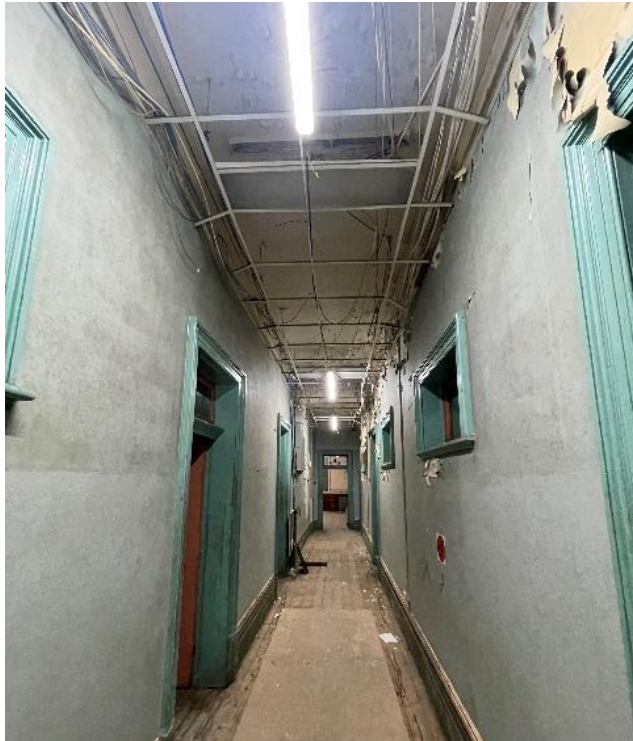
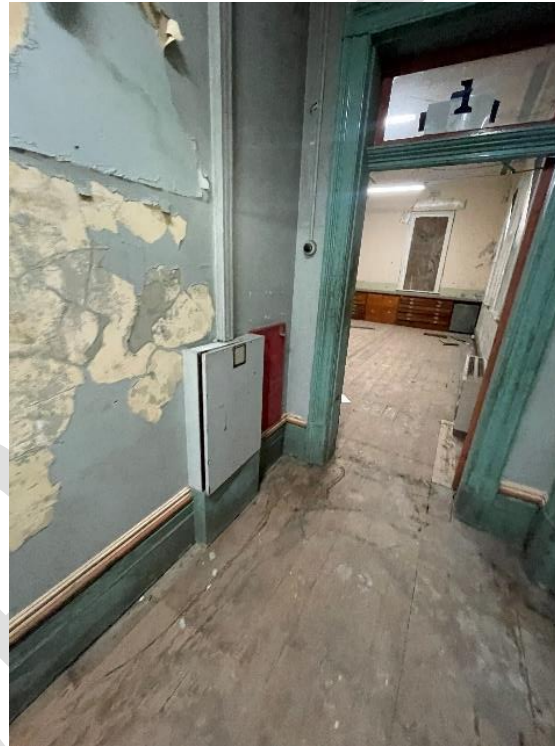
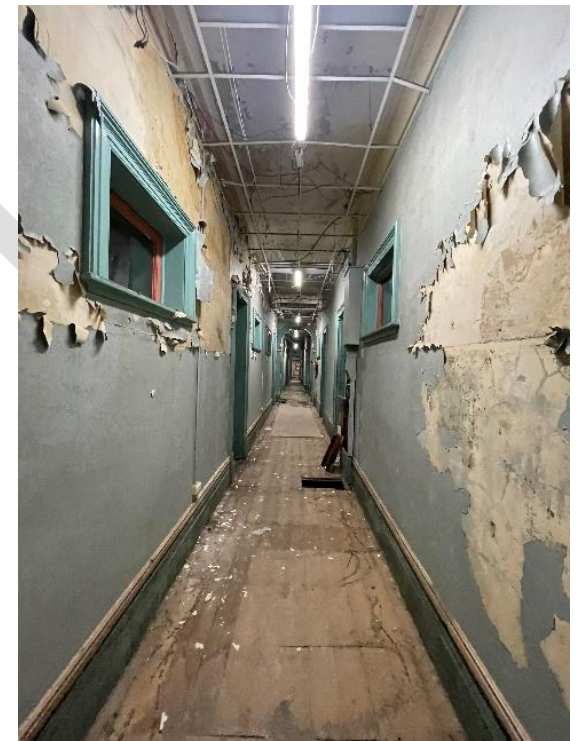
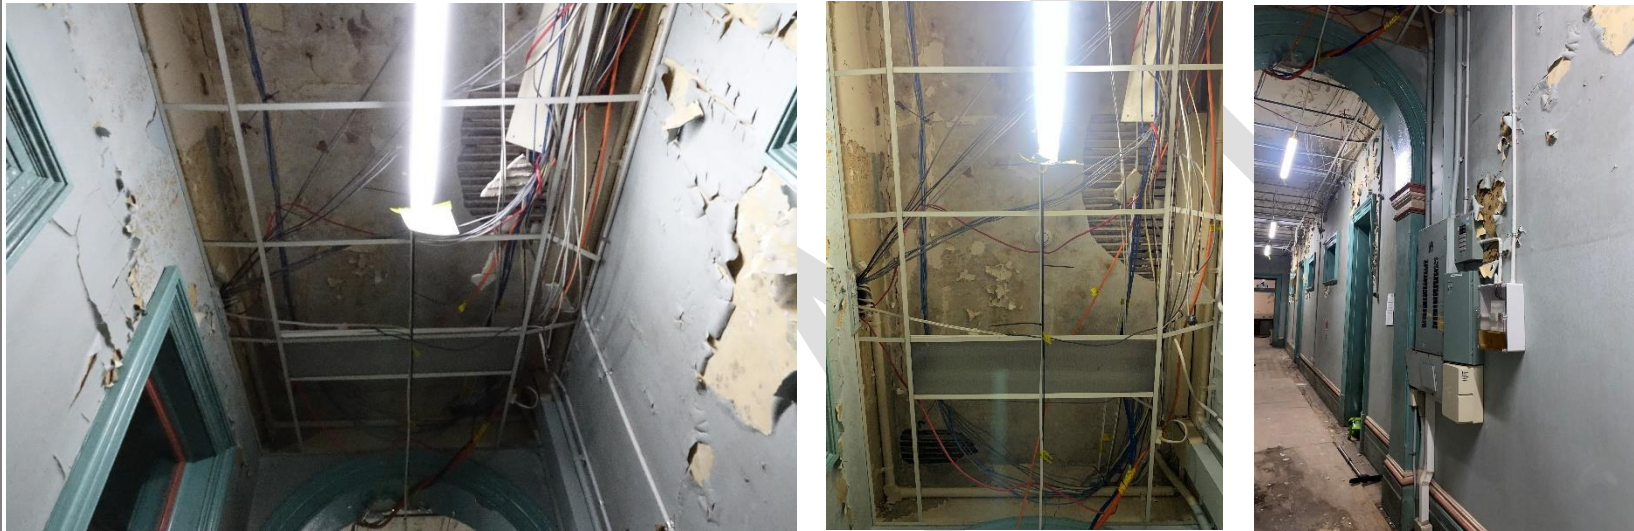
## CME Building – Room G25 & G26

CME Building – Room G25 & G26		
Fabric	Current Condition	Description and Recommendation
Floor	Fair to Poor	<p><b>Description:</b> fair condition Kauri pine wide boards running east-west to parts with various sections of poor condition narrow boards running in a north-south direction. The western end of G25 has water damage and is lifting. One section is covered by plywood and could not be inspected.</p> <p><b>Recommendation:</b> All floors on ground floor will need to be temporarily removed to facilitate subfloor works, including installation of concealed services. It is intended to salvage as much as possible of the remnant floorboards for reuse in accordance with Section 3.1.4. Floors in the <i>Physical Condition and Schedule of Conservation Works</i> methodology for floor works. Salvaged flooring from the entire building should be collated and graded for condition from best to worst before being re-laid at the completion of subfloor works. Priority should be given to the rooms in key view lines and of most significance to have the floorboards in the best condition as per section 3.1 - 6 General recommendations in the <i>Physical Condition and Schedule of Conservation Works</i></p> <p>North-south running narrow boards should be replaced with east west running wide Kauri boards.</p> <p><b>Grading of Significance: High</b></p>

Walls	Poor	<p><b>Description:</b> Rising damp at lower levels and falling damp at high level. Very poor paint that is flaking in places, many surface fixed fittings and penetrations for services. This section of the hallway is divided into two sections with a decorative arch. This arch has ornate in situ formed plaster arch mouldings and a plaster crown moulding to the columns at either side. Flaking paint has revealed two tone previous colour schemes with a contrasting pinstripe detail below the colour change at mid-height. This section of the hallway is wider than the western end of the building.</p> <p><b>Recommendation:</b> Paint strip areas of loose or flaking paint, and where the damp has affected it. The rest can be subject to overcoating and or spot repairs as per the guidelines within <i>AS4361.1:2017 Guide to Hazardous Paint Management</i>. Render to be removed up to 1200mm high where rising damp has occurred and in other areas of badly affected falling damp and wet vacuum wash the brickwork for multiple cycles with a contained head wet system. Allow to dry for min 6 weeks and apply a salt retardant render prior to white set and painting.</p> <p>Also refer to section 3.1.2. Walls and Section 3.1.3. Painted Surfaces in the <i>Physical Condition and Schedule of Conservation Works</i> report for further treatment recommendations.</p>

CME Building – Room G25 & G26		
		Grading of Significance: High
Ceilings	Fair	<p><b>Description:</b> Intrusive modern ceiling grid framework below water damaged lath and plaster ceilings. The more western end of the hallway at G25 has remnant lath and plaster that has collapsed with only the lath remaining. Many surface fixed conduits, fittings and penetrations for services. Likely to be original Lath and Plaster.</p> <p><b>Recommendation:</b> Remove intrusive modern grid ceiling, Fixtures and fittings.</p> <ul style="list-style-type: none"> <li>• Where intact and not at risk of collapse, undertake conservation works to reinstate back to original condition. This could be inclusive of patching existing holes, replacing missing, badly damaged or rusted sections.</li> <li>• Where areas are damaged beyond salvage, to replace with salvaged corrugated iron from other rooms of less significance within the building, replace with second hand salvaged material or replace with replicated modern equivalent.</li> <li>• Instead of removing large sections of heritage fabric ceilings to facilitate the installation of services or structural repairs, It would be a more preferable heritage outcome to leave any stable remnant ceiling fabric in situ and install a modern ceiling replica of the original ceiling based on existing documentation from the original build or from evidence of remnant fabric. These new ceilings would be installed lower to provide space to conceal services provided that any loss of height does not detract from the overall scale of the rooms or cover necessary ventilation grills or vents. The original ceiling would remain in its current condition concealed above it.</li> </ul> <p>See also section Room by Room Schedule 3.1.1.Ceilings in the <i>Physical Condition and Schedule of Conservation Works</i> report for further treatment recommendations.</p> <p>Grading of Significance: High</p>

CME Building – Room G25 & G26		
Cornice	Fair	<p><b>Description:</b> N/A -Square set ceilings with no cornice in this area</p> <p><b>Recommendation:</b> N/A</p> <p><b>Grading of Significance:</b> N/A</p>
Skirting	Fair to Poor	<p><b>Description:</b> Tall ornate skirtings, likely rotten due to rising damp.</p> <p><b>Recommendation:</b> Skirting to be removed to facilitate rising damp repairs and floor removal.</p> <ul style="list-style-type: none"> <li>Generally, skirtings should remain in their existing positions. Any skirting being replaced due to damage such as water ingress, dry rot and termite damage or that are missing should be reproduced to replicate other skirtings in the same room, or if none at all, should replicate its most likely profile based on the findings of the 1997 CMP.</li> <li>Ground floor skirtings that are required to be removed for the subfloor excavation works, should have their locations recorded, labelled clearly, carefully removed, de-nailed, cleaned up and reinstated post excavation and subfloor works.</li> <li>Consideration should be put into packing out skirtings with battens to create a void space for wiring prior to reinstallation where they are required to be removed to facilitate other works such as floor replacement, Subfloor excavation or rising damp remediation.</li> <li>Consideration should be made towards sensitively and sympathetically incorporating a skirting duct into the current skirting profiles to facilitate ease of future services reticulation and to minimize the requirement for future invasive works.</li> </ul> <p>See also section 3.1.7. Skirtings in the <i>Physical Condition Report and Schedule of Conservation Works</i>.</p> <p><b>Grading of Significance:</b> High</p>

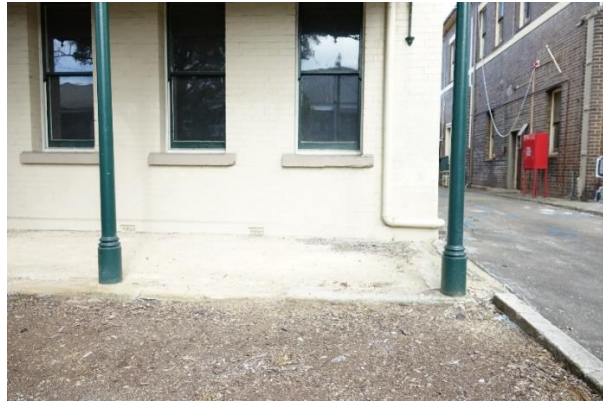
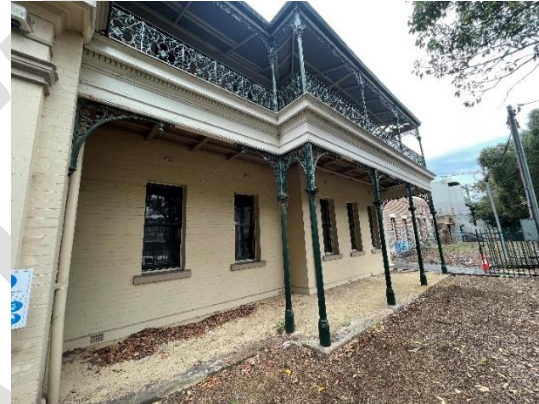
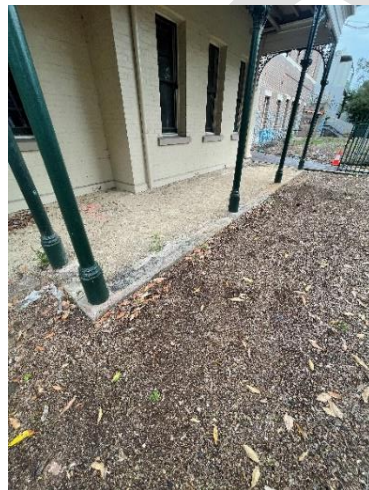
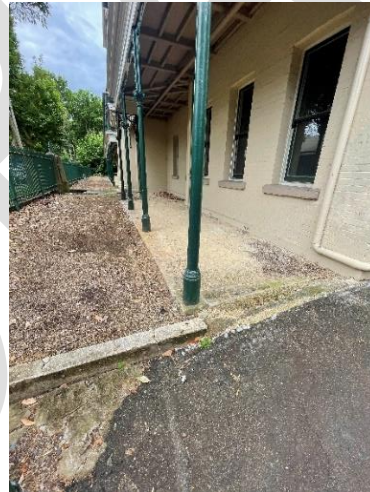
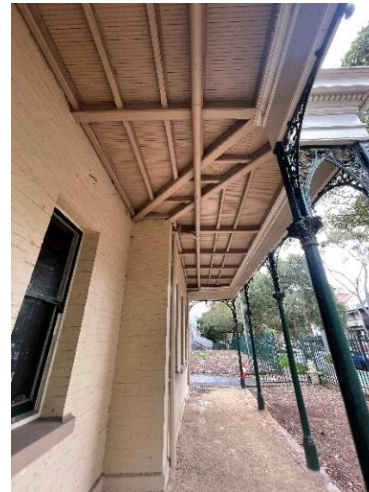
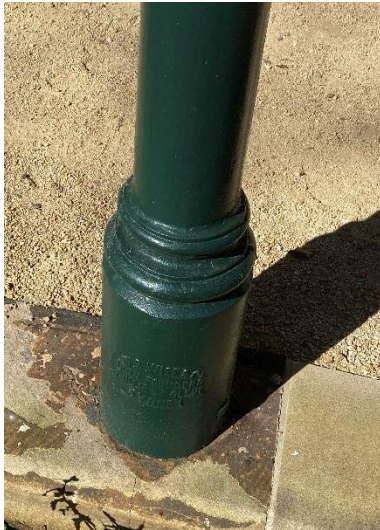
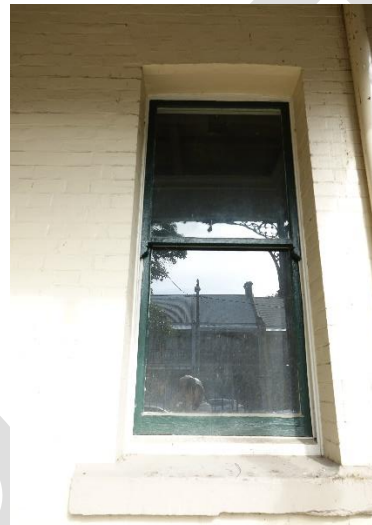
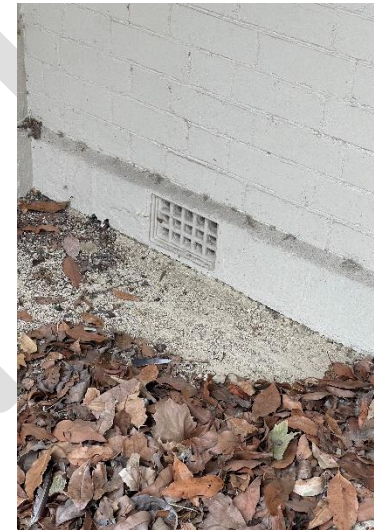
## CME Building – Room G27

CME Building – Room G27		
Fabric	Current Condition	Description and Recommendation
Floor	Fair	<p><b>Description:</b> Decomposed Granite with a Sandstone edge border.</p> <p><b>Recommendation:</b> Replace decomposed granite with sawn sandstone paving or in concrete using off white cement, river gravel and a locally sourced sand. Aim to keep levels low enough so that subfloor vents remain exposed and clear.</p> <p><b>Grading of Significance:</b> Neutral</p>
Walls	Fair	<p><b>Description:</b> External Paint finish brick walls with an expressed render plinth detail with a splayed top edge. Various mismatched subfloor ventilation grills are located at the base and the top of the wall</p> <p><b>Recommendation:</b> Repair and prep spot repairs and repoint wall as necessary. Prepare existing paint for overcoating and repaint. Also refer to section 3.1.2. Walls and Section 3.1.3 Painted Surfaces in the <i>Physical Condition and Schedule of Conservation Works</i> report for further treatment recommendations.</p> <p><b>Grading of Significance:</b> High</p>

Ceilings	Fair	<p><b>Description:</b> Underside of first floor balcony with exposed joists, outer edge beam and underside of the decking. Pigeon spikes in place and considerable vermin droppings. Exposed stormwater drainage throughout</p> <p><b>Recommendation:</b> Remove pigeon spikes and pressure clean. Prep joists, decking and stormwater pipes for overcoating and repaint. Replace pigeon spikes with new. Refer to Section 3.1.3. Painted Surfaces in the <i>Physical Condition and Schedule of Conservation Works</i> report for further treatment recommendations.</p> <p><b>Grading of Significance:</b> High</p>
Veranda Posts	Good	<p><b>Description:</b> Cast iron veranda posts with ornate latticework braces. The posts bear onto the sandstone edge border</p> <p><b>Recommendation:</b> Prep for overcoating, wire brush and chemically treat any evident rust and repaint. Refer to Section 3.1.3. Painted Surfaces in the <i>Physical Condition and Schedule of Conservation Works</i> report for further treatment recommendations.</p> <p><b>Grading of Significance:</b> High</p>

CME Building – Room G27		
Subfloor Vents	Fair to Poor	<p><b>Description:</b> Various mismatched subfloor ventilation grills are located at the base of the wall plinth.</p> <p><b>Recommendation:</b> Replace modern terracotta vents with cast replicas of the originals. Replace damaged originals with replicas. Raise vents that fall below ground levels where possible.</p> <p><b>Grading of Significance: Moderate</b></p>
Windows	Fair to poor	<p><b>Description:</b> Double hung windows, generally sound condition, however likely painted shut.</p> <p><b>Recommendation:</b> Windows detailed internally in room notes. Externally Strip all lead paint completely from all surfaces and prepare all surfaces under HAZMAT conditions in accordance with <i>AS4361.1:2017 Guide to Hazardous Paint Management</i> prior to commencement of works. \</p> <ul style="list-style-type: none"> <li>Windows should generally be repaired adjusted and cleaned up in their original locations. This could be inclusive of sash cord and weight replacement, glazing putty touch ups or replacement, adjustment and refitting of sashes, rot and damage repairs, broken glass replacement and hardware repairs and or replacement.</li> </ul> <p>See also section 3.1.3 Painted Surfaces and section 3.1.5.Windows in the <i>Physical Condition and Schedule of Conservation Works</i> report for further treatment recommendations.</p> <p><b>Grading of Significance: High</b></p>

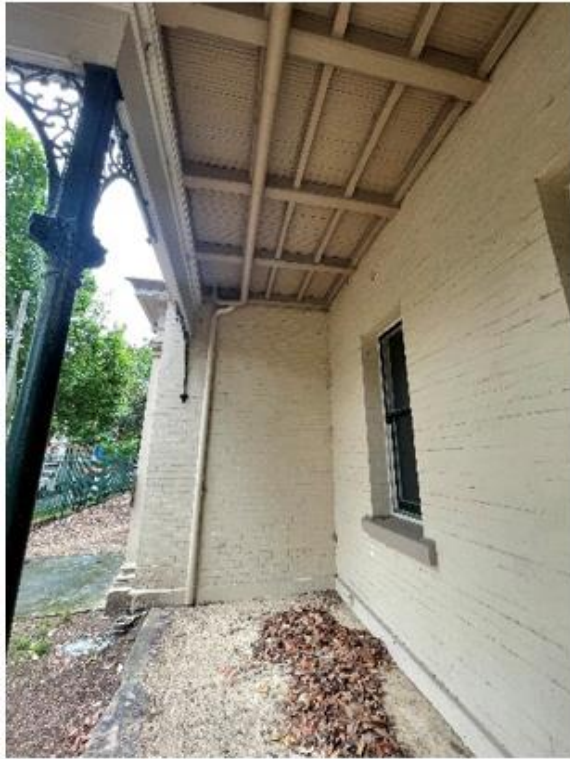
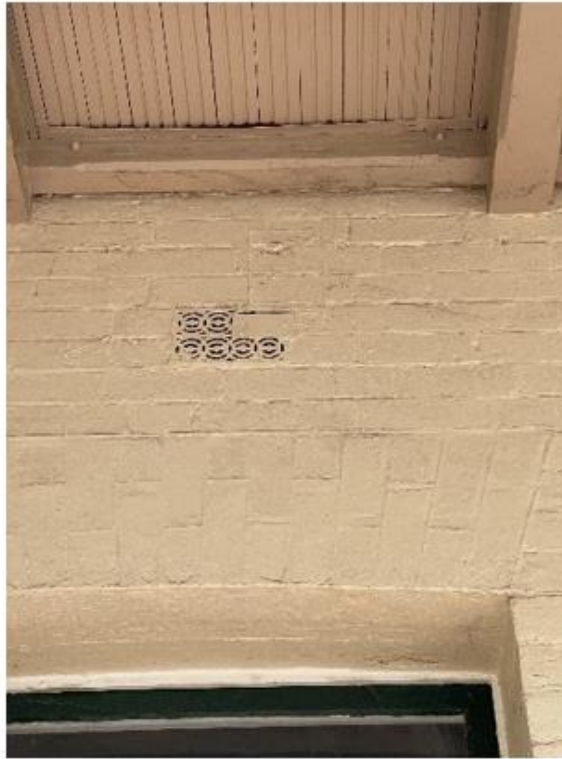
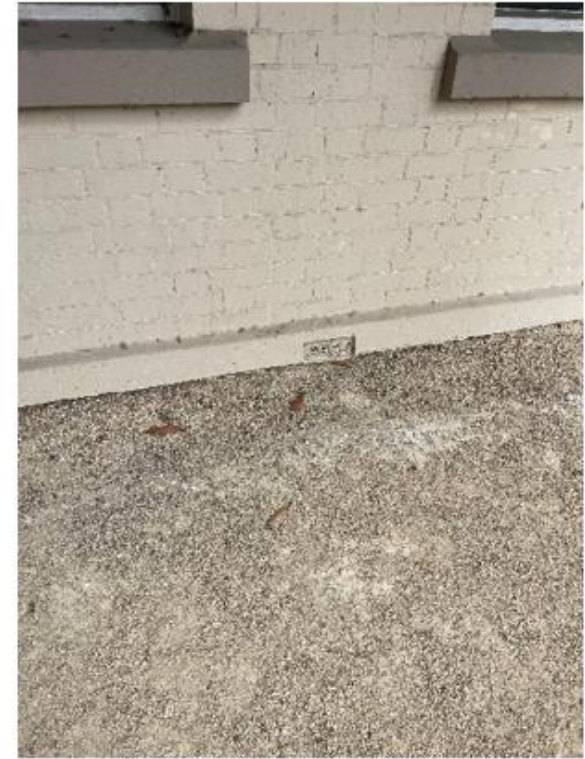
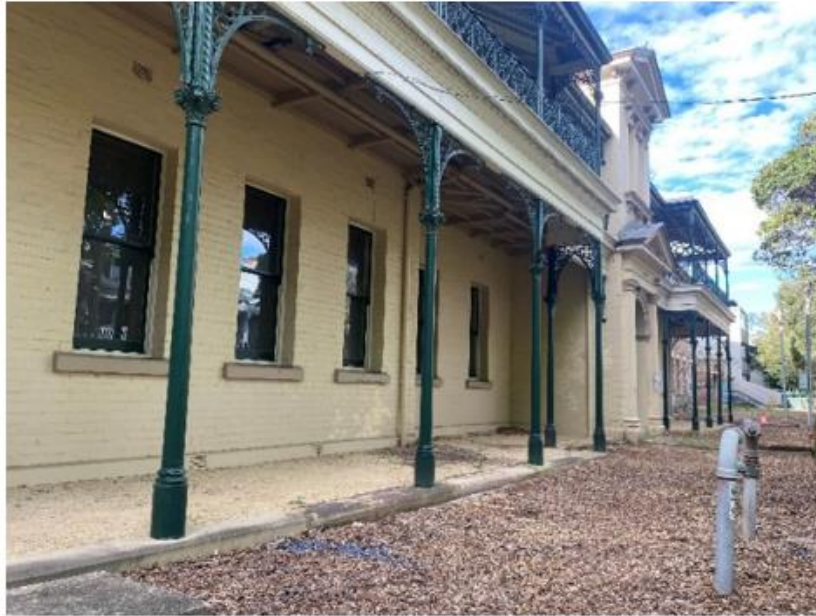
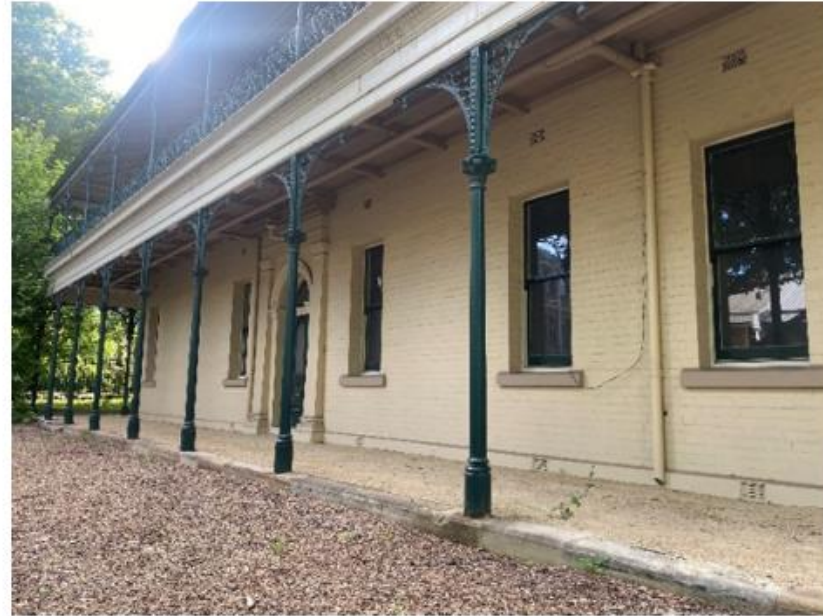
## CME Building – Room G28 & G29

CME Building – Room G28 & G29		
Fabric	Current Condition	Description and Recommendation
Floor	Fair	<p><b>Description:</b> Decomposed Granite with a Sandstone edge border.</p> <p><b>Recommendation:</b> Replace decomposed granite with sawn sandstone paving or in concrete using off white cement, river gravel and a locally sourced sand. Aim to keep levels low enough so that subfloor vents exposed and clear.</p> <p><b>Grading of Significance:</b> Neutral</p>
Walls	Fair	<p><b>Description:</b> External Paint finish brick walls with an expressed render plinth detail with a splayed top edge. Various mismatched subfloor ventilation grills are located at the base and the top of the wall</p> <p><b>Recommendation:</b> Repair and prep spot repairs and repoint wall as necessary. Prepare existing paint for overcoating and repaint. Also refer to section 3.1.2. Walls and Section 3.1.3. Painted Surfaces in the <i>Physical Condition and Schedule of Conservation Works</i> report for further treatment recommendations.</p> <p><b>Grading of Significance:</b> High</p>

Ceilings	Fair	<p><b>Description:</b> Underside of first floor balcony with exposed joists, outer edge beam and underside of the decking. Pigeon spikes in place and considerable vermin droppings. Exposed stormwater drainage throughout</p> <p><b>Recommendation:</b> Remove pigeon spikes and pressure clean. Prep joists and stormwater pipes for overcoating and repaint. Replace pigeon spikes with new. Refer to Section 3.1.3 Painted Surfaces in the <i>Physical Condition and Schedule of Conservation Works</i> report for further treatment recommendations.</p> <p><b>Grading of Significance:</b> High</p>
Veranda Posts	Good	<p><b>Description:</b> Cast iron veranda posts with ornate latticework braces. The posts bear onto the sandstone edge border</p> <p><b>Recommendation:</b> Prep for overcoating, wire brush and chemically treat any evident rust and repaint. Refer to Section 3.1.3. Painted Surfaces in the <i>Physical Condition and Schedule of Conservation Works</i> report for further treatment recommendations.</p> <p><b>Grading of Significance:</b> High</p>

CME Building – Room G28 & G29		
Subfloor Vents	Fair to Poor	<p><b>Description:</b> Various mismatched subfloor ventilation grills are located at the base of the wall plinth.</p> <p><b>Recommendation:</b> Replace modern terracotta vents with cast replicas of the originals. Replace damaged originals with replicas. Raise vents that fall below ground levels where possible.</p> <p><b>Grading of Significance: Moderate</b></p>
Windows	Fair to poor	<p><b>Description:</b> Double hung windows, generally sound condition, however likely painted shut.</p> <p><b>Recommendation:</b> Windows detailed internally in room notes. Externally Strip all lead paint completely from all surfaces and prepare all surfaces under HAZMAT conditions in accordance with <i>AS4361.1:2017 Guide to Hazardous Paint Management</i> prior to commencement of works. \</p> <ul style="list-style-type: none"> <li>Windows should generally be repaired adjusted and cleaned up in their original locations. This could be inclusive of sash cord and weight replacement, glazing putty touch ups or replacement, adjustment and refitting of sashes, rot and damage repairs, broken glass replacement and hardware repairs and or replacement.</li> </ul> <p>See also section 3.1.3. Painted Surfaces and section 3.1.5. Windows in the <i>Physical Condition and Schedule of Conservation Works</i> report for further treatment recommendations.</p> <p><b>Grading of Significance: High</b></p>

Doors	N/A	<p><b>Description:</b> This ornate double door located at the eastern end of the northern façade was the entry for the Chief Mechanical Engineer. The two panel double doors have a heavy bolelection mould defining the lower panel and a glazed upper panel with a semicircular top rail. Two expressed render columns with detailed skirting moulds and a crown mould stand either side of the door. A detailed moulded semicircular highlight with a central keystone detail sits above the door with a detailed header and crown pelmet mould detail above.</p> <p><b>Recommendation:</b></p> <ul style="list-style-type: none"> <li>• Doors should generally be adjusted, cleaned up, and rehung in their original locations.</li> <li>• Doors and jambs that need to be replaced for fire rating, should be replaced with compliant metal jambs and fire doors. Existing architraves should be reinstated, and sympathetic bolelection mouldings should be installed onto the fire doors to recreate the appearance of the original panel doors.</li> <li>• -Existing heritage hardware that is non-operational should be stripped, polished, decommissioned and reinstated in as close to its original position provided that it does not interfere with compliance of new door control hardware. New modern hardware that is sympathetic to the heritage aspect of the building yet compliant with relevant Building codes and Australian Standards (AS1428.1) should be installed.</li> <li>• Fanlights should be cleaned up and made good. They should be made to operate if required as part of the HVAC requirements of the building. Existing hardware should be removed, polished and reinstated. Any missing hardware should be replaced with reproduction items to match the existing. Consideration as to make the fanlights operable, fixed open or fixed closed should be made in conjunction with the requirements of the buildings HVAC system and acoustic considerations.</li> <li>• Any damage or cut outs to architraves or jambs should be reinstated with timber inlays and reshaped to blend in.</li> </ul> <p>Also refer to section 3.1.6. Doors in the <i>Physical Condition Report and Schedule of Conservation Works</i>.</p> <p><b>Grading of Significance:</b> High</p>

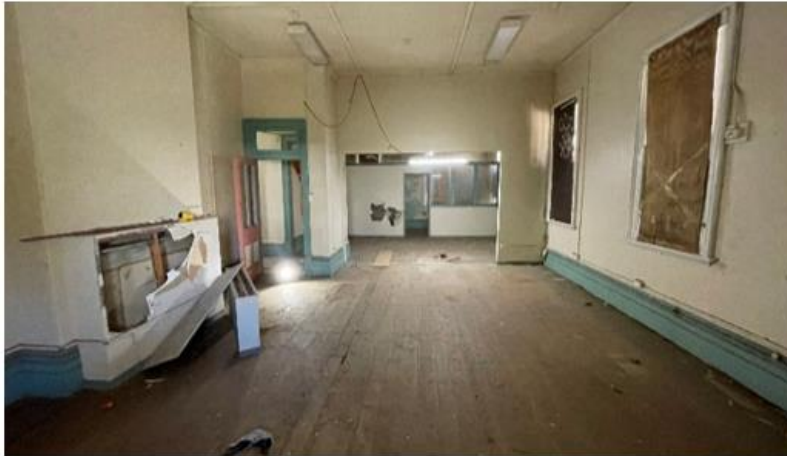
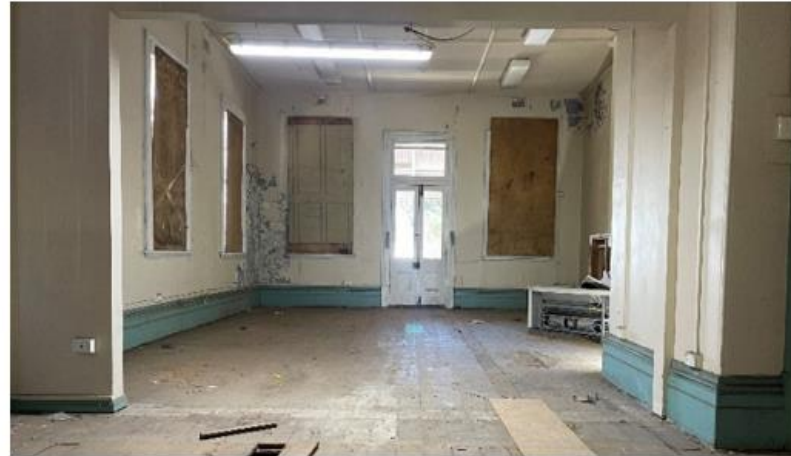
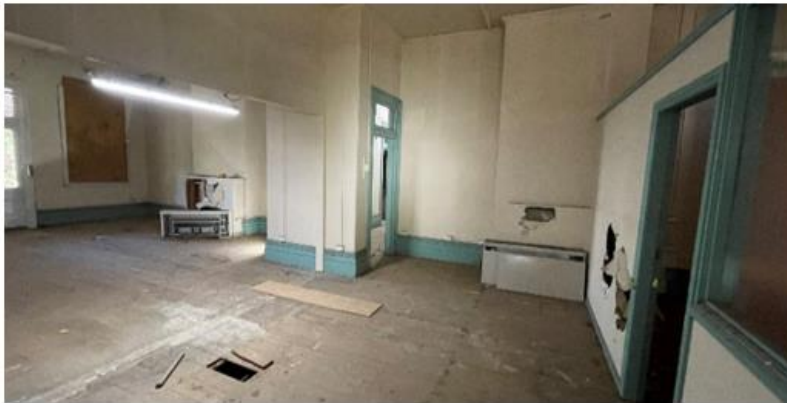
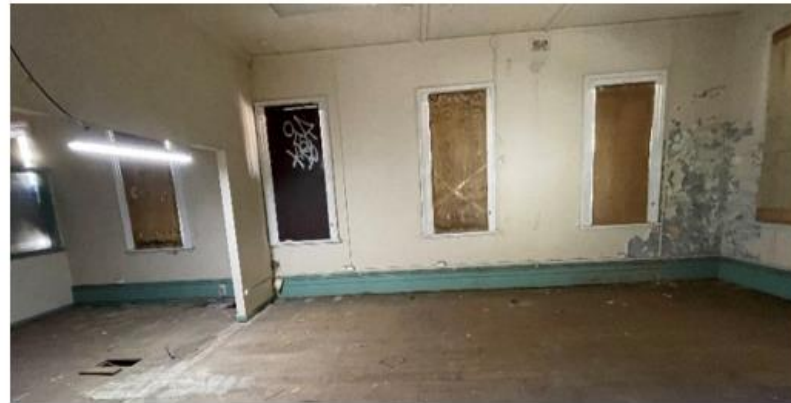
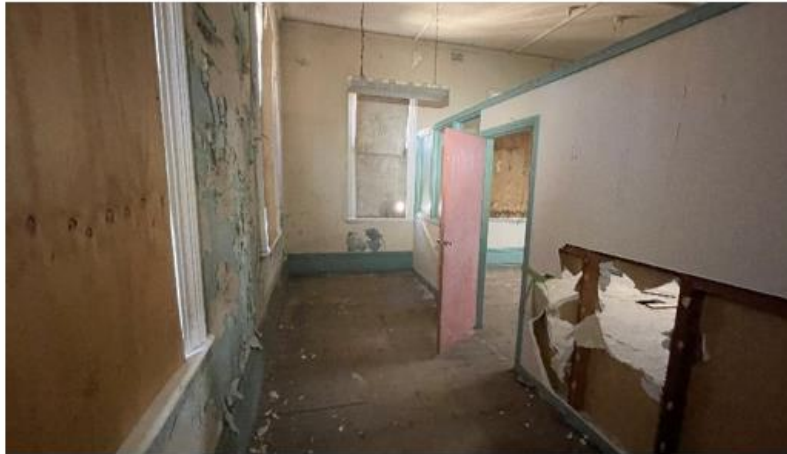
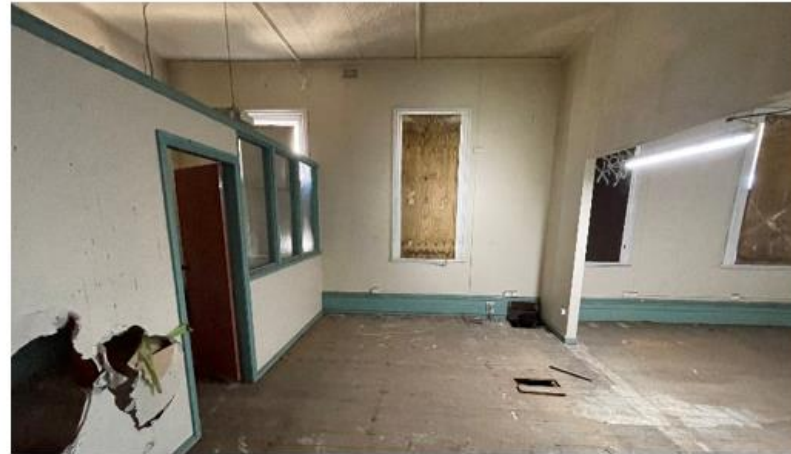
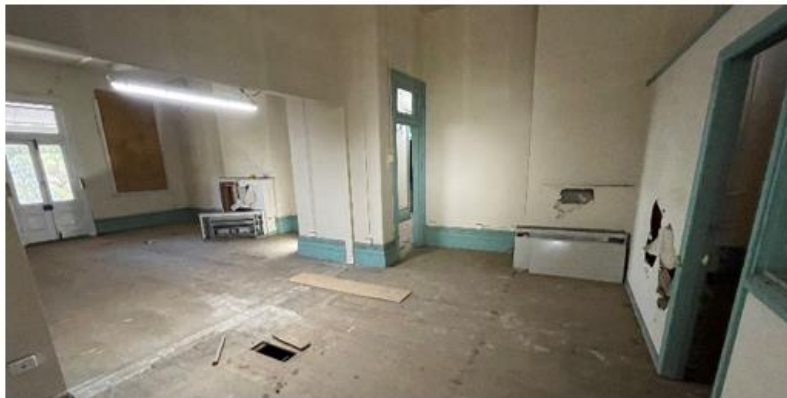
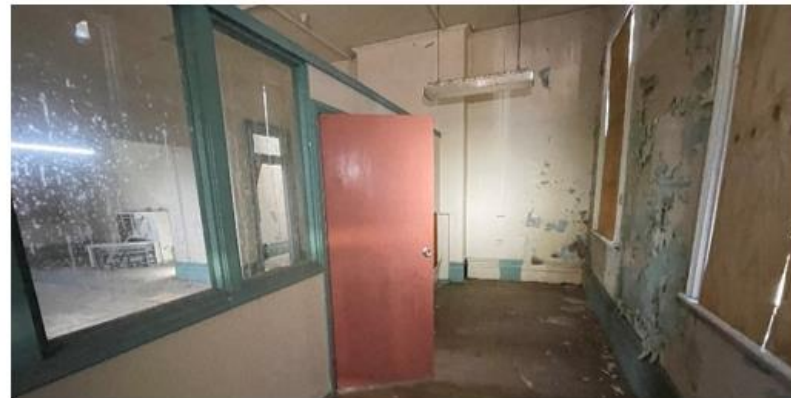
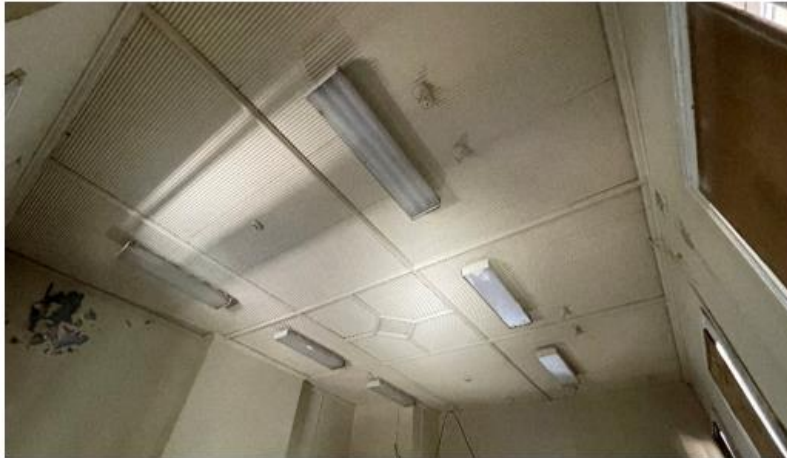
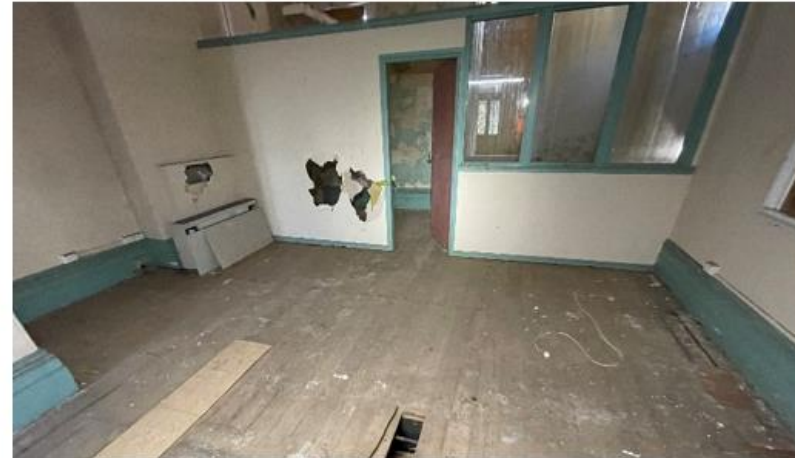
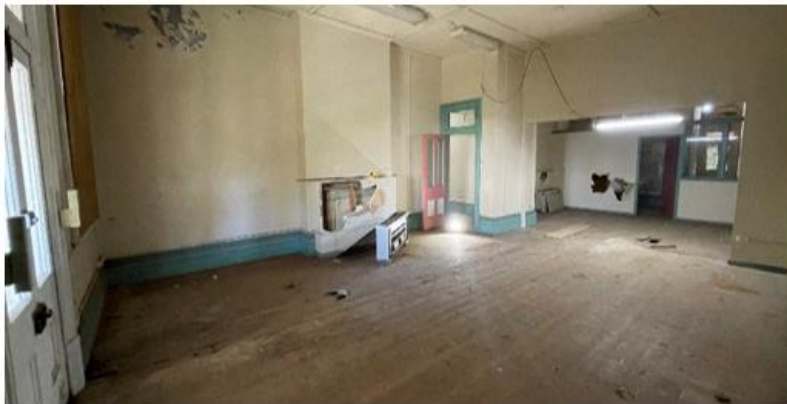
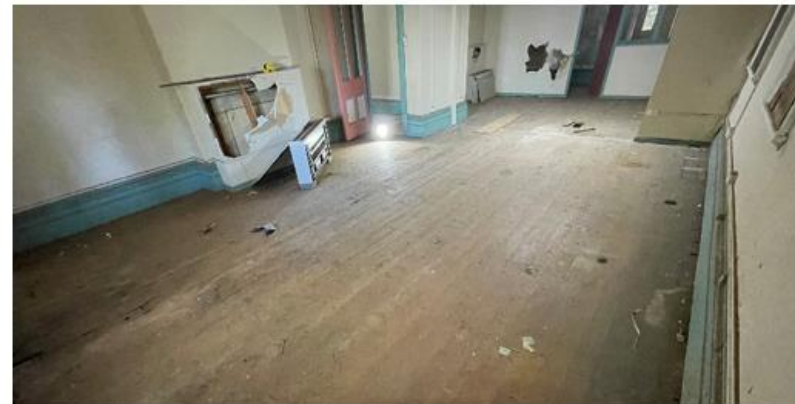
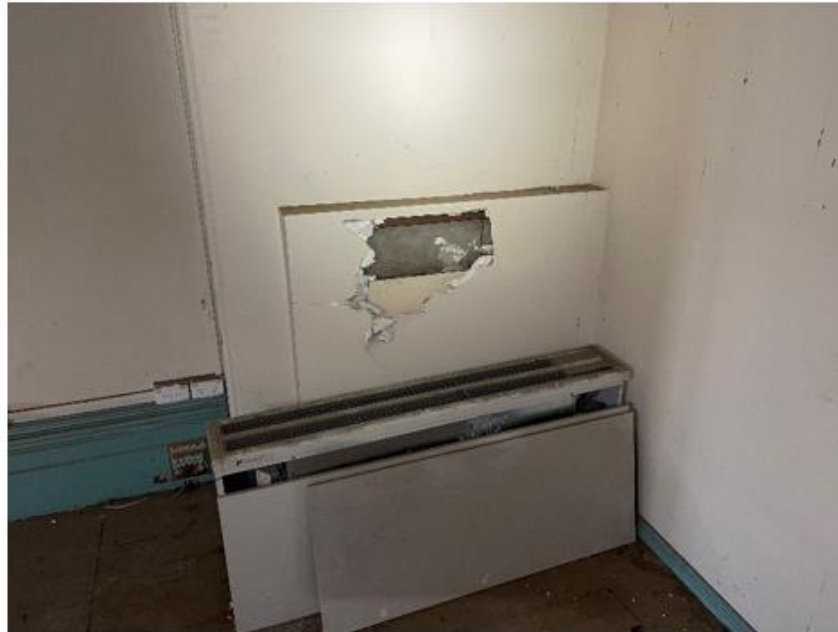
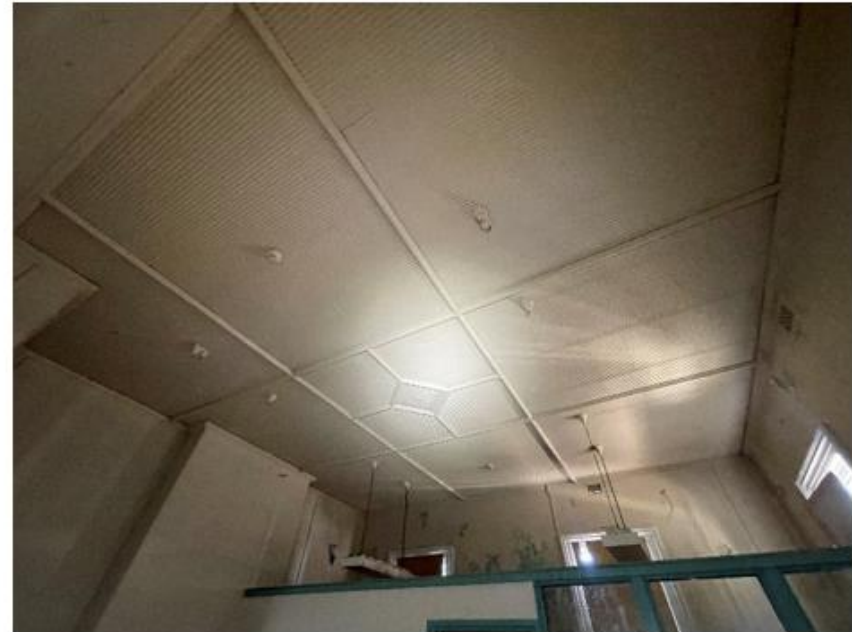
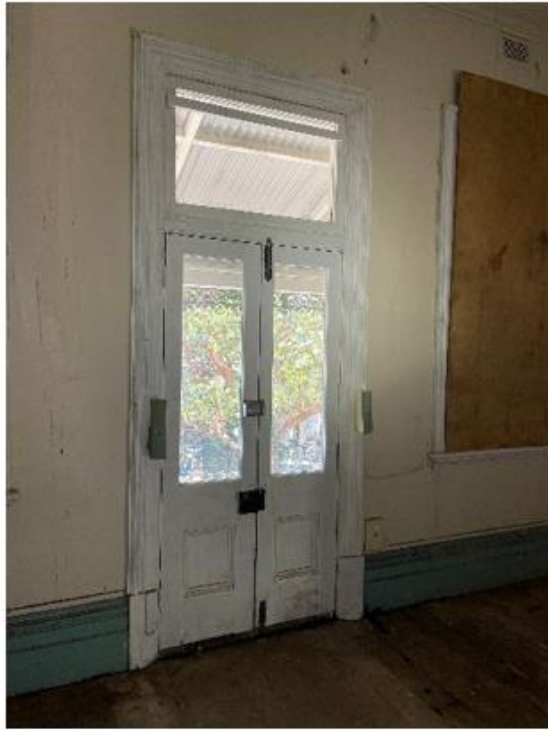
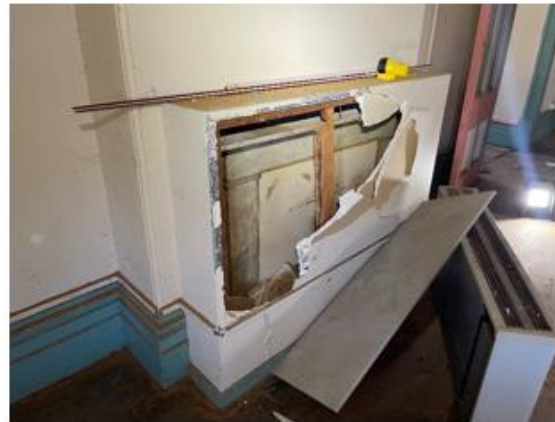
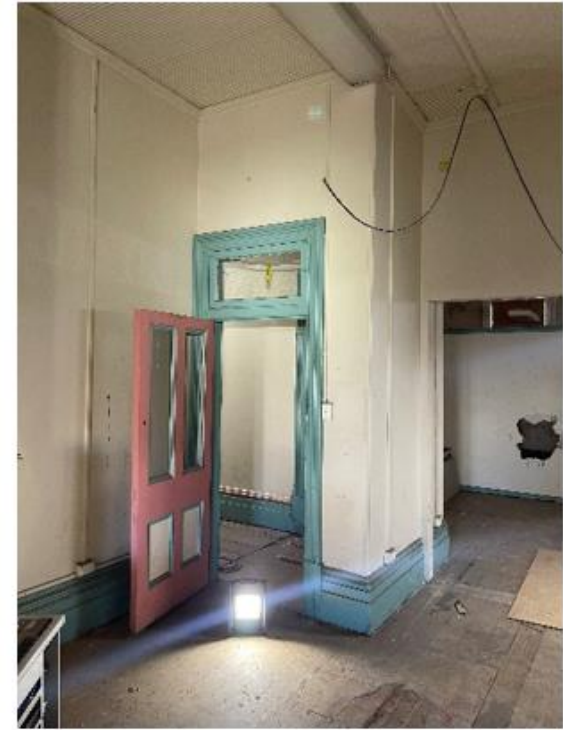
## CME Building – Room F1

Walls	Poor	<p><b>Description:</b> Falling damp mostly contained to the northern and southern ends of the room, Many surface fixed conduits and fittings, various patches required. The original 1887 end of hallway door has been removed and the hallway has been extended into the room with a door to both the north and south added as a later addition. Two intrusive modern partitions running from east to west divide the room into three. Brick vents are miss matched and some are damaged.</p> <p><b>Recommendation:</b> Remove modern partitions and reinstate original entry layout. Paint strip areas of loose or flaking paint, and where the damp has affected it. The rest can be subject to overcoating and or spot repairs as per the guidelines within <i>AS4361.1:2017 Guide to Hazardous Paint Management</i>. Render to be removed where falling damp has occurred and wet vacuum wash the brickwork for multiple cycles with a contained head wet system. Allow to dry for min 6 weeks and apply a salt retardant render prior to white set and painting.</p> <p>Also refer to section 3.1.2 Walls and Section 3.1.3. Painted Surfaces in the <i>Physical Condition and Schedule of Conservation Works</i> report for further treatment recommendations.</p> <p><b>Grading of Significance: High</b></p>

CME Building – Room F1		
Ceilings	Fair	<p><b>Description:</b> Corrugated metal ceilings with timber battens covering joints. A decorative diamond pattern is formed by the mouldings at the centre of either end of the room. Many surface fixed fittings and penetrations for services</p> <p><b>Recommendation:</b> Remove Intrusive modern fixtures fittings and conduits</p> <ul style="list-style-type: none"> <li>Where intact and not at risk of collapse, complete conservation works to reinstate back to original condition. This could be inclusive of patching existing holes, replacing missing, badly damaged sections and missing timber mouldings.</li> <li>Where small areas are damaged beyond salvage, replace with salvaged fabric from other rooms of less significance within the building, replace with second hand salvaged material or replace with replicated modern equivalent.</li> <li>Instead of removing large sections of heritage fabric ceilings to facilitate the installation of services or structural repairs, It would be a more preferable heritage outcome to leave any stable remnant ceiling fabric in situ and install a modern ceiling replica of the original ceiling based on existing documentation from the original build or from evidence of remnant fabric. These new ceilings would be installed lower to provide space to conceal services provided that any loss of height does not detract from the overall scale of the rooms or cover necessary ventilation grills or vents. The original ceiling would remain in its current condition concealed above it.</li> </ul> <p>See also Section 3.1.1. Ceilings in the <i>Physical Condition and Schedule of Conservation Works</i> report for further treatment recommendations.</p> <p><b>Grading of Significance:</b> High</p>

CME Building – Room F1		
Windows	Poor	<p><b>Description:</b> Windows appear to have been mostly stripped and primed/sealed. Windows are currently boarded up and not accessible for full assessment.</p> <p><b>Recommendation:</b> Remove boarding to expose windows. Strip all lead paint completely from all surfaces and prepare all surfaces under HAZMAT conditions in accordance with <i>AS4361.1:2017 Guide to Hazardous Paint Management</i> prior to commencement of works.</p> <ul style="list-style-type: none"> <li>• Windows should generally be repaired adjusted and cleaned up in their original locations. This could be inclusive of sash cord and weight replacement, glazing putty touch ups or replacement, adjustment and refitting of sashes, rot repairs, broken glass replacement and hardware repairs and or replacement.</li> <li>• Existing heritage hardware should be stripped, polished and reinstated in as close to its original position. Missing hardware should be reinstated with new modern reproduction equivalents.</li> <li>• Locks should be made operational if windows are to be operable. Opening restrictions should be added for both security and code compliance if windows present a climb or fall risk.</li> </ul> <p>See also section 3.1.3 Painted Surfaces and section 3.1.5 Windows in the <i>Physical Condition and Schedule of Conservation Works</i> report for further treatment recommendations.</p> <p><b>Grading of Significance: High</b></p>

Doors	Fair	<p><b>Description:</b> Inward opening double french door to the north leading to the balcony with glazed top panels. The modified entry into the room from the hallway has a damaged four panel door with clear glazed top panels to the north, yet the southern door is missing. Both have highlights above. The southernmost intrusive modern partition has a plain modern door.</p> <p><b>Recommendation:</b> The French doors doors should be tidied up and made good. The entry into the room for the hallway should be returned back to its original configuration and the northern door and jamb repaired and reinstated into this location.</p> <p>The modern door should be removed along with the partition.</p> <ul style="list-style-type: none"> <li>• Doors should generally be adjusted, cleaned up, and rehung in their original locations.</li> </ul>

Fireplace	Very Poor	<p><b>Description:</b> 2 x fireplaces, both sheeted over. The most northern fireplace has a marble mantle in place, however the cast iron insert was boarded over and not able to be assessed. The southern fireplace has been covered over, however is missing.</p> <p><b>Recommendation:</b></p> <ul style="list-style-type: none"> <li>Generally, intact existing cast iron fireplaces should be conserved and restored. Where they are missing, they should be replaced with recycled salvaged heritage equivalents of the same period in the more significant</li> </ul>

Cornice	Fair	<p><b>Description:</b> Timber Scotia mould Cornice.</p> <p><b>Recommendation:</b> Remove intrusive modern fixtures and fittings. Decorative timber mouldings should be repaired in situ if possible. When beyond salvage or if ceilings are replaced, or relocated, timber mouldings should be reinstated with originals salvaged from elsewhere within the building where available or with replicated remakes of</p>

CME Building – Room F1		
		<ul style="list-style-type: none"> <li>Doors and jambs that need to be replaced for fire rating, should be replaced with compliant metal jambs and fire doors. Existing architraves should be reinstated, and sympathetic bolection mouldings should be installed onto the fire doors to recreate the appearance of the original panel doors.</li> <li>-Existing heritage hardware that is non-operational should be stripped, polished, decommissioned and reinstated in as close to its original position provided that it does not interfere with compliance of new door control hardware. New modern hardware that is sympathetic to the heritage aspect of the building yet compliant with relevant Building codes and Australian Standards (AS1428.1) should be installed.</li> <li>Fanlights should be cleaned up and made good. They should be made to operate if required as part of the HVAC requirements of the building. Existing hardware should be removed, polished and reinstated. Any missing hardware should be replaced with reproduction items to match the existing. Consideration as to make the fanlights operable, fixed open or fixed closed should be made in conjunction with the requirements of the buildings HVAC system and acoustic considerations.</li> <li>Any damage or cut outs to architraves or jambs should be reinstated with timber inlays and reshaped to blend in.</li> <li>Doors that need to be pinned in an open position should be fixed in place with a concealed fixing.</li> </ul> <p>Also refer to section 3.1.6 Doors.</p> <p><b>Grading of Significance: High</b></p>
