## 9. Inventory Sheets

This chapter includes the inventory sheets for each room within the CME Building. Each datasheet includes:

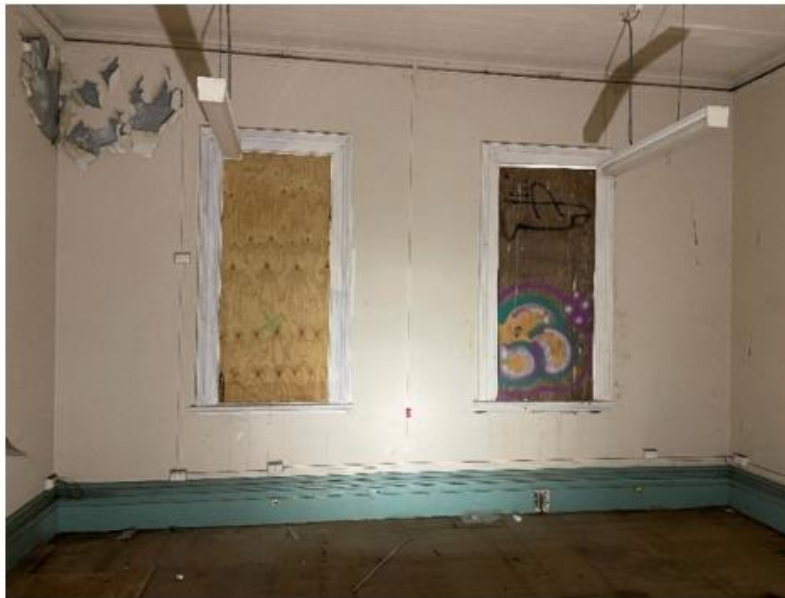
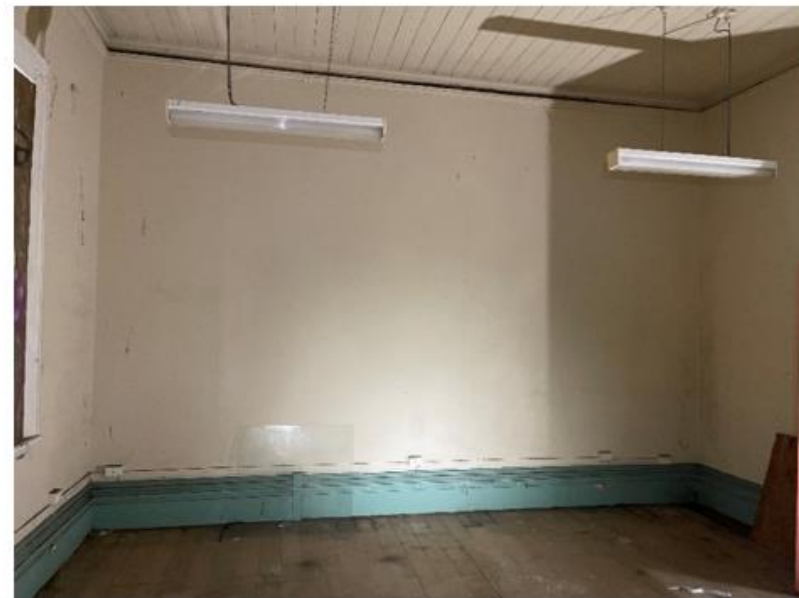
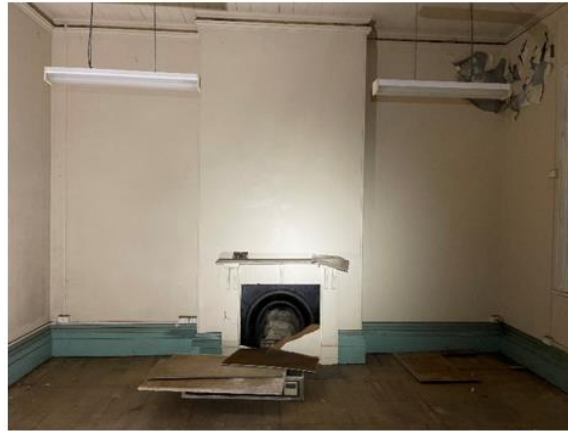
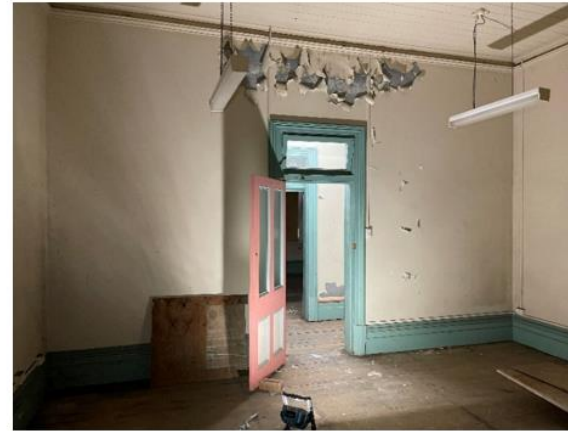
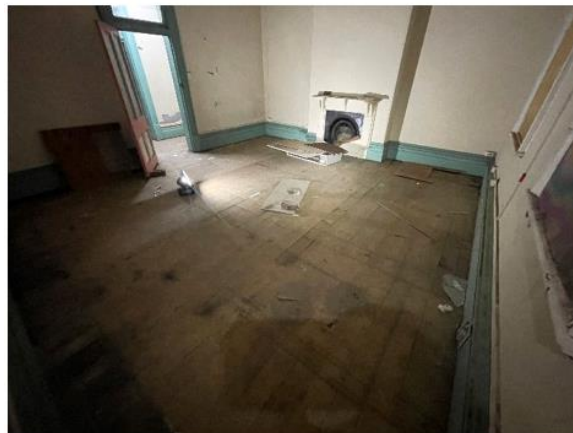
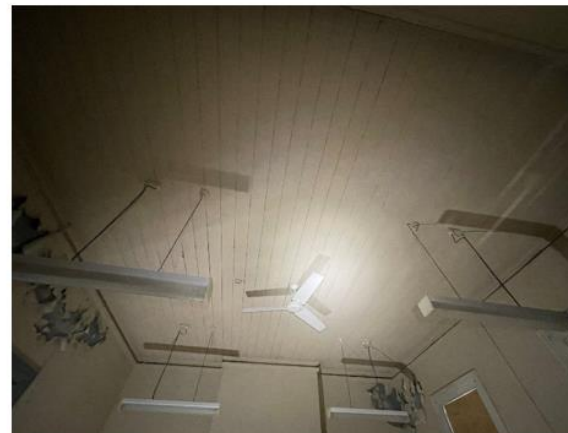
**Photos**

CME Building – Room F2		
Fabric	Current Condition	Description and Recommendation
Floor	Fair	<p><b>Description:</b>– Wide boards, Kauri Pine. Generally fair condition besides a few patches.</p> <p><b>Recommendation:</b> Certain areas may need to be temporarily removed to facilitate subfloor works, including installation of concealed services and structural repairs. Reticulation of services should prioritise the areas of flooring being pulled up to replace damaged flooring to minimise the unnecessary removal of boards. It is intended to salvage as many as possible of the floorboards for reuse in accordance with Section 3.1.4. Floors in the <i>Physical Condition and Schedule of Conservation Works</i> methodology for floor works. Salvaged flooring from the entire building should be collated and graded for condition from best to worst before being re-laid at the completion of subfloor works. Priority should be given to the rooms in key view lines and of most significance to have the floorboards in the best condition as per section 3.1 - 6 General recommendations in the <i>Physical Condition and Schedule of Conservation Works</i></p> <p><b>Grading of Significance: High</b></p>

Walls	Poor to Fair	<p><b>Description:</b> Falling damp mostly contained to North and South walls, cracks on north wall, particularly near windows, brick vents are concealed in the cornice, paint poor and flaking in places, many surface fixed conduits, fittings and penetrations for services. Various surface fixed conduits around the room.</p> <p><b>Recommendation:</b> Remove conduits and fittings. Paint strip areas of loose or flaking paint, and where the damp has affected it. The rest can be subject to overcoating and or spot repairs as per the guidelines within <i>AS4361.1:2017 Guide to Hazardous Paint Management</i>. Render to be removed where falling damp has occurred and wet vacuum wash the brickwork for multiple cycles with a contained head wet system. Allow to dry for min 6 weeks and apply a salt retardant render prior to white set and painting.</p> <p>Also refer to section 3.1.2 Walls and Section 3.1.3. Painted Surfaces in the <i>Physical Condition and Schedule of Conservation Works</i> report for further treatment recommendations.</p> <p><b>Grading of Significance: High</b></p>

CME Building – Room F2		
Ceilings	Fair	<p><b>Description:</b> Lining boards in good condition. Many surface fixed conduits, fittings and penetrations for services. It was likely that the lining boards were used for economic reasons.</p> <p><b>Recommendation:</b> Remove Intrusive modern fixtures fittings and conduits</p> <ul style="list-style-type: none"> <li>Where intact and not at risk of collapse, complete conservation works to reinstate back to original condition. This could be inclusive of patching existing holes, replacing missing, badly damaged sections and in situ cornice template moulding repairs.</li> <li>Where small areas are damaged beyond salvage, replace with salvaged lining boards from other rooms of less significance within the building, replace with second hand salvaged material or replace with replicated modern equivalent.</li> <li>Instead of removing large sections of heritage fabric ceilings to facilitate the installation of services or structural repairs, It would be a more preferable heritage outcome to leave any stable remnant ceiling fabric in situ and install a modern ceiling replica of the original ceiling based on existing documentation from the original build or from evidence of remnant fabric. These new ceilings would be installed lower to provide space to conceal services provided that any loss of height does not detract from the overall scale of the rooms or cover necessary ventilation grills or vents. The original ceiling would remain in its current condition concealed above it.</li> </ul> <p>See also Section 3.1.1. Ceilings in the <i>Physical Condition and Schedule of Conservation Works</i> report for further treatment recommendations.</p> <p><b>Grading of Significance:</b> High</p>

Cornice	Fair	<p><b>Description:</b> fair condition, timber Scotia mould Cornice with lower section of original plaster cornice below</p> <p><b>Recommendation:</b> Remove intrusive modern fixtures and fittings. Decorative plaster cornice and timber mouldings should be repaired in situ if possible. When beyond salvage or if ceilings are replaced, or relocated, cornices and timber mouldings should be reinstated with originals salvaged from elsewhere within the building where available</p>

CME Building – Room F2		
Windows	Poor	<p><b>Description:</b> Windows appear to have been mostly stripped and primed/sealed. Windows are currently boarded up and not accessible for full assessment. The Eastern end of the eastern window sill has been cut short.</p> <p><b>Recommendation:</b> Remove boarding to expose windows. Strip all lead paint completely from all surfaces and prepare all surfaces under HAZMAT conditions in accordance with <i>AS4361.1:2017 Guide to Hazardous Paint Management</i> prior to commencement of works.</p> <ul style="list-style-type: none"> <li>• Windows should generally be repaired adjusted and cleaned up in their original locations. This could be inclusive of sash cord and weight replacement, glazing putty touch ups or replacement, adjustment and refitting of sashes, rot repairs, broken glass replacement and hardware repairs and or replacement.</li> <li>• Existing heritage hardware should be stripped, polished and reinstated in as close to its original position. Missing hardware should be reinstated with new modern reproduction equivalents.</li> <li>• Locks should be made operational if windows are to be operable. Opening restrictions should be added for both security and code compliance if windows present a climb or fall risk.</li> </ul> <p>See also section 3.1.3. Painted Surfaces and section 3.1.5. Windows</p> <p><b>Grading of Significance: High</b></p>

Doors	Fair	<p><b>Description:</b> Four panel door with top 2 panels obscure glazed. The architrave has a check out from a previously installed lock.</p> <p><b>Recommendation:</b></p> <ul style="list-style-type: none"> <li>• Doors should generally be adjusted, cleaned up, and rehung in their original locations.</li> <li>• Existing heritage hardware that is non-operational should be stripped, polished, decommissioned and reinstated in as close to its original position provided that it does not interfere with compliance of new door control hardware. New modern hardware that is sympathetic to the heritage aspect of the building yet compliant with relevant Building codes and Australian Standards (AS1428.1) should be installed.</li> </ul>

- Doors that need to be pinned in an open position should be fixed in place with a concealed fixing.
- Doors and jambs that need to be replaced for fire rating, should be replaced with compliant metal jambs and fire doors. Existing architraves should be reinstated, and sympathetic bolection mouldings should be installed onto the fire doors to recreate the appearance of the original panel doors.

- Fanlights should be cleaned up and made good. They should be made to operate if required as part of the HVAC requirements of the building. Existing hardware should be removed, polished and reinstated. Any missing hardware should be replaced with reproduction items to match the existing. Consideration as to make the fanlights operable, fixed open or fixed closed should be made in conjunction with the requirements of the buildings HVAC system and acoustic considerations.

- Any damage or cut outs to architraves or jambs should be reinstated with timber inlays and reshaped to blend in.

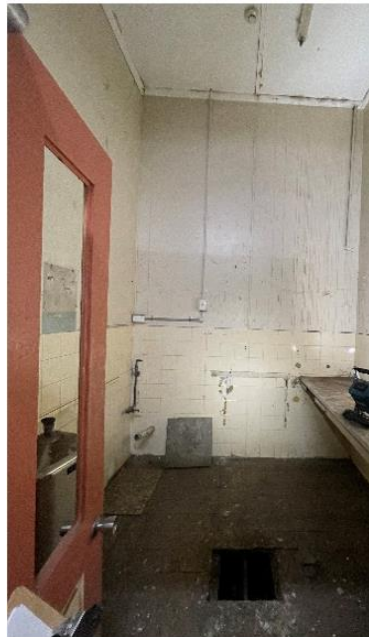
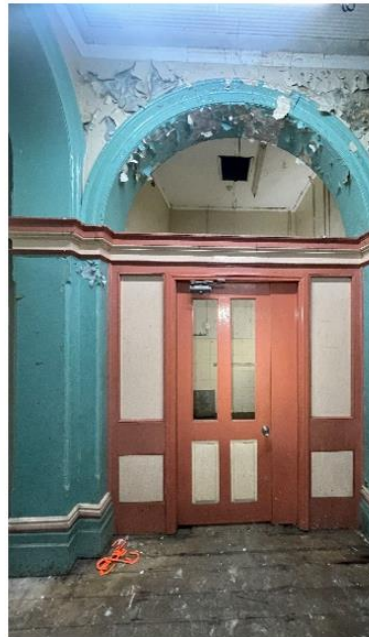
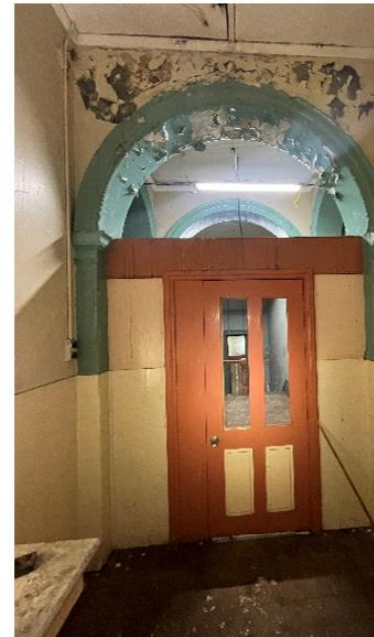
**Photos**

CME Building – Room F3A		
Fabric	Current Condition	Description and Recommendation
Floor	Poor	<p><b>Description:</b>– Wide boards, Kauri Pine, Many cut outs and patches. The western side has a metal plate covering pipework.</p> <p><b>Recommendation:</b> Certain areas may need to be temporarily removed to facilitate subfloor works, including installation of concealed services and structural repairs. Reticulation of services should prioritise the areas of flooring being pulled up to replace damaged flooring to minimise the unnecessary removal of boards. It is intended to salvage as many as possible of the floorboards for reuse in accordance with Section 3.1.4. Floors in the <i>Physical Condition and Schedule of Conservation Works</i> methodology for floor works. Salvaged flooring from the entire building should be collated and graded for condition from best to worst before being re-laid at the completion of subfloor works. Priority should be given to the rooms in key view lines and of most significance to have the floorboards in the best condition as per section 3.1 - 6 General recommendations in the <i>Physical Condition and Schedule of Conservation Works</i></p> <p><b>Grading of Significance: High</b></p>

Walls	Poor	<p><b>Description:</b> Falling damp mostly contained to southern arch. A modern yet heritage sympathetic partition under the arch to the south. The room is tiled to around 1500 high on all sides. Cracks on walls, paint is poor and flaking in places, many surface fixed conduits, fittings and penetrations for services. A benchtop is fixed to the wall in the north eastern corner</p> <p><b>Recommendation:</b> Remove conduits, fittings, tiles and entry wall partition structure. Paint strip areas of loose or flaking paint, and where the damp has affected it. The rest can be subject to overcoating and or spot repairs as per the guidelines within <i>AS4361.1:2017 Guide to Hazardous Paint Management</i>. Render to be removed where falling damp has occurred and wet vacuum wash the brickwork for multiple cycles with a contained head wet system. Allow to dry for min 6 weeks and apply a salt retardant render prior to white set and painting.</p> <p>Also refer to section 3.1.2. Walls and Section 3.1.3 Painted Surfaces in the <i>Physical Condition and Schedule of Conservation Works</i> report for further treatment recommendations.</p> <p><b>Grading of Significance: High</b></p>

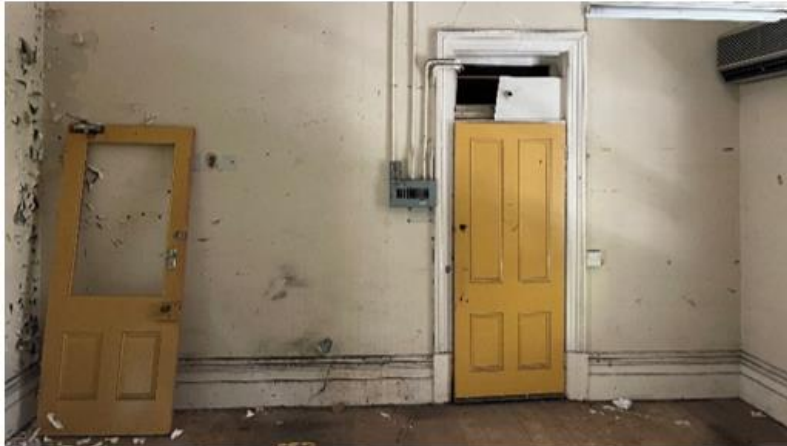
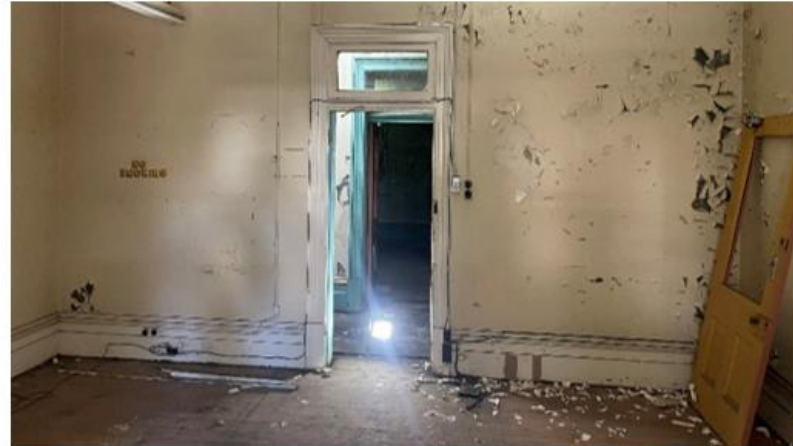
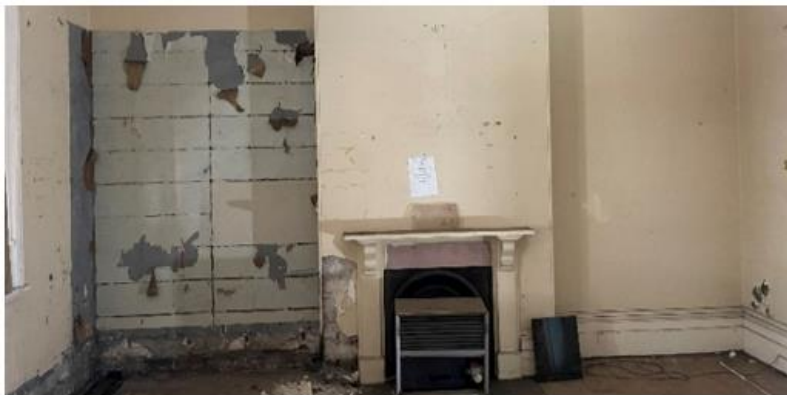
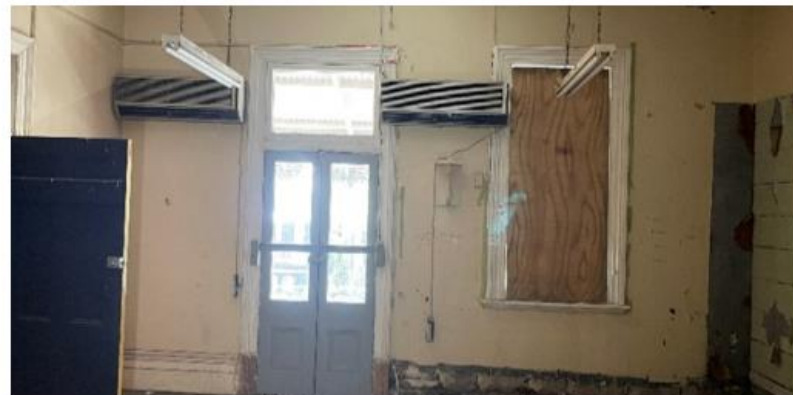
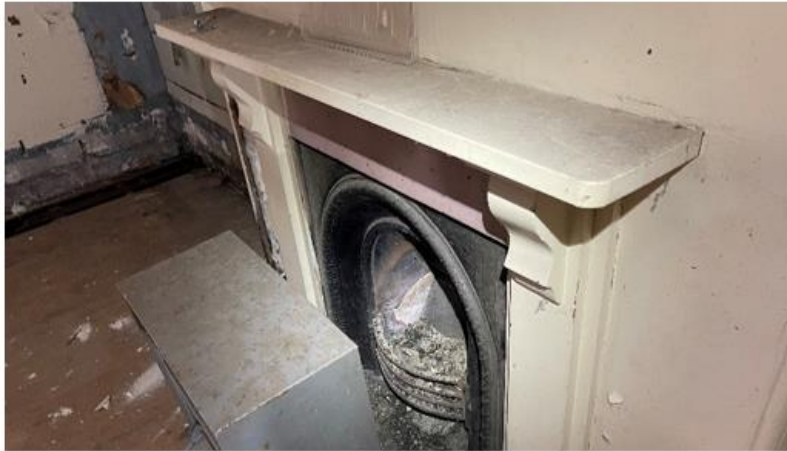
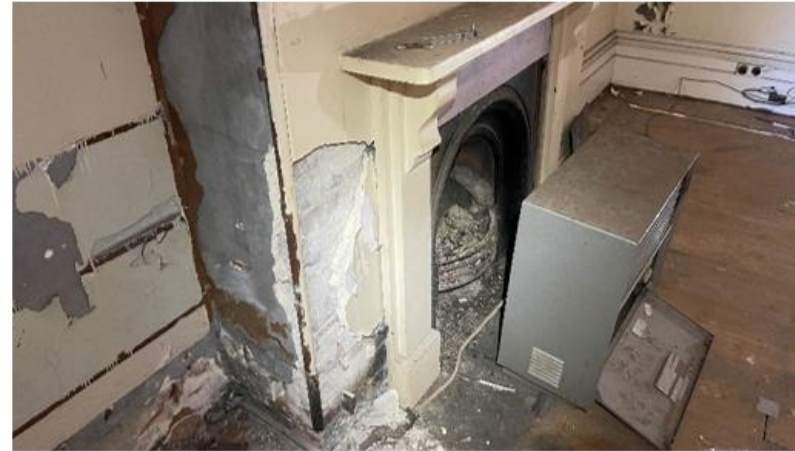
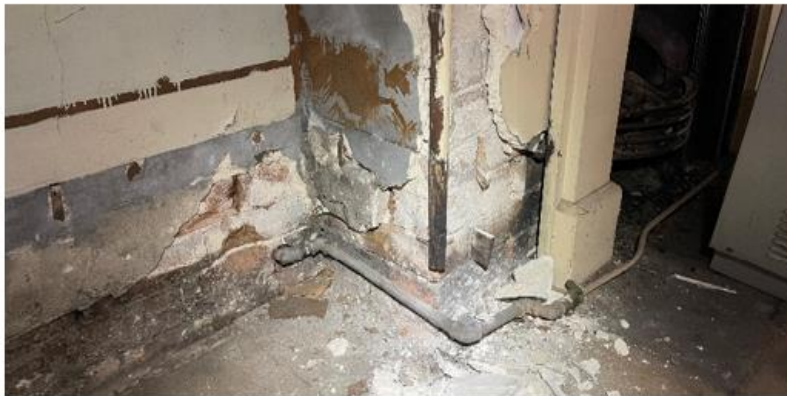
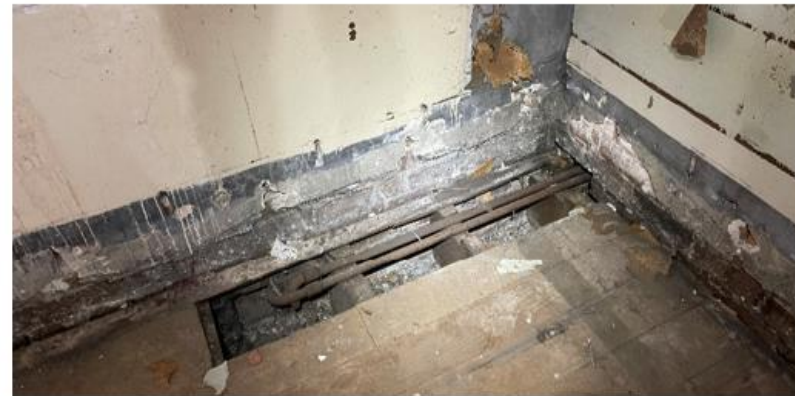
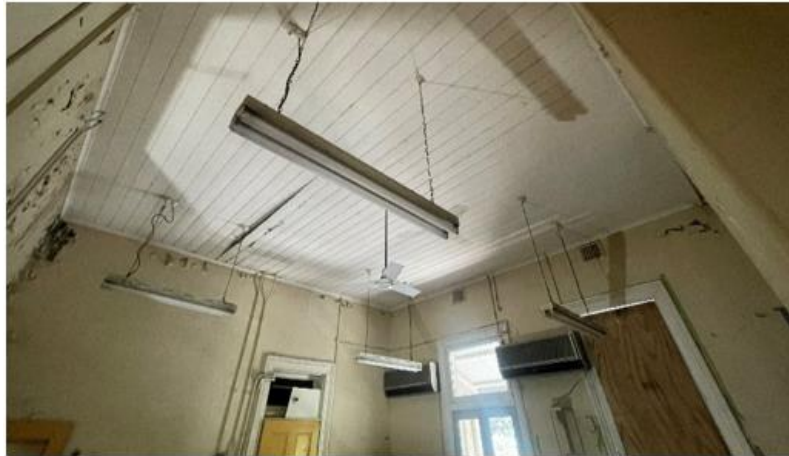
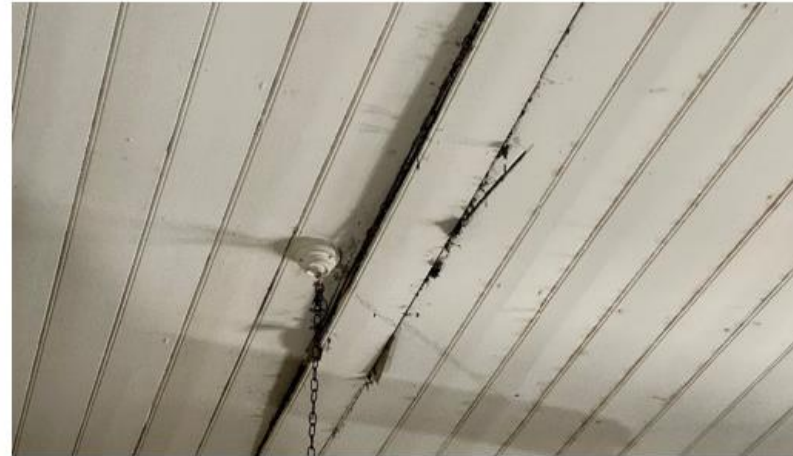
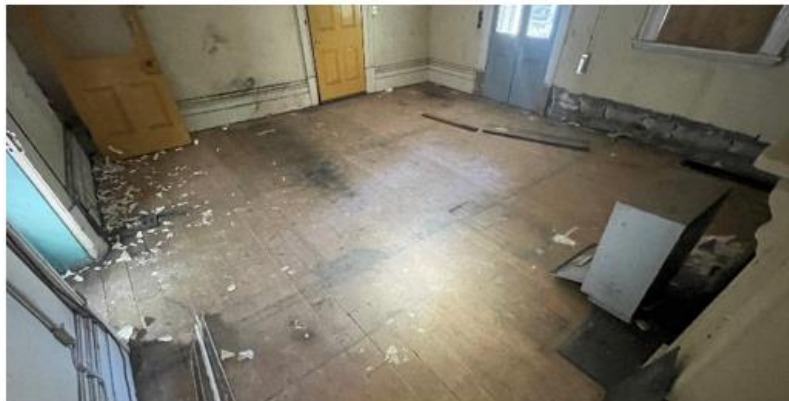
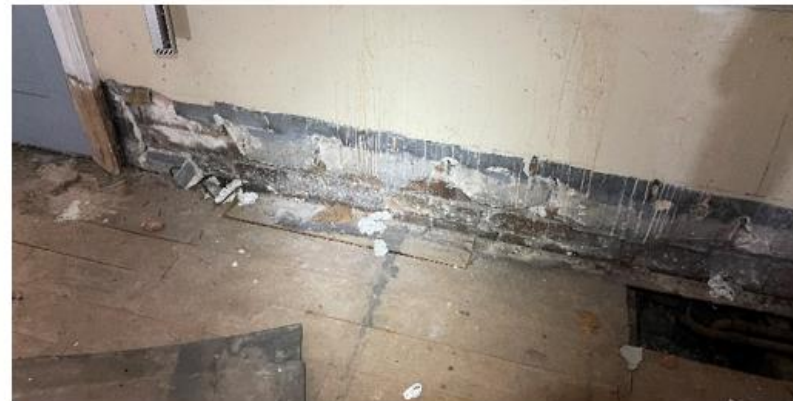
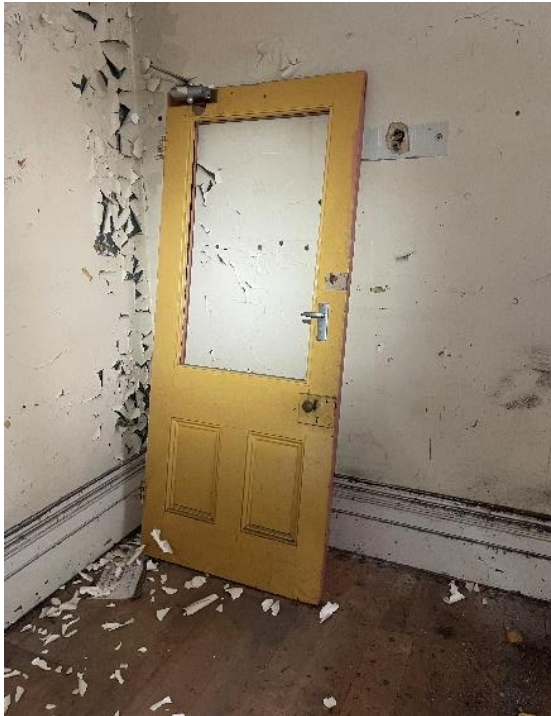
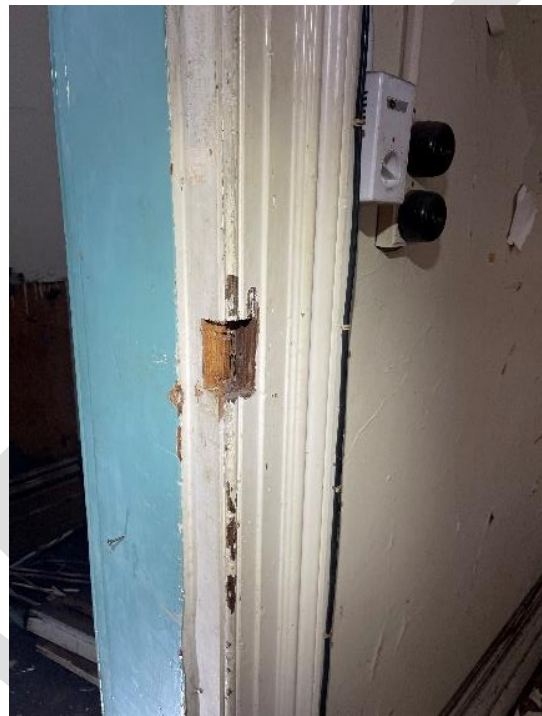
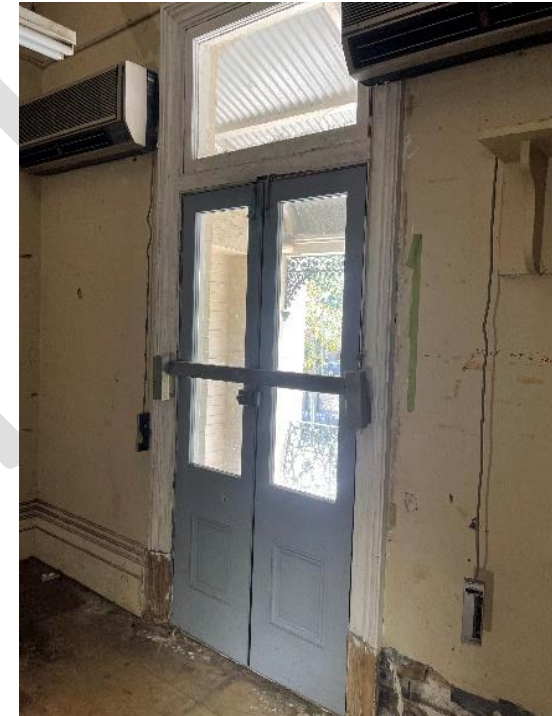
## CME Building – Room F4

CME Building – Room F4		
Fabric	Current Condition	Description and Recommendation
Floor	Fair	<p><b>Description:</b> Wide Kauri floorboards, various cutouts and patches. Missing section in north eastern corner.</p> <p><b>Recommendation:</b> Certain areas may need to be temporarily removed to facilitate subfloor works, including installation of concealed services and structural repairs. Reticulation of services should prioritise the areas of flooring being pulled up to replace damaged flooring to minimise the unnecessary removal of boards. It is intended to salvage as many as possible of the floorboards for reuse in accordance with Section 3.1.4. Floors in the <i>Physical Condition and Schedule of Conservation Works</i> methodology for floor works. Salvaged flooring from the entire building should be collated and graded for condition from best to worst before being re-laid at the completion of subfloor works. Priority should be given to the rooms in key view lines and of most significance to have the floorboards in the best condition as per section 3.1 - 6 General recommendations in the <i>Physical Condition and Schedule of Conservation Works</i></p> <p><b>Grading of Significance: High</b></p>

Walls	Poor	<p><b>Description:</b> Falling damp around most of the room, but worse at the southern end of the room, Many surface fixed conduits and fittings, various patches required. Brick vents are intact, northern side of the chimney breast is damaged, many cracks on face of chimney breast.</p> <p><b>Recommendation:</b> Paint strip areas of loose or flaking paint, and where the damp has affected it. Repair damage to chimney breast and where skirtings have been removed and the wall damaged above them. The rest can be subject to overcoating and or spot repairs as per the guidelines within <i>AS4361.1:2017 Guide to Hazardous Paint Management</i>. Render to be removed where falling damp has occurred and wet vacuum wash the brickwork for multiple cycles with a contained head wet system. Allow to dry for min 6 weeks and apply a salt retardant render prior to white set and painting.</p> <p>Also refer to section 3.1.2 Walls and Section 3.1.3. Painted Surfaces in the <i>Physical Condition and Schedule of Conservation Works</i> report for further treatment recommendations.</p> <p><b>Grading of Significance: High</b></p>

CME Building – Room F4		
Ceilings	Poor	<p><b>Description:</b> Lining board ceilings, water damaged, sagging and about to fall in places. Many surface fixed fittings.</p> <p><b>Recommendation:</b> Remove Intrusive modern fixtures fittings and conduits</p> <ul style="list-style-type: none"> <li>Where intact and not at risk of collapse, complete conservation works to reinstate back to original condition. This could be inclusive of patching existing holes, replacing missing, badly damaged sections and in situ cornice template moulding repairs.</li> <li>Where small areas are damaged beyond salvage, replace with salvaged lining boards from other rooms of less significance within the building, replace with second hand salvaged material or replace with replicated modern equivalent.</li> <li>Instead of removing large sections of heritage fabric ceilings to facilitate the installation of services or structural repairs, it would be a more preferable heritage outcome to leave any stable remnant ceiling fabric in situ and install a modern ceiling replica of the original ceiling based on existing documentation from the original build or from evidence of remnant fabric. These new ceilings would be installed lower to provide space to conceal services provided that any loss of height does not detract from the overall scale of the rooms or cover necessary ventilation grills or vents. The original ceiling would remain in its current condition concealed above it.</li> </ul> <p>See also Section 3.1.1. Ceilings in the <i>Physical Condition and Schedule of Conservation Works</i> report for further treatment recommendations.</p> <p><b>Grading of Significance: High</b></p>

CME Building – Room F4		
Windows	Poor	<p><b>Description:</b> Windows appear to have been mostly stripped and primed/sealed. Windows are currently boarded up and not accessible for full assessment.</p> <p><b>Recommendation:</b> Remove boarding to expose windows. Strip all lead paint completely from all surfaces and prepare all surfaces under HAZMAT conditions in accordance with <i>AS4361.1:2017 Guide to Hazardous Paint Management</i> prior to commencement of works.</p> <ul style="list-style-type: none"> <li>• Windows should generally be repaired adjusted and cleaned up in their original locations. This could be inclusive of sash cord and weight replacement, glazing putty touch ups or replacement, adjustment and refitting of sashes, rot repairs, broken glass replacement and hardware repairs and or replacement.</li> <li>• Existing heritage hardware should be stripped, polished and reinstated in as close to its original position. Missing hardware should be reinstated with new modern reproduction equivalents.</li> <li>• Locks should be made operational if windows are to be operable. Opening restrictions should be added for both security and code compliance if windows present a climb or fall risk.</li> </ul> <p>See also section 3.1.3. Painted Surfaces and section 3.1.5 Windows in the <i>Physical Condition and Schedule of Conservation Works</i> report for further treatment recommendations.</p> <p><b>Grading of Significance: High</b></p>

Doors	Poor	<p><b>Description:</b> Inward opening double french door to the north leading to the balcony with glazed top panels. It has a timber security brace. A solid four panel door to the west enters through to room F3A. The entry into the room from the hallway to the south has a three panel door with clear glazed top panel yet the southern door is currently not attached. All have highlights above.</p> <p><b>Recommendation:</b> The French doors doors to the north should be tidied up and made good. The timber security brace should be removed. The entry into the room from the hallway should be reattached and its jamb repaired.</p> <ul style="list-style-type: none"> <li>• Any door leaves removed as part of works should be either reused within the building in other areas requiring doors or documented on an inventory, labelled and placed in storage on site.</li> </ul>

Fireplace	Very Poor	<p><b>Description:</b> The fireplace has a timber mantle in place, and a cast iron insert. The middle of the cast iron insert is rusted and damaged. The chimney breast is damaged on the northern side. Cracking is visible on the face.</p> <p><b>Recommendation:</b> Repair render and add skirting.</p> <ul style="list-style-type: none"> <li>Generally, intact existing cast iron fireplaces should be conserved and restored. Where they are missing, they should be replaced with recycled salvaged heritage equivalents of the same period in the more significant</li> </ul>

CME Building – Room F4		
		<ul style="list-style-type: none"> <li>Doors should generally be adjusted, cleaned up, and rehung in their original locations.</li> <li>Doors and jambs that need to be replaced for fire rating, should be replaced with compliant metal jambs and fire doors. Existing architraves should be reinstated, and sympathetic bolection mouldings should be installed onto the fire doors to recreate the appearance of the original panel doors.</li> <li>-Existing heritage hardware that is non-operational should be stripped, polished, decommissioned and reinstated in as close to its original position provided that it does not interfere with compliance of new door control hardware. New modern hardware that is sympathetic to the heritage aspect of the building yet compliant with relevant Building codes and Australian Standards (AS1428.1) should be installed.</li> <li>Fanlights should be cleaned up and made good. They should be made to operate if required as part of the HVAC requirements of the building. Existing hardware should be removed, polished and reinstated. Any missing hardware should be replaced with reproduction items to match the existing. Consideration as to make the fanlights operable, fixed open or fixed closed should be made in conjunction with the requirements of the buildings HVAC system and acoustic considerations.</li> <li>Any damage or cut outs to architraves or jambs should be reinstated with timber inlays and reshaped to blend in.</li> <li>Doors that need to be pinned in an open position should be fixed in place with a concealed fixing.</li> </ul> <p>Also refer to section 3.1.6. Doors in the <i>Physical Condition Report and Schedule of Conservation Works</i>.</p> <p><b>Grading of Significance: High</b></p>

- Cast iron fireplaces in rooms of lesser significance with rusted or missing centres should have a steel plate infill welded over the opening inside the decorative arch to close them off.

- Existing mantles should be conserved and restored. Missing mantles should be replaced with secondhand heritage mantles or modern reproductions. The type and materiality of replaced mantles should be representative of the room type. The more significant rooms should have marble mantles reinstated whereas the less significant rooms should have more basic timber examples installed. Rooms with fireplaces bricked in or sheeted over should at least have a mantle installed as an interpretive element.

- Hearths should be restored where they are relatively intact. Damaged or bare hearths should be either tiled, overlayed with stone or painted.
- Cast iron and other metal componentry should be painted with satin black paint.

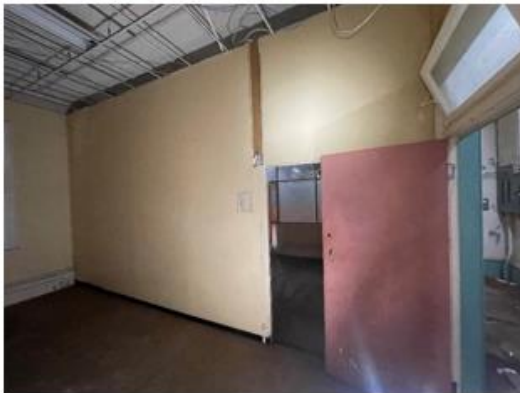
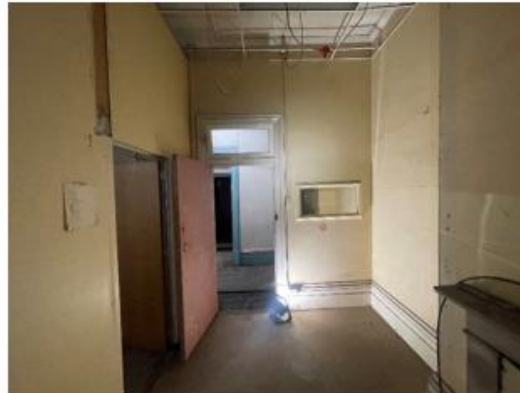
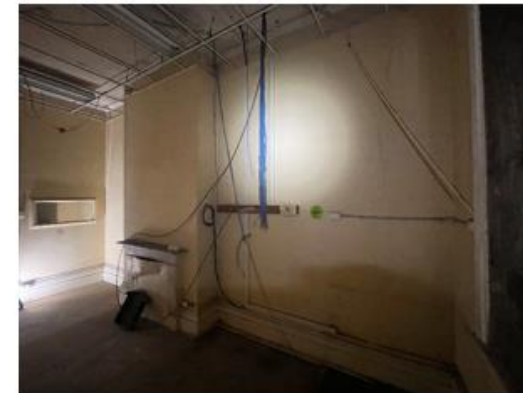
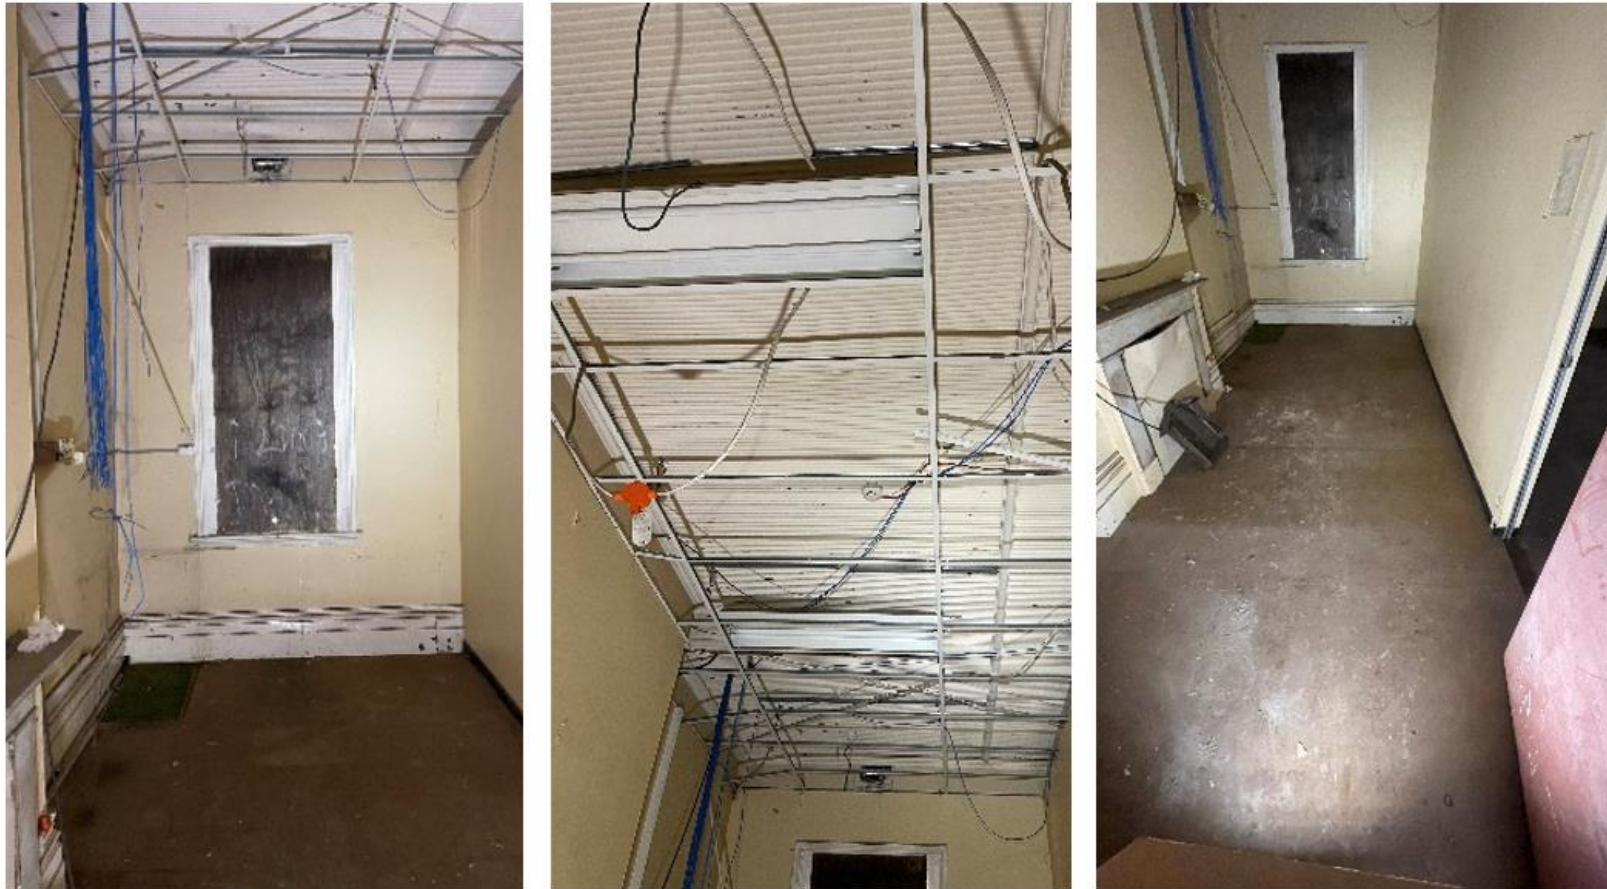
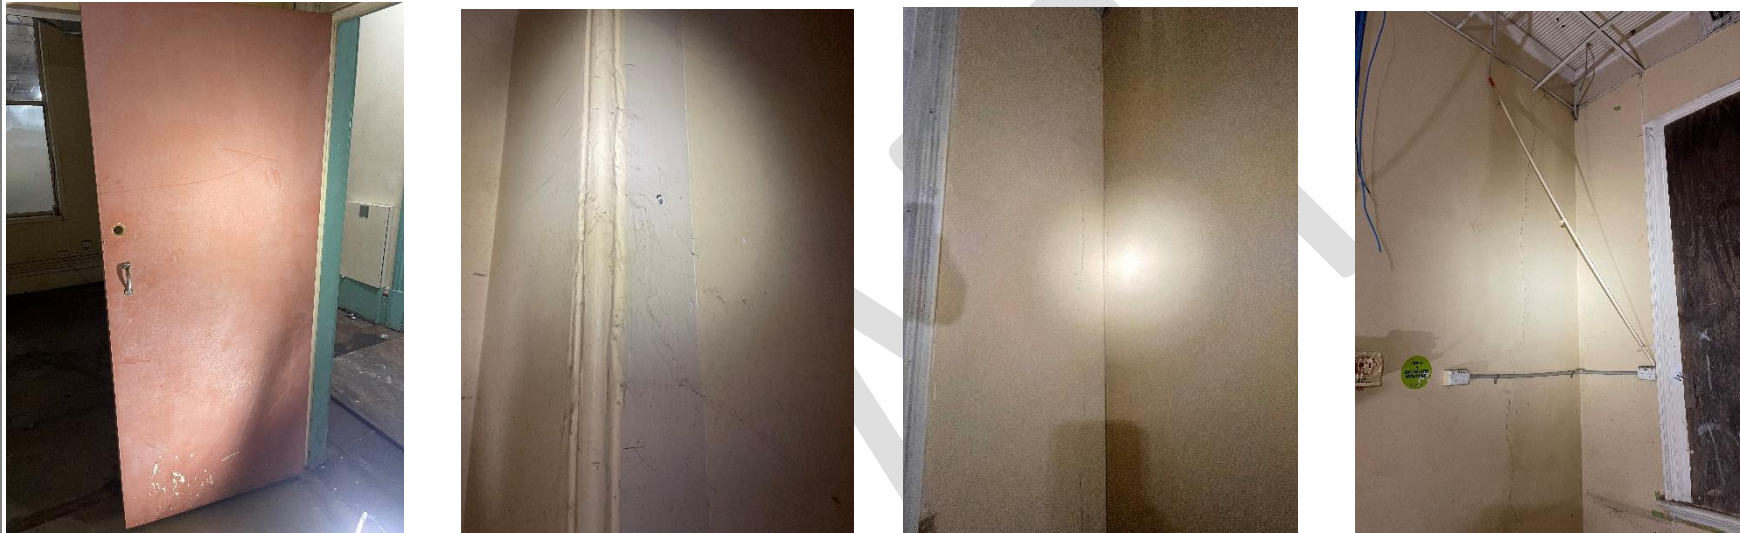
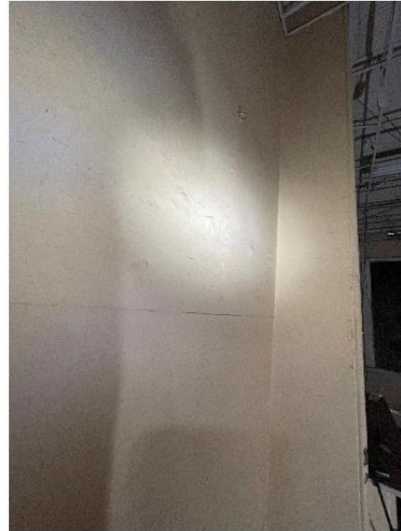
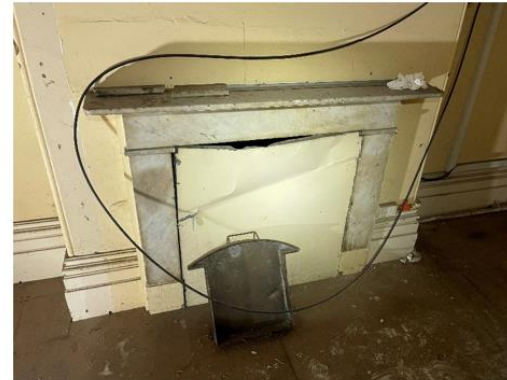
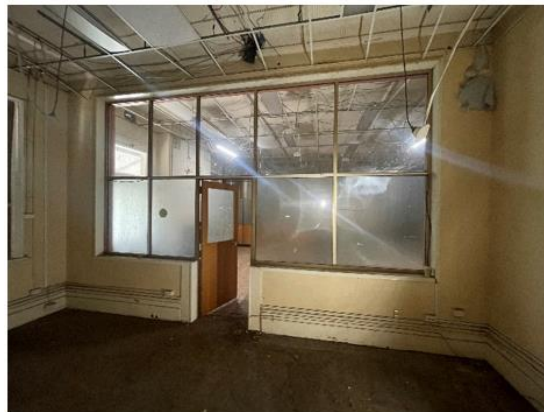
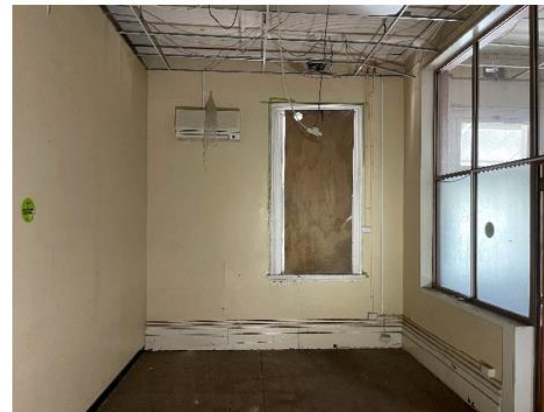
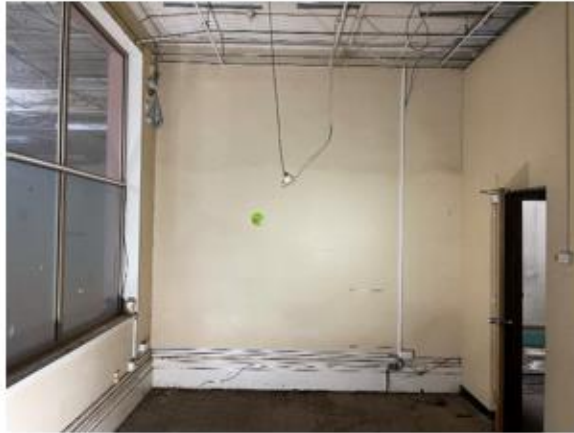
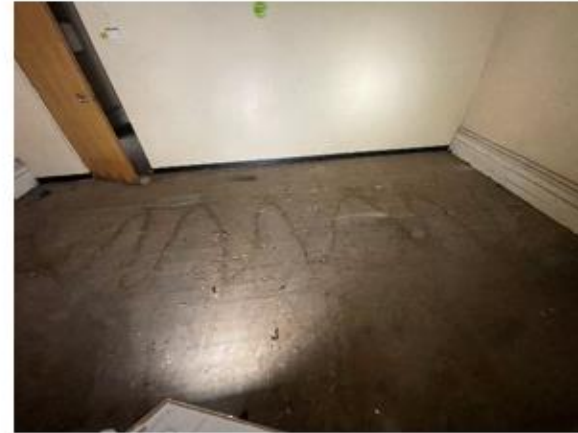
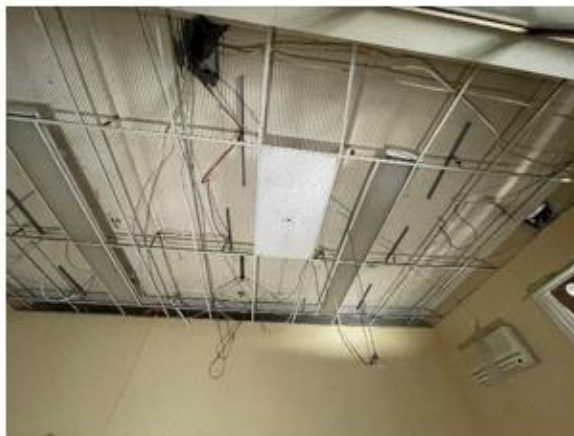
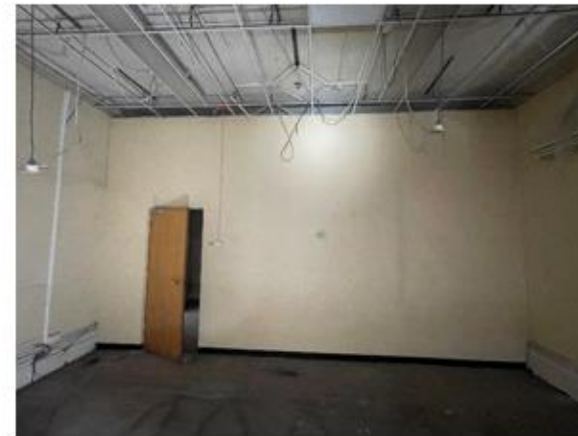
## CME Building – Room F5

CME Building – Room F5		
Fabric	Current Condition	Description and Recommendation
Floor	Fair	<p><b>Description:</b>– Plywood covering over assumed wide kauri floorboards in the western side of the room F5A. Wide kauri boards to the east in fair condition</p> <p><b>Recommendation:</b> Remove plywood and assess flooring beneath. Certain areas may need to be temporarily removed to facilitate subfloor works, including installation of concealed services and structural repairs. Reticulation of services should prioritise the areas of flooring being pulled up to replace damaged flooring to minimise the unnecessary removal of boards. It is intended to salvage as many as possible of the floorboards for reuse in accordance with Section 3.1.4 in the <i>Physical Condition and Schedule of Conservation Works</i> methodology for floor works. Salvaged flooring from the entire building should be collated and graded for condition from best to worst before being re-laid at the completion of subfloor works. Priority should be given to the rooms in key view lines and of most significance to have the floorboards in the best condition as per section 3.1 - 6 General recommendations in the <i>Physical Condition and Schedule of Conservation Works</i></p> <p><b>Grading of Significance:</b> High</p>

Walls	Poor	<p><b>Description:</b> Some falling damp, many cracks and drummy render to the northwest and northern wall. Some very untidy patching has been done in the past. The chimney breast has cracks, and the staff moulding is untidy. brick vents are missing, paint poor and flaking in places, many surface fixed conduits, fittings and penetrations for services. An intrusive modern partition wall running north-south divides this room into two. The eastern wall has been partially cut out and an intrusive modern glazed partition is installed with a doorway.</p> <p><b>Recommendation:</b> Remove modern partitions. Paint strip areas of loose or flaking paint, and where the damp has affected it. The rest can be subject to overcoating and or spot repairs as per the guidelines within <i>AS4361.1:2017 Guide to Hazardous Paint Management</i>. Render to be removed where falling damp is evident. Wet vacuum wash the brickwork for multiple cycles with a contained head wet system. Allow to dry for min 6 weeks and apply a salt retardant render prior to white set and painting. Render that is drummy or poorly patched should be removed and replaced. The cut down section to the eastern wall could be left out as a feature / interpretive element or reinstated.</p>

CME Building – Room F5		
Cornice	Fair	<p><b>Description:</b> Fair condition decorative timber moulding cornice.</p> <p><b>Recommendation:</b> Remove intrusive modern fixtures and fittings. Decorative timber mouldings should be repaired in situ if possible. When beyond salvage or if ceilings are replaced, or relocated, timber mouldings should be reinstated with originals salvaged from elsewhere within the building where available or with replicated remakes of the originals should they be beyond salvage. As per section 3.1.1. Ceilings in the <i>Physical Condition and Schedule of Conservation Works</i> report for further treatment recommendations.</p> <p><b>Grading of Significance:</b> High</p>
Skirting	Poor	<p><b>Description:</b> Tall ornate skirtings around the perimeter of the room, the northern skirting is cracked and damaged. The modern centre partition has vinyl skirting.</p> <p><b>Recommendation:</b> Skirting to be removed to facilitate rising damp repairs and floor removal if required.</p> <ul style="list-style-type: none"> <li>• Generally, skirtings should remain in their existing positions. Any skirting being replaced due to damage such as water ingress, dry rot and termite damage or that are missing should be reproduced to replicate other skirtings in the same room, or if none at all, should replicate its most likely profile based on the findings of the 1997 CMP.</li> <li>• Ground floor skirtings that are required to be removed for the subfloor excavation works, should have their locations recorded, labelled clearly, carefully removed, de-nailed, cleaned up and reinstated post excavation and subfloor works.</li> <li>• Consideration should be put into packing out skirtings with battens to create a void space for wiring prior to reinstallation where they are required to be removed to facilitate other works such as floor replacement, Subfloor excavation or rising damp remediation.</li> <li>• Consideration should be made towards sensitively and sympathetically incorporating a skirting duct into the current skirting profiles to facilitate ease of future services reticulation and to minimize the requirement for future invasive works.</li> </ul>

Doors	Fair	<p><b>Description:</b> All modern plain doors. The southern door has a cut out in the architrave. The eastern door has a concrete threshold.</p> <p><b>Recommendation:</b> All doors reinstated should be replaced with salvaged redundant doors from within the building. The southern architrave should have the cut out infilled to match.</p> <ul style="list-style-type: none"> <li>• Fanlights should be cleaned up and made good. They should be made to operate if required as part of the HVAC requirements of the building. Existing hardware should be removed, polished and reinstated. Any missing hardware should be replaced with reproduction items to match the existing. Consideration as to make</li> </ul>

CME Building – Room F5		
		<p>Also refer to section 3.1.2. Walls and Section 3.1.3. Painted Surfaces in the <i>Physical Condition and Schedule of Conservation Works</i> report for further treatment recommendations.</p> <p><b>Grading of Significance: High</b></p>
Ceilings	Poor	<p><b>Description:</b> Corrugated metal ceiling with timber mouldings covering the joints and creating a diamond pattern in the centre. Some mouldings are missing. Many surface fixed conduits, fittings and penetrations for services. An intrusive modern ceiling grid frame sits below the corrugated metal.</p> <p><b>Recommendation:</b> Remove Intrusive modern grid ceiling, fixtures fittings and conduits</p> <ul style="list-style-type: none"> <li>• Where intact and not at risk of collapse, complete conservation works to reinstate back to original condition. This could be inclusive of patching existing holes, replacing missing, badly damaged sections, mouldings and in situ cornice template moulding repairs.</li> <li>• Where small areas are damaged beyond salvage, replace with salvaged fabric from other rooms of less significance within the building, replace with second hand salvaged material or replace with replicated modern equivalent.</li> <li>• Instead of removing large sections of heritage fabric ceilings to facilitate the installation of services or structural repairs, It would be a more preferable heritage outcome to leave any stable remnant ceiling fabric in situ and install a modern ceiling replica of the original ceiling based on existing documentation from the original build or from evidence of remnant fabric. These new ceilings would be installed lower to provide space to conceal services provided that any loss of height does not detract from the overall scale of the rooms or cover necessary ventilation grills or vents. The original ceiling would remain in its current condition concealed above it.</li> </ul> <p>See also Section 3.1.1. Ceilings in the <i>Physical Condition and Schedule of Conservation Works</i> report for further treatment recommendations.</p> <p><b>Grading of Significance: High</b></p>
