## 9. Inventory Sheets

This chapter includes the inventory sheets for each room within the CME Building. Each datasheet includes:

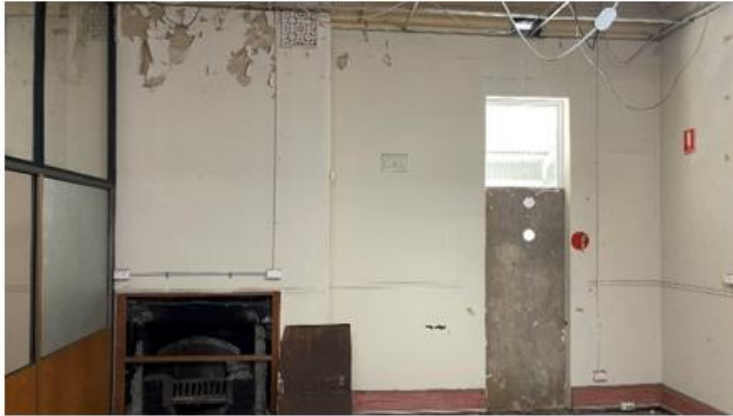
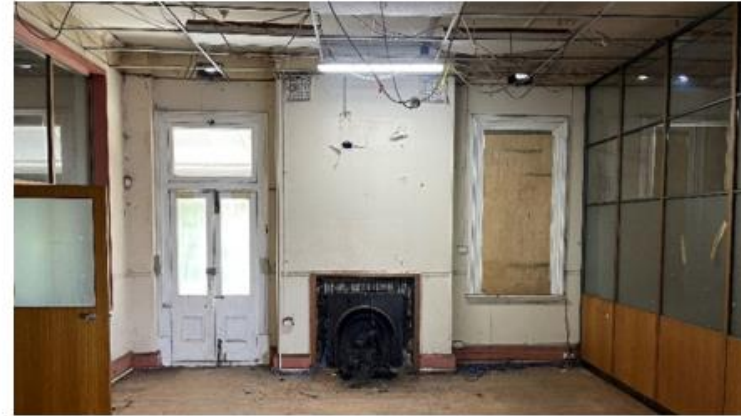
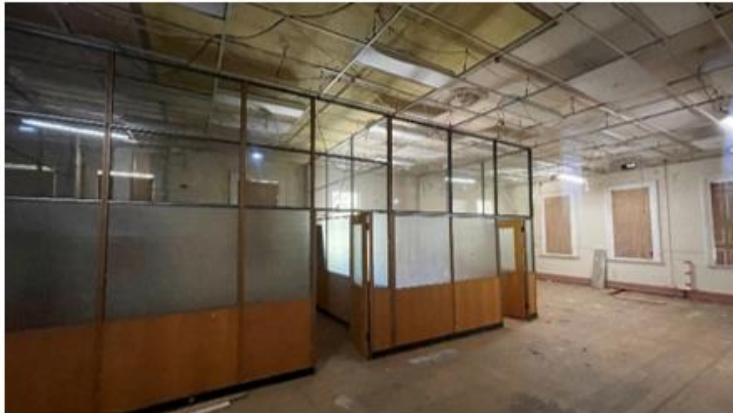
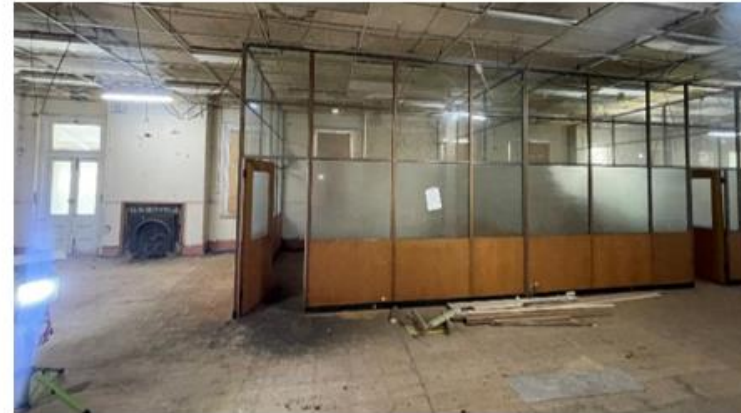
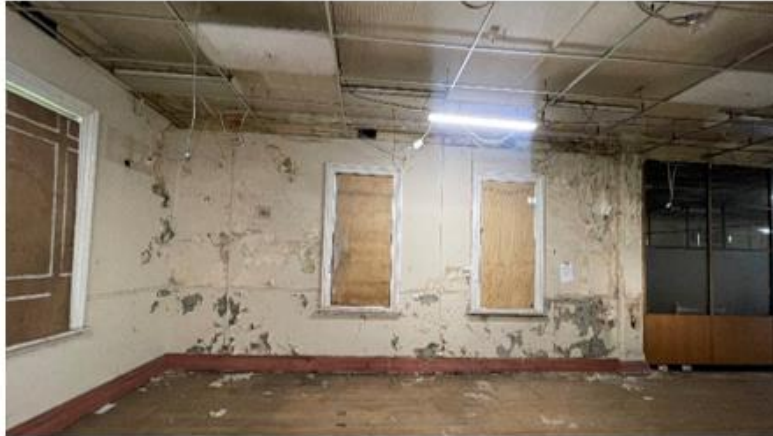
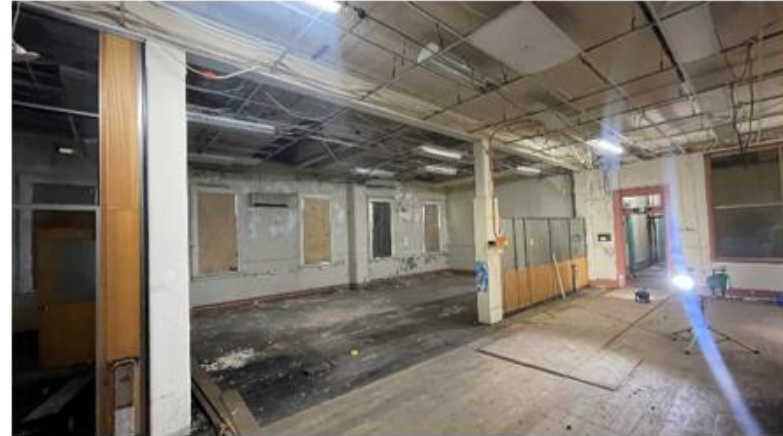
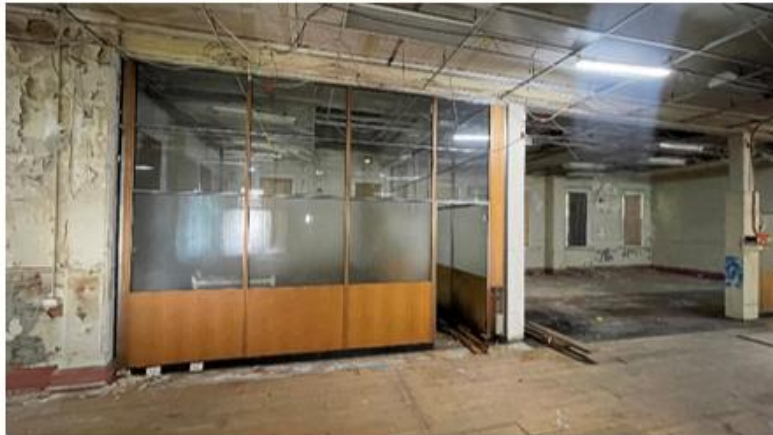
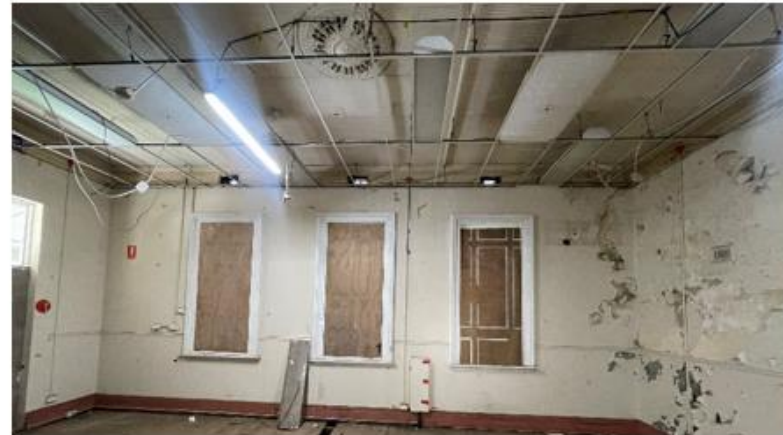
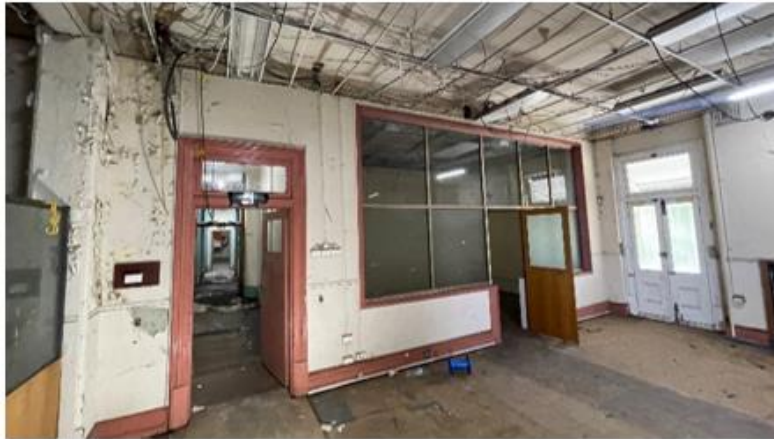
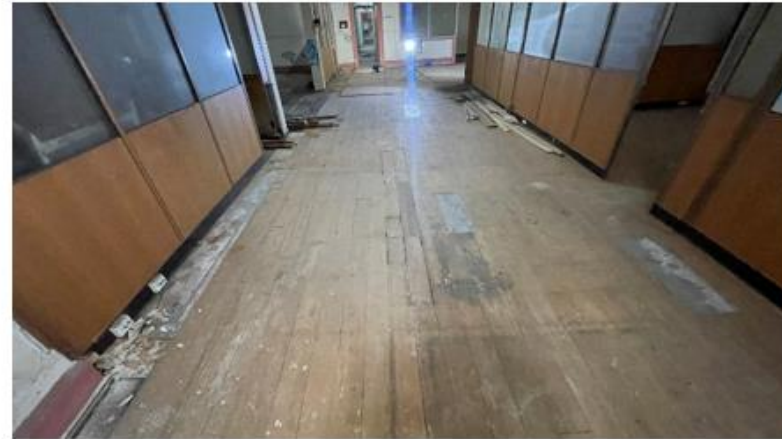
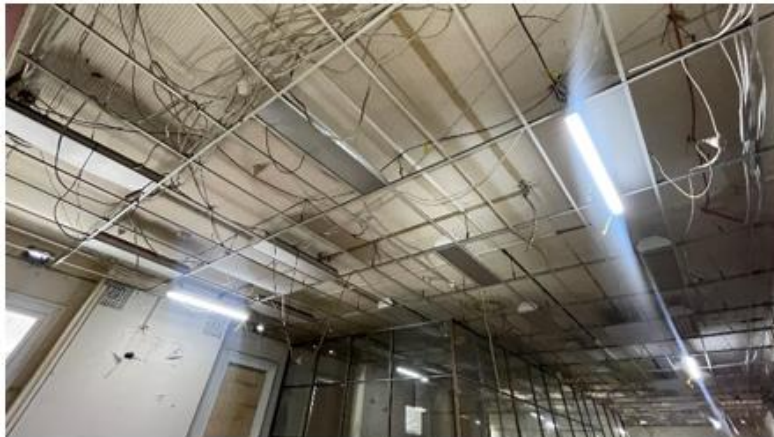
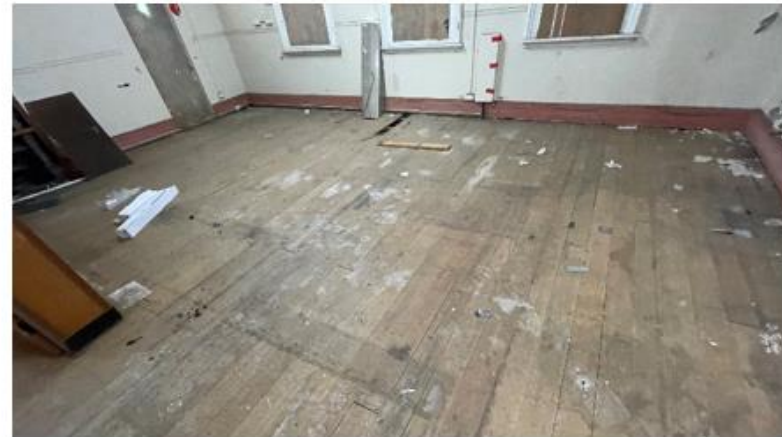
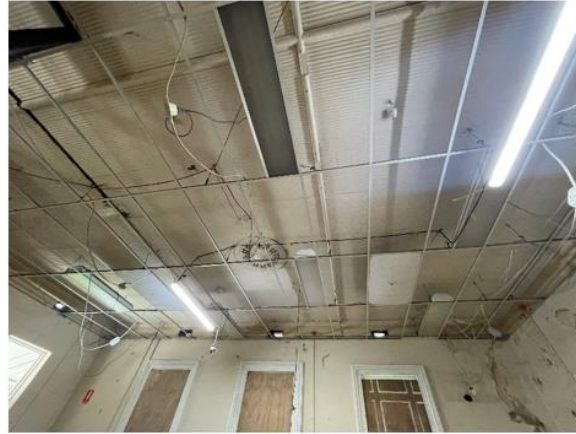
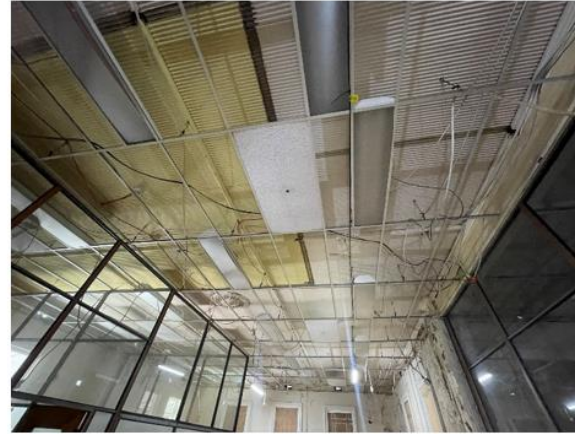
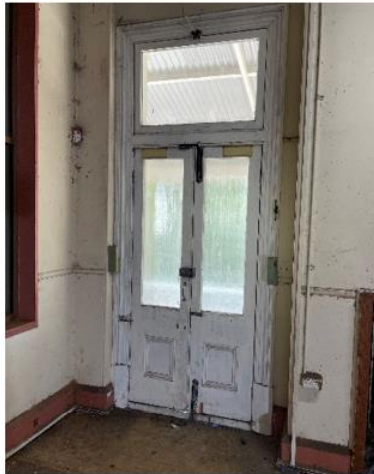
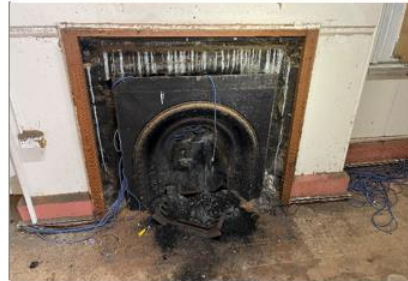
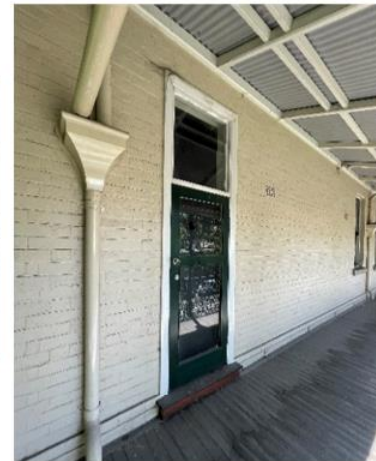
## CME Building – Room F6A

CME Building – Room F6A		
Fabric	Current Condition	Description and Recommendation
Floor	Fair	<p><b>Description:</b> Wide Kauri floorboards, various cut outs and patches. Plywood overlaying the floorboards to the west at the entry was not inspected beneath.</p> <p><b>Recommendation:</b> Certain areas may need to be temporarily removed to facilitate subfloor works, including installation of concealed services and structural repairs. Reticulation of services should prioritise the areas of flooring being pulled up to replace damaged flooring to minimise the unnecessary removal of boards. It is intended to salvage as many as possible of the floorboards for reuse in accordance with Section 3.1.4. Floors in the <i>Physical Condition and Schedule of Conservation Works</i> methodology for floor works. Salvaged flooring from the entire building should be collated and graded for condition from best to worst before being re-laid at the completion of subfloor works. Priority should be given to the rooms in key view lines and of most significance to have the floorboards in the best condition as per section 3.1 - 6 General recommendations in the <i>Physical Condition and Schedule of Conservation Works</i></p> <p><b>Grading of Significance: High</b></p>

Walls	Poor	<p><b>Description:</b> Falling damp, and cracks, Bad in places. An in situ cast dado rail runs around the perimeter of the room at midheight. Many surface fixed conduits and fittings, various patches required. Intrusive modern modular partitions with obscure glazing midheight and clear glazing to the top divide the room into smaller offices. Brick vents are miss matched, some are damaged, most are missing. Various decorative vents are placed around the walls and on the chimney breasts.</p> <p><b>Recommendation:</b> Remove intrusive modern partitions. Paint strip areas of loose or flaking paint, and where the damp has affected it. The rest can be subject to overcoating and or spot repairs as per the guidelines within <i>AS4361.1:2017 Guide to Hazardous Paint Management</i>. Render to be removed where falling damp has occurred and wet vacuum wash the brickwork for multiple cycles with a contained head wet system. Allow to dry for min 6 weeks and apply a salt retardant render prior to white set and painting. Areas with substantial cracking should have proprietary ties such as helifix chased into the mortar joints to brace the wall.</p> <p>Also refer to section 3.1.2 Walls and Section 3.1.3. Painted Surfaces in the <i>Physical Condition and Schedule of Conservation Works</i> report for further treatment recommendations.</p> <p><b>Grading of Significance: High</b></p>

CME Building – Room F6A		
Ceilings	poor	<p><b>Description:</b> Corrugated metal ceilings with timber mouldings covering joints. An intrusive modern ceiling grid frame is hung below the original ceiling. A row of three ceiling roses are spaced along the length of the room. Many surface fixed fittings and penetrations for services. Some of the timber mouldings are missing</p> <p><b>Recommendation:</b> Remove Intrusive modern grid ceiling, fixtures fittings and conduits</p> <ul style="list-style-type: none"> <li>• Where intact and not at risk of collapse, complete conservation works to reinstate back to original condition. This could be inclusive of patching existing holes, replacing missing, badly damaged sections, mouldings and in situ cornice template moulding repairs.</li> <li>• Where small areas are damaged beyond salvage, replace with salvaged fabric from other rooms of less significance within the building, replace with second hand salvaged material or replace with replicated modern equivalent.</li> <li>• Instead of removing large sections of heritage fabric ceilings to facilitate the installation of services or structural repairs, It would be a more preferable heritage outcome to leave any stable remnant ceiling fabric in situ and install a modern ceiling replica of the original ceiling based on existing documentation from the original build or from evidence of remnant fabric. These new ceilings would be installed lower to provide space to conceal services provided that any loss of height does not detract from the overall scale of the rooms or cover necessary ventilation grills or vents. The original ceiling would remain in its current condition concealed above it.</li> </ul> <p>See also Section 3.1.1. Ceilings in the <i>Physical Condition and Schedule of Conservation Works</i> report for further treatment recommendations.</p> <p><b>Grading of Significance:</b> High</p>

Cornice	Fair	<p><b>Description:</b> Timber moulding Cornice.</p> <p><b>Recommendation:</b> Remove intrusive modern fixtures and fittings. Decorative timber mouldings should be repaired in situ if possible. When beyond salvage or if ceilings are replaced, or relocated, timber mouldings should be reinstated with originals salvaged from elsewhere within the building where available or with replicated remakes of</p>

CME Building – Room F6A		
Windows	Poor	<p><b>Description:</b> Windows appear to have been mostly stripped and primed/sealed. Windows are currently boarded up and not accessible for full assessment.</p> <p><b>Recommendation:</b> Remove boarding to expose windows. Strip all lead paint completely from all surfaces and prepare all surfaces under HAZMAT conditions in accordance with <i>AS4361.1:2017 Guide to Hazardous Paint Management</i> prior to commencement of works.</p> <ul style="list-style-type: none"> <li>• Windows should generally be repaired adjusted and cleaned up in their original locations. This could be inclusive of sash cord and weight replacement, glazing putty touch ups or replacement, adjustment and refitting of sashes, rot repairs, broken glass replacement and hardware repairs and or replacement.</li> <li>• Existing heritage hardware should be stripped, polished and reinstated in as close to its original position. Missing hardware should be reinstated with new modern reproduction equivalents.</li> <li>• Locks should be made operational if windows are to be operable. Opening restrictions should be added for both security and code compliance if windows present a climb or fall risk.</li> </ul> <p>See also section 3.1.3. Painted Surfaces and section 3.1.5 Windows in the <i>Physical Condition and Schedule of Conservation Works</i> report for further treatment recommendations.</p> <p><b>Grading of Significance: High</b></p>

Doors	poor	<p><b>Description:</b> Inward opening double french door to the north leading to the balcony with glazed top panels. The western entry into the room from the hallway has a modern door with clear glazed top panel set high. To the eastern end of the north wall, a single modern 2 panel glazed door opens out onto the balcony. All have highlights above. The intrusive modern partitions all have plain modern doors with top half obscure glazing.</p> <p><b>Recommendation:</b> The French doors and single balcony door should be tidied up and made good. The entry into the room from the hallway should have an original door from elsewhere in the building reinstated into this location. The other modern doors should be removed along with the partitions.</p> <ul style="list-style-type: none"> <li>• Any door leaves removed as part of works should be either reused within the building in other areas requiring doors or documented on an inventory, labelled and placed in storage on site.</li> </ul>

Fireplace	Very Poor	<p><b>Description:</b> two fireplaces on the northern wall, both had been previously sheeted over. The most western fireplace has no mantle in place and the cast iron insert is considerably rusted. The more eastern fireplace has also been covered over in the past, and is missing both its mantle and cast iron insert. A slightly more modern cast iron fire box has been installed with the remainder of the opening partly tiled.</p>

- Generally, intact existing cast iron fireplaces should be conserved and restored. Where they are missing, they should be replaced with recycled salvaged heritage equivalents of the same period in the more significant rooms or boarded up in the less significant rooms. Restored fireplaces should be welded closed or disabled to ensure they cannot be used as functional fireplaces and vermin cannot access them.

- Cast iron fireplaces in rooms of lesser significance with rusted or missing centres should have a steel plate infill welded over the opening inside the decorative arch to close them off.

- Existing mantles should be conserved and restored. Missing mantles should be replaced with secondhand heritage mantles or modern reproductions. The type and materiality of replaced mantles should be representative of the room type. The more significant rooms should have marble mantles reinstated whereas the less significant rooms should have more basic timber examples installed. Rooms with fireplaces bricked in or sheeted over should at least have a mantle installed as an interpretive element.

- Hearths should be restored where they are relatively intact. Damaged or bare hearths should be either tiled, overlaid with stone or painted.
- Cast iron and other metal componentry should be painted with satin black paint.

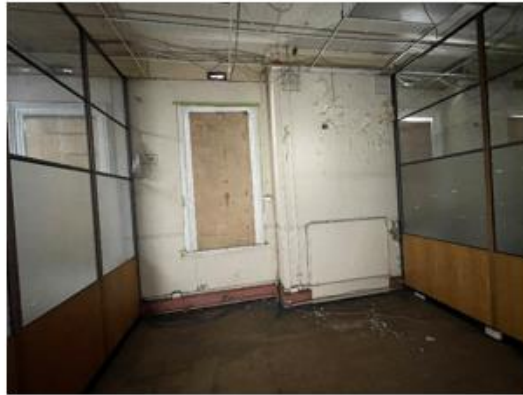
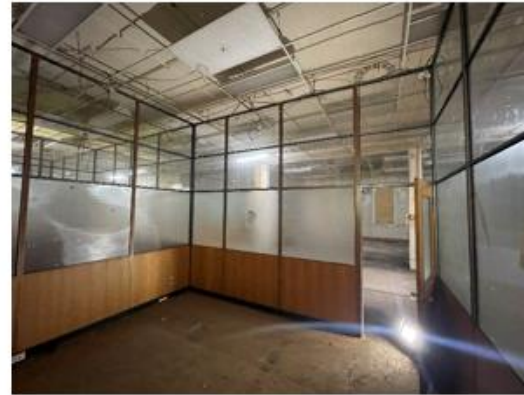
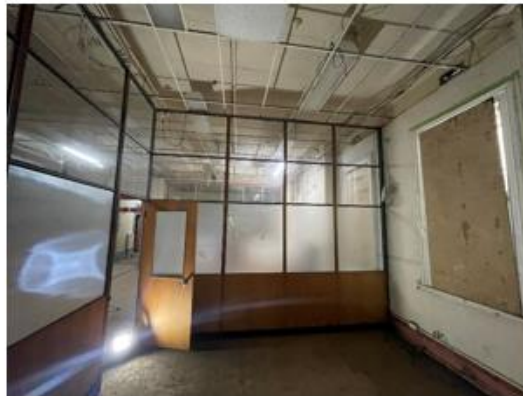
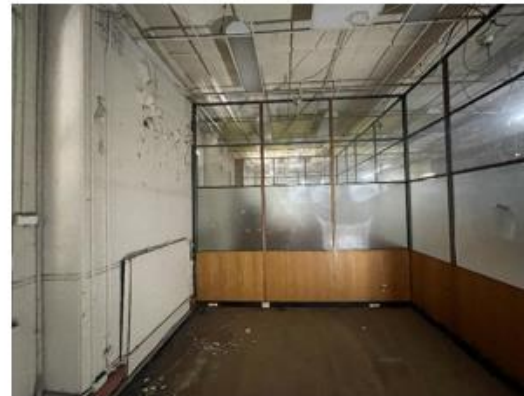
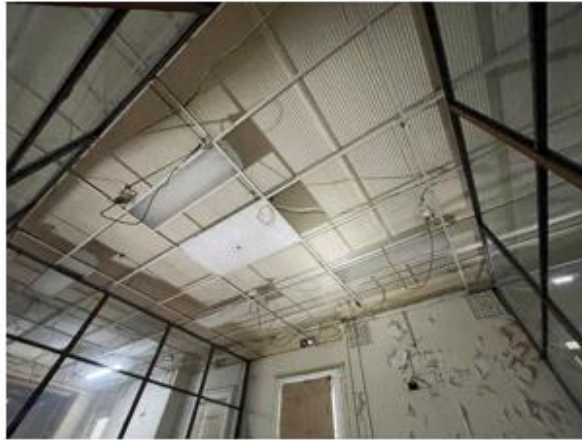
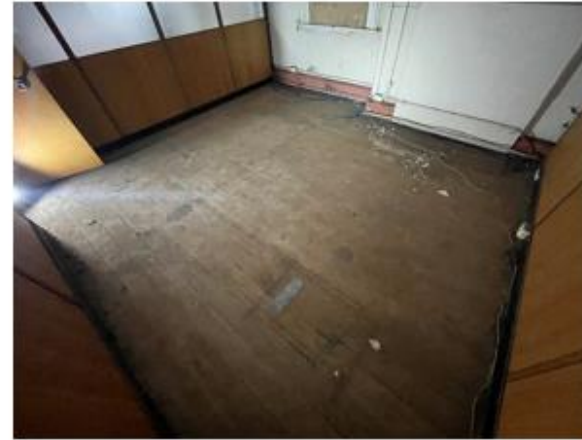
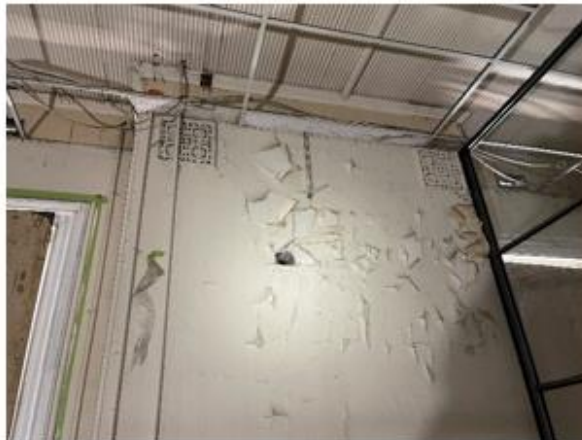
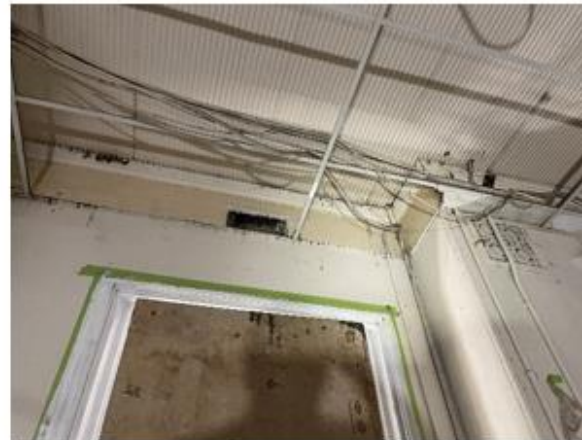
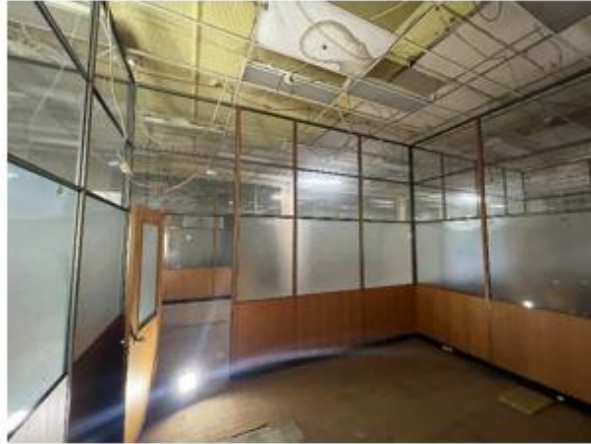
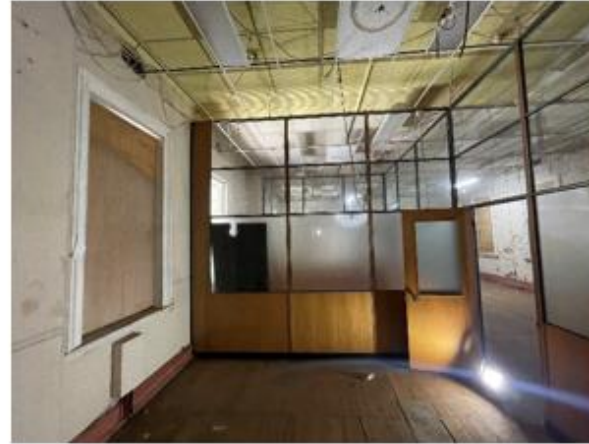
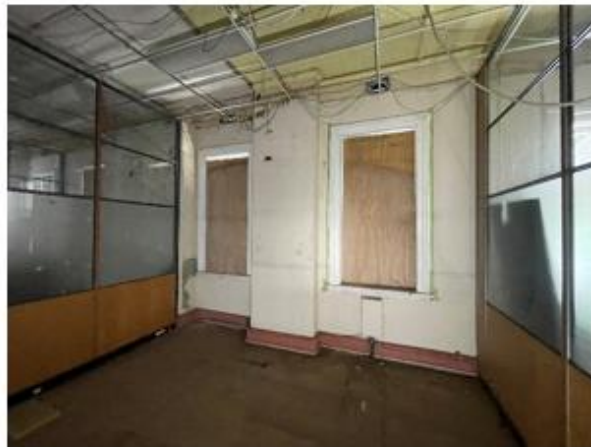
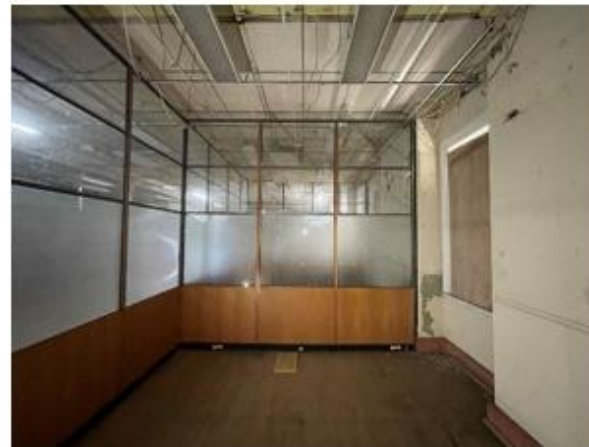
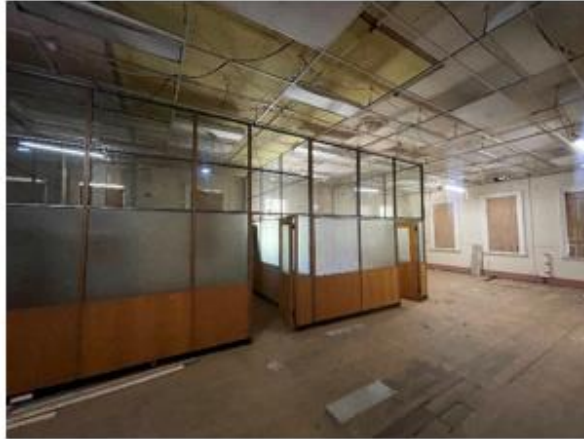
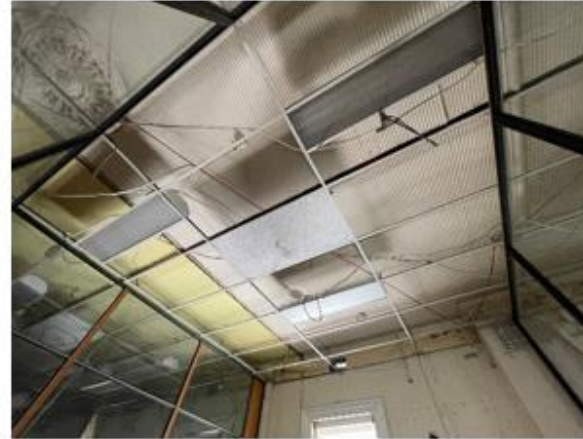
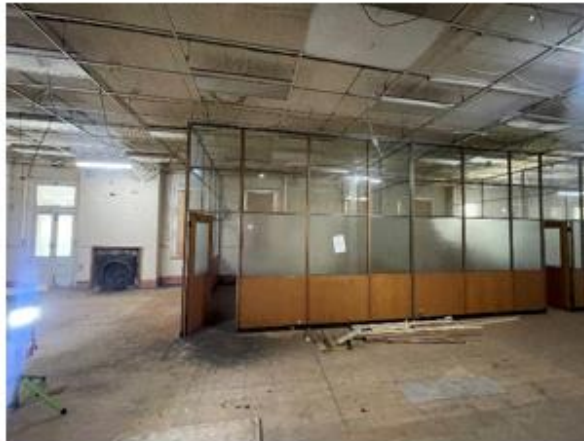
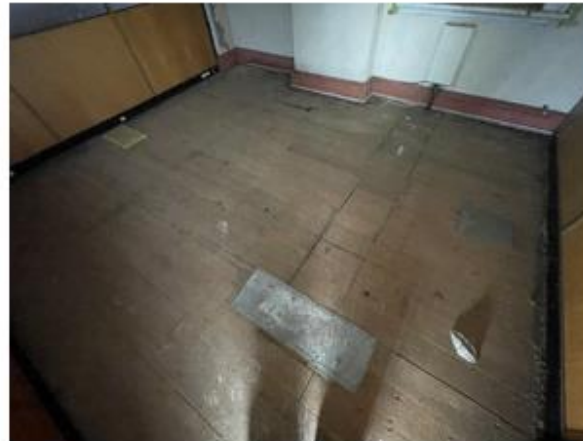
CME Building – Room F6B, F6C, F6D		
Photos

CME Building – Room F6B, F6C, F6D		
Fabric	Current Condition	Description and Recommendation
Floor	Poor	<p><b>Description:</b> Wide kauri floorboards with various cut outs, patches and chases.</p> <p><b>Recommendation:</b> Certain areas may need to be temporarily removed to facilitate subfloor works, including installation of concealed services and structural repairs. Reticulation of services should prioritise the areas of flooring being pulled up to replace damaged flooring to minimise the unnecessary removal of boards. It is intended to salvage as many as possible of the floorboards for reuse in accordance with 3.1.4 Floors in the <i>Physical Condition and Schedule of Conservation Works</i> methodology for floor works. Salvaged flooring from the entire building should be collated and graded for condition from best to worst before being re-laid at the completion of subfloor works. Priority should be given to the rooms in key view lines and of most significance to have the floorboards in the best condition as per section 3.1 - 6 General recommendations in the <i>Physical Condition and Schedule of Conservation Works</i></p> <p><b>Grading of Significance: High</b></p>

Walls	Poor	<p><b>Description:</b> Falling damp, and cracks, Bad in places. An in situ cast dado rail to the northern wall at midheight. Many surface fixed conduits and fittings, various patches required. Intrusive modern modular partitions to three sides with obscure glazing midheight and clear glazing to the top divide these rooms into smaller offices within the overall F6 room. Brick vents are miss matched, some are damaged, most are missing. Various decorative vents are placed around the walls and on the chimney breasts.</p> <p><b>Recommendation:</b> Remove intrusive modern partitions. Paint strip areas of loose or flaking paint, and where the damp has affected it. The rest can be subject to overcoating and or spot repairs as per the guidelines within AS4361.1:2017 <i>Guide to Hazardous Paint Management</i>. Render to be removed where falling damp has occurred and wet vacuum wash the brickwork for multiple cycles with a contained head wet system. Allow to dry for min 6 weeks and apply a salt retardant render prior to white set and painting. Areas with substantial cracking should have proprietary ties such as helifix chased into the mortar joints to brace the wall.</p> <p>Also refer to section 3.1.2 Walls and Section 3.1.3 Painted Surfaces in the <i>Physical Condition and Schedule of Conservation Works</i> report for further treatment recommendations.</p> <p><b>Grading of Significance: High</b></p>

CME Building – Room F6B, F6C, F6D		
Ceilings	Poor	<p><b>Description:</b> Corrugated metal ceilings with timber mouldings covering joints. An intrusive modern ceiling grid frame is hung below the original ceiling. A row of three ceiling roses are spaced along the length of the F6 room. Many surface fixed fittings and penetrations for services. Some of the timber mouldings are missing</p> <p><b>Recommendation:</b> Remove Intrusive modern grid ceiling, fixtures fittings and conduits</p> <ul style="list-style-type: none"> <li>• Where intact and not at risk of collapse, complete conservation works to reinstate back to original condition. This could be inclusive of patching existing holes, replacing missing, badly damaged sections, mouldings and in situ cornice template moulding repairs.</li> <li>• Where small areas are damaged beyond salvage, replace with salvaged fabric from other rooms of less significance within the building, replace with second hand salvaged material or replace with replicated modern equivalent.</li> <li>• Instead of removing large sections of heritage fabric ceilings to facilitate the installation of services or structural repairs, It would be a more preferable heritage outcome to leave any stable remnant ceiling fabric in situ and install a modern ceiling replica of the original ceiling based on existing documentation from the original build or from evidence of remnant fabric. These new ceilings would be installed lower to provide space to conceal services provided that any loss of height does not detract from the overall scale of the rooms or cover necessary ventilation grills or vents. The original ceiling would remain in its current condition concealed above it.</li> </ul> <p>See also Section 3.1.3 Ceilings in the <i>Physical Condition and Schedule of Conservation Works</i> report for further treatment recommendations.</p> <p><b>Grading of Significance:</b> High</p>

Cornice	Poor	<p><b>Description:</b> Decorative timber moulding cornice.</p> <p><b>Recommendation:</b> Remove intrusive modern fixtures and fittings. Decorative timber mouldings should be repaired in situ if possible. When beyond salvage or if ceilings are replaced, or relocated, timber mouldings should be reinstated with originals salvaged from elsewhere within the building where available or with replicated remakes of</p>

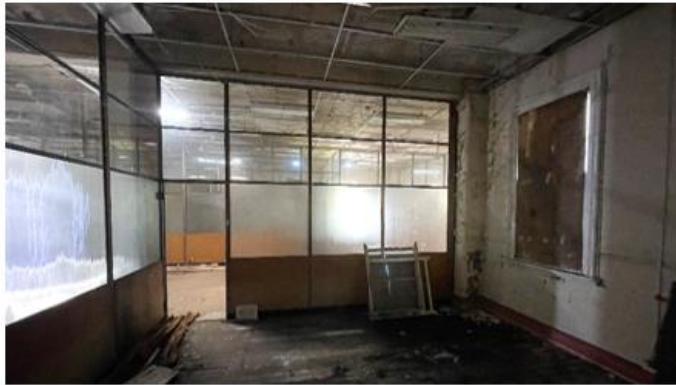
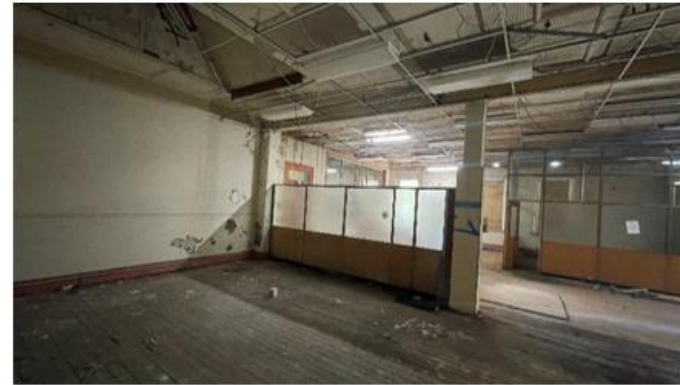
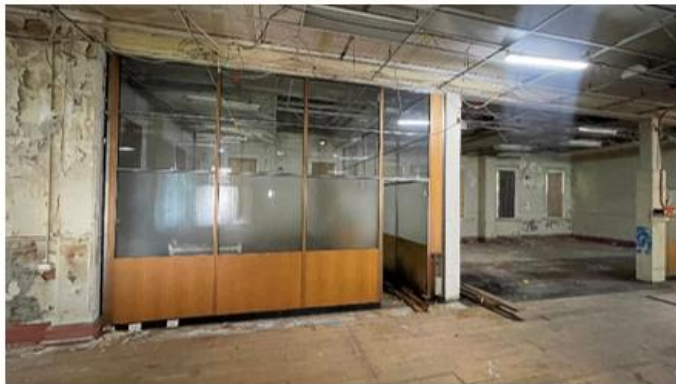
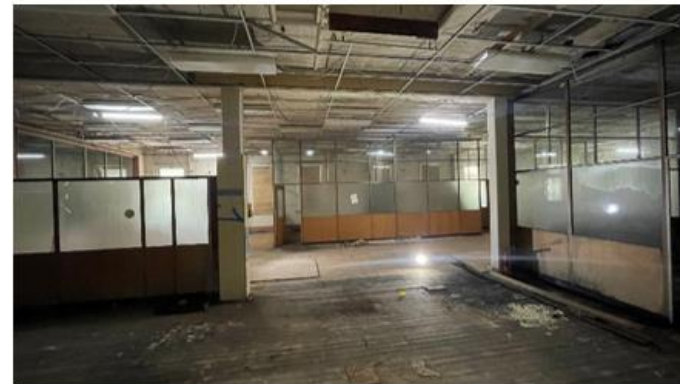
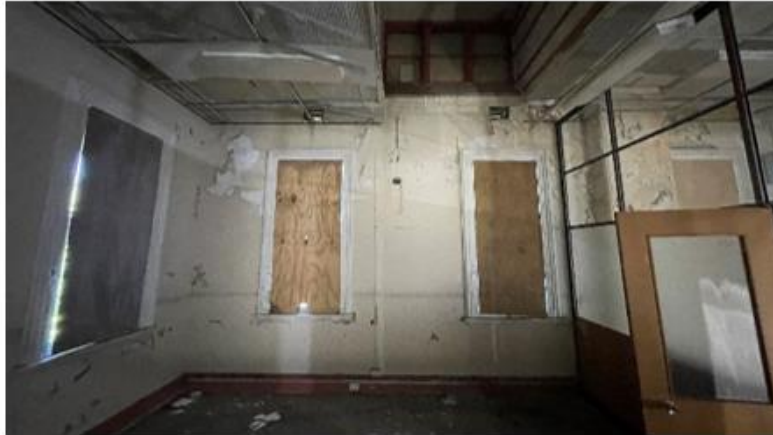
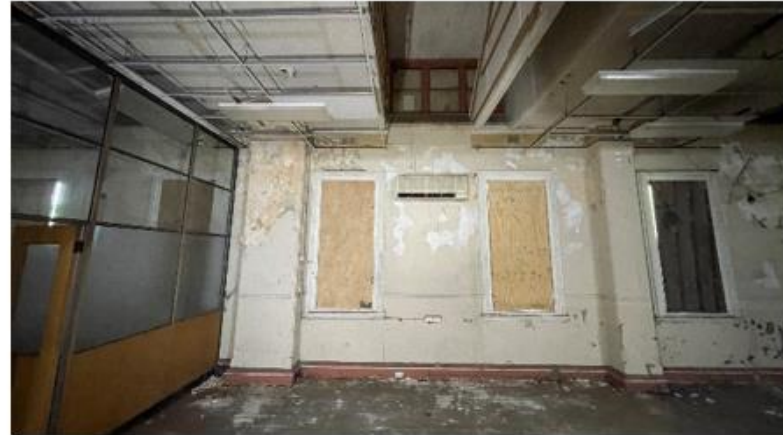
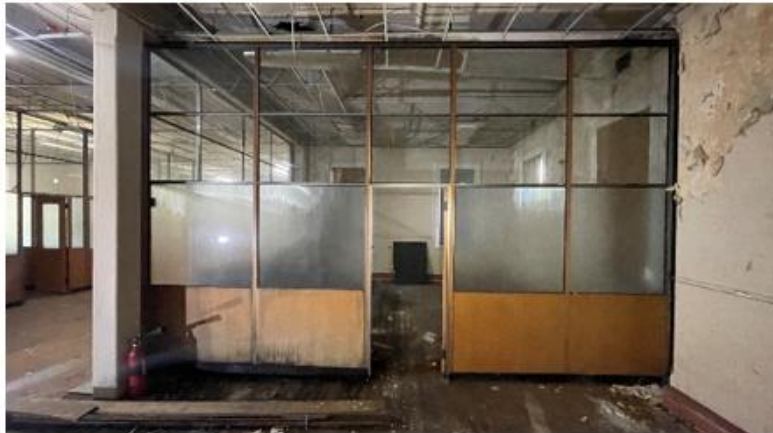
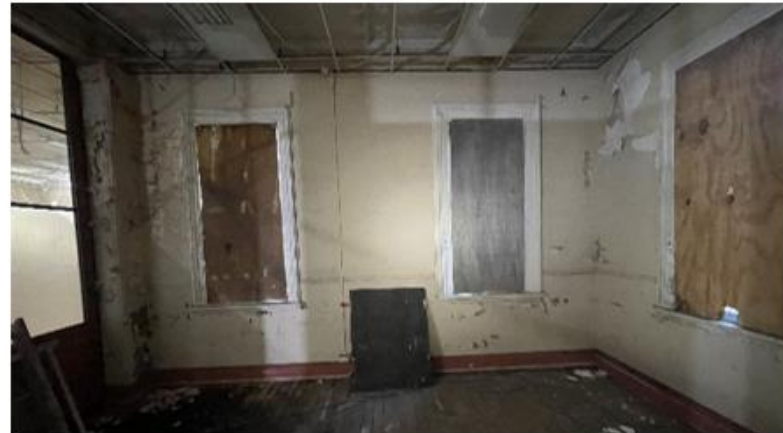
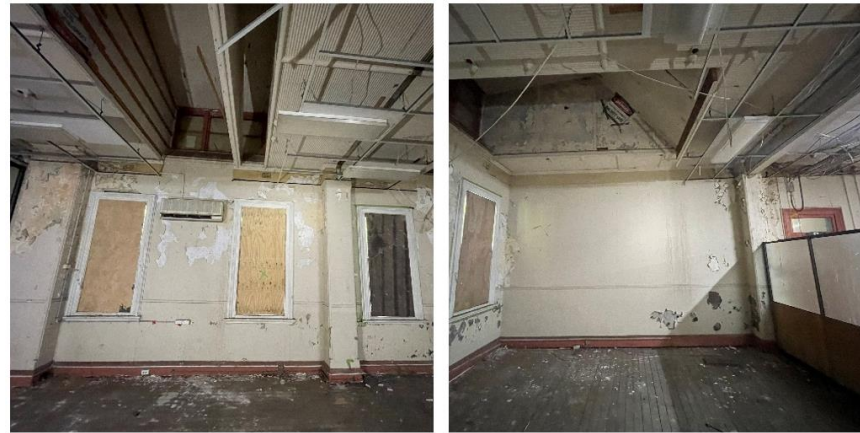
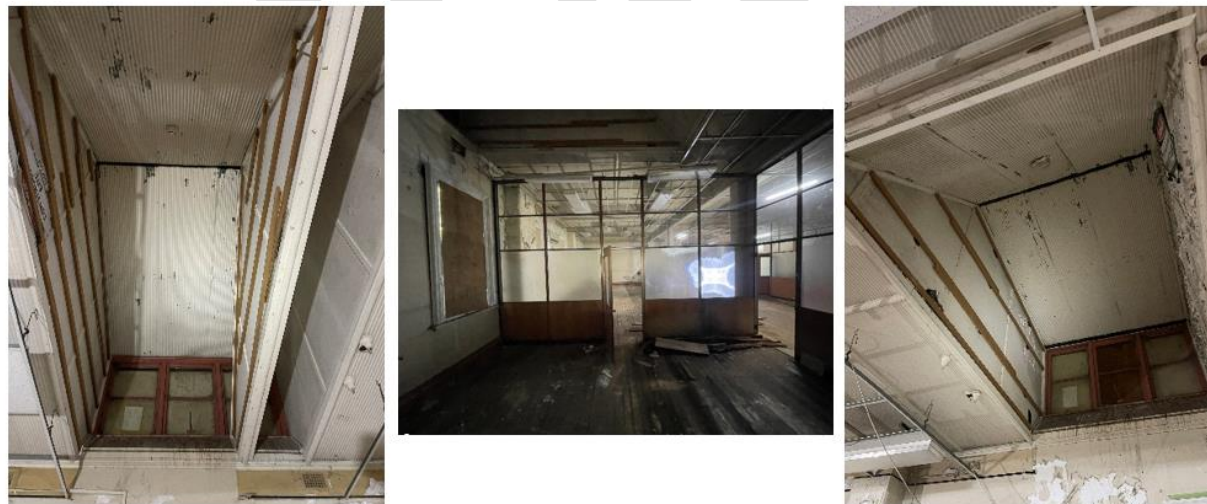
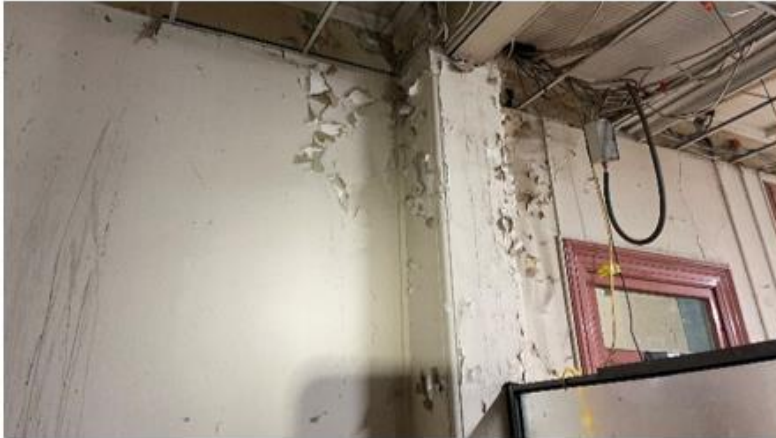
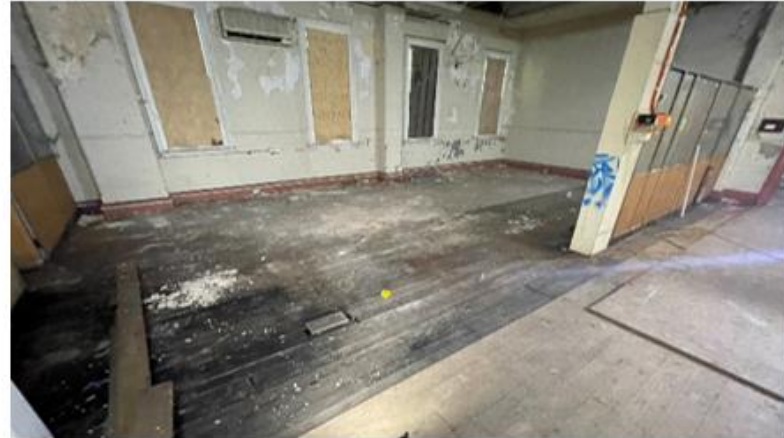
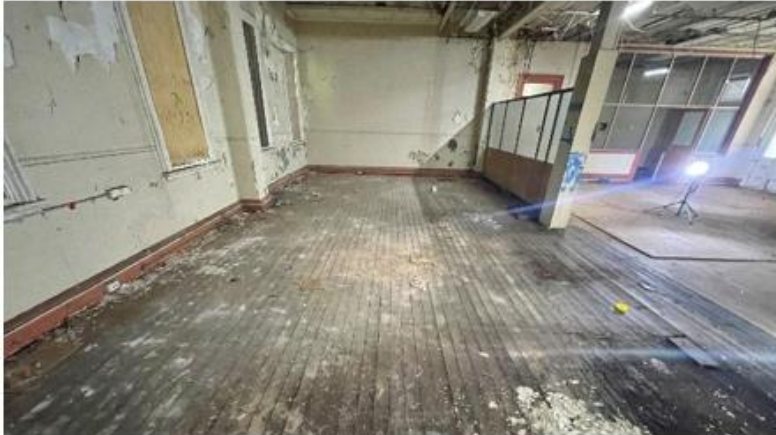
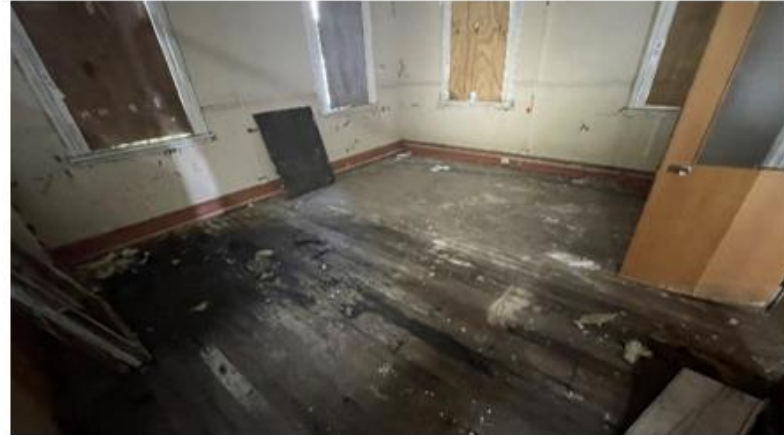
CME Building – Room F6E, F6F		
Fabric	Current Condition	Description and Recommendation
Floor	Poor	<p><b>Description:</b>– Narrow hardwood floorboards with various cut outs and patches. Floors are badly water damaged</p> <p><b>Recommendation:</b> After repair of water leaks, let the flooring dry and reassess if the boards can be salvaged. If unsalvageable, replace them. Certain areas may need to be temporarily removed to facilitate subfloor works, including installation of concealed services and structural repairs. Reticulation of services should prioritise the areas of flooring being pulled up to replace damaged flooring to minimise the unnecessary removal of boards. It is intended to salvage as many as possible of the floorboards for reuse in accordance with Section 3.1.4 Floors in the <i>Physical Condition and Schedule of Conservation Works</i> methodology for floor works. Salvaged flooring from the entire building should be collated and graded for condition from best to worst before being re-laid at the completion of subfloor works. Priority should be given to the rooms in key view lines and of most significance to have the floorboards in the best condition as per section 3.1 - 6 General recommendations in the <i>Physical Condition and Schedule of Conservation Works</i></p> <p><b>Grading of Significance: High</b></p>

Walls	Poor	<p><b>Description:</b> Falling damp, and cracks, Bad in places. An in situ cast dado rail to the northern wall at midheight. Many surface fixed conduits and fittings, various patches required. An intrusive modern modular partitions with obscure glazing midheight and clear glazing to the top divides the area into a smaller office and a larger semi enclosed room within the overall F6 room. Brick vents are miss matched and or missing.</p> <p><b>Recommendation:</b> Remove intrusive modern partitions. Paint strip areas of loose or flaking paint, and where the damp has affected it. The rest can be subject to overcoating and or spot repairs as per the guidelines within <i>AS4361.1:2017 Guide to Hazardous Paint Management</i>. Render to be removed where falling damp has occurred and wet vacuum wash the brickwork for multiple cycles with a contained head wet system. Allow to dry for min 6 weeks and apply a salt retardant render prior to white set and painting. Areas with substantial cracking should have proprietary ties such as helifix chased into the mortar joints to brace the wall.</p> <p>Also refer to section 3.1.2 Walls and Section 3.1.3 Painted Surfaces in the <i>Physical Condition and Schedule of Conservation Works</i> report for further treatment recommendations.</p> <p><b>Grading of Significance: High</b></p>

CME Building – Room F6E, F6F		
Ceilings	Poor	<p><b>Description:</b> Corrugated metal ceilings with timber mouldings covering joints. An intrusive modern ceiling grid frame is hung below the original ceiling. Three large south facing dormer windows open up the ceiling and provide light. The internal linings of the sides of the dormers are asbestos sheeting whilst the upper ceilings are corrugated metal. Many surface fixed fittings and penetrations for services. Some of the timber mouldings are missing</p> <p><b>Recommendation:</b> Remove Intrusive modern grid ceiling, fixtures fittings and conduits. Remove asbestos sheeting under AZMAT conditions and replace with modern equivalent.</p> <ul style="list-style-type: none"> <li>• Where intact and not at risk of collapse, complete conservation works to reinstate back to original condition. This could be inclusive of patching existing holes, replacing missing, badly damaged sections, mouldings and in situ cornice template moulding repairs.</li> <li>• Where small areas are damaged beyond salvage, replace with salvaged fabric from other rooms of less significance within the building, replace with second hand salvaged material or replace with replicated modern equivalent.</li> <li>• Instead of removing large sections of heritage fabric ceilings to facilitate the installation of services or structural repairs, It would be a more preferable heritage outcome to leave any stable remnant ceiling fabric in situ and install a modern ceiling replica of the original ceiling based on existing documentation from the original build or from evidence of remnant fabric. These new ceilings would be installed lower to provide space to conceal services provided that any loss of height does not detract from the overall scale of the rooms or cover necessary ventilation grills or vents. The original ceiling would remain in its current condition concealed above it.</li> </ul> <p>See also Section 3.1.1 Ceilings in the <i>Physical Condition and Schedule of Conservation Works</i> report for further treatment recommendations.</p> <p><b>Grading of Significance:</b> High</p>

CME Building – Room F6E, F6F		
Cornice	Poor	<p><b>Description:</b> Decorative timber moulding cornice.</p> <p><b>Recommendation:</b> Remove intrusive modern fixtures and fittings. Decorative timber mouldings should be repaired in situ if possible. When beyond salvage or if ceilings are replaced, or relocated, timber mouldings should be reinstated with originals salvaged from elsewhere within the building where available or with replicated remakes of the originals should they be beyond salvage. As per section 3.1.1. Ceilings in the <i>Physical Condition and Schedule of Conservation Works</i> report for further treatment recommendations.</p> <p><b>Grading of Significance:</b> High</p>
Skirting	Poor	<p><b>Description:</b> Skirtings in this room are a heavy utilitarian style with a splayed top and decorative lines on the face. The bulky thickness may have been consistent with cable management and concealment in the past. The skirtings in places may have water damage from the falling damp. Various conduits, wires and fittings are attached to them.</p> <p><b>Recommendation:</b> Remove conduits, wires and fittings. Skirting to be removed to facilitate falling damp repairs and floor removal if required.</p> <ul style="list-style-type: none"> <li>• Generally, skirtings should remain in their existing positions. Any skirting being replaced due to damage such as water ingress, dry rot and termite damage or that are missing should be reproduced to replicate other skirtings in the same room, or if none at all, should replicate its most likely profile based on the findings of the 1997 CMP.</li> <li>• Ground floor skirtings that are required to be removed for the subfloor excavation works, should have their locations recorded, labelled clearly, carefully removed, de-nailed, cleaned up and reinstated post excavation and subfloor works.</li> <li>• Consideration should be put into packing out skirtings with battens to create a void space for wiring prior to reinstallation where they are required to be removed to facilitate other works such as floor replacement, Subfloor excavation or rising damp remediation.</li> </ul>

Doors	Fair	<p><b>Description:</b> All intrusive modern plain doors with an obscure glazed top half.</p> <p><b>Recommendation:</b> All doors should be removed along with the intrusive modern partitions.</p> <p><b>Grading of Significance: Intrusive</b></p>
