## 9. Inventory Sheets

This chapter includes the inventory sheets for each room within the CME Building. Each datasheet includes:

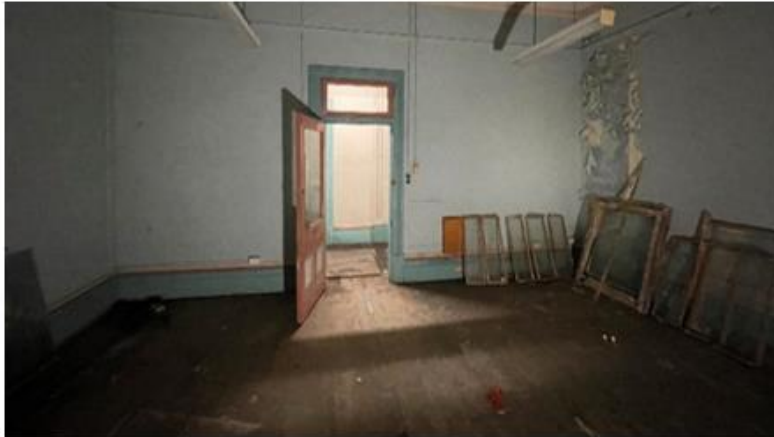
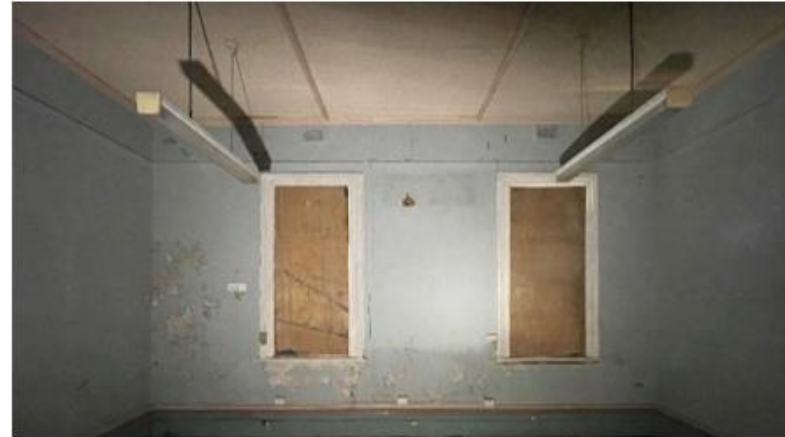
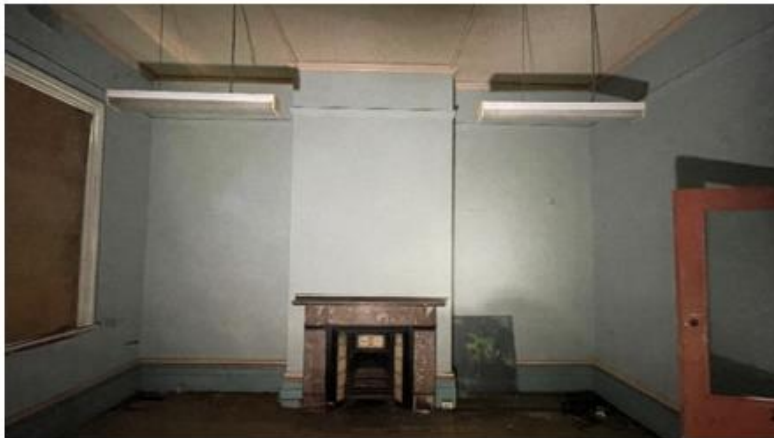
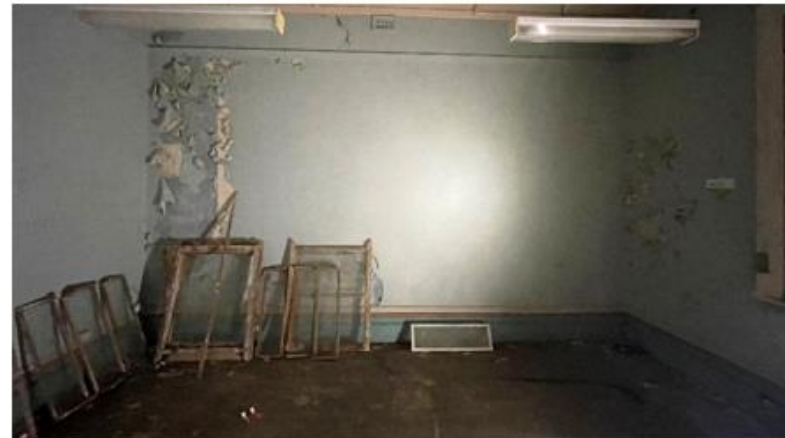
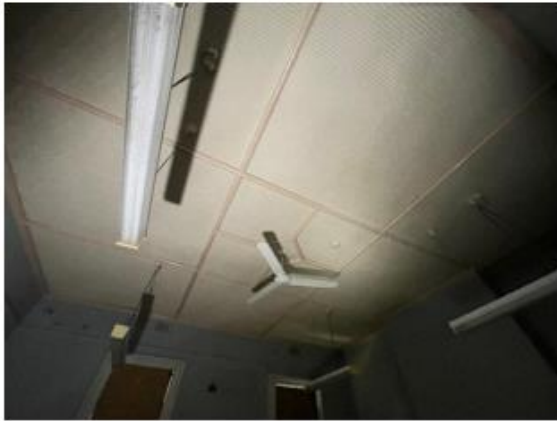
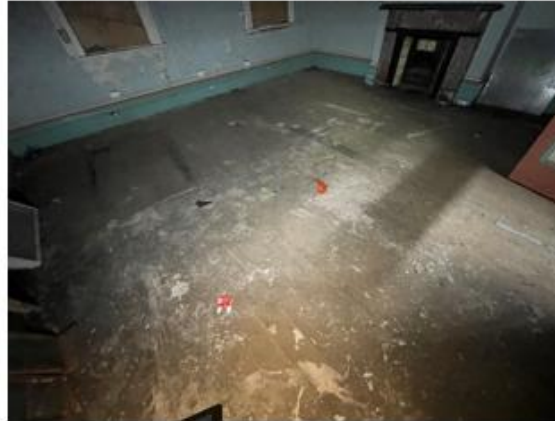
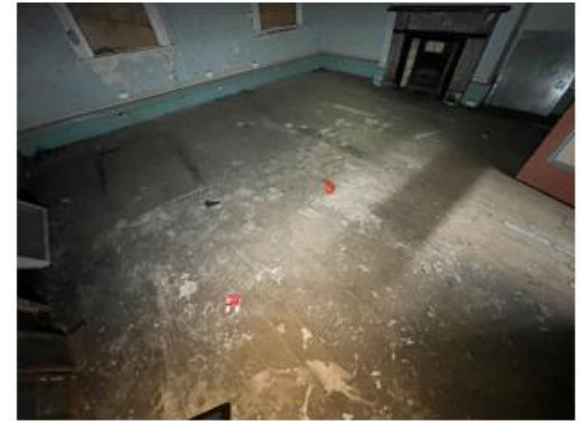
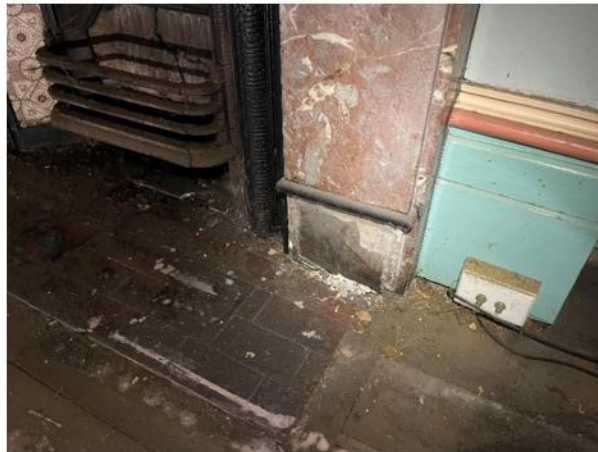
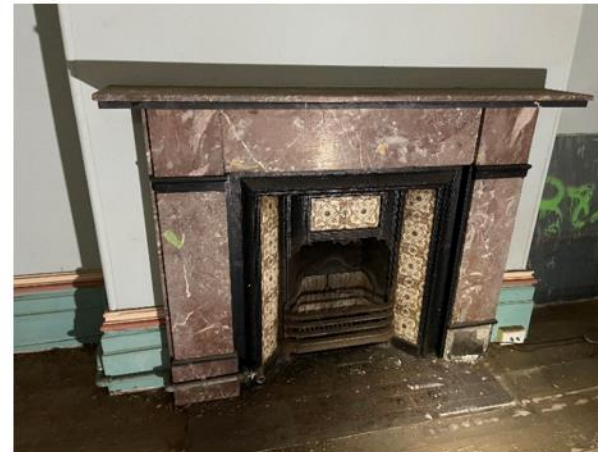
## CME Building – Room F7

CME Building – Room F7		
Fabric	Current Condition	Description and Recommendation
Floor	Fair	<p><b>Description:</b>– Wide boards, Kauri Pine. Generally fair condition besides a few patches.</p> <p><b>Recommendation:</b> Certain areas may need to be temporarily removed to facilitate subfloor works, including installation of concealed services and structural repairs. Reticulation of services should prioritise the areas of flooring being pulled up to replace damaged flooring to minimise the unnecessary removal of boards. It is intended to salvage as many as possible of the floorboards for reuse in accordance with Section 3.1.4 Floors in the <i>Physical Condition and Schedule of Conservation Works</i> methodology for floor works. Salvaged flooring from the entire building should be collated and graded for condition from best to worst before being re-laid at the completion of subfloor works. Priority should be given to the rooms in key view lines and of most significance to have the floorboards in the best condition as per section 3.1 - 6 General recommendations in the <i>Physical Condition and Schedule of Conservation Works</i></p> <p><b>Grading of Significance:</b> High</p>

Walls	Poor to Fair	<p><b>Description:</b> Falling damp mostly contained to North and South walls, cracks on north wall, particularly near windows, brick vents are concealed in the cornice, paint poor and flaking in places, many surface fixed conduits, fittings and penetrations for services. Various surface fixed conduits around the room. A Picture rails runs around the perimeter of the room.</p> <p><b>Recommendation:</b> Remove conduits and fittings. Paint strip areas of loose or flaking paint, and where the damp has affected it. The rest can be subject to overcoating and or spot repairs as per the guidelines within <i>AS4361.1:2017 Guide to Hazardous Paint Management</i>. Render to be removed where falling damp has occurred and wet vacuum wash the brickwork for multiple cycles with a contained head wet system. Allow to dry for min 6 weeks and apply a salt retardant render prior to white set and painting.</p> <p>Also refer to section 3.1.2 Walls and Section 3.1.3 Painted Surfaces in the <i>Physical Condition and Schedule of Conservation Works</i> report for further treatment recommendations.</p> <p><b>Grading of Significance:</b> High</p>

CME Building – Room F7		
Ceilings	Fair	<p><b>Description:</b> Corrugated metal in Fair condition with timber mouldings covering the joints and also forming a diamond pattern in the centre. Many surface fixed fittings and penetrations for services</p> <p><b>Recommendation:</b> Remove Intrusive modern, fixtures fittings and conduits</p> <ul style="list-style-type: none"> <li>Where intact and not at risk of collapse, complete conservation works to reinstate back to original condition. This could be inclusive of patching existing holes, replacing missing, badly damaged sections, mouldings and in situ cornice template moulding repairs.</li> <li>Where small areas are damaged beyond salvage, replace with salvaged fabric from other rooms of less significance within the building, replace with second hand salvaged material or replace with replicated modern equivalent.</li> <li>Instead of removing large sections of heritage fabric ceilings to facilitate the installation of services or structural repairs, It would be a more preferable heritage outcome to leave any stable remnant ceiling fabric in situ and install a modern ceiling replica of the original ceiling based on existing documentation from the original build or from evidence of remnant fabric. These new ceilings would be installed lower to provide space to conceal services provided that any loss of height does not detract from the overall scale of the rooms or cover necessary ventilation grills or vents. The original ceiling would remain in its current condition concealed above it.</li> </ul> <p>See also Section 3.1.1. in the <i>Physical Condition and Schedule of Conservation Works</i> report for further treatment recommendations.</p> <p><b>Grading of Significance:</b> High</p>

Cornice	Fair	<p><b>Description:</b> fair condition, timber mould Cornice.</p> <p><b>Recommendation:</b> Remove intrusive modern fixtures and fittings. Decorative timber mouldings should be repaired in situ if possible. When beyond salvage or if ceilings are replaced, or relocated, timber mouldings should be reinstated with originals salvaged from elsewhere within the building where available or with replicated remakes of</p>

CME Building – Room F7		
Windows	Poor	<p><b>Description:</b> Windows appear to have been mostly stripped and primed/sealed. Windows are currently boarded up and not accessible for full assessment. Spare sashes are stored in this room. The sill has a notch cut out of it.</p> <p><b>Recommendation:</b> Remove boarding to expose windows. Strip all lead paint completely from all surfaces and prepare all surfaces under HAZMAT conditions in accordance with <i>AS4361.1:2017 Guide to Hazardous Paint Management</i> prior to commencement of works.</p> <ul style="list-style-type: none"> <li>• Windows should generally be repaired adjusted and cleaned up in their original locations. This could be inclusive of sash cord and weight replacement, glazing putty touch ups or replacement, adjustment and refitting of sashes, rot repairs, broken glass replacement and hardware repairs and or replacement.</li> <li>• Existing heritage hardware should be stripped, polished and reinstated in as close to its original position. Missing hardware should be reinstated with new modern reproduction equivalents.</li> <li>• Locks should be made operational if windows are to be operable. Opening restrictions should be added for both security and code compliance if windows present a climb or fall risk.</li> </ul> <p>See also section 3.1.3 Painted Surfaces and section 3.1.5 Windows in the <i>Physical Condition and Schedule of Conservation Works</i> report for further treatment recommendations.</p> <p><b>Grading of Significance: High</b></p>

Doors	Fair	<p><b>Description:</b> Three panel door with top panel glazed. The architrave has a check out from a previously installed lock.</p> <p><b>Recommendation:</b></p> <ul style="list-style-type: none"> <li>• Any door leaves removed as part of works should be either reused within the building in other areas requiring doors or documented on an inventory, labelled and placed in storage on site.</li> <li>• Doors should generally be adjusted, cleaned up, and rehung in their original locations.</li> </ul>

Fireplace	Fair	<p><b>Description:</b> fireplace and marble mantle intact. Cast iron centre has some cracks. Hearth is higher tiled. Lower left piece of marble missing</p> <p><b>Recommendation:</b> Replace missing marble.</p> <ul style="list-style-type: none"> <li>Generally, intact existing cast iron fireplaces should be conserved and restored. Where they are missing, they should be replaced with recycled salvaged heritage equivalents of the same period in the more significant</li> </ul>

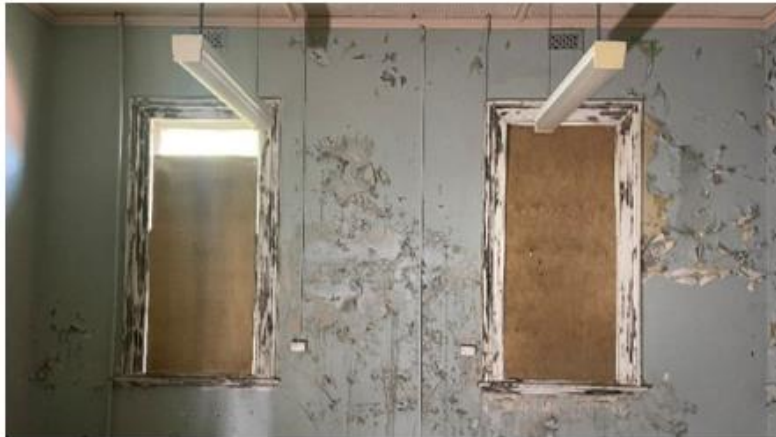
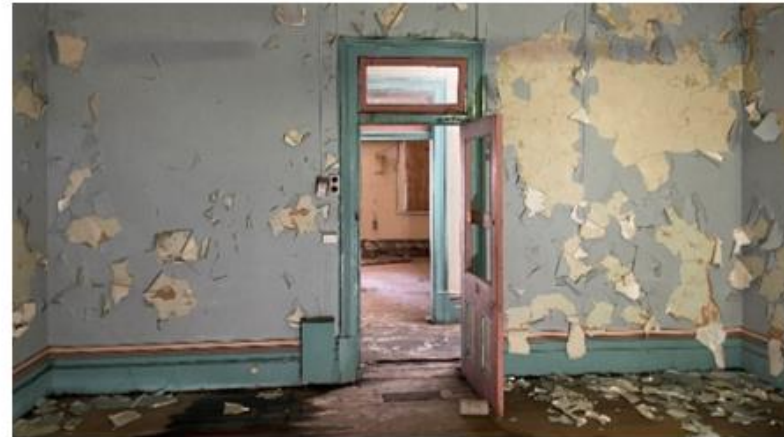
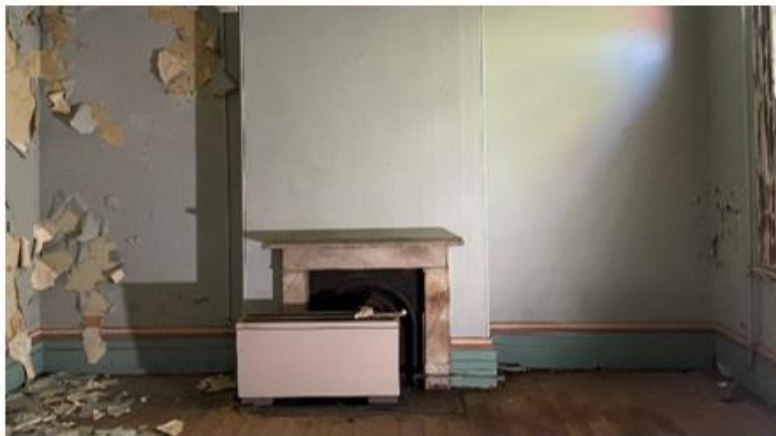
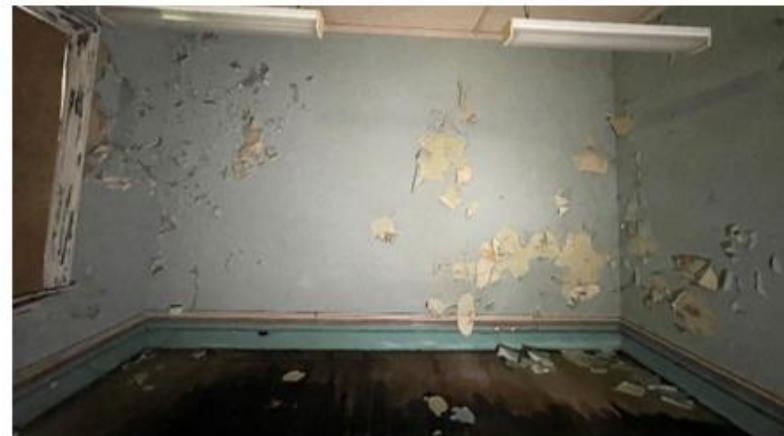
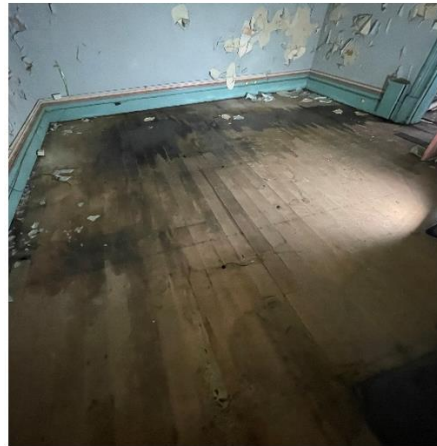
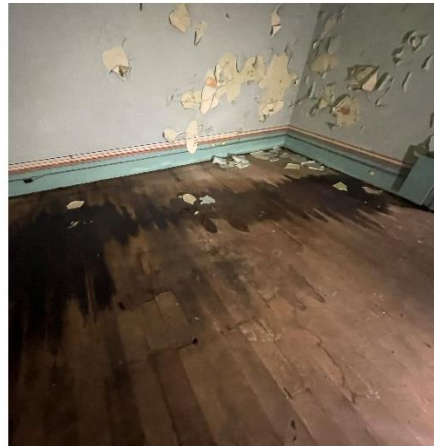
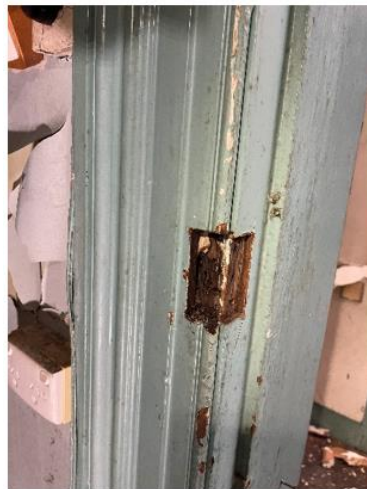
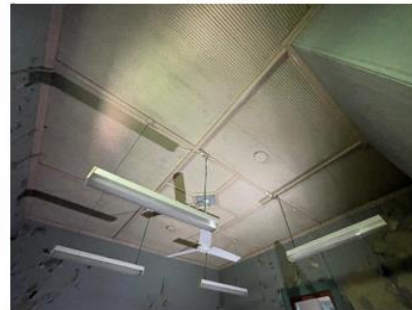
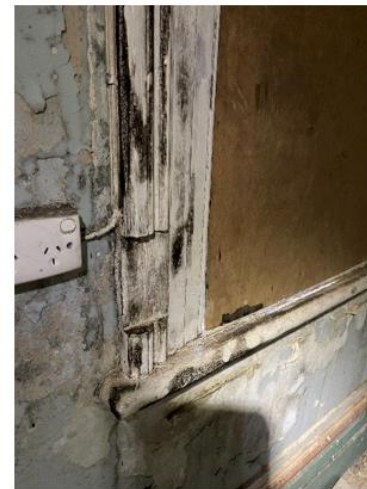
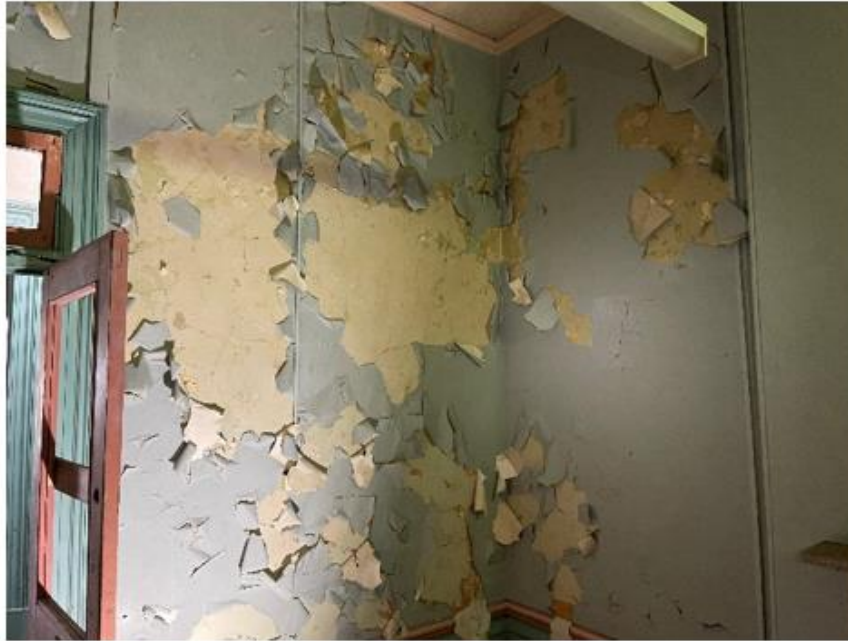
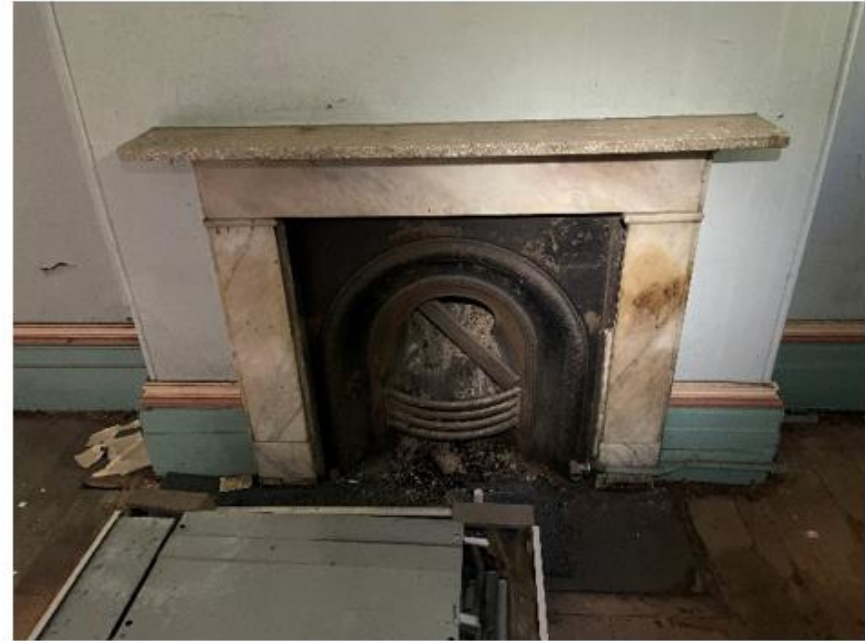
## CME F8

CME F8		
Fabric	Current Condition	Description and Recommendation
Floor	Poor	<p><b>Description:</b>– Wide boards, Kauri Pine. A few patches, bad water damage in sections</p> <p><b>Recommendation:</b> Certain areas may need to be temporarily removed to facilitate subfloor works, including installation of concealed services and structural repairs. Reticulation of services should prioritise the areas of flooring being pulled up to replace damaged flooring to minimise the unnecessary removal of boards. It is intended to salvage as many as possible of the floorboards for reuse in accordance with Section 3.1.4. Floors in the <i>Physical Condition and Schedule of Conservation Works</i> methodology for floor works. Salvaged flooring from the entire building should be collated and graded for condition from best to worst before being re-laid at the completion of subfloor works. Priority should be given to the rooms in key view lines and of most significance to have the floorboards in the best condition as per section 3.1 - 6 General recommendations in the <i>Physical Condition and Schedule of Conservation Works</i></p> <p><b>Grading of Significance: High</b></p>

Walls	Poor	<p><b>Description:</b> Bad falling damp, paint poor and flaking in places, many surface fixed conduits, fittings and penetrations for services. Bricks vents are intact and match.</p> <p><b>Recommendation:</b> Remove conduits and fittings. Paint strip areas of loose or flaking paint, and where the damp has affected it. The rest can be subject to overcoating and or spot repairs as per the guidelines within <i>AS4361.1:2017 Guide to Hazardous Paint Management</i>. Render to be removed where falling damp has occurred and wet vacuum wash the brickwork for multiple cycles with a contained head wet system. Allow to dry for min 6 weeks and apply a salt retardant render prior to white set and painting.</p> <p>Also refer to section 3.1.2 Walls and Section 3.1.3 Painted Surfaces in the <i>Physical Condition and Schedule of Conservation Works</i> report for further treatment recommendations.</p> <p><b>Grading of Significance: High</b></p>

CME F8		
Ceilings	Fair	<p><b>Description:</b> Corrugated metal with timber mouldings covering joints. Timber mouldings form a diamond pattern in the centre. Many surface fixed fittings and penetrations for services</p> <p><b>Recommendation:</b> Remove Intrusive modern grid ceiling, fixtures fittings and conduits</p> <ul style="list-style-type: none"> <li>Where intact and not at risk of collapse, complete conservation works to reinstate back to original condition. This could be inclusive of patching existing holes, replacing missing, badly damaged sections, mouldings and in situ cornice template moulding repairs.</li> <li>Where small areas are damaged beyond salvage, replace with salvaged fabric from other rooms of less significance within the building, replace with second hand salvaged material or replace with replicated modern equivalent.</li> <li>Instead of removing large sections of heritage fabric ceilings to facilitate the installation of services or structural repairs, It would be a more preferable heritage outcome to leave any stable remnant ceiling fabric in situ and install a modern ceiling replica of the original ceiling based on existing documentation from the original build or from evidence of remnant fabric. These new ceilings would be installed lower to provide space to conceal services provided that any loss of height does not detract from the overall scale of the rooms or cover necessary ventilation grills or vents. The original ceiling would remain in its current condition concealed above it.</li> </ul> <p>See also Section 3.1.1. Ceilings in the <i>Physical Condition and Schedule of Conservation Works</i> report for further treatment recommendations.</p> <p><b>Grading of Significance:</b> High</p>

Cornice	Fair	<p><b>Description:</b> fair condition, timber mould Cornice.</p> <p><b>Recommendation:</b> Remove intrusive modern fixtures and fittings. Decorative timber mouldings should be repaired in situ if possible. When beyond salvage or if ceilings are replaced, or relocated, timber mouldings should be reinstated with originals salvaged from elsewhere within the building where available or with replicated remakes of</p>

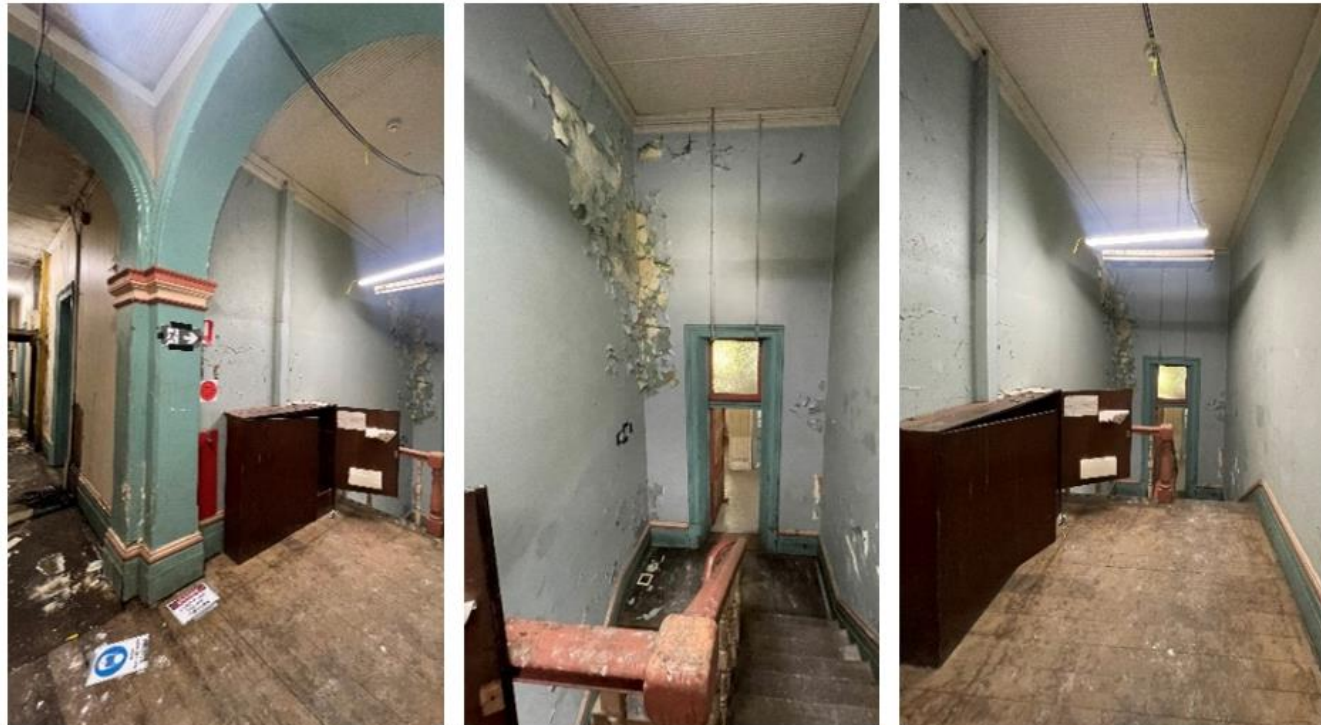
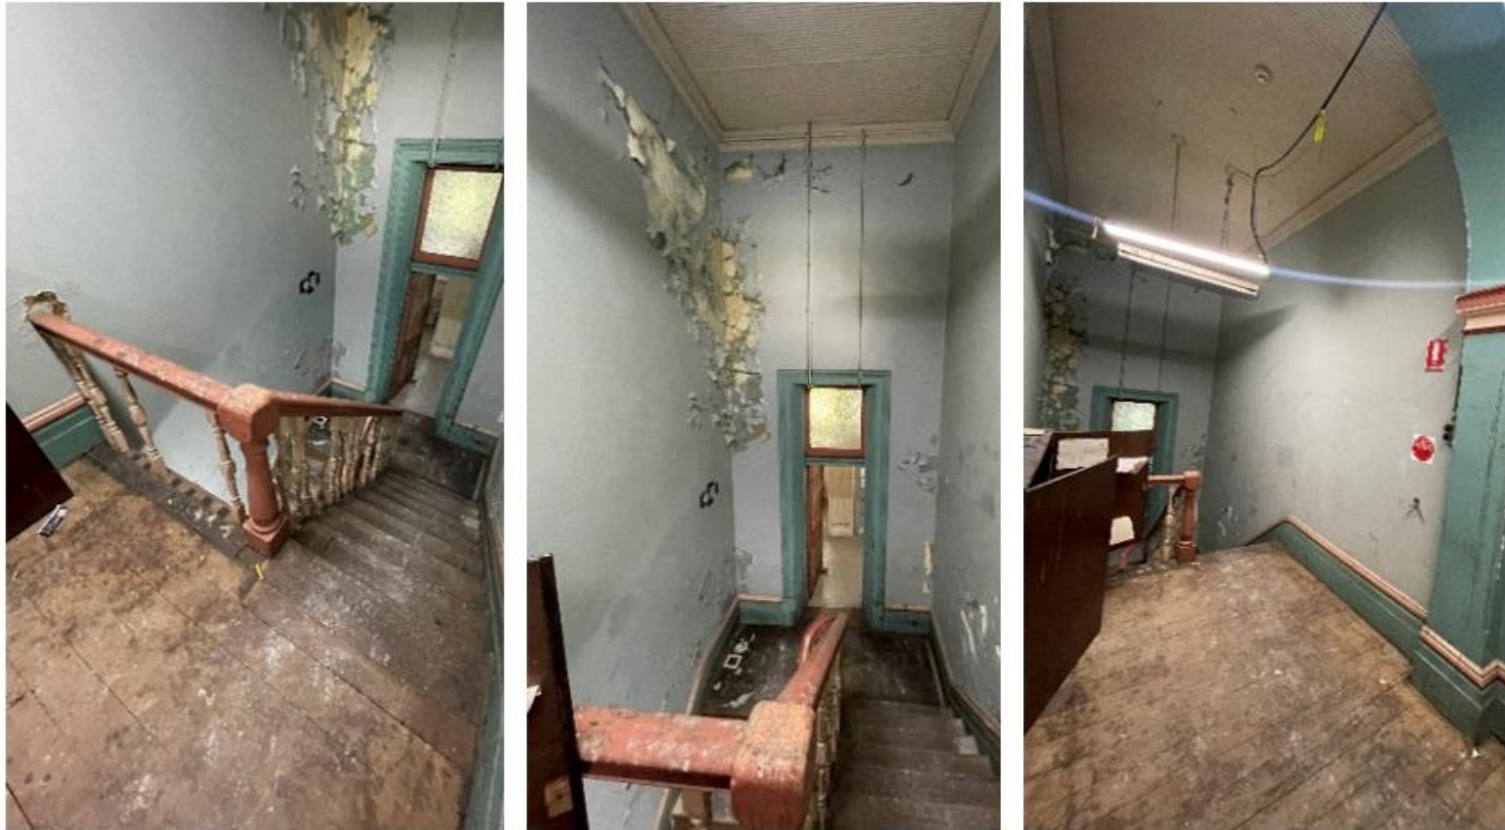
## CME Building – Room F9

CME Building – Room F9		
Fabric	Current Condition	Description and Recommendation
Floor	Poor	<p><b>Description:</b> Wide Kauri floorboards, some water damage. Several damaged boards and infill repairs. The stair treads are in a poor state with considerable wear and splitting.</p> <p><b>Recommendation:</b> Stair treads should be repaired where possible. Treads damaged beyond salvage will need to be replaced. Certain areas may need to be temporarily removed to facilitate subfloor works, including installation of concealed services and structural repairs. Reticulation of services should prioritise the areas of flooring being pulled up to replace damaged flooring to minimise the unnecessary removal of boards. It is intended to salvage as many as possible of the floorboards for reuse in accordance with Section 3.1.4 Floors in the <i>Physical Condition and Schedule of Conservation Works</i> methodology for floor works. Salvaged flooring from the entire building should be collated and graded for condition from best to worst before being re-laid at the completion of subfloor works. Priority should be given to the rooms in key view lines and of most significance to have the floorboards in the best condition as per section 3.1 - 6 General recommendations in the <i>Physical Condition and Schedule of Conservation Works</i></p> <p><b>Grading of Significance: High</b></p>

Walls	Poor	<p><b>Description:</b> Falling damp in parts of the room, paint poor with flaking in places, many surface fixed conduits, fittings and penetrations for services. Various cracks. A will fixed intrusive joinery cabinet concealing telephone wiring sits on the east side of the top landing.</p> <p><b>Recommendation:</b> Remove intrusive joinery cabinet, paint strip areas of loose or flaking paint, and where the damp has affected it. The rest can be subject to overcoating and or spot repairs as per the guidelines within <i>AS4361.1:2017 Guide to Hazardous Paint Management</i>. Render to be removed where falling damp has occurred and wet vacuum wash the brickwork for multiple cycles with a contained head wet system. Allow to dry for min 6 weeks and apply a salt retardant render prior to white set and painting. Also refer to section 3.1.2 Walls and Section 3.1.3 Painted Surfaces in the <i>Physical Condition and Schedule of Conservation Works</i> report for further treatment recommendations.</p> <p><b>Grading of Significance: High</b></p>

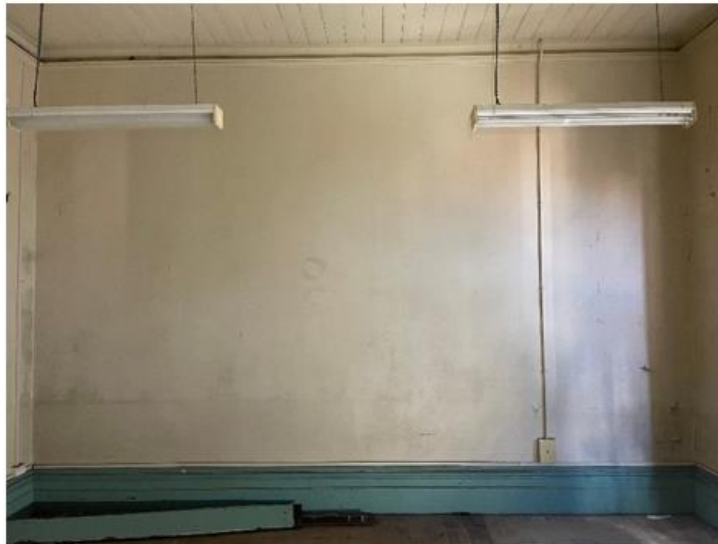
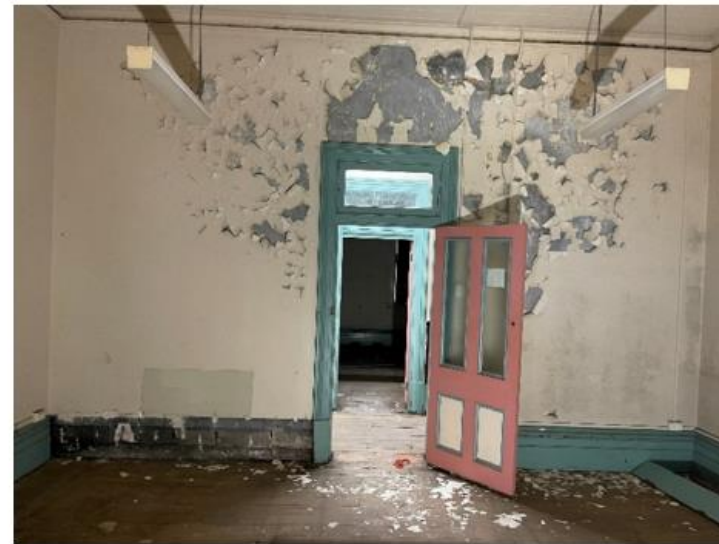
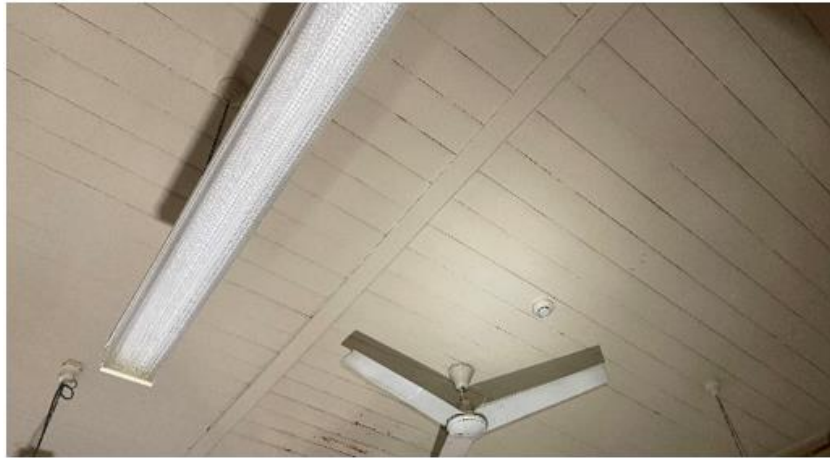
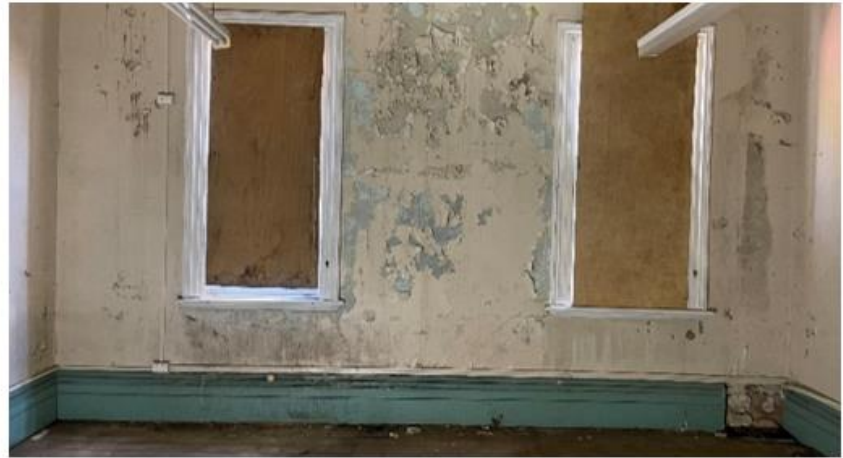
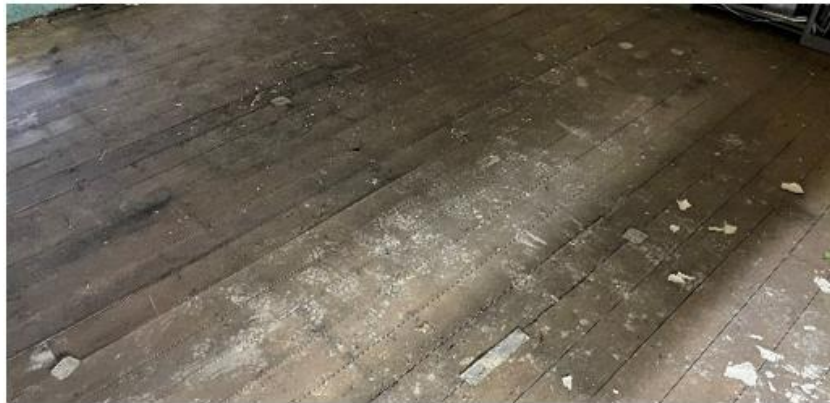
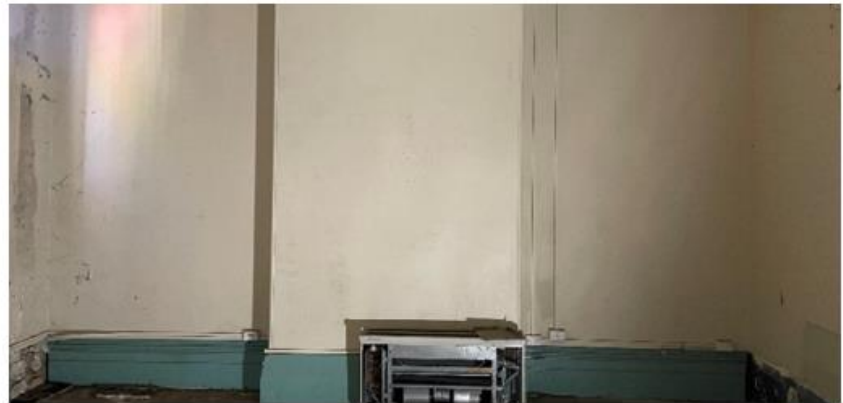
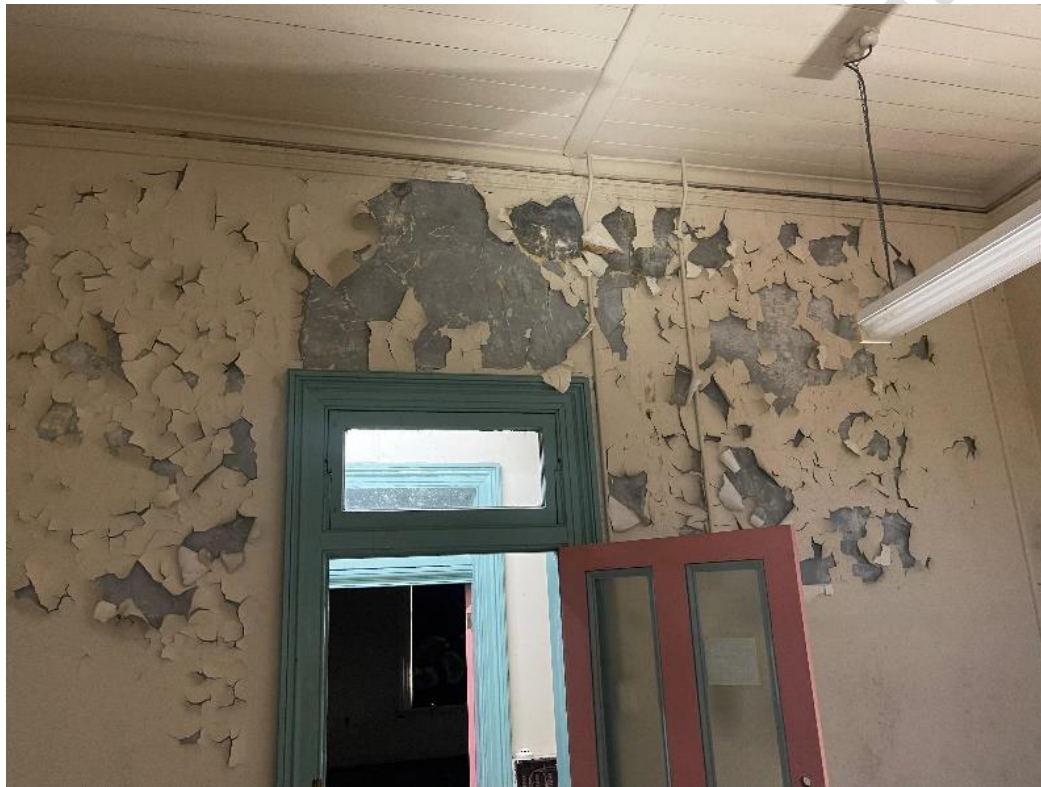
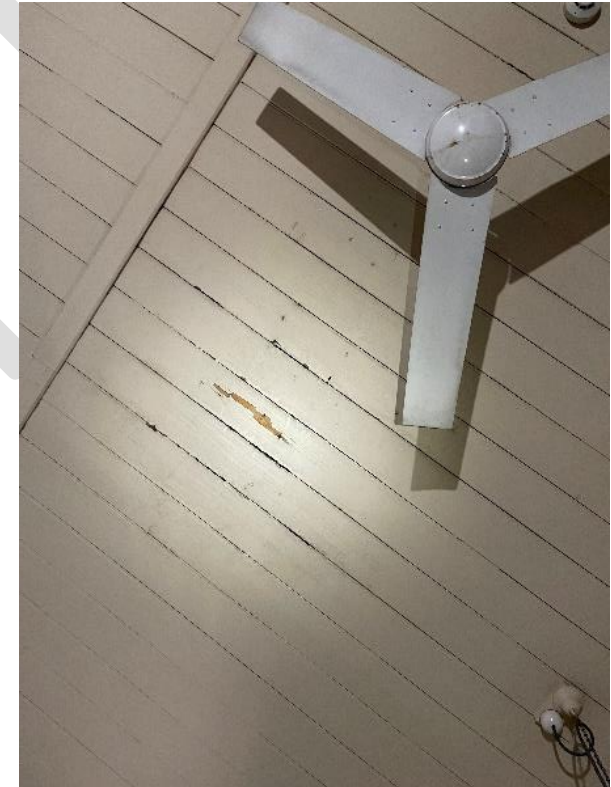
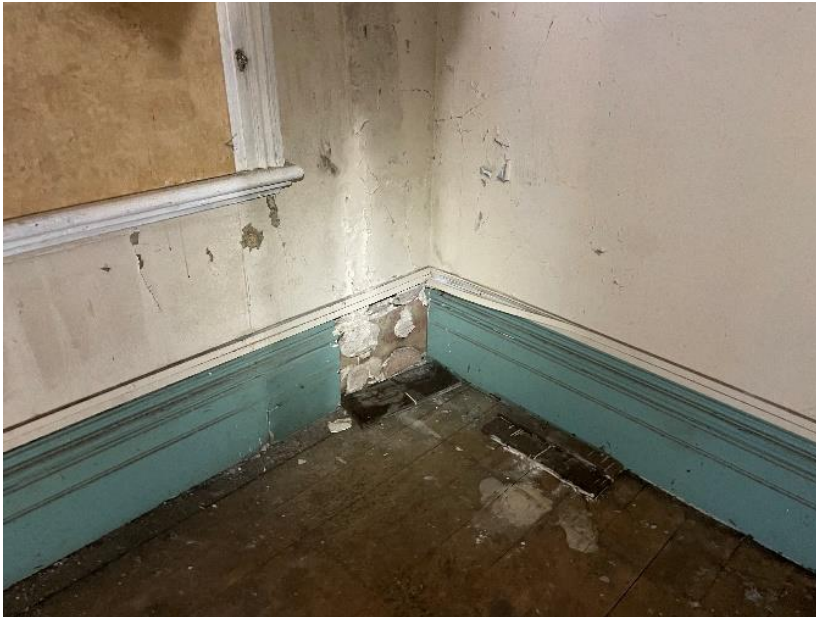
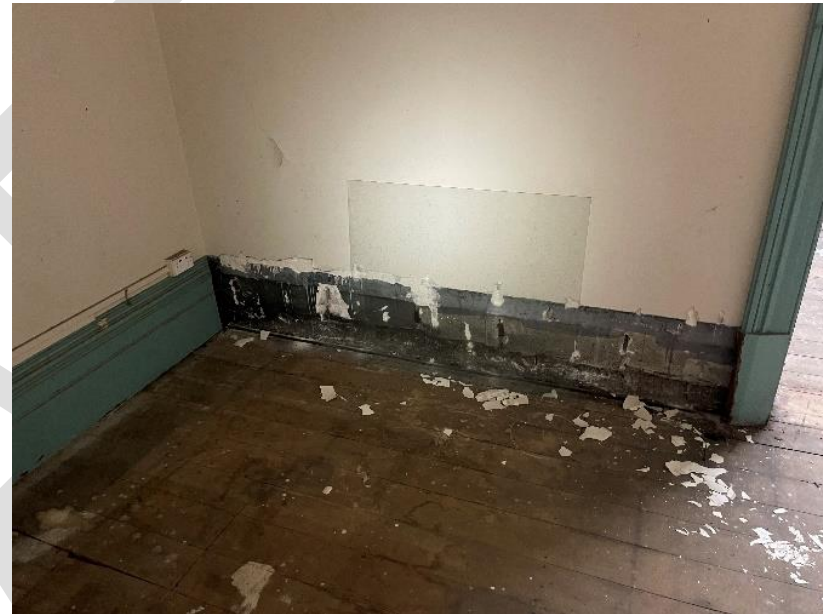
CME F10		
Fabric	Current Condition	Description and Recommendation
Floor	Poor	<p><b>Description:</b> Wide boards, Kauri Pine. A few patches.</p> <p><b>Recommendation:</b> Certain areas may need to be temporarily removed to facilitate subfloor works, including installation of concealed services and structural repairs. Reticulation of services should prioritise the areas of flooring being pulled up to replace damaged flooring to minimise the unnecessary removal of boards. It is intended to salvage as many as possible of the floorboards for reuse in accordance with Section 3.1.4. Floors in the <i>Physical Condition and Schedule of Conservation Works</i> methodology for floor works. Salvaged flooring from the entire building should be collated and graded for condition from best to worst before being re-laid at the completion of subfloor works. Priority should be given to the rooms in key view lines and of most significance to have the floorboards in the best condition as per section 3.1 - 6 General recommendations in the <i>Physical Condition and Schedule of Conservation Works</i></p> <p><b>Grading of Significance: High</b></p>

Walls	Poor	<p><b>Description:</b> Bad falling damp, paint poor and flaking in places, many surface fixed conduits, fittings and penetrations for services. Bricks vents are concealed with the cornice</p> <p><b>Recommendation:</b> Remove conduits and fittings. Paint strip areas of loose or flaking paint, and where the damp has affected it. The rest can be subject to overcoating and or spot repairs as per the guidelines within <i>AS4361.1:2017 Guide to Hazardous Paint Management</i>. Render to be removed where falling damp has occurred and wet vacuum wash the brickwork for multiple cycles with a contained head wet system. Allow to dry for min 6 weeks and apply a salt retardant render prior to white set and painting.</p> <p>Also refer to section 3.1.2. Walls and Section 3.1.3. Painted Surfaces in the <i>Physical Condition and Schedule of Conservation Works</i> report for further treatment recommendations.</p> <p><b>Grading of Significance: High</b></p>

Cornice	Fair	<p><b>Description:</b> Timber scotia top half with decorative plaster cornice bottom half. Some patching required, brick vents concealed between scotia and plaster cornice sections</p> <p><b>Recommendation:</b> Remove intrusive modern fixtures and fittings. Decorative plaster cornices and timber mouldings should be repaired in situ if possible. When beyond salvage or if ceilings are replaced, or relocated, cornices and timber mouldings should be reinstated with originals salvaged from elsewhere within the building where available or with replicated remakes of the originals should they be beyond salvage. As per section 3.1.1. Ceilings in the <i>Physical Condition and Schedule of Conservation Works</i> report for further treatment recommendations.</p> <p><b>Grading of Significance: High</b></p>

CME F10		
Skirting	Poor	<p><b>Description:</b> Tall ornate skirtings within the room, various fittings and fixtures. Some small sections missing. Likely to be water damaged.</p> <p><b>Recommendation:</b> Remove fittings and fixtures. Skirting to be removed to facilitate rising damp repairs and floor removal if required.</p> <ul style="list-style-type: none"> <li>Generally, skirtings should remain in their existing positions. Any skirting being replaced due to damage such as water ingress, dry rot and termite damage or that are missing should be reproduced to replicate other skirtings in the same room, or if none at all, should replicate its most likely profile based on the findings of the 1997 CMP.</li> <li>Ground floor skirtings that are required to be removed for the subfloor excavation works, should have their locations recorded, labelled clearly, carefully removed, de-nailed, cleaned up and reinstated post excavation and subfloor works.</li> <li>Consideration should be put into packing out skirtings with battens to create a void space for wiring prior to reinstallation where they are required to be removed to facilitate other works such as floor replacement, Subfloor excavation or rising damp remediation.</li> <li>Consideration should be made towards sensitively and sympathetically incorporating a skirting duct into the current skirting profiles to facilitate ease of future services reticulation and to minimize the requirement for future invasive works.</li> </ul> <p>See also section 3.1.7 Skirtings in the <i>Physical Condition Report and Schedule of Conservation Works</i>.</p> <p><b>Grading of Significance:</b> High</p>

Doors	Fair	<p><b>Description:</b> Four panel door with top two panels glazed. The architrave has a check out from a previously installed lock.</p> <p><b>Recommendation:</b> Patch architrave.</p> <ul style="list-style-type: none"> <li>• Any door leaves removed as part of works should be either reused within the building in other areas requiring doors or documented on an inventory, labelled and placed in storage on site.</li> <li>• Doors should generally be adjusted, cleaned up, and rehung in their original locations.</li> <li>• Doors and jambs that need to be replaced for fire rating, should be replaced with compliant metal jambs and fire doors. Existing architraves should be reinstated, and sympathetic bolelection mouldings should be installed onto the fire doors to recreate the appearance of the original panel doors.</li> </ul>

Fireplace	Poor	<p><b>Description:</b> fireplace has been bricked over. The hearth is still visible</p> <p><b>Recommendation:</b></p> <ul style="list-style-type: none"> <li>Rooms with fireplaces bricked in or sheeted over should at least have a mantle installed as an interpretive element.</li> <li>Hearths should be restored where they are relatively intact. Damaged or bare hearths should be either tiled, overlaid with stone or painted.</li> <li>Chimneys breasts should remain as an expressed feature of a room. In places where services risers are placed beside them, new partition walls beside chimney breasts should</li> </ul>

CME F10		
		<p><b>Recommendation:</b> Remove Intrusive modern fixtures fittings and conduits</p> <ul style="list-style-type: none"> <li>Where intact and not at risk of collapse, complete conservation works to reinstate back to original condition. This could be inclusive of patching existing holes, replacing missing, badly damaged sections and in situ cornice template moulding repairs.</li> <li>Where small areas are damaged beyond salvage, replace with salvaged lining boards from other rooms of less significance within the building, replace with second hand salvaged material or replace with replicated modern equivalent.</li> <li>Instead of removing large sections of heritage fabric ceilings to facilitate the installation of services or structural repairs, It would be a more preferable heritage outcome to leave any stable remnant ceiling fabric in situ and install a modern ceiling replica of the original ceiling based on existing documentation from the original build or from evidence of remnant fabric. These new ceilings would be installed lower to provide space to conceal services provided that any loss of height does not detract from the overall scale of the rooms or cover necessary ventilation grills or vents. The original ceiling would remain in its current condition concealed above it.</li> </ul> <p>See also Section 3.1.1. in the <i>Physical Condition and Schedule of Conservation Works</i> report for further treatment recommendations.</p> <p><b>Grading of Significance: High</b></p>

CME F10		
		<p><b>Recommendation:</b> Remove boarding to expose windows. Strip all lead paint completely from all surfaces and prepare all surfaces under HAZMAT conditions in accordance with <i>AS4361.1:2017 Guide to Hazardous Paint Management</i> prior to commencement of works.</p> <ul style="list-style-type: none"> <li>• Windows should generally be repaired adjusted and cleaned up in their original locations. This could be inclusive of sash cord and weight replacement, glazing putty touch ups or replacement, adjustment and refitting of sashes, rot repairs, broken glass replacement and hardware repairs and or replacement.</li> <li>• Existing heritage hardware should be stripped, polished and reinstated in as close to its original position. Missing hardware should be reinstated with new modern reproduction equivalents.</li> <li>• Locks should be made operational if windows are to be operable. Opening restrictions should be added for both security and code compliance if windows present a climb or fall risk.</li> </ul> <p>See also section 3.1.3. Painted Surfaces and section 3.1.5 Windows in the <i>Physical Condition and Schedule of Conservation Works</i> report for further treatment recommendations.</p> <p><b>Grading of Significance: High</b></p>
