## 9. Inventory Sheets

This chapter includes the inventory sheets for each room within the CME Building. Each datasheet includes:

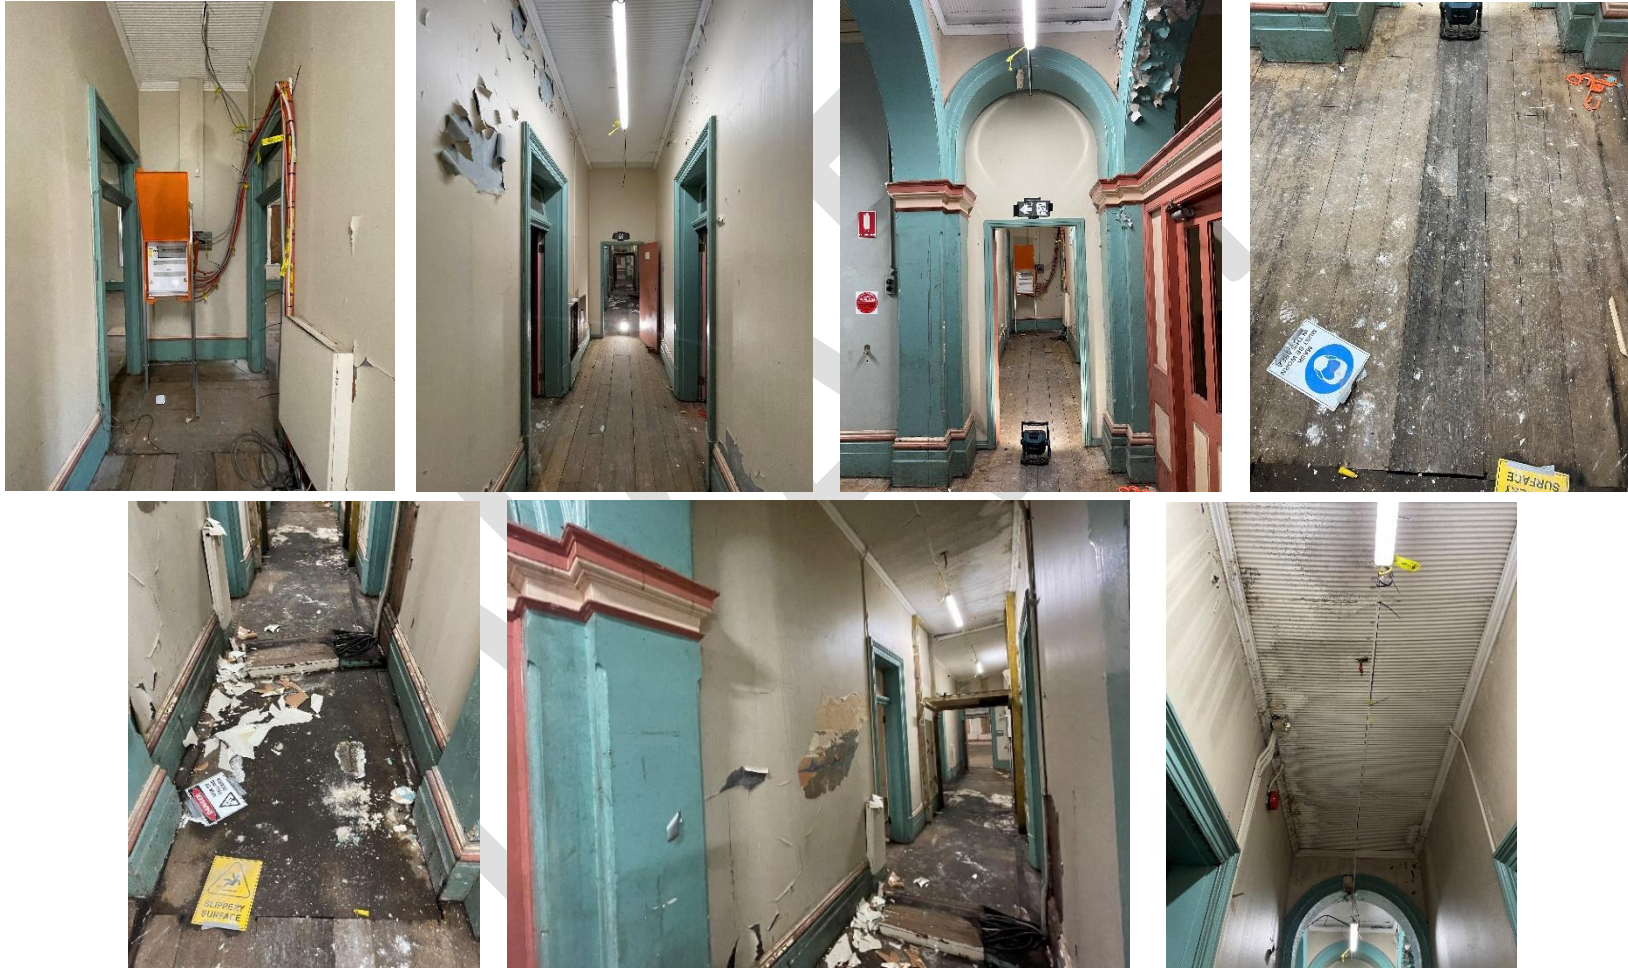
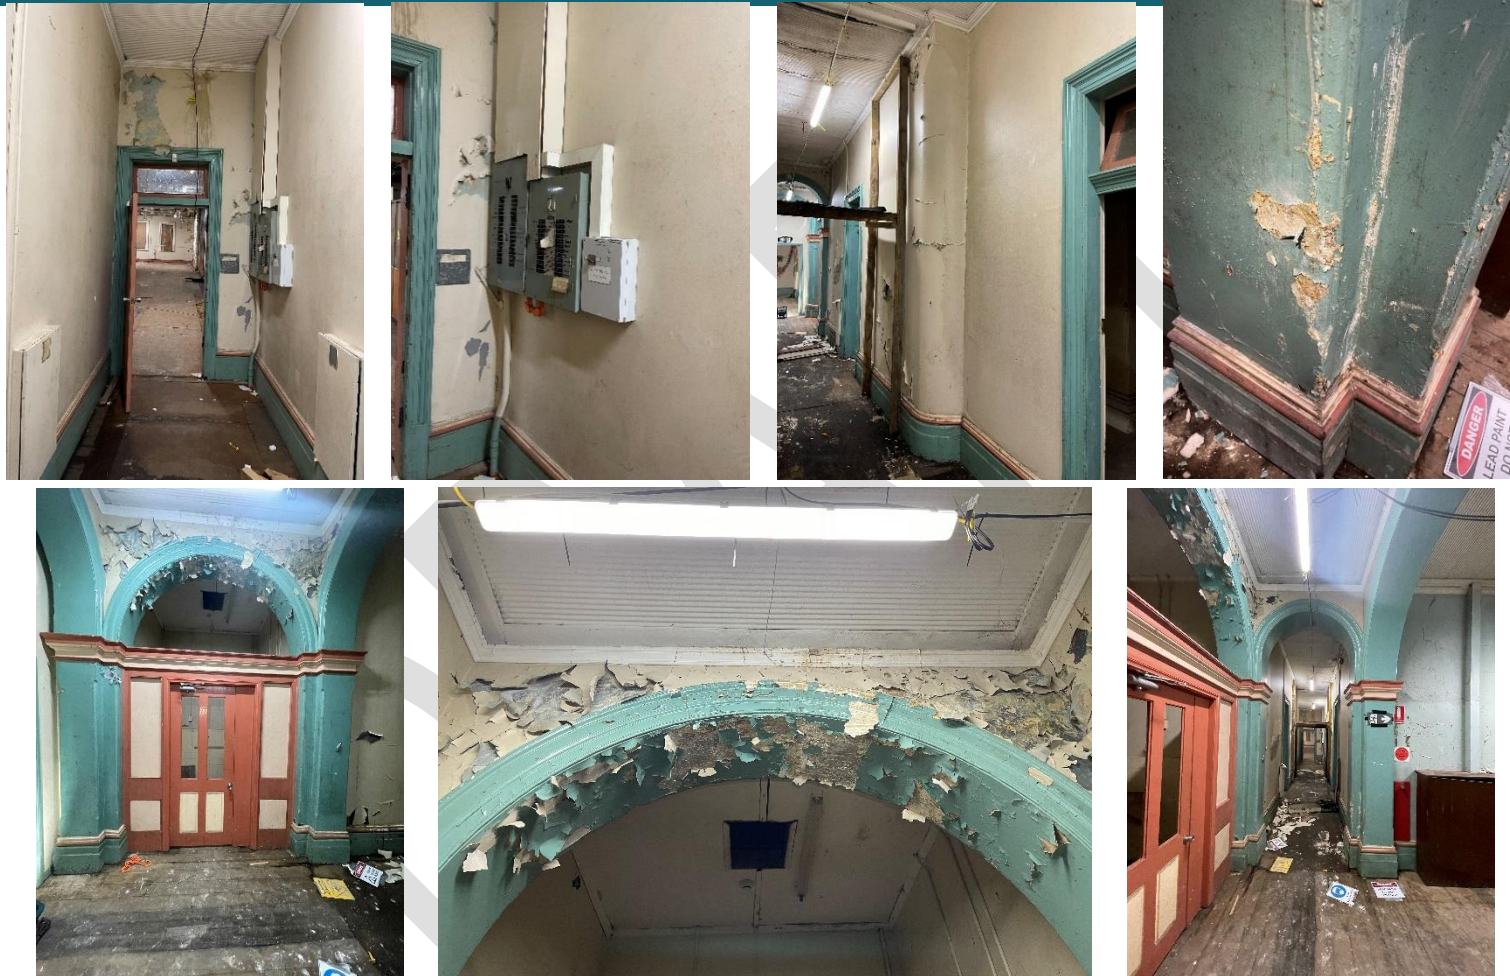
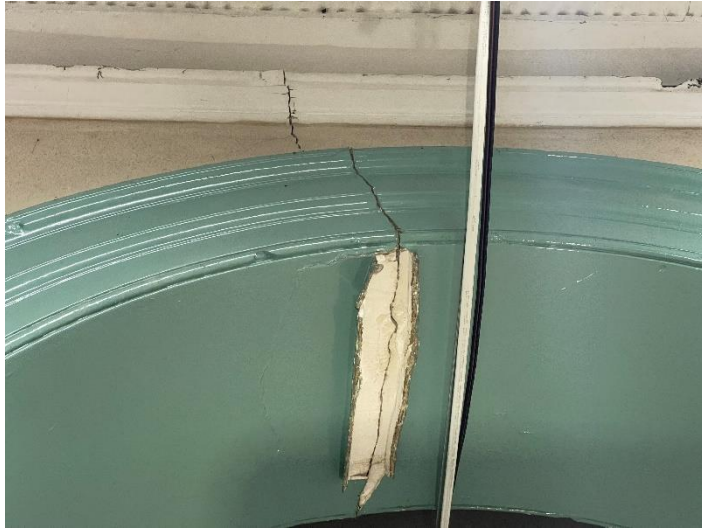
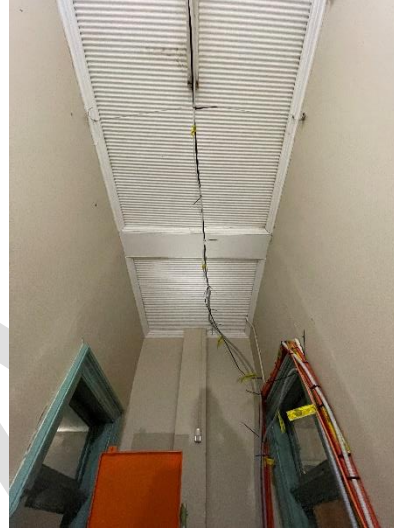
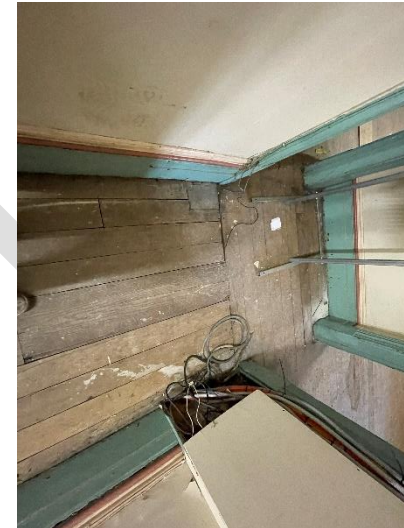
## CME Building – Room F11,F12,F13,F14

CME Building – Room F11,F12,F13,F14		
Fabric	Current Condition	Description and Recommendation
Floor	Fair to Poor	<p><b>Description:</b> Kauri pine wide boards to the western sections -F11 &amp;F12 with various cut outs for services and infills of narrow hardwood boards and plywood. Minor water damage to the crossover section of the hallway at F12. F13 and F14 eastern end of the hallway is a combination of yellow tongue flooring and timber floorboards, all badly water damaged and partially covered with plywood. Some sections were not able to be inspected. The joists in this section are likely rotten.</p> <p><b>Recommendation:</b> Yellow tongue and rotten sections should be replaced with wide kauri boards. Joists should be inspected for structural adequacy and replaced if necessary. Certain areas may need to be temporarily removed to facilitate subfloor works, including installation of concealed services and structural repairs. Reticulation of services should prioritise the areas of flooring being pulled up to replace damaged flooring to minimise the unnecessary removal of boards. It is intended to salvage as many as possible of the floorboards for reuse in accordance with Section 3.1.4 Floors in the <i>Physical Condition and Schedule of Conservation Works</i> methodology for floor works. Salvaged flooring from the entire building should be collated and graded for condition from best to worst before being re-laid at the completion of subfloor works. Priority should be given to the rooms in key view lines and of most significance to have the floorboards in the best condition as per section 3.1 - 6 General recommendations in the <i>Physical Condition and Schedule of Conservation Works</i></p> <p><b>Grading of Significance: High</b></p>

CME Building – Room F11,F12,F13,F14		
Walls	Poor	<p><b>Description:</b> Falling damp throughout, damp is particularly bad. Very poor paint that is flaking in places, many surface fixed fittings and penetrations for services. This section of the hallway is divided in to Four sections with decorative arches. These arches have ornate in situ formed plaster arch mouldings and a plaster crown moulding to the columns at either side. The western end of the hallway has been removed and the hallway continued through into room F1. The F14 section of the hallway is wider than the rest.</p> <p><b>Recommendation:</b> Paint strip areas of loose or flaking paint, and where the damp has affected it. The rest can be subject to overcoating and or spot repairs as per the guidelines within <i>AS4361.1:2017 Guide to Hazardous Paint Management</i>. Render to be removed in areas of badly affected falling damp and wet vacuum wash the brickwork for multiple cycles with a contained head wet system. Allow to dry for min 6 weeks and apply a salt retardant render prior to white set and painting. Also refer to section 3.1.2 Walls and Section 3.1.3. Painted Surfaces in the <i>Physical Condition and Schedule of Conservation Works</i> report for further treatment recommendations.</p> <p><b>Grading of Significance: High</b></p>

Ceilings	Fair	<p><b>Description:</b> Corrugated metal ceilings. Various surface fixed fittings and penetrations for services. Ceilings are badly water affected at the eastern end and likely to collapse</p> <p><b>Recommendation:</b> Assess rafters above for structural adequacy. Reattached ceiling if salvageable. Remove Intrusive modern fixtures fittings and conduits.</p> <ul style="list-style-type: none"> <li>• Where intact and not at risk of collapse, complete conservation works to reinstate back to original condition. This could be inclusive of patching existing holes, replacing missing, badly damaged sections, mouldings and in situ cornice template moulding repairs.</li> <li>• Where small areas are damaged beyond salvage, replace with salvaged fabric from other rooms of less significance within the building, replace with second hand salvaged material or replace with replicated modern equivalent.</li> <li>• Instead of removing large sections of heritage fabric ceilings to facilitate the installation of services or structural repairs, It would be a more preferable heritage outcome to leave any stable remnant ceiling fabric in situ and</li> </ul>

Skirting	Fair to Poor	<p><b>Description:</b> Tall ornate skirtings, likely rotten at the eastern end due to falling damp.</p> <p><b>Recommendation:</b> Skirting to be removed to facilitate rising damp repairs and floor removal if required.</p> <ul style="list-style-type: none"> <li>• Generally, skirtings should remain in their existing positions. Any skirting being replaced due to damage such as water ingress, dry rot and termite damage or that are missing should be reproduced to replicate other skirtings in the same room, or if none at all, should replicate its most likely profile based on the findings of the 1997 CMP.</li> <li>• Ground floor skirtings that are required to be removed for the subfloor excavation works, should have their locations recorded, labelled clearly, carefully removed, de-nailed, cleaned up and reinstated post excavation and subfloor works.</li> </ul>

CME Building – Room F11,F12,F13,F14		
		<p>install a modern ceiling replica of the original ceiling based on existing documentation from the original build or from evidence of remnant fabric. These new ceilings would be installed lower to provide space to conceal services provided that any loss of height does not detract from the overall scale of the rooms or cover necessary ventilation grills or vents. The original ceiling would remain in its current condition concealed above it. See also Section 3.1.1 in the <i>Physical Condition and Schedule of Conservation Works</i> report for further treatment recommendations.</p> <p><b>Grading of Significance: High</b></p>
Cornice	Fair	<p><b>Description:</b> Timber moulding cornice below Corrugated metal ceilings. Eastern sections may be water damaged</p> <p><b>Recommendation:</b> Remove intrusive modern fixtures and fittings. Decorative timber mouldings should be repaired in situ if possible. When beyond salvage or if ceilings are replaced, or relocated, timber mouldings should be reinstated with originals salvaged from elsewhere within the building where available or with replicated remakes of the originals should they be beyond salvage. As per section 3.1.1. Ceilings in the <i>Physical Condition and Schedule of Conservation Works</i> report for further treatment recommendations.</p> <p><b>Grading of Significance: High</b></p>

CME Building – Room F11,F12,F13,F14		
		<ul style="list-style-type: none"> <li>Consideration should be put into packing out skirtings with battens to create a void space for wiring prior to reinstallation where they are required to be removed to facilitate other works such as floor replacement, Subfloor excavation or rising damp remediation.</li> <li>Consideration should be made towards sensitively and sympathetically incorporating a skirting duct into the current skirting profiles to facilitate ease of future services reticulation and to minimize the requirement for future invasive works.</li> </ul> <p>See also section 3.1.7 Skirtings in the <i>Physical Condition Report and Schedule of Conservation Works</i>.</p> <p>Grading of Significance: High</p>
Windows	N/A	<p>Description: No windows in this area</p> <p>Recommendation: N/A</p> <p>Grading of Significance: N/A</p>
Doors	N/A	<p>Description: Door descriptions noted in room descriptions.</p> <p>Recommendation: N/A</p> <p>Grading of Significance: N/A</p>

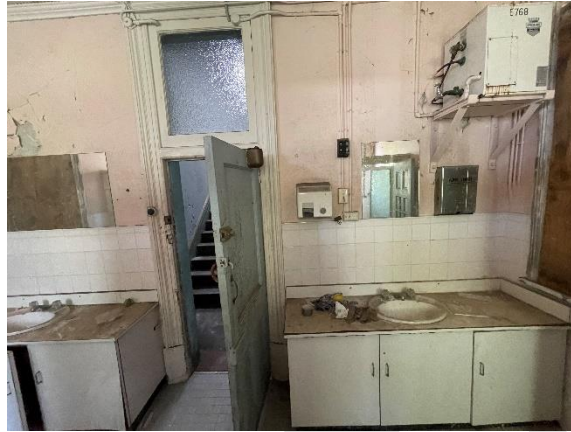
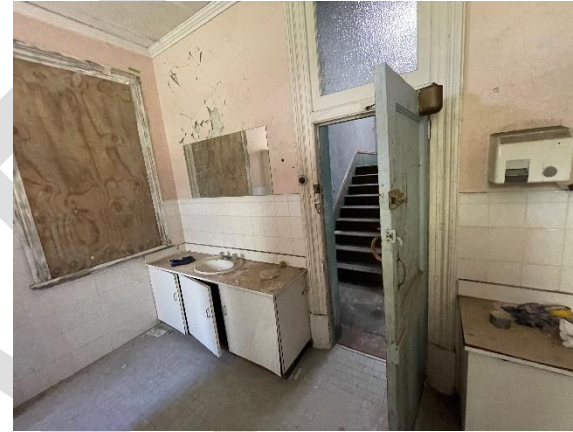
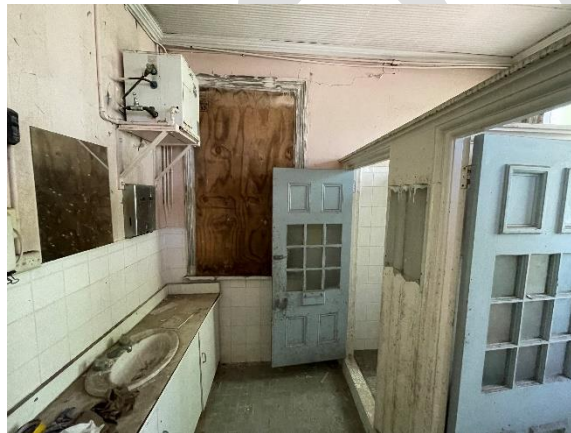
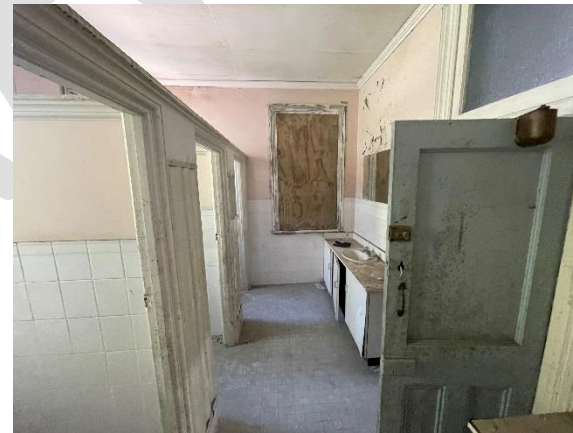
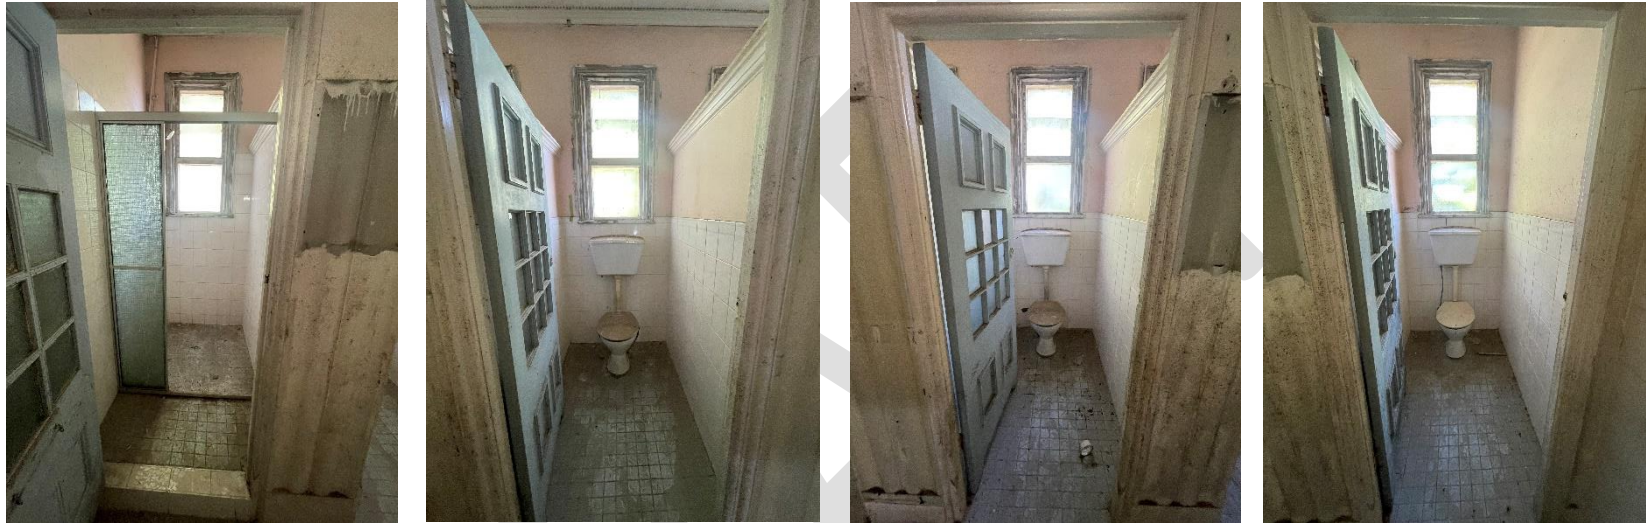
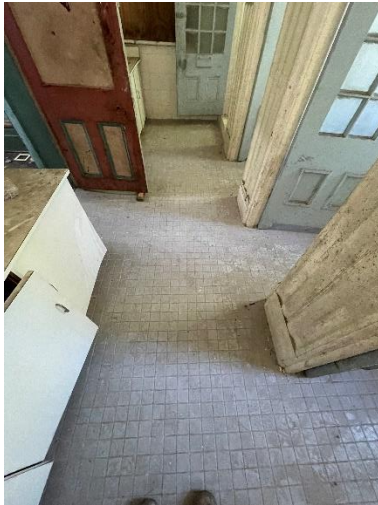
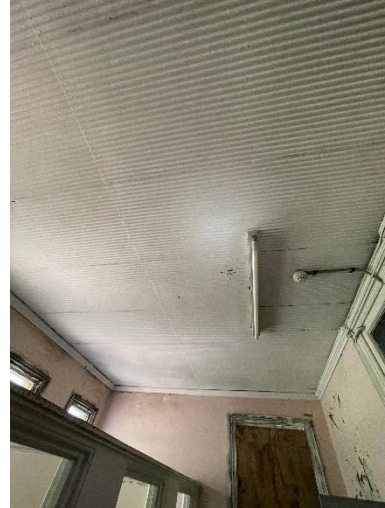
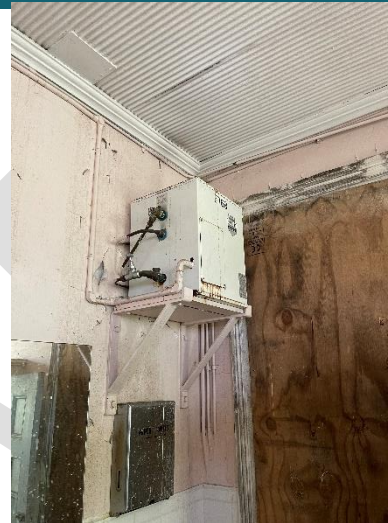
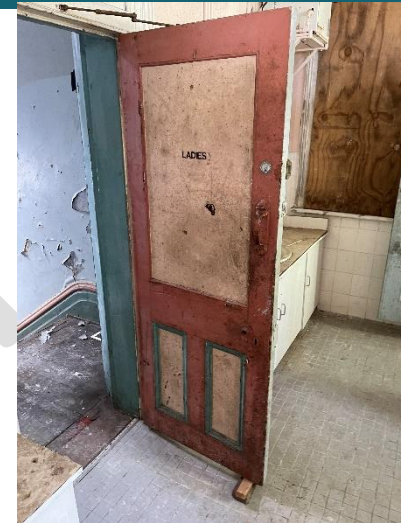
## CME Building – Room F15

CME Building – Room F15		
Fabric	Current Condition	Description and Recommendation
Floor	Fair	<p><b>Description:</b> Tiled Floor, currently in fair condition</p> <p><b>Recommendation:</b> Tiles on the floor in this room will be removed to facilitate Hydraulic upgrades, waterproofing and re-tiling with sympathetic modern tiles. See section 3.1.4 Floors in the <i>Physical Condition and Schedule of Conservation Works</i> methodology for floor works.</p> <p><b>Grading of Significance:</b> Little</p>
Walls	Poor	<p><b>Description:</b> Paint poor with flaking in places, mould, uneven surfaces and various cracks. southern half of the room is three toilet cubicles and a shower cubicle. The majority of the room is tiled to approx. 1500mm High except the shower cubicle to 1800high with modern ceramic tiles. The Northern side of the room has two intrusive modern vanities with hand basins, mirrors, hand dryers and paper towel dispensers sit above the vanities with a high level wall mounted hot water system above.</p> <p><b>Recommendation:</b> Remove toilets, vanities and fittings, paint strip areas of loose or flaking paint, The rest can be subject to overcoating and or spot repairs as per the guidelines within <i>AS4361.1:2017 Guide to Hazardous Paint Management</i>. Intrusive modern wall tiles to be removed. If falling damp has occurred, wet vacuum wash the brickwork for multiple cycles with a contained head wet system. Allow to dry for min 6 weeks and apply a salt retardant render prior to white set and painting. Also refer to section 3.1.2 Walls and Section 3.1.3 Painted Surfaces in the <i>Physical Condition and Schedule of Conservation Works</i> methodology.</p> <p><b>Grading of Significance:</b> Moderate</p>

Ceilings	Fair	<p><b>Description:</b> Corrugated metal ceiling, surface fixed conduits, fittings and penetrations for services. Some water damage in places</p> <p><b>Recommendation:</b> Remove Intrusive modern grid ceiling, fixtures fittings and conduits</p> <ul style="list-style-type: none"> <li>Where intact and not at risk of collapse, complete conservation works to reinstate back to original condition. This could be inclusive of patching existing holes, replacing missing, badly damaged sections, mouldings and in situ cornice template moulding repairs.</li> </ul>

Cornice	fair	<p><b>Description:</b> Timber moulding cornice. Some surface mounted conduits.</p> <p><b>Recommendation:</b> Remove intrusive modern fixtures and fittings. Decorative timber mouldings should be repaired in situ if possible. When beyond salvage or if ceilings are replaced, or relocated, timber mouldings should be reinstated with originals salvaged from elsewhere within the building where available or with replicated remakes of the originals should they be beyond salvage. As per section 3.1.1 Ceilings in the <i>Physical Condition and Schedule of Conservation Works</i> report for further treatment recommendations.</p> <p><b>Grading of Significance: Moderate</b></p>
Skirting	Fair	<p><b>Description:</b> Tiled walls, no skirting, currently in fair condition</p> <p><b>Recommendation:</b> Tile Floors in this room will be removed in part to facilitate Hydraulic upgrades, waterproofing and re-tiling See section 3.1.4 Floors. In the <i>Physical Condition and Schedule of Conservation Works</i> report for further treatment recommendations.</p> <p><b>Grading of Significance: N/A</b></p>

CME Building – Room F15		
Windows	Poor	<p><b>Description:</b> Each cubicle has a smaller window with a single lift up sash with obscure glass. The top fixed glazing has an overlapped ventilation gap. Windows appear to have been mostly stripped and primed/sealed. East and west windows are currently boarded up and not accessible for full assessment.</p> <p><b>Recommendation:</b> Remove boarding to expose windows. Strip all lead paint completely from all surfaces and prepare all surfaces under HAZMAT conditions in accordance with <i>AS4361.1:2017 Guide to Hazardous Paint Management</i> prior to commencement of works.</p> <ul style="list-style-type: none"> <li>• Windows should generally be repaired adjusted and cleaned up in their original locations. This could be inclusive of sash cord and weight replacement, glazing putty touch ups or replacement, adjustment and refitting of sashes, rot repairs, broken glass replacement and hardware repairs and or replacement.</li> <li>• Existing heritage hardware should be stripped, polished and reinstated in as close to its original position. Missing hardware should be reinstated with new modern reproduction equivalents.</li> <li>• Locks should be made operational if windows are to be operable. Opening restrictions should be added for both security and code compliance if windows present a climb or fall risk.</li> </ul> <p>See also section 3.1.3 Painted Surfaces and section 3.1.5 Windows in the <i>Physical Condition and Schedule of Conservation Works</i> report for further treatment recommendations.</p> <p><b>Grading of Significance: Moderate</b></p>

Doors	Poor	<p><b>Description:</b> 13 panel doors enclose the cubicles with 2 solid panels at the top and two solid panels at the bottom with an array of 9 obscure glass panels mid-height. An arched cut-out provides a large central undercut. The main entry door into the room to the north is a three panel solid door with a tall highlight above. The architrave has cut outs from previous hardware.</p> <p><b>Recommendation.</b></p> <ul style="list-style-type: none"> <li>• Any door leaves removed as part of works should be either reused within the building in other areas requiring doors or documented on an inventory, labelled and placed in storage on site.</li> </ul>

CME Building – Room F15		
		<ul style="list-style-type: none"> <li>Where small areas are damaged beyond salvage, replace with salvaged fabric from other rooms of less significance within the building, replace with second hand salvaged material or replace with replicated modern equivalent.</li> <li>Instead of removing large sections of heritage fabric ceilings to facilitate the installation of services or structural repairs, It would be a more preferable heritage outcome to leave any stable remnant ceiling fabric in situ and install a modern ceiling replica of the original ceiling based on existing documentation from the original build or from evidence of remnant fabric. These new ceilings would be installed lower to provide space to conceal services provided that any loss of height does not detract from the overall scale of the rooms or cover necessary ventilation grills or vents. The original ceiling would remain in its current condition concealed above it.</li> </ul> <p>See also Section 3.1.1 Ceilings in the <i>Physical Condition and Schedule of Conservation Works</i> report for further treatment recommendations.</p> <p><b>Grading of Significance: Moderate</b></p>

CME Building – Room F15		
		<ul style="list-style-type: none"> <li>Doors should generally be adjusted, cleaned up, and rehung in their original locations.</li> <li>Doors and jambs that need to be replaced for fire rating, should be replaced with compliant metal jambs and fire doors. Existing architraves should be reinstated, and sympathetic bolection mouldings should be installed onto the fire doors to recreate the appearance of the original panel doors.</li> <li>-Existing heritage hardware that is non-operational should be stripped, polished, decommissioned and reinstated in as close to its original position provided that it does not interfere with compliance of new door control hardware. New modern hardware that is sympathetic to the heritage aspect of the building yet compliant with relevant Building codes and Australian Standards (AS1428.1) should be installed.</li> <li>Fanlights should be cleaned up and made good. They should be made to operate if required as part of the HVAC requirements of the building. Existing hardware should be removed, polished and reinstated. Any missing hardware should be replaced with reproduction items to match the existing. Consideration as to make the fanlights operable, fixed open or fixed closed should be made in conjunction with the requirements of the buildings HVAC system and acoustic considerations.</li> <li>Any damage or cut outs to architraves or jambs should be reinstated with timber inlays and reshaped to blend in.</li> <li>Doors that need to be pinned in an open position should be fixed in place with a concealed fixing.</li> </ul> <p>Also refer to section 3.1.6 Doors in the <i>Physical Condition Report and Schedule of Conservation Works</i>.</p> <p><b>Grading of Significance: High</b></p>

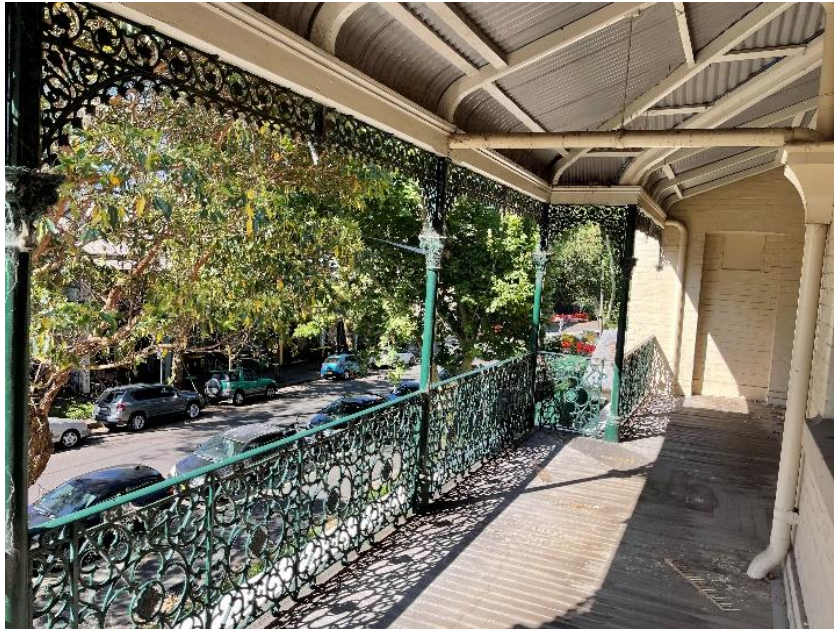
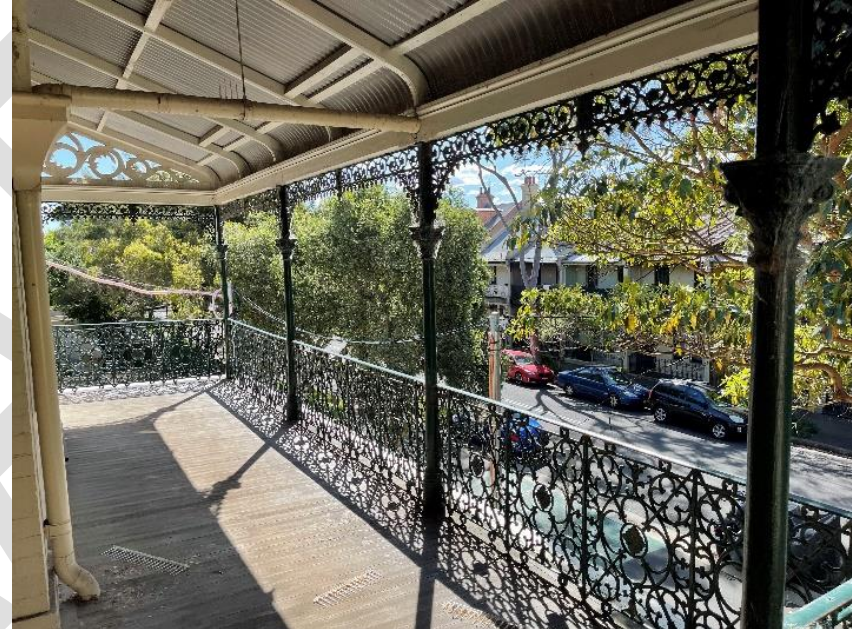
## CME Building – Room F16

CME Building – Room F16		
Fabric	Current Condition	Description and Recommendation
Floor	Fair	<p><b>Description:</b> Timber decking, replaced around 2015. Fair weathered condition</p> <p><b>Recommendation:</b> Sand and oil decking.</p> <p><b>Grading of Significance:</b> High</p>
Walls	Fair	<p><b>Description:</b> External Paint finish brick walls with an expressed lower brick course plinth detail. A lead flashing covers the bottom brick and returns onto the deck. Recessed brickwork detail to the eastern end with an infilled opening. Exposed stormwater drainage throughout</p> <p><b>Recommendation:</b> Repair and prep spot repairs and repoint wall as necessary. Prepare existing paint for overcoating and repaint. Also refer to section 3.1.2 Walls and Section 3.1.3 Painted Surfaces in the <i>Physical Condition and Schedule of Conservation Works</i> report for further treatment recommendations.</p> <p><b>Grading of Significance:</b> High</p>

Ceilings	Good	<p><b>Description:</b> Underside of metal bullnose roof with exposed timbers, outer edge beam and topside surfaces with ledges have pigeon spikes in place and considerable vermin droppings. Exposed stormwater drainage throughout</p> <p><b>Recommendation:</b> Remove pigeon spikes and pressure clean. Prep joists, decking and stormwater pipes for overcoating and repaint. Replace pigeon spikes with new. Refer to Section 3.1.3 Painted Surfaces in the <i>Physical Condition and Schedule of Conservation Works</i> report for further treatment recommendations.</p> <p><b>Grading of Significance:</b> High</p>
Veranda Posts	Good	<p><b>Description:</b> Cast iron veranda posts with ornate latticework braces. The posts bear onto the timber deck.</p> <p><b>Recommendation:</b> Prep for overcoating, wire brush and chemically treat any evident rust and repaint. Refer to Section 3.1.3 Painted Surfaces in the <i>Physical Condition and Schedule of Conservation Works</i> report for further treatment recommendations</p> <p><b>Grading of Significance:</b> Exceptional</p>

CME Building – Room F16		
Balustrade	Good	<p><b>Description:</b> Cast iron lacework panels with a wrought iron top railing. Currently in good condition.</p> <p><b>Recommendation:</b> : Prep for overcoating, wire brush and chemically treat any evident rust and repaint. Will need a suitable solution to ensure compliance requirements are met. Refer to Section 3.1.3 Painted Surfaces in the <i>Physical Condition and Schedule of Conservation Works</i> report for further treatment recommendations</p> <p><b>Grading of Significance:</b> Exceptional</p>
Windows	Fair to poor	<p><b>Description:</b> Double hung windows, generally sound condition, however likely painted shut.</p> <p><b>Recommendation:</b> Windows detailed internally in room notes. Externally Strip all lead paint completely from all surfaces and prepare all surfaces under HAZMAT conditions in accordance with <i>AS4361.1:2017 Guide to Hazardous Paint Management</i> prior to commencement of works. \</p> <ul style="list-style-type: none"> <li>Windows should generally be repaired adjusted and cleaned up in their original locations. This could be inclusive of sash cord and weight replacement, glazing putty touch ups or replacement, adjustment and refitting of sashes, rot and damage repairs, broken glass replacement and hardware repairs and or replacement.</li> </ul> <p>See also section 3.1.3 Painted Surfaces and section 3.1.5 Windows in the <i>Physical Condition and Schedule of Conservation Works</i> report for further treatment recommendations.</p> <p><b>Grading of Significance:</b> High</p>

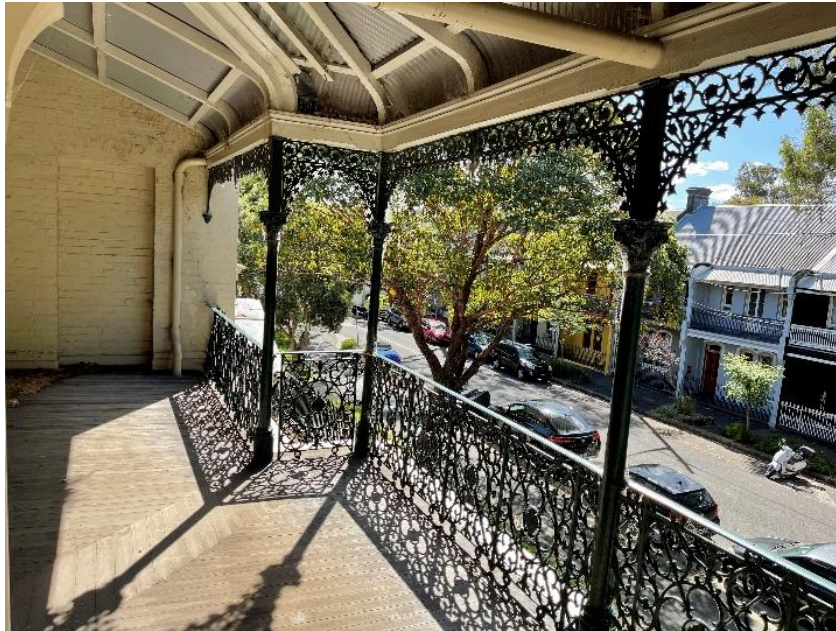
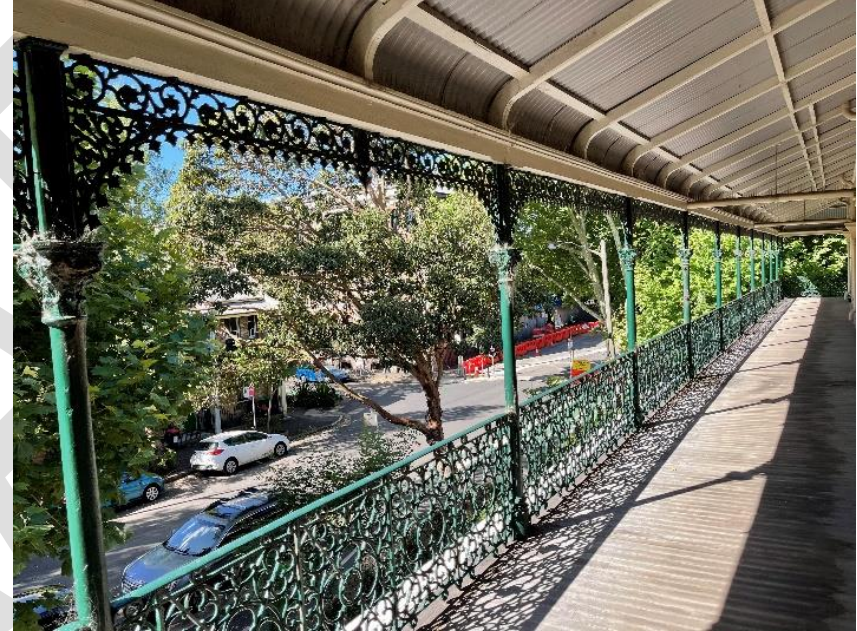
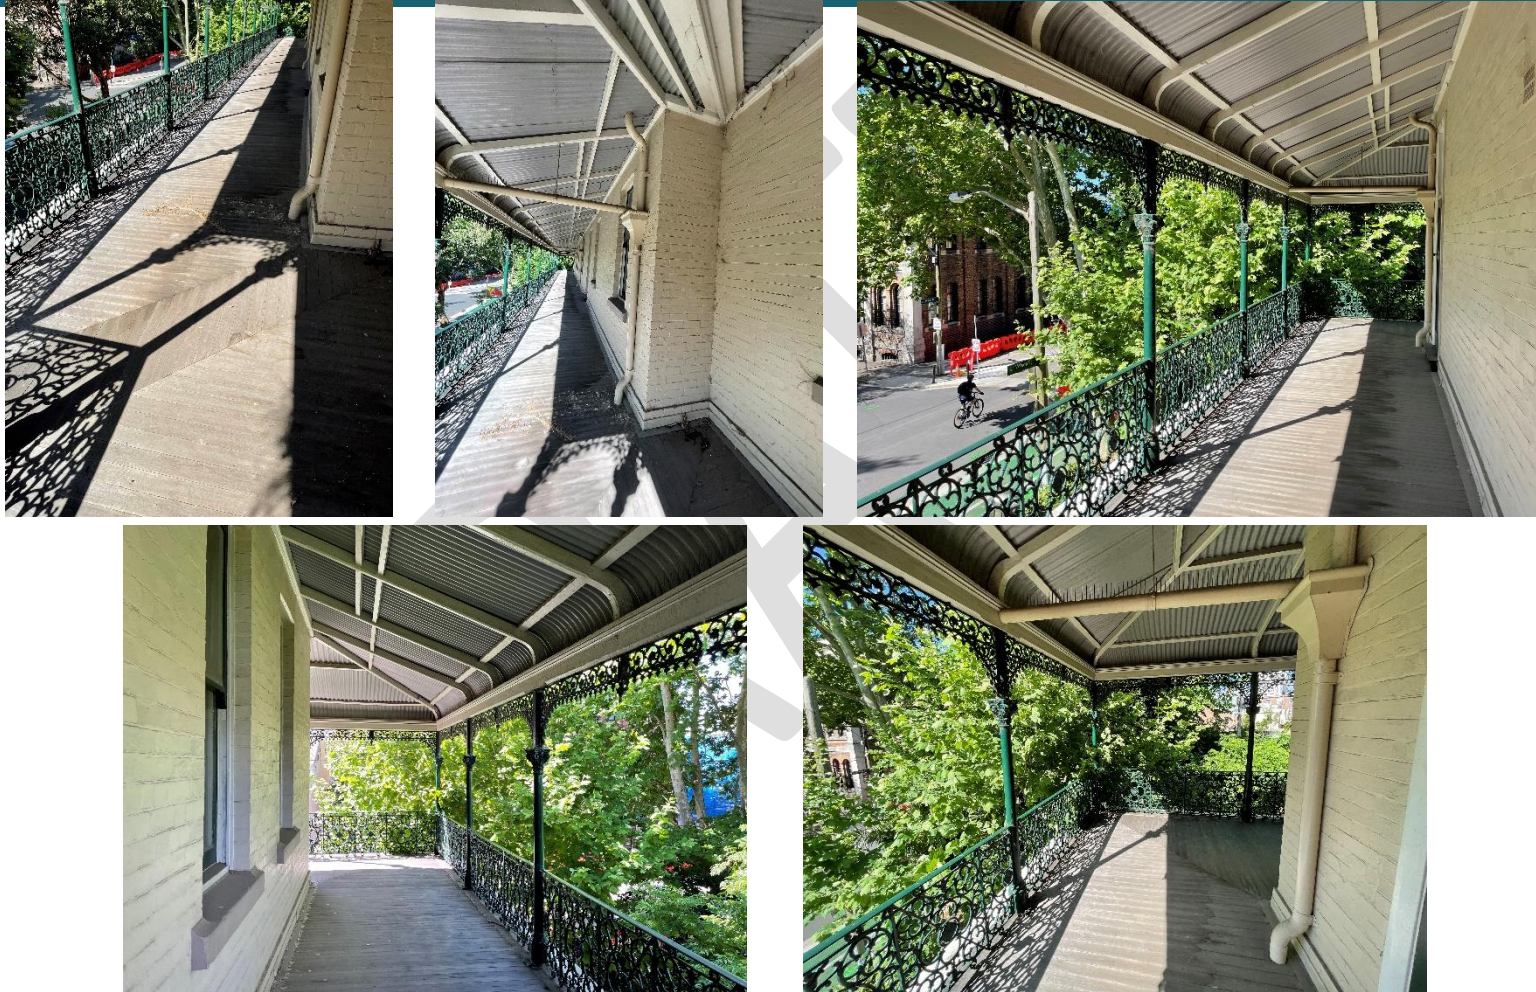
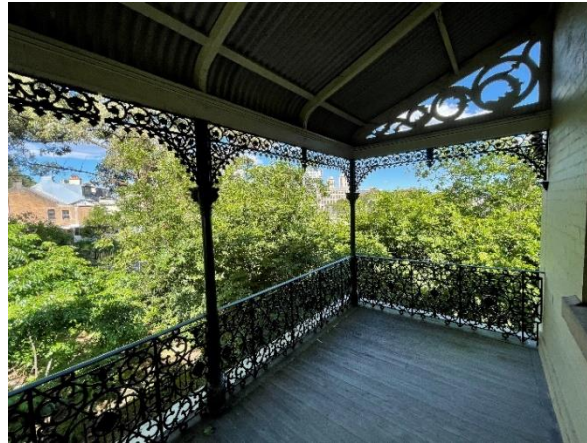
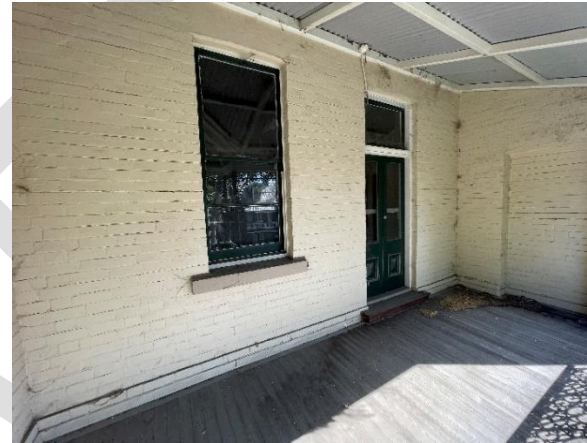
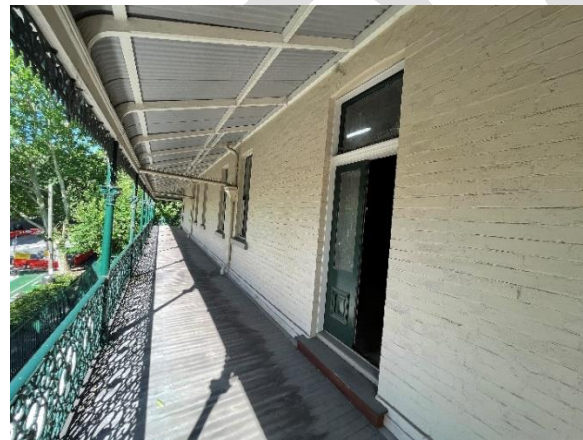
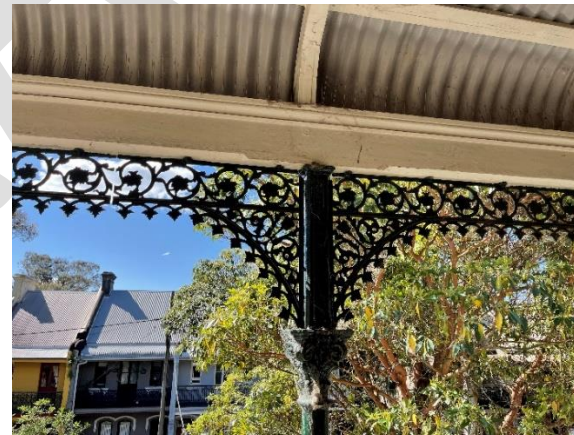
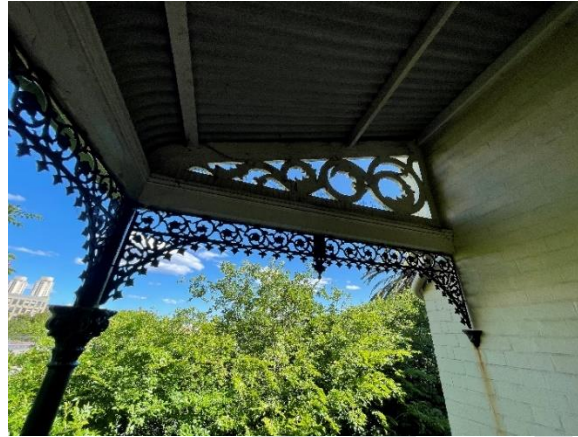
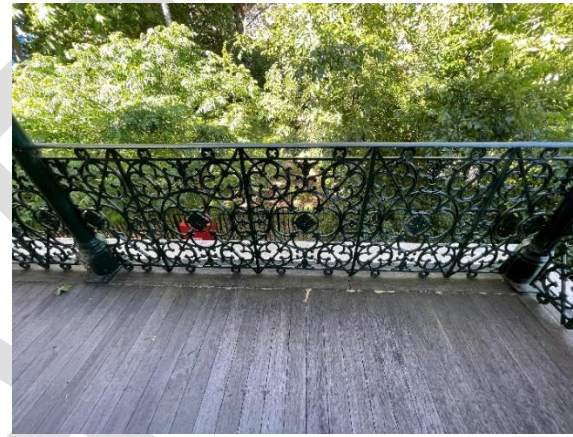
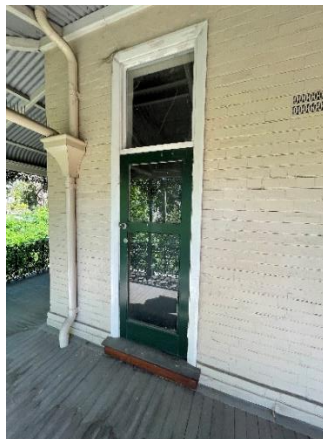
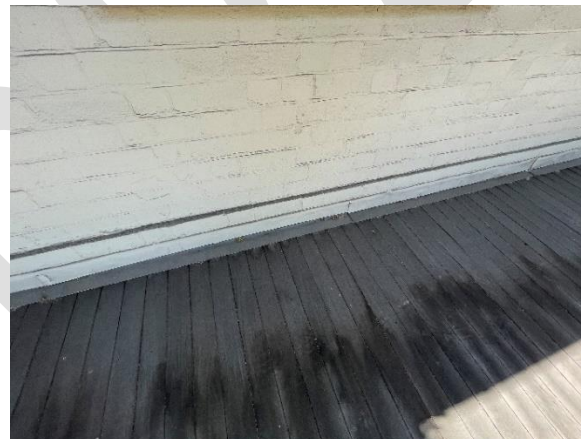
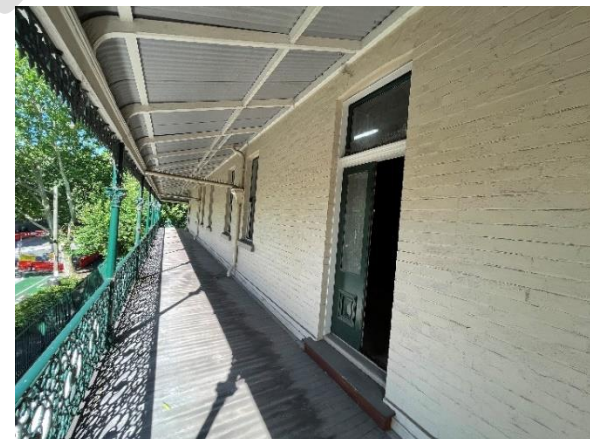
## CME Building – Room F17, F18

CME Building – Room F17, F18		
Fabric	Current Condition	Description and Recommendation
Floor	Fair	<p><b>Description:</b> Timber decking, replaced around 2015. Fair weathered condition</p> <p><b>Recommendation:</b> Sand and oil decking.</p> <p><b>Grading of Significance:</b> High</p>
Walls	Fair	<p><b>Description:</b> External Paint finish brick walls with an expressed lower brick course plinth detail. A lead flashing covers the bottom brick and returns onto the deck. Recessed brickwork detail to the eastern end with an infilled opening. Exposed stormwater drainage throughout</p> <p><b>Recommendation:</b> Repair and prep spot repairs and repoint wall as necessary. Prepare existing paint for overcoating and repaint. Also refer to section 3.1.2 Walls and Section 3.1.3. Painted Surfaces in the <i>Physical Condition and Schedule of Conservation Works</i> report for further treatment recommendations.</p> <p><b>Grading of Significance:</b> High</p>

Ceilings	Good	<p><b>Description:</b> Underside of metal bullnose roof with exposed timbers, outer edge beam and topside surfaces with ledges have pigeon spikes in place and considerable vermin droppings. Exposed stormwater drainage throughout</p> <p><b>Recommendation:</b> Remove pigeon spikes and pressure clean. Prep joists, decking and stormwater pipes for overcoating and repaint. Replace pigeon spikes with new. Refer to Section 3.1.3 Painted Surfaces in the <i>Physical Condition and Schedule of Conservation Works</i> report for further treatment recommendations.</p> <p><b>Grading of Significance:</b> High</p>
Veranda Posts	Good	<p><b>Description:</b> Cast iron veranda posts with ornate lacework braces. The posts bear onto the timber deck.</p> <p><b>Recommendation:</b> Prep for overcoating, wire brush and chemically treat any evident rust and repaint. Refer to Section 3.1.3 Painted Surfaces in the <i>Physical Condition and Schedule of Conservation Works</i> report for further treatment recommendations.</p> <p><b>Grading of Significance:</b> Exceptional</p>

CME Building – Room F17, F18		
Balustrade	Good	<p><b>Description:</b> Cast iron lacework panels with a wrought iron top railing. Currently in good condition.</p> <p><b>Recommendation:</b> : Prep for overcoating, wire brush and chemically treat any evident rust and repaint. Will need a suitable solution to ensure compliance requirements are met. Refer to Section 3.1.3 Painted Surfaces in the <i>Physical Condition and Schedule of Conservation Works</i> report for further treatment recommendations.</p> <p><b>Grading of Significance:</b> Exceptional</p>
Windows	Fair to poor	<p><b>Description:</b> Double hung windows, generally sound condition, however likely painted shut.</p> <p><b>Recommendation:</b> Windows detailed internally in room notes. Externally Strip all lead paint completely from all surfaces and prepare all surfaces under HAZMAT conditions in accordance with <i>AS4361.1:2017 Guide to Hazardous Paint Management</i> prior to commencement of works. \</p> <ul style="list-style-type: none"> <li>Windows should generally be repaired adjusted and cleaned up in their original locations. This could be inclusive of sash cord and weight replacement, glazing putty touch ups or replacement, adjustment and refitting of sashes, rot and damage repairs, broken glass replacement and hardware repairs and or replacement.</li> </ul> <p>See also section 3.1.3 Painted Surfaces and section 3.1.5 Windows in the <i>Physical Condition and Schedule of Conservation Works</i> report for further treatment recommendations.</p> <p><b>Grading of Significance:</b> High</p>
