## 9. Inventory Sheets

This chapter includes the inventory sheets for each room within the CME Building. Each datasheet includes:

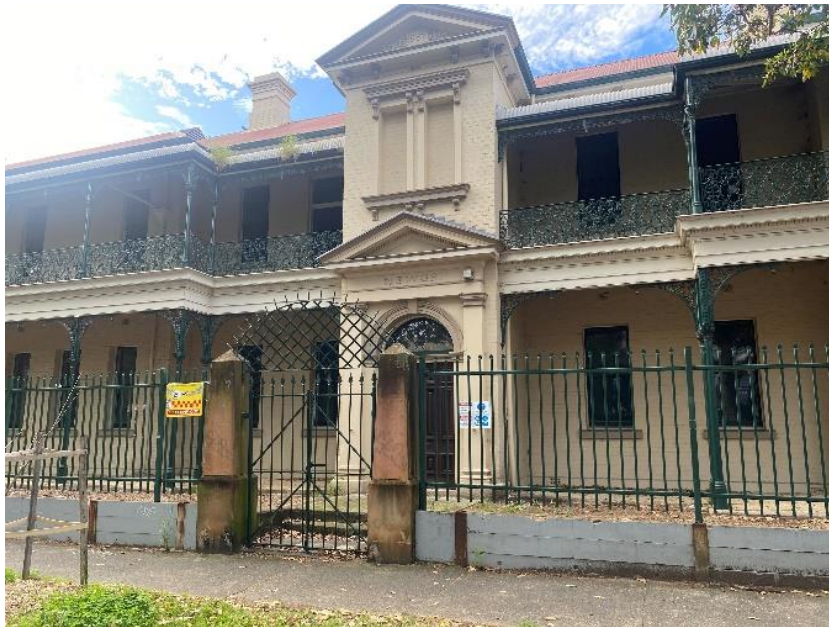
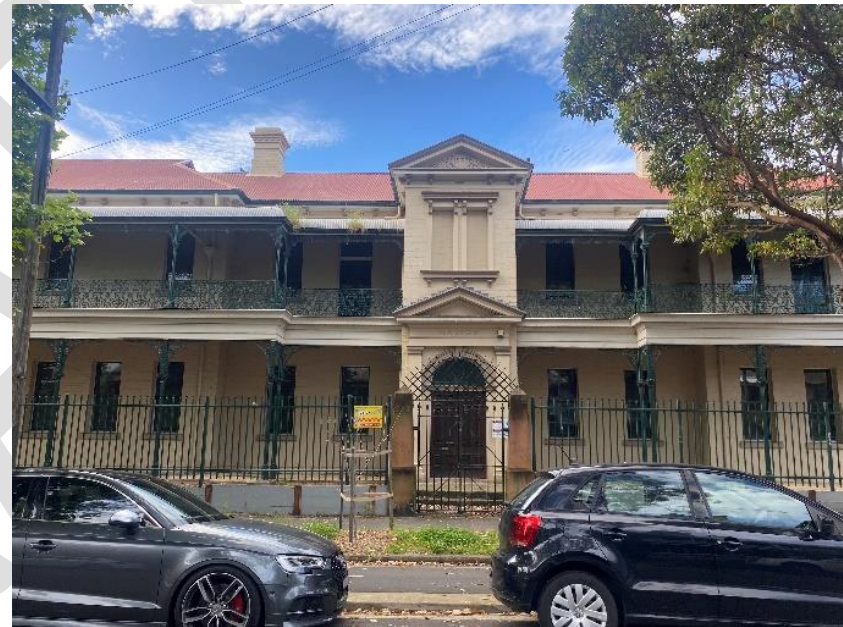
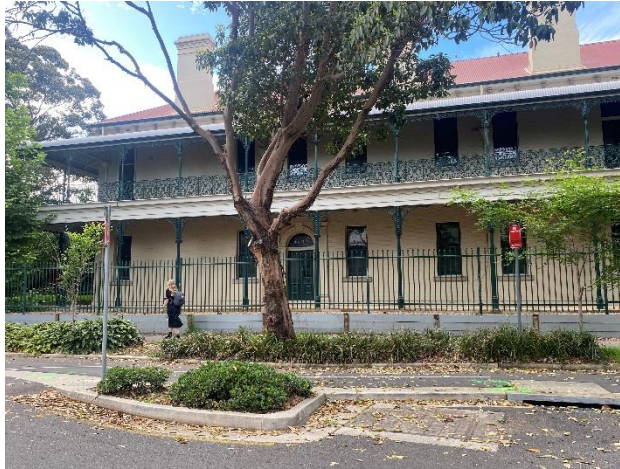
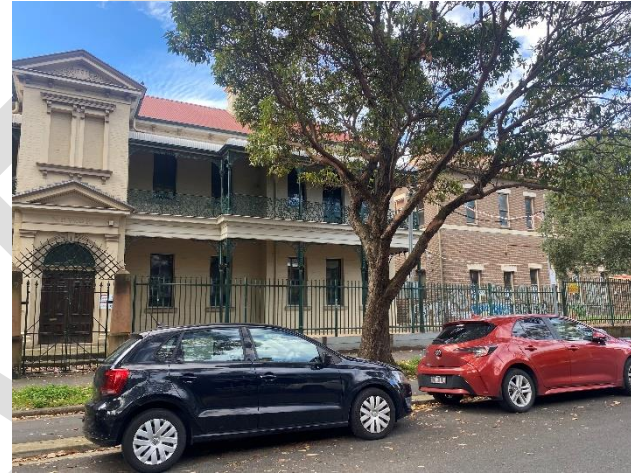
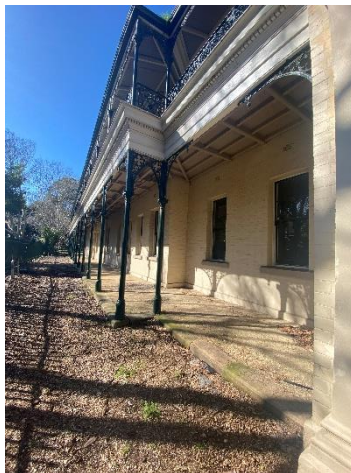
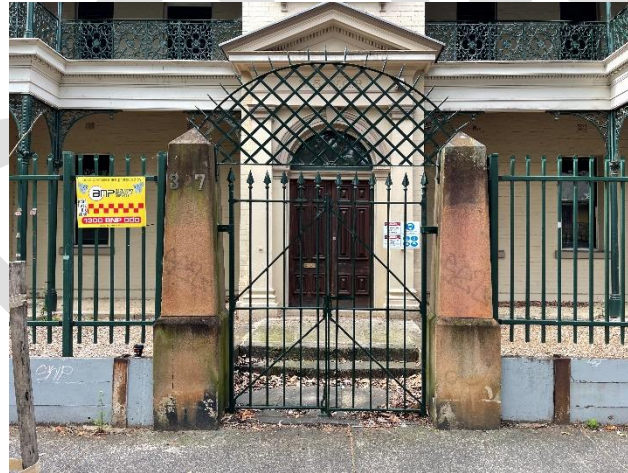
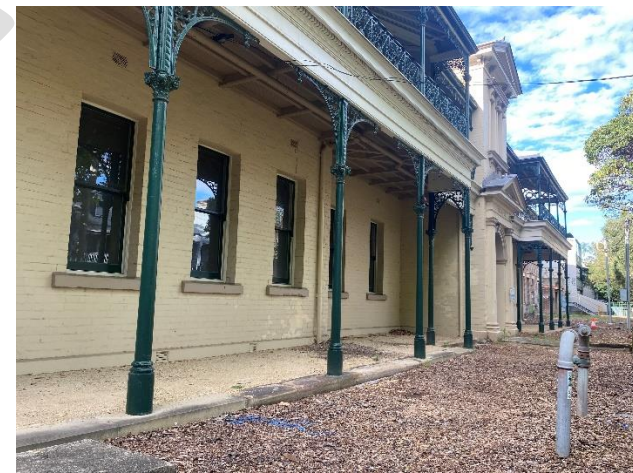
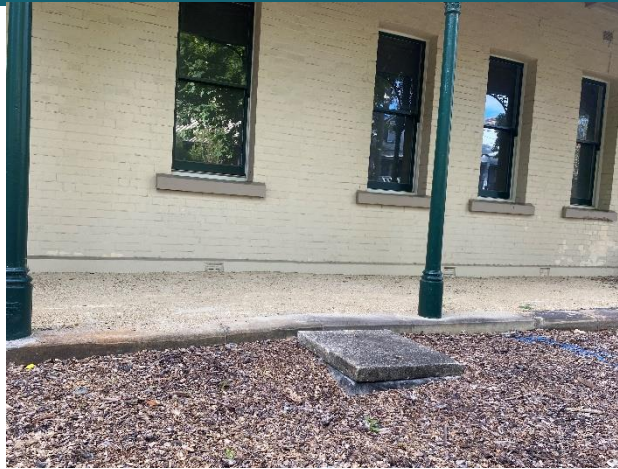
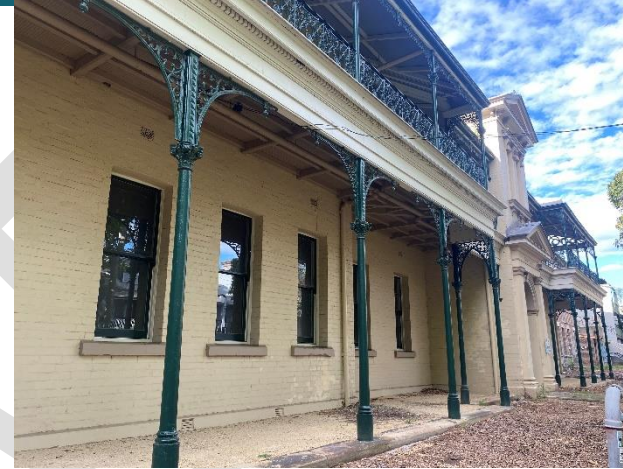
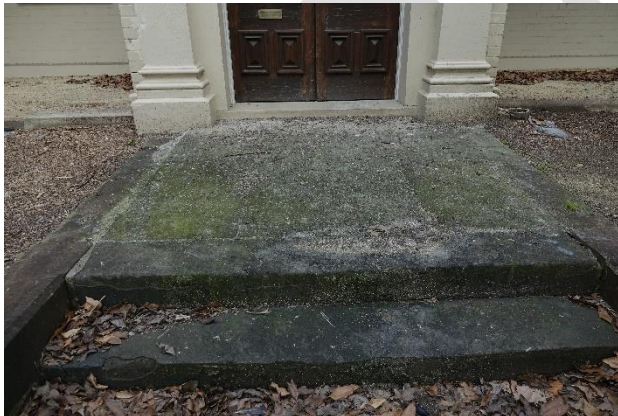
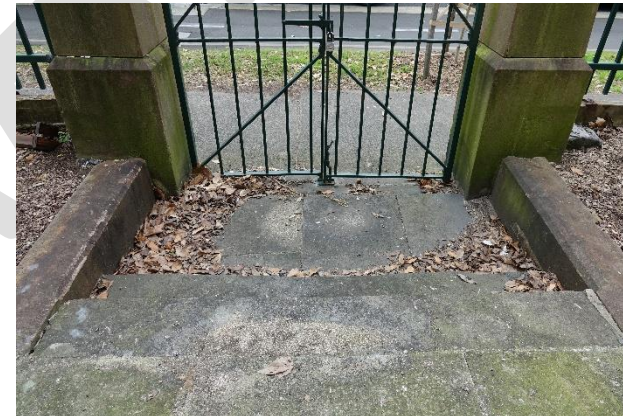
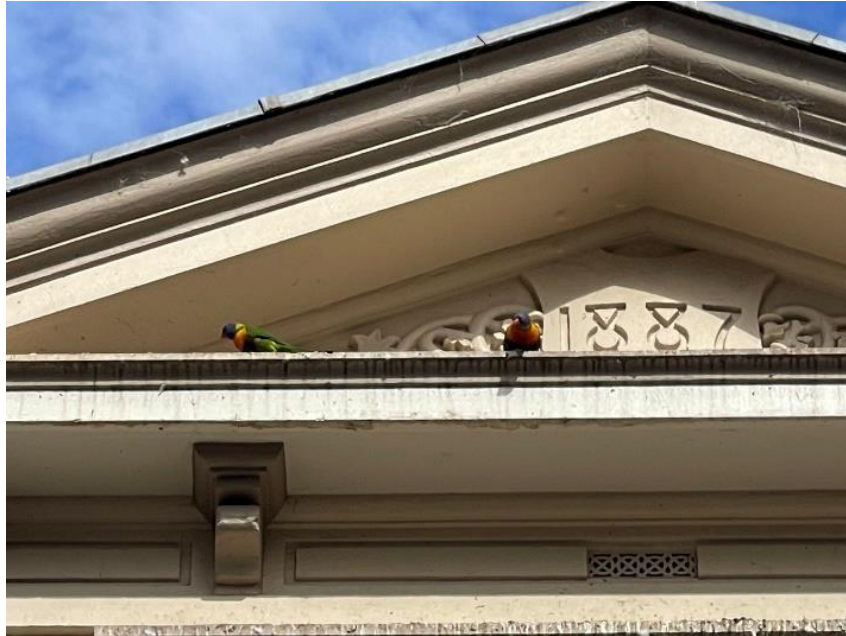
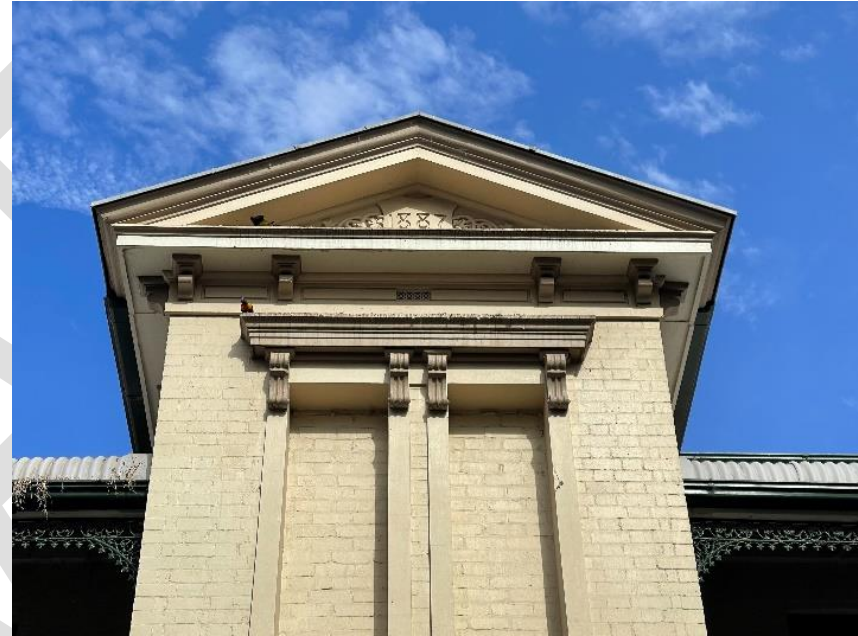
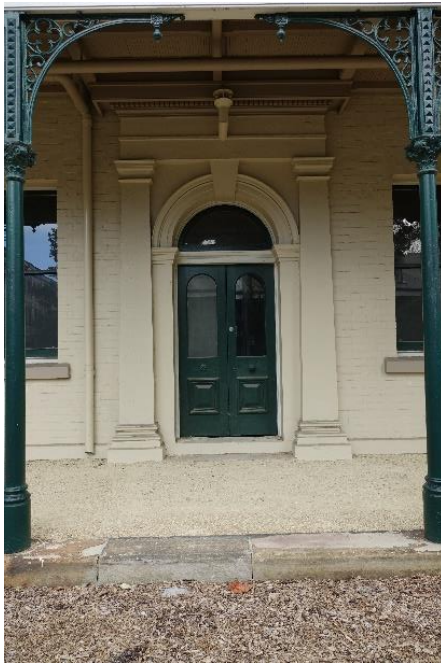
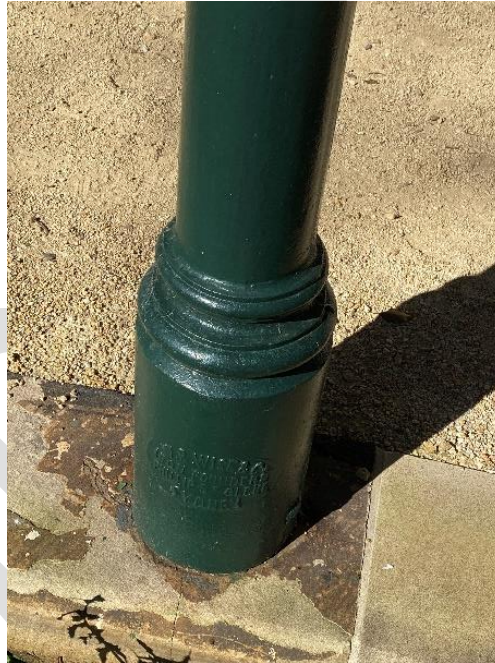
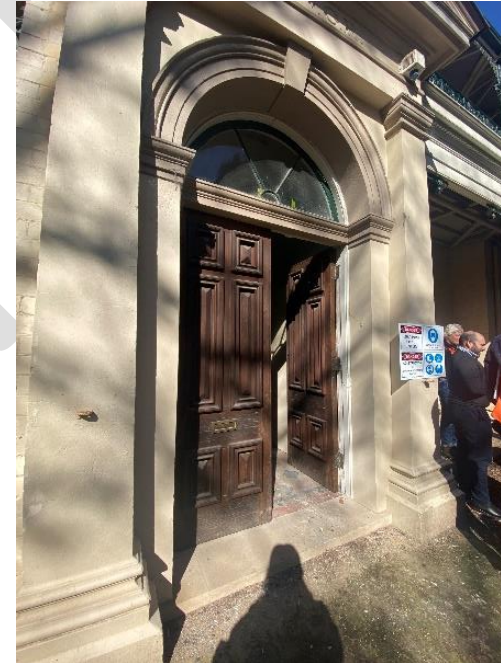
## CME Building – External North Elevation

CME Building – External North Elevation		
Fabric	Current Condition	Description and Recommendation
Floor	Poor	<p><b>Description:</b> Wood chip and Mulch to the majority of the front area. The area is poorly graded and not compliant with access requirements. There is a sandstone path and steps from the Wilson Street footpath to the main front entry. At the far west, a bitumen driveway from the Wilson Street footpath proceeds past the eastern end of the building. At the far east, a narrow set of concrete stairs from the Wilson Street footpath steps up to a concrete landing in the yard. The Verandas and balconies are detailed in G27, G28, F17 and F18</p> <p><b>Recommendation:</b> Wood chip and mulch to be removed, area to be regraded and landscaped. Sandstone steps and path to be re-laid to suit levels in line with DDA compliance. All levels to be amended to suit compliance. See Landscape Plans for further details.</p> <p><b>Grading of Significance:</b> Intrusive</p>

Walls	Fair	<p><b>Description:</b> External Paint finish brick walls</p> <p><b>Recommendation:</b> Repair and prep spot repairs and repoint wall as necessary. Prepare existing paint for overcoating and repaint. See also section 3.1.3 Painted Surfaces in the <i>Physical Condition and Schedule of Conservation Works</i> report for further treatment recommendations.</p> <p><b>Grading of Significance:</b> High</p>
Veranda Posts	Good	<p><b>Description:</b> Cast iron veranda posts with ornate lacework braces.</p> <p><b>Recommendation:</b> Prep for overcoating, wire brush and chemically treat any evident rust and repaint. Refer to Section 3.1.3 Painted Surfaces in the <i>Physical Condition and Schedule of Conservation Works</i> report for further treatment recommendations.</p> <p><b>Grading of Significance:</b> Exceptional</p>
Balustrade	Good	<p><b>Description:</b> Cast iron lacework panels with a wrought iron top railing. Currently in good condition, however, non-compliant. Detailed further in F16 and F17</p>

CME Building – External North Elevation		
		<p><b>Recommendation:</b> Prep for overcoating, wire brush and chemically treat any evident rust and repaint. Refer to Section 3.1.3 Painted Surfaces in the <i>Physical Condition and Schedule of Conservation Works</i> report for further treatment recommendations.</p> <p><b>Grading of Significance:</b> Exceptional</p>
Windows	Fair to poor	<p><b>Description:</b> Double hung windows, generally sound condition, however likely painted shut.</p> <p><b>Recommendation:</b> Windows detailed internally in room notes. Externally Paint strip areas of loose or flaking paint, and anywhere that rot or damp has affected it. The rest can be subject to overcoating and or spot repairs as per the guidelines within <i>AS4361.1:2017 Guide to Hazardous Paint Management</i>. Make windows operable, Re-putty glazing as required with linseed putty. Section 3.1.3 Painted Surfaces and section 3.1.5 Windows Surfaces in the <i>Physical Condition and Schedule of Conservation Works</i> report for further treatment recommendations.</p> <p><b>Grading of Significance:</b> High</p>

Doors	N/A	<p><b>Description:</b> Doors detailed in Rooms G3, G9, F1A and F6A</p> <p><b>Recommendation:</b> N/A</p> <p><b>Grading of Significance:</b> N/A</p>
Roof and Eaves	N/A	<p>Unable to access roof, eaves or gutters and upper areas of the façade for assessment.</p> <p><b>Grading of Significance:</b> N/A</p>

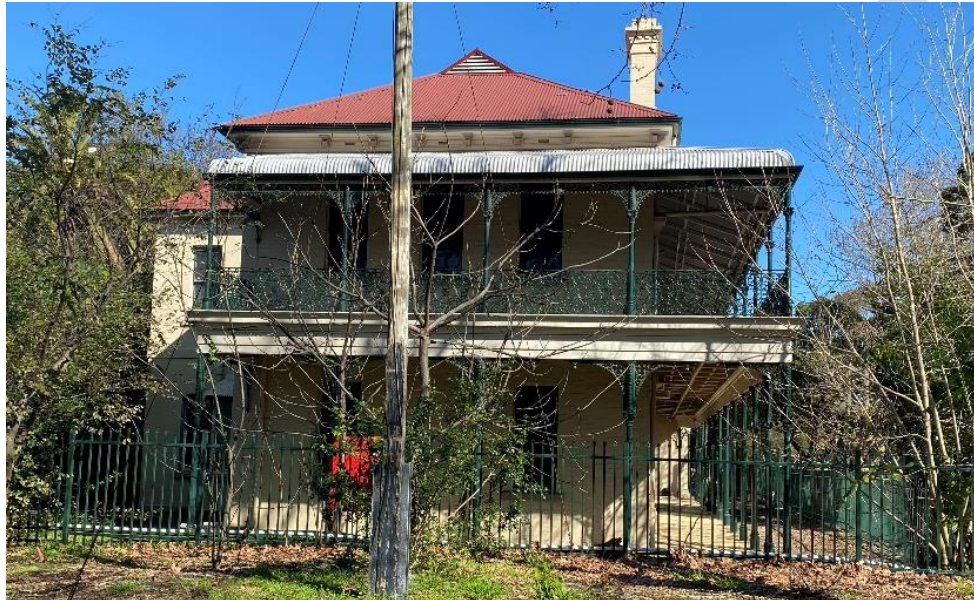
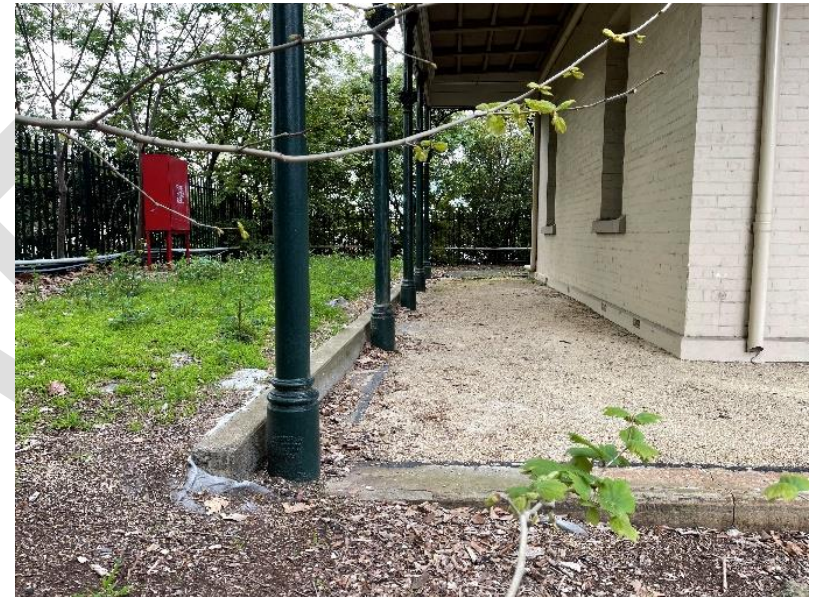
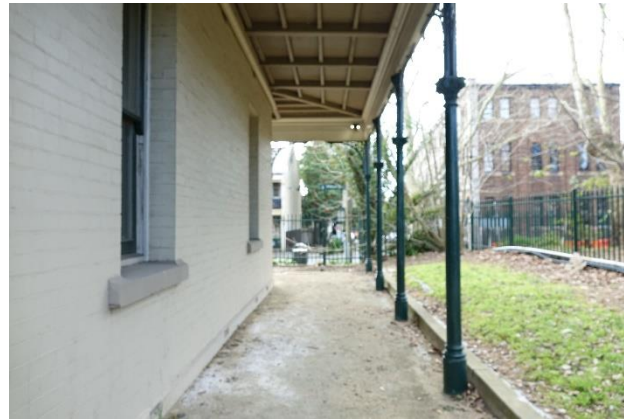
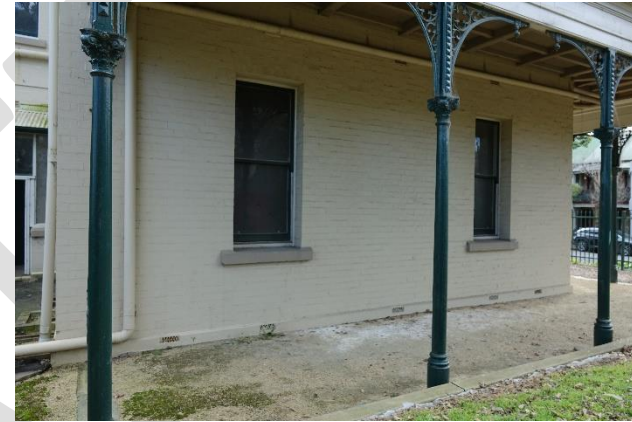
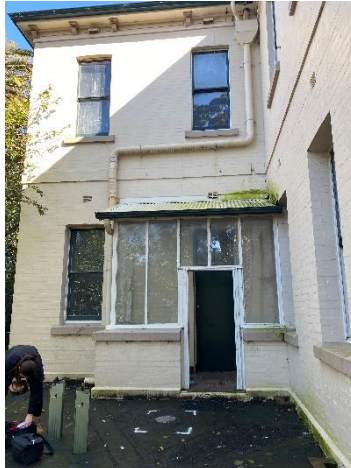
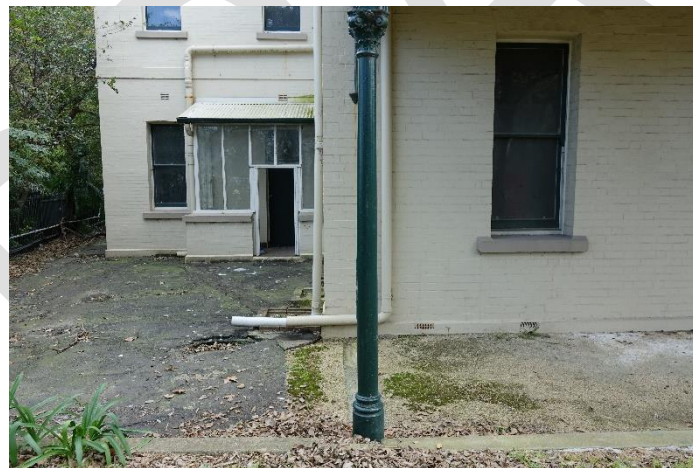
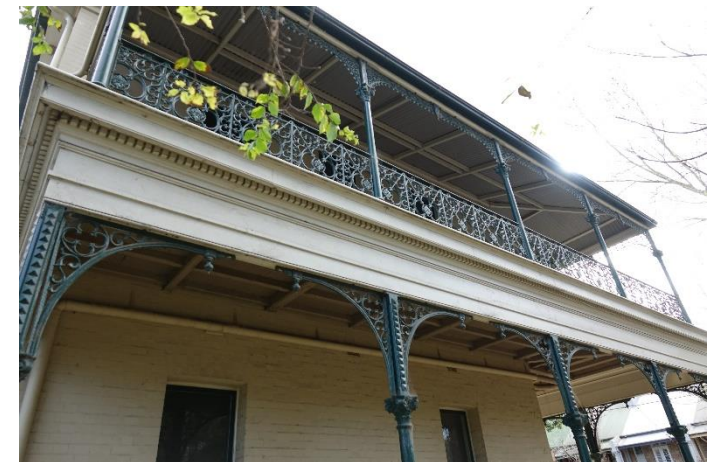
**CME Building – External East Elevation**

CME Building – External East Elevation		
Fabric	Current Condition	Description and Recommendation
Floor	Poor	<p><b>Description:</b> Wood chip and Mulch to north, grass to the rest. The area is poorly graded and not compliant with access requirements. The Veranda and balcony is detailed in G29 and F18.</p> <p><b>Recommendation:</b> Concrete hob, wood chip and grass to be removed, area to be regraded and landscaped. All levels to be amended to suit compliance. See Landscape Plans for further details.</p> <p><b>Grading of Significance:</b> Intrusive</p>
Walls	Fair	<p><b>Description:</b> External Paint finish brick walls</p> <p><b>Recommendation:</b> Repair and prep spot repairs and repoint wall as necessary. Prepare existing paint for overcoating and repaint. See also section 3.1.3 Painted Surfaces in the <i>Physical Condition and Schedule of Conservation Works</i> report for further treatment recommendations.</p> <p><b>Grading of Significance:</b> High</p>

Veranda Posts	Good	<p><b>Description:</b> Cast iron veranda posts with ornate lacework braces.</p> <p><b>Recommendation:</b> Prep for overcoating, wire brush and chemically treat any evident rust and repaint. Refer to Section 3.1.3 Painted Surfaces in the <i>Physical Condition and Schedule of Conservation Works</i> report for further treatment recommendations.</p> <p><b>Grading of Significance:</b> Exceptional</p>
Balustrade	Good	<p><b>Description:</b> Cast iron lacework panels with a wrought iron top railing. Currently in good condition, however, non-compliant. Detailed further in F16 and F17</p> <p><b>Recommendation:</b> Prep for overcoating, wire brush and chemically treat any evident rust and repaint. Refer to Section 3.1.3 Painted Surfaces in the <i>Physical Condition and Schedule of Conservation Works</i> report for further treatment recommendations.</p> <p><b>Grading of Significance:</b> Exceptional</p>

CME Building – External East Elevation		
Windows	Fair to poor	<p><b>Description:</b> Double hung windows, generally sound condition, however likely painted shut.</p> <p><b>Recommendation:</b> Windows detailed internally in room notes. Externally Paint strip areas of loose or flaking paint, and anywhere that rot or damp has affected it. The rest can be subject to overcoating and or spot repairs as per the guidelines within <i>AS4361.1:2017 Guide to Hazardous Paint Management</i>. Make windows operable, Re-putty glazing as required with linseed putty. Section 3.1.3 Painted Surfaces and section 3.1.5 Windows Surfaces in the <i>Physical Condition and Schedule of Conservation Works</i> report for further treatment recommendations.</p> <p><b>Grading of Significance:</b> High</p>
Doors	N/A	<p><b>Description:</b> Doors detailed in Rooms G11</p> <p><b>Recommendation:</b> N/A</p> <p><b>Grading of Significance:</b> N/A</p>

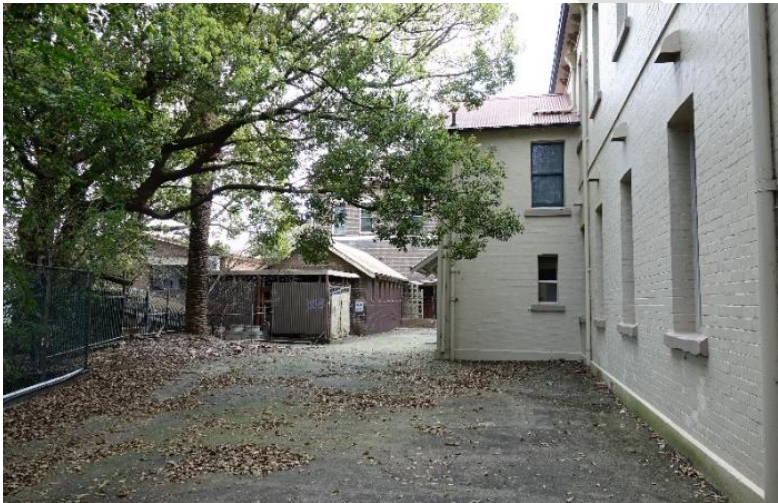
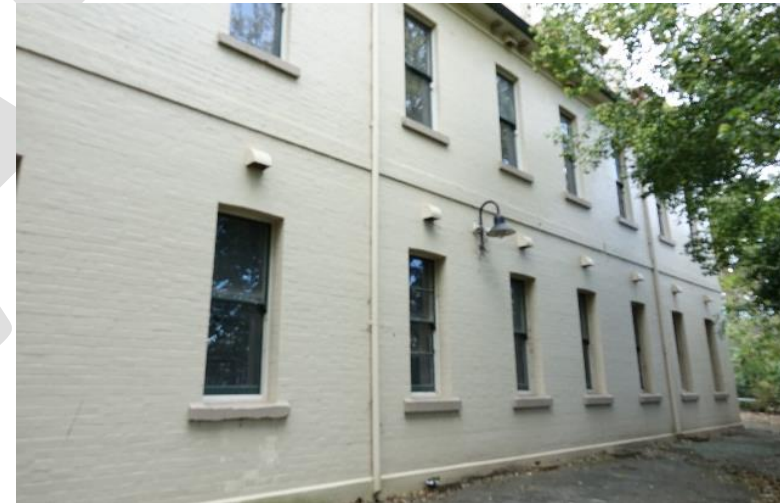
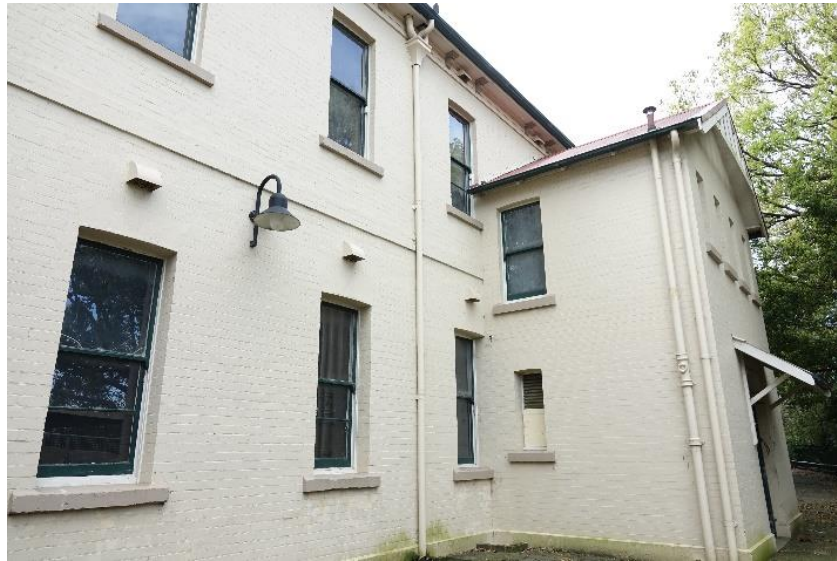
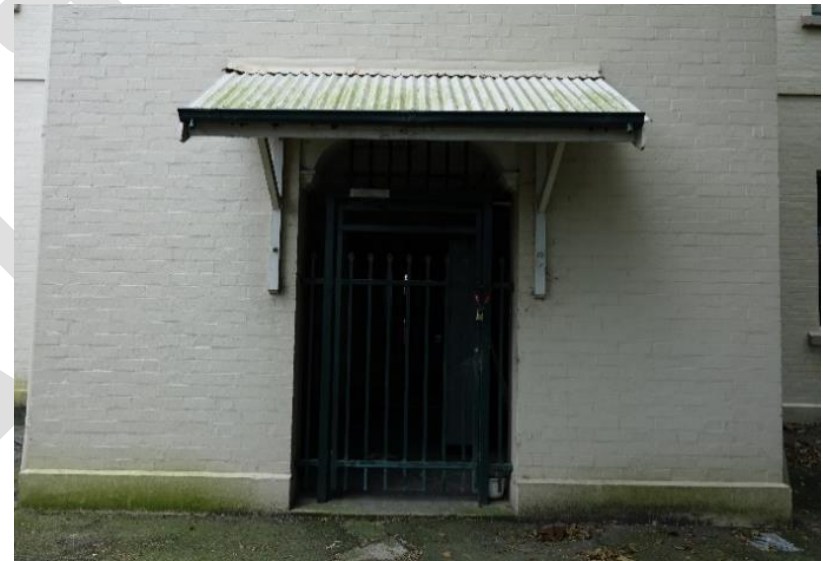
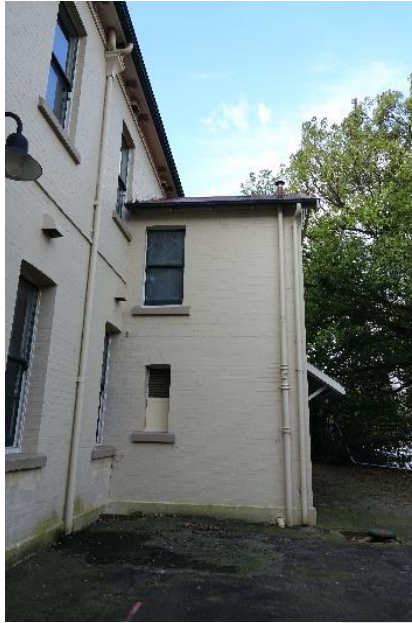
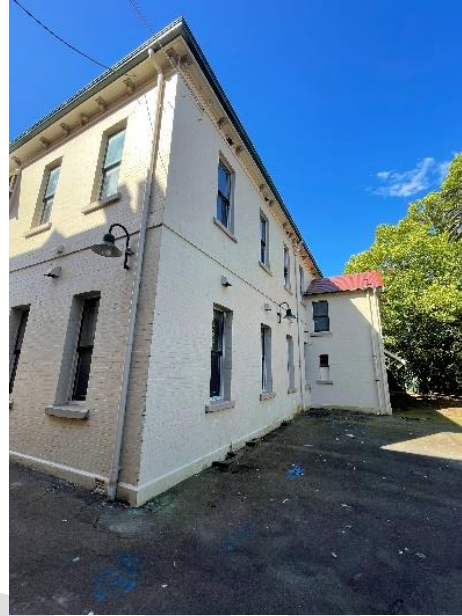
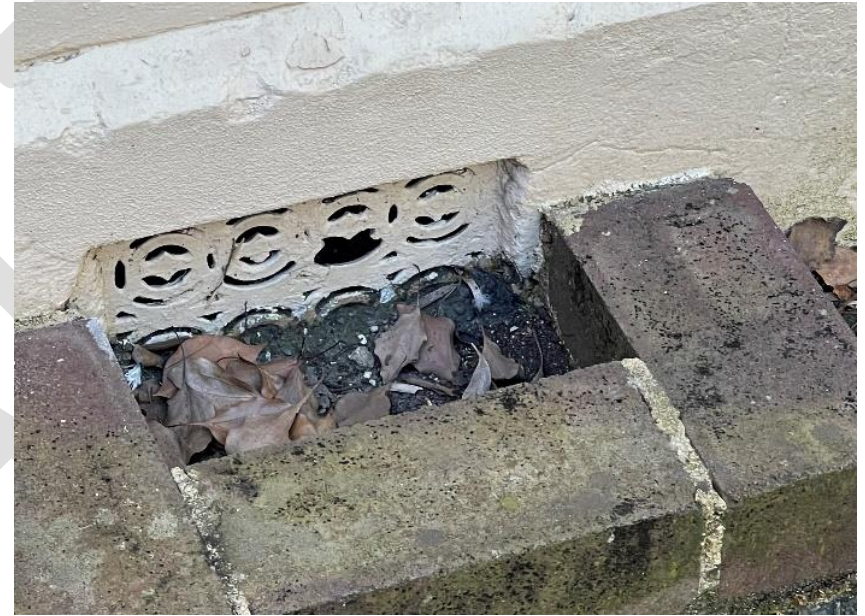
### CME Building – External South Elevation

CME Building – External South Elevation		
Fabric	Current Condition	Description and Recommendation
Floor	Poor	<p><b>Description:</b> Poor condition asphalt. With brick dams around the subfloor ventilation grills. The area is poorly graded and not compliant with access requirements. Various drainage pits in poor condition.</p> <p><b>Recommendation:</b> Area to be regraded and asphalt reinstated. All levels to be amended to suit compliance. See Landscape Plans for further details.</p> <p><b>Grading of Significance:</b> Neutral</p>
Walls	Fair	<p><b>Description:</b> External Paint finish brick walls. Gooseneck style lights are located in various locations at high level. All high level brick vents have a metal shroud protecting them from the weather.</p> <p><b>Recommendation:</b> Repair and prep spot repairs and repoint wall as necessary. Prepare existing paint for overcoating and repaint. See also section 3.1.3 Painted Surfaces in the <i>Physical Condition and Schedule of Conservation Works</i> report for further treatment recommendations.</p> <p><b>Grading of Significance:</b> High</p>

Windows	Fair to poor	<p><b>Description:</b> Double hung windows, generally sound condition, however likely painted shut.</p> <p><b>Recommendation:</b> Windows detailed internally in room notes. Externally Paint strip areas of loose or flaking paint, and anywhere that rot or damp has affected it. The rest can be subject to overcoating and or spot repairs as per the guidelines within <i>AS4361.1:2017 Guide to Hazardous Paint Management</i>. Make windows operable, Re-putty glazing as required with linseed putty. Section 3.1.3 Painted Surfaces and section 3.1.5 Windows Surfaces in the <i>Physical Condition and Schedule of Conservation Works</i> report for further treatment recommendations.</p> <p><b>Grading of Significance:</b> High</p>
Doors	N/A	<p><b>Description:</b> Doors detailed in Rooms G11 and G19</p> <p><b>Recommendation:</b> N/A</p> <p><b>Grading of Significance:</b> N/A</p>

Roof and Eaves	N/A	<p><b>Description:</b> Unable to access roof, eaves or gutters and upper areas of the façade for assessment. A small skillion roof awning is fixed to the rear of G19</p> <p><b>Recommendation:</b> N/A</p> <p>Unable to access roof, eaves or gutters and upper areas of the façade for assessment.</p> <p><b>Grading of Significance:</b> N/A</p>
Photos

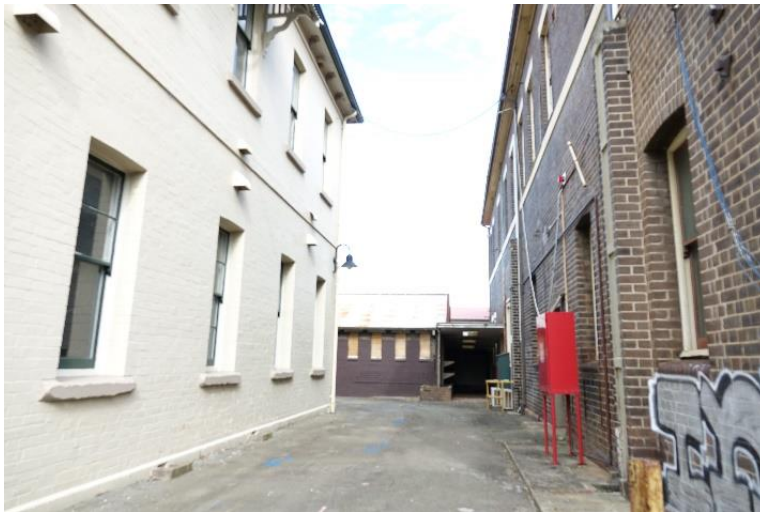
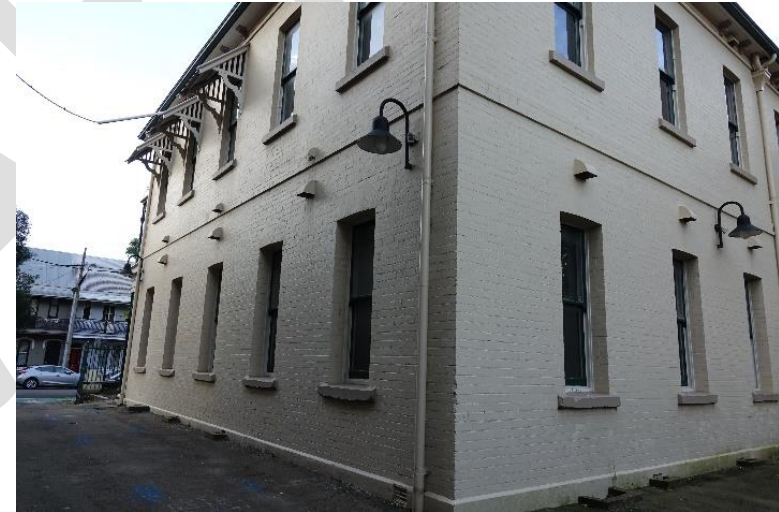
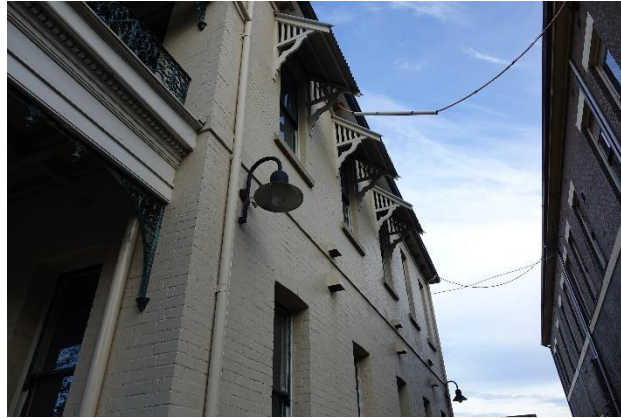
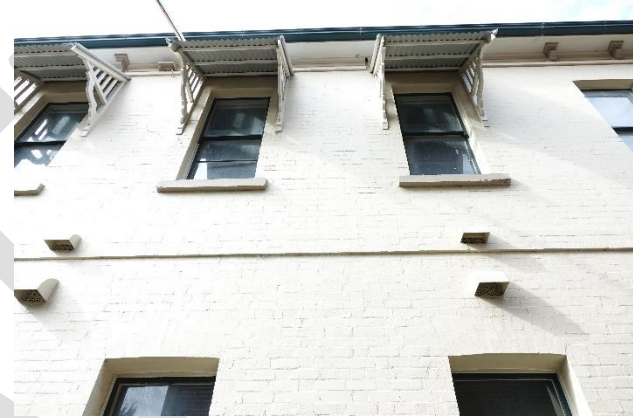
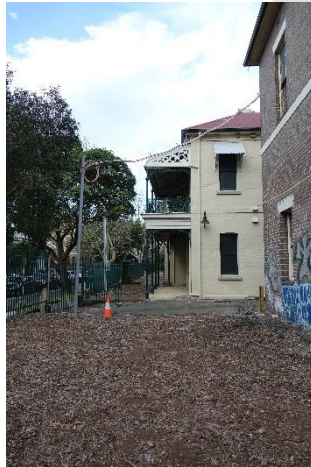
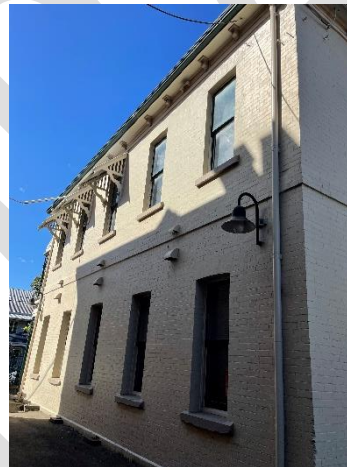
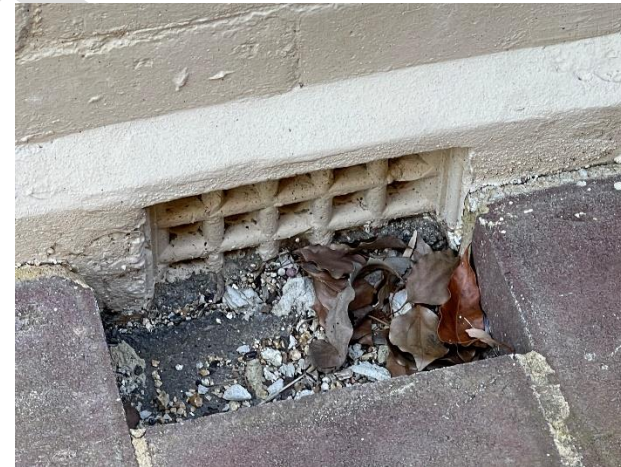
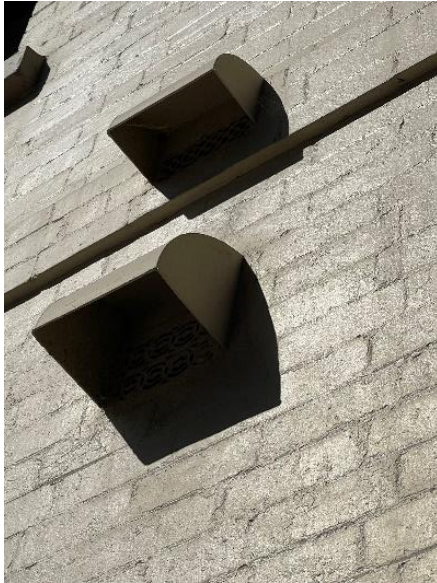
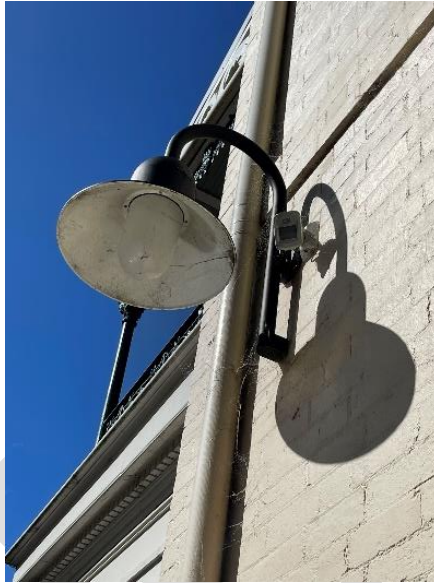
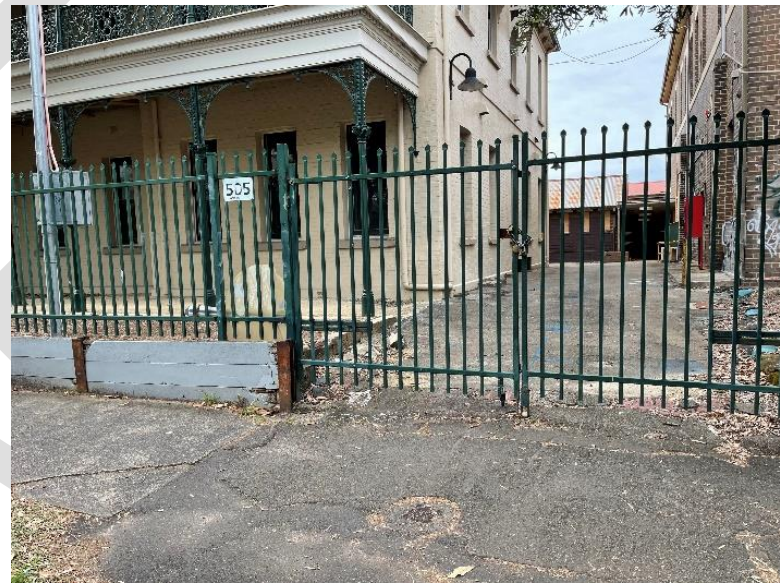
### CME Building – External West Elevation

CME Building – External West Elevation		
Fabric	Current Condition	Description and Recommendation
Floor	Poor	<p><b>Description:</b> Poor condition asphalt. With brick dams around some of the the subfloor ventilation grills. The area is poorly graded and not compliant with access requirements to the Veranda.</p> <p><b>Recommendation:</b> Area to be regraded and asphalt reinstated. All levels to be amended to suit compliance. See Landscape Plans for further details.</p> <p><b>Grading of Significance:</b> Neutral</p>
Walls	Fair	<p><b>Description:</b> External Paint finish brick walls. Gooseneck style lights are located in various locations at high level. All high level brick vents have a metal shroud protecting them from the weather.</p> <p><b>Recommendation:</b> Repair and prep spot repairs and repoint wall as necessary. Prepare existing paint for overcoating and repaint. See also section 3.1.3 Painted Surfaces in the <i>Physical Condition and Schedule of Conservation Works</i> report for further treatment recommendations.</p> <p><b>Grading of Significance:</b> High</p>

Windows	Fair to poor	<p><b>Description:</b> Double hung windows, generally sound condition, however likely painted shut. Several of the first floor windows have ornate awnings above them with decorative fretwork.</p> <p><b>Recommendation:</b> Windows detailed internally in room notes. Externally Paint strip areas of loose or flaking paint, and anywhere that rot or damp has affected it. The rest can be subject to overcoating and or spot repairs as per the guidelines within <i>AS4361.1:2017 Guide to Hazardous Paint Management</i>. Make windows operable, Re-putty glazing as required with linseed putty. Section 3.1.3 Painted Surfaces and section 3.1.5 Windows Surfaces in the <i>Physical Condition and Schedule of Conservation Works</i> report for further treatment recommendations.</p> <p><b>Grading of Significance:</b> High</p>
Doors	N/A	<p><b>Description:</b> N/A -No doors in this area</p> <p><b>Recommendation:</b> N/A</p> <p><b>Grading of Significance:</b> N/A</p>

Roof and Eaves	N/A	<p>Description: Unable to access roof, eaves or gutters and upper areas of the façade for assessment.</p> <p>Recommendation: N/A</p> <p>Grading of Significance: N/A</p>
Photos

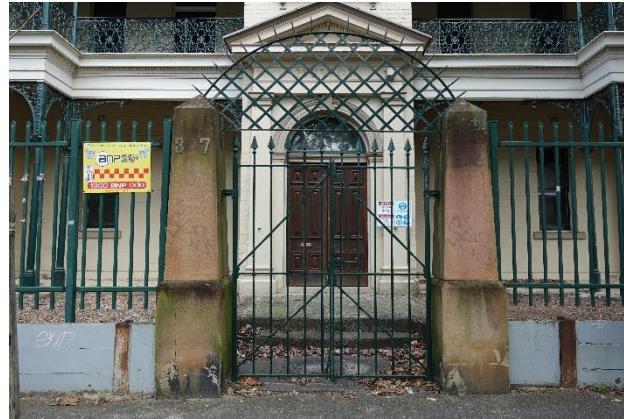
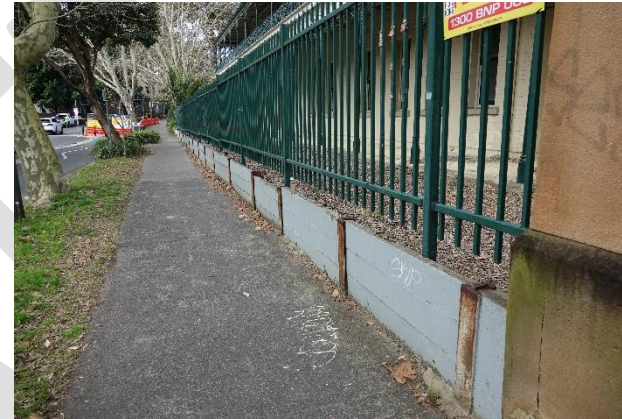
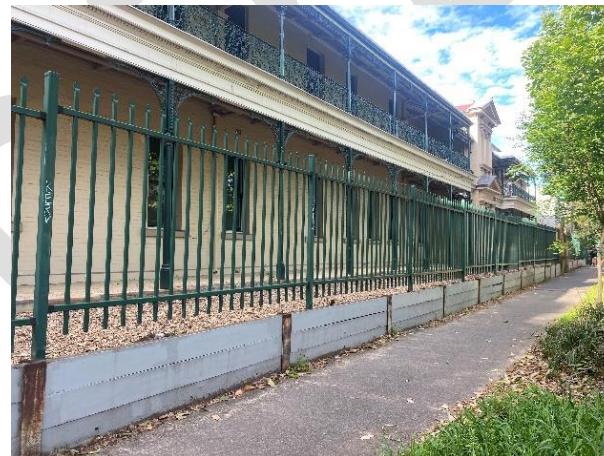
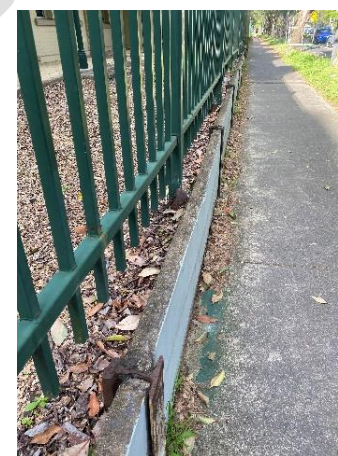
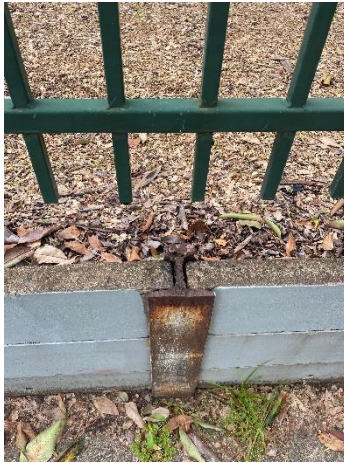
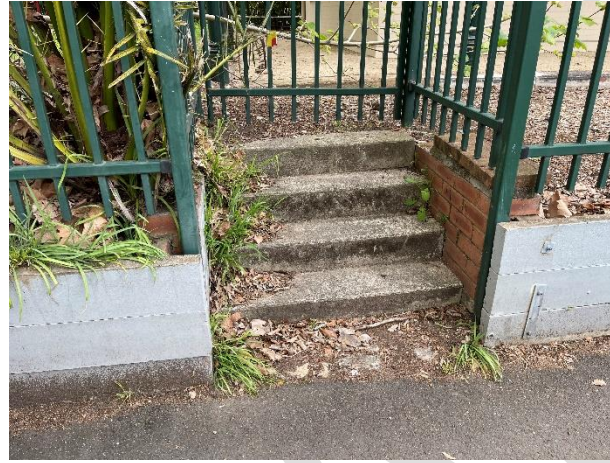
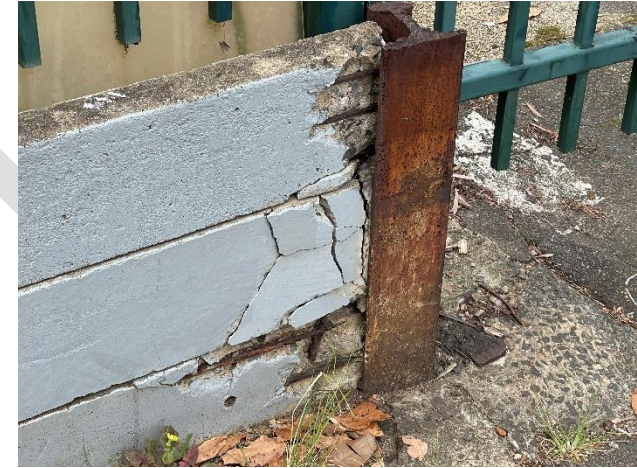
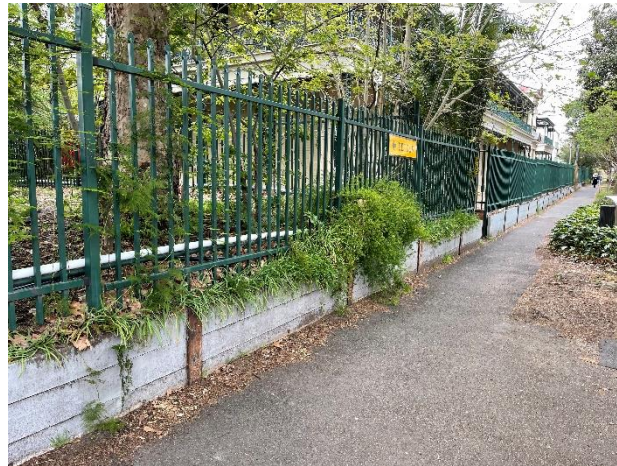
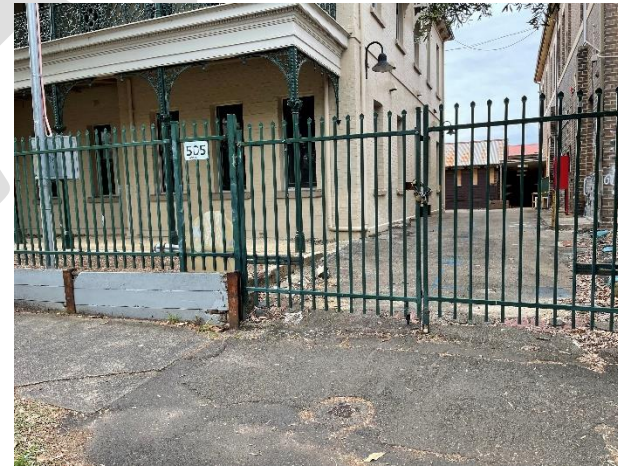
## CME Building – Front Fence

CME Building – Front Fence		
Fabric	Current Condition	Description and Recommendation
Metal Fence	Poor	<p><b>Description:</b> Poor condition metal fence, rusty in places. At the western end at the driveway, a large pair of gates with inoperable openers swing inwards into the site. At the eastern end, a single gate provides access from the Wilson street footpath via some concrete stairs.</p> <p><b>Recommendation:</b> Fence to be removed and replaced. See Landscape Plans for further details.</p> <p><b>Grading of Significance:</b> Intrusive</p>
Retaining Wall	Poor	<p><b>Description:</b> Concrete sleeper retaining wall with vertical railway iron retaining posts. Evidence of concrete cancer and is leaning towards the street. Damaged in places.</p> <p><b>Recommendation:</b> Remove and replace retaining wall. See Landscape Plans for further details.</p> <p><b>Grading of Significance:</b> Intrusive</p>

Heritage Entry Gate	Poor	<p><b>Description:</b> A pair of wrought iron spear head gates beneath a semicircular head with wrought iron lattice and spikes hung on Sandstone columns. One of the columns is leaning.</p> <p><b>Recommendation:</b> Level up sandstone column. Prep wrought iron gates and head for overcoating, wire brush and chemically treat any evident rust and repaint. Refer to Section 3.1.3 Painted Surfaces in the <i>Physical Condition and Schedule of Conservation Works</i> report for further treatment recommendations.</p> <p><b>Grading of Significance:</b> Exceptional</p>

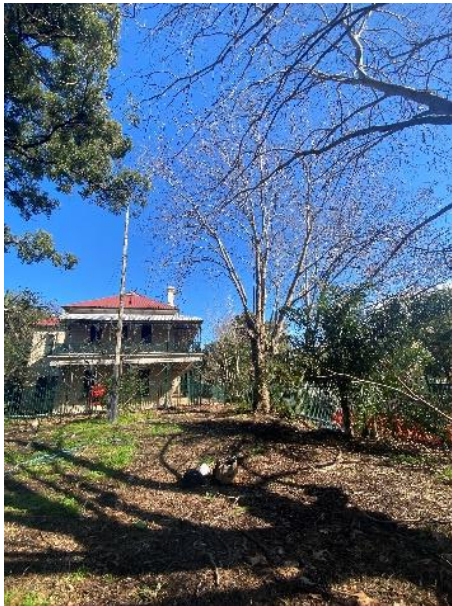
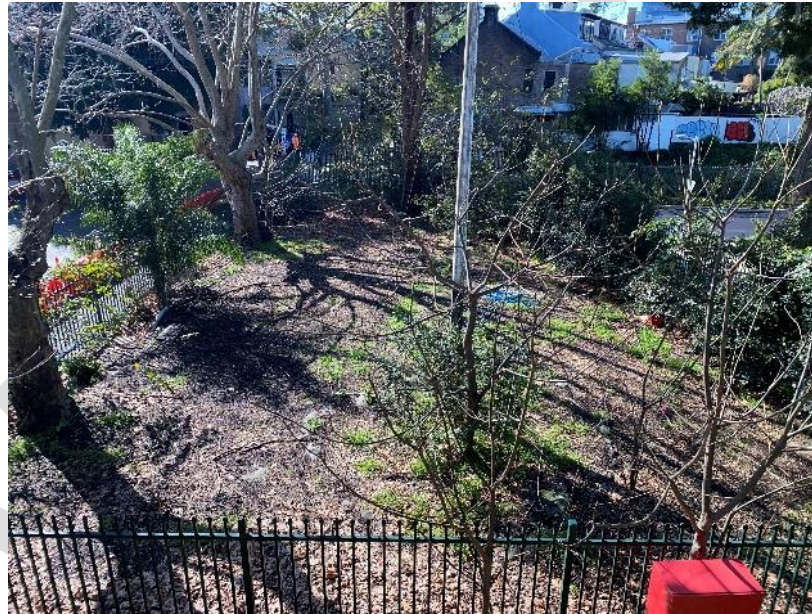
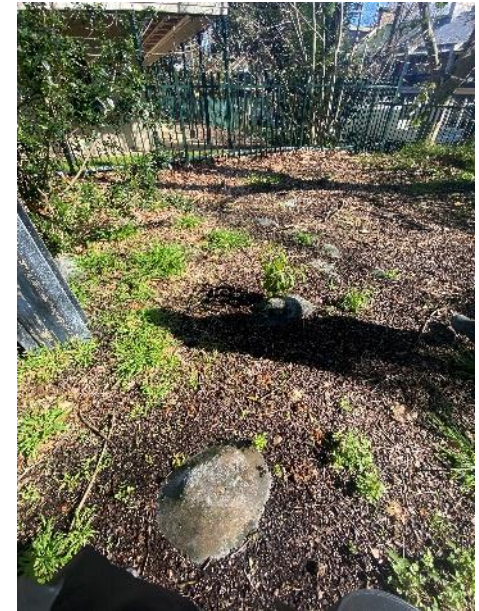
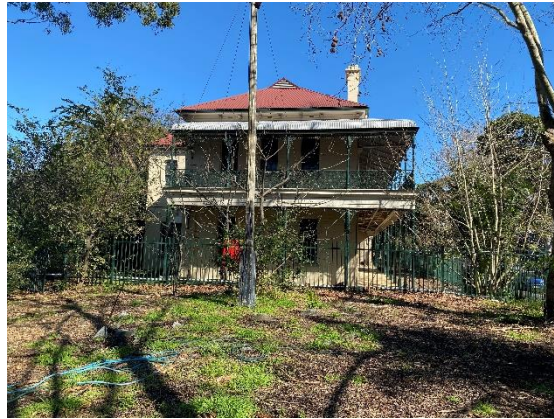
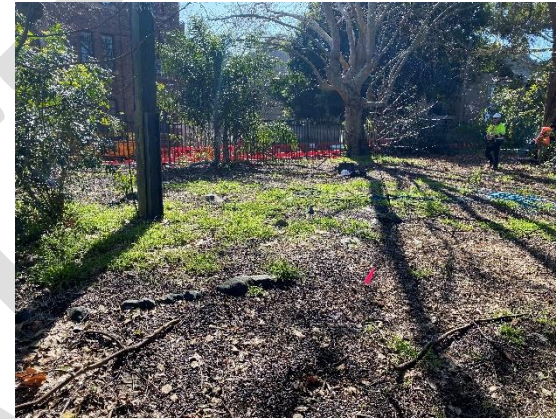
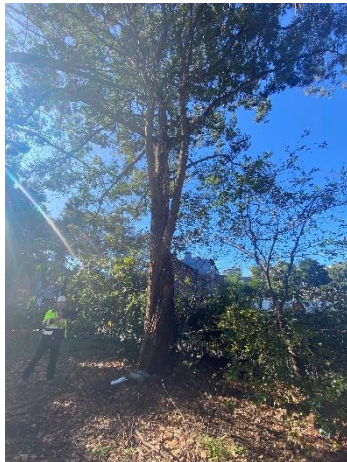
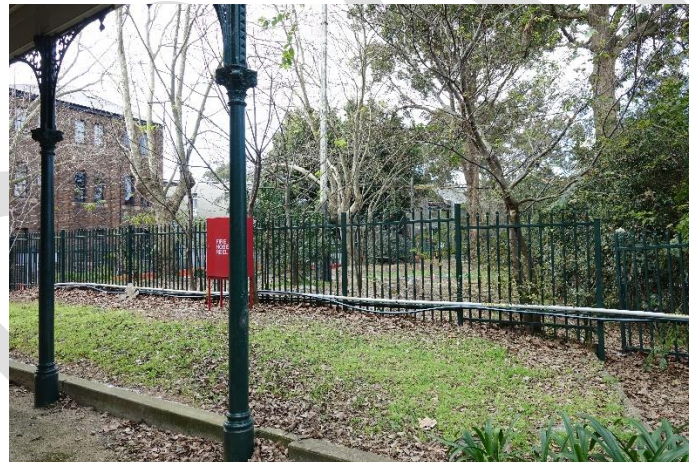
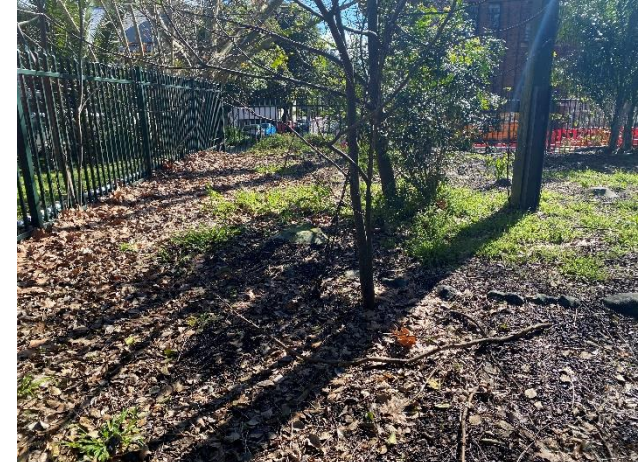
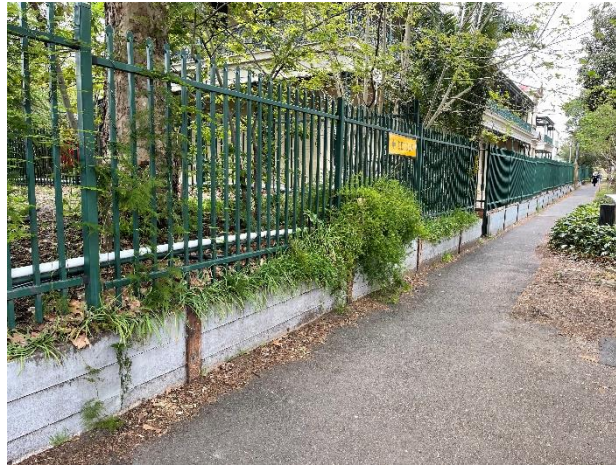
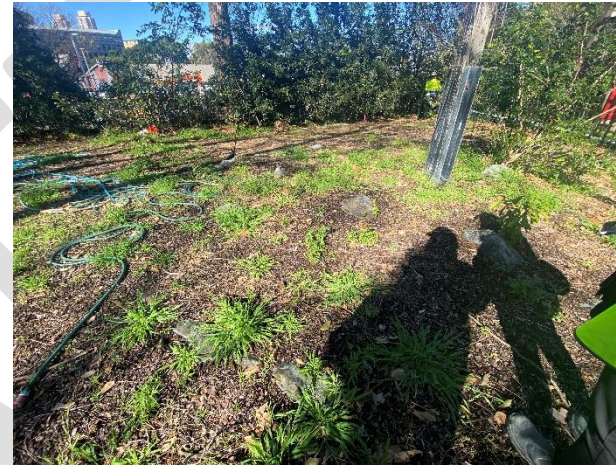
**CME Building – Eastern Garden**

CME Building – Eastern Garden		
Fabric	Current Condition	Description and Recommendation
Metal Fence	Poor	<p><b>Description:</b> Poor condition metal fence around the perimeter, rusty in places. A gate at the south western corner.</p> <p><b>Recommendation:</b> Fence to be removed and to the north east and south only. Western section not to be replaced to provide clear access to the CME. See Landscape Plans for further details.</p> <p><b>Grading of Significance:</b> Intrusive</p>
Retaining Wall	Poor	<p><b>Description:</b> Concrete sleeper retaining wall with vertical railway iron retaining posts. Evidence of concrete cancer and is leaning towards the street. Damaged in places.</p> <p><b>Recommendation:</b> Remove and replace retaining wall. See Landscape Plans for further details.</p> <p><b>Grading of Significance:</b> Intrusive</p>
Gardens	Poor	<p><b>Description:</b> Overgrown gardens, overrun by certain species. Rockery and railway sleeper borders. A flagpole at the western end with guide wires maintaining stability. High potential for Aboriginal Archaeology in this area.</p> <p><b>Recommendation:</b> Trim gardens, remove invasive species and weeds. Restore flagpole. See landscape plans for further details.</p> <p><b>Grading of Significance:</b> Intrusive</p>
