**ADDITIONAL CONTAMINATION ASSESSMENT
&
REMEDIAL ACTION PLAN**

PROPOSED NARWEE PARKLAND CARE COMMUNITY

**LOTS D & C DP403467, LOT 2 DP518877 AND LOTS 2 & 3 DP16063
59-67 KARNE STREET NORTH, NARWEE**

REPORT NO 20219/6-AA 8 DECEMBER 2022

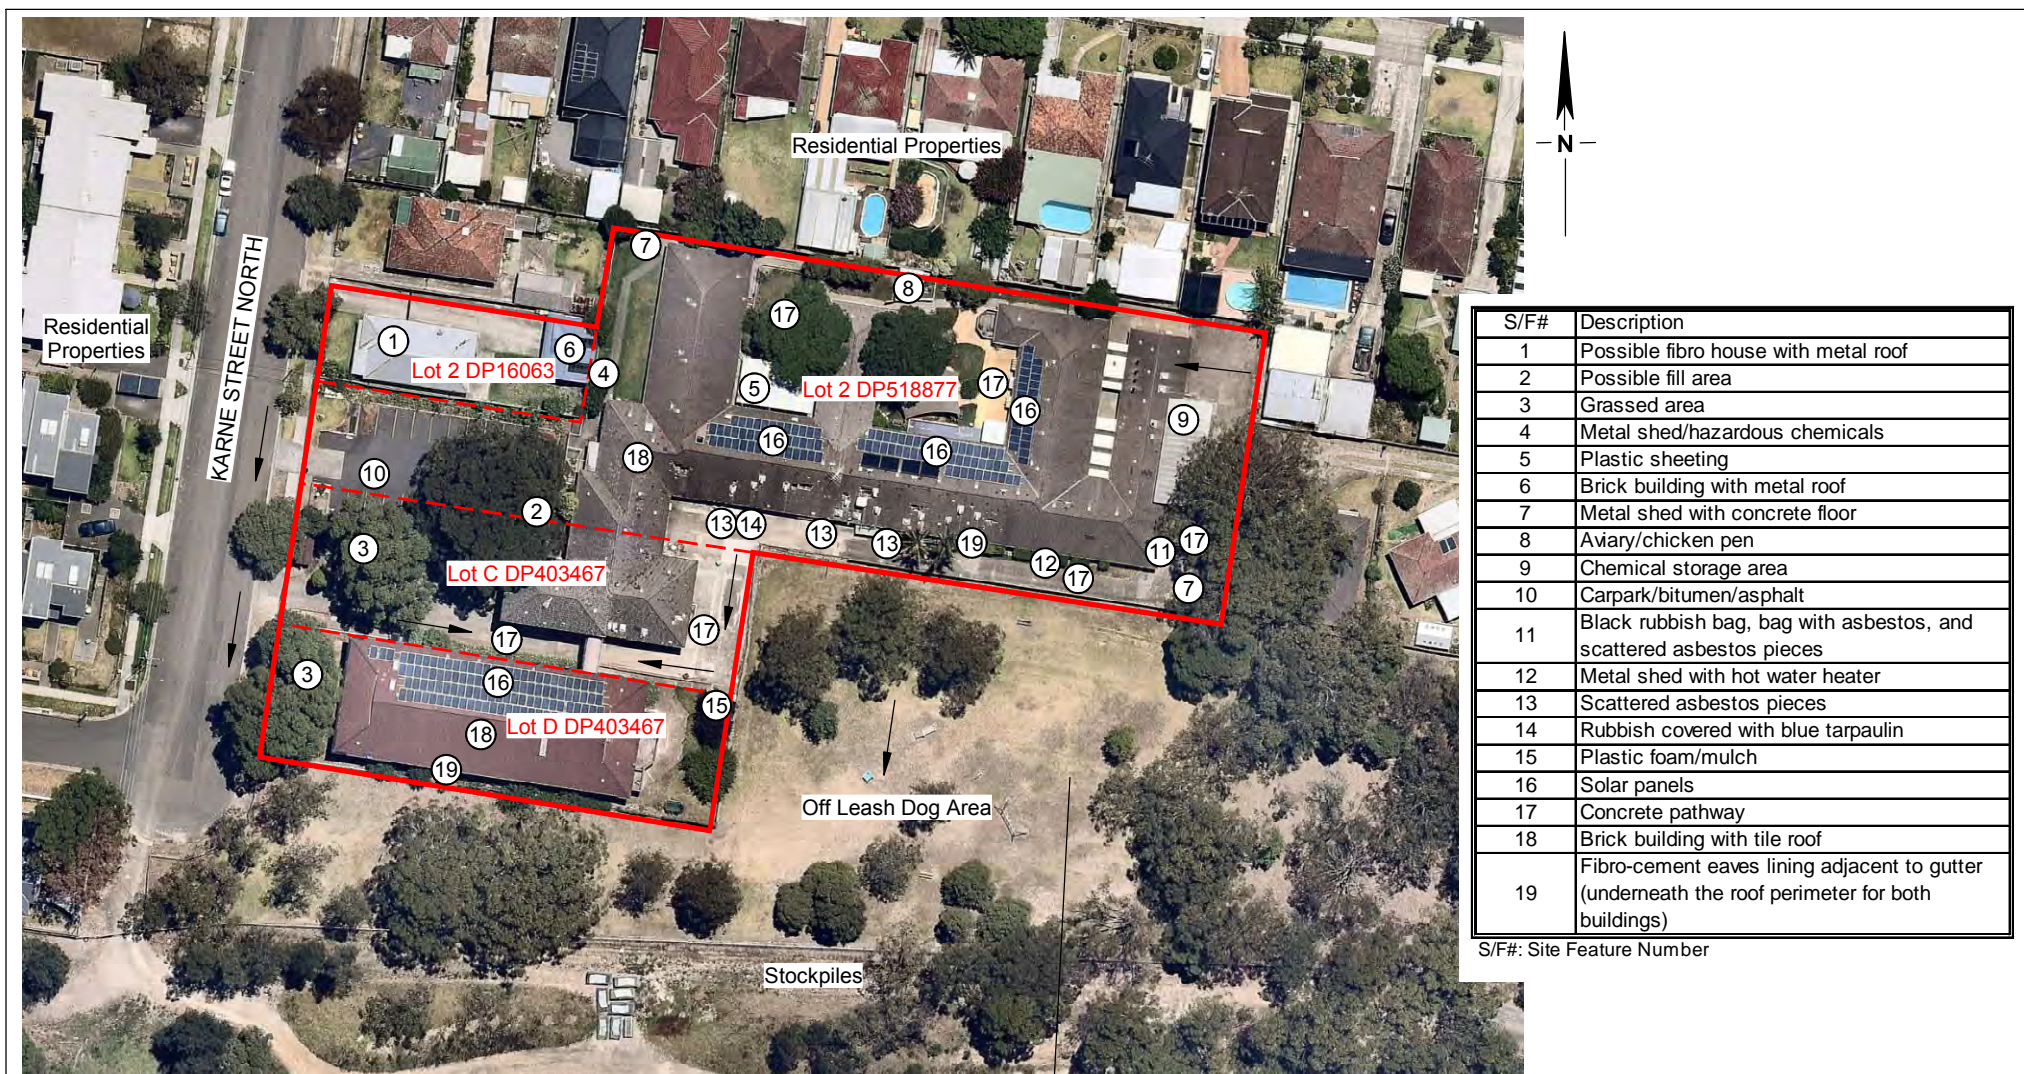
Drawing No: 13977/1-AA1
 Job No: 13977/1
 Drawn By: MH
 Date: 30 March 2017
 Checked By: AB/SS

During the inspection for the phase 2 CA, the site was utilised primarily as a nursing home, with one property in the north-west corner being used for residential purposes. The site remained unchanged as observed during Phase 1 PSA in March 2017, as shown on Drawing No 13977/1-AA1.
