# Arboricultural Impact Assessment Report

**AIA-01**

Revision C  
5 March, 2025

## **BaptistCare Macquarie Park - Concept Master Plan State Significant Development Application (SSDA)**

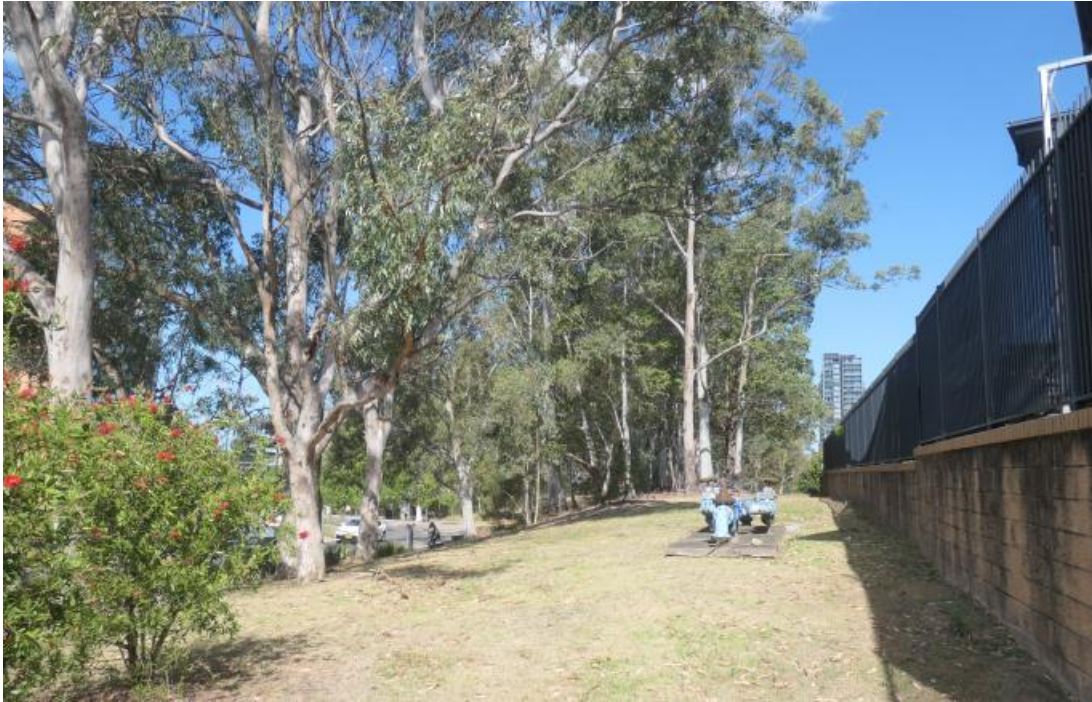
Figure 1.7 – Typical photo of the adjoining University site and conditions. There are large neighbouring trees in the University grounds on periphery of the site. These are typically well setback from the site and can, and will be, retained and protected. (Photo: Arterra 18/10/23)

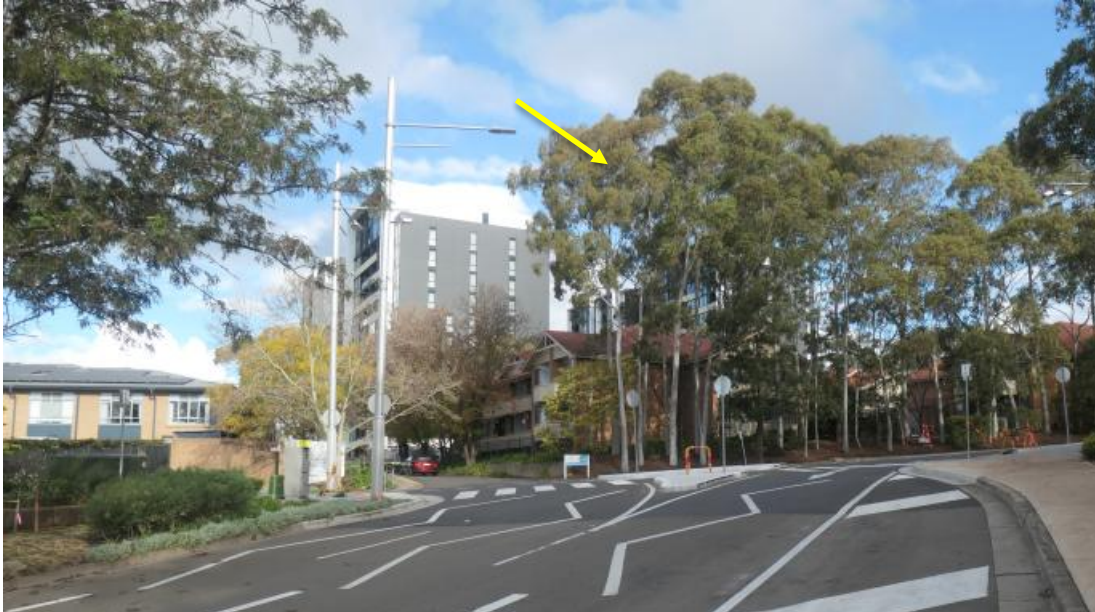
Figure 1.9 – Prominent groupings of relatively tall and healthy Lemon-scented gums (*Corymbia citriodora*) around the south-west perimeter of the site, fronting Balaclava Rd. Although individually these may not be ‘high’ retention value trees, as a group their significance is higher and great emphasis has been placed on maintaining an extensive proportion of these trees. (Photo: Arterra 15/8/23).

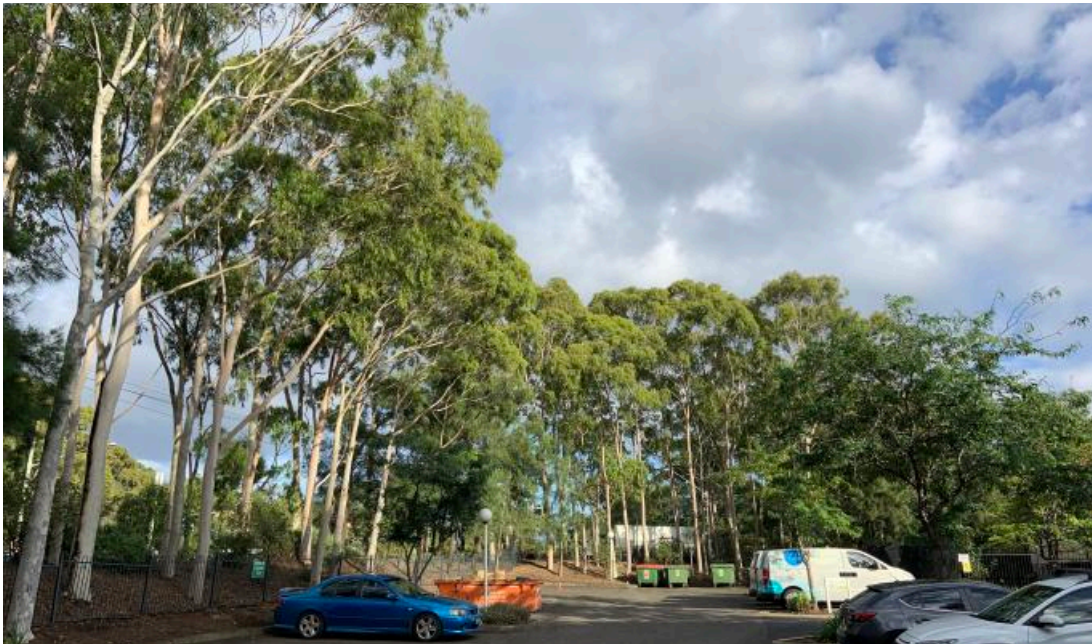
Figure 2.7 – Prominent groupings of relatively tall and prominent Lemon-scented Gums around the south-west perimeter of the site, fronting Epping Rd. Although individually these are not high retention value trees, as a group their significance is greater and emphasis and focus has been placed on maintaining a good proportion of these trees as part of the ultimate Master Plan. (Photo: Arterra 11/3/22).

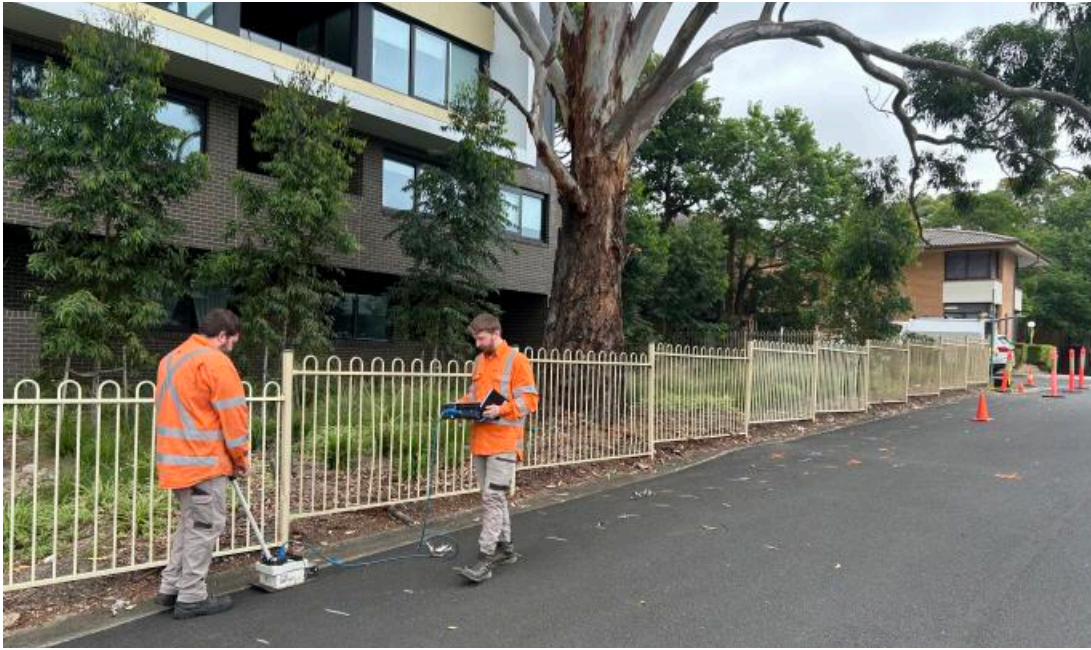
Figure 2.13 – Photo of subsurface root investigations being undertaken using ground penetrating radar north of T76 over the existing internal roadway. (Photo: Arterra 01/3/24)

The results from the GPR indicated that the tree roots found under the existing road were mostly shallow and spreading radially from the centre of the tree. An interpretation of the GPR imagery suggest that there may have been an historic trench excavated for services (likely Telstra) beneath the road to the north of the tree, with the roots typically stopping at the line of the disturbance to this trench. No significant tree roots of any size or kind were recorded to the north of this historical disturbance. Therefore, it is the author's opinion, that the notional incursion to construct the proposed road carriageway is acceptable and unlikely to result in any material, negative impacts to the condition of the tree. The existing bitumen driveway must be carefully demolished to the north of this tree, with care to minimise or root damage or disturbance near the tree.

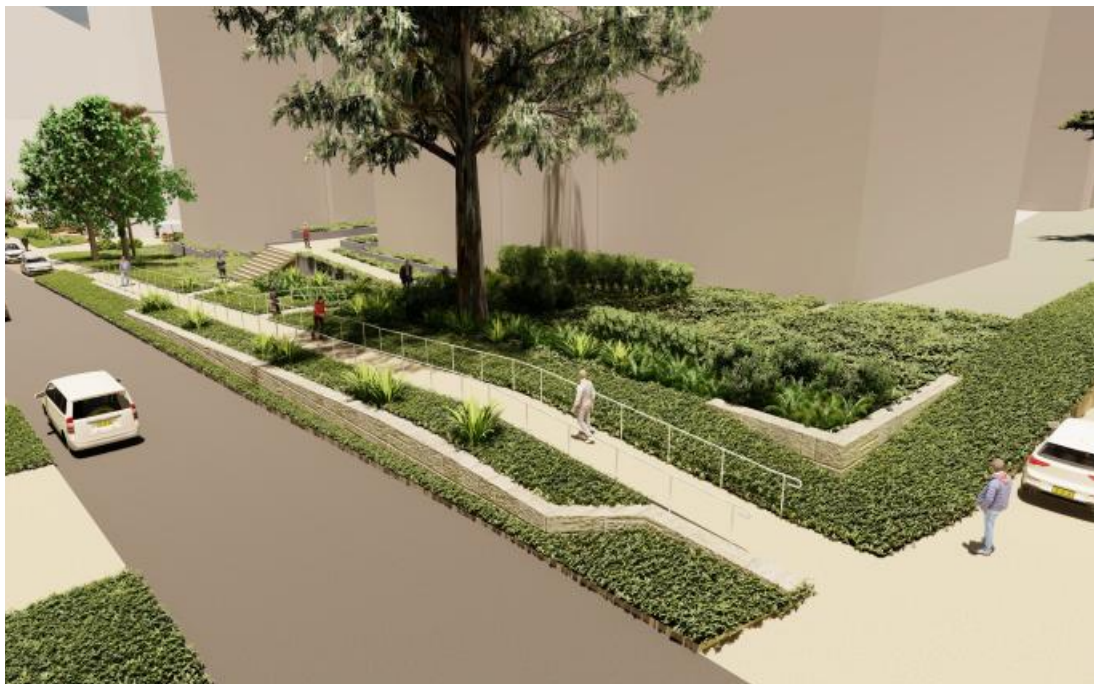
Figure 2.15 –Illustrative render of proposed design highlighting the implementation of a retaining wall to maintain the existing levels to the north of the tree (Illustrative Render: Arterra)

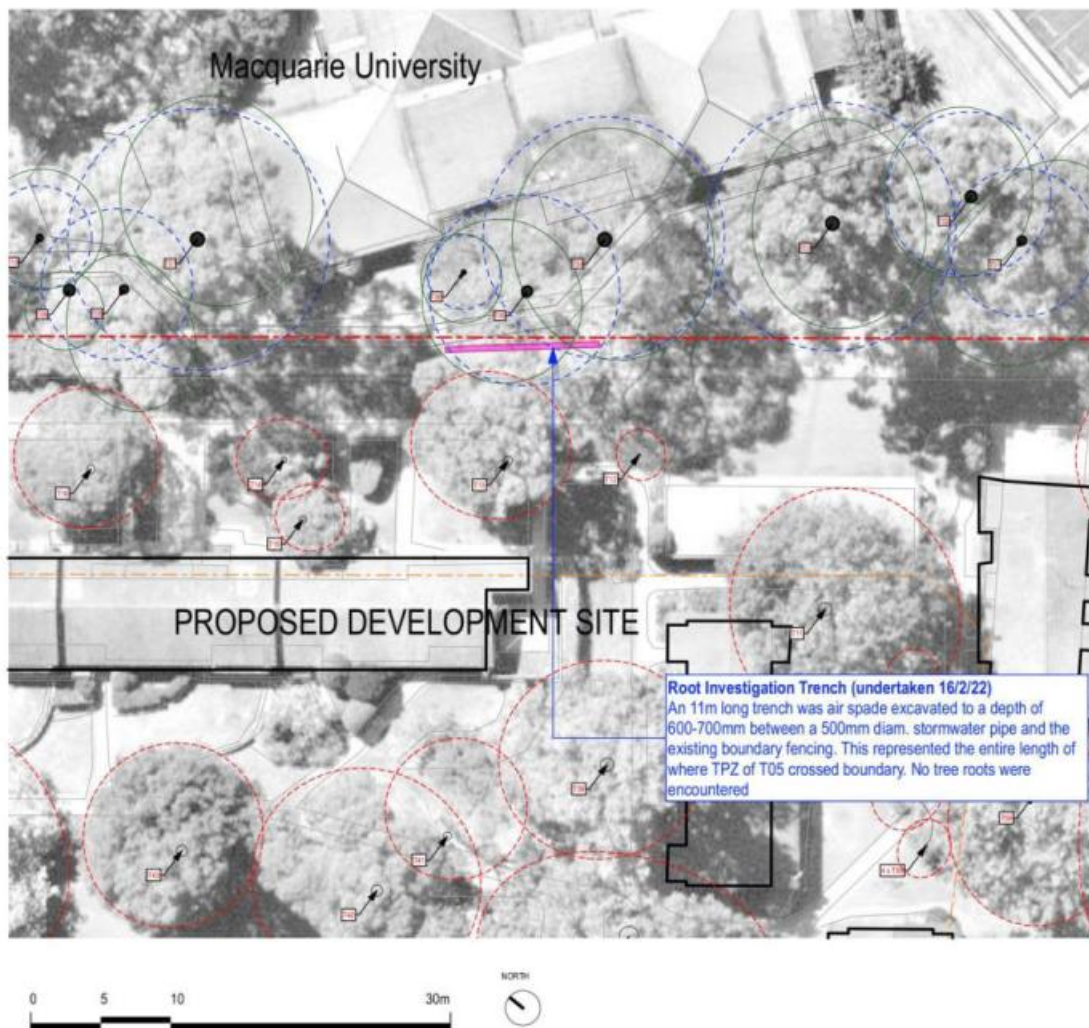
Figure 3 – Plan of the trenching location and extent and relationship to boundary and tree. (Source: Arterra)

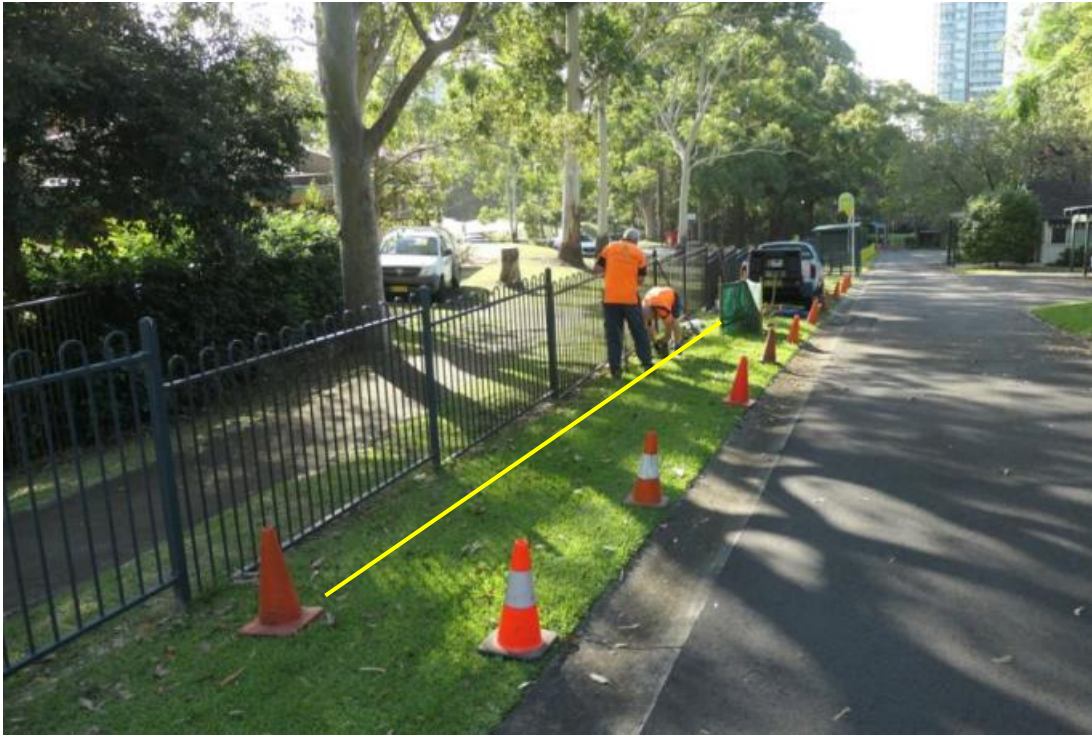
Figure 4 – Photo of the area where root investigations were carried out. Line of trench marked in yellow. (Photo: Arterra 16/2/22)

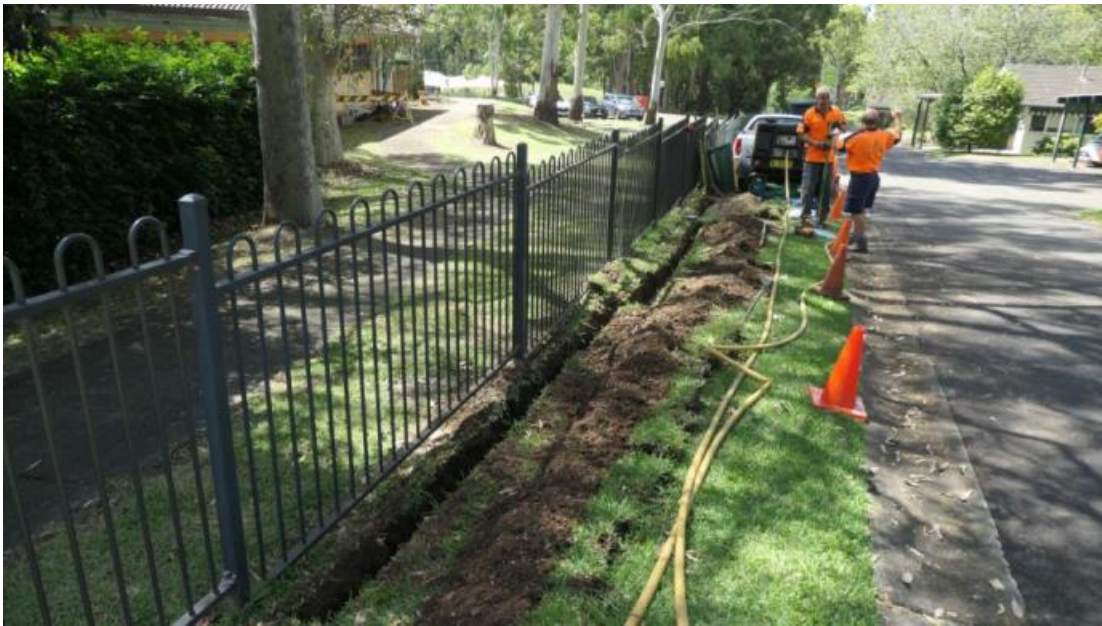
Figure 4 – Photo of the area where root investigations were carried out, with trenching completed. (Photo: Arterra 16/2/22)

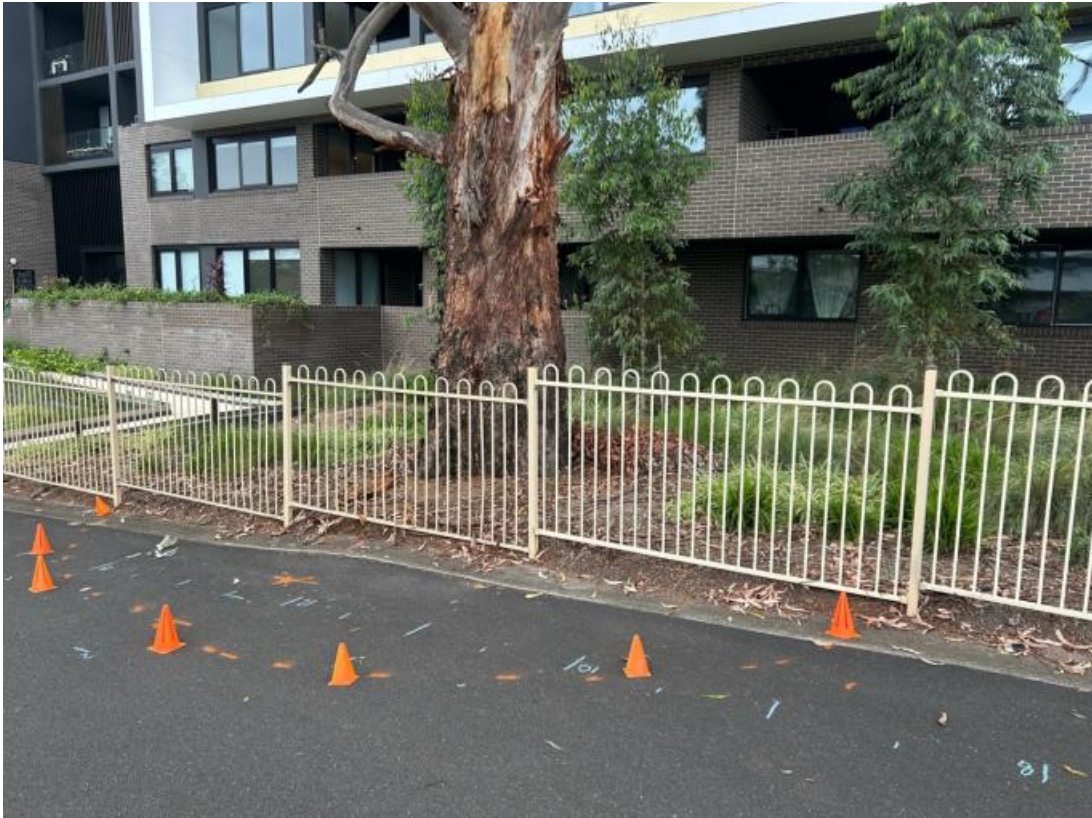
Figure 2 – Image of the area where GPR root investigations were carried out. The SRZ of the tree was clearly defined with the witches hats and spray paint. Note the recently completed gardens and new *Euc. saligna* planting. (Photo: Arterra 1 March 2024)

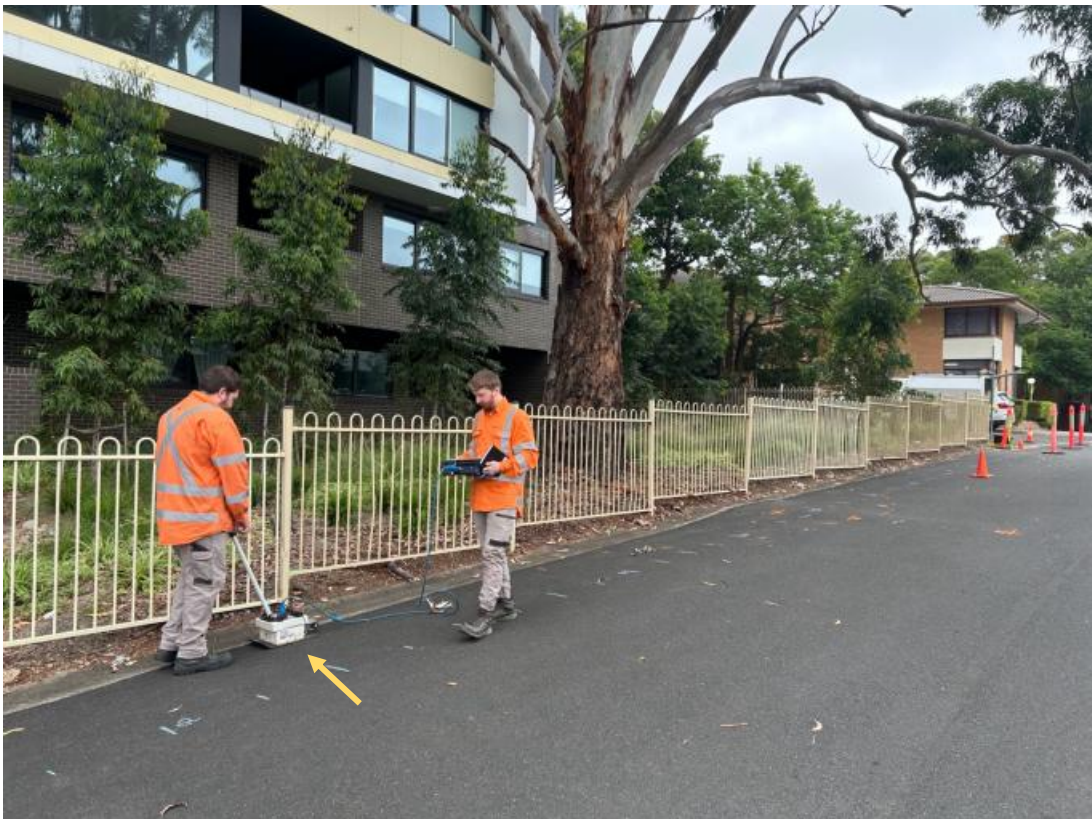
Figure 3 – Image of the area where GPR root investigations were carried out looking west. The ground penetrating radar equipment is visible (arrowed) and being used to map existing potential subsurface tree roots and services. (Photo: Arterra 1 March 2024)

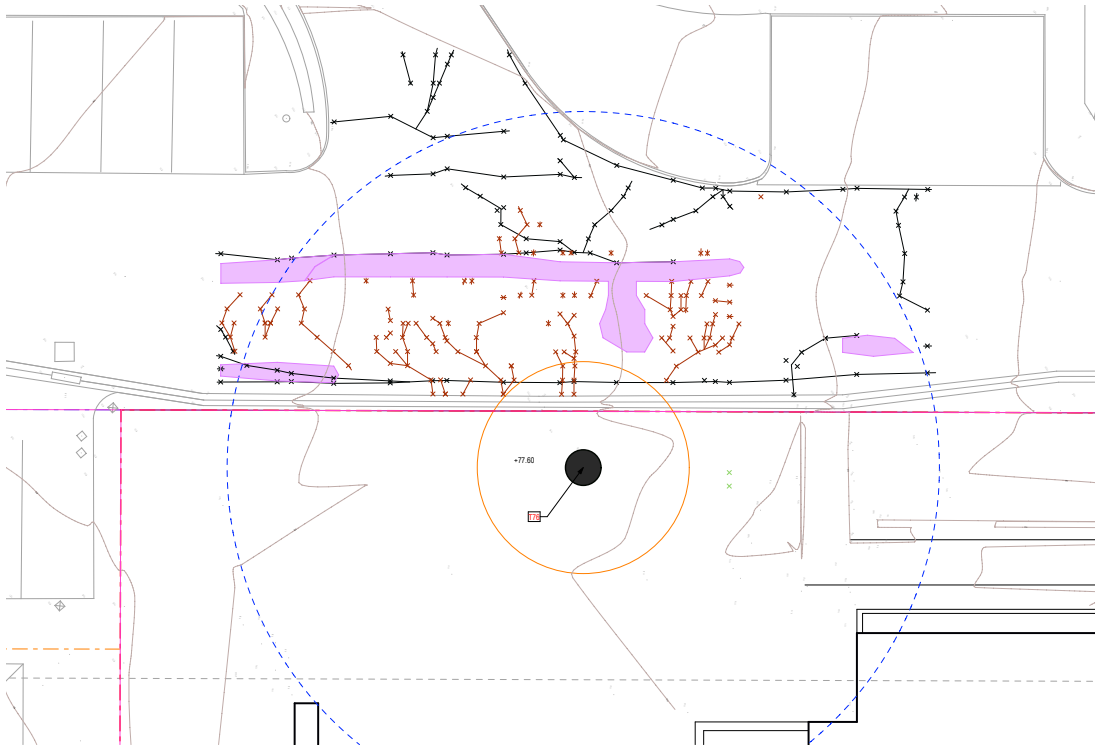
Figure 4 – Plan drawing of the root investigation area, with the RAW data results received from the GPR shown within the TPZ of T76 (TPZ shown as a blue dashed line and the SRZ shown as a solid orange line). The boundary to Parkside is shown as a red dashed line with the BaptistCare site to the north of this line. The pink fill highlights an area that was likely trenched and backfilled and/or disturbed, the red-brown line work indicates the likely location of existing tree roots, and the black line work are unknown items which are likely to be existing services. (Drawing: By Arterra - utilising GBG Group supplied CAD Data 17/05/24)

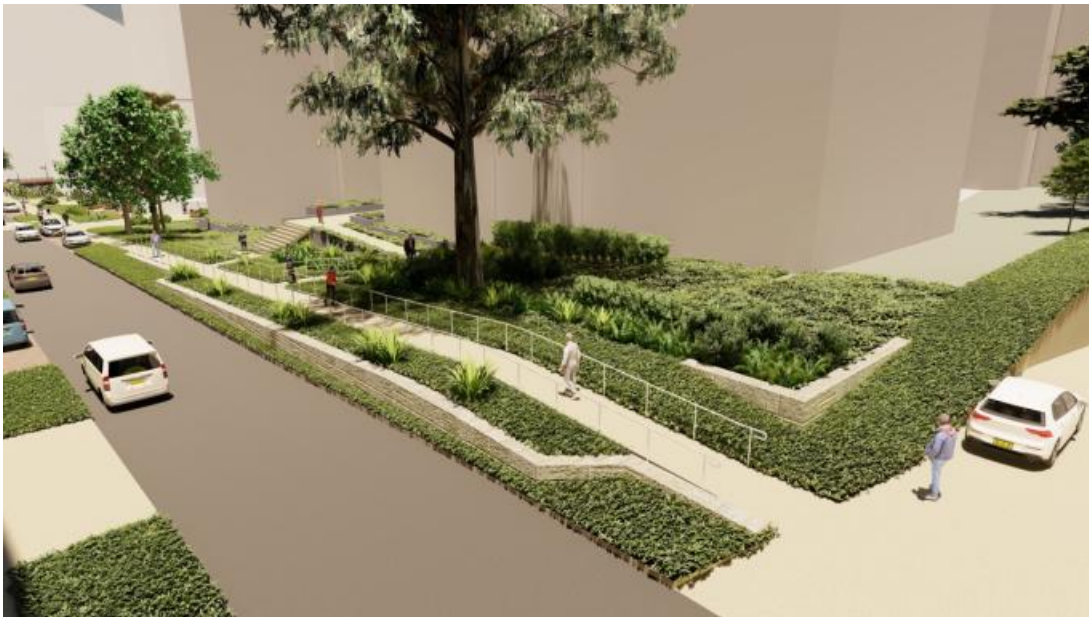
Figure 7 – Illustrative render of the proposed Concept Master Plan highlighting the design modifications to ensure that the existing levels are retained around T76 to protect tree roots. The proposed footpath is a series of 1:14 ramps and a new low impact retaining wall has been utilised along the proposed new road edge to retain the existing levels close to the tree. (Illustrative Render: Arterra 10 October 2024)

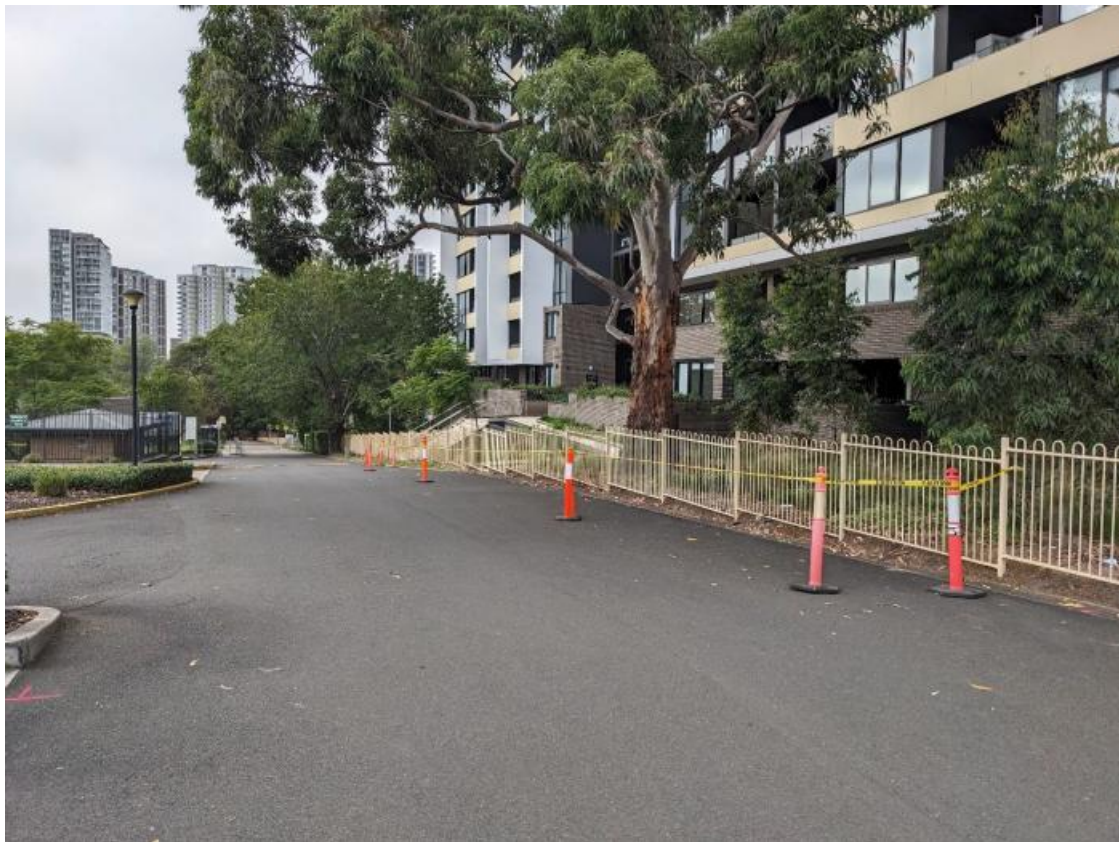
**Figure 1. Site Image looking south-east along the road towards tree T76**
