## DILAPIDATION REPORT

10 EASTERN CREEK DRIVE EASTERN CREEK, NSW, 2766

THURSDAY, 22 FEBRUARY 2024

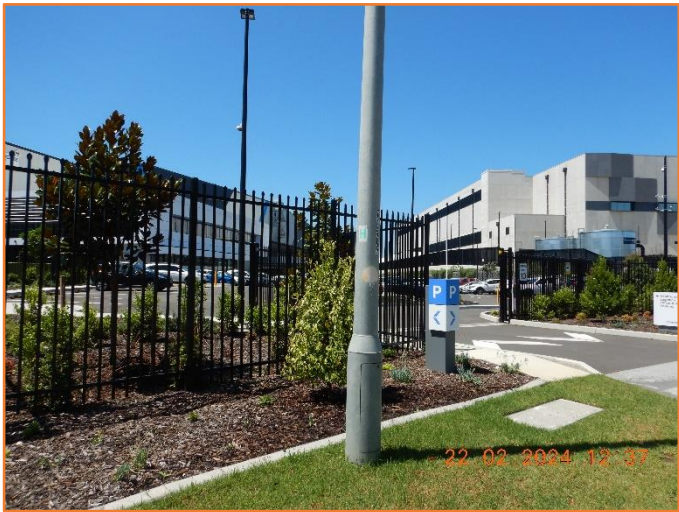
Figure 1: Reasonable - General condition of monopole assembly.

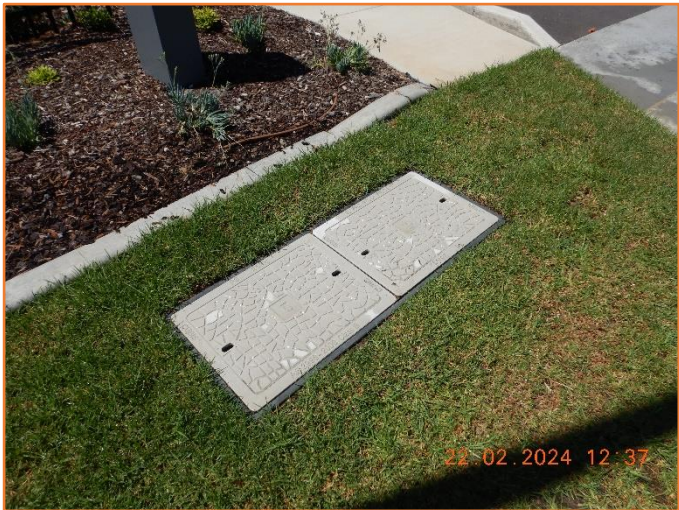
Figure 2: Good - General condition of service pit.

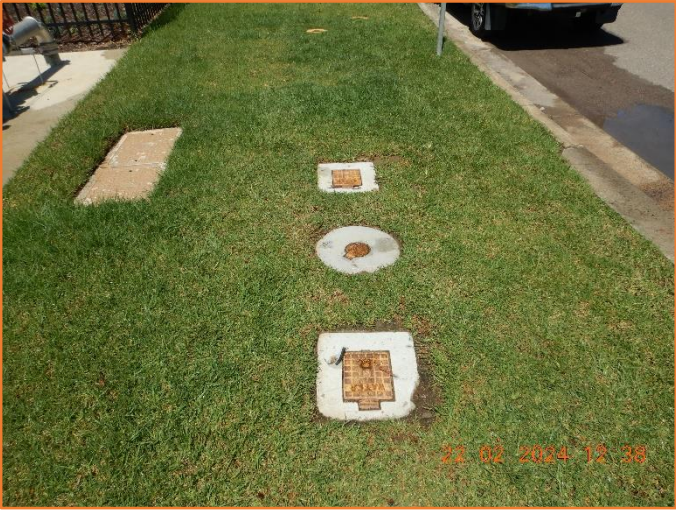
Figure 7: Reasonable - General condition of service pits.

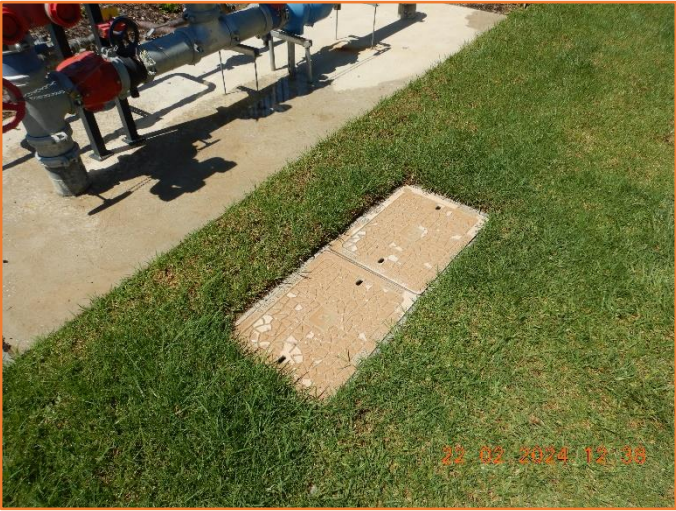
Figure 8: Reasonable - General condition of service pit.

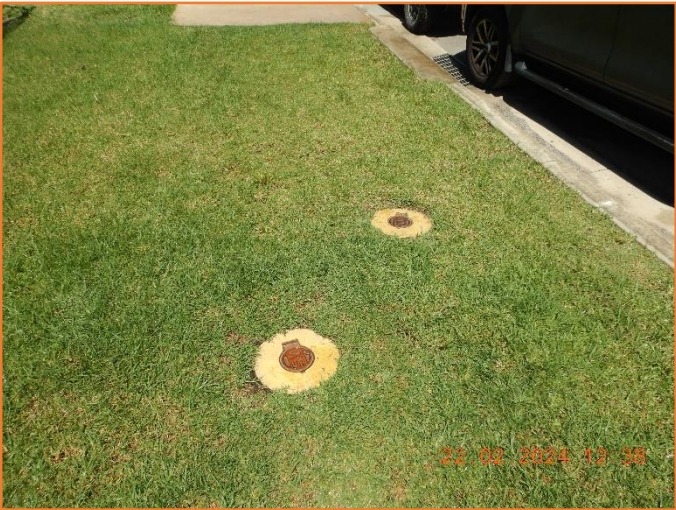
Figure 9: Reasonable - General condition of service pits.

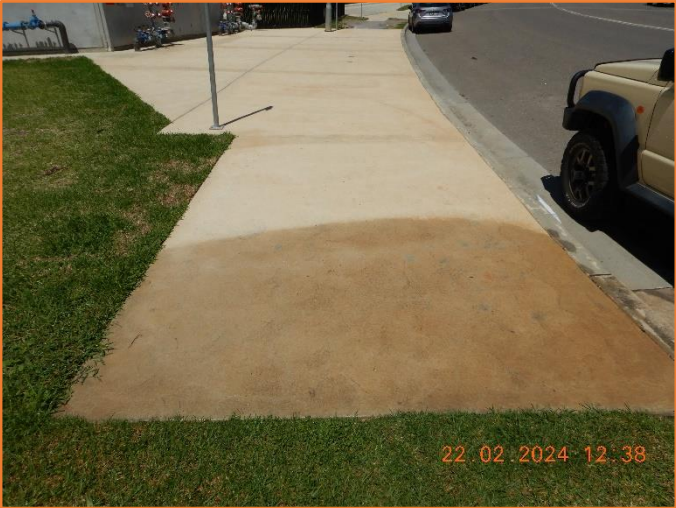
Figure 10: Reasonable - General condition of footpath.

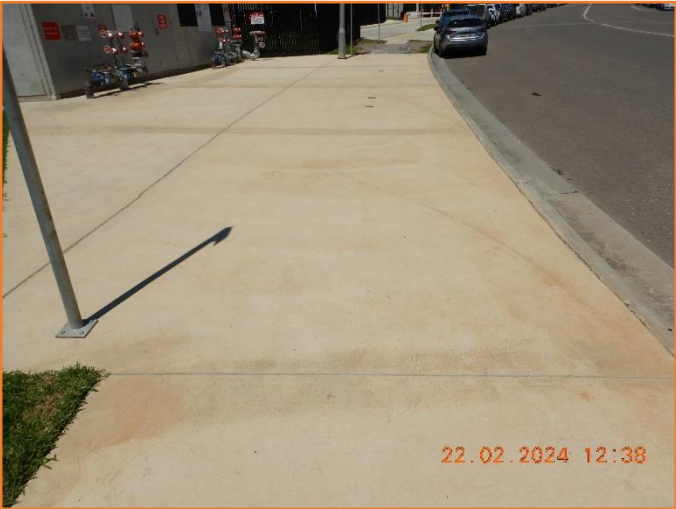
Figure 11: Reasonable - General condition of footpath.

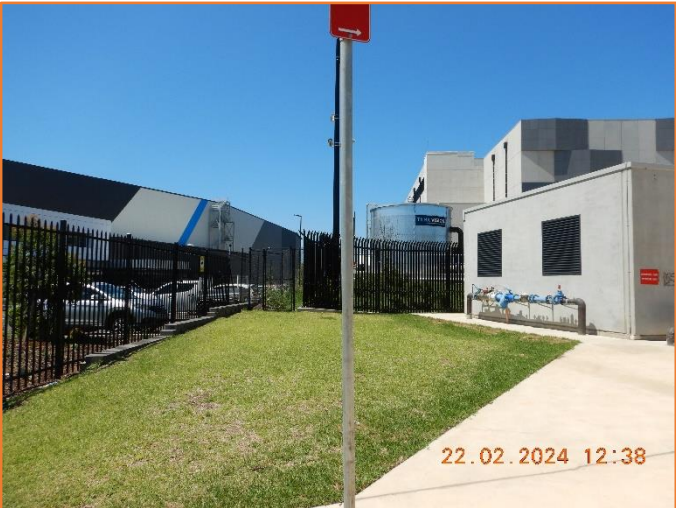
Figure 12: Good - General condition of traffic signage.

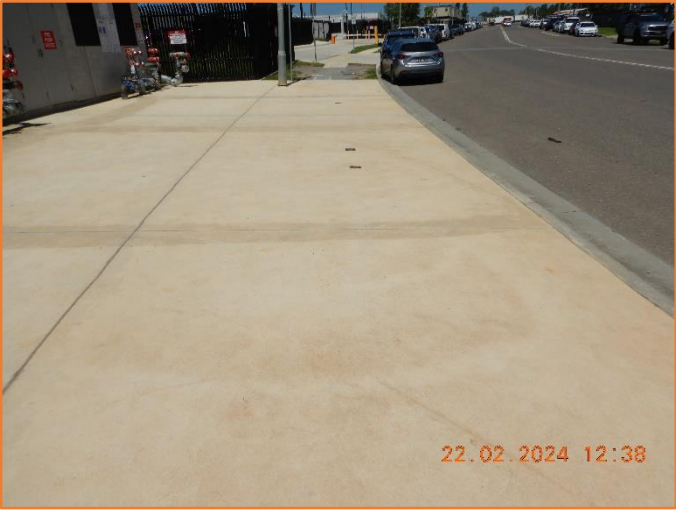
Figure 13: Reasonable - General condition of footpath.

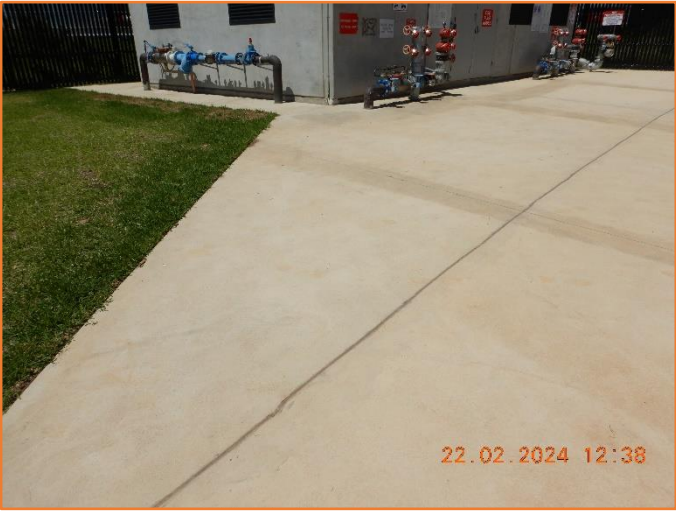
Figure 14: Reasonable - General condition of footpath.

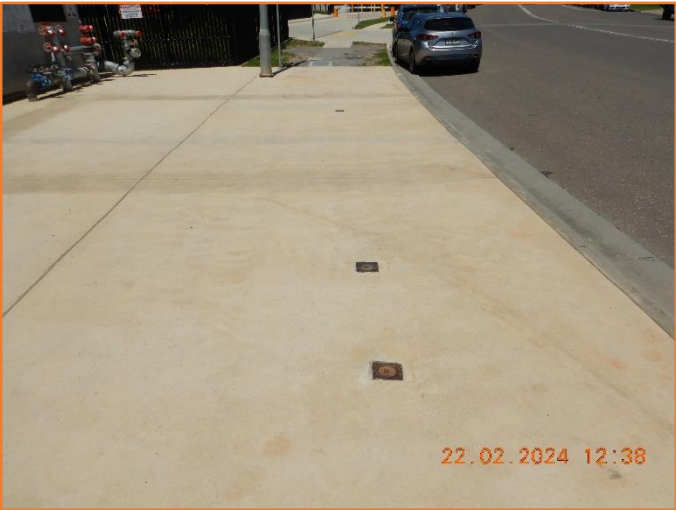
Figure 15: Good - General condition of footpath and service pits.

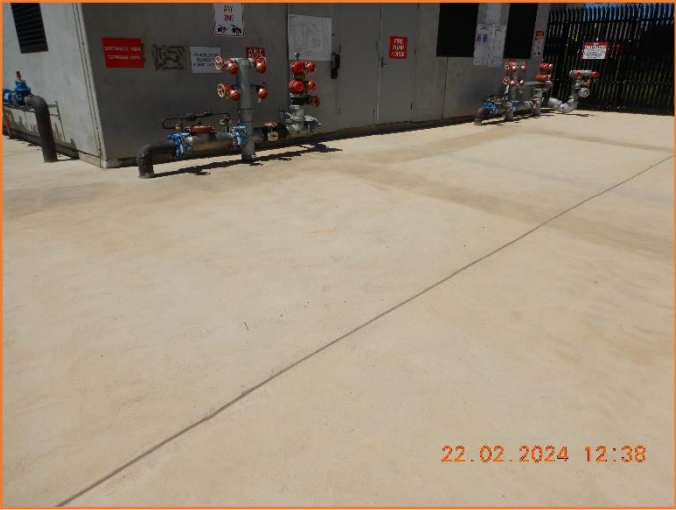
Figure 16: Reasonable - General condition of footpath.

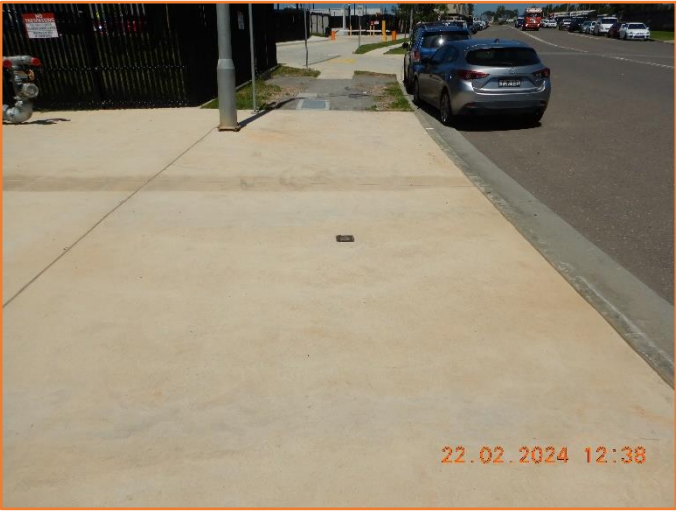
Figure 17: Reasonable - General condition of footpath.

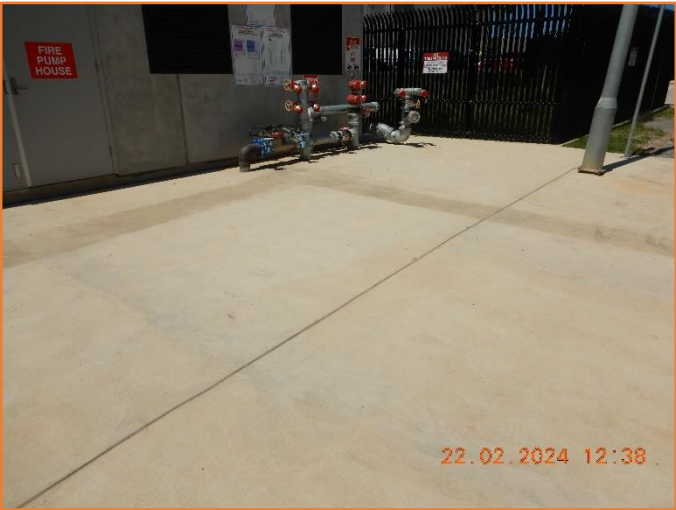
Figure 18: Reasonable - General condition of footpath.

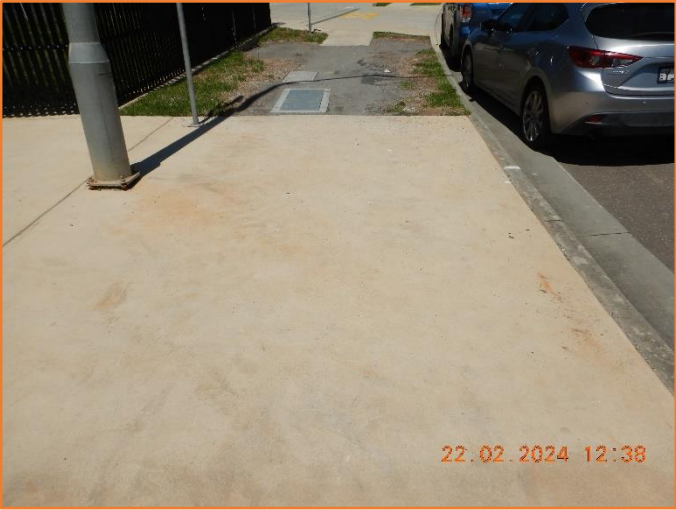
Figure 19: Reasonable - General condition of footpath.

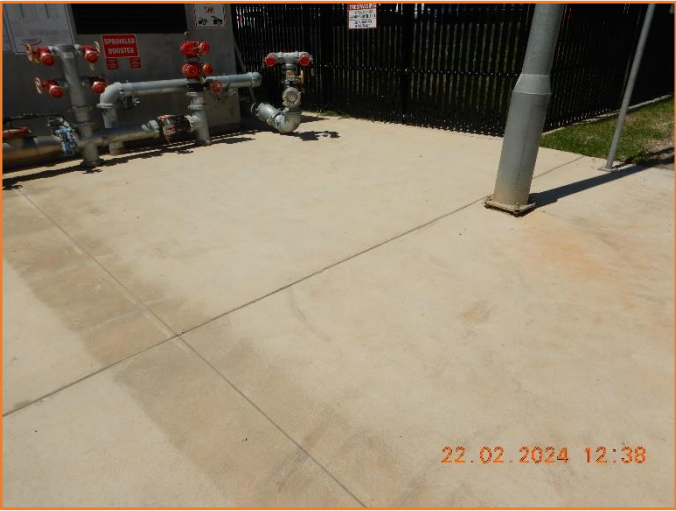
Figure 20: Reasonable - General condition of footpath.

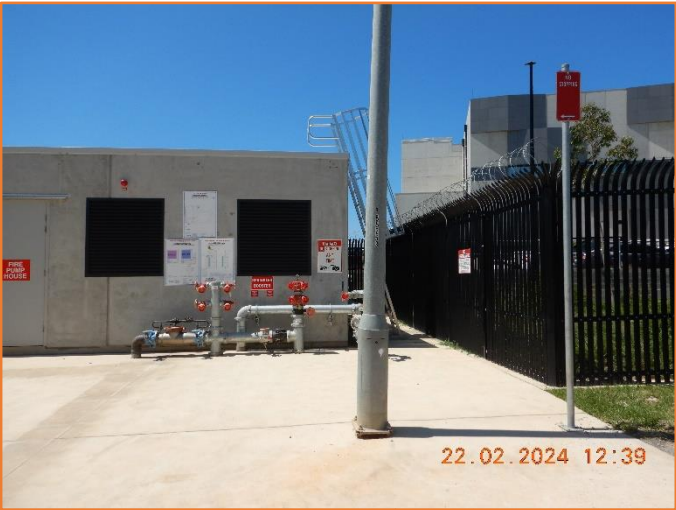
Figure 21: Poor - General condition of monopole assembly. Moderate rotation observed.

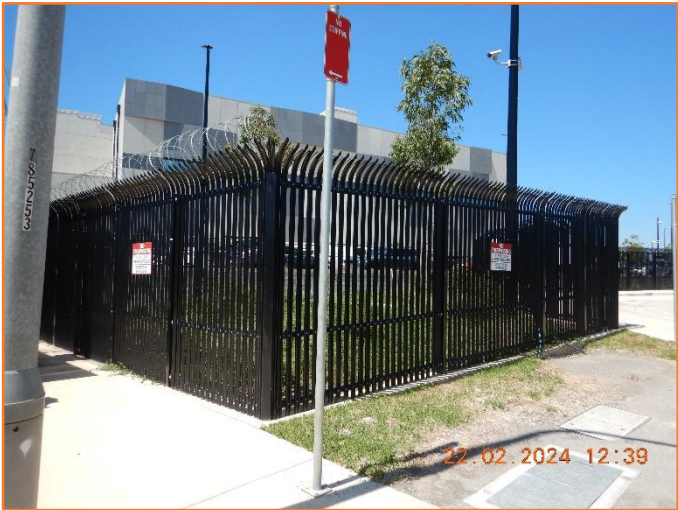
Figure 22: Good - General condition of traffic signage.

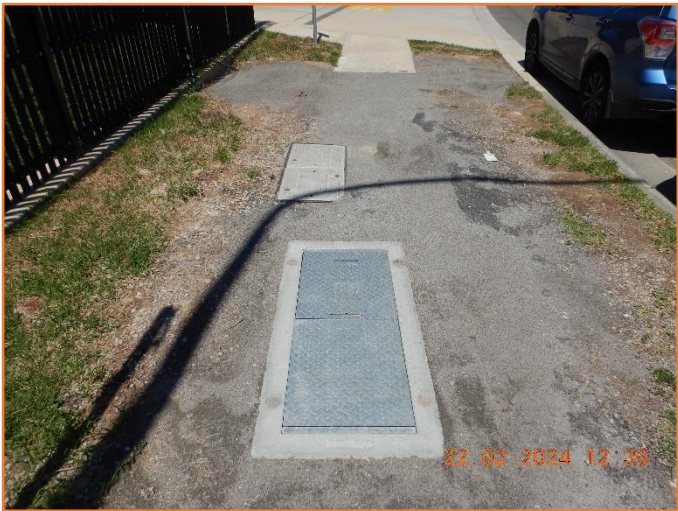
Figure 23: Reasonable - General condition of service pits.

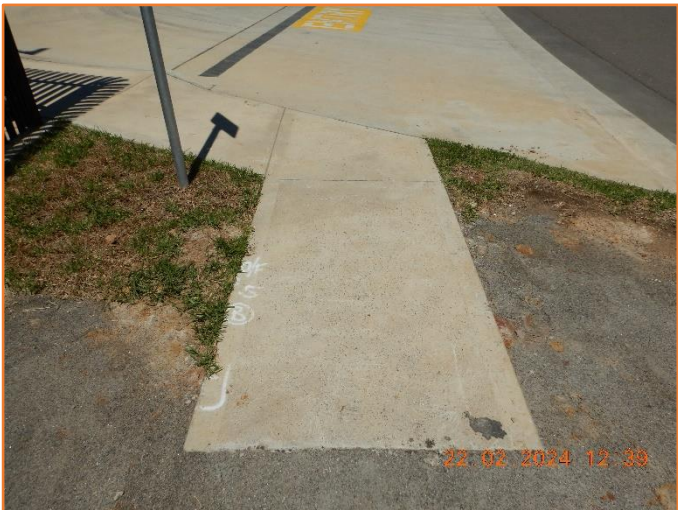
Figure 24: Reasonable - General condition of footpath.

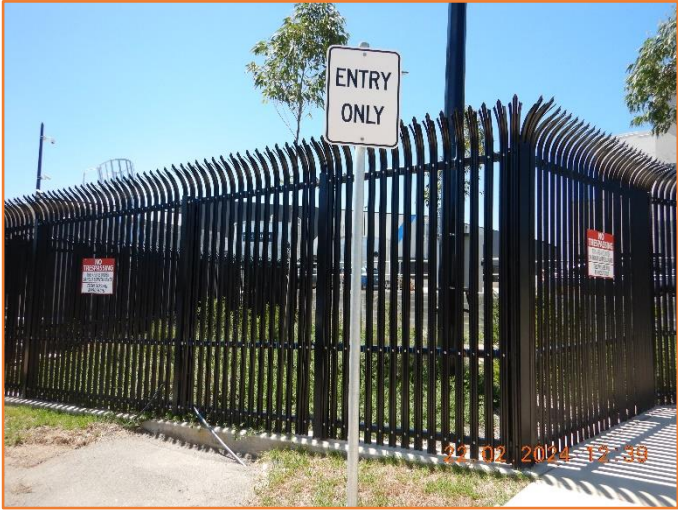
Figure 25: Good - General condition of traffic signage.

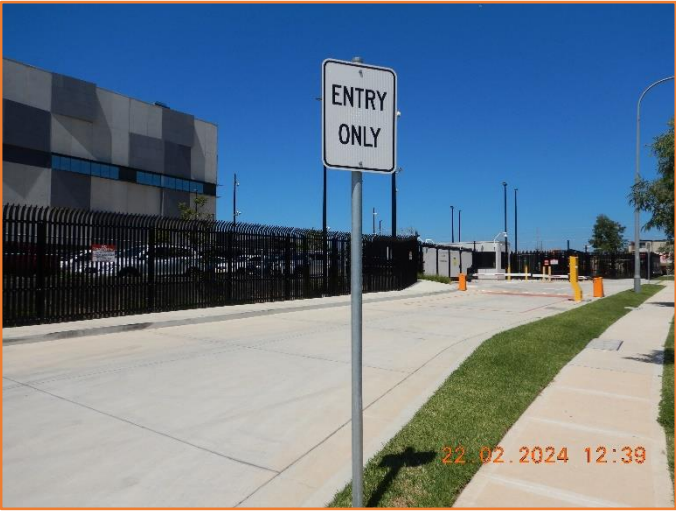
Figure 29: Good - General condition of traffic signage.

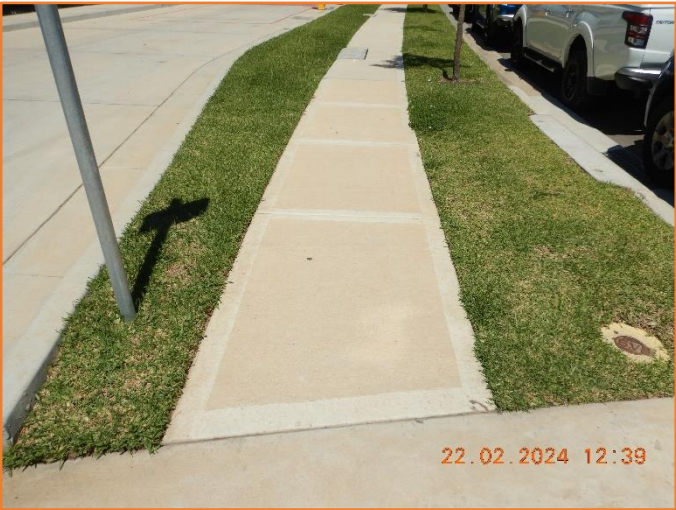
Figure 30: Good - General condition of footpath.

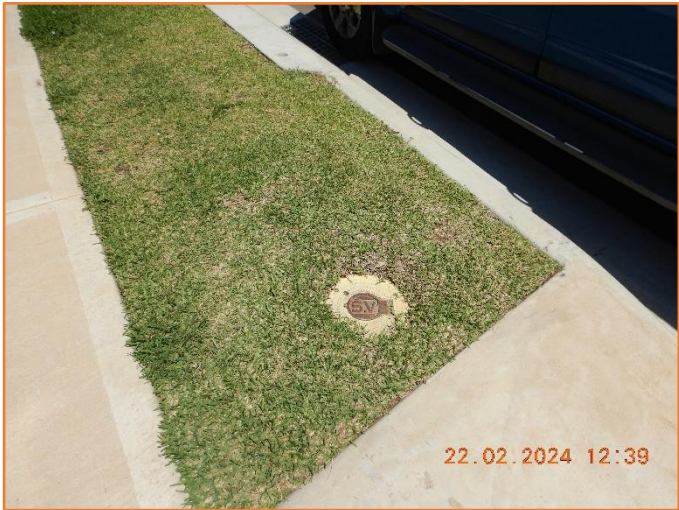
Figure 31: Reasonable - General condition of service pit.

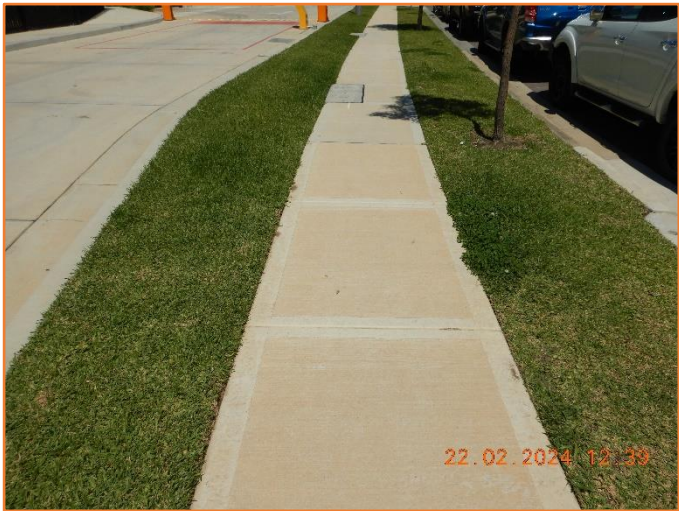
Figure 32: Good - General condition of footpath.

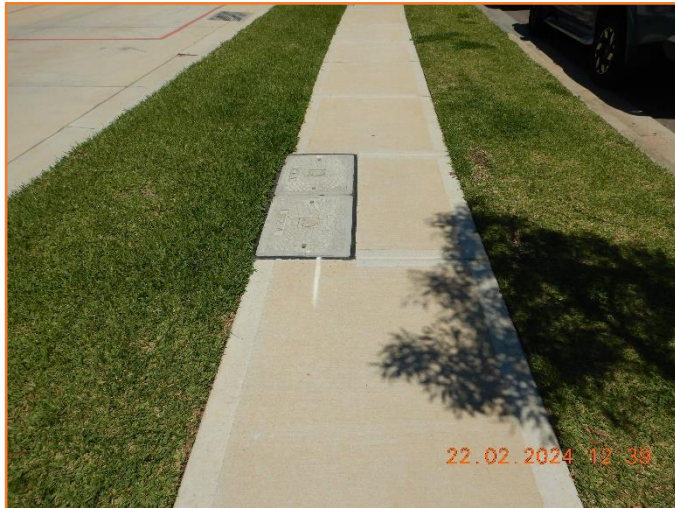
Figure 34: Good - General condition of footpath and service pits.

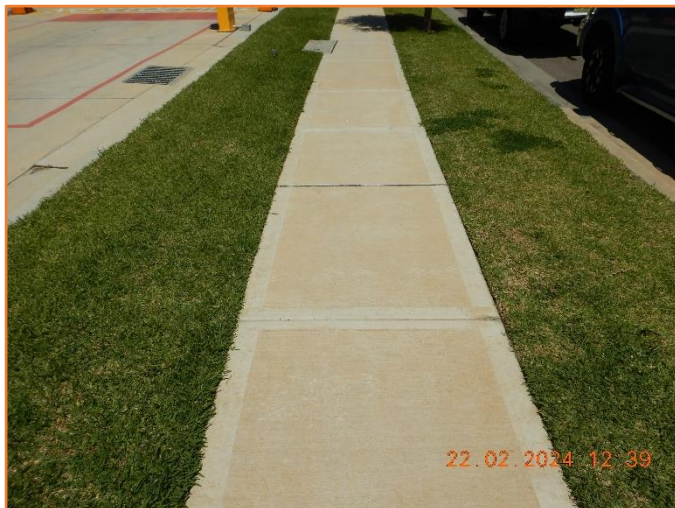
Figure 35: Good - General condition of footpath.

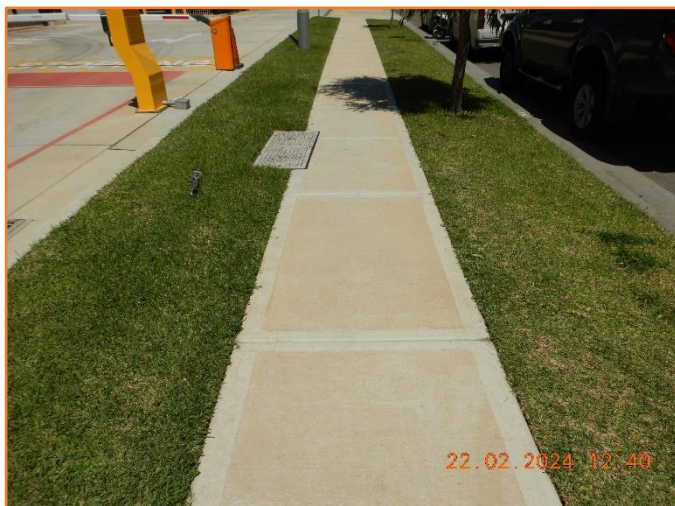
Figure 36: Good - General condition of footpath.

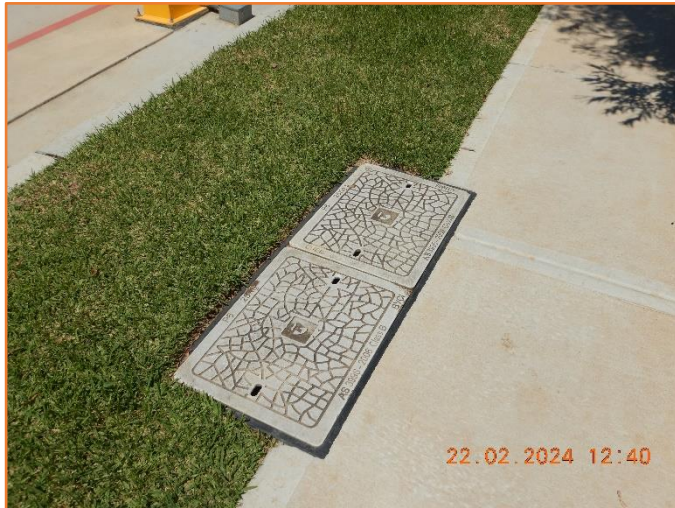
Figure 37: Good - General condition of service pits.

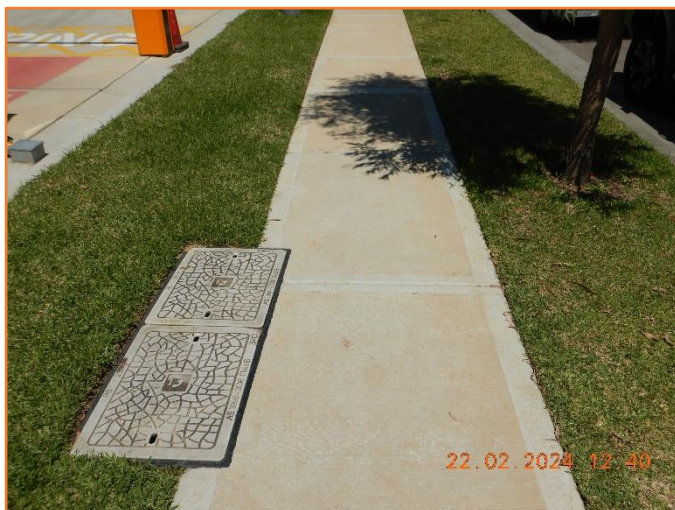
Figure 38: Good - General condition of footpath.

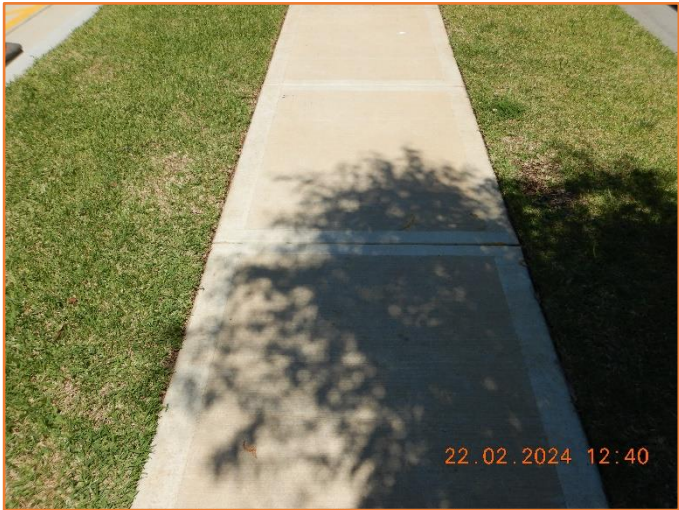
Figure 40: Good - General condition of footpath.

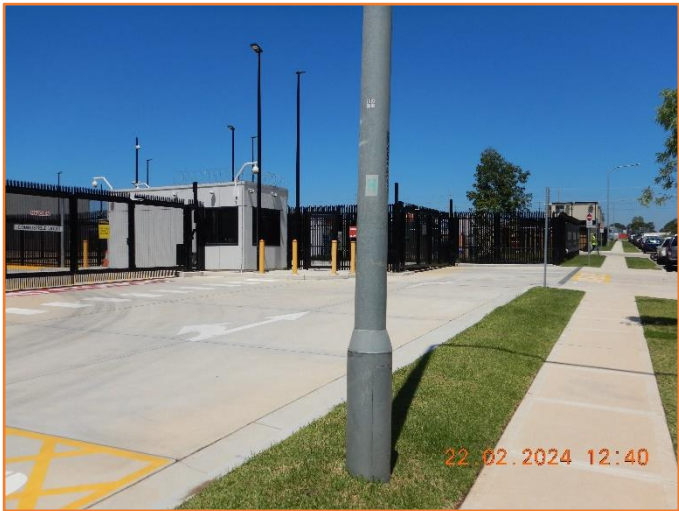
Figure 41: Good - General condition of monopole assembly.

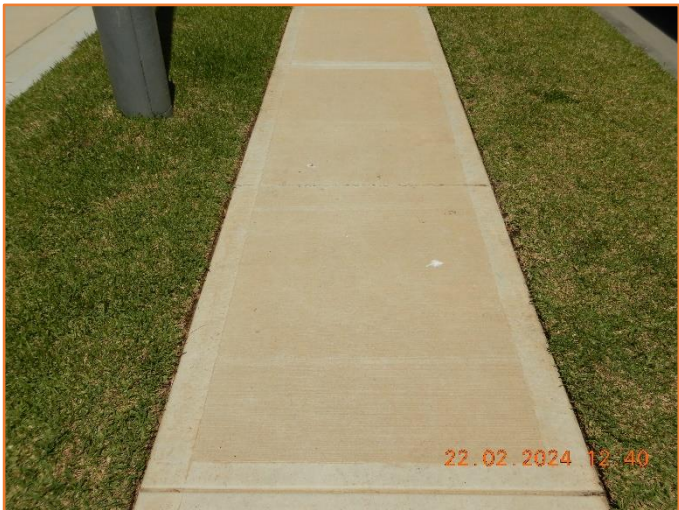
Figure 42: Good - General condition of footpath.

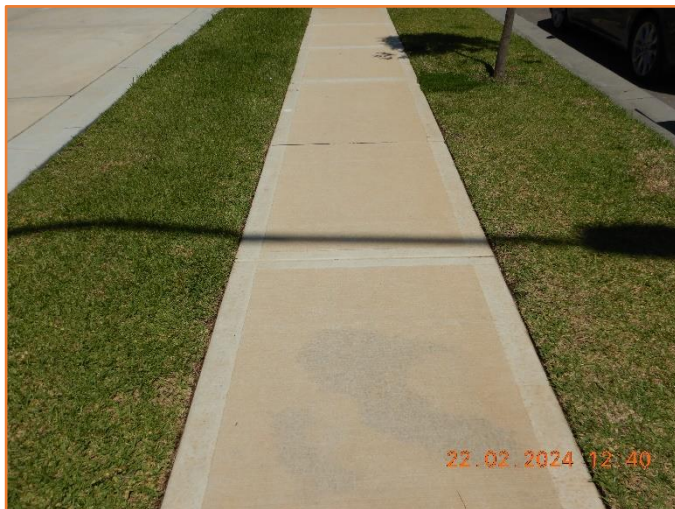
Figure 43: Good - General condition of footpath.

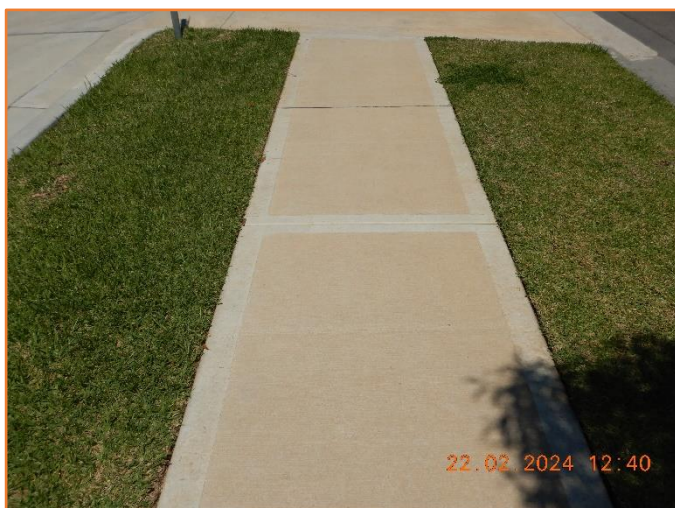
Figure 45: Good - General condition of footpath.

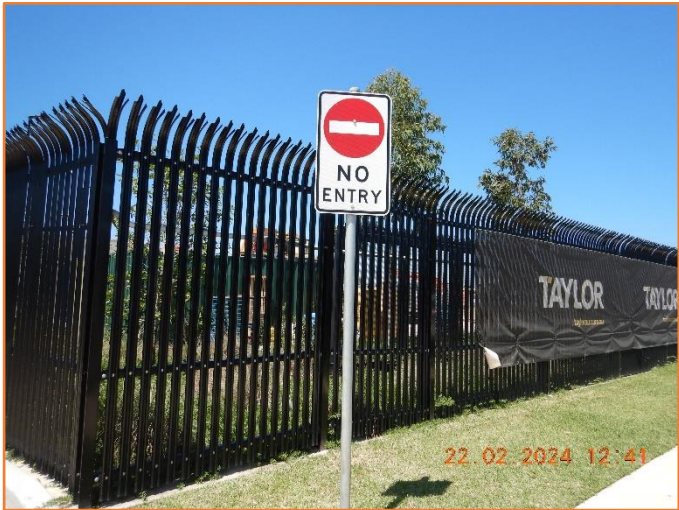
Figure 52: Good - General condition of traffic signage.

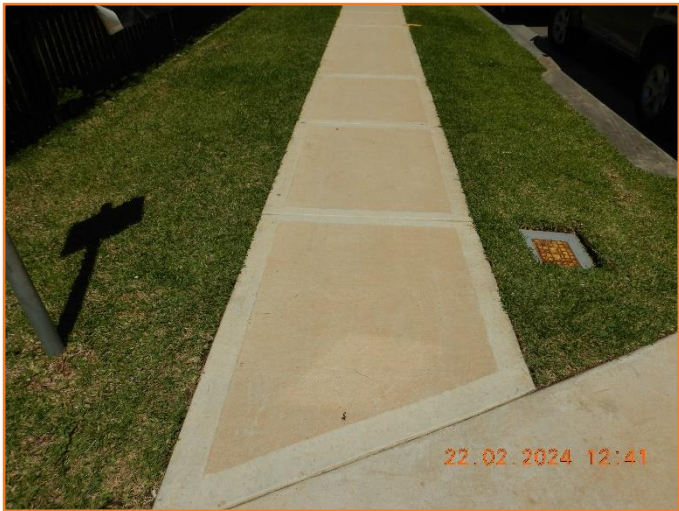
Figure 53: Good - General condition of footpath.

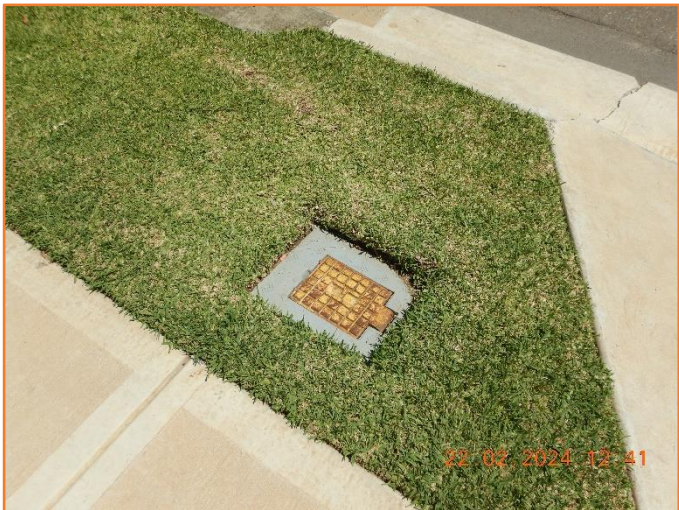
Figure 54: Reasonable - General condition of service pit.

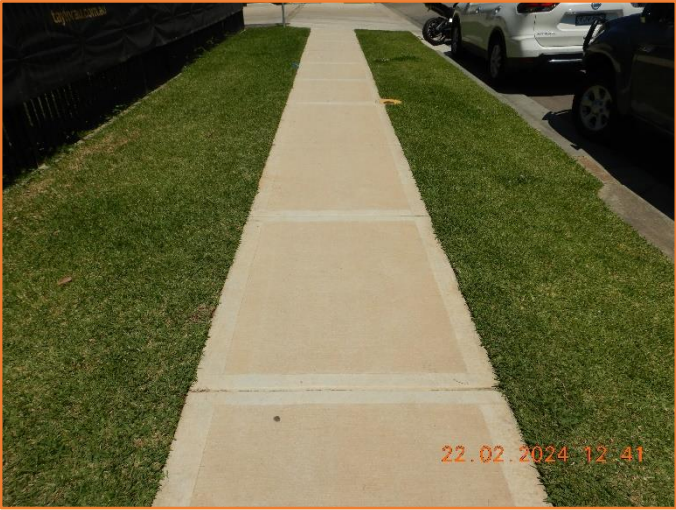
Figure 55: Good - General condition of footpath.

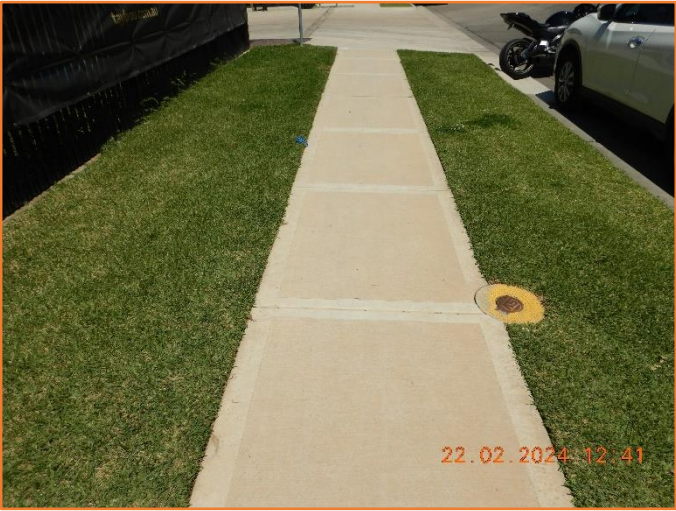
Figure 56: Good - General condition of footpath.

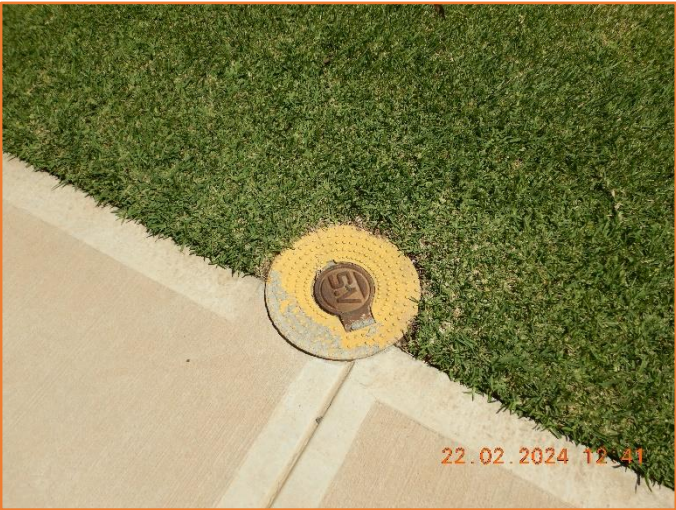
Figure 57: Good - General condition of service pit.

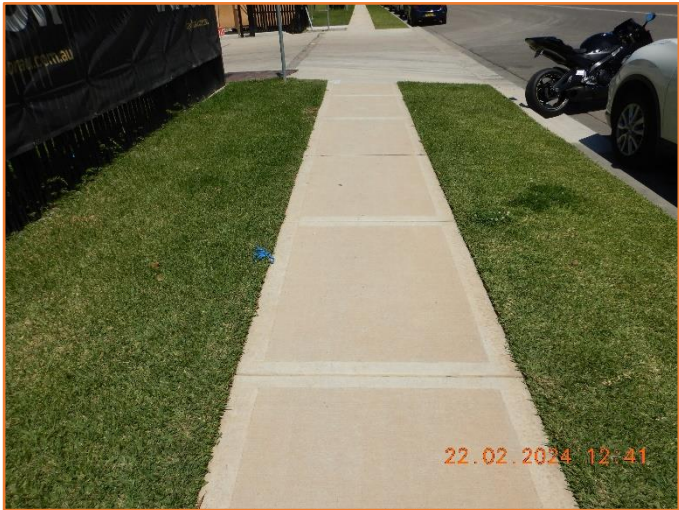
Figure 58: Good - General condition of footpath.

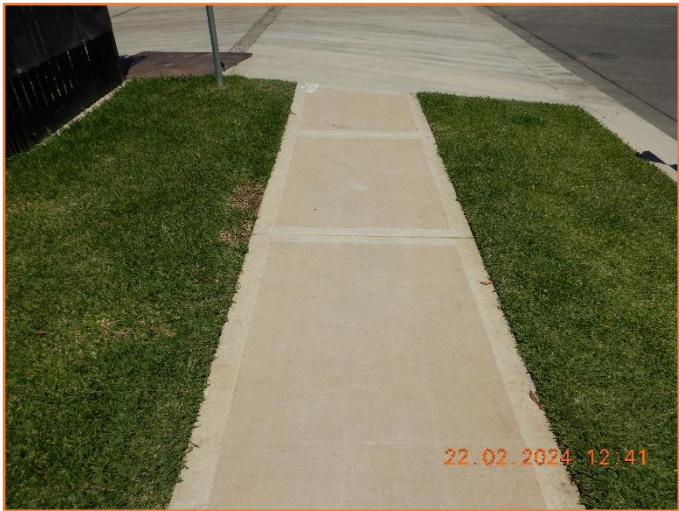
Figure 59: Good - General condition of footpath.

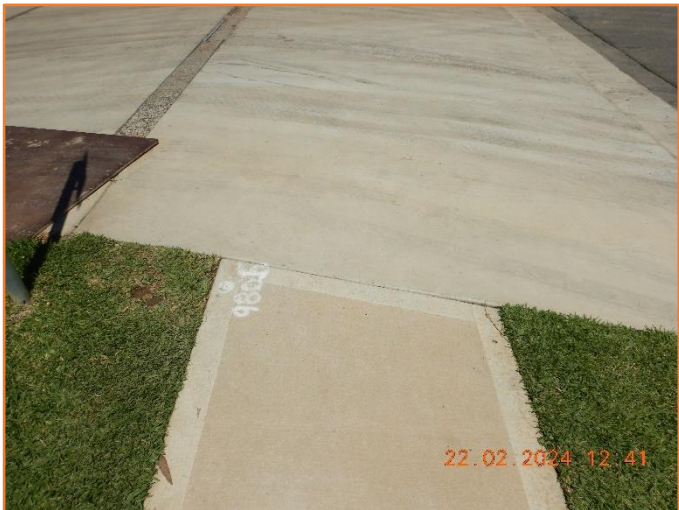
Figure 60: Good - General condition of footpath.

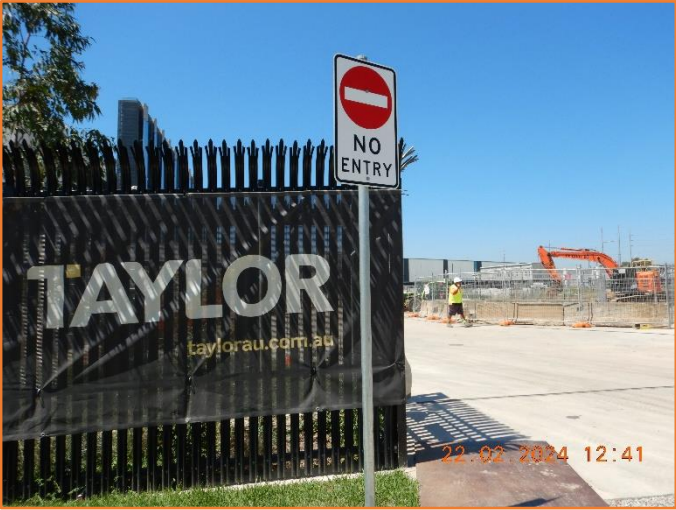
Figure 61: Good - General condition of traffic signage.

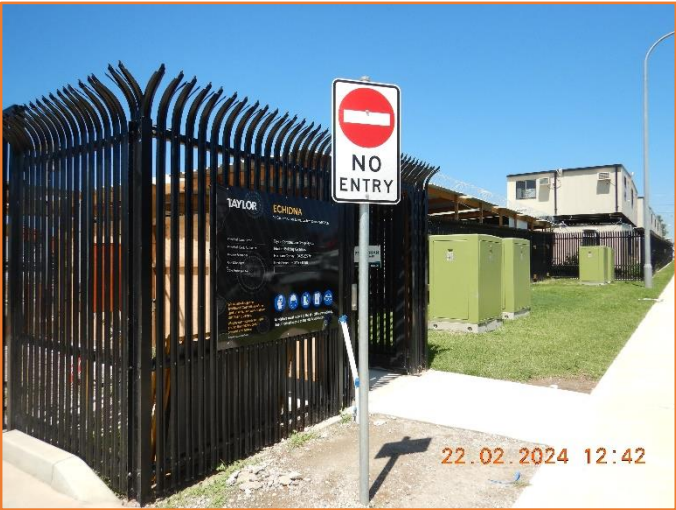
Figure 66: Good - General condition of traffic signage.

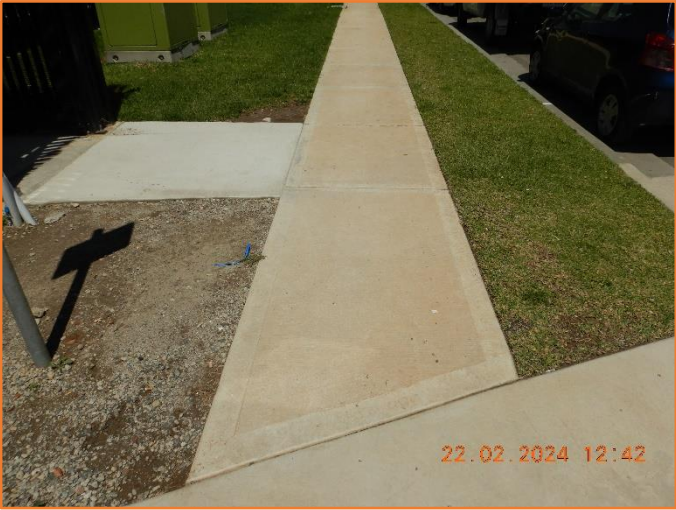
Figure 67: Good - General condition of footpath.

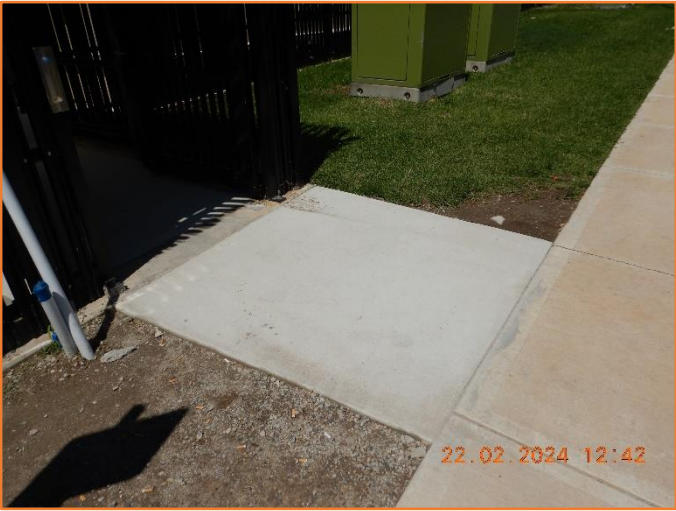
Figure 68: Good - General condition of footpath.

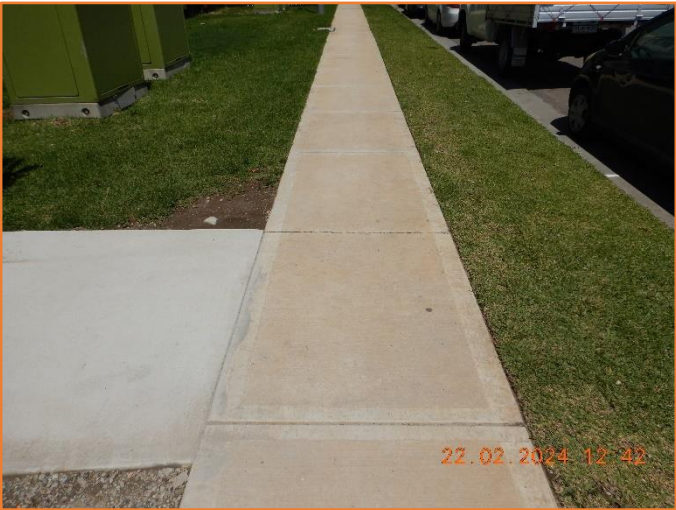
Figure 69: Good - General condition of footpath.

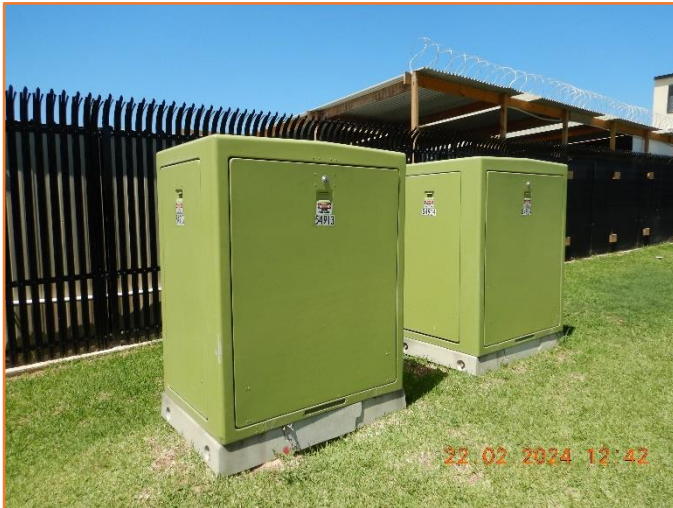
Figure 70: Good - General condition of substations.

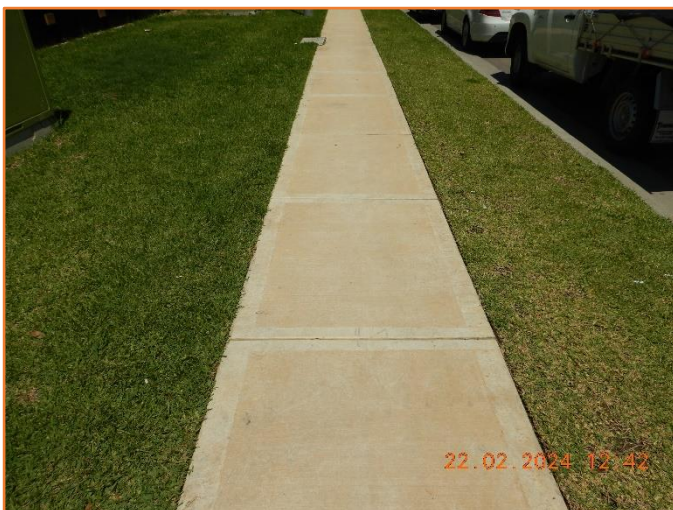
Figure 71: Good - General condition of footpath.

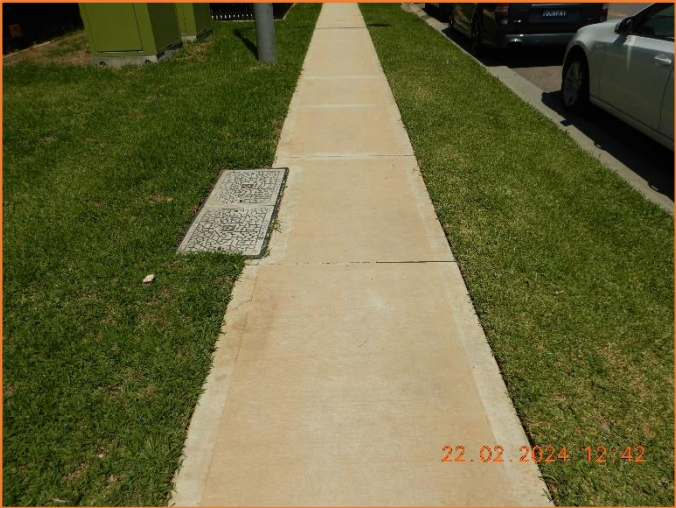
Figure 73: Good - General condition of footpath.

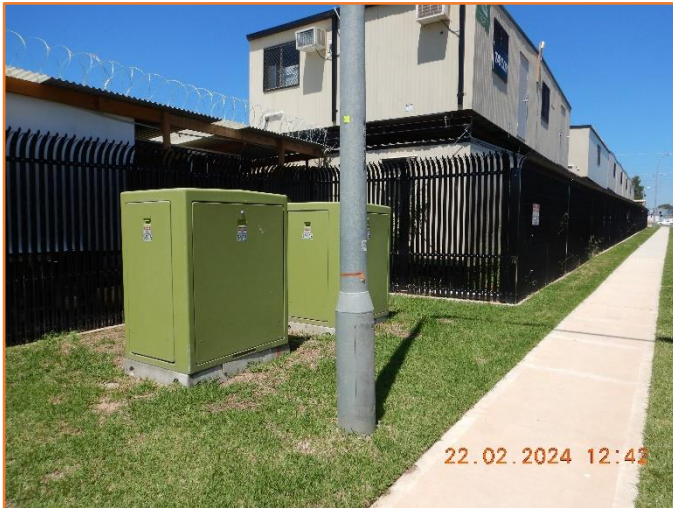
Figure 76: Good - General condition of monopole assembly.

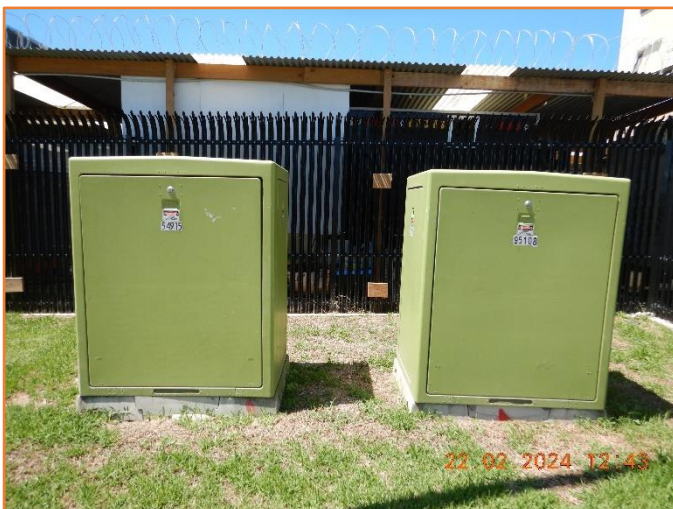
Figure 78: Good - General condition of substations.

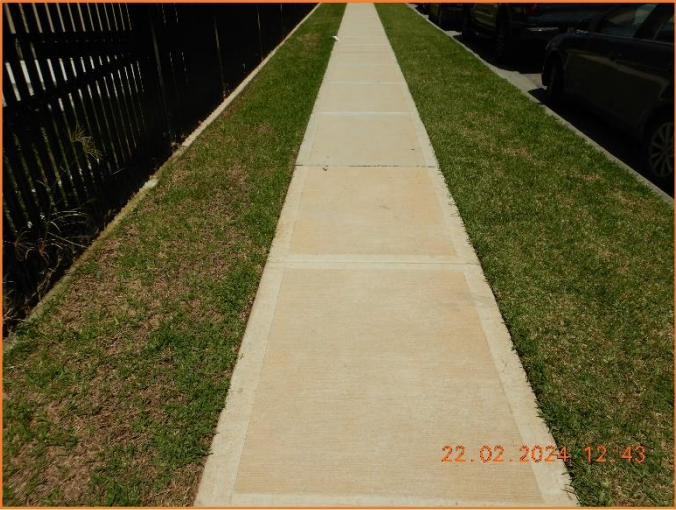
Figure 82: Good - General condition of footpath.

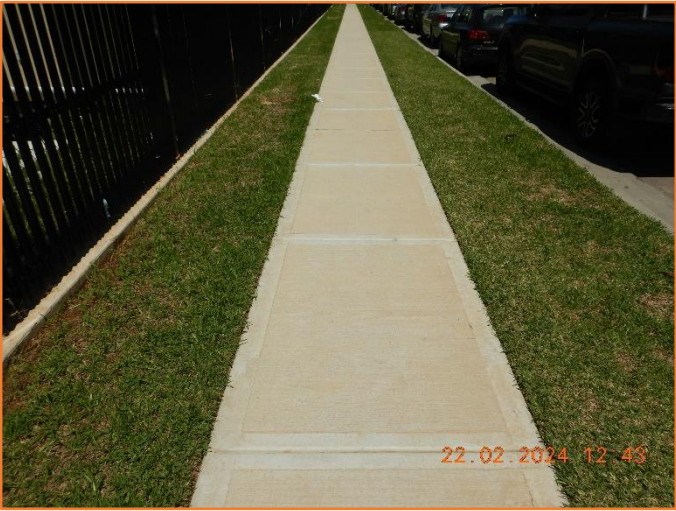
Figure 83: Good - General condition of footpath.

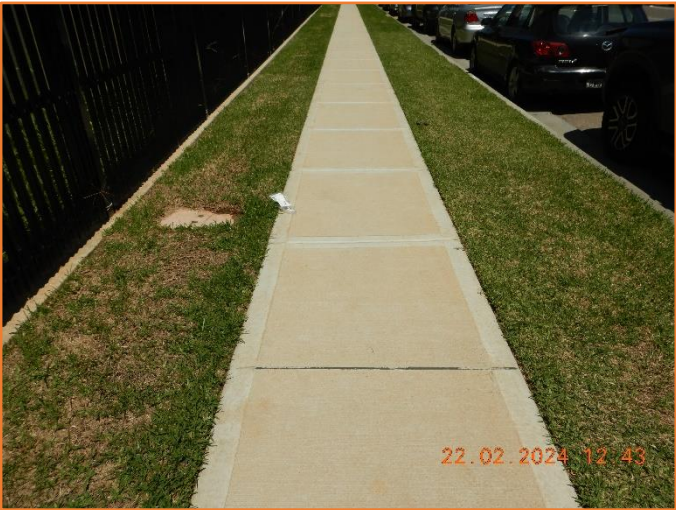
Figure 84: Good - General condition of footpath.

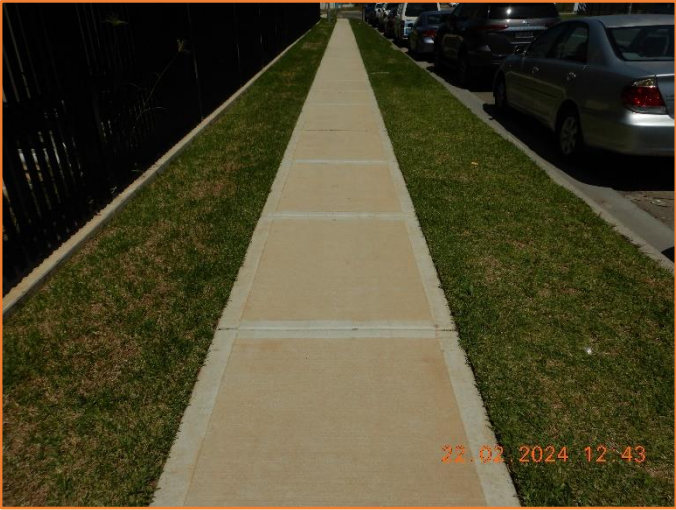
Figure 88: Good - General condition of footpath.

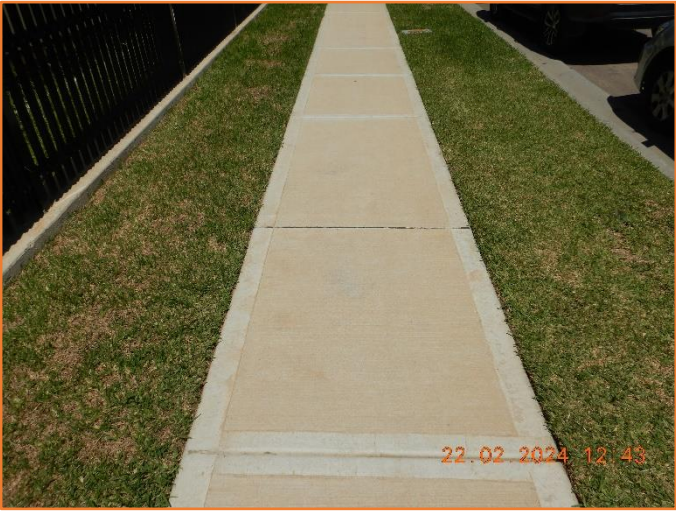
Figure 89: Good - General condition of footpath.

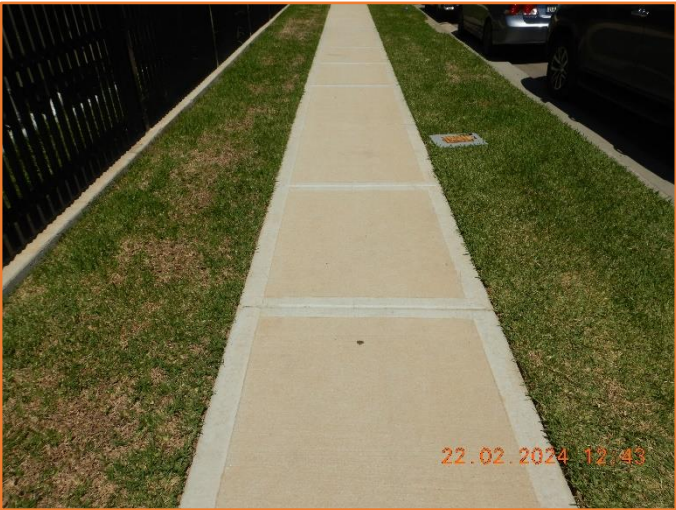
Figure 90: Good - General condition of footpath.

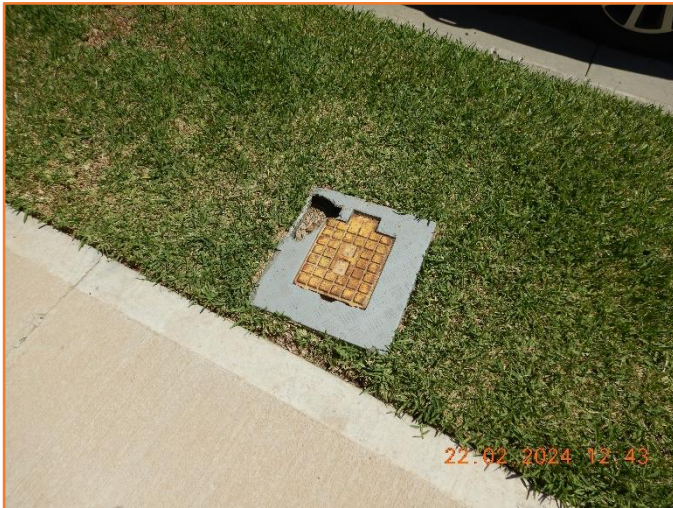
Figure 91: Good - General condition of service pit.

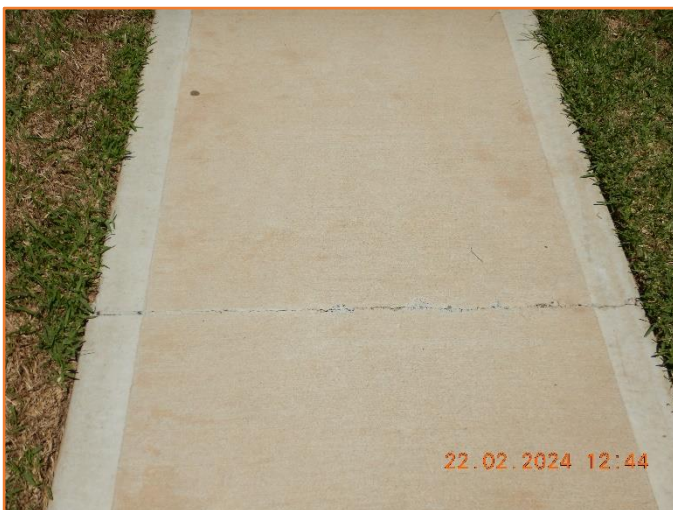
Figure 95: Reasonable - General condition of footpath. Moderate hairline cracking observed.

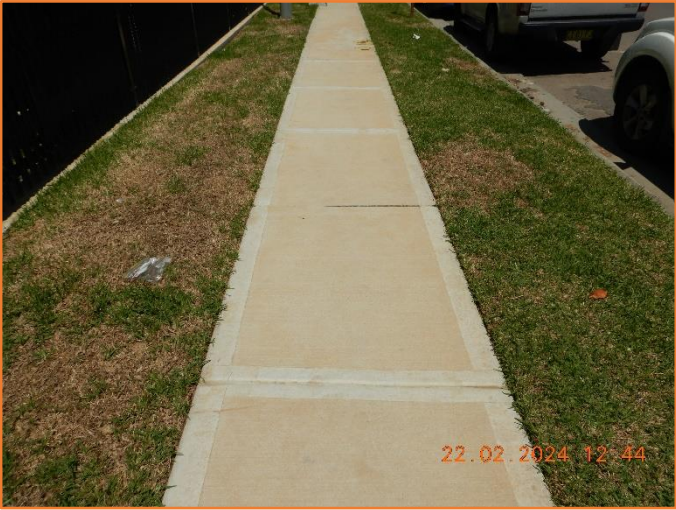
Figure 100: Good - General condition of footpath.

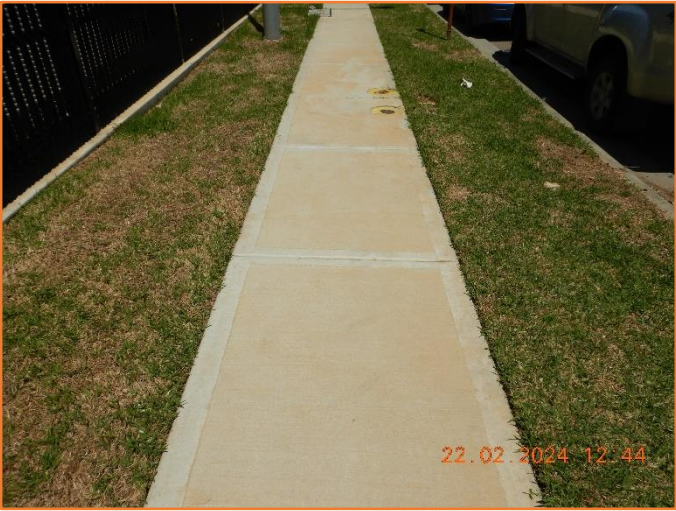
Figure 101: Good - General condition of footpath.
