## DILAPIDATION REPORT

10 EASTERN CREEK DRIVE EASTERN CREEK, NSW, 2766

THURSDAY, 22 FEBRUARY 2024

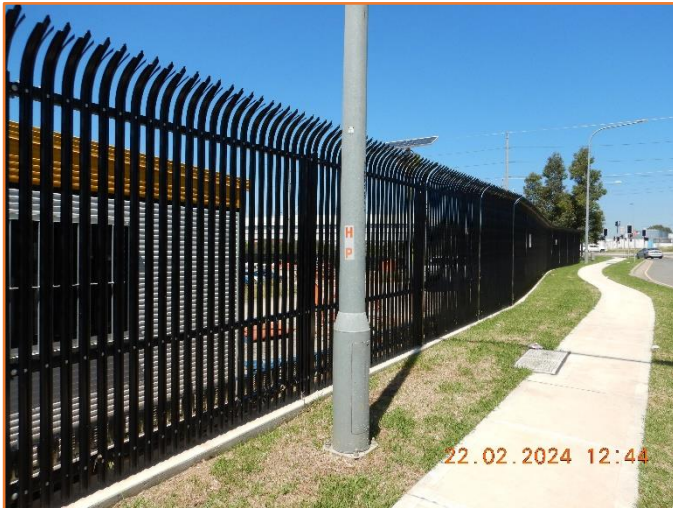
Figure 103: Good - General condition of monopole assembly.

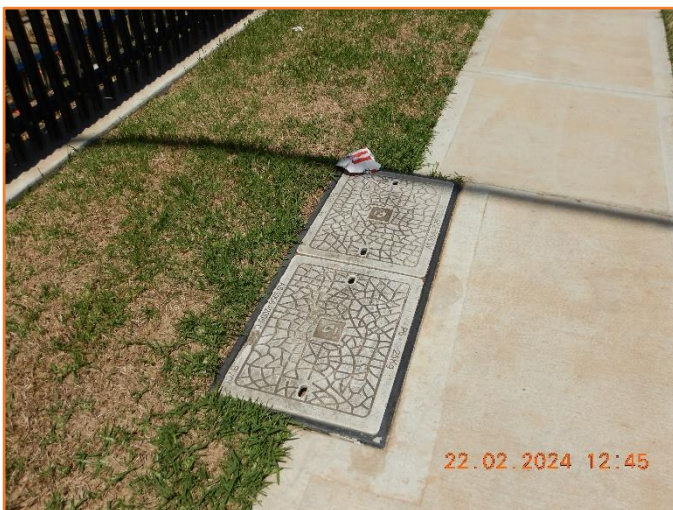
Figure 107: Reasonable - General condition of service pits.

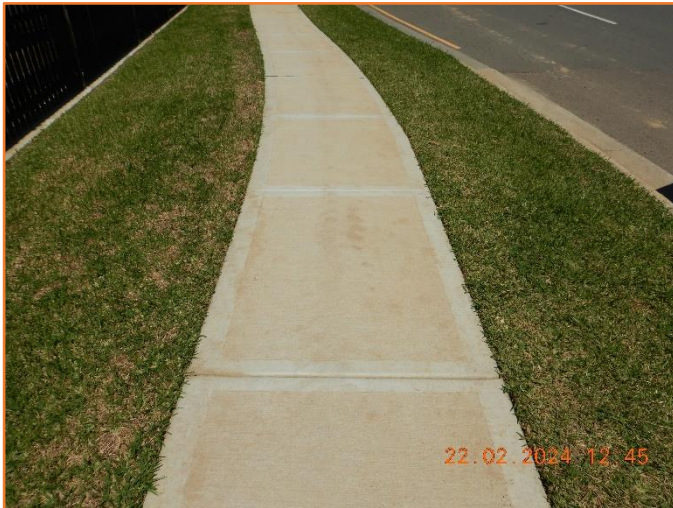
Figure 109: Good - General condition of footpath.

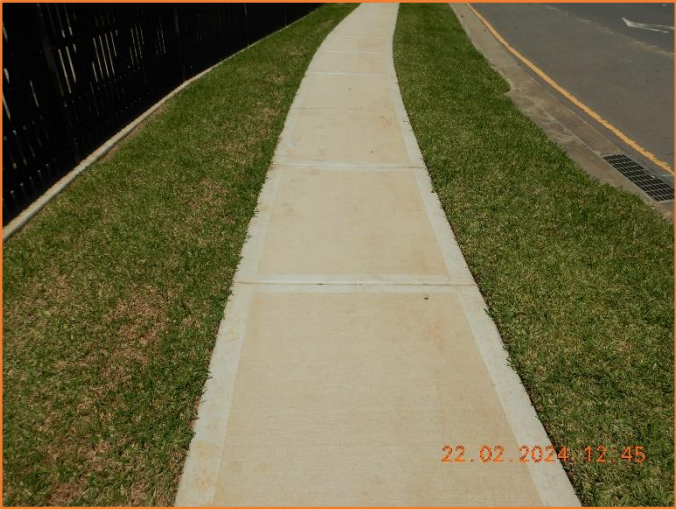
Figure 112: Good - General condition of footpath.

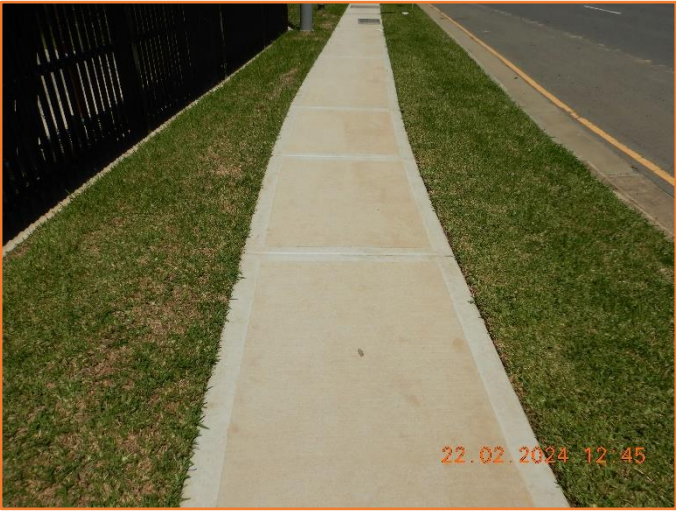
Figure 113: Good - General condition of footpath.

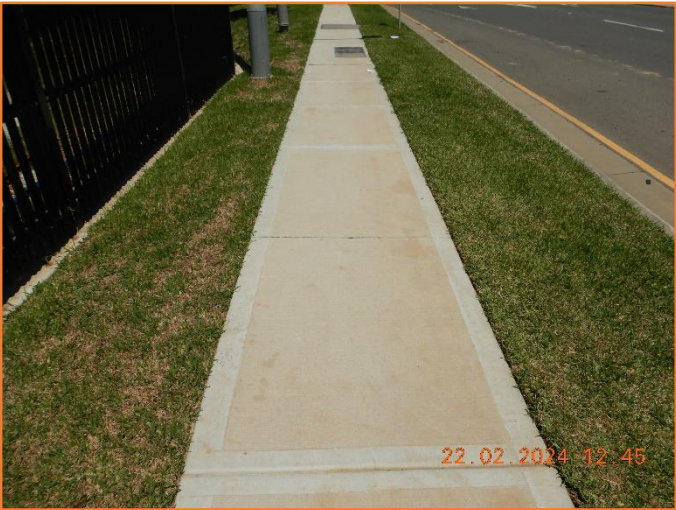
Figure 114: Good - General condition of footpath.

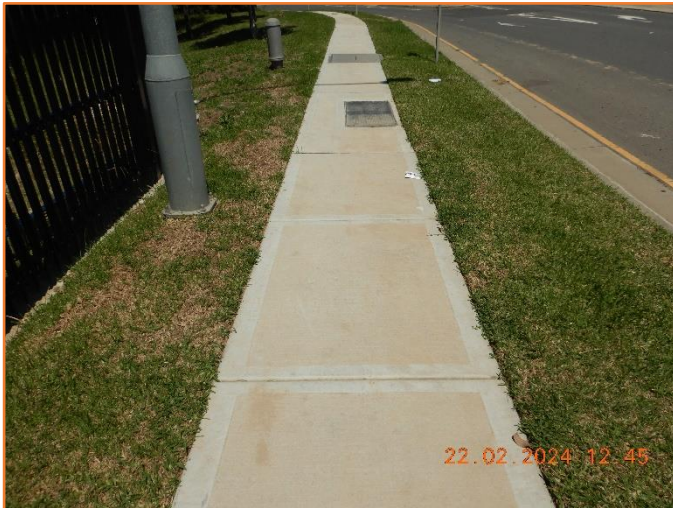
Figure 115: Good - General condition of footpath.

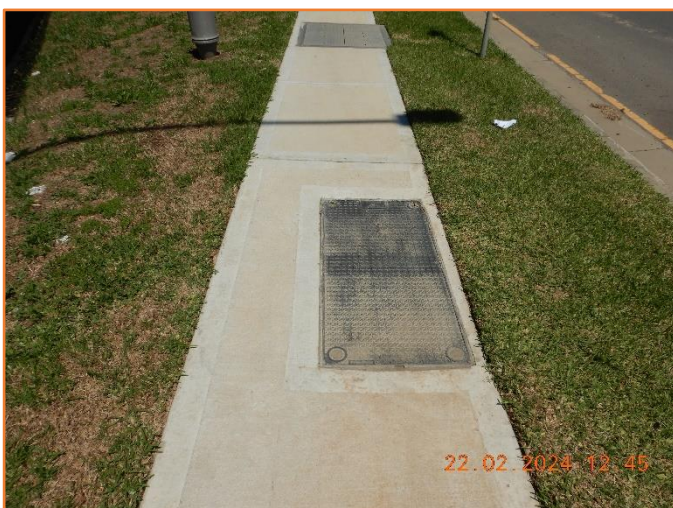
Figure 117: Reasonable - General condition of footpath and service pit.

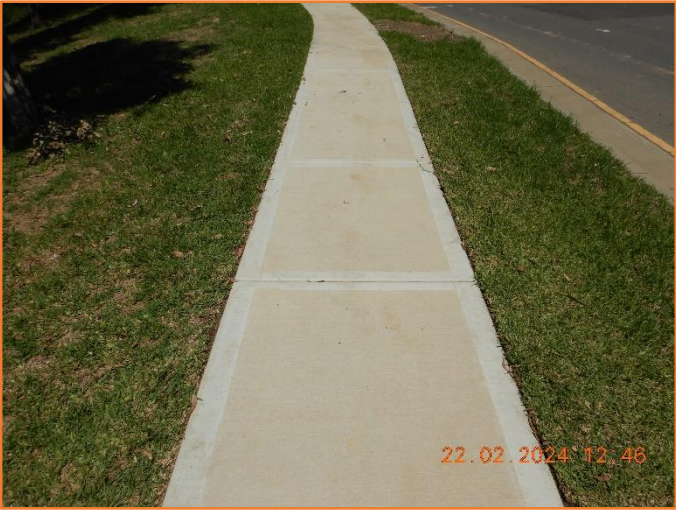
Figure 122: Good - General condition of footpath.

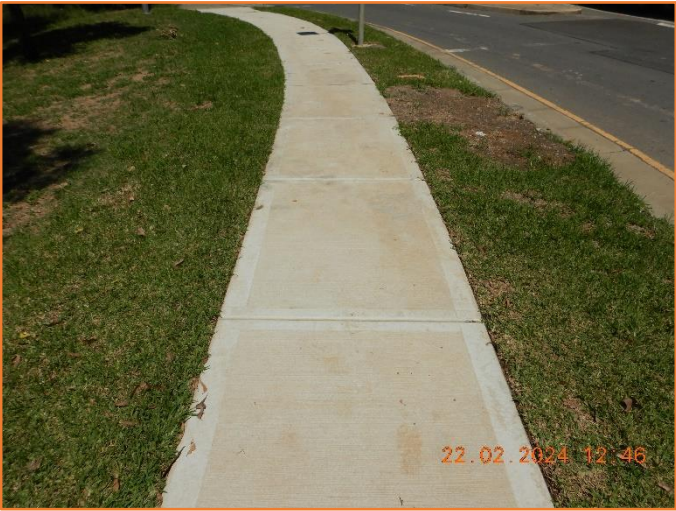
Figure 123: Good - General condition of footpath.

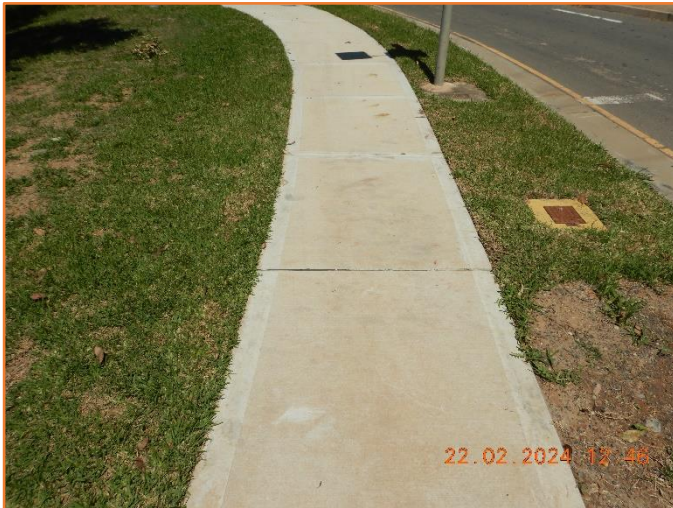
Figure 124: Good - General condition of footpath.

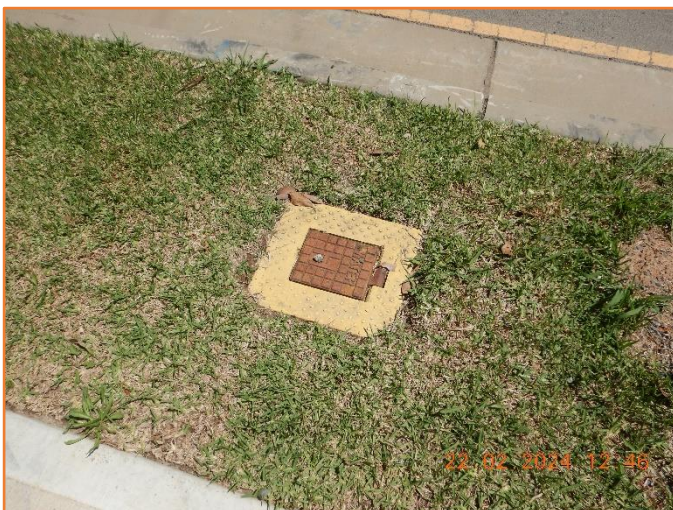
Figure 125: Good - General condition of service pit.

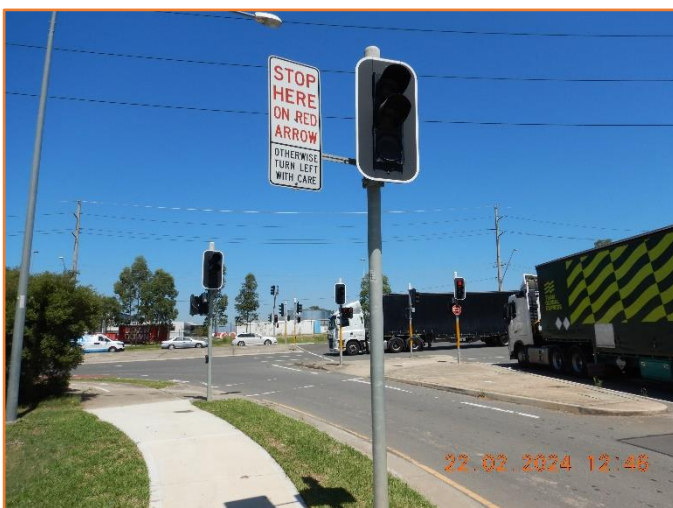
Figure 126: Good - General condition of traffic signage.

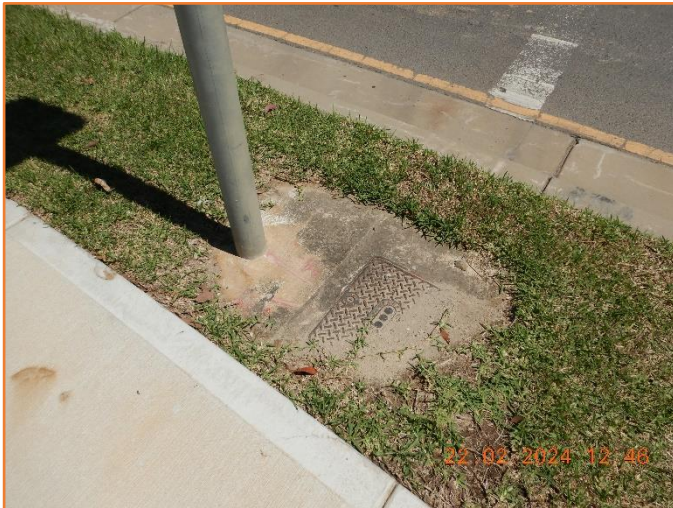
Figure 127: Reasonable - General condition of service pit.

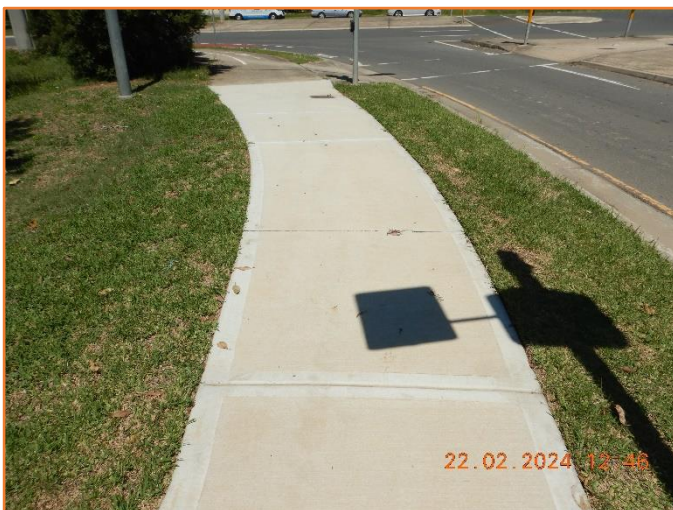
Figure 128: Good - General condition of footpath.

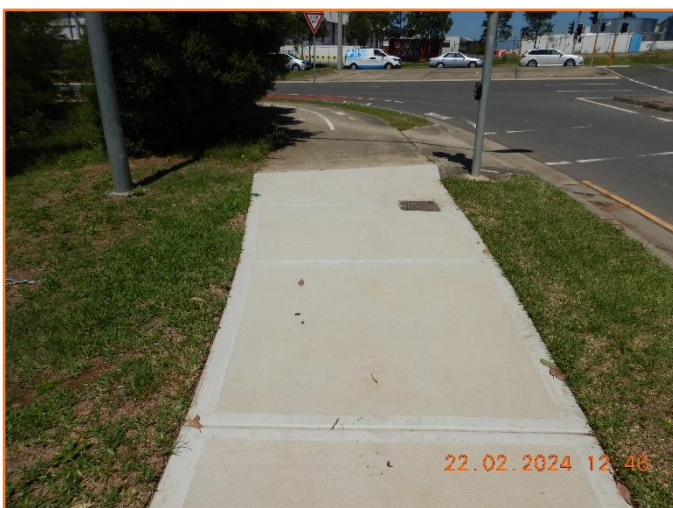
Figure 129: Good - General condition of footpath.

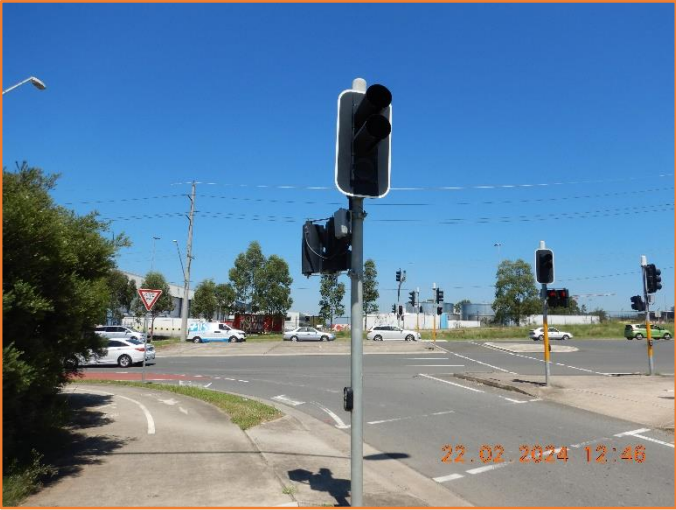
Figure 130: Good - General condition of traffic signage.

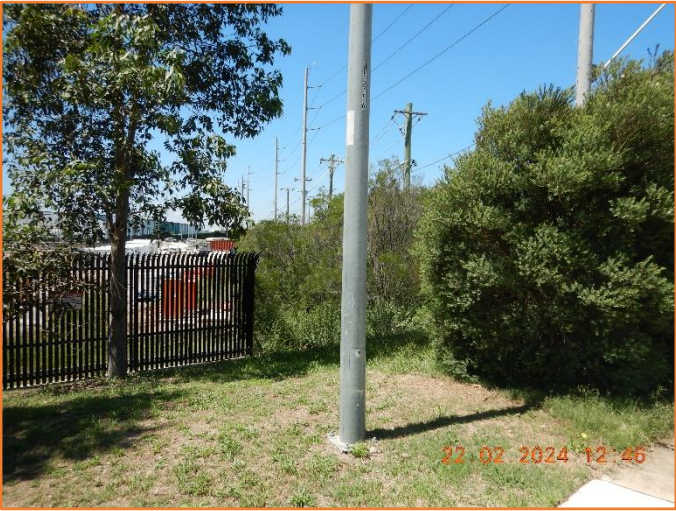
Figure 131: Good - General condition of monopole assembly.

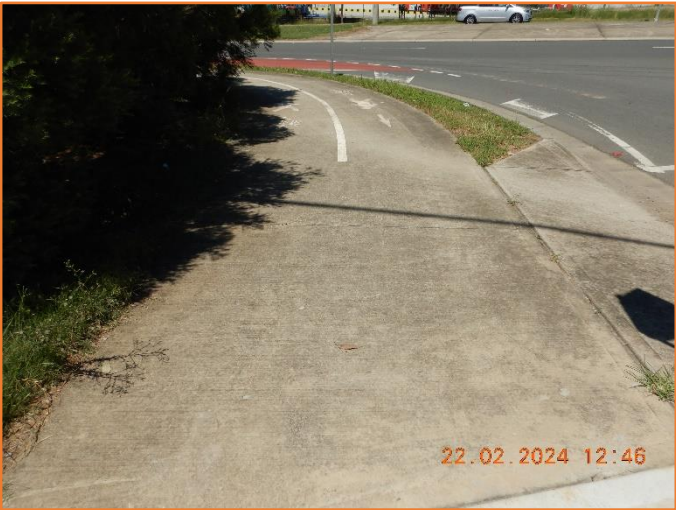
Figure 132: Reasonable - General condition of footpath.

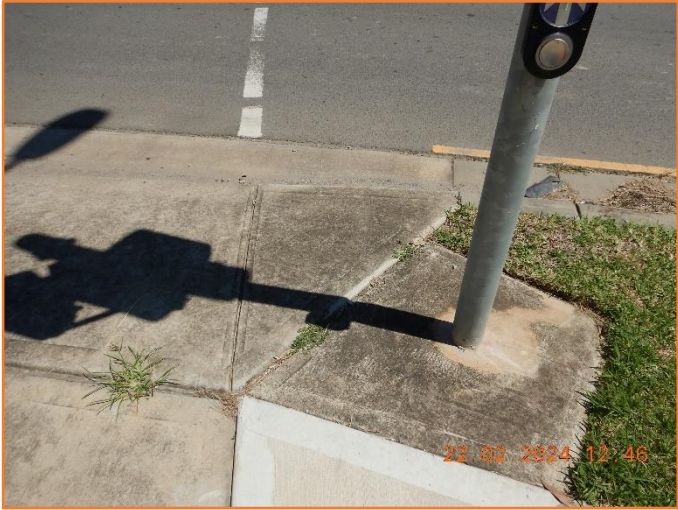
Figure 133: Reasonable - General condition of footpath.

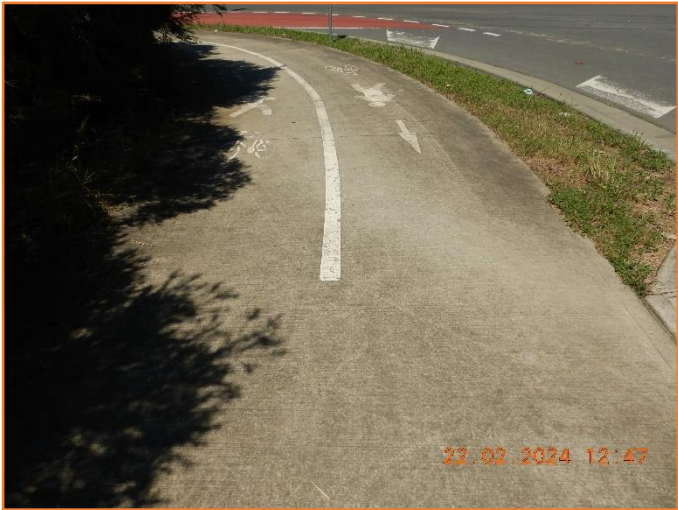
Figure 135: Reasonable - General condition of footpath.

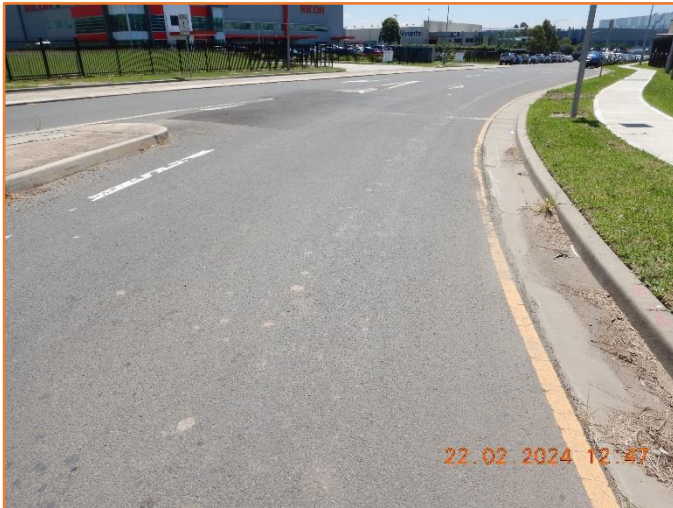
Figure 136: Reasonable - General condition of flexible pavement.

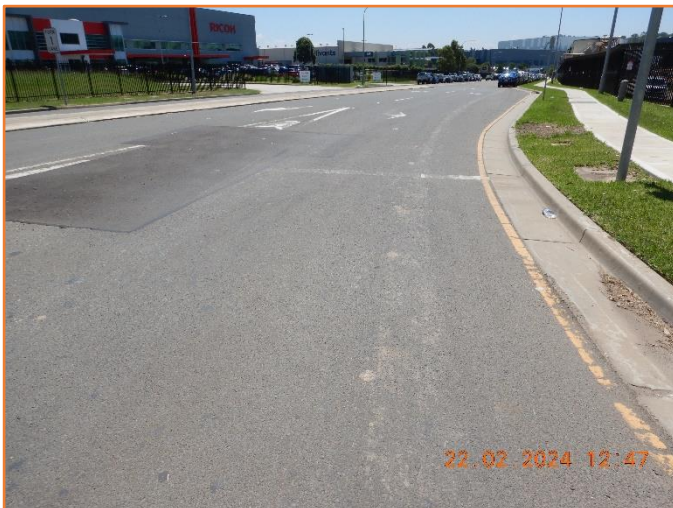
Figure 137: Reasonable - General condition of flexible pavement.

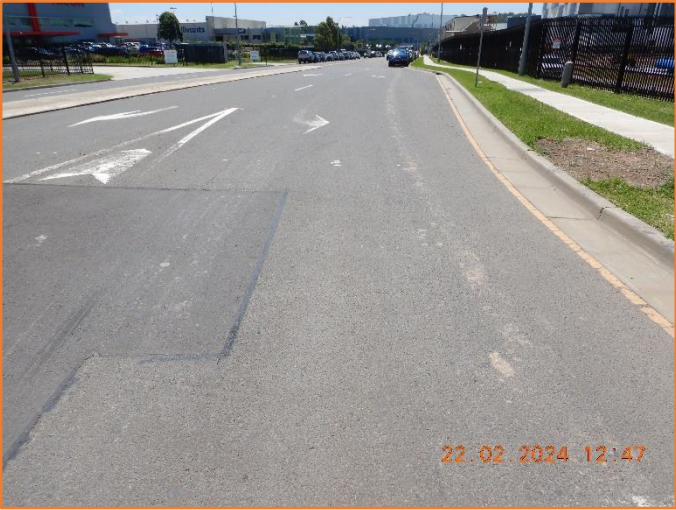
Figure 139: Reasonable - General condition of flexible pavement.

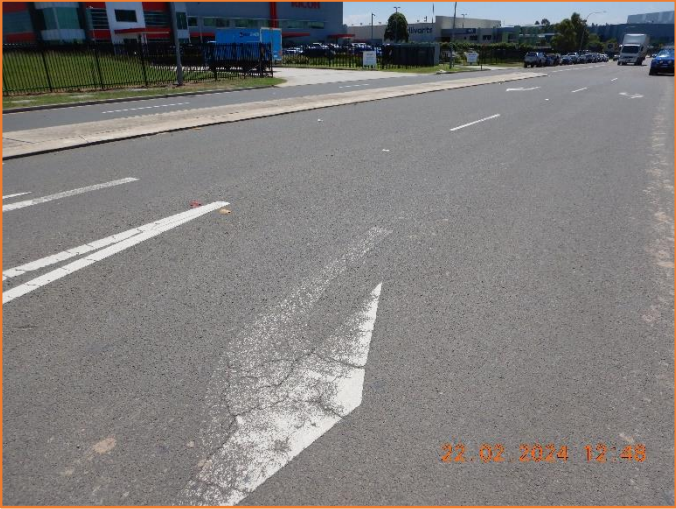
Figure 141: Reasonable - General condition of flexible pavement.

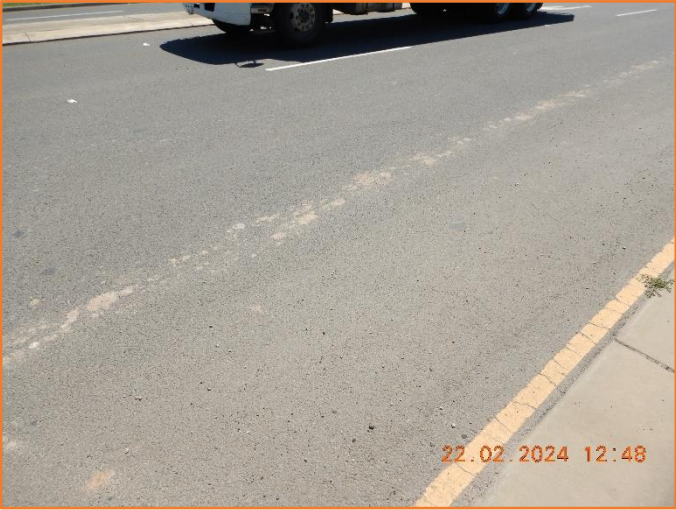
Figure 142: Reasonable - General condition of flexible pavement.

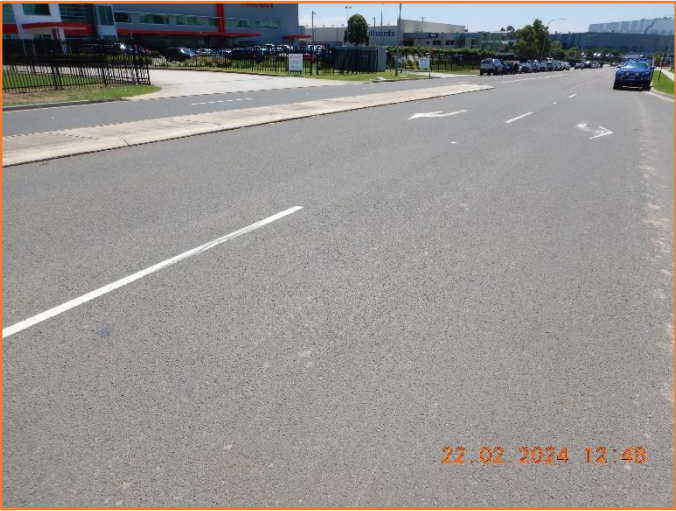
Figure 143: Reasonable - General condition of flexible pavement.

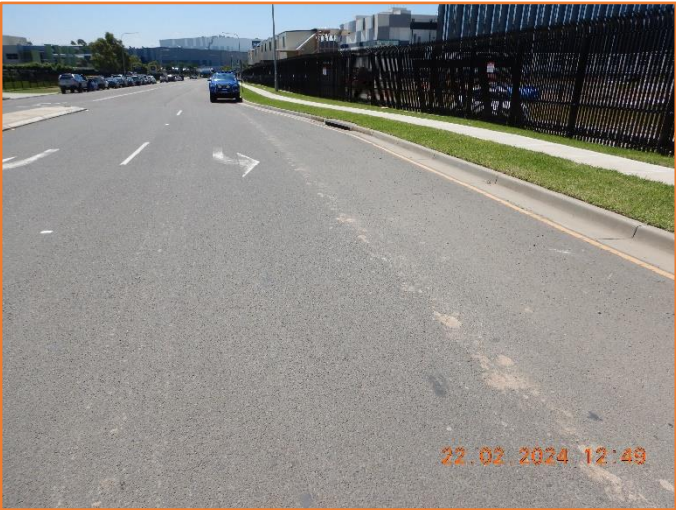
Figure 144: Reasonable - General condition of flexible pavement.

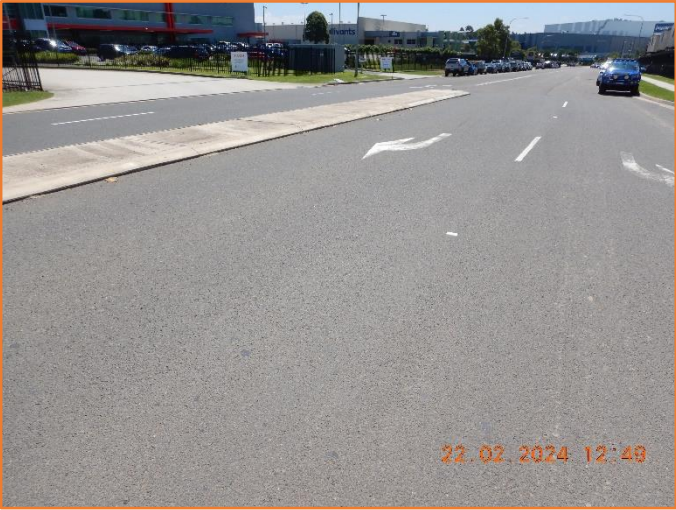
Figure 145: Reasonable - General condition of flexible pavement.

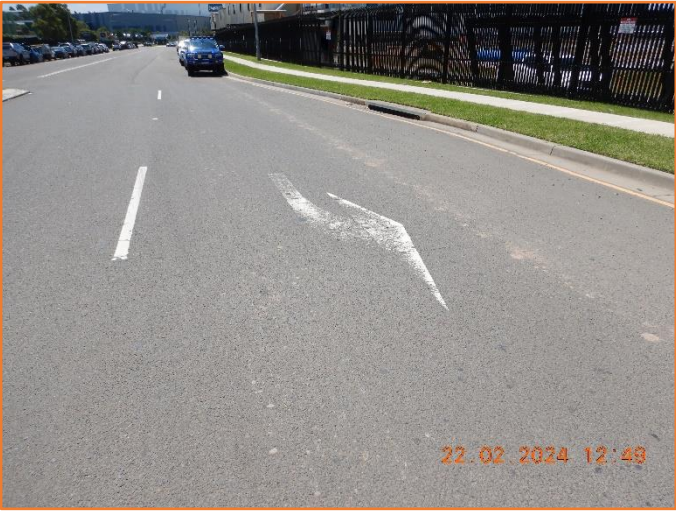
Figure 146: Reasonable - General condition of flexible pavement.

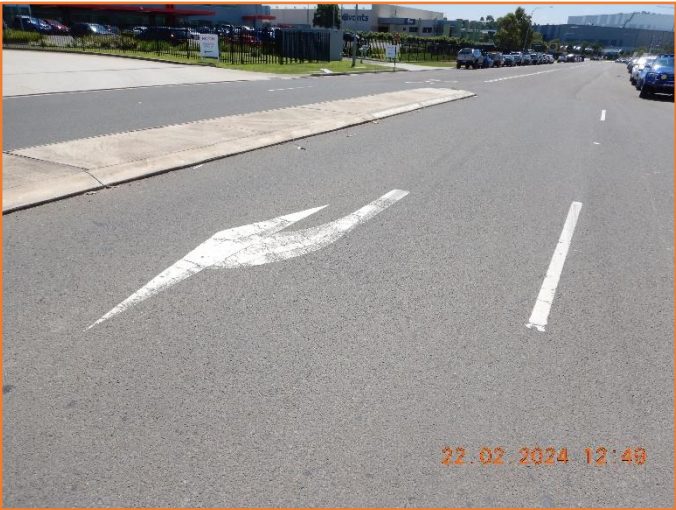
Figure 147: Reasonable - General condition of flexible pavement.

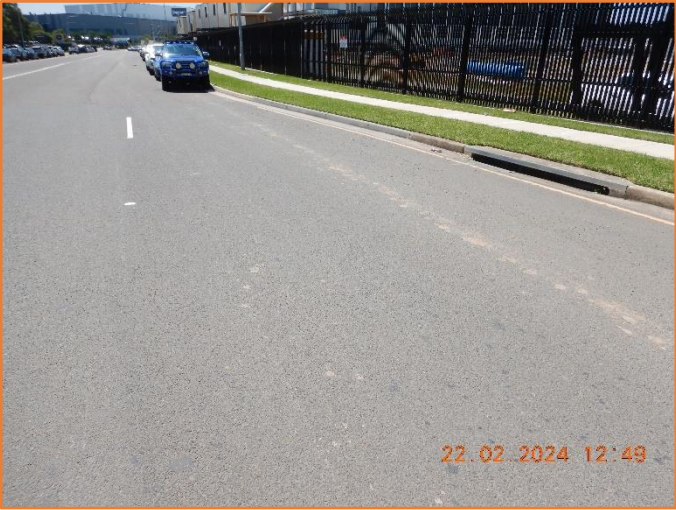
Figure 148: Reasonable - General condition of flexible pavement.

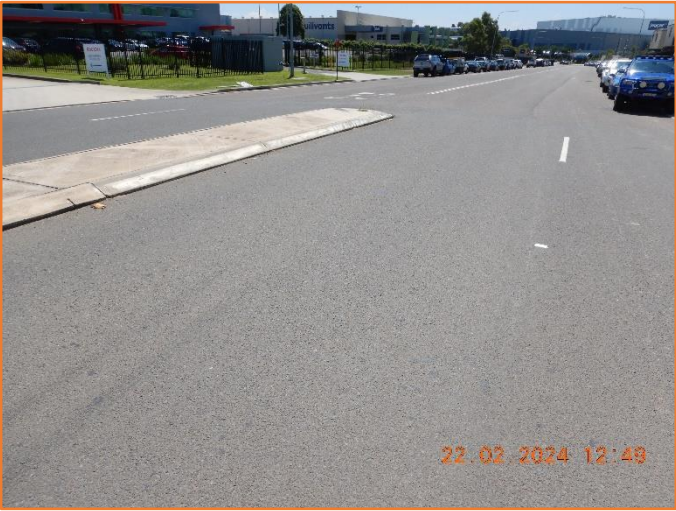
Figure 149: Reasonable - General condition of flexible pavement.

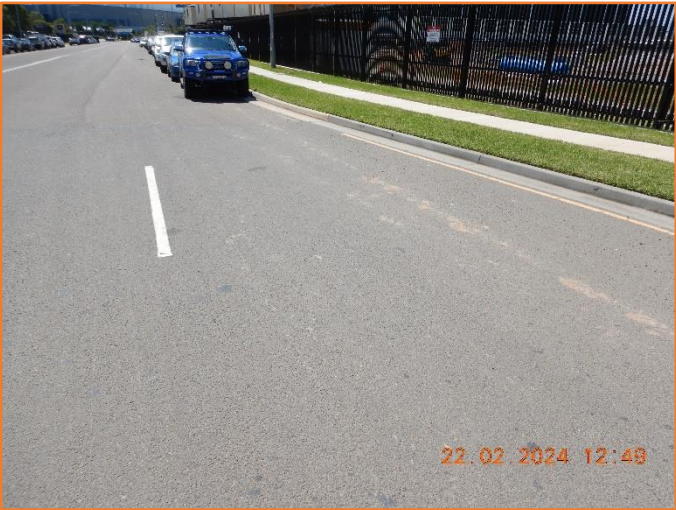
Figure 150: Reasonable - General condition of flexible pavement.

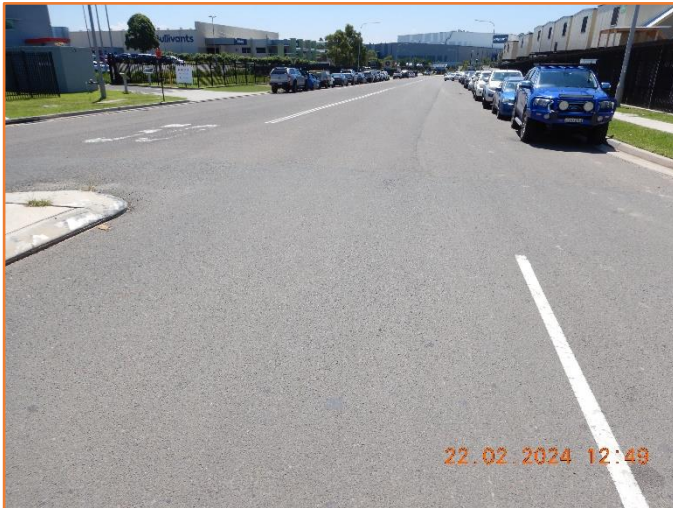
Figure 151: Reasonable - General condition of flexible pavement.

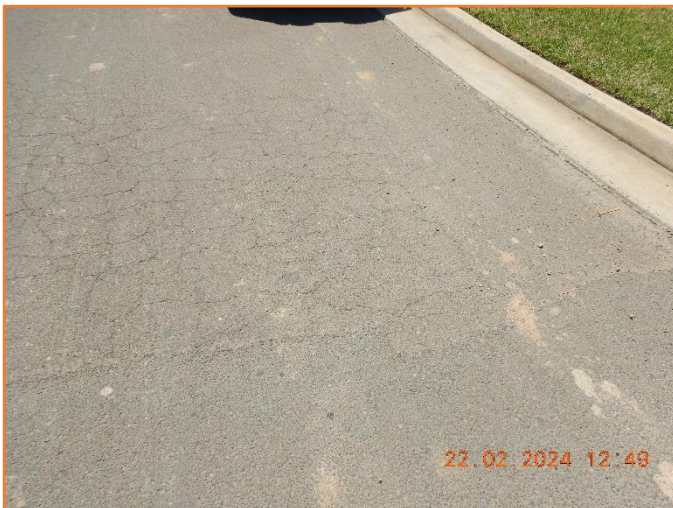
Figure 152: Reasonable - General condition of flexible pavement.  
 Moderate alligator cracking observed.

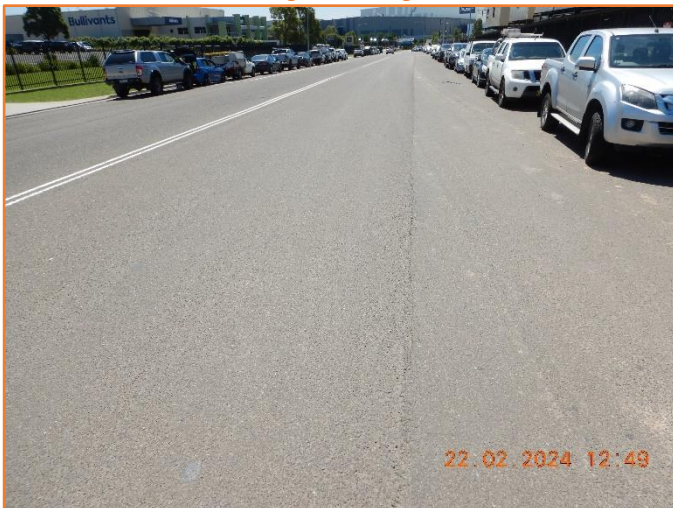
Figure 155: Reasonable - General condition of flexible pavement.

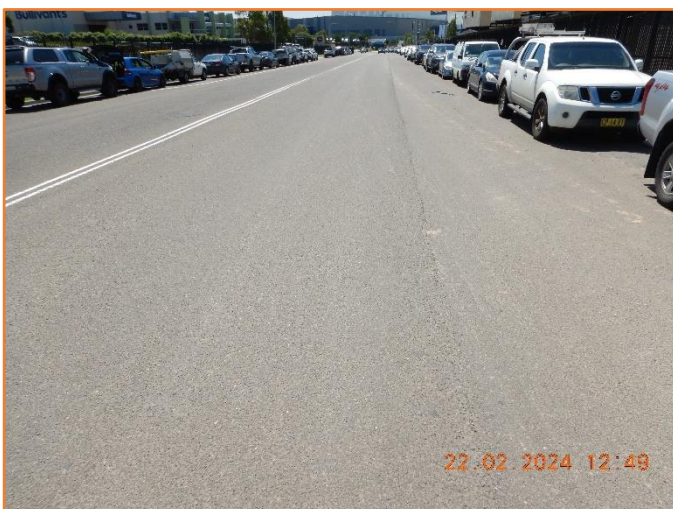
Figure 156: Reasonable - General condition of flexible pavement.

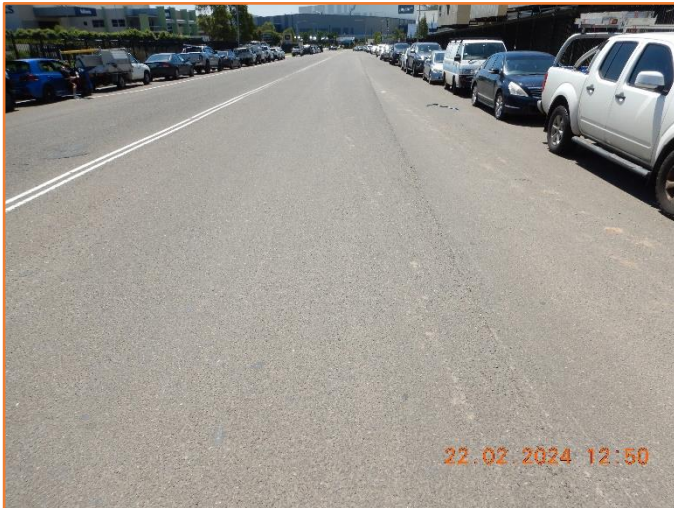
Figure 157: Reasonable - General condition of flexible pavement.

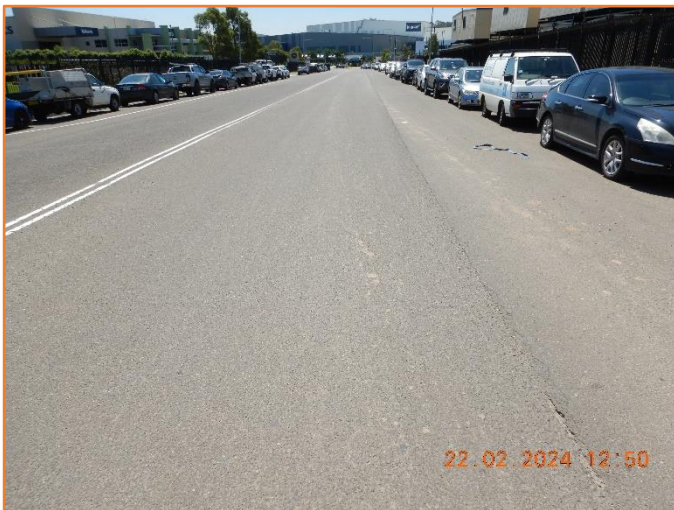
Figure 158: Reasonable - General condition of flexible pavement.

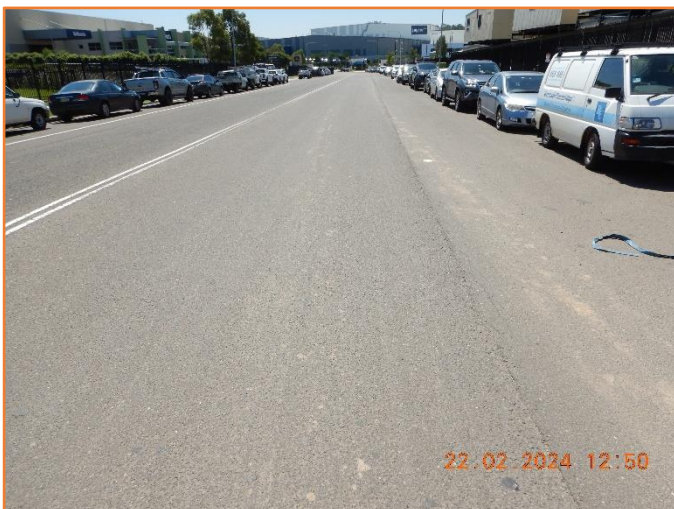
Figure 159: Reasonable - General condition of flexible pavement.

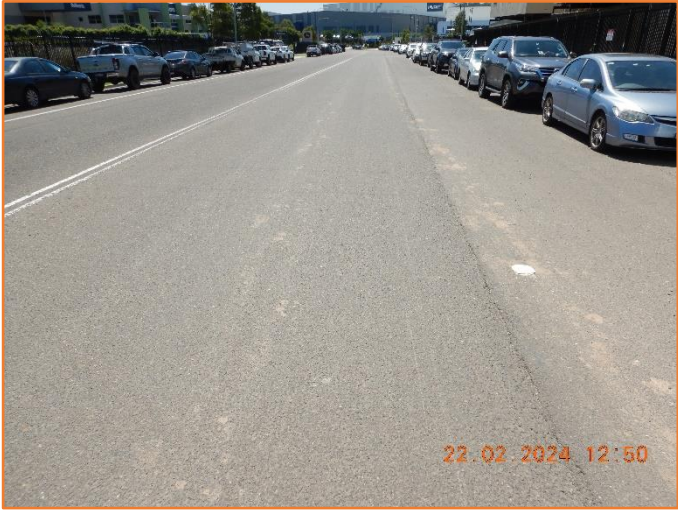
Figure 160: Reasonable - General condition of flexible pavement.

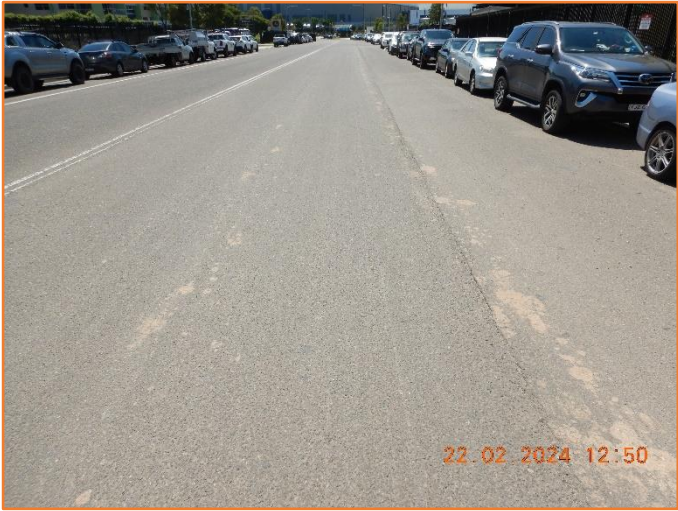
Figure 161: Reasonable - General condition of flexible pavement.

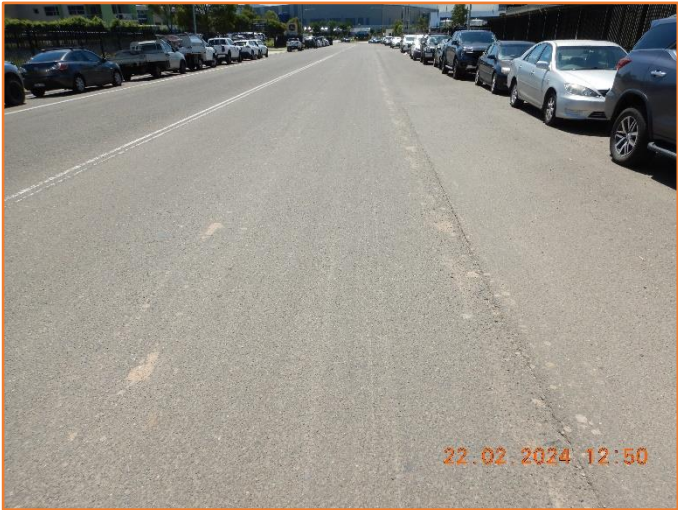
Figure 162: Reasonable - General condition of flexible pavement.

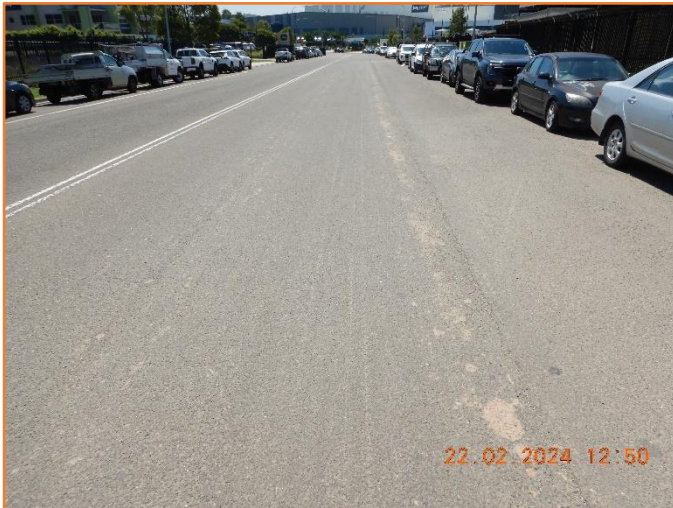
Figure 163: Reasonable - General condition of flexible pavement.

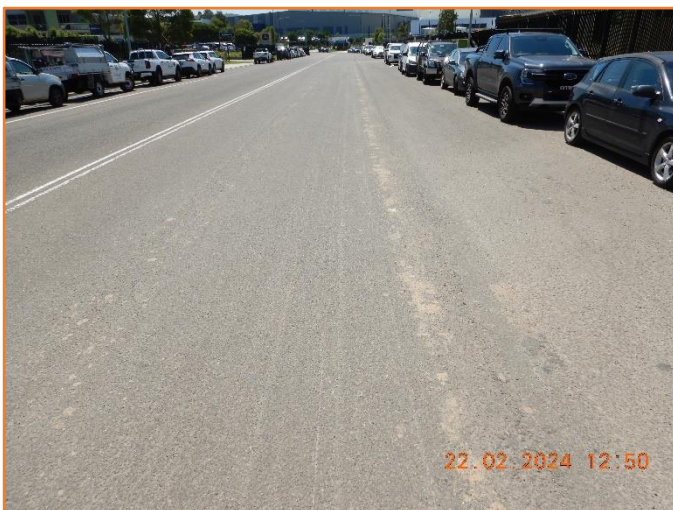
Figure 164: Reasonable - General condition of flexible pavement.

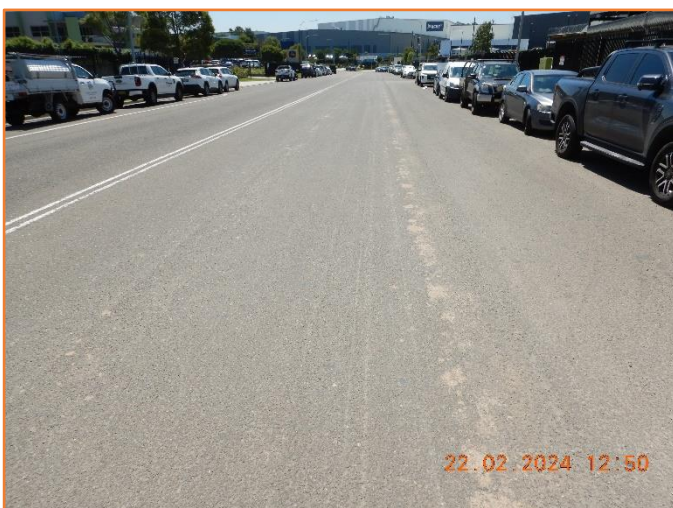
Figure 165: Reasonable - General condition of flexible pavement.

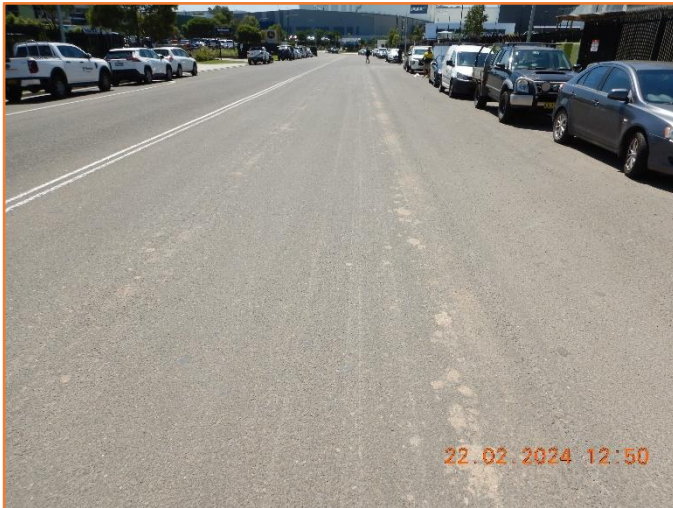
Figure 166: Reasonable - General condition of flexible pavement.

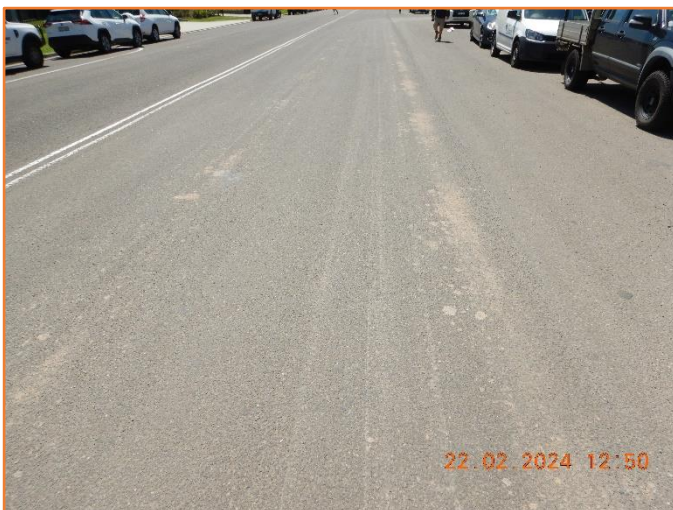
Figure 167: Reasonable - General condition of flexible pavement.

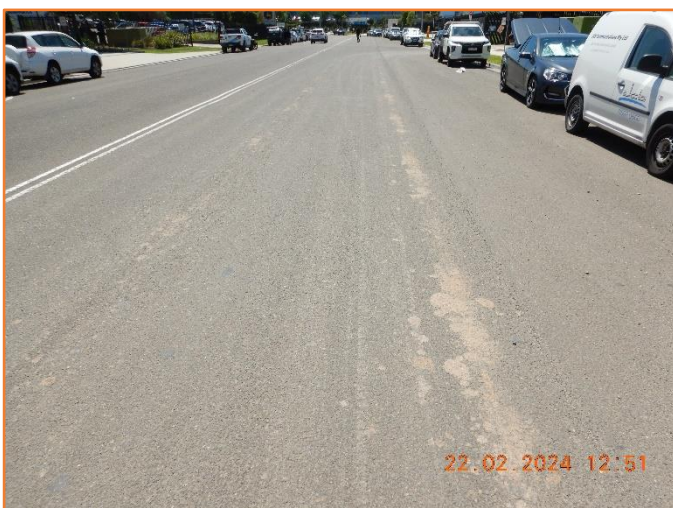
Figure 168: Reasonable - General condition of flexible pavement.

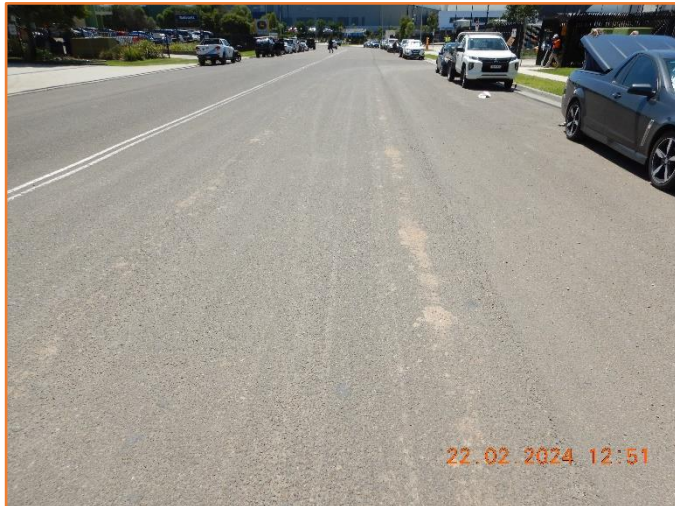
Figure 169: Reasonable - General condition of flexible pavement.

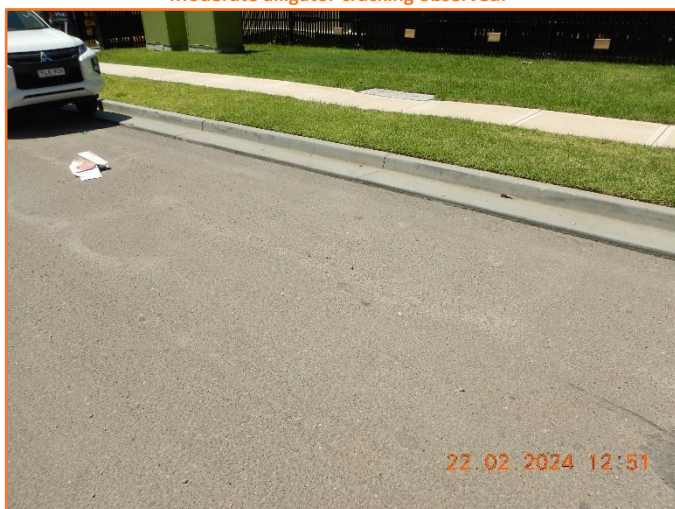
Figure 171: Reasonable - General condition of flexible pavement.

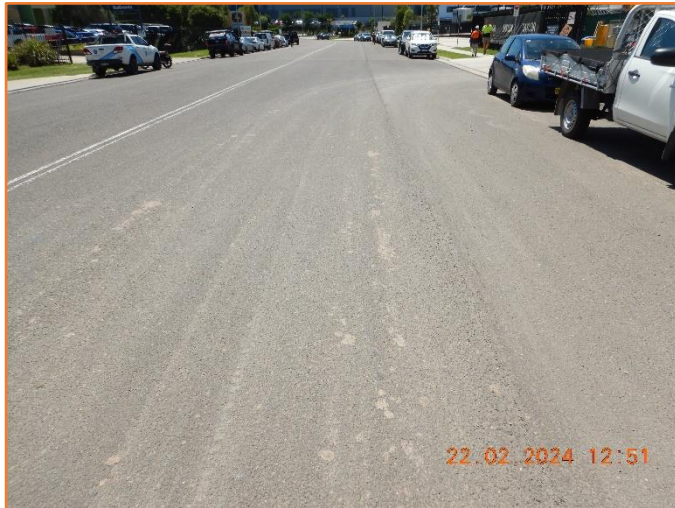
Figure 172: Reasonable - General condition of flexible pavement.

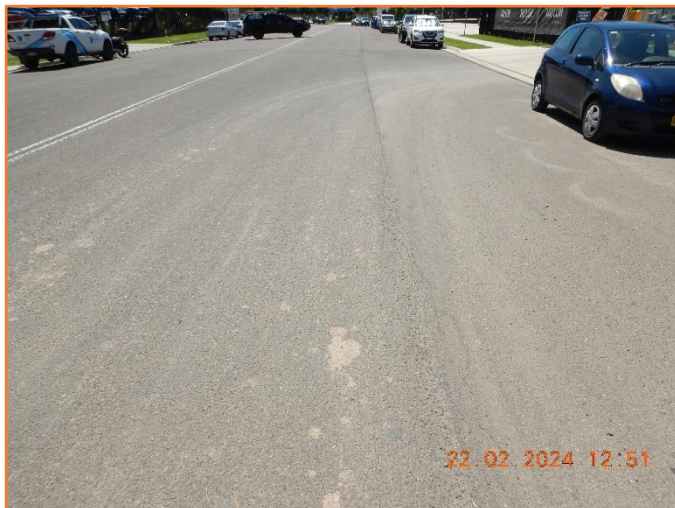
Figure 173: Reasonable - General condition of flexible pavement.

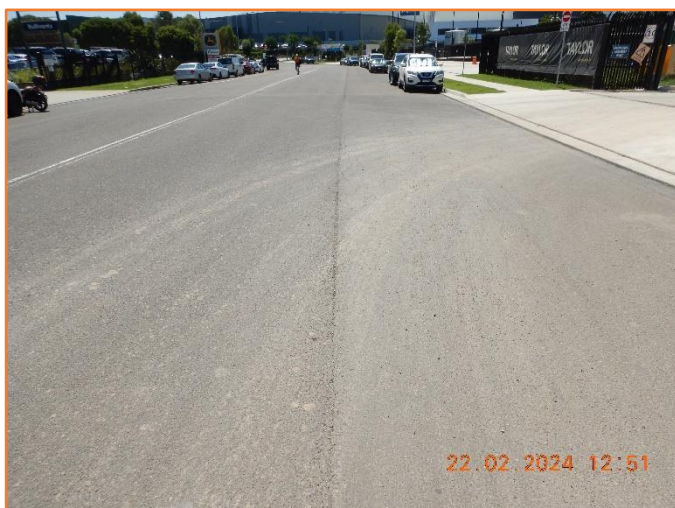
Figure 174: Reasonable - General condition of flexible pavement.

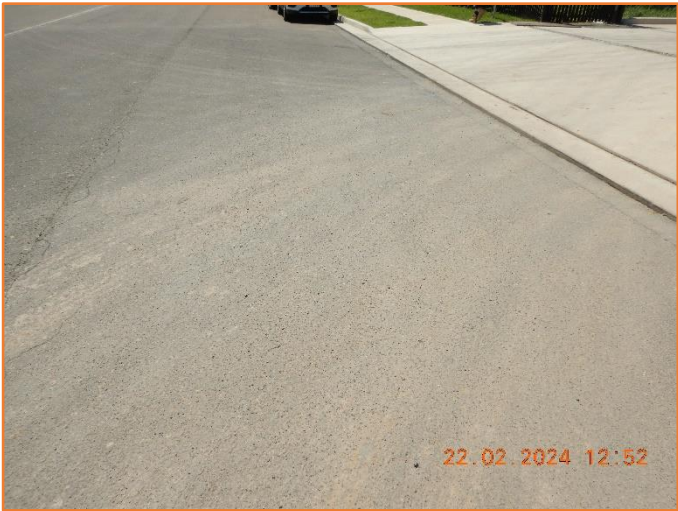
Figure 176: Reasonable - General condition of flexible pavement.

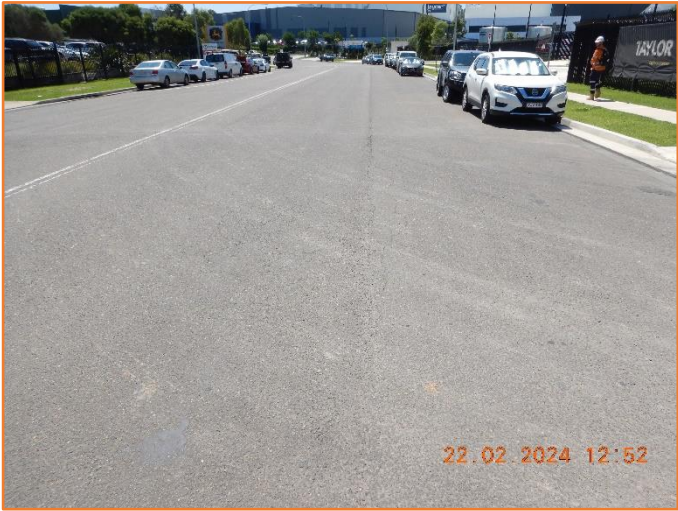
Figure 177: Reasonable - General condition of flexible pavement.

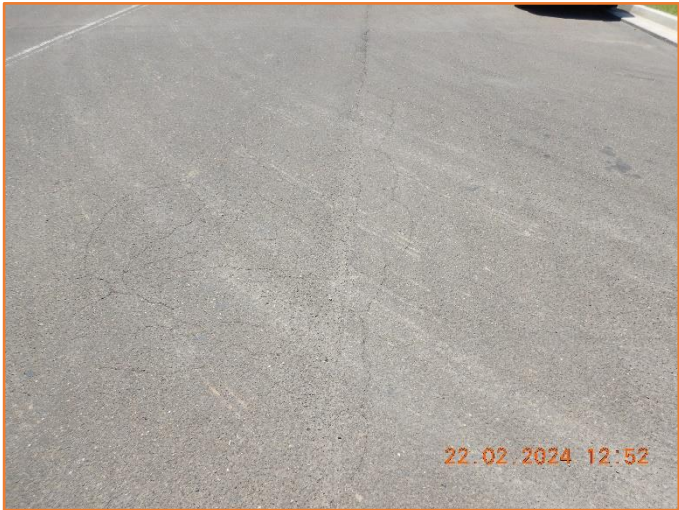
Figure 178: Reasonable - General condition of flexible pavement.  
Moderate alligator cracking observed.

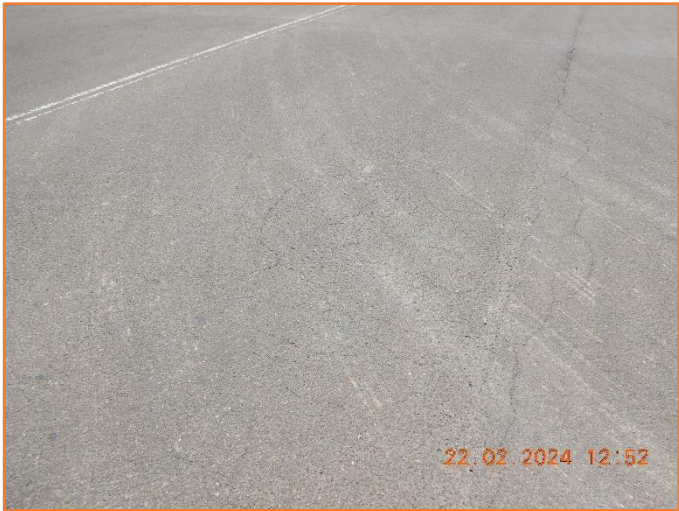
Figure 179: Reasonable - General condition of flexible pavement.  
Moderate alligator cracking observed.

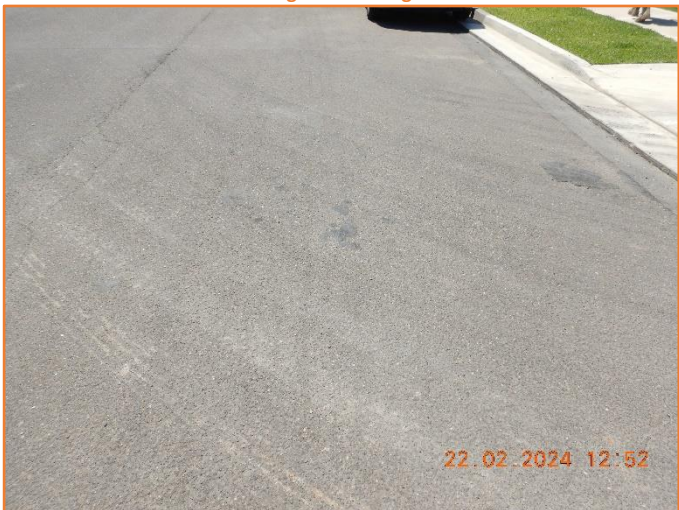
Figure 180: Reasonable - General condition of flexible pavement.

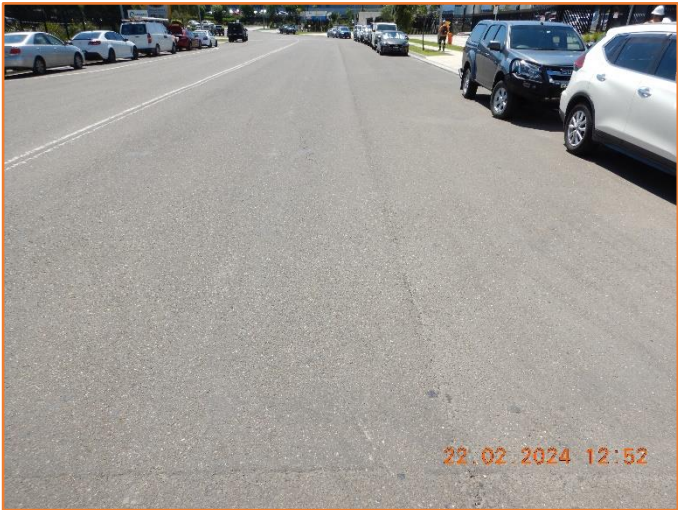
Figure 181: Reasonable - General condition of flexible pavement.

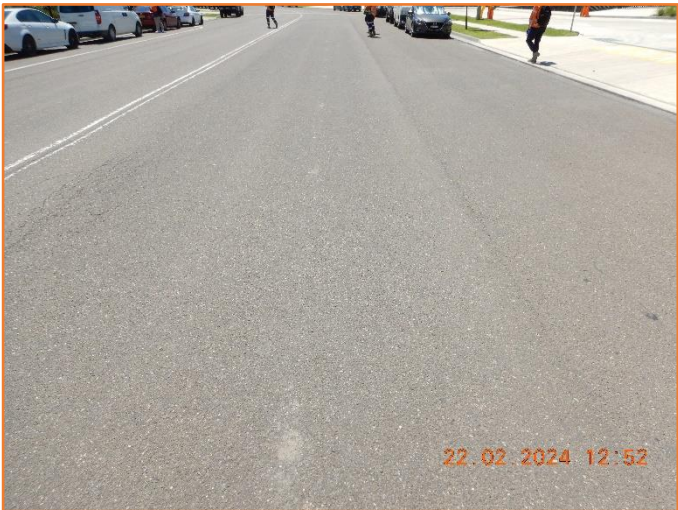
Figure 183: Reasonable - General condition of flexible pavement.

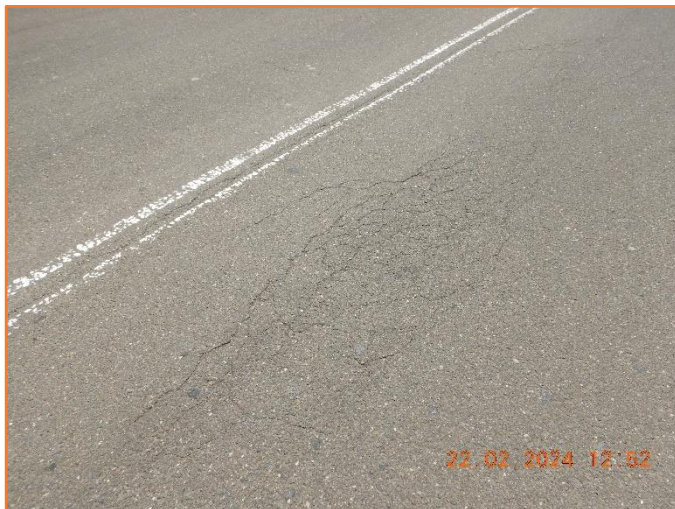
Figure 184: Reasonable - General condition of flexible pavement.  
Moderate alligator cracking and rutting observed.

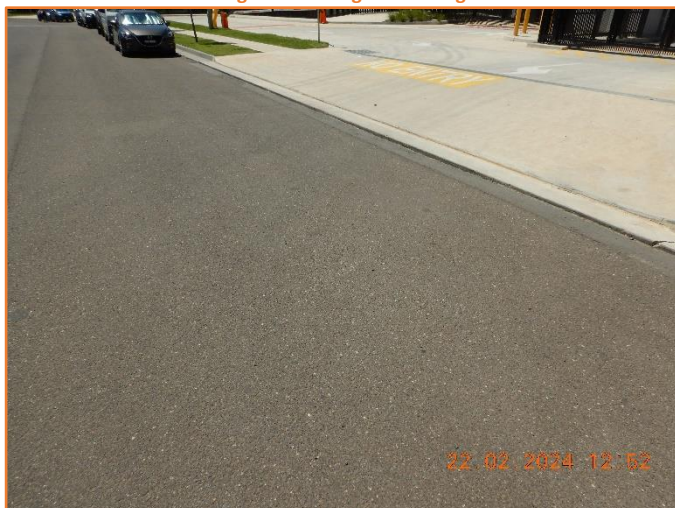
Figure 185: Reasonable - General condition of flexible pavement.
