## DILAPIDATION REPORT

10 EASTERN CREEK DRIVE EASTERN CREEK, NSW, 2766

THURSDAY, 22 FEBRUARY 2024

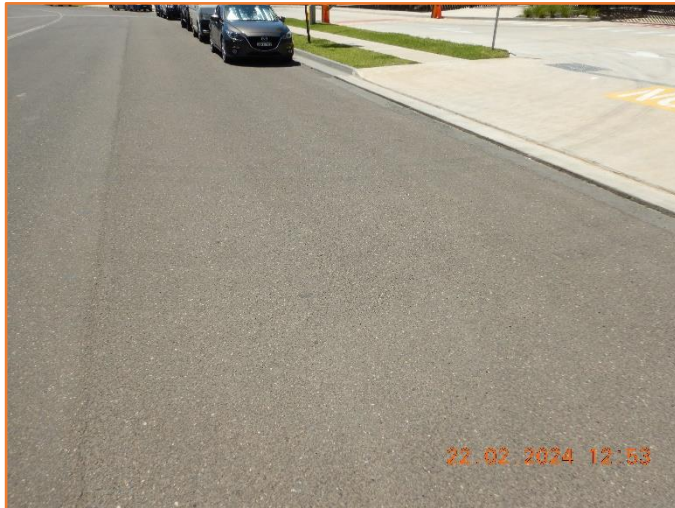
Figure 187: Reasonable - General condition of flexible pavement.

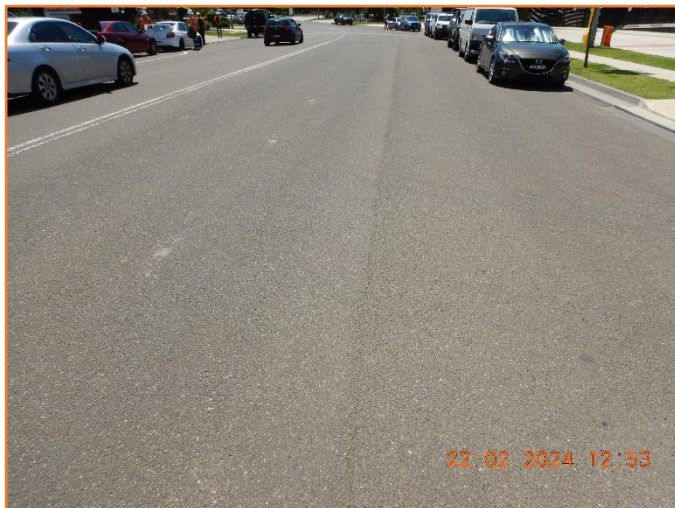
Figure 188: Reasonable - General condition of flexible pavement.

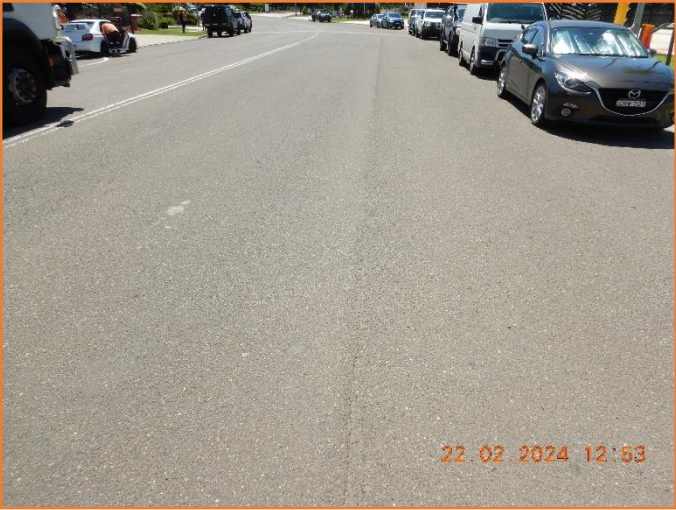
Figure 190: Reasonable - General condition of flexible pavement.

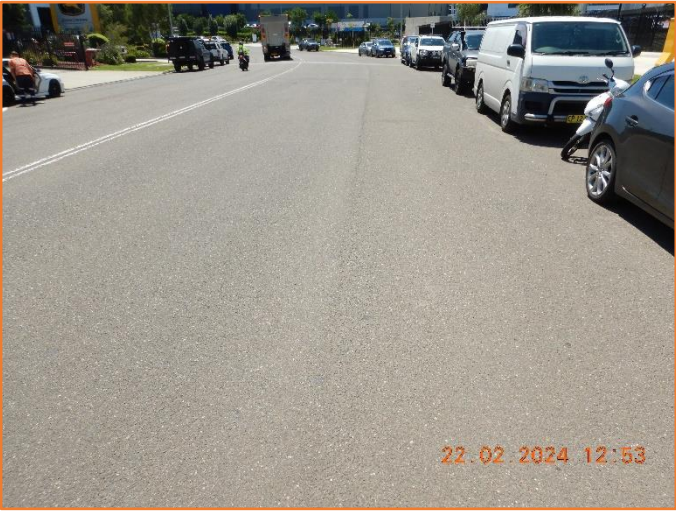
Figure 191: Reasonable - General condition of flexible pavement.

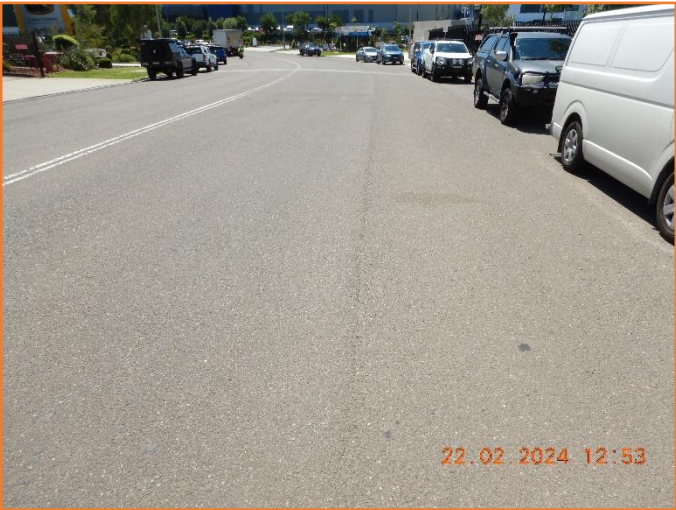
Figure 192: Reasonable - General condition of flexible pavement.

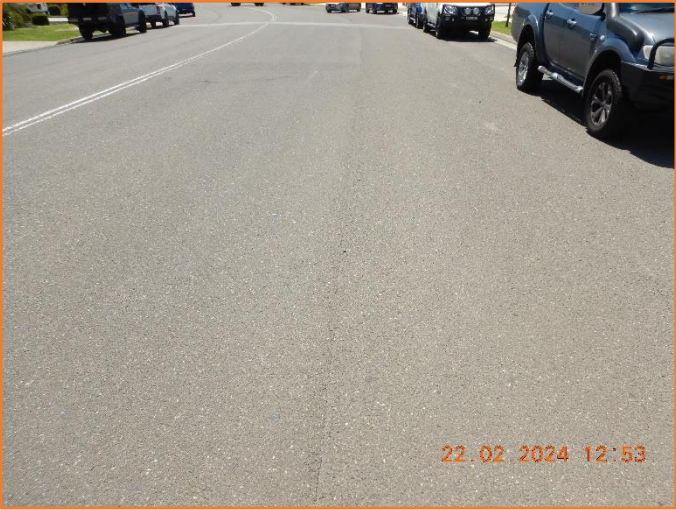
Figure 193: Reasonable - General condition of flexible pavement.

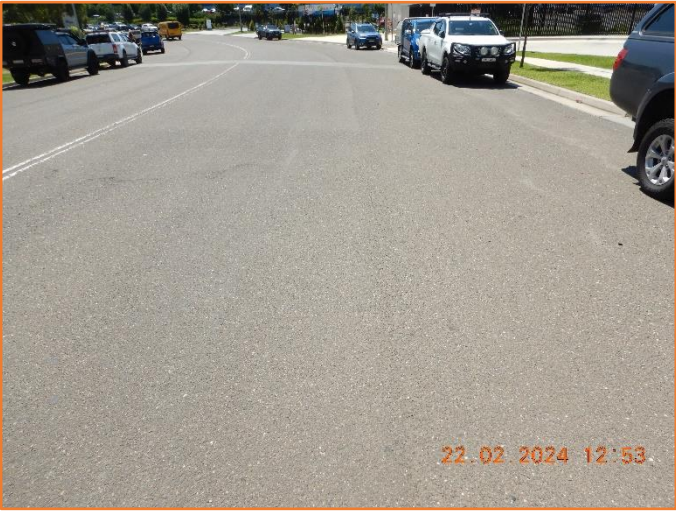
Figure 194: Reasonable - General condition of flexible pavement.

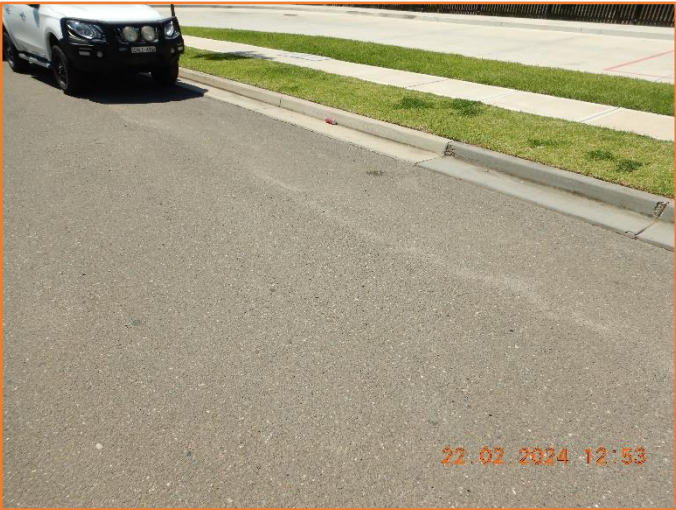
Figure 195: Reasonable - General condition of flexible pavement.

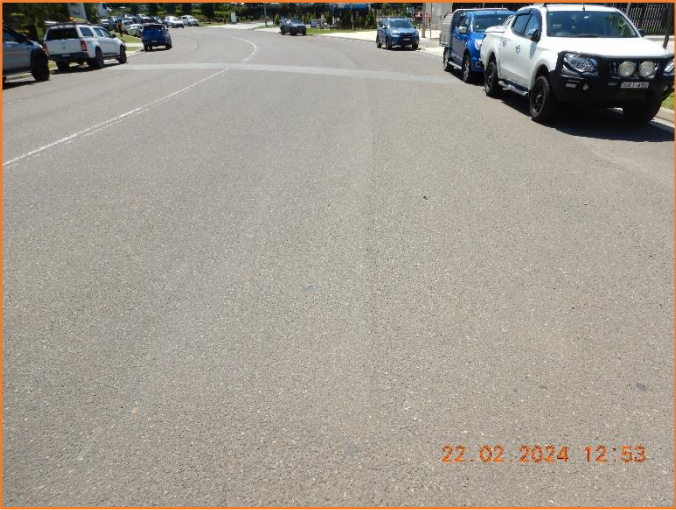
Figure 196: Reasonable - General condition of flexible pavement.

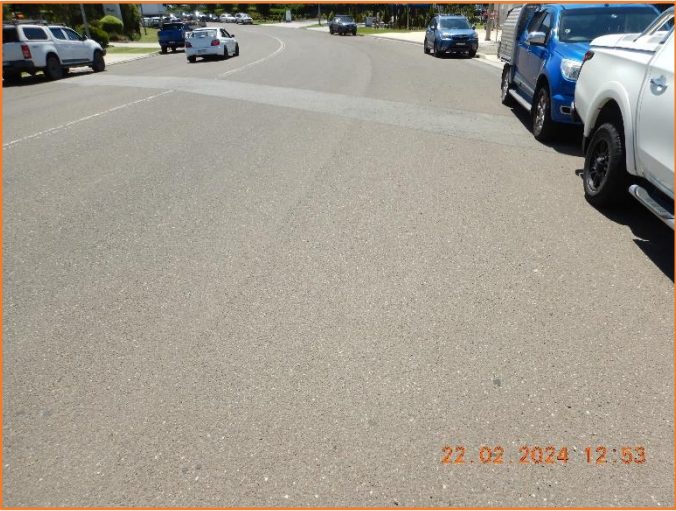
Figure 197: Reasonable - General condition of flexible pavement.

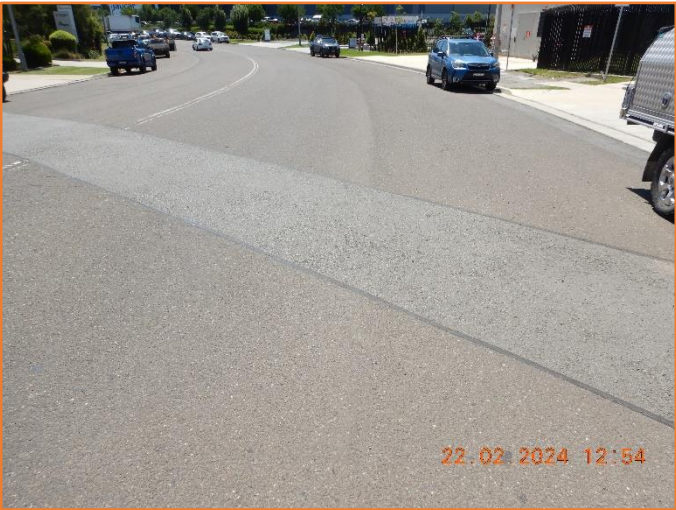
Figure 198: Reasonable - General condition of flexible pavement.

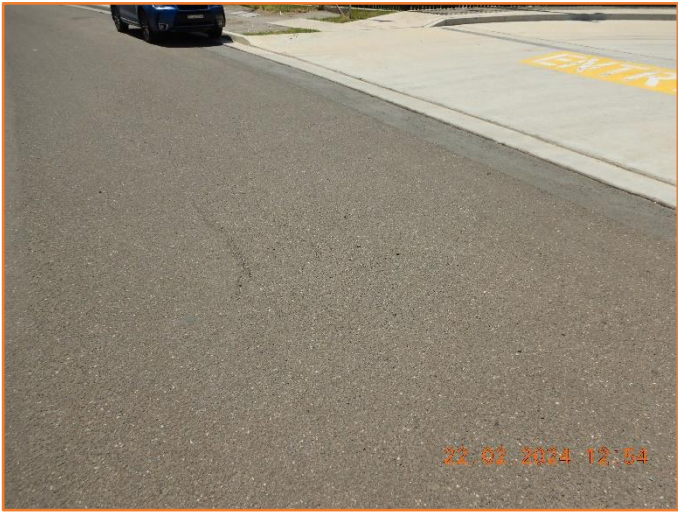
Figure 199: Reasonable - General condition of flexible pavement.

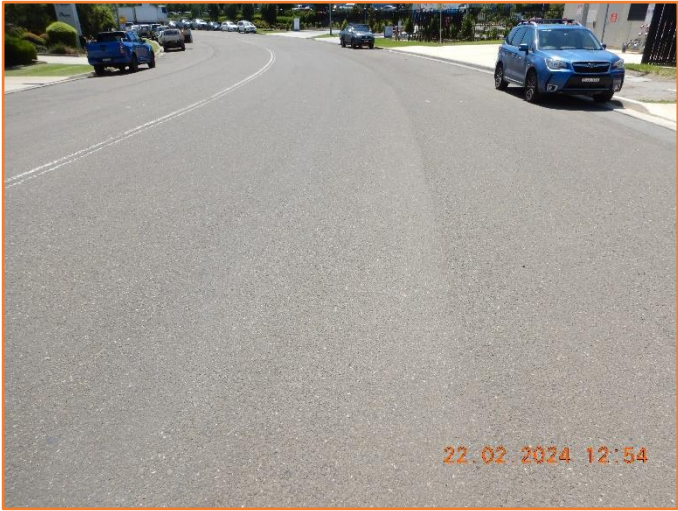
Figure 200: Reasonable - General condition of flexible pavement.

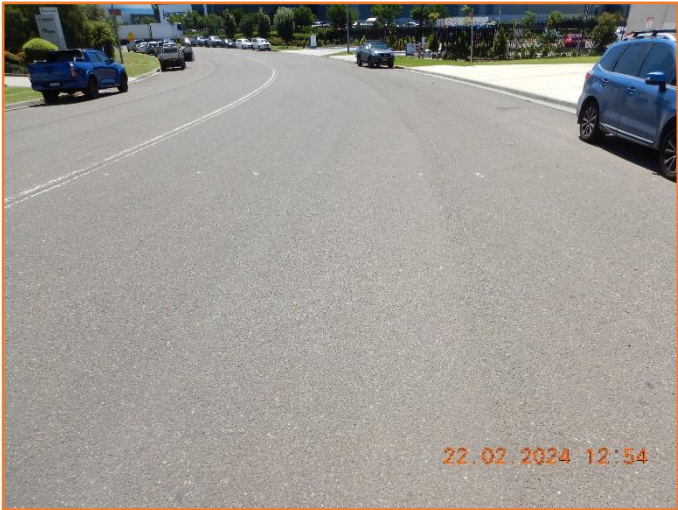
Figure 201: Reasonable - General condition of flexible pavement.

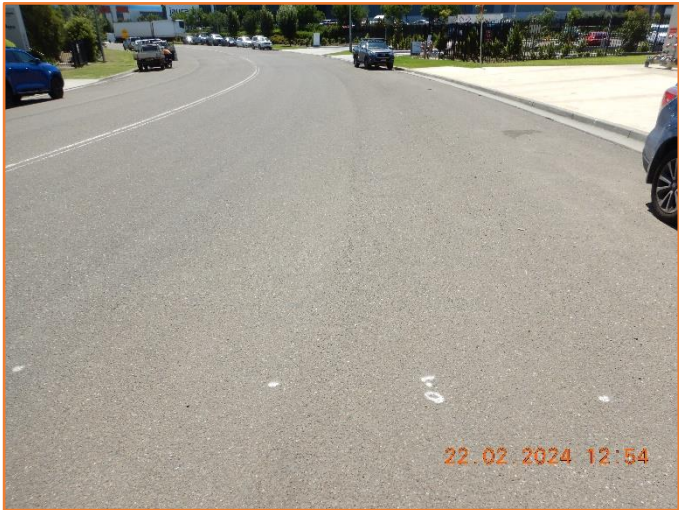
Figure 202: Reasonable - General condition of flexible pavement.

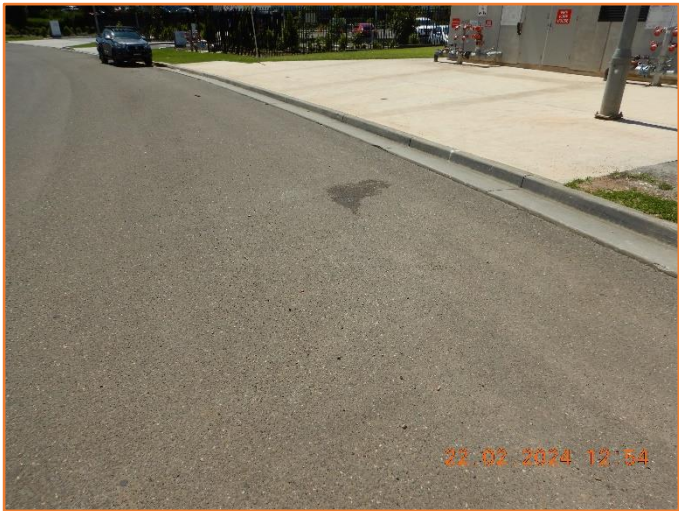
Figure 203: Reasonable - General condition of flexible pavement.

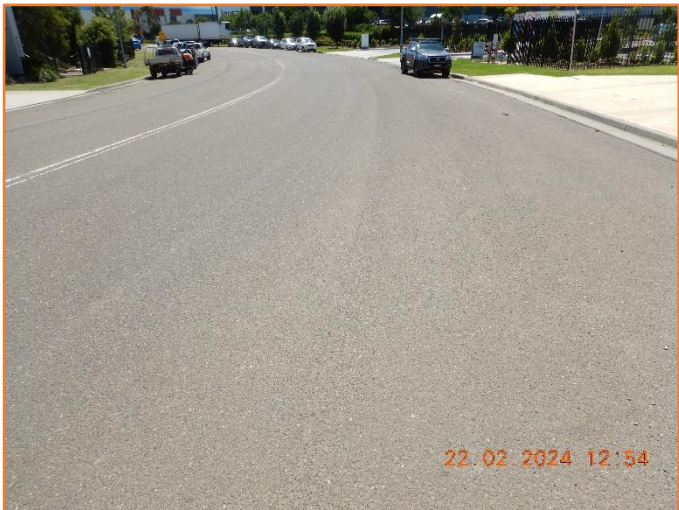
Figure 204: Reasonable - General condition of flexible pavement.

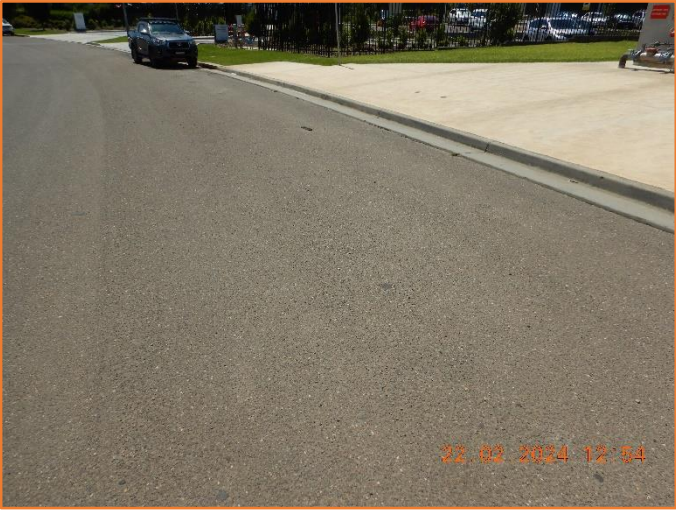
Figure 205: Reasonable - General condition of flexible pavement.

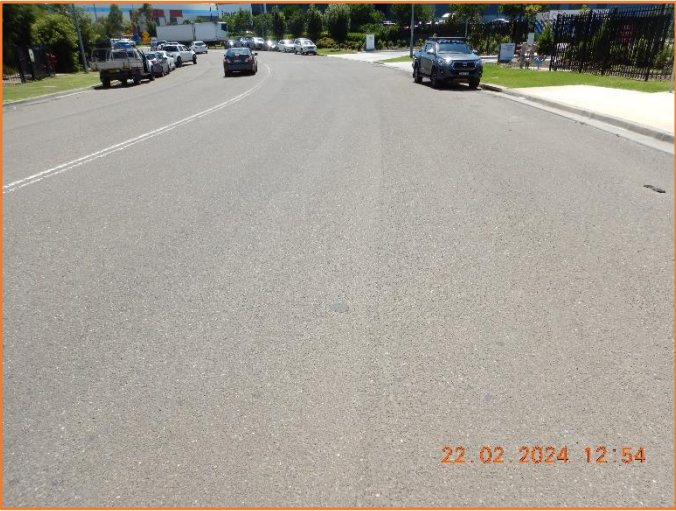
Figure 206: Reasonable - General condition of flexible pavement.

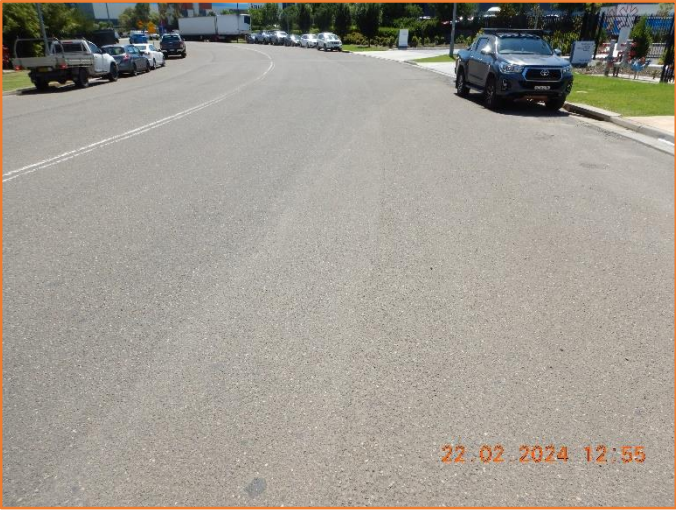
Figure 208: Reasonable - General condition of flexible pavement.

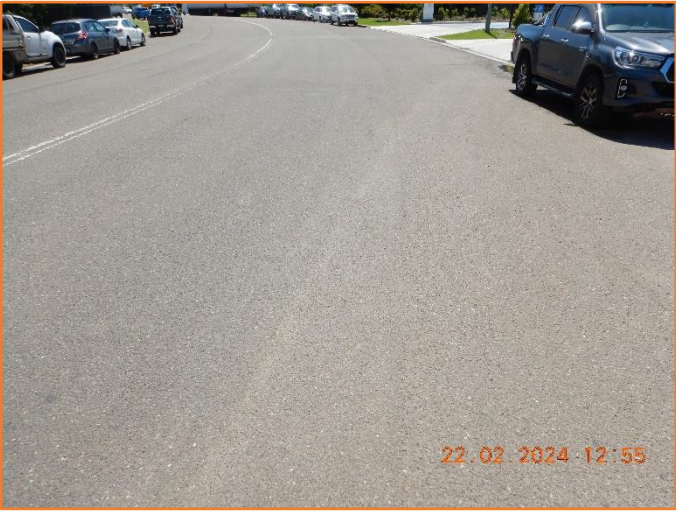
Figure 209: Reasonable - General condition of flexible pavement.

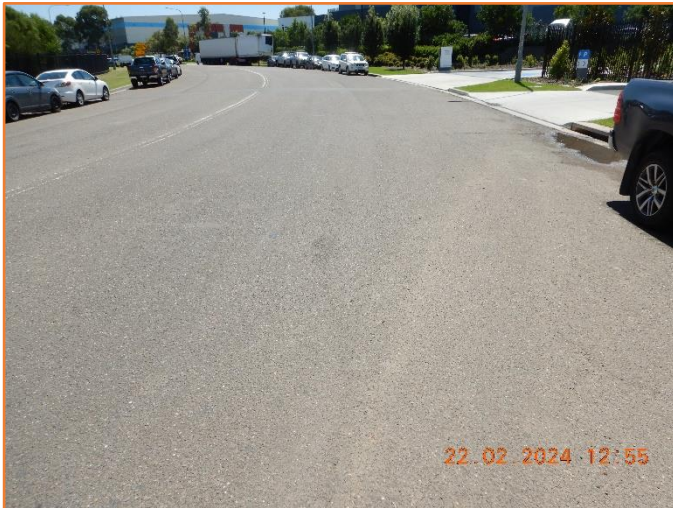
Figure 211: Reasonable - General condition of flexible pavement.

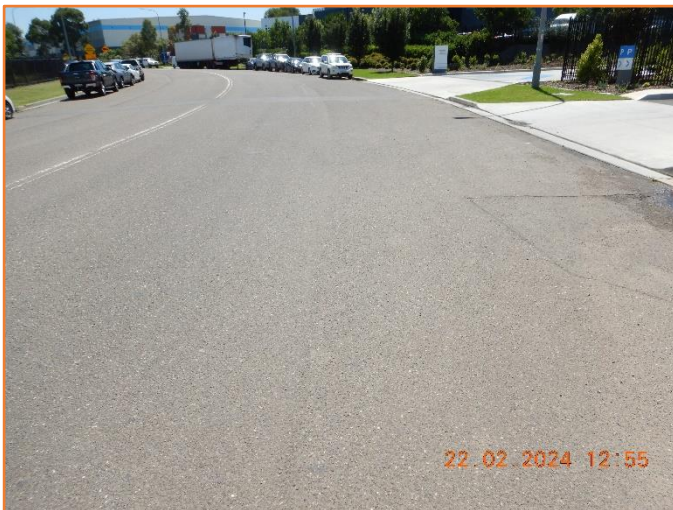
Figure 212: Reasonable - General condition of flexible pavement.

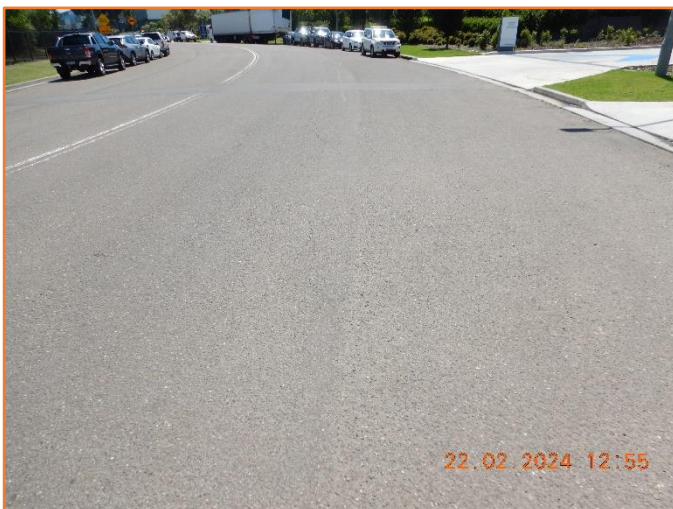
Figure 213: Reasonable - General condition of flexible pavement.

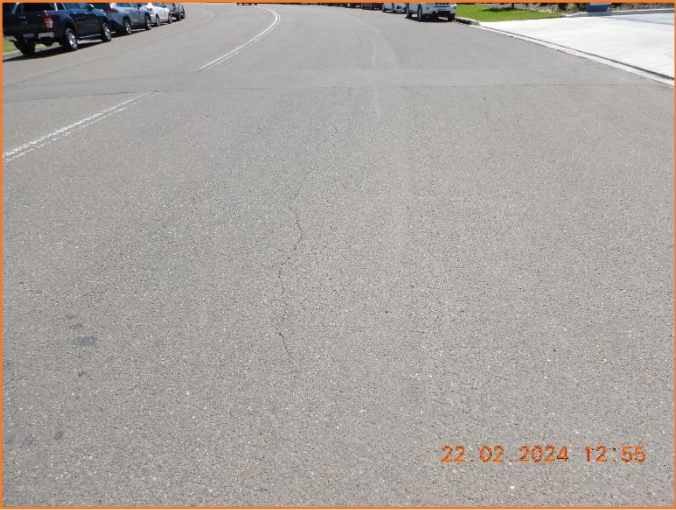
Figure 214: Reasonable - General condition of flexible pavement.  
Moderate cracking observed.

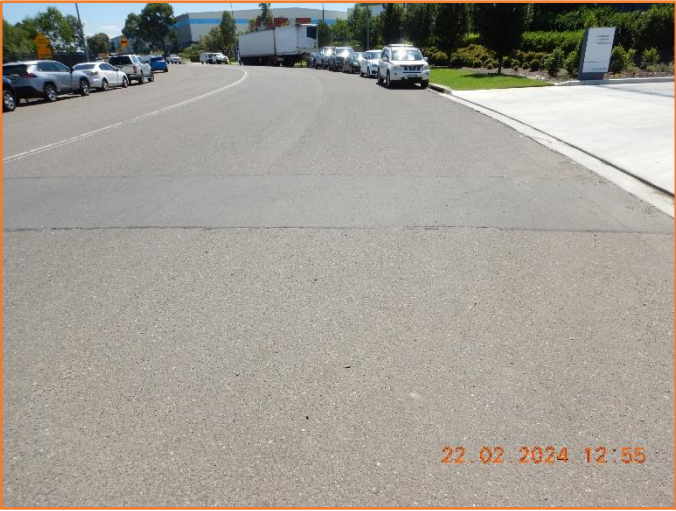
Figure 215: Reasonable - General condition of flexible pavement.

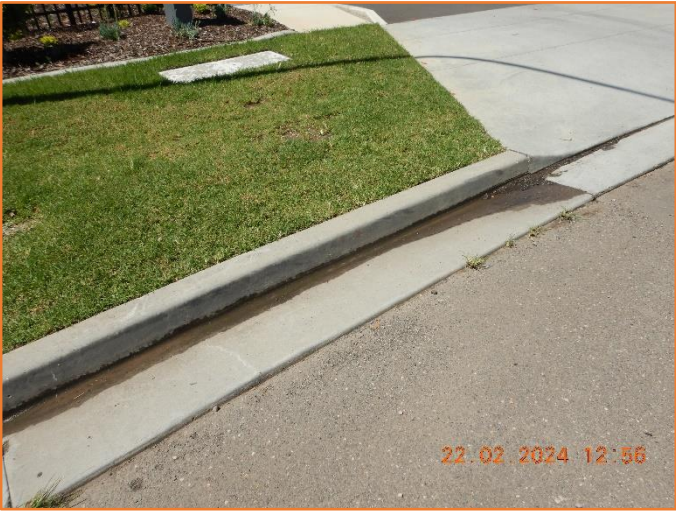
Figure 216: Reasonable - General condition of kerb and gutter.

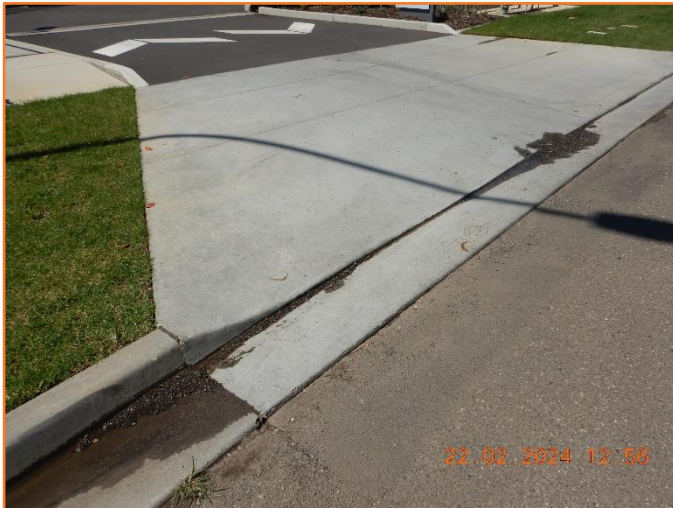
Figure 217: Reasonable - General condition of driveway layback.

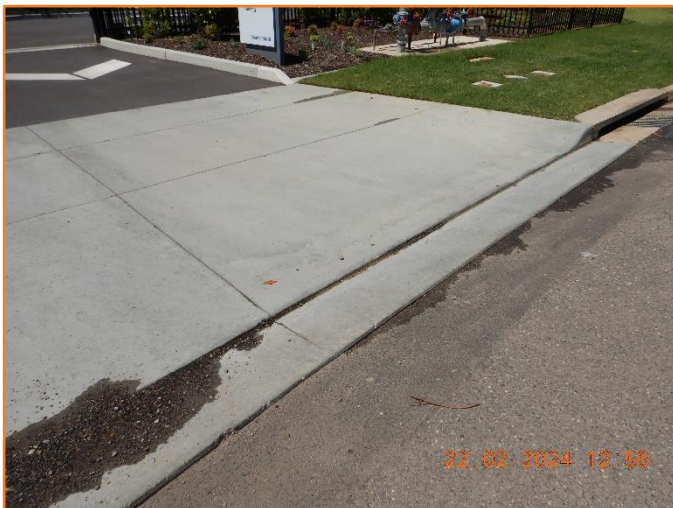
Figure 218: Reasonable - General condition of driveway layback.

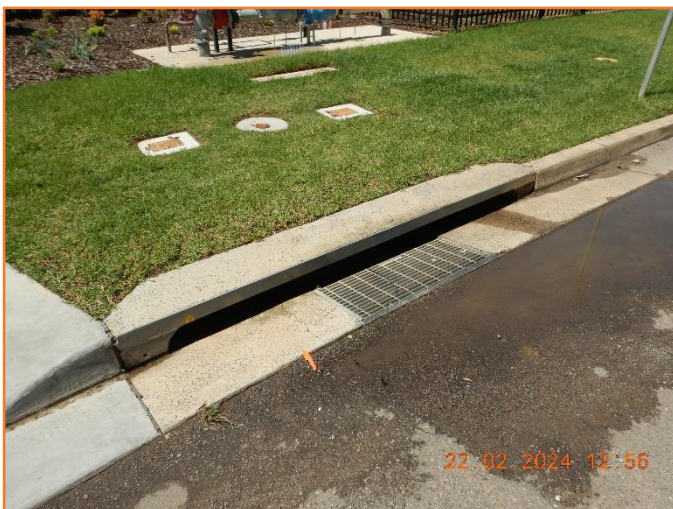
Figure 219: Reasonable - General condition of kerb inlet pit.

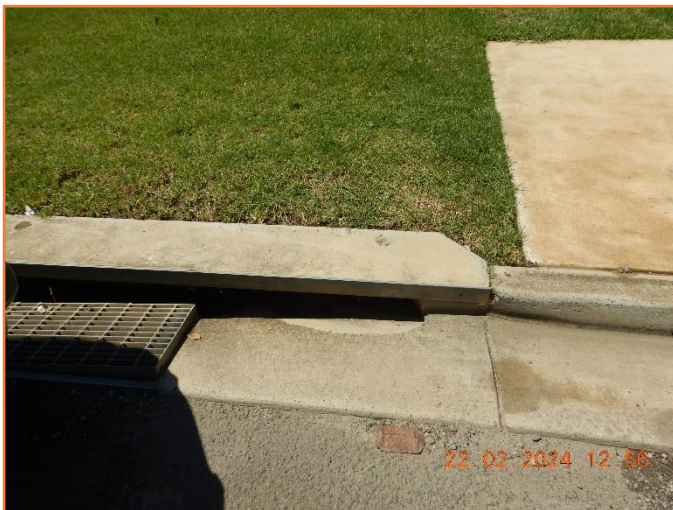
Figure 224: Reasonable - General condition of kerb inlet pit.

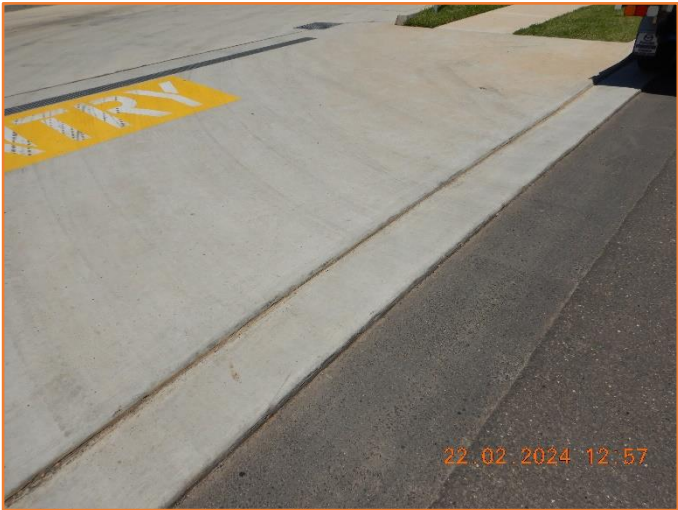
Figure 238: Reasonable - General condition of driveway layback.

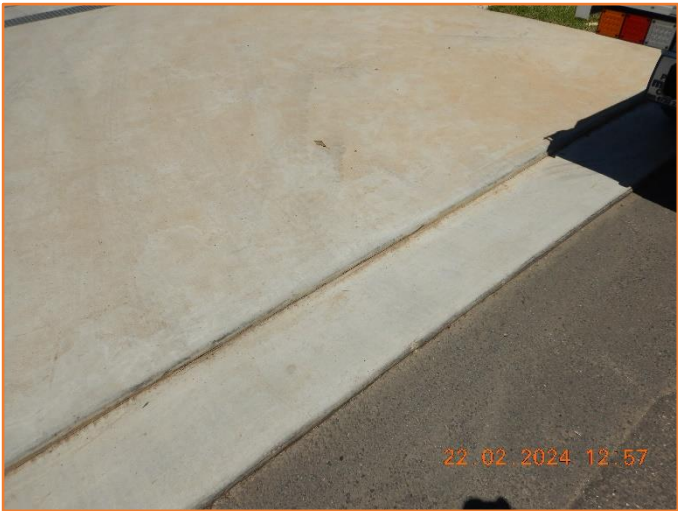
Figure 239: Reasonable - General condition of driveway layback.

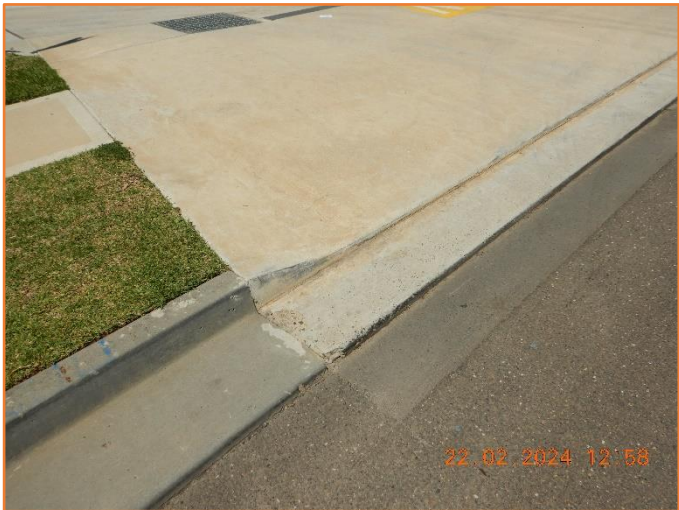
Figure 252: Reasonable - General condition of driveway splay.

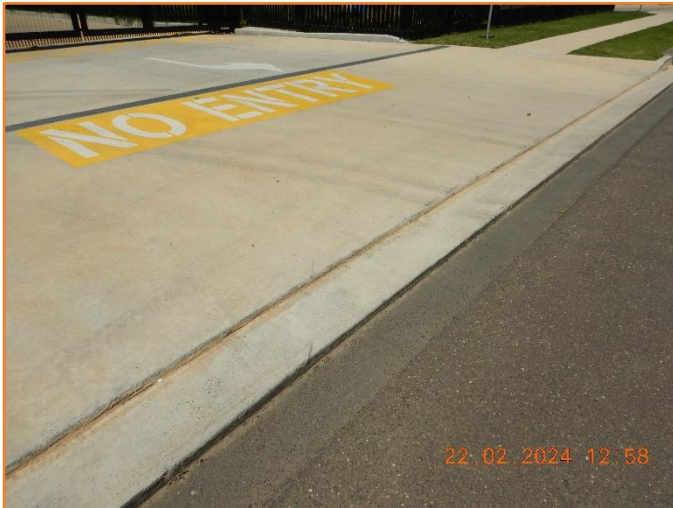
Figure 253: Reasonable - General condition of driveway layback.

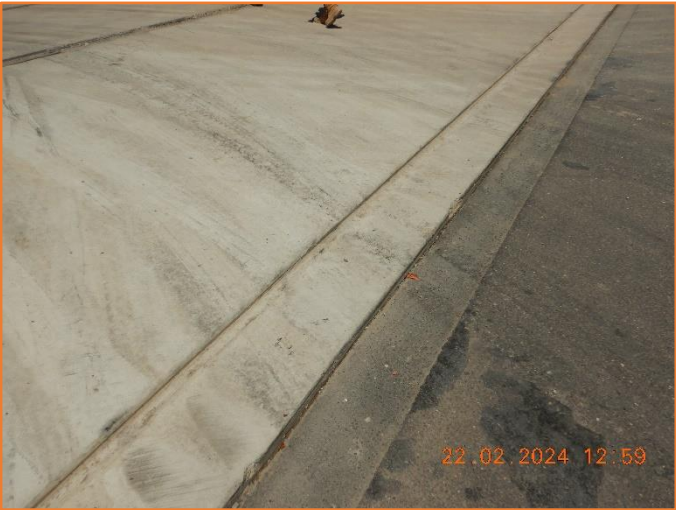
Figure 261: Reasonable - General condition of driveway layback.

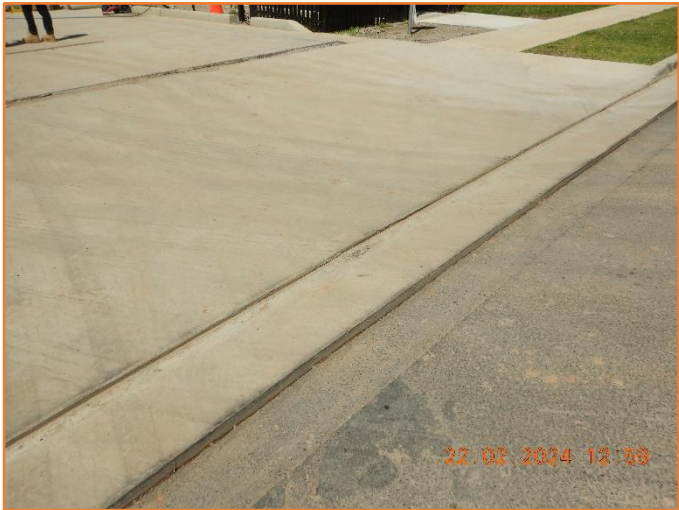
Figure 262: Reasonable - General condition of driveway layback.

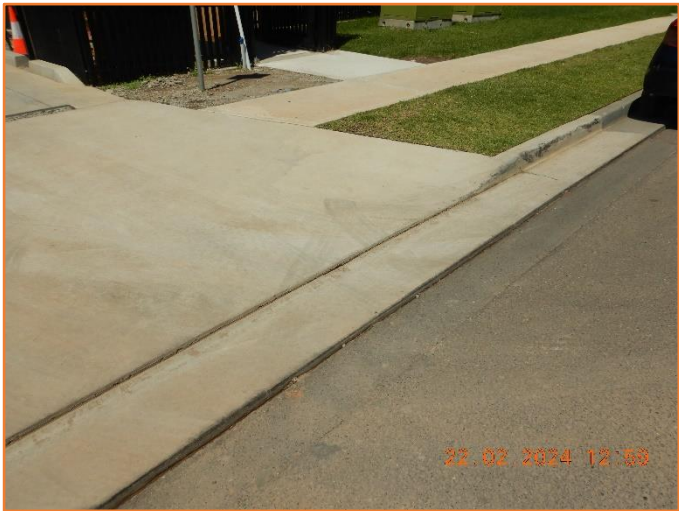
Figure 263: Reasonable - General condition of driveway layback.

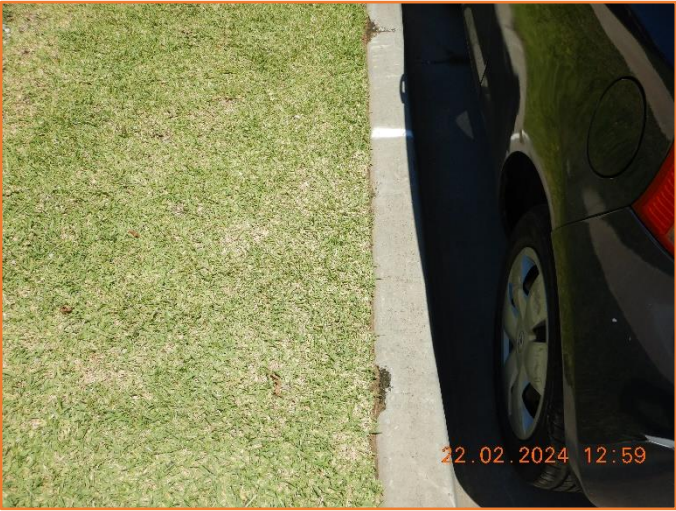
Figure 266: Reasonable - General condition of kerb and gutter. Minor spalling observed.

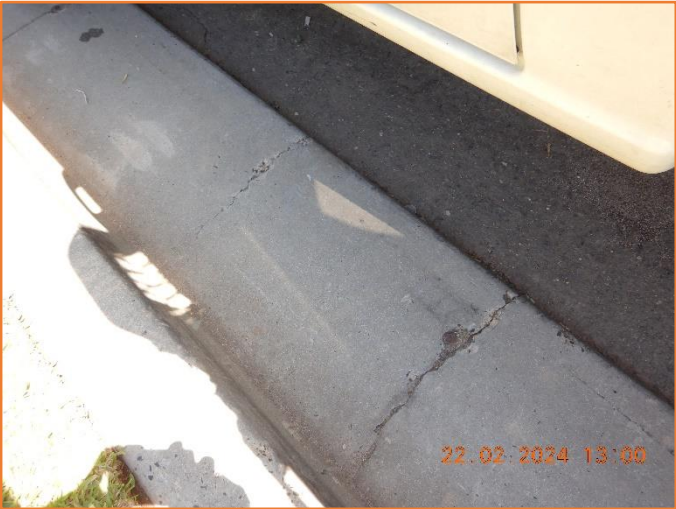
Figure 269: Reasonable - General condition of kerb and gutter. Moderate cracking observed.

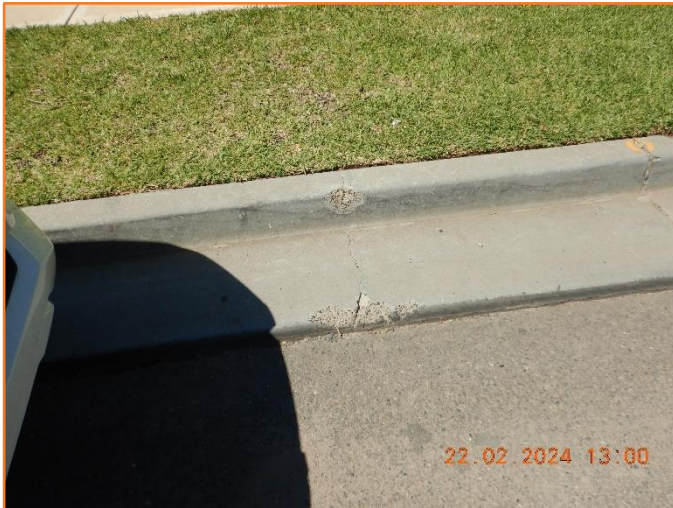
Figure 271: Reasonable - General condition of kerb and gutter. Moderate cracking and spalling observed.

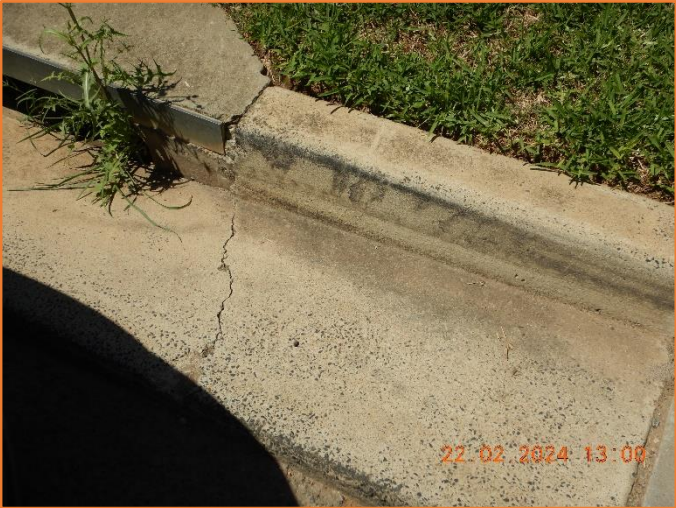
Figure 277: Reasonable - General condition of kerb inlet pit. Moderate cracking observed.

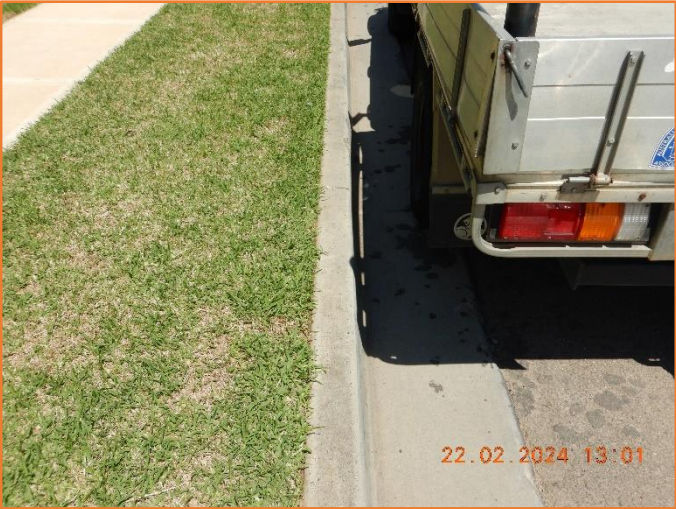
Figure 278: Reasonable - General condition of kerb and gutter.

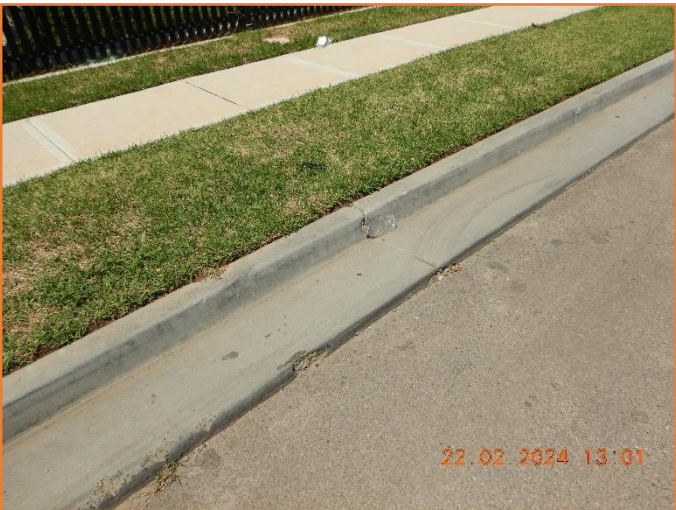
Figure 282: Reasonable - General condition of kerb and gutter.

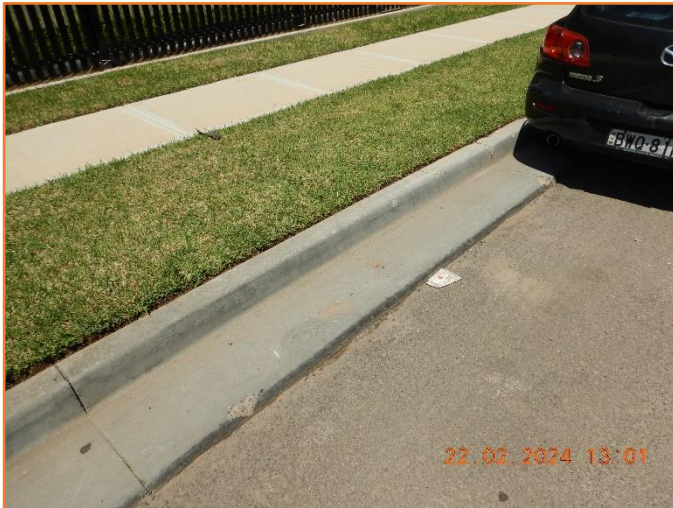
Figure 283: Reasonable - General condition of kerb and gutter.

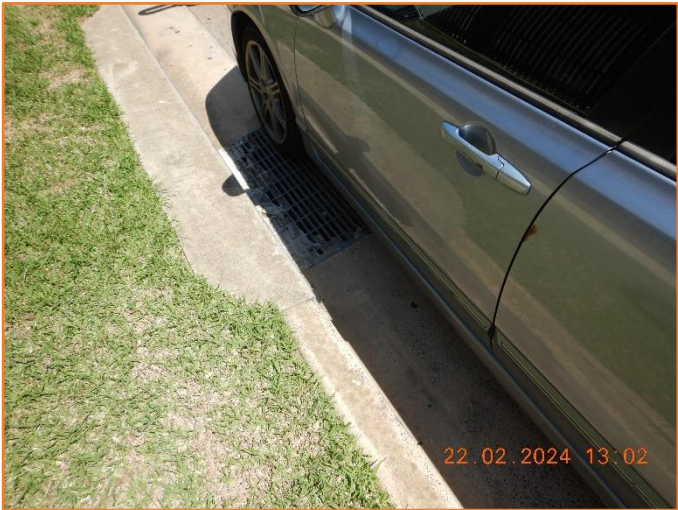
Figure 292: Reasonable - General condition of kerb inlet pit.

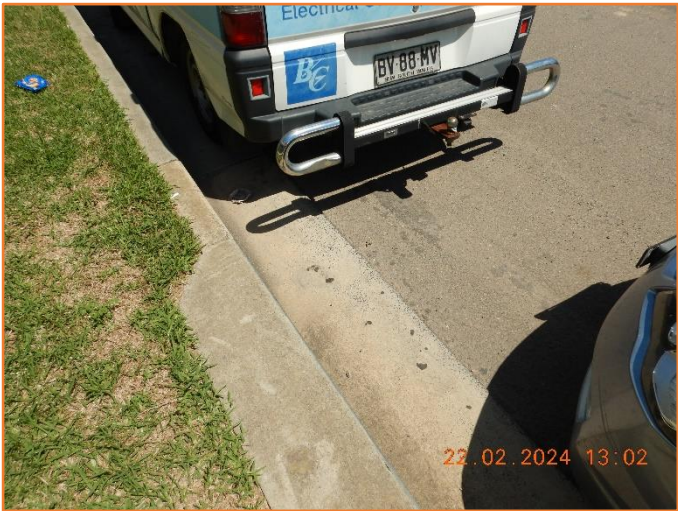
Figure 293: Reasonable - General condition of kerb inlet pit.

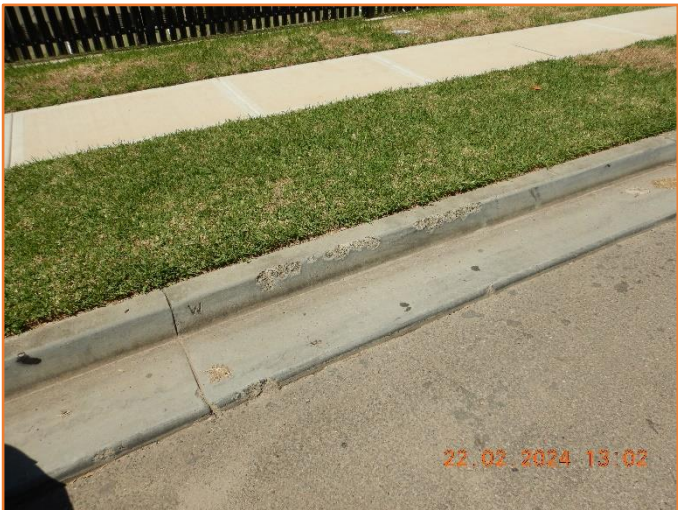
Figure 297: Poor - General condition of kerb and gutter. Moderate spalling observed.

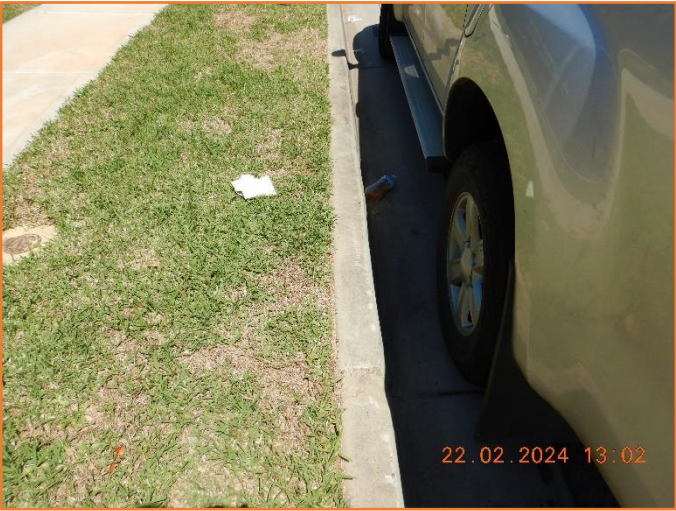
Figure 300: Reasonable - General condition of kerb and gutter.

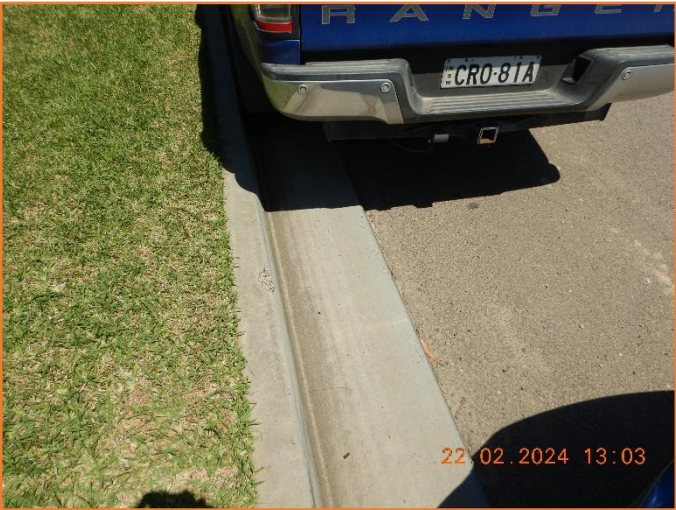
Figure 303: Reasonable - General condition of kerb and gutter.

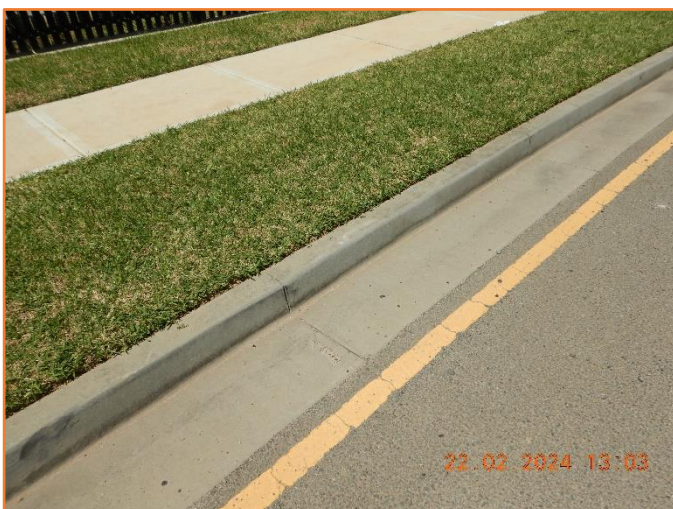
Figure 306: Reasonable - General condition of kerb and gutter.

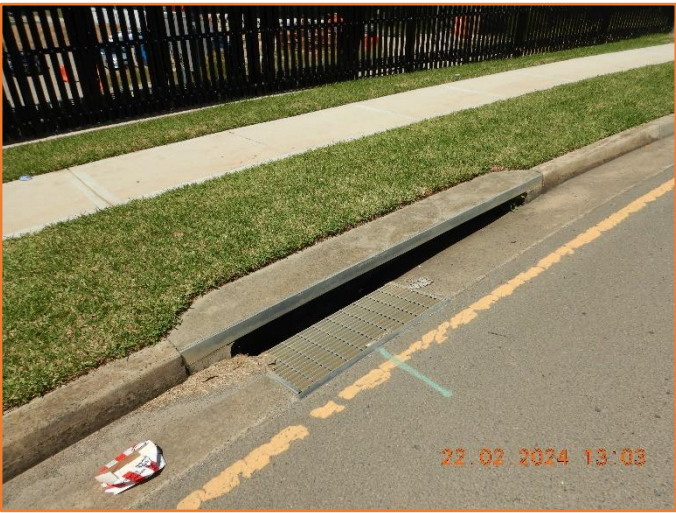
Figure 308: Reasonable - General condition of kerb inlet pit.

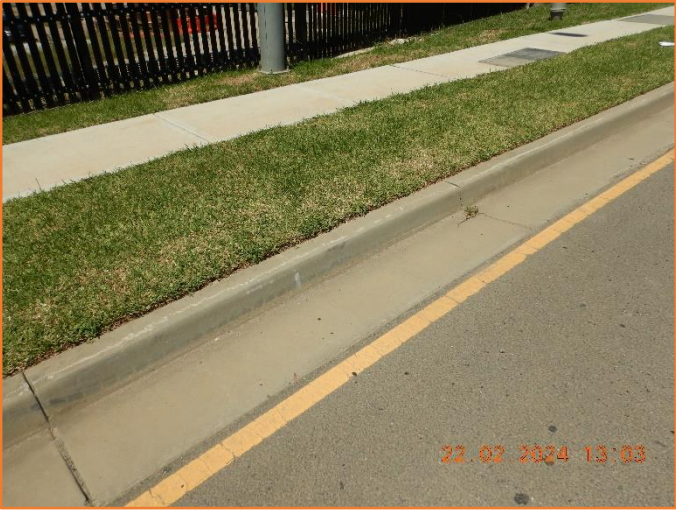
Figure 310: Reasonable - General condition of kerb and gutter.

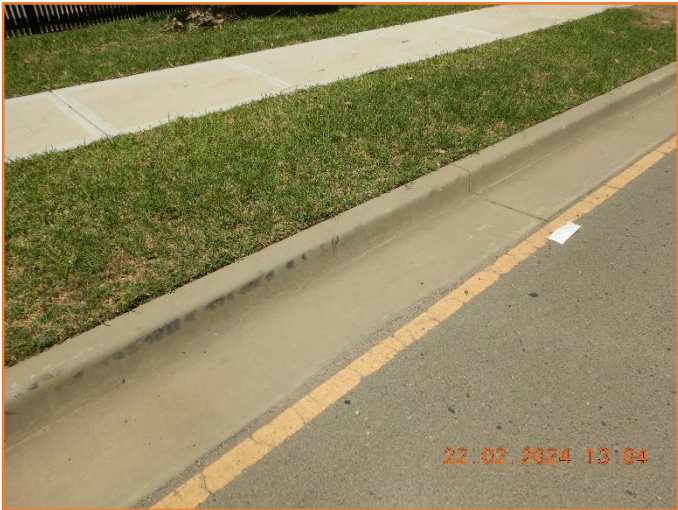
Figure 313: Reasonable - General condition of kerb and gutter.

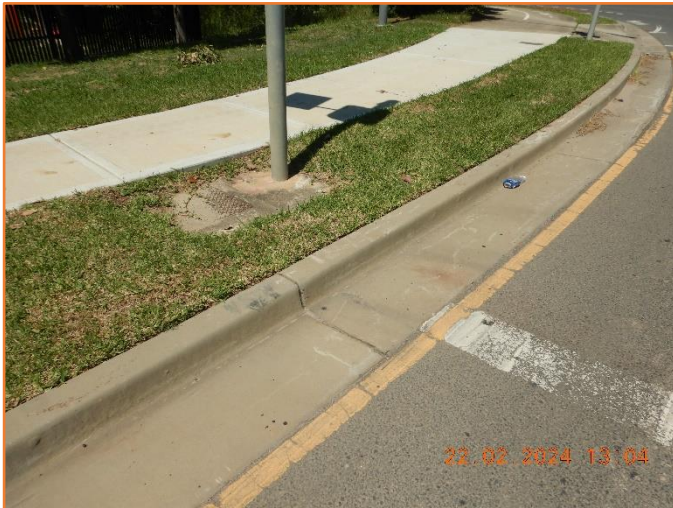
Figure 316: Reasonable - General condition of kerb and gutter.

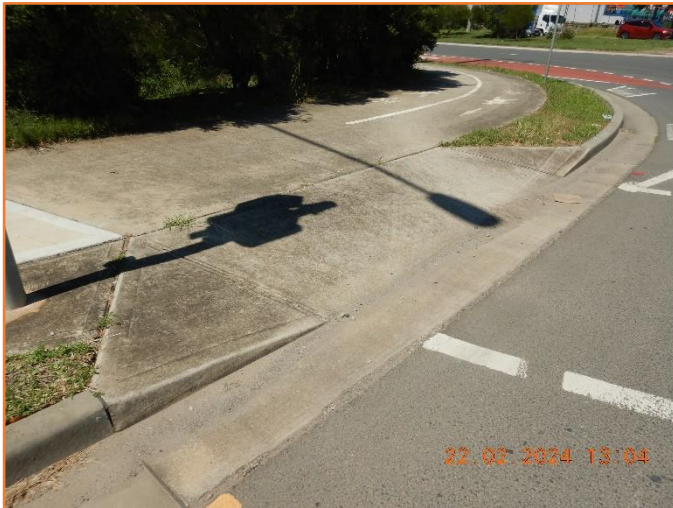
Figure 319: Reasonable - General condition of pram ramp.

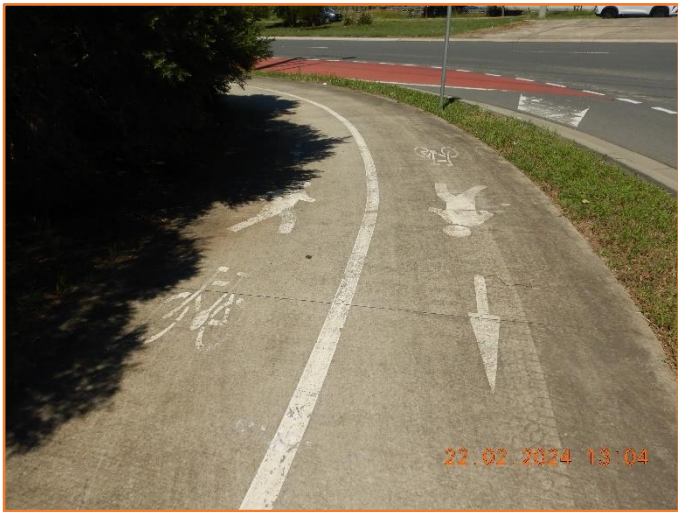
Figure 320: Reasonable - General condition of footpath.

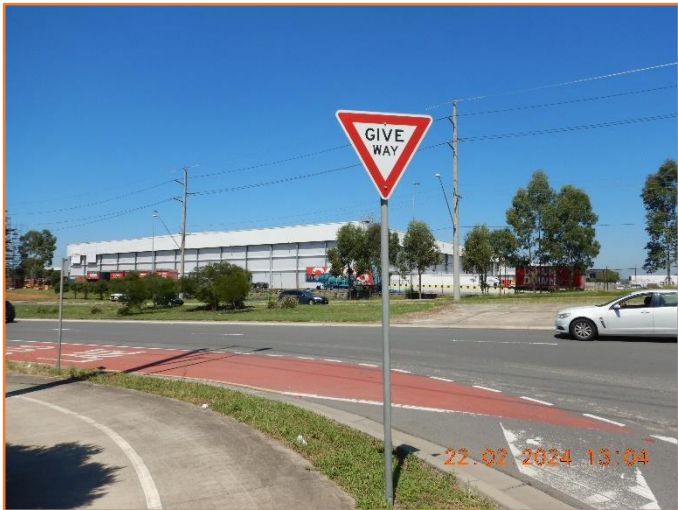
Figure 321: Good - General condition of traffic signage.

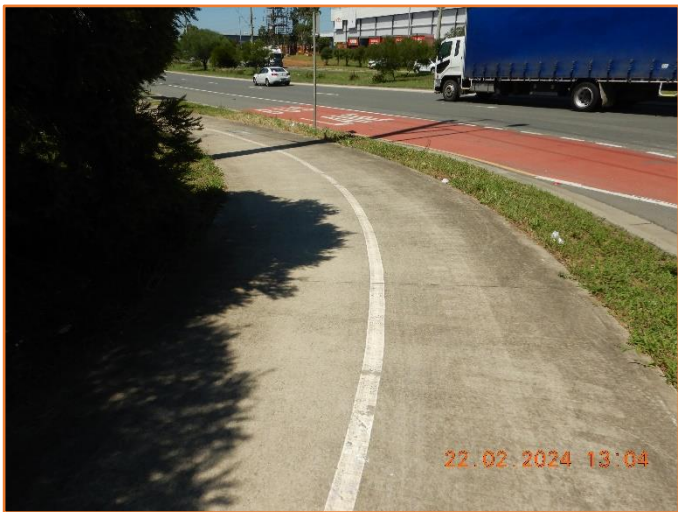
Figure 322: Reasonable - General condition of footpath.

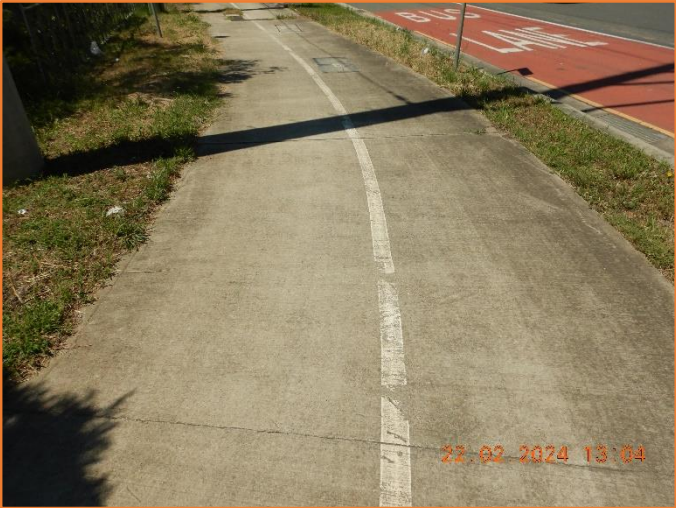
Figure 323: Reasonable - General condition of footpath.

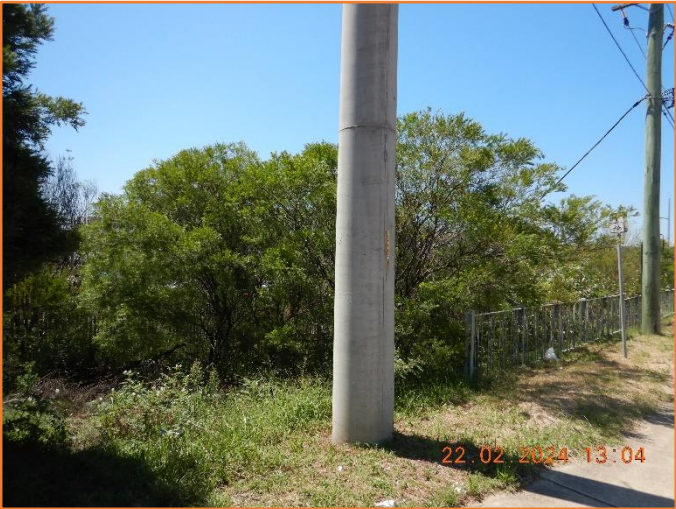
Figure 324: Good - General condition of monopole assembly.

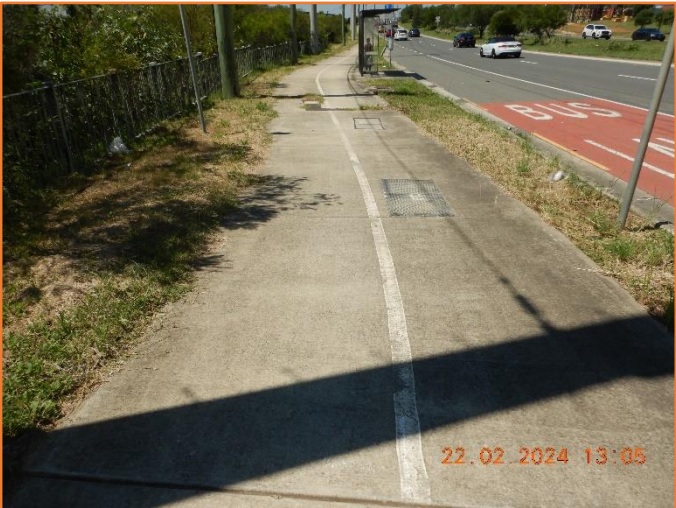
Figure 325: Reasonable - General condition of footpath.

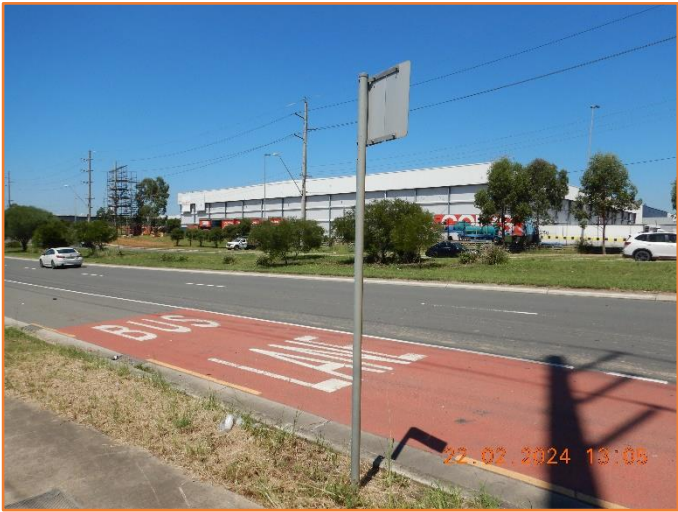
Figure 326: Good - General condition of traffic signage.

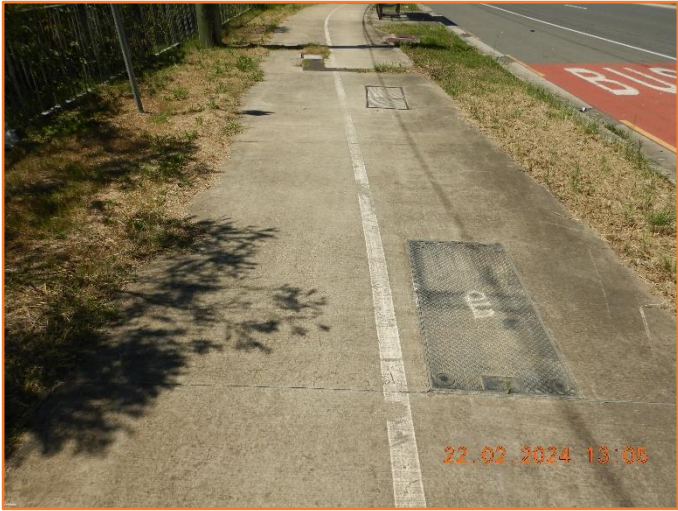
Figure 327: Reasonable - General condition of footpath and service pit.
