## DILAPIDATION REPORT

10 EASTERN CREEK DRIVE EASTERN CREEK, NSW, 2766

THURSDAY, 22 FEBRUARY 2024

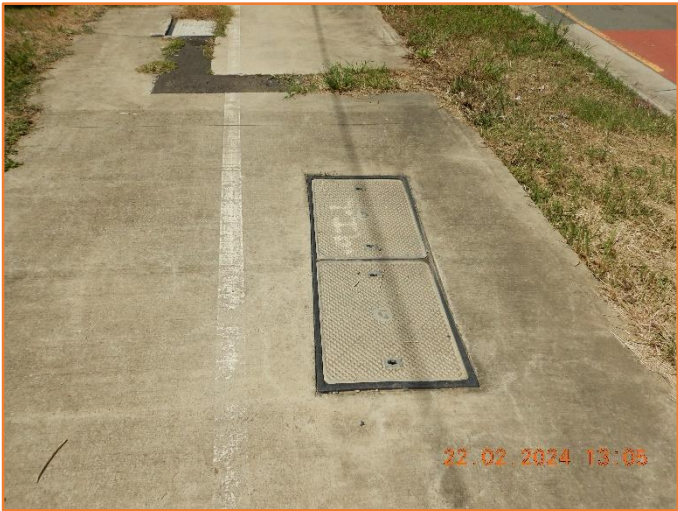
Figure 330: Reasonable - General condition of footpath and service pit.

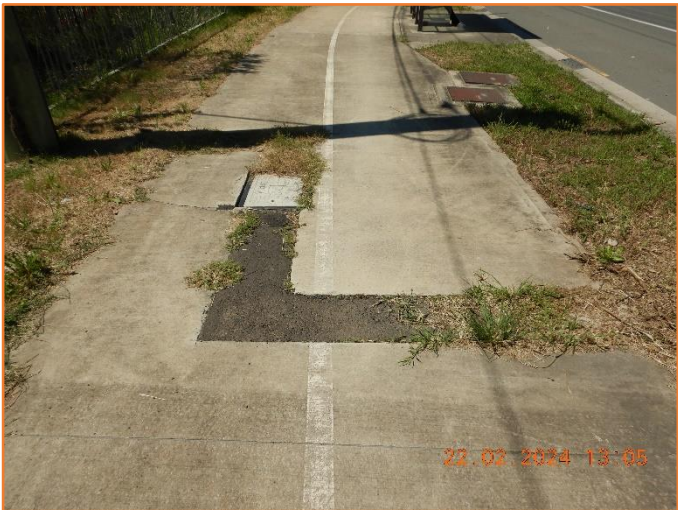
Figure 331: Poor - General condition of footpath. Previous repair works observed.

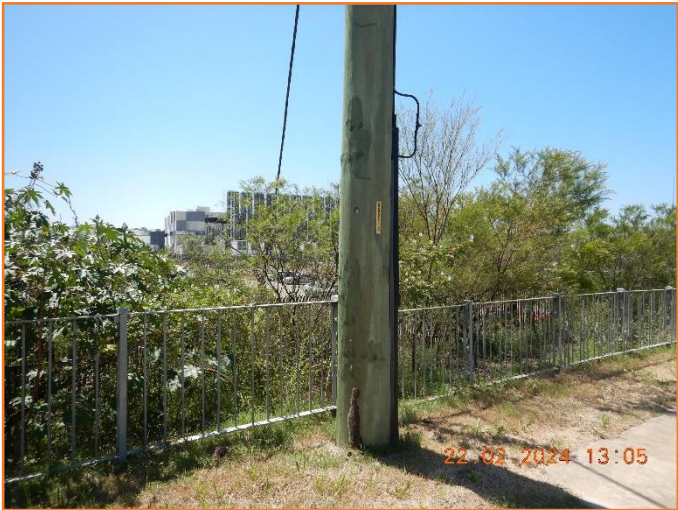
Figure 332: Reasonable - General condition of monopole assembly.

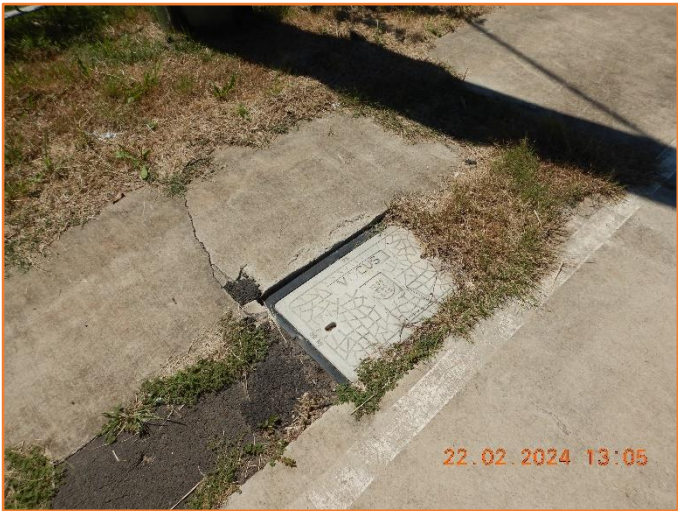
Figure 333: Poor - General condition of footpath and service pit. Moderate cracking observed.

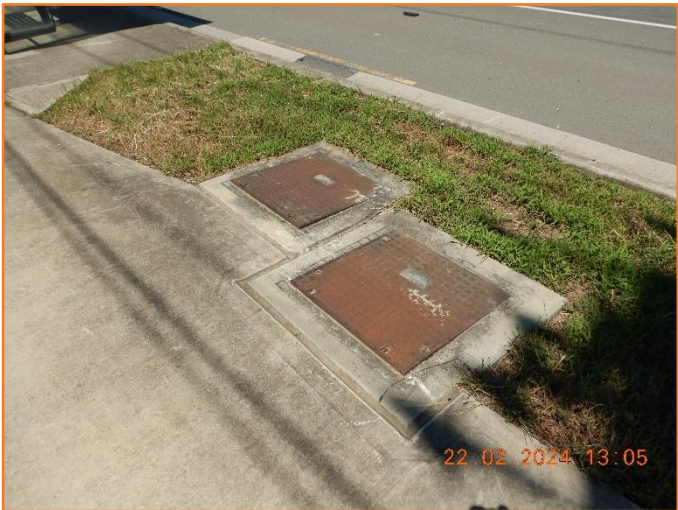
Figure 334: Reasonable - General condition of service pit.

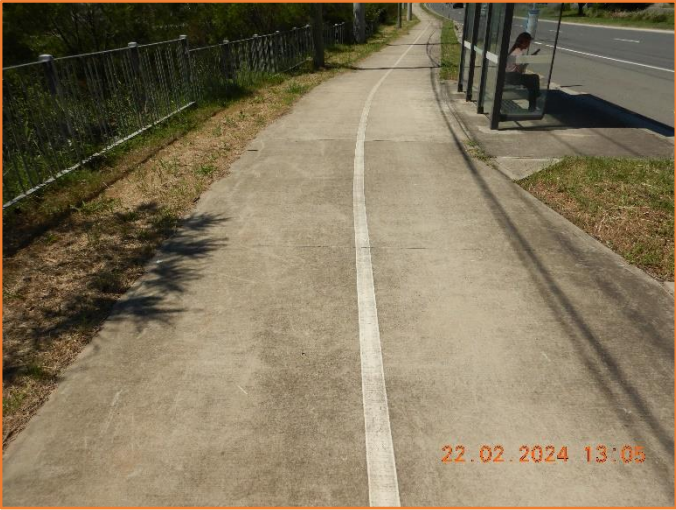
Figure 335: Reasonable - General condition of footpath.

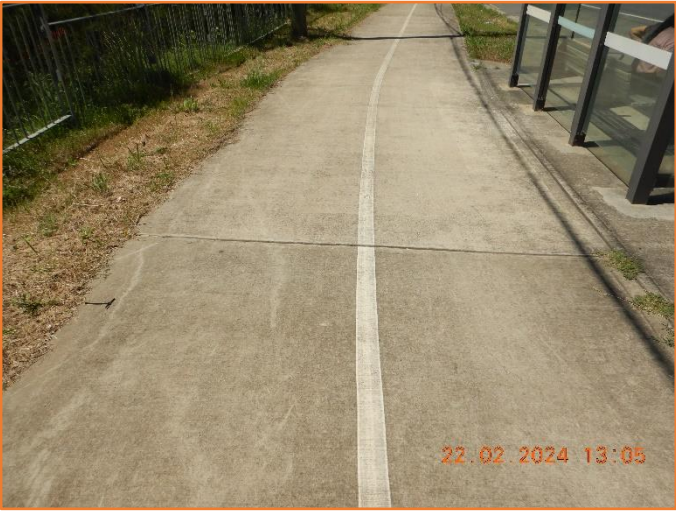
Figure 336: Reasonable - General condition of footpath.

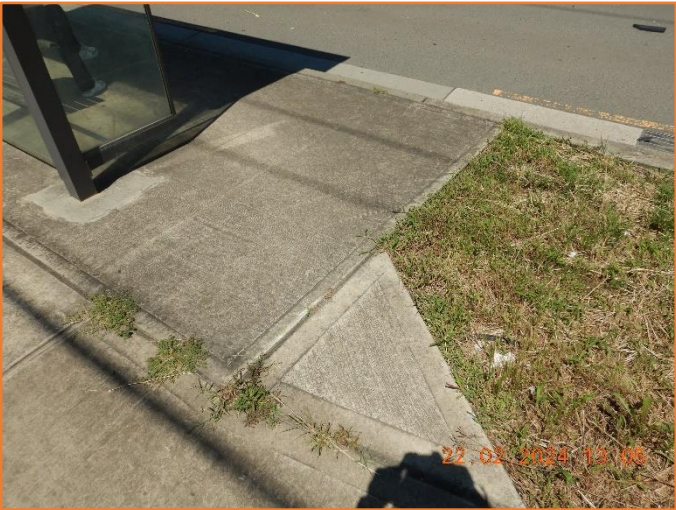
Figure 337: Reasonable - General condition of footpath.

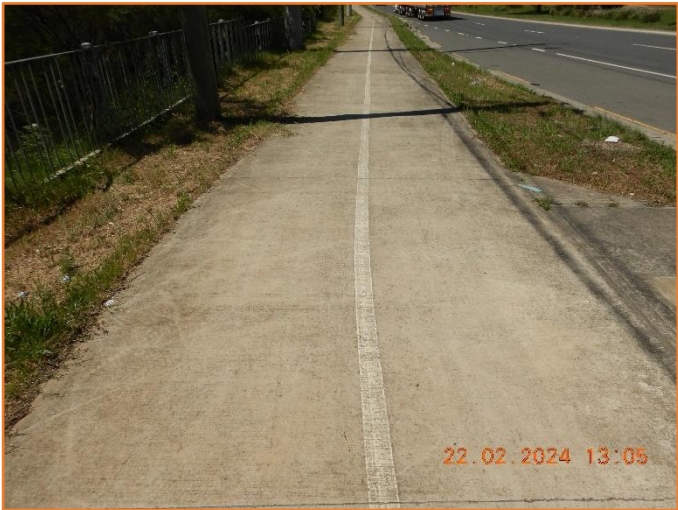
Figure 338: Reasonable - General condition of footpath.

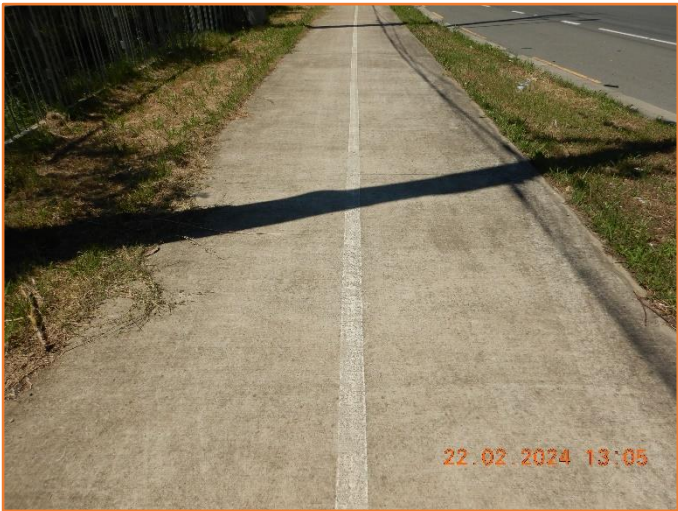
Figure 339: Reasonable - General condition of footpath.

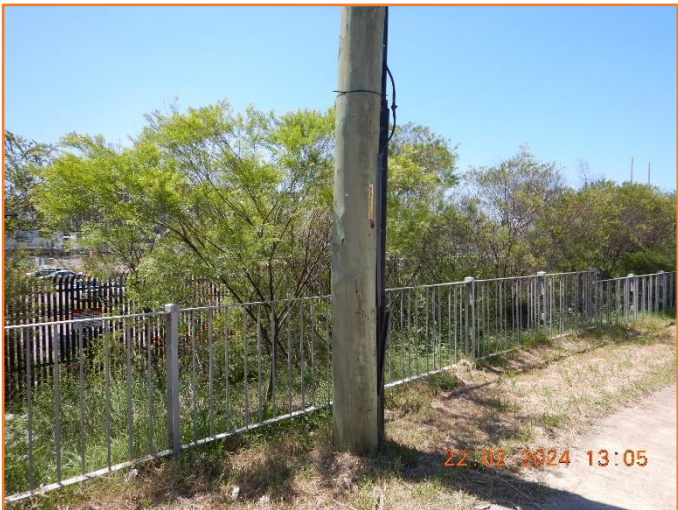
Figure 340: Reasonable - General condition of monopole assembly.

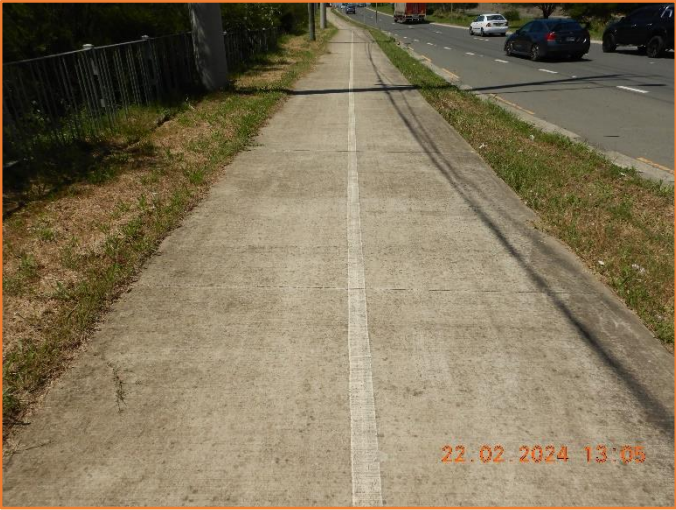
Figure 341: Reasonable - General condition of footpath.

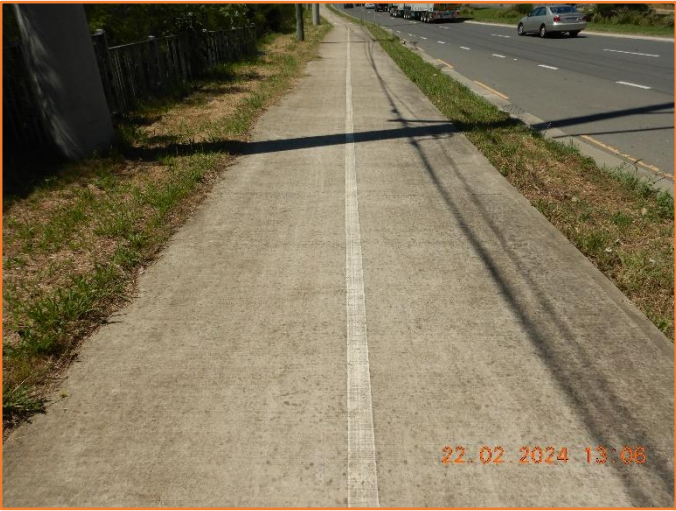
Figure 342: Reasonable - General condition of footpath.

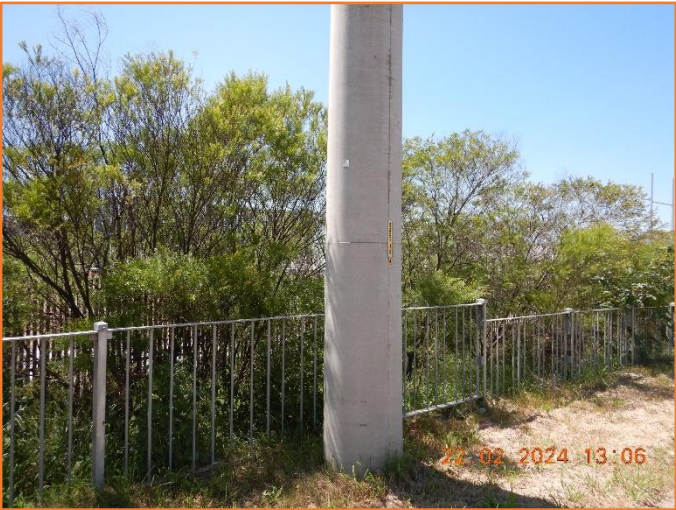
Figure 343: Good - General condition of monopole assembly.

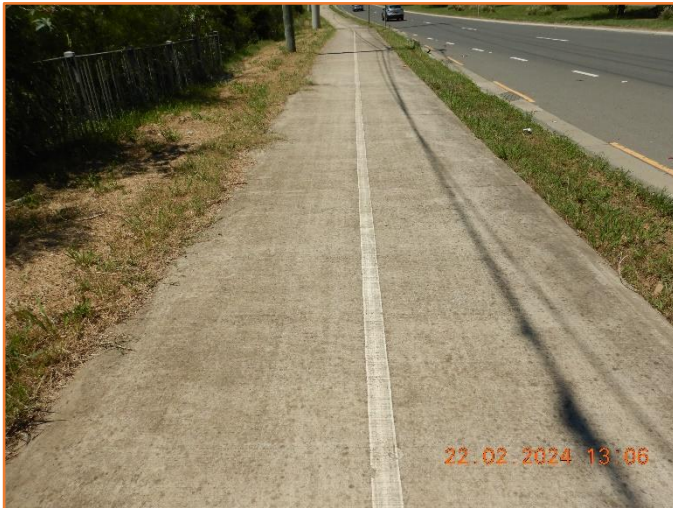
Figure 344: Reasonable - General condition of footpath.

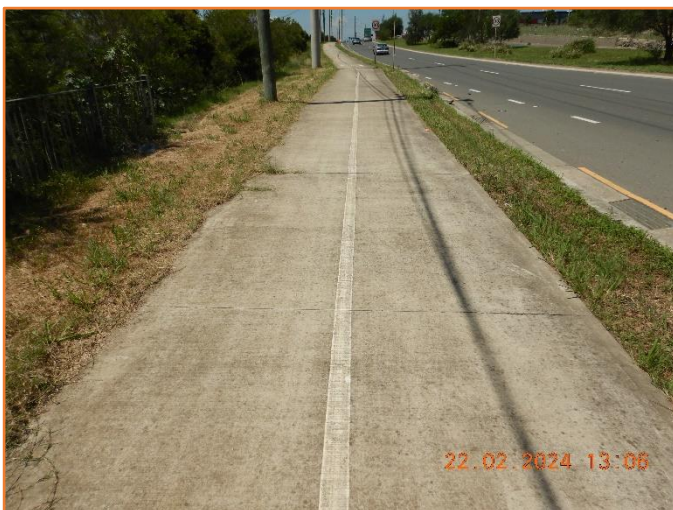
Figure 345: Reasonable - General condition of footpath.

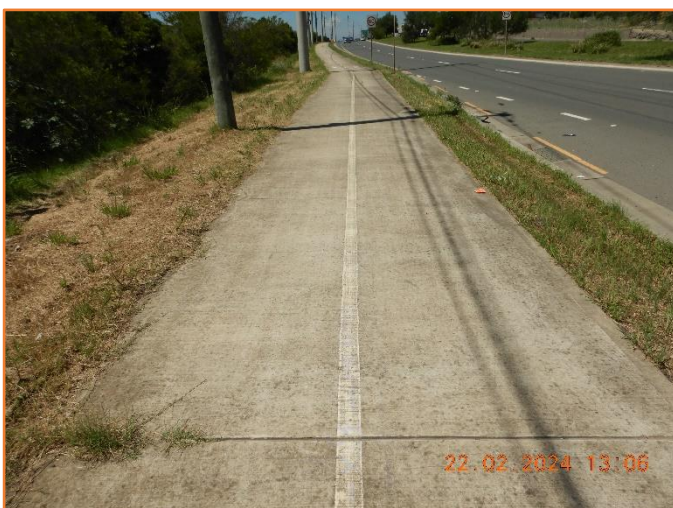
Figure 346: Reasonable - General condition of footpath.

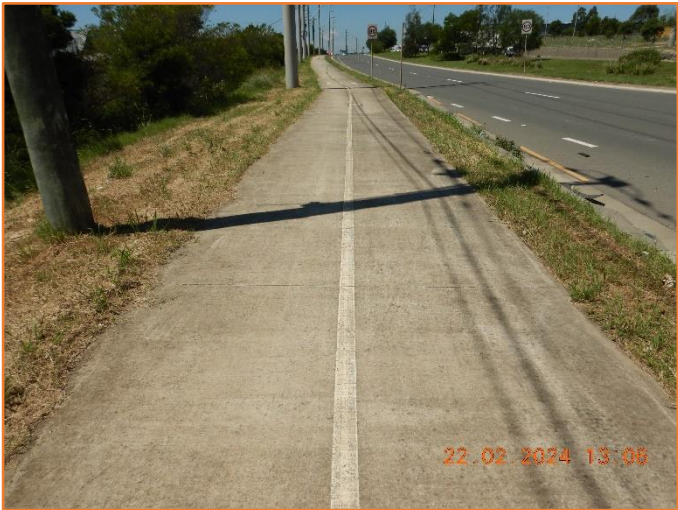
Figure 347: Reasonable - General condition of footpath.

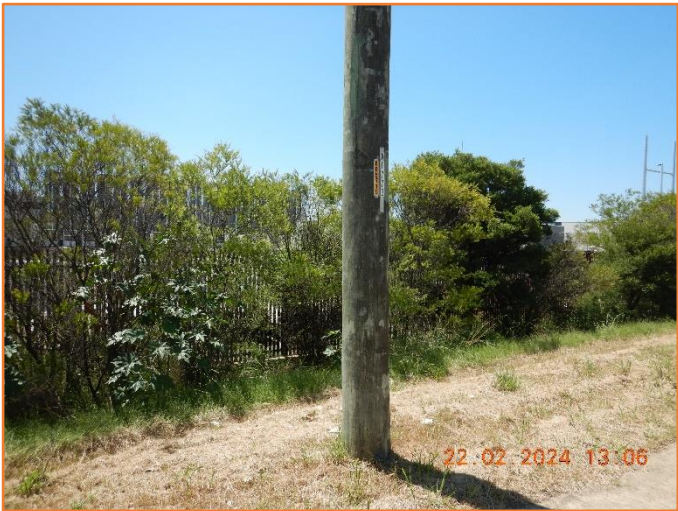
Figure 348: Reasonable - General condition of monopole assembly.

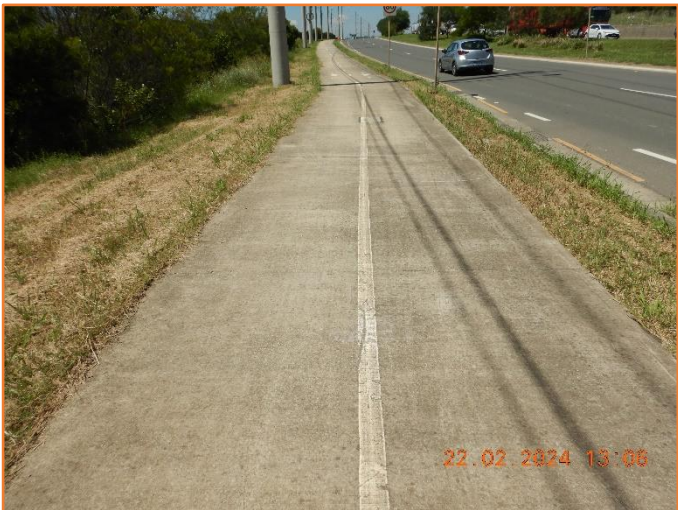
Figure 349: Reasonable - General condition of footpath.

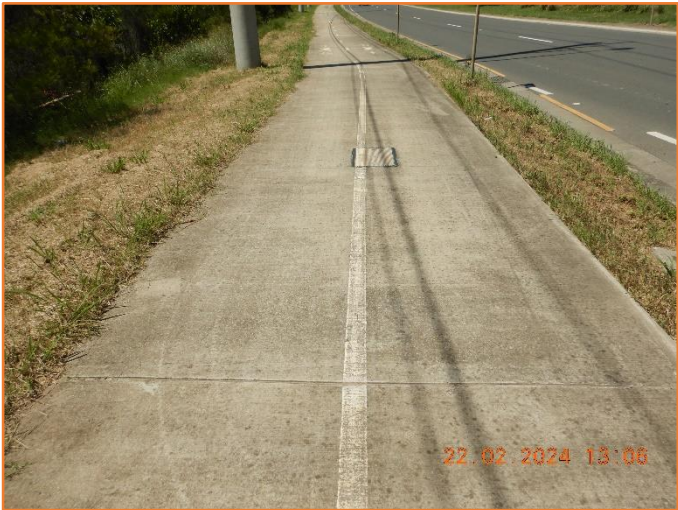
Figure 350: Reasonable - General condition of footpath.

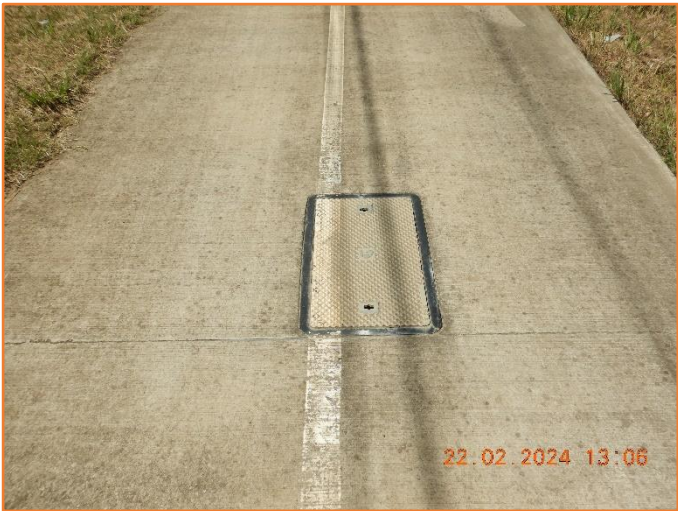
Figure 351: Reasonable - General condition of service pit.

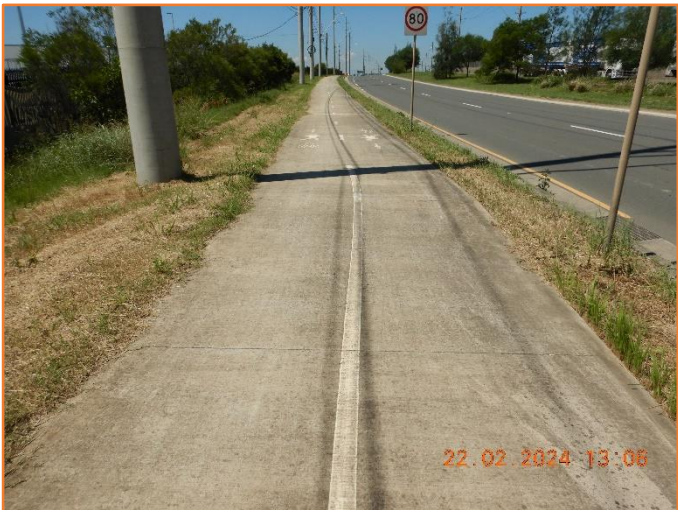
Figure 352: Reasonable - General condition of footpath.

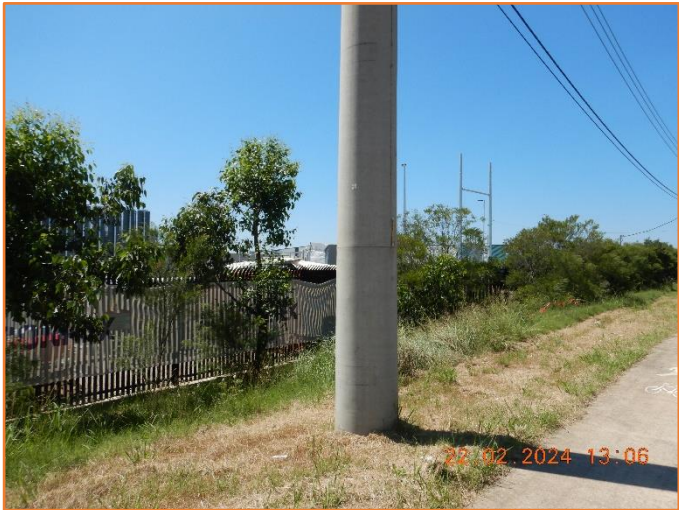
Figure 353: Good - General condition of monopole assembly.

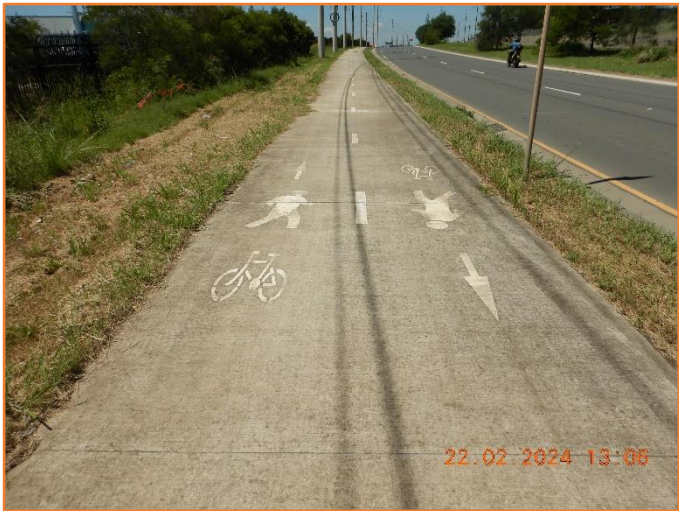
Figure 354: Reasonable - General condition of footpath.

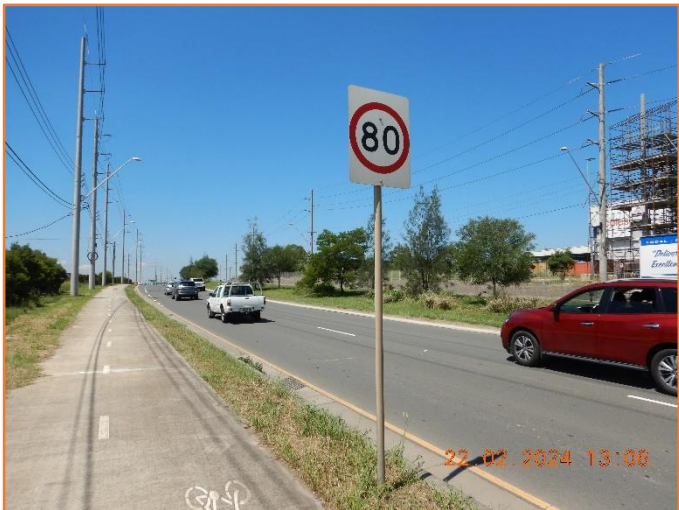
Figure 355: Good - General condition of traffic signage.

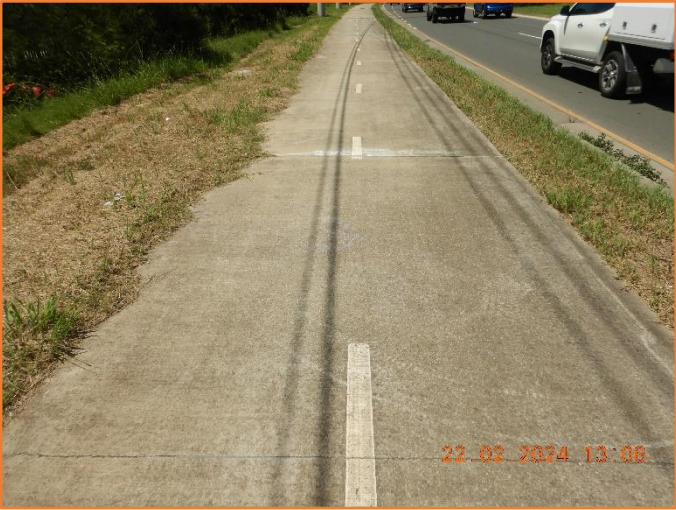
Figure 356: Reasonable - General condition of footpath.

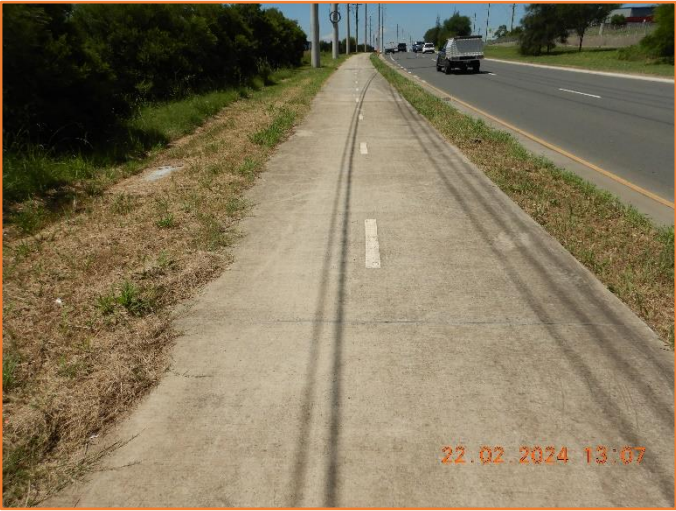
Figure 357: Reasonable - General condition of footpath.

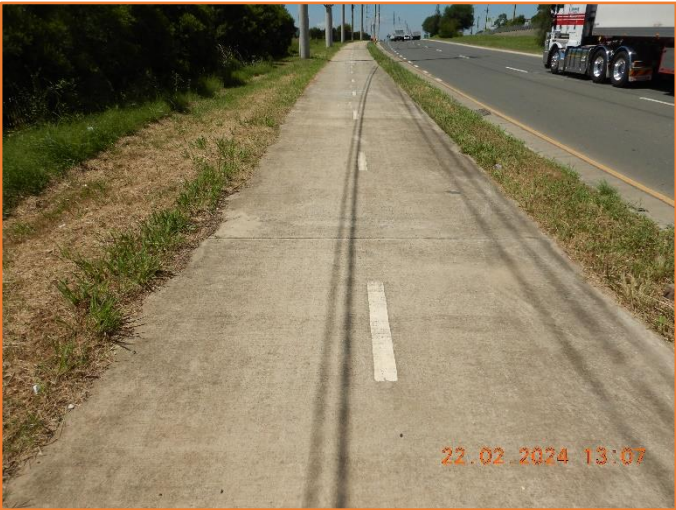
Figure 358: Reasonable - General condition of footpath.

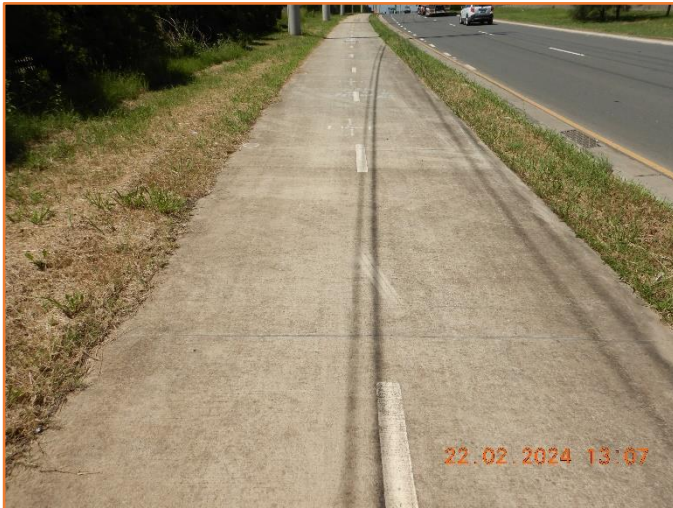
Figure 359: Reasonable - General condition of footpath.

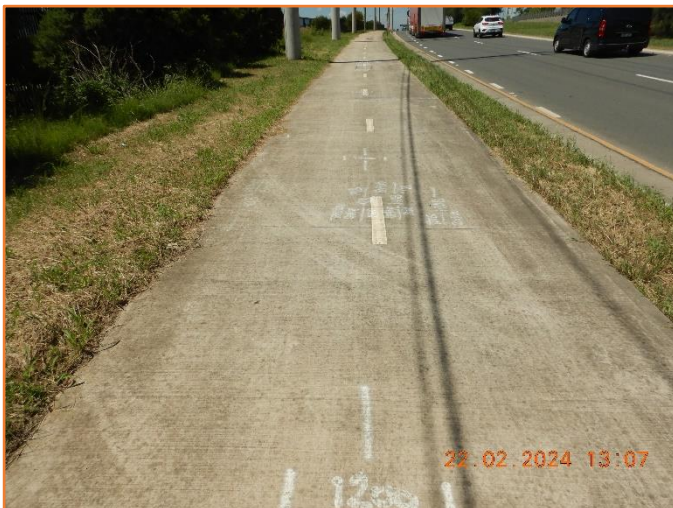
Figure 360: Reasonable - General condition of footpath.

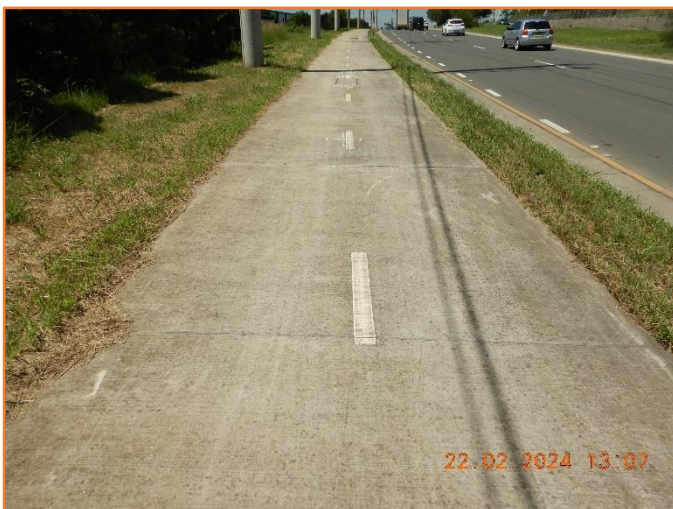
Figure 361: Reasonable - General condition of footpath.

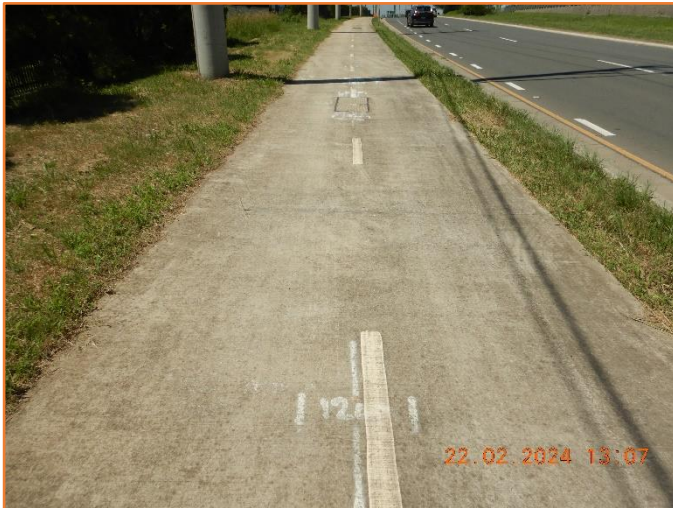
Figure 362: Reasonable - General condition of footpath.

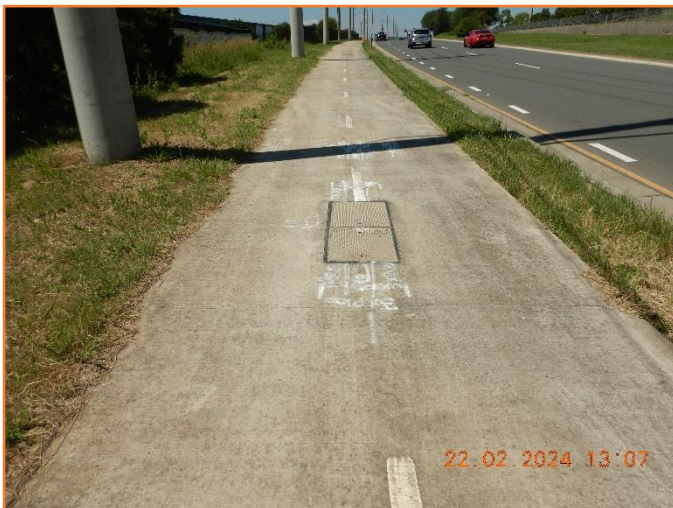
Figure 363: Reasonable - General condition of footpath.

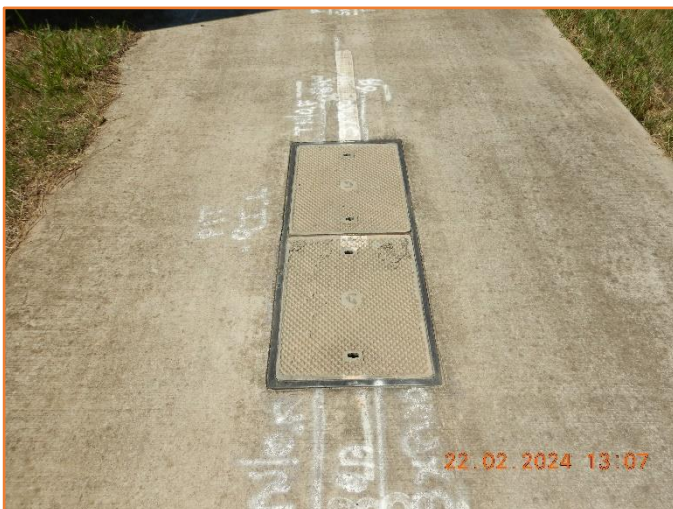
Figure 364: Reasonable - General condition of service pit.

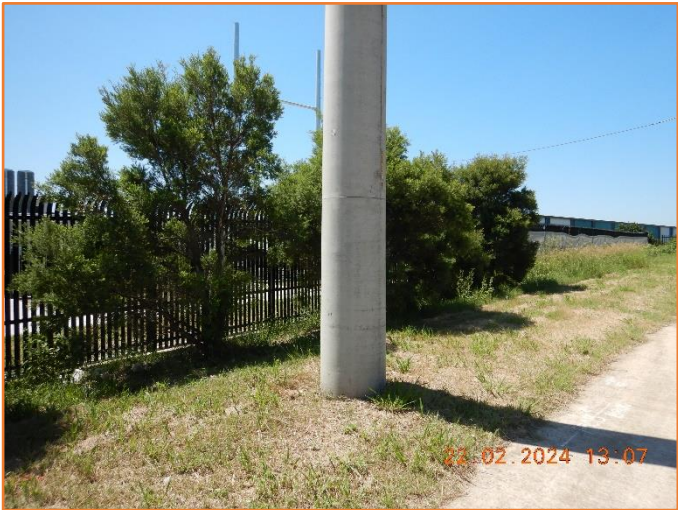
Figure 365: Good - General condition of monopole assembly.

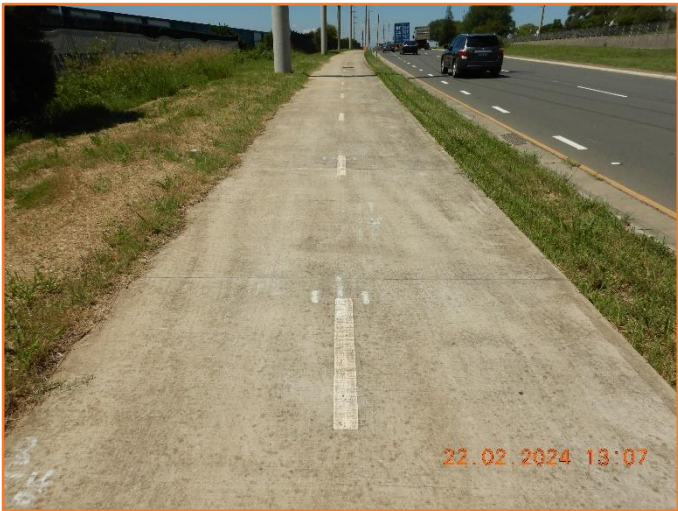
Figure 366: Reasonable - General condition of footpath.

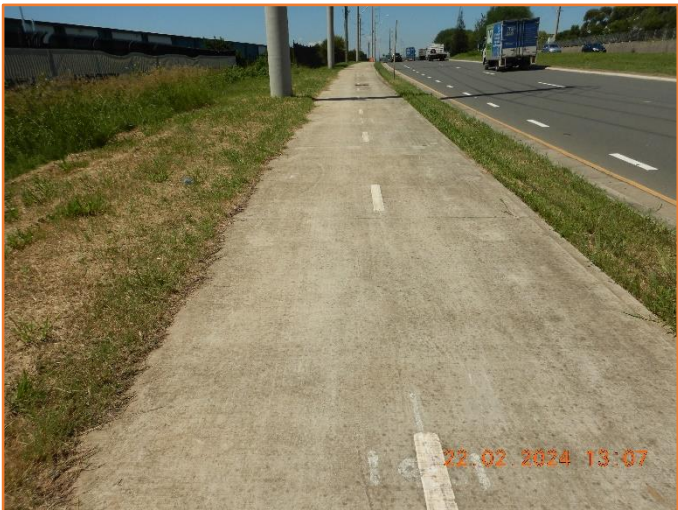
Figure 367: Reasonable - General condition of footpath.

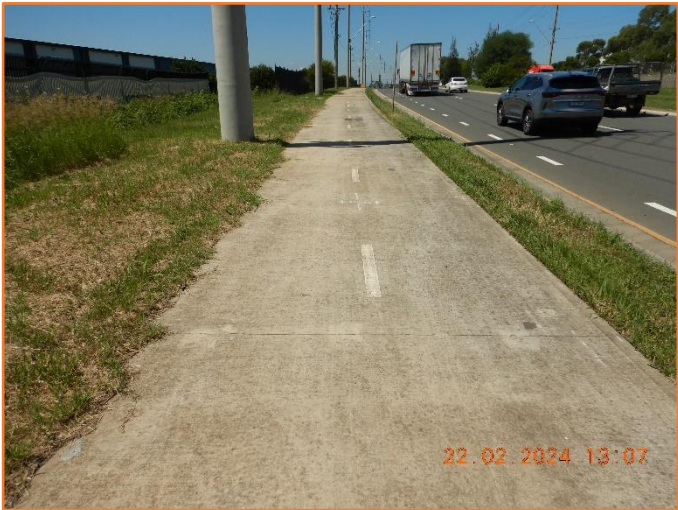
Figure 368: Reasonable - General condition of footpath.

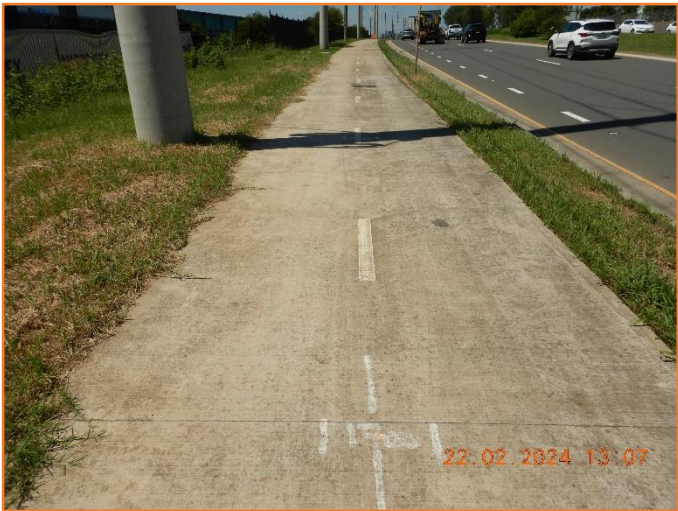
Figure 369: Reasonable - General condition of footpath.

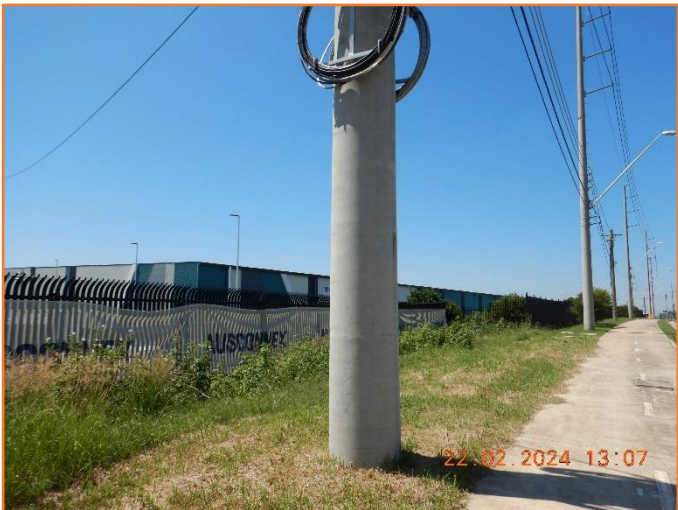
Figure 370: Good - General condition of monopole assembly.

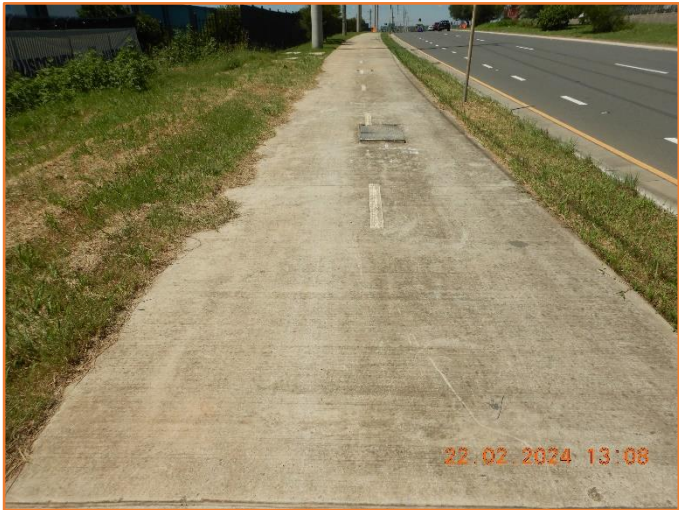
Figure 371: Reasonable - General condition of footpath.

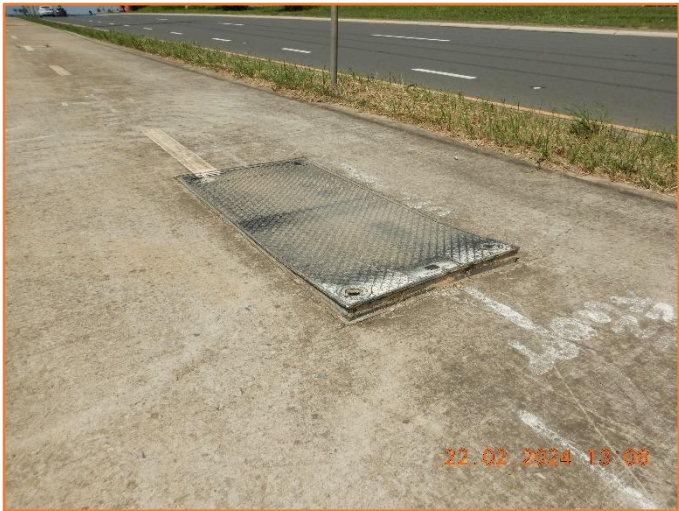
Figure 372: Poor - General condition of service pit. Moderate vertical displacement observed.

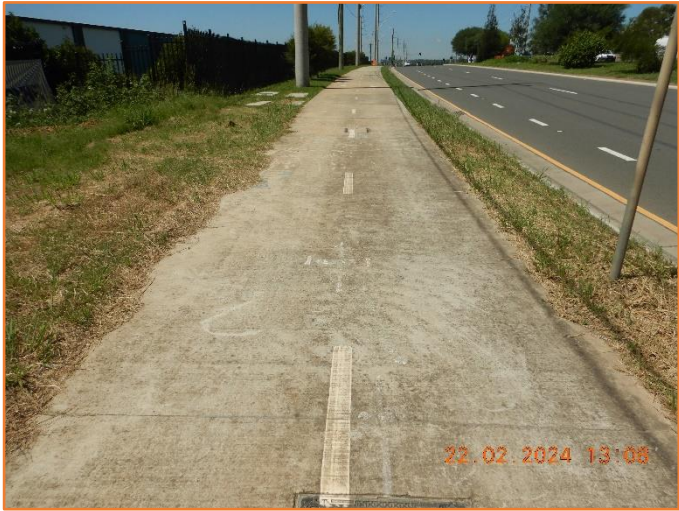
Figure 373: Reasonable - General condition of footpath.

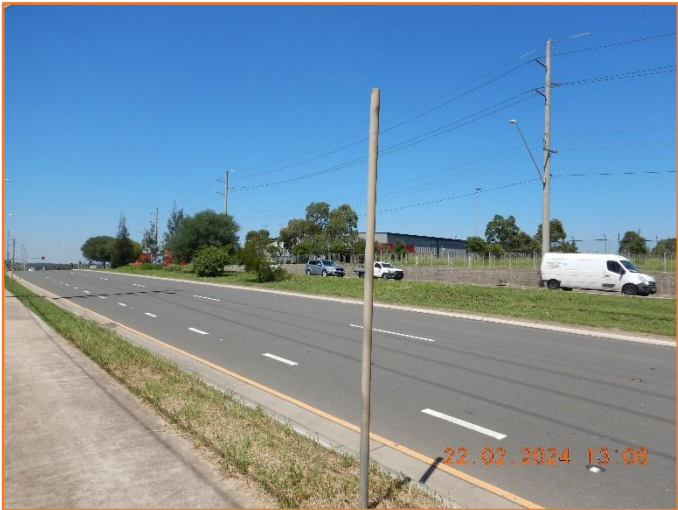
Figure 374: Defective - General condition of signage.

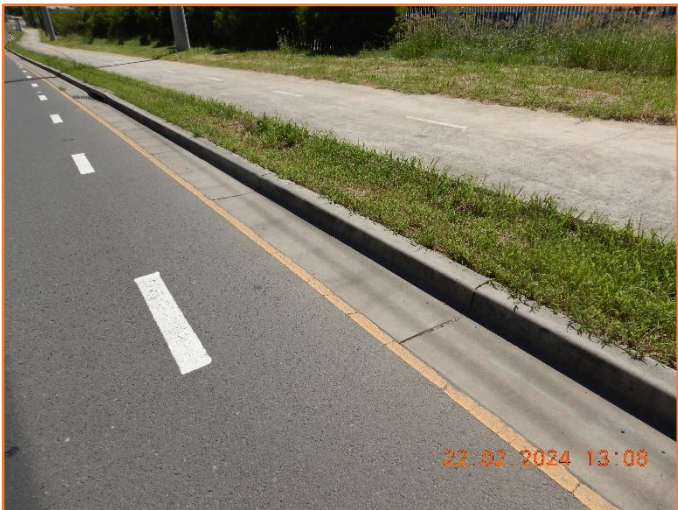
Figure 376: Reasonable - General condition of kerb and gutter.

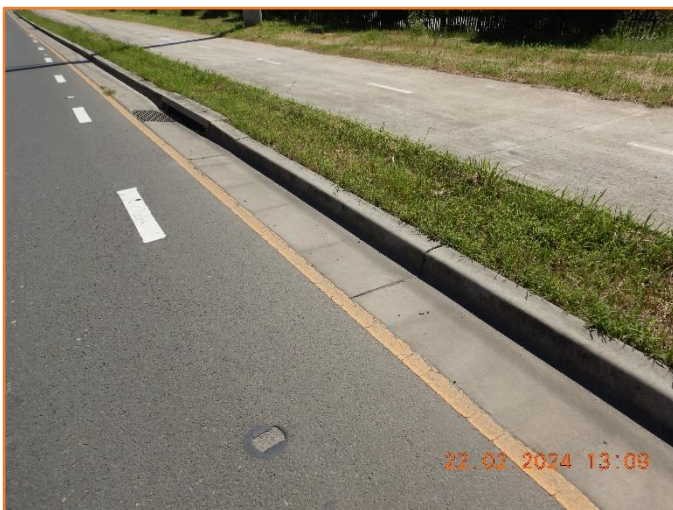
Figure 378: Reasonable - General condition of kerb and gutter.

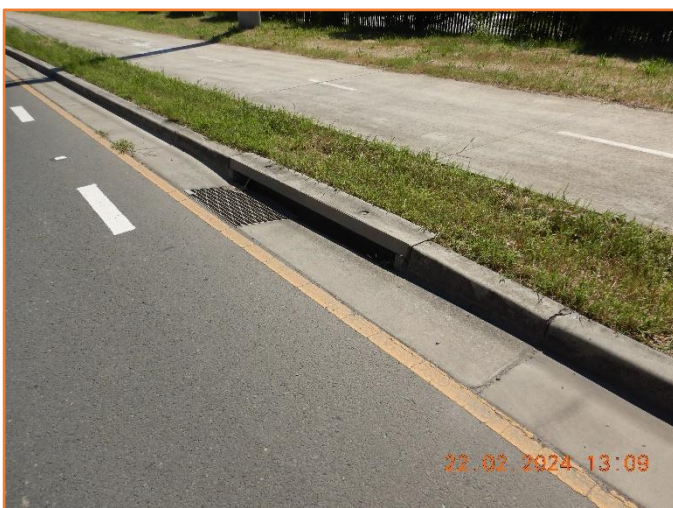
Figure 379: Reasonable - General condition of kerb inlet pit.

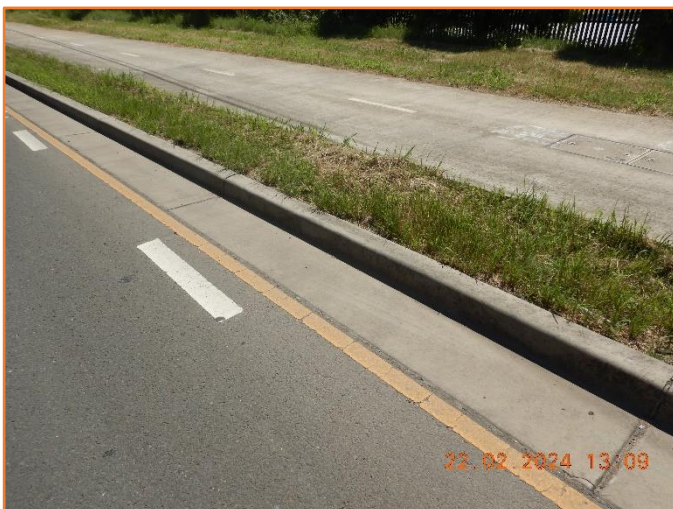
Figure 382: Reasonable - General condition of kerb and gutter.

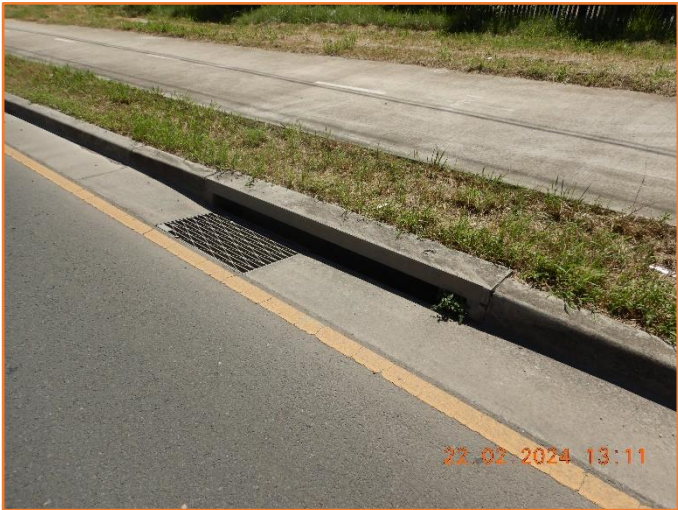
Figure 386: Reasonable - General condition of kerb inlet pit.

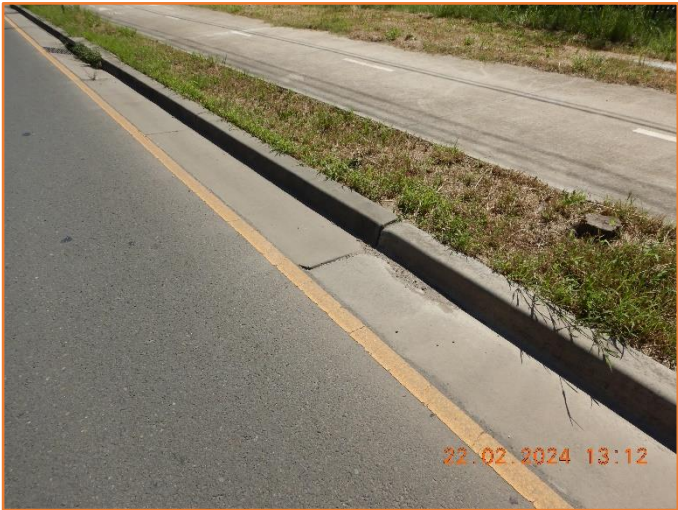
Figure 389: Reasonable - General condition of kerb and gutter.

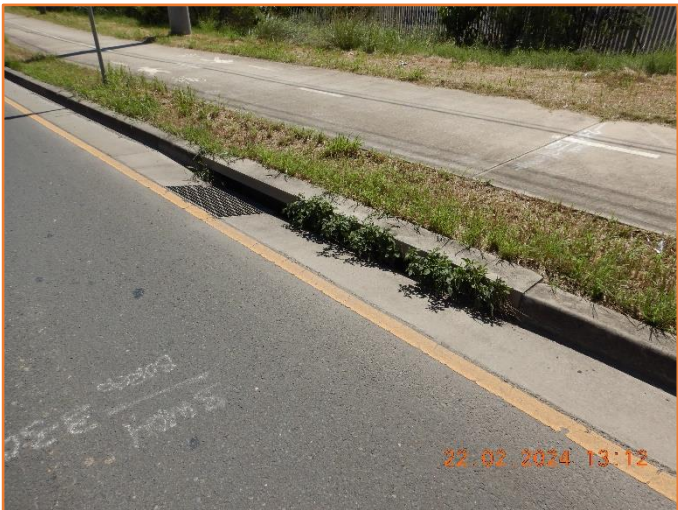
Figure 390: Reasonable - General condition of kerb and gutter.

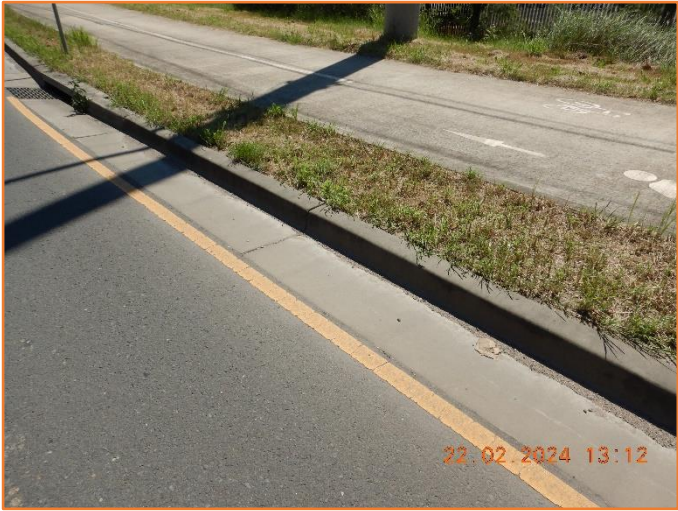
Figure 393: Reasonable - General condition of kerb and gutter.

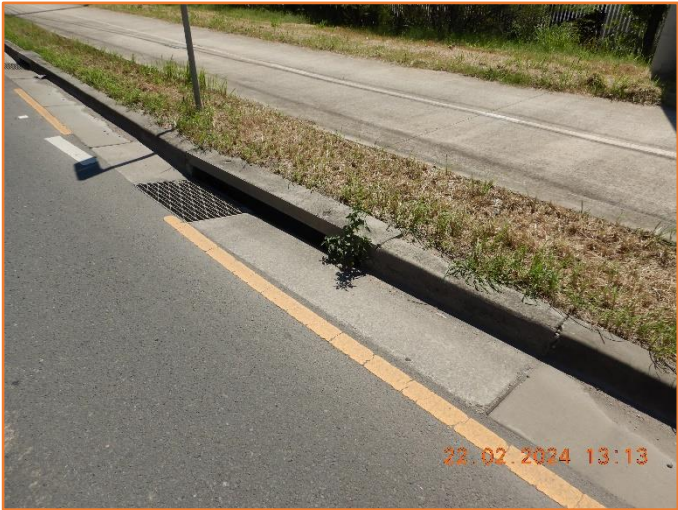
Figure 394: Reasonable - General condition of kerb inlet pit.

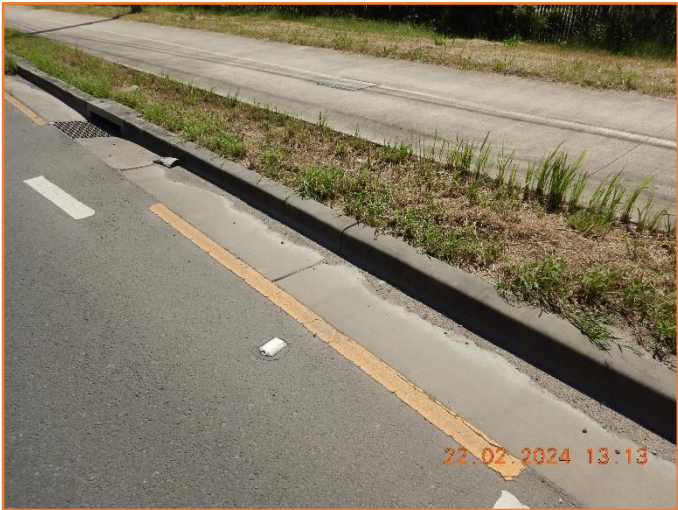
Figure 395: Reasonable - General condition of kerb and gutter.

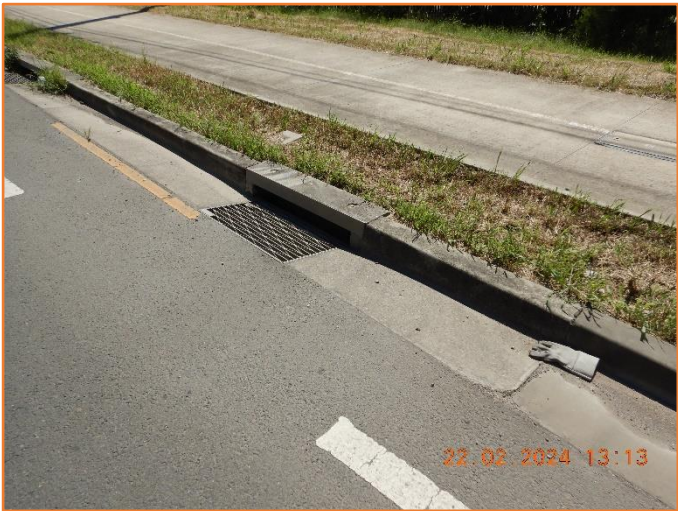
Figure 396: Reasonable - General condition of kerb inlet pit.

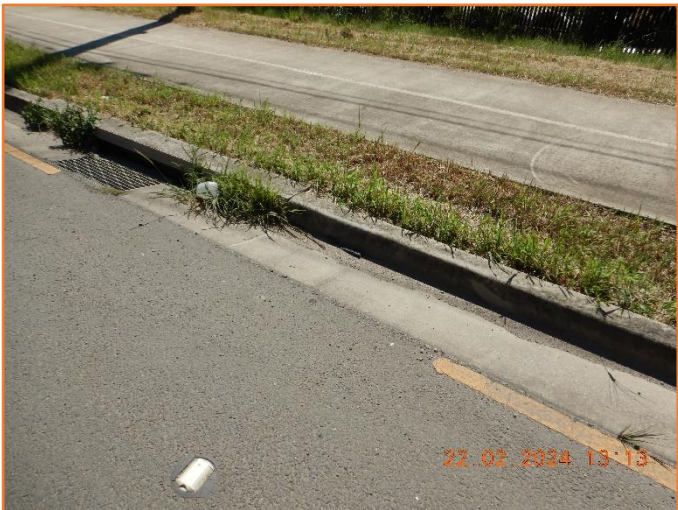
Figure 397: Reasonable - General condition of kerb and gutter.

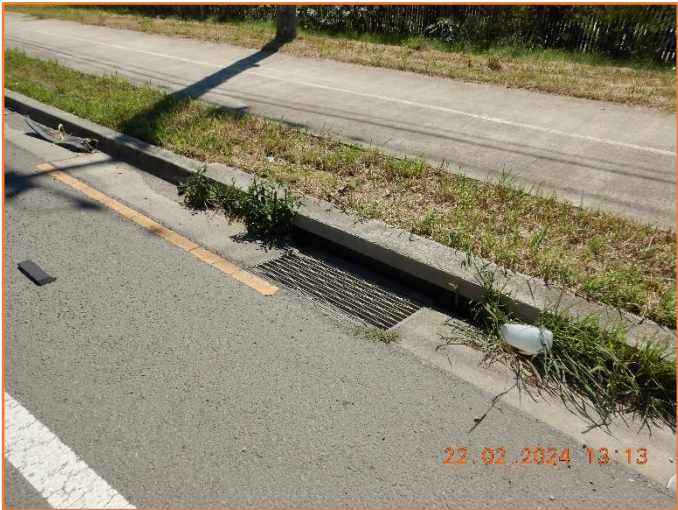
Figure 398: Reasonable - General condition of kerb inlet pit.

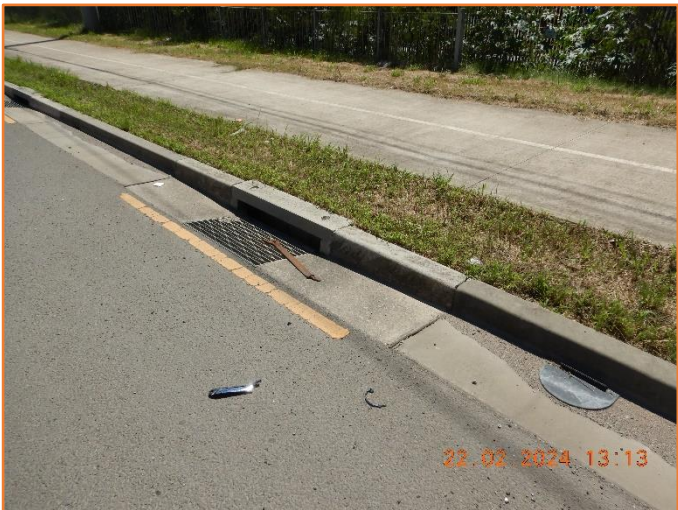
Figure 400: Reasonable - General condition of kerb and gutter and kerb inlet pit.

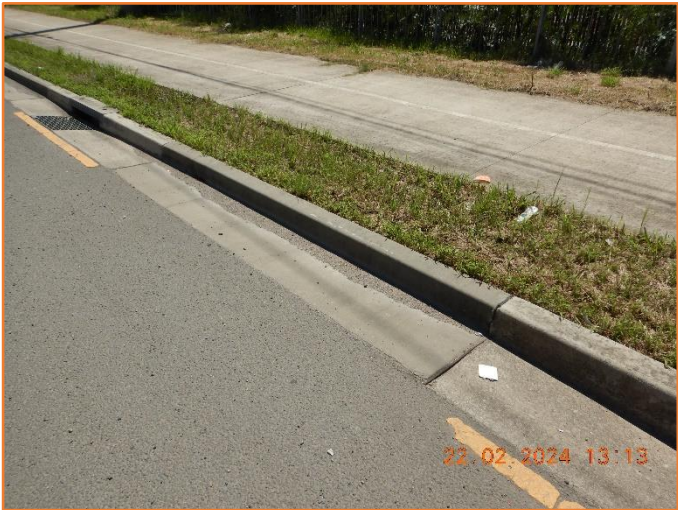
Figure 401: Reasonable - General condition of kerb and gutter.

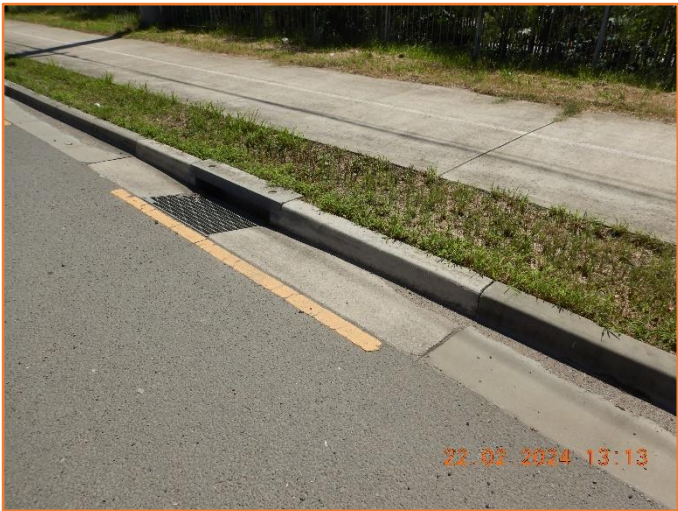
Figure 402: Reasonable - General condition of kerb and gutter and kerb inlet pit.

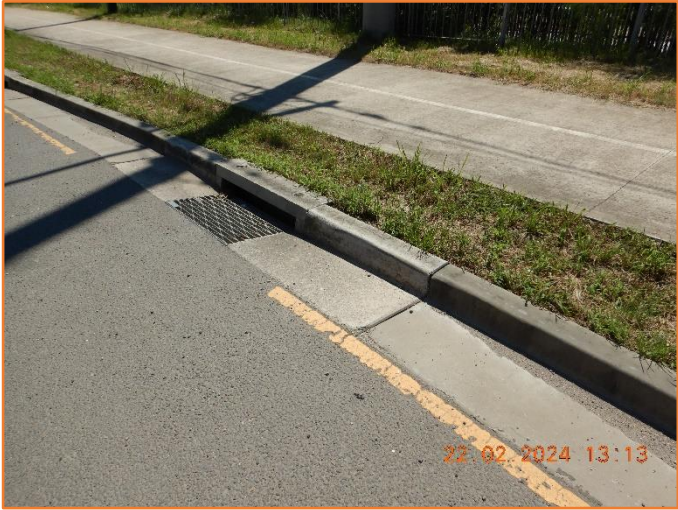
Figure 404: Reasonable - General condition of kerb and gutter and kerb inlet pit.

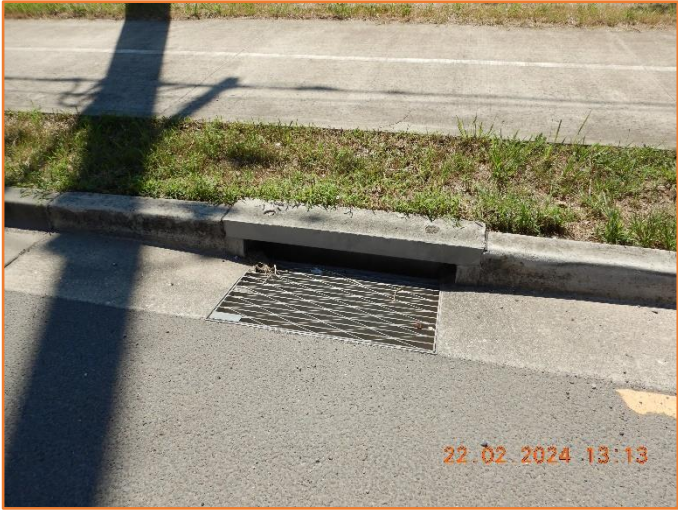
Figure 405: Reasonable - General condition of kerb inlet pit.

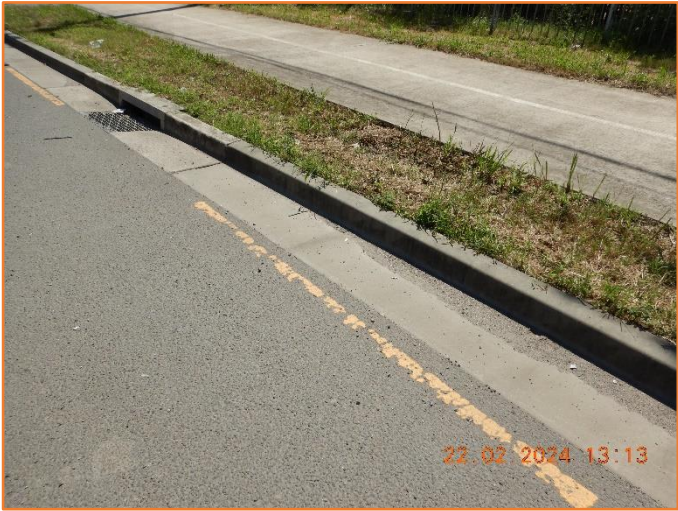
Figure 406: Reasonable - General condition of kerb and gutter.
